GREATER DUBLIN DRAINAGE PROJECT

ElAR Addendum Chapter 11A (Biodiversity (Terrestrial and Freshwater Aquatic))
Appendix A11.1 Terrestrial Baseline Survey Report

IE000258
S4P01
October 2023

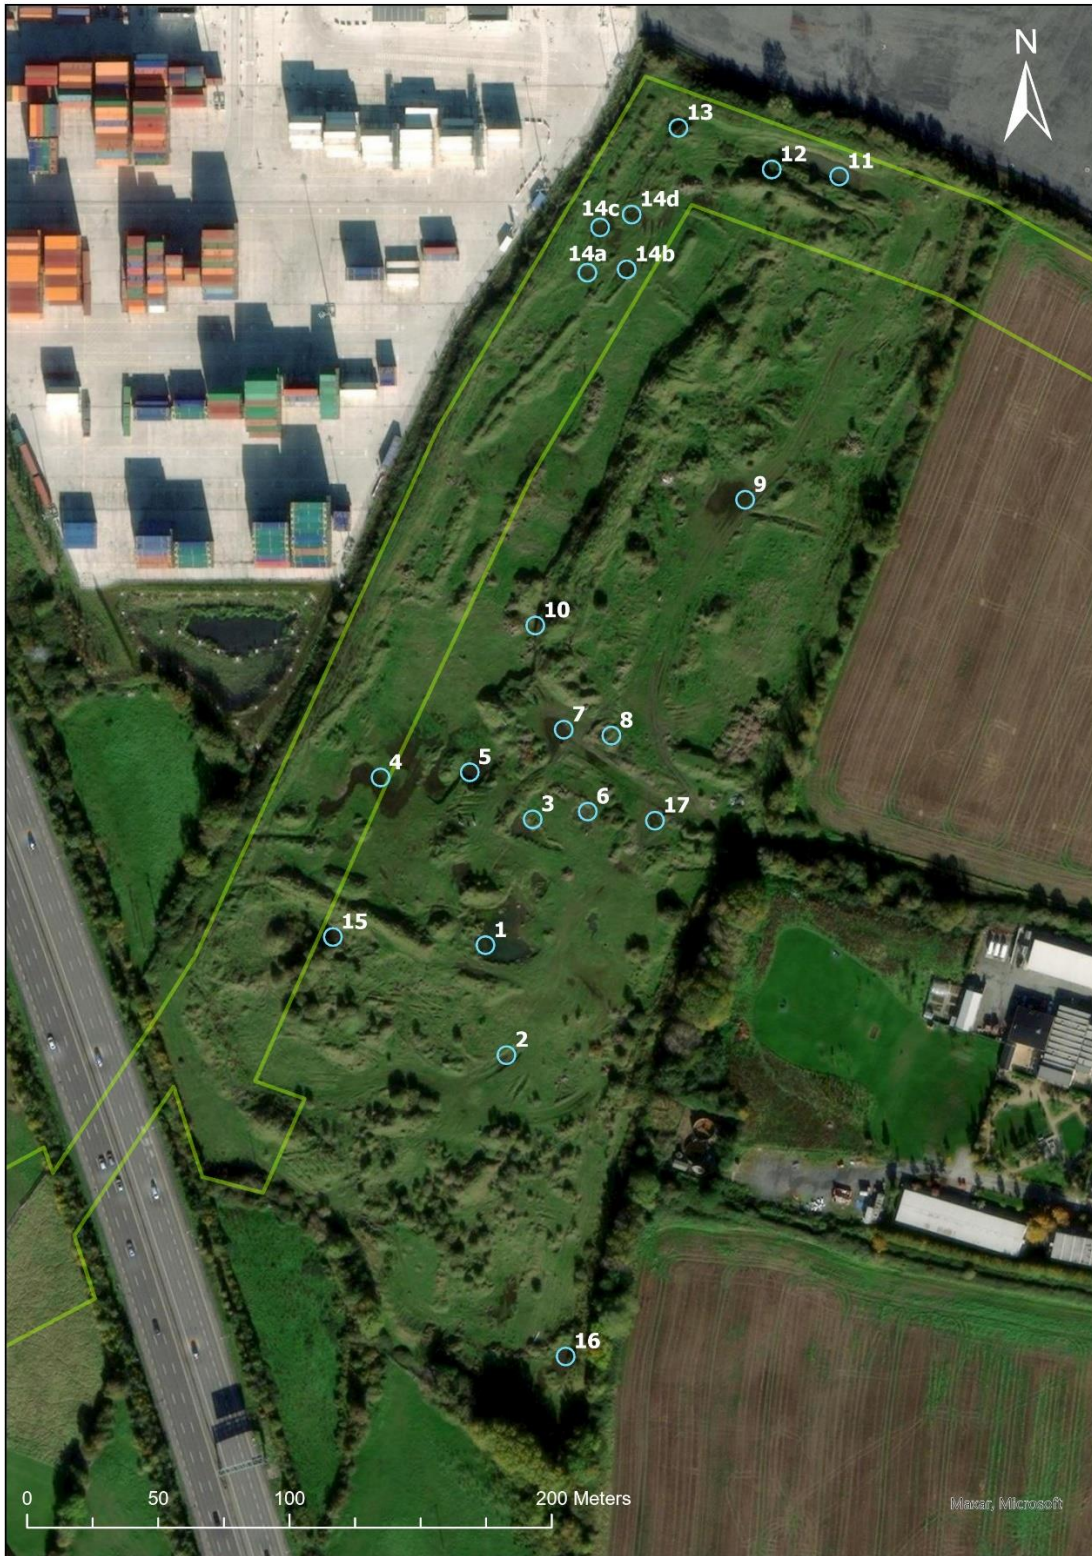
Figure 3.2: Site 1 waterbodies and indication of proposed wayleave

The site (circa 8.8ha) (**Figure 3.2**) consists entirely of worked spoil and rubble presumably all from nearby road development. The site best resembles the habitat 'Recolonising bare ground (ED3)' described in Fossitt (2000). Many hollows and/or depressions created by these works have evolved into permanent and seasonal waterbodies, some with established flora including emergent, floating, and submerged macrophytes as well as a diverse array of freshwater invertebrate species. Photos of each of the individual waterbodies described below are found in the 2015 survey report (RPS, 2015).

In 2023, a number of additional water-filled depressions or pools were noted in the vicinity of waterbody 14. As such, waterbody 14 was transposed into four broadly separate waterbodies namely 14a, 14b, 14c and 14d. An additional water-filled depression namely waterbody 17 was also noted and subject to survey. The

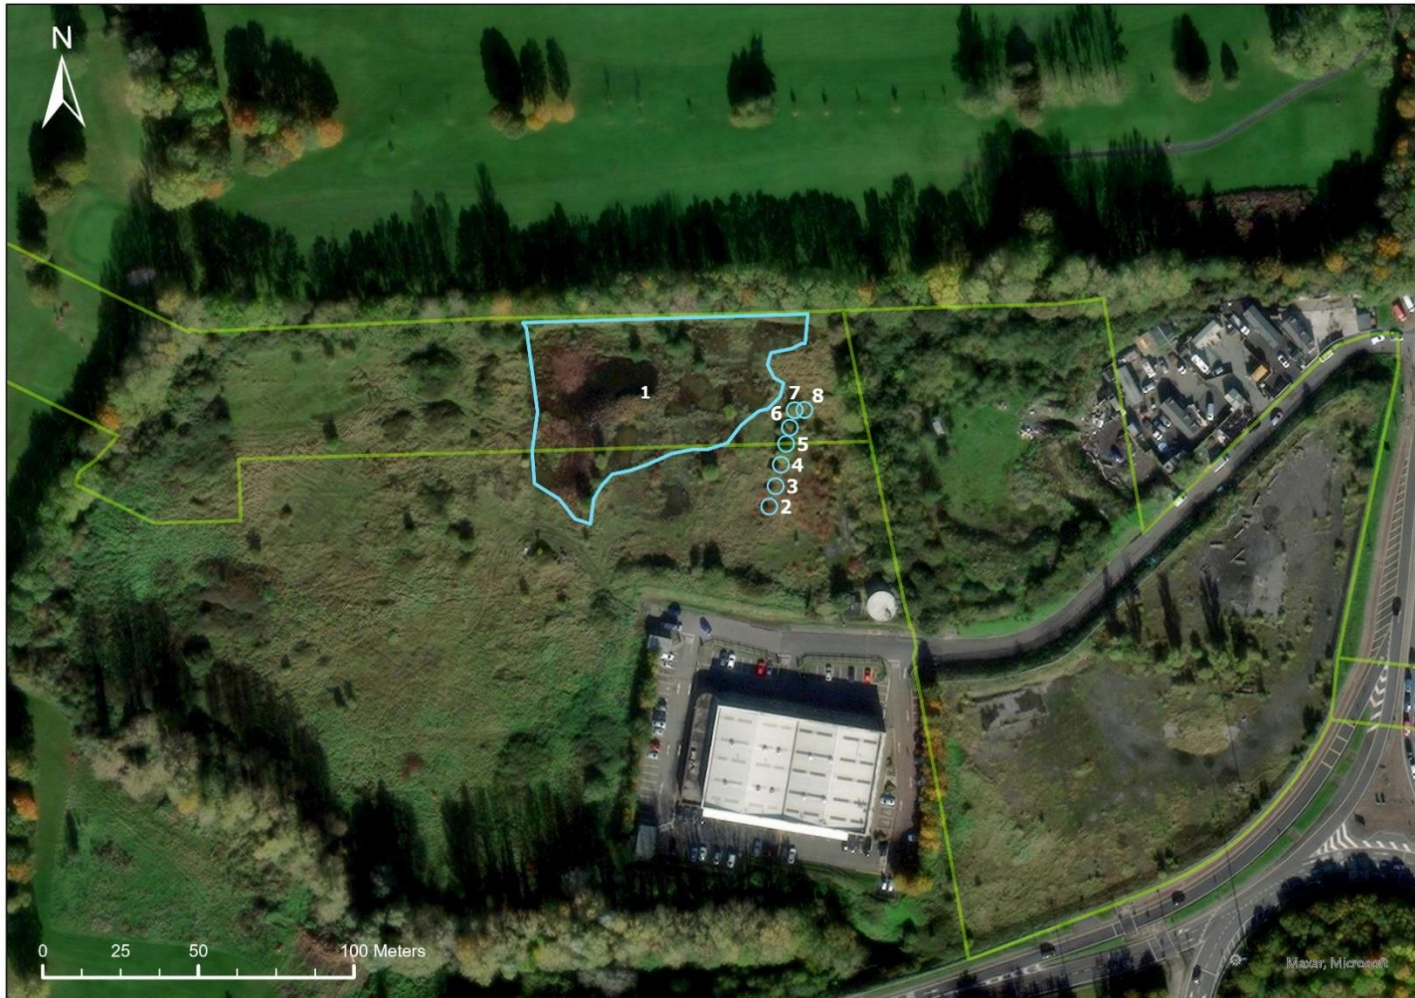
Figure 3.3: Site 2 waterbodies and indication of proposed wayleave

This site (**Figure 3.3**) has similarities with Site 1. These ponds have also evolved from past disturbance / construction works on what is now an abandoned site. Construction had begun on a large structure here, but these works were abandoned. These consist of foundations with steel mesh and concrete. The main pond (Waterbody 1) is more accurately a series of interconnected pools and deeper ponds. The other 7 ponds are an alignment of foundation works with only seasonal water.

The habitat was formerly recolonising bare ground (ED3) but is now a grassland. There is no active management. The site was found to be negative for the presence of smooth newt (torchlight and netting) in 2015, 2017 and 2021. Photos of each of the individual waterbodies described below are found in the 2015 survey report.

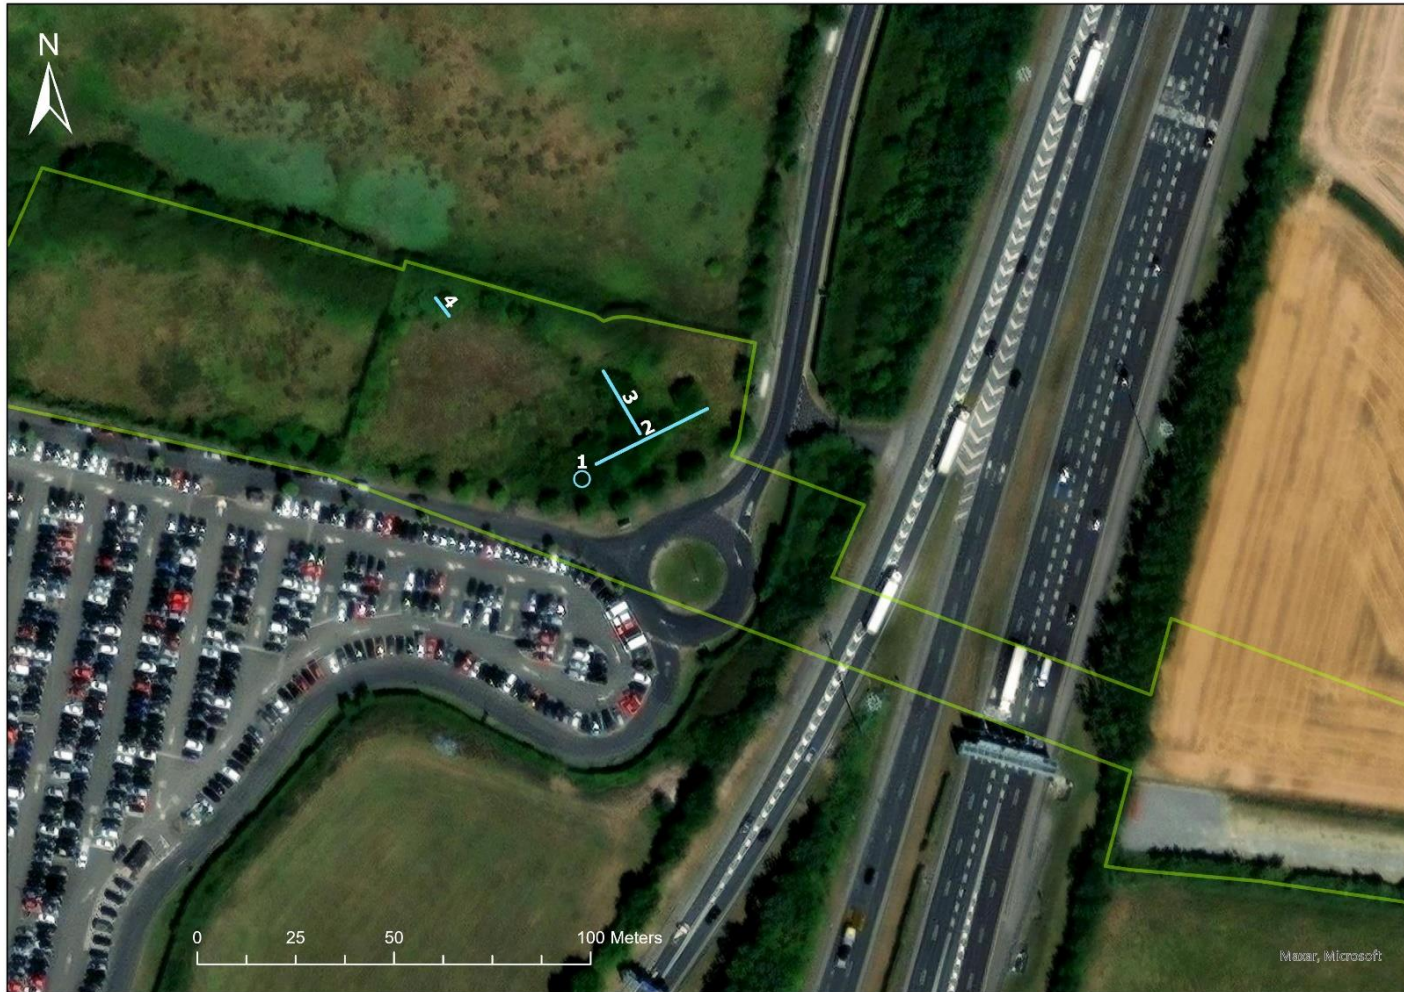
Figure 3.4: Site 3 waterbodies and indication of proposed wayleave

This enclosed site (**Figure 3.4**) is a Surface Water Monitoring Location adjacent to the long stay (Red) car park at Dublin Airport, east of Dardistown Cemetery. It consisted of a small pool beneath some willows along with 3 drainage ditches. The drainage ditches were already heavily vegetated since the initial 2015 survey.

In 2015, the wider habitat was described as recolonising bare ground (ED3) but it is now well vegetated. The site is disadvantaged by its proximity to large carpark along with road and motorway to the south and east. Previous surveys noted evidence of hydrocarbons on water surfaces.

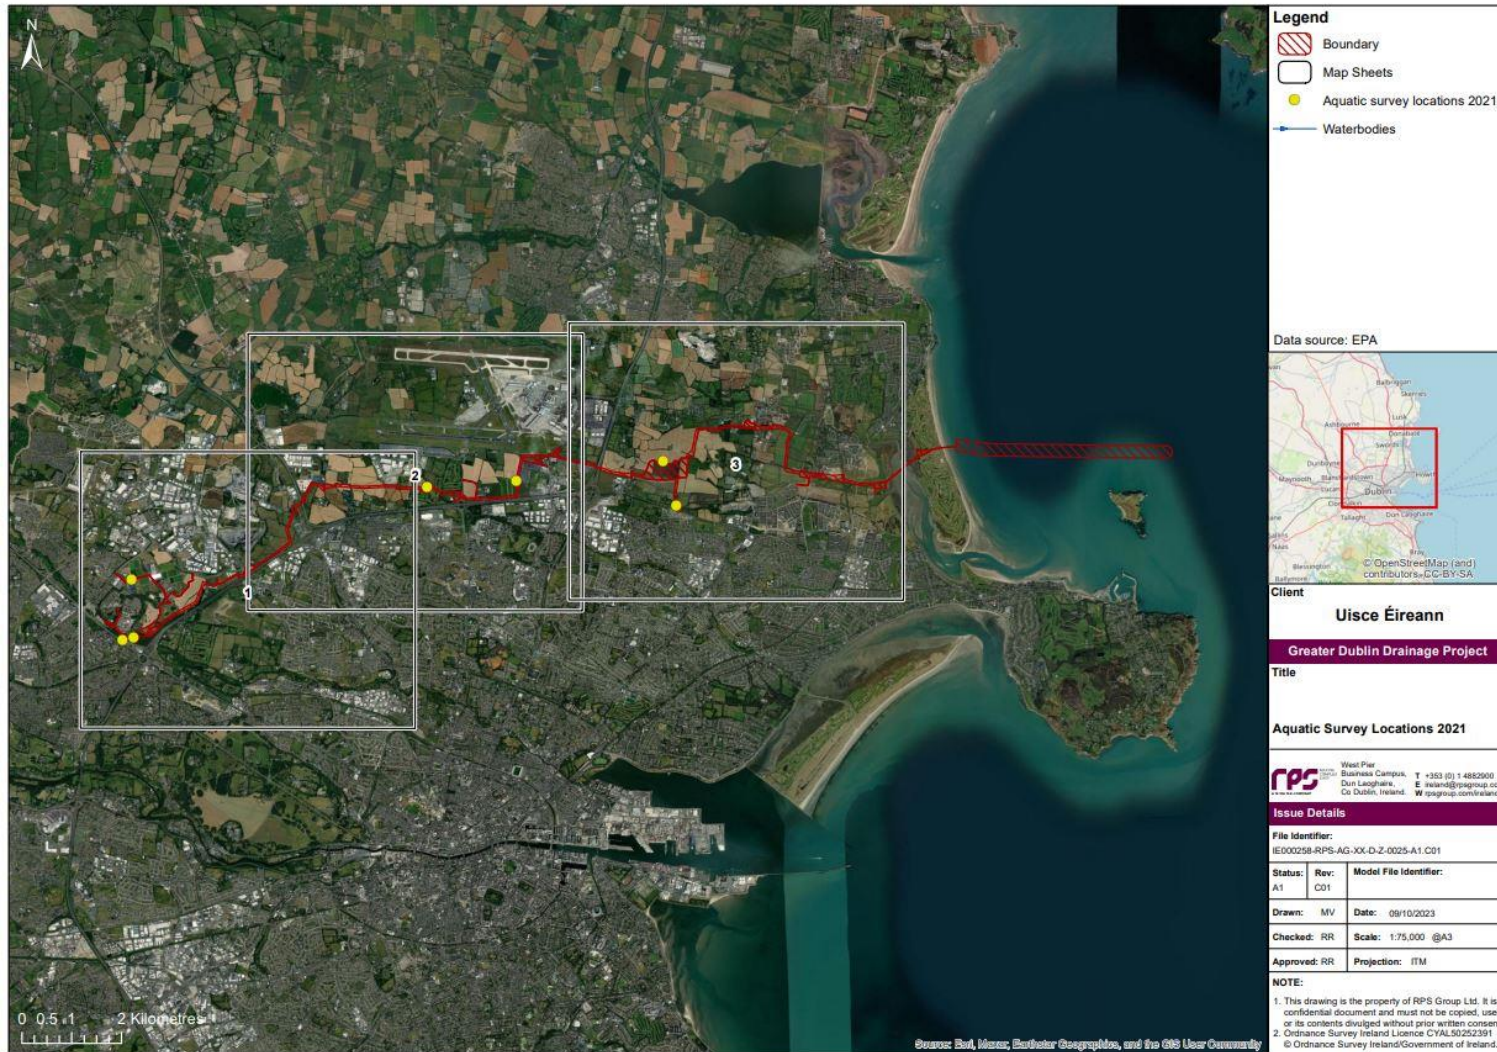
Figure O-1 Aquatic survey locations 2021 (Overview)

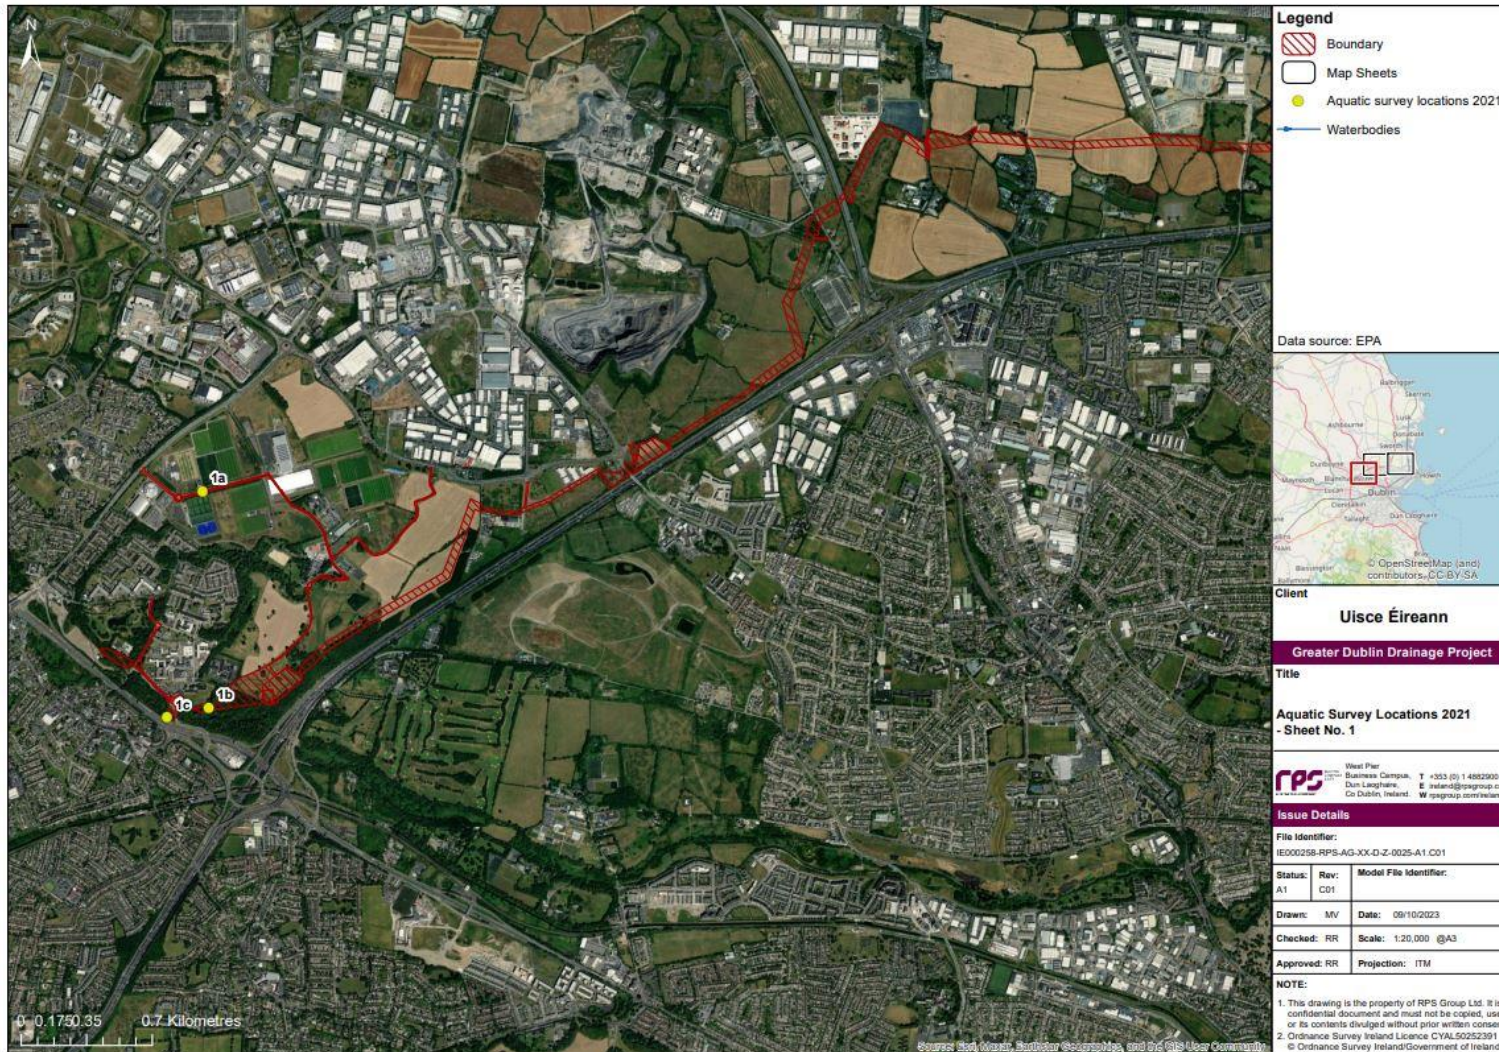
Figure O-2 Aquatic survey locations 2021 (1)

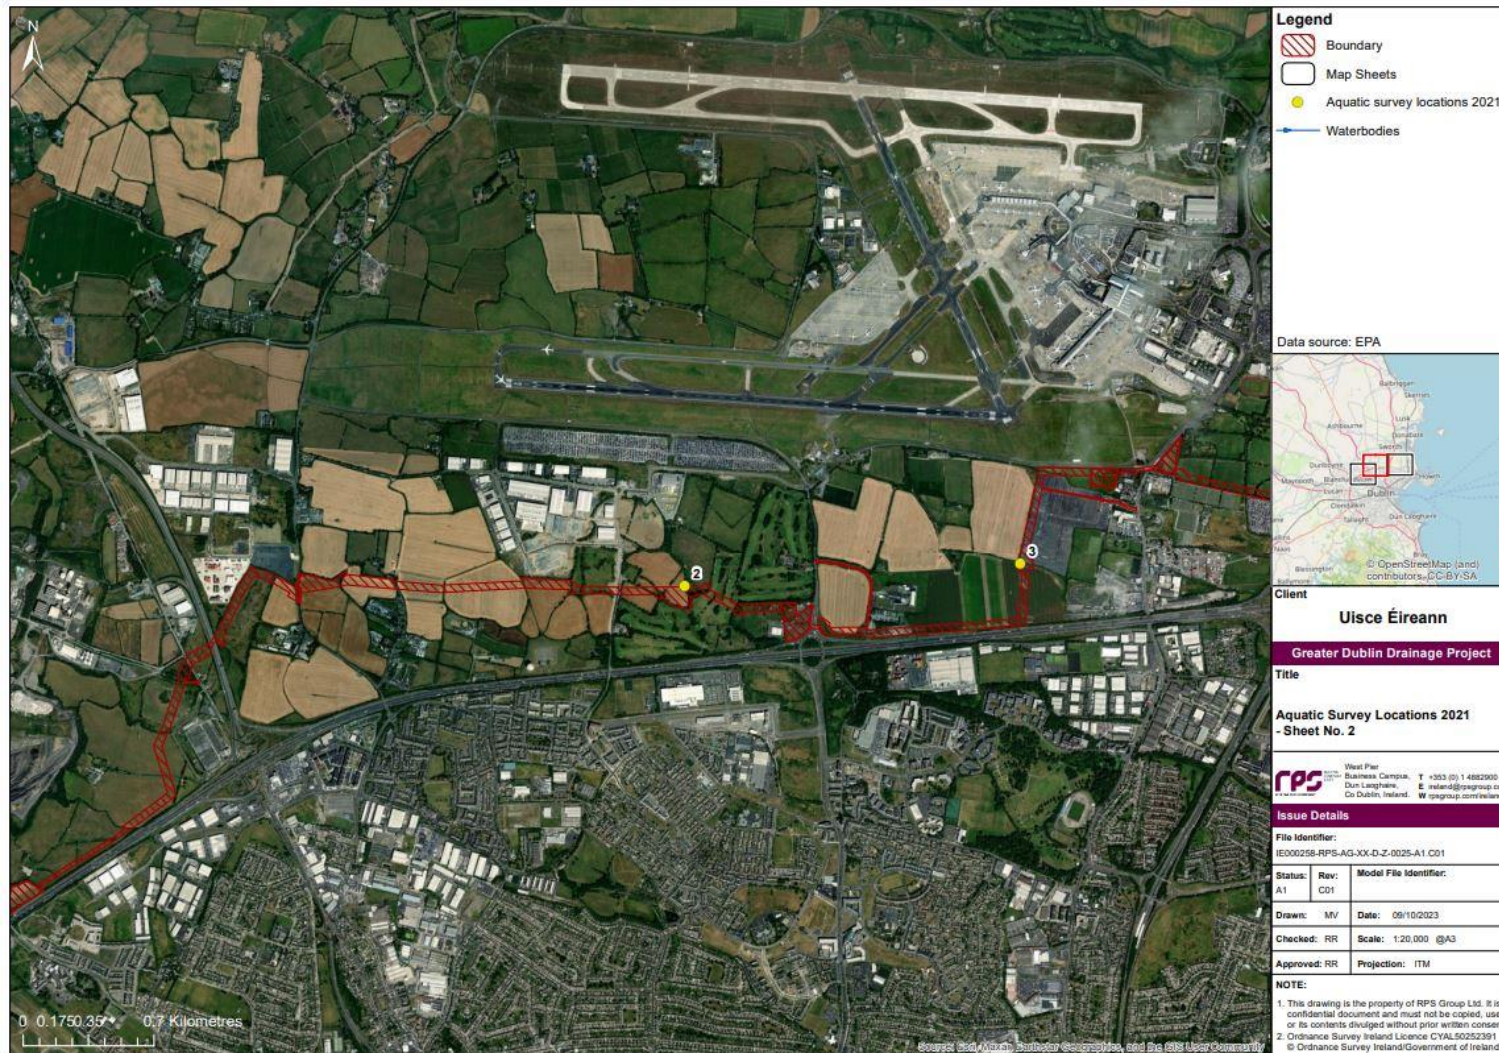
Figure O-3 Aquatic survey locations 2021 (2)

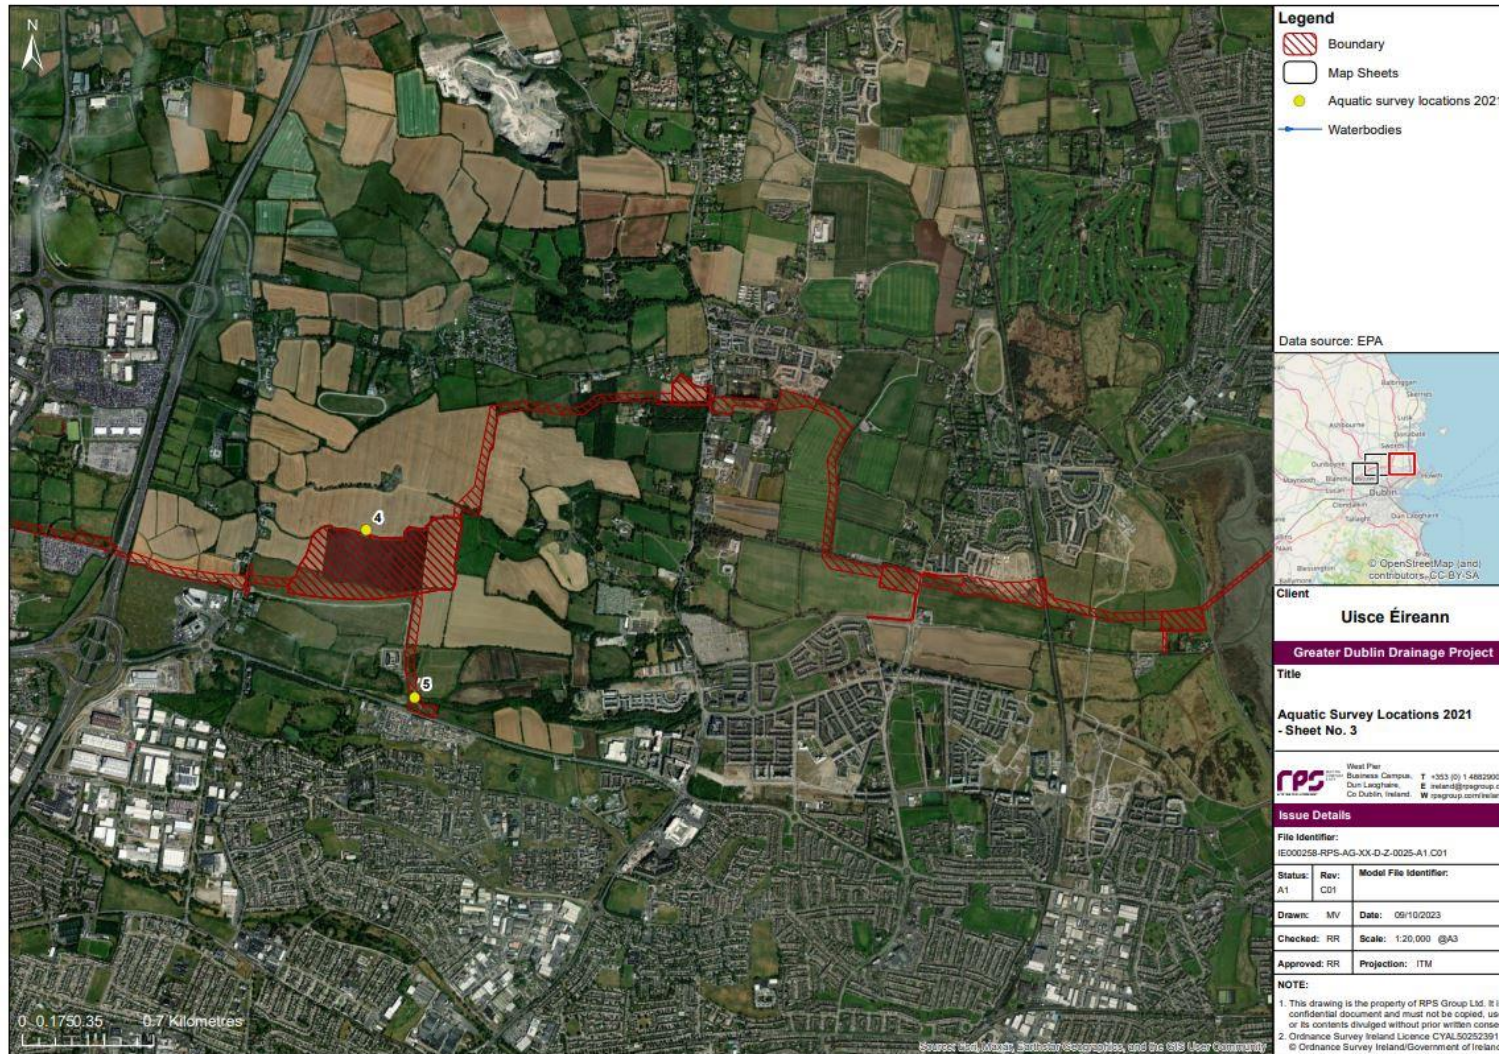
Figure O-4 Aquatic survey locations 2021 (3)

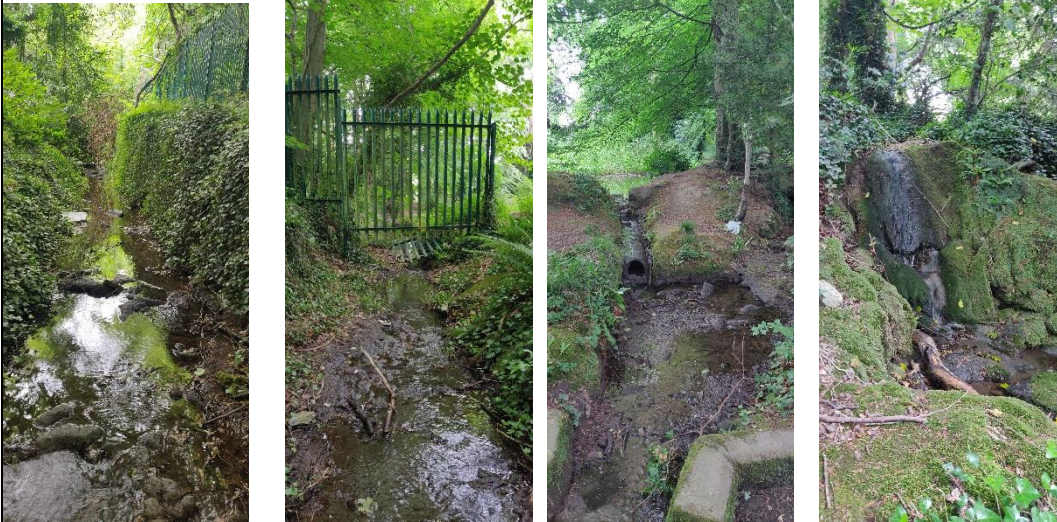
Crayfish- No crayfish habitat available due to shallow water levels and general lack of coarse substrates. The left bank comprises a concrete wall, whereas the right bank is earth. However, the right bank was not soft and is unlikely to be suitable for burrowing. No submerged roots.

From left to right: the survey location looking upstream, the survey location looking downstream, the outfall of the pond downstream of the survey location, the waterfall downstream of the survey location.

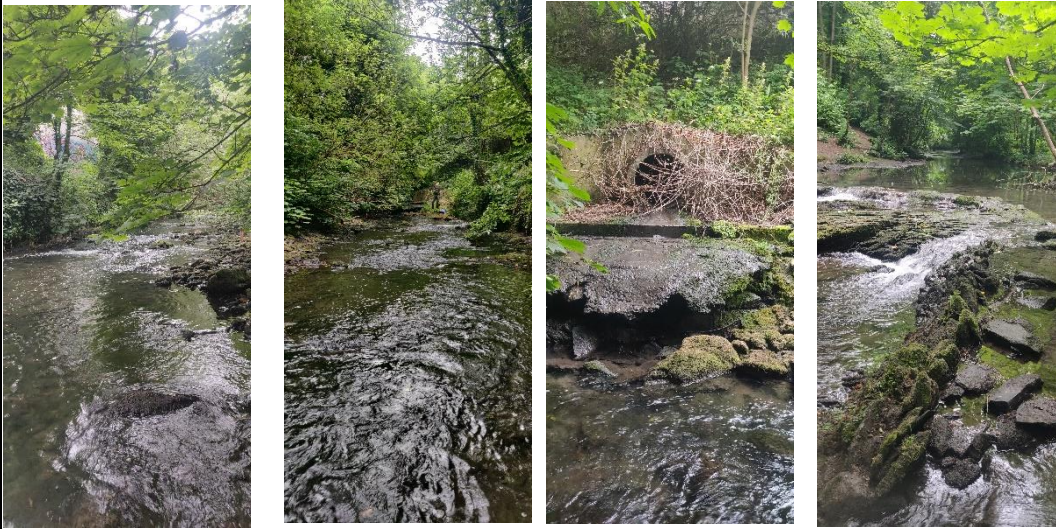
Crayfish- Crayfish habitat was assigned a rating of 'good'. The coarse substrate (boulders and cobbles) within the river could provide refuge habitat. Furthermore, exposed tree roots were noted on the left bank. Some areas of deeper water were noted. Water quality and siltation is likely to be an issue for this species. No crayfish were observed during the survey.

From left to right: the survey location looking upstream, the survey location looking downstream, the culvert pipe located on the right bank, the waterfall/bedrock outcrop upstream of the survey location.

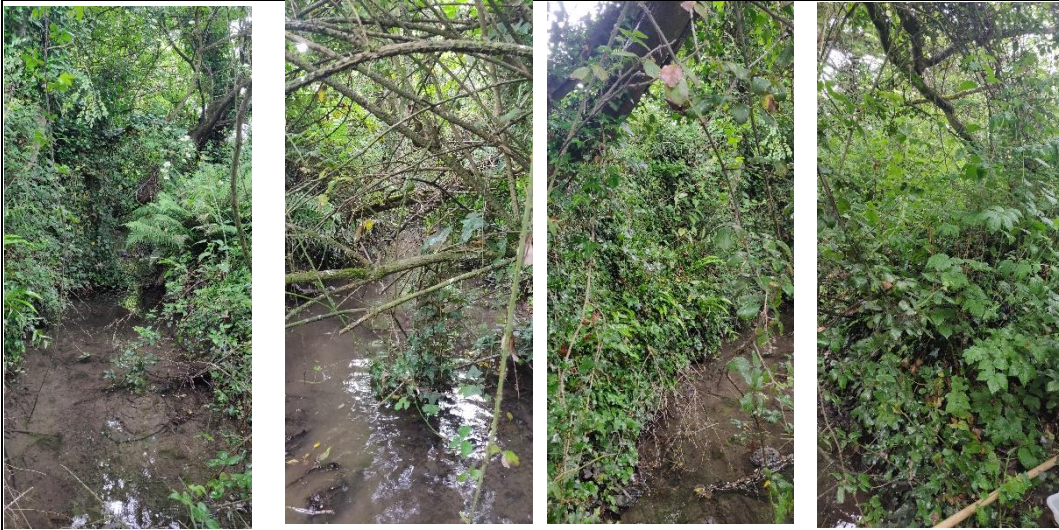
<p>Crayfish- Crayfish habitat was assigned a rating of 'none-poor'. The stream was very shallow with no large coarse substrates which could provide habitat. There is a small chance that the banks could be burrowed into by crayfish, and overhanging vegetation was noted along the margins. Water quality and siltation is likely to be an issue for this species. No crayfish were observed during the survey.</p>					
Images:

From left to right: the survey location looking upstream, the survey location looking downstream, the right bank, the left bank.

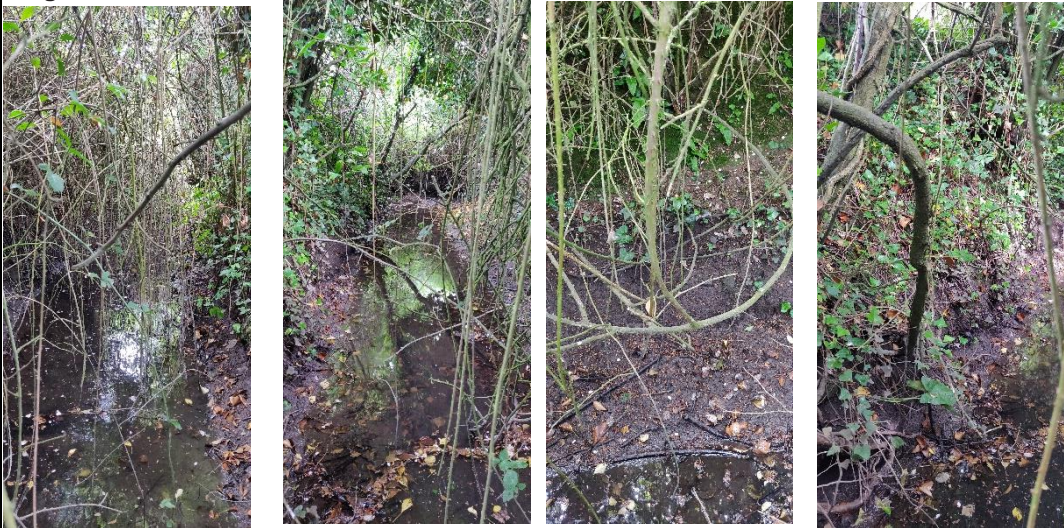
Mayne River (Mayne_010)				Date: 12/6/2023	
Site ID:	Site 3	GPS Location:	53.4131850, -6.2497687	Site info:	Accessed from Collinstown Lane (L2015).
DO (%):	44.7	Bedrock:	0%	Flow discharge:	Low
DO (mg/l):	4.46	Boulder (>250mm):	0%	Velocity:	Stagnant
Temp (°C):	15.4	Cobble (65-250mm):	0%	Turbidity:	None
Conductivity (µS/cm):	-	Gravel (17-64mm):	0%	Colour:	None
pH:	-	Fine Gravel (3-16mm):	0%	Siltation:	Heavy
Bank height (m)	1.6	Sand (<2mm):	0%	Sewage Fungus:	None
Bank width (m):	1.2	Silt (<0.06mm):	100%	Filamentous Algae:	None
Wet width (m):	1.2	Main land use US:	Tillage	Shading:	Heavy
Avg depth (cm):	10	Cattle Access US/DS:	None	Substrate condition:	Normal
Comments:	<p>The site was not suitable for kick-sampling or Q-value assessment. However, a sweep of the margins and substrate identified a number of pollution tolerant species including <i>Asellus aquaticus</i>, <i>Gammarus</i> sp., Gerridae, <i>Chironomus</i> sp., Planorbidae and excessive numbers of pea/orb mussels (Sphaeriidae).</p> <p>Given the ditch-like nature of the stream with stagnant flow conditions and high levels of siltation, it is deemed unlikely to support salmonids, lamprey or crayfish. The silty substrate could potentially support lamprey ammocetes, however, the stagnant conditions and potential lack of upstream spawning habitat (assuming the habitat is similar upstream in this watercourse) makes this very unlikely.</p>

<p>From left to right: the survey location looking downstream, the survey location looking upstream, the right bank, the left bank.</p>

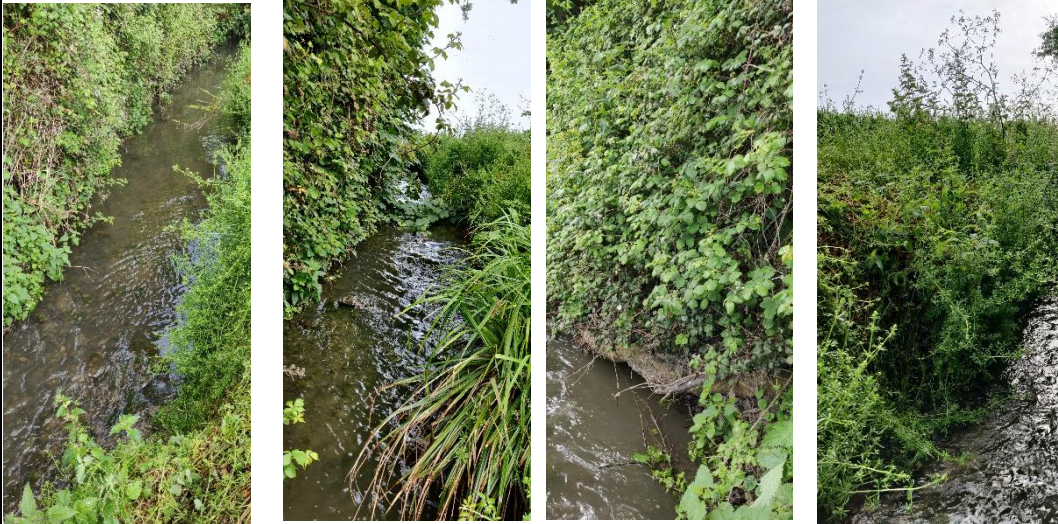
Crayfish- Crayfish habitat was assigned a rating of 'fair'. No large boulders were noted in the stream, with some siltation and high turbidity noted. However, soft banks for burrowing and overhanging vegetation and tree roots were noted. No crayfish were observed during the survey.

From left to right: representative image of the survey location, the survey location looking upstream, the right bank, the left bank.

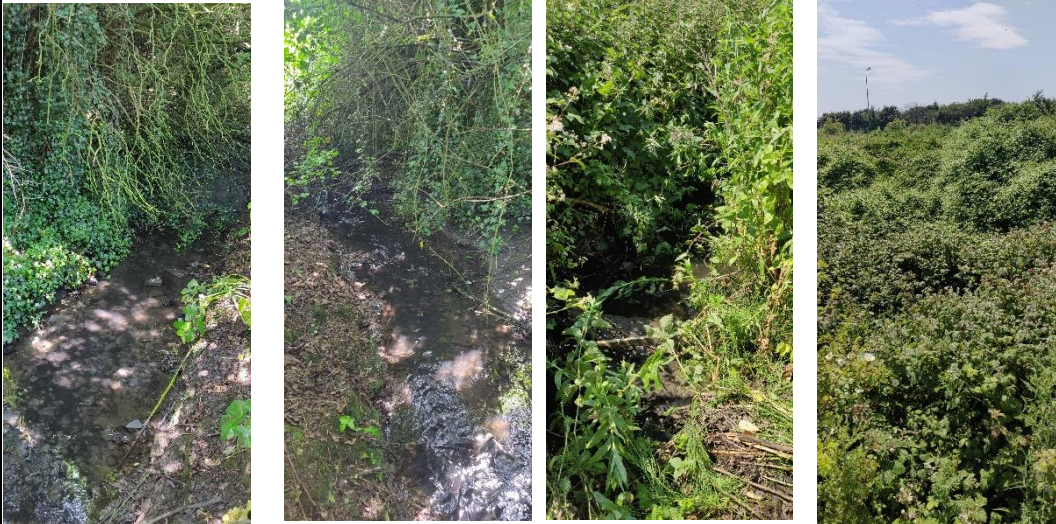
Crayfish- Crayfish habitat was assigned a rating of 'none-poor'. No large boulders and cobbles which could provide cover were noted in the stream, with heavy siltation observed. Some instream vegetation noted in the less shaded part of the stream immediately downstream of the culvert. No crayfish were observed during the survey.

From left to right: the survey location looking upstream, the survey location looking downstream, the uppermost section of the surveyed reach, dense bramble growth within the stream valley.
