**Geotechnical & Peat Stability
Assessment Report**

ENVIRONMENTAL IMPACT ASSESSMENT REPORT (EIAR) FOR THE PROPOSED BALLINAGREE WIND FARM

GEOTECHNICAL & PEAT STABILITY ASSESSMENT REPORT

Date: January 2022

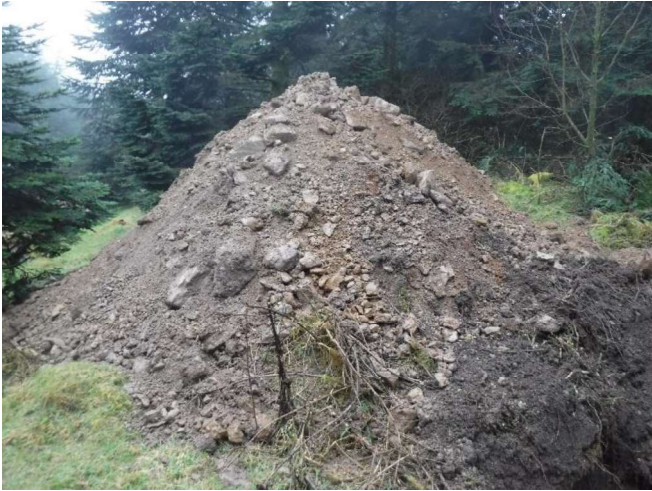
Figure 1 H:\21C101_Ballinagree TP
Photos\Photos\T1\DSCF4037.JPG

Photographs (Trial Pit)

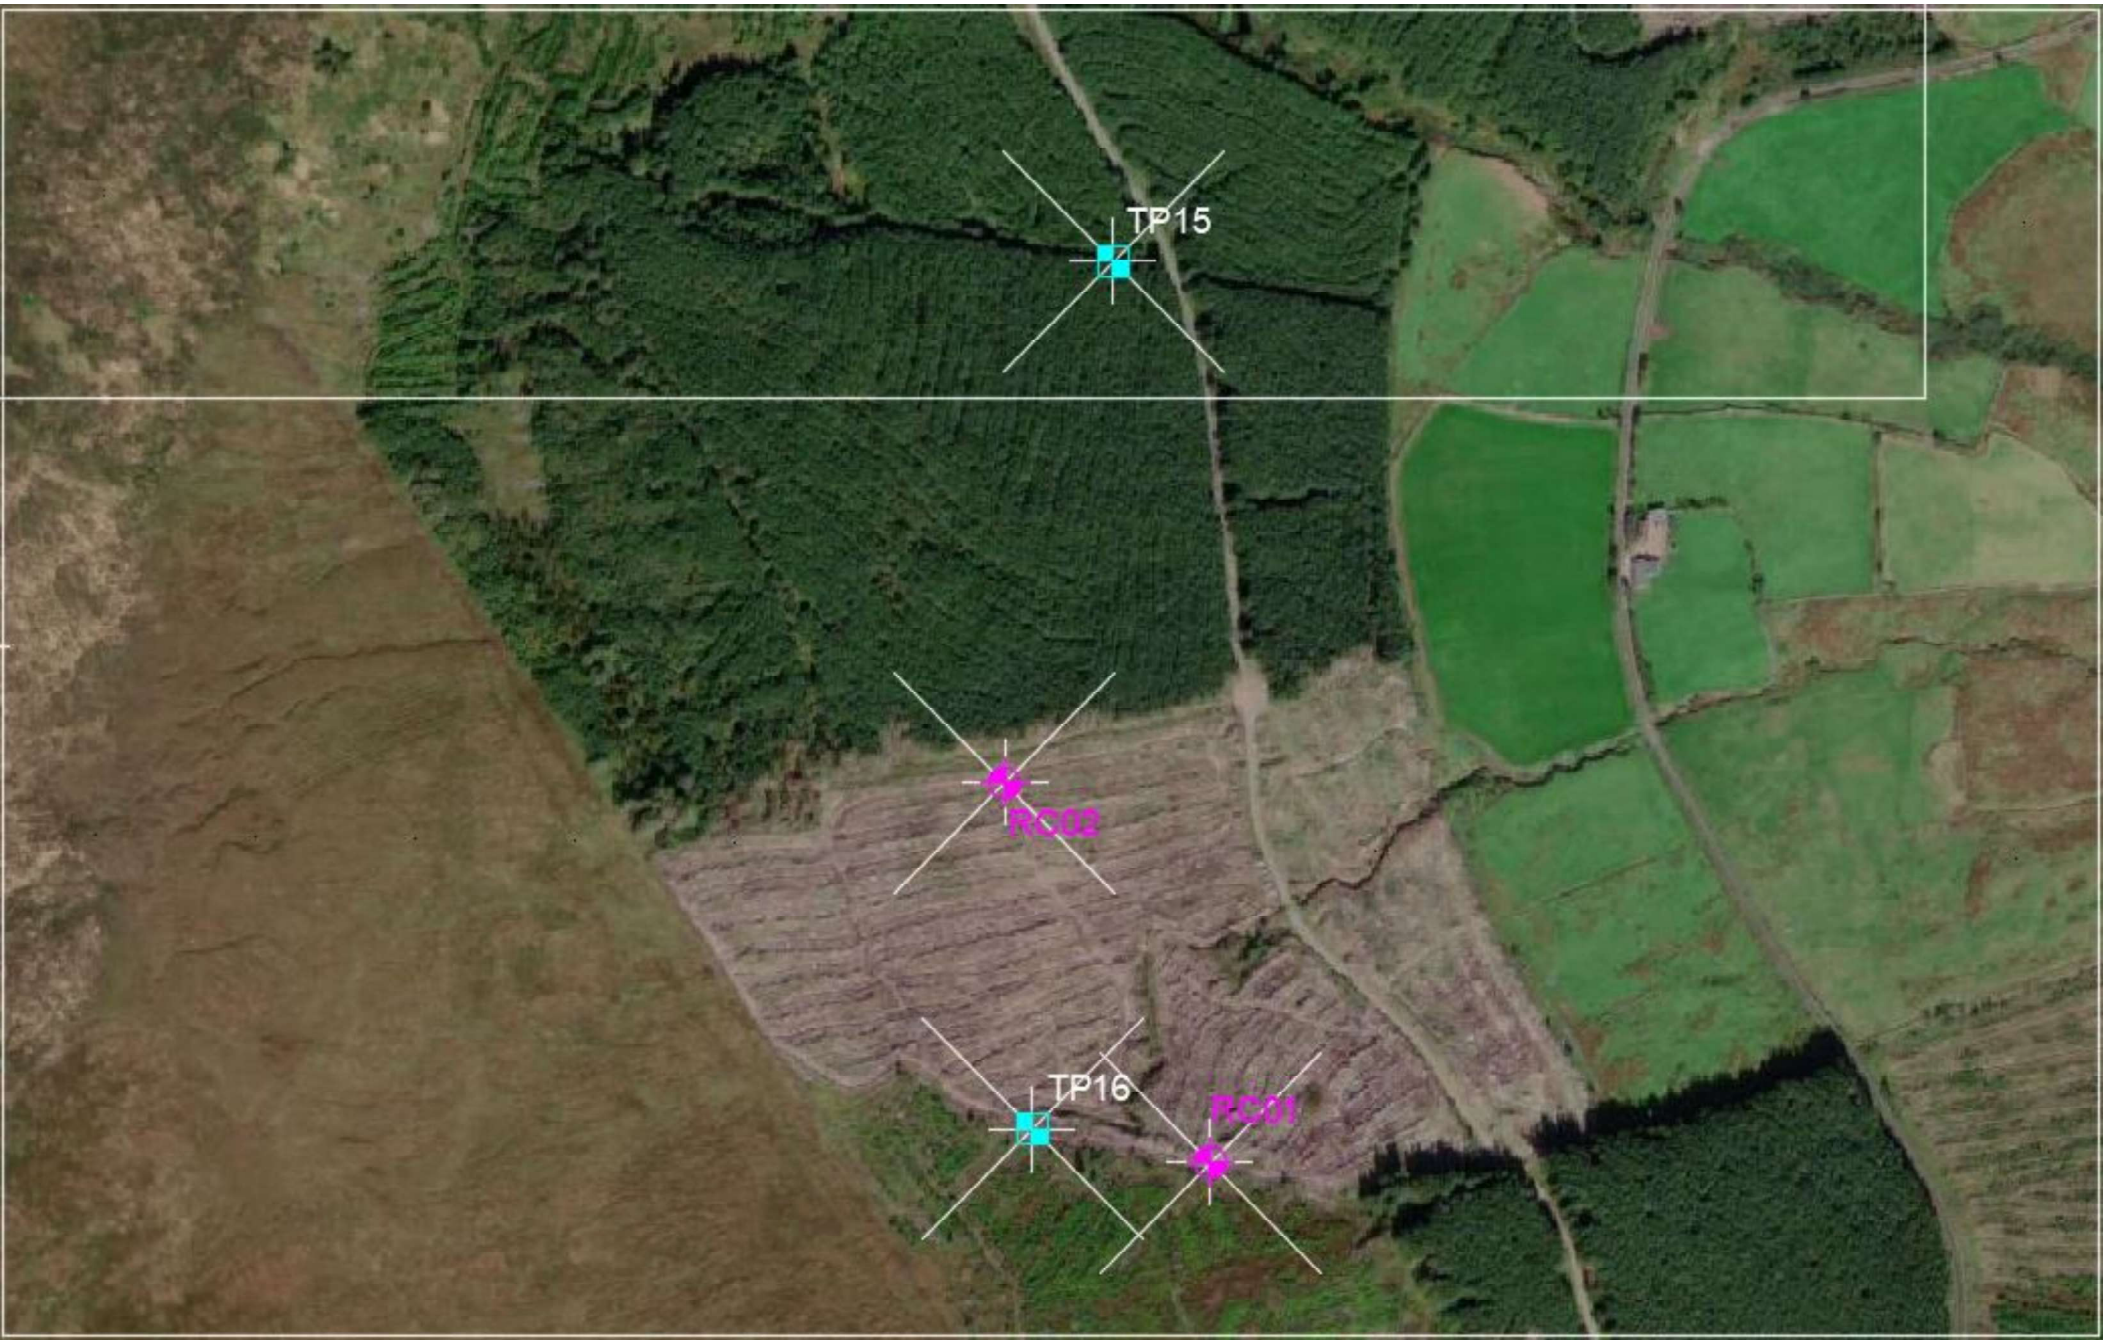
TP15

RC02

TP16

RC01
