## Appendix B – Schedule of Survey Sheets

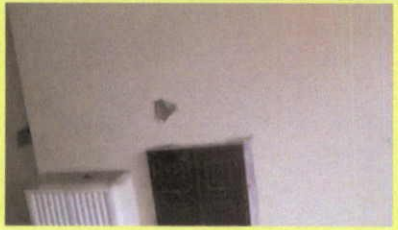
Ref No.	Building or Area of Site	Location or Functional Space	Sample No.	Material Description, surface treatment and condition	Extent	Asbestos identified (presumed, strongly presumed or identified)	Product type	Condition	Surface treatment	Asbestos type	Material assessment score	Recommendations	Photo
21	No. 20/21 Moore Street	1 <sup>st</sup> floor		Integral areas of the storage heater and the wall mounted safe		Presumed to contain asbestos						Dismantling and investigation by a competent contractor prior to work likely to cause disturbance.
