**Appendix A17.1**  
Arboricultural Impact  
Assessment

Arbor-Care Ltd (Professional Consulting Tree Service) was retained by Arup Consulting Engineers on behalf of the National Transport Authority (NTA) to undertake an Arboricultural Impact Assessment, and a Tree Protection Plan identifying the trees, groups of trees or hedgerows that may be impacted on by the BusConnects Core Bus Corridor. The surveyed trees contained within this report are located within or adjacent to the Belfield / Blackrock to City Centre Core Bus Corridor Scheme (Figure 1.0 below) (hereinafter referred to as “The Proposed Scheme”). The objective of the impact assessment was to identify the areas that contained trees, groups of trees or hedgerows, and to ensure where practicable that these areas would be retained and to identify the trees that are to be removed to facilitate the Proposed Scheme.

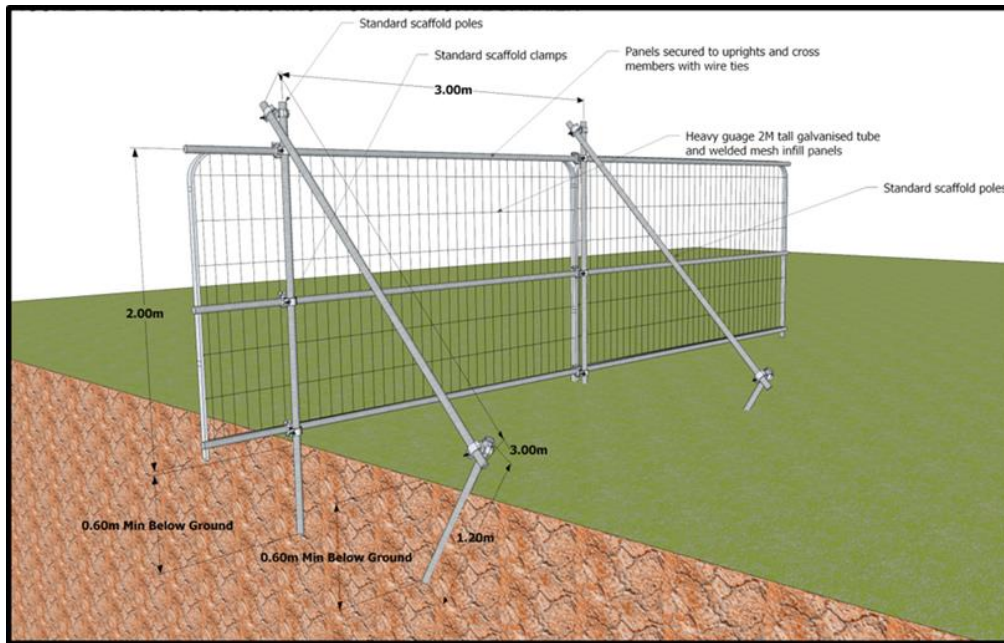
Figure 4: Default specification for tree protection barrier in accordance with BS5837:2012 figure 2

Fencing shall be constructed with robust vertical and horizontal scaffold framework with weldmesh panels firmly attached in accordance with BS 5837:2012 Figure 2. Vertical support poles and bracing poles must be located with care to avoid underground utility services and will be sited to avoid the structural roots of retained trees. Where driven supports are not practicable due to the presence of roots or underground utilities block trays, counterweights or equivalent can be utilised.

Alternative equivalent robust and immovable fencing specification including site hoarding will also be appropriate.

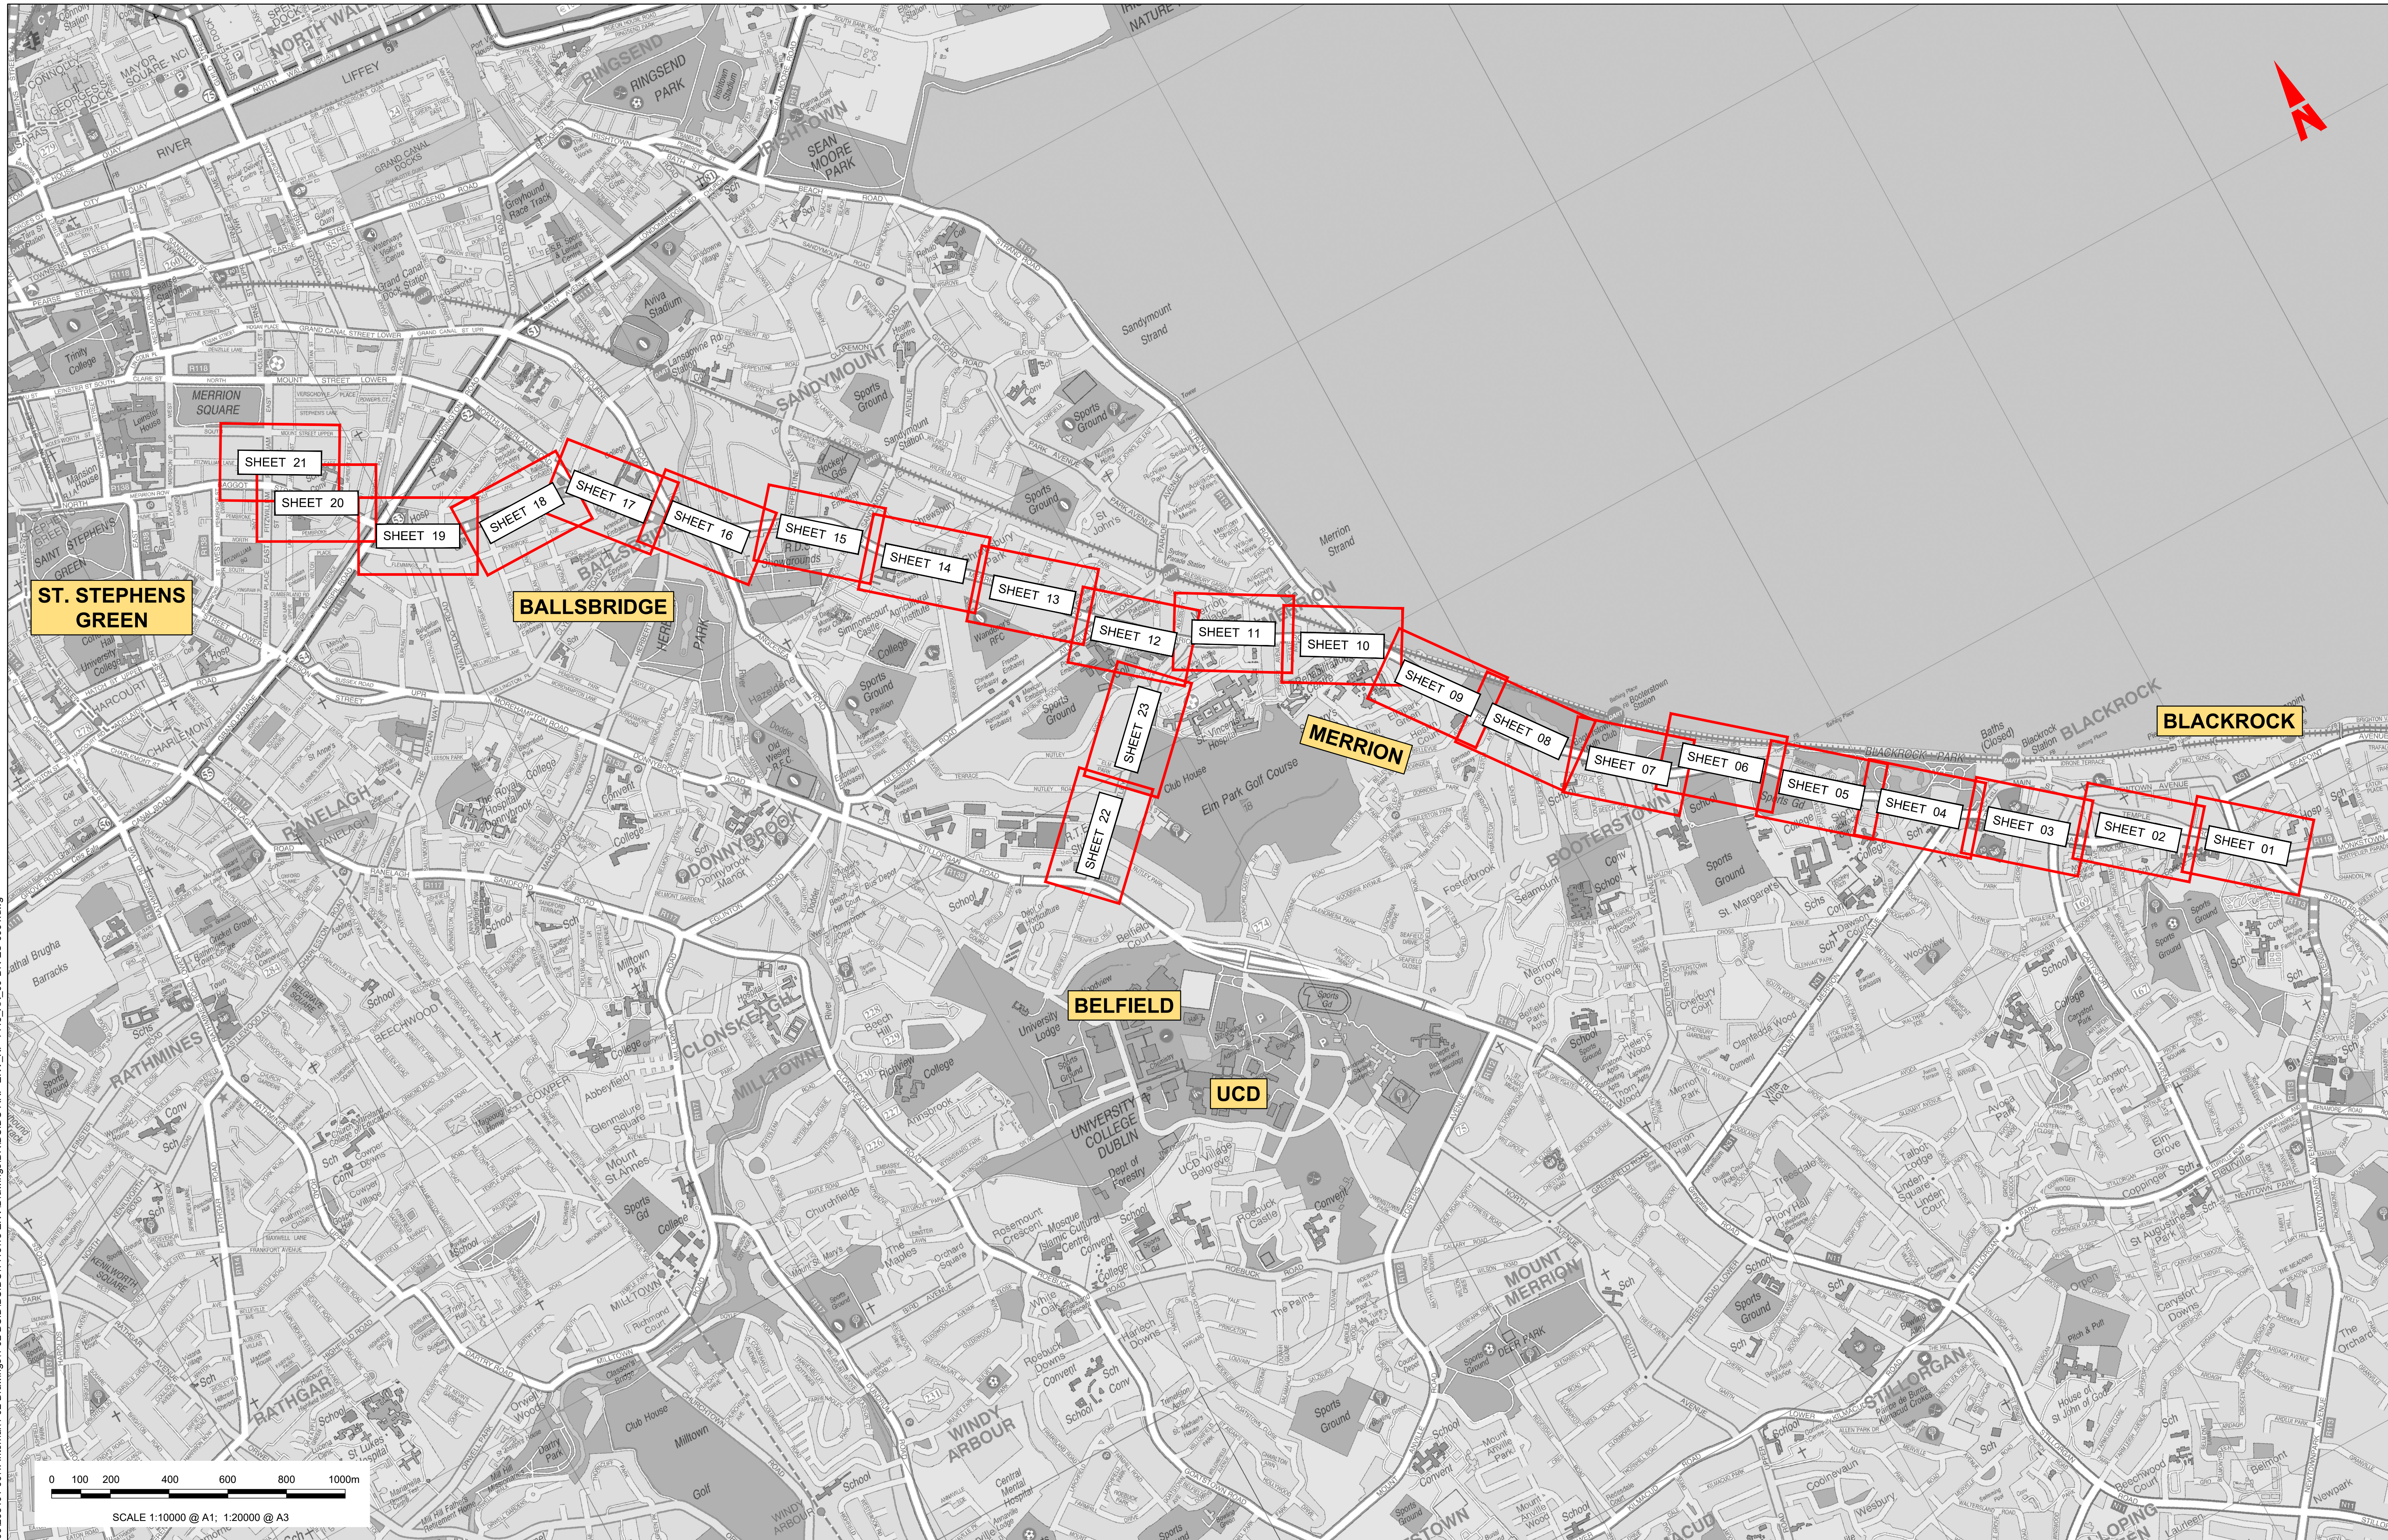
- BCIDC-ARP-ENV\_KP-1415\_XX\_00-DR-ES-0001
- BCIDC-ARP-ENV\_LA-1415\_XX\_00-DR-ES-0001 to 0023

SCALE 1:10000 @ A1; 1:20000 @ A3
