National Transport Authority Blanchardstown to City Centre Core Bus Corridor Scheme

Arboricultural Impact Assessment Report

Issue | 4 April 2022

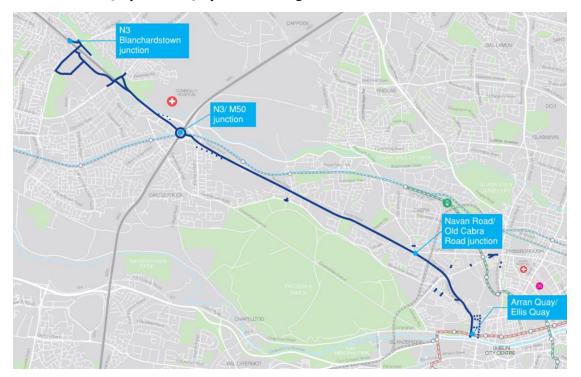
Figure 1: Proposed Blanchardstown to City Centre Scheme

The Proposed Scheme commences at Junction 3 (Blanchardstown / Mulhuddart) southbound off-slip from the N3. The Proposed Scheme proceeds along the R121 Blanchardstown Road South into the Blanchardstown Shopping Centre.

From a new terminus to the north-west of Blanchardstown Shopping Centre the Proposed Scheme is routed onto the N3 Navan Road via the Snugborough Road junction and follows the N3 and Navan Road as far as the junction with the Old Cabra Road. From here, the Proposed Scheme is routed along Old Cabra Road, Prussia Street, Manor Street and Stoneybatter to the junction with King Street North. The core bus corridor is then routed via Blackhall Place as far as the junction with Ellis Quay, where it joins the prevailing traffic management regime on the North Quays. At the Stoneybatter / Brunswick Street North junction, cyclists proceed along Brunswick Street North, George's Lane and Queen Street as far as Ellis Quay/Arran Quay. Refer to Figure 1.

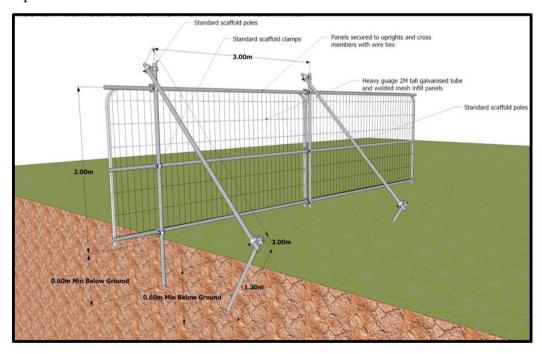
Figure 4: Default specification for tree protection barrier in accordance with BS5837:2012 figure 2.

Fencing shall be constructed with robust vertical and horizontal scaffold framework with weldmesh panels firmly attached in accordance with BS 5837:2012 Figure 2. Vertical support poles and bracing poles must be located with care to avoid underground utility services and will be sited to avoid the structural roots of retained trees. Where driven supports are not practicable due to the presence of roots or underground utilities block trays, counterweights or equivalent can be utilised.

Where retained trees are at risk of damage, the default position as set out by *BS* 5837:2012 is that retained trees must be protected from construction operations with the erection of robust protective fencing positioned on the outer edge of the RPA or crown spread (whichever is greatest).
