Report

Construction Environmental Management Plan (rev 3)

Bailey Gibson SHD No. 2

LOCATION	BLOCKS BUILDINGS	LEVELS	DISP.	REPORT NO. REV
FORMER BAILEY GIBSON SITE, FORMER PLAYER WILLS SITE, DUBLIN CITY COUNCIL LAND (FORMERLY BOYS BRIGADE PITCH AND PART OF ST. TERESA'S GARDENS (ALL WITHIN STRATEGIC DEVELOPMENT REGENERATION AREA 12)), SOUTH CIRCULAR ROAD AND DONORE AVENUE, DUBLIN 8	BG1-BG5 A - K	ALL (ABOVE AND BELOW GROUND)	PSDP	CEMP-DCON-RPT-001-03

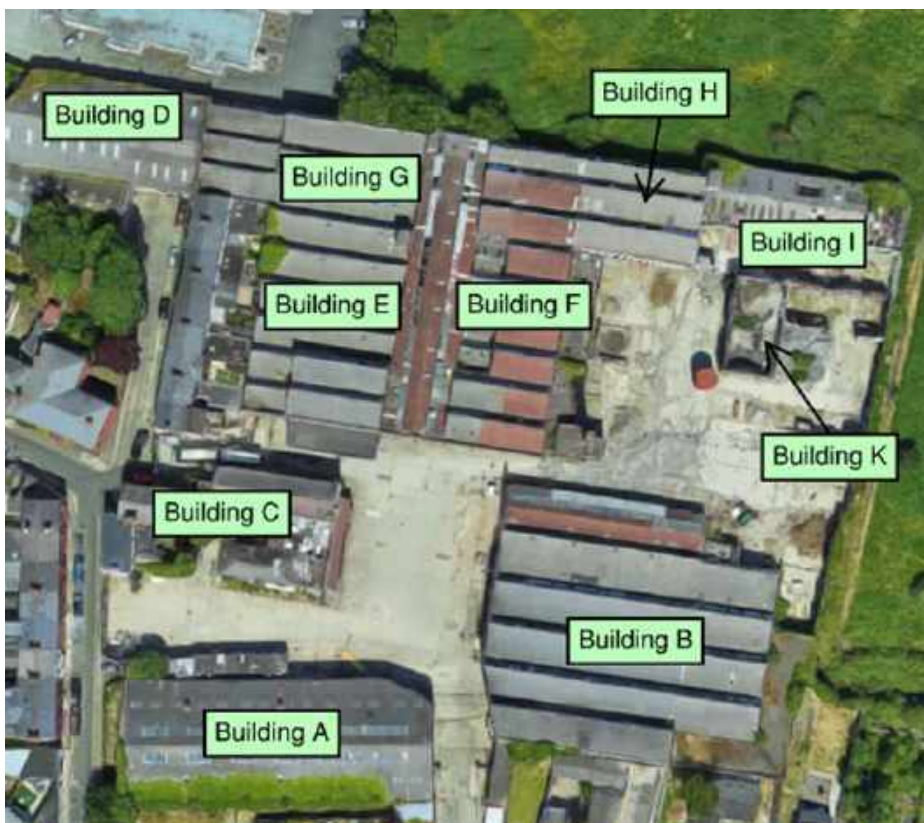
2.3 Site setting

The application area predominately forms part of a wider regeneration area, SDRA 12, located between the South Circular Road (SCR), Cork Street and Donore Avenue in Dublin 8. It is approximately 2.3km southwest of Dublin city centre and within the canal cordons. The Bailey Gibson site has frontage with SCR and Rehoboth Place/Avenue and is occupied by vacant industrial buildings and associated hardstanding required to be demolished. Previous use of these structures include:

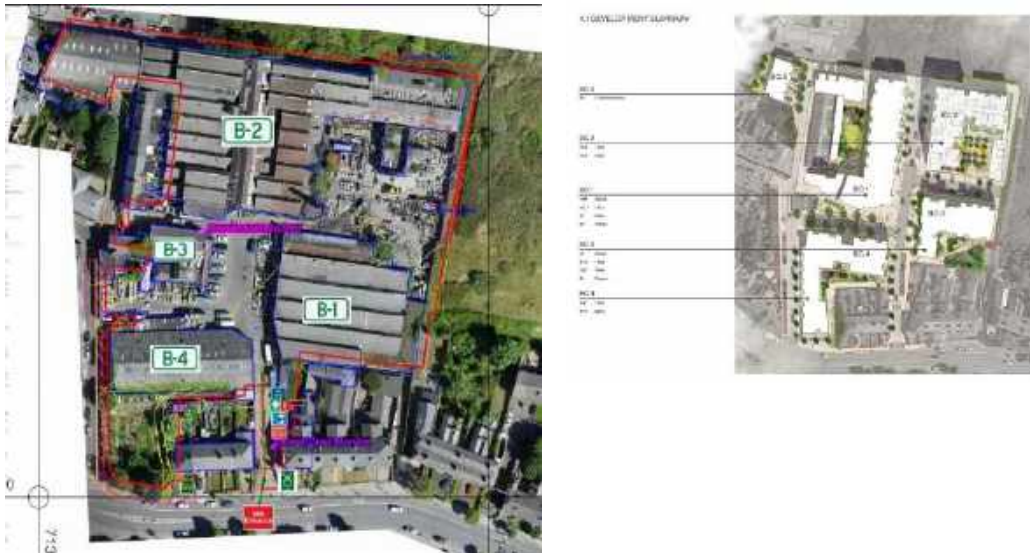
3.2.3 Demolition of existing structures - proposed sequence

- Block 2;
- Block 1 including various non connected independent structures and chimney;
- Block 3; and
- Block 4

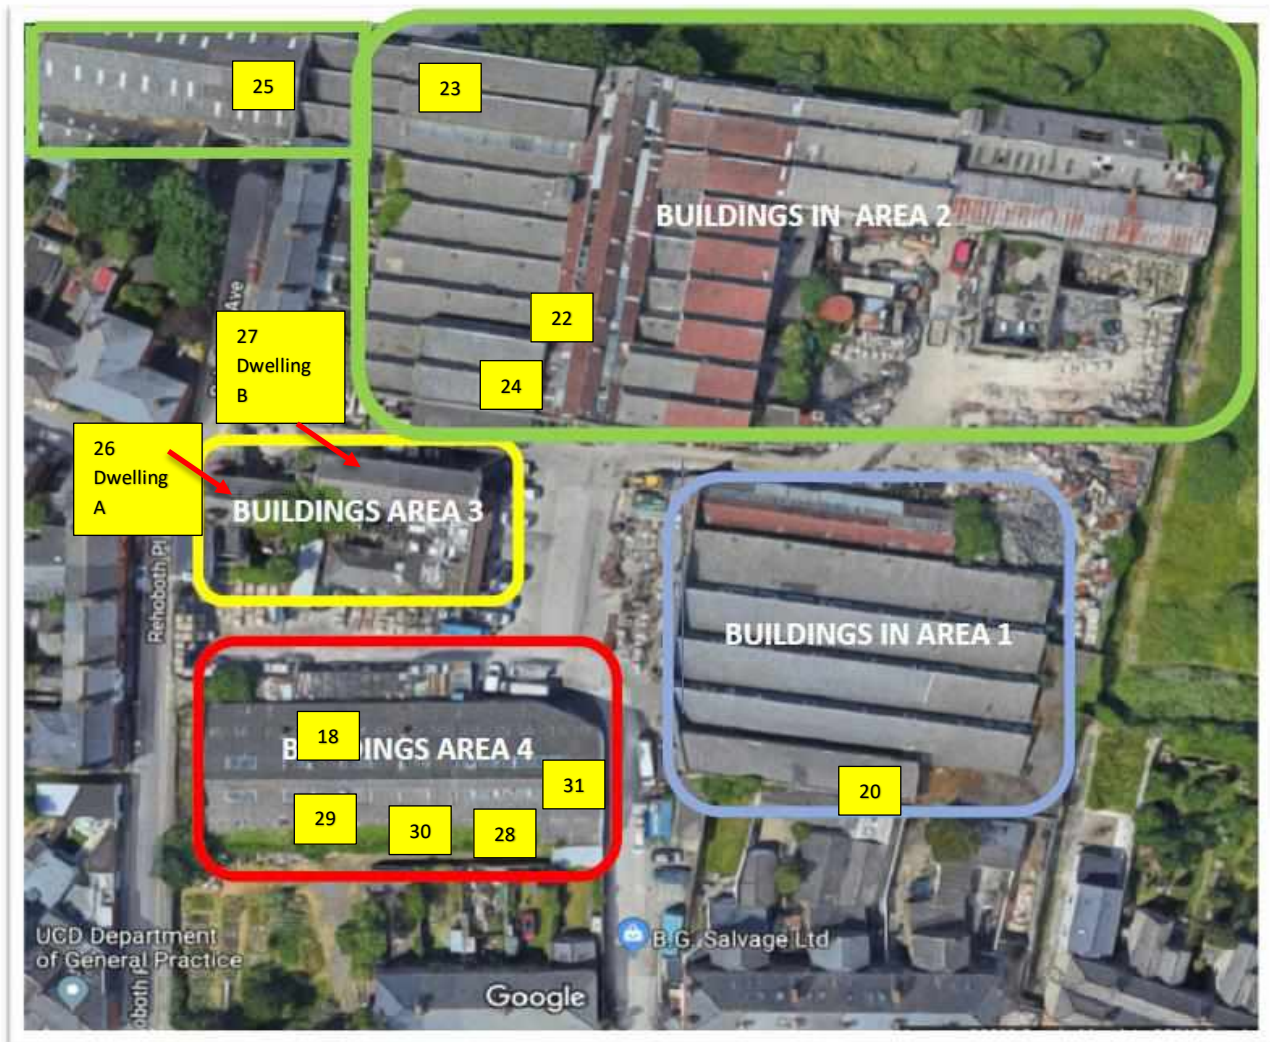
Presumed ACM's Reference No. & Outline Locations

Appendix B Ref. No	STRONGLY PRESUMED/PRESUMED ASBESTOS
18	Building Area 4 – Thermal Insulation to High Level Pipes returning through wall mid- section of Showroom 20 Linear/m.
20	Building Area 1 - Flat Roof Material amount TBD.
21	All Buildings onsite with “North Facing Windows” presumed Rope Seals amount TBD.
22	Building Area 2 – Ground Floor Quarantine Area AC Water Tank.
23	Building Area 2- First Floor No Access Lift Area, Shaft, Carriage & Motor presumed ACM’s
24	Building Area 2 – First Floor Fire Door top of stairs First Floor presumed ACM components.
25	Building Area 2 – First Floor High Level no access presumed AC Sheeting.
26	Building Area 3 – Dwelling A Ground Floor & First Floor Areas not accessible due to structural collapse in area.
27	Building Area 3 – Dwelling B First Floor Areas not accessible due no floors in area.
28	Building Area 4 – First Floor Presumed Concealed Thermal Insulation to concealed pipework.

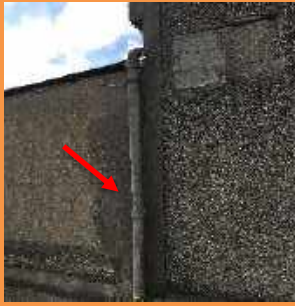
7	Old B&G Salvage Site , Dolphins Barn, Dublin 8.	Building Area 4 Asbestos Cement Gutters & down pipes.	N/A	AC Cement Rainware	200 linear meters approx	Strongly Presumed Chrysotile	1	2	1	1	5	n/a	n/a	n/a	n/a	n/a	5	L	Removal by competent Contractor prior to any Refurbishment &/or Demolition Works. Disposal as Hazardous Waste.

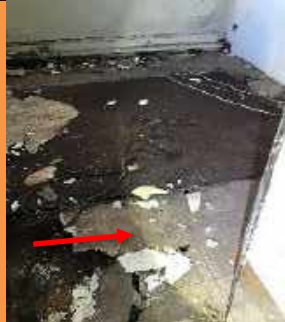
14	Old B&G Salvage Site , Dolphins Barn, Dublin 8.	Building Area 3 House A Ground Floor	1914512	Asbestos Lino to floor ground floor room.	<20 sq./metres approx	Chrysotile	2	3	3	1	9	n/a	n/a	n/a	n/a	n/a	9	M	Removal by Specialist Contractor prior to any activity likely to cause disturbance. Disposal as Hazardous Waste.

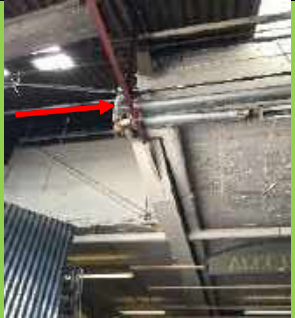
16	Old B&G Salvage Site , Dolphins Barn, Dublin 8.	Building Area 4 Ground Floor Inside Main Entrance	1914523	High Level Thermal Insulation to old redundant pipes.	40 linear metres approx	Amosite	3	3	2	2	10	n/a	n/a	n/a	n/a	n/a	10	H	Removed by Specialist Contractor under controlled cond.

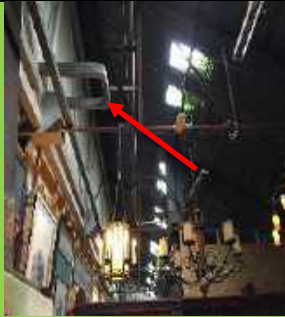
18	Old B&G Salvage Site , Dolphins Barn, Dublin 8.	Building Area 4 Ground Floor Rear of Building	N/A	High Level Thermal Insulation to old redundant pipes- no access pipe returns through wall.	20 linear metres approx	Strongly Presumed Amosite	3	3	2	2	10	n/a	n/a	n/a	n/a	n/a	10	H	Removed by Specialist Contractor under controlled cond.
