INTERPRETATIVE GEOTECHNICAL REPORT

WESTGATE, DUBLIN 8

O'CONNOR SUTTON CRONIN

SITE-SPECIFIC FLOOD RISK ASSESSMENT

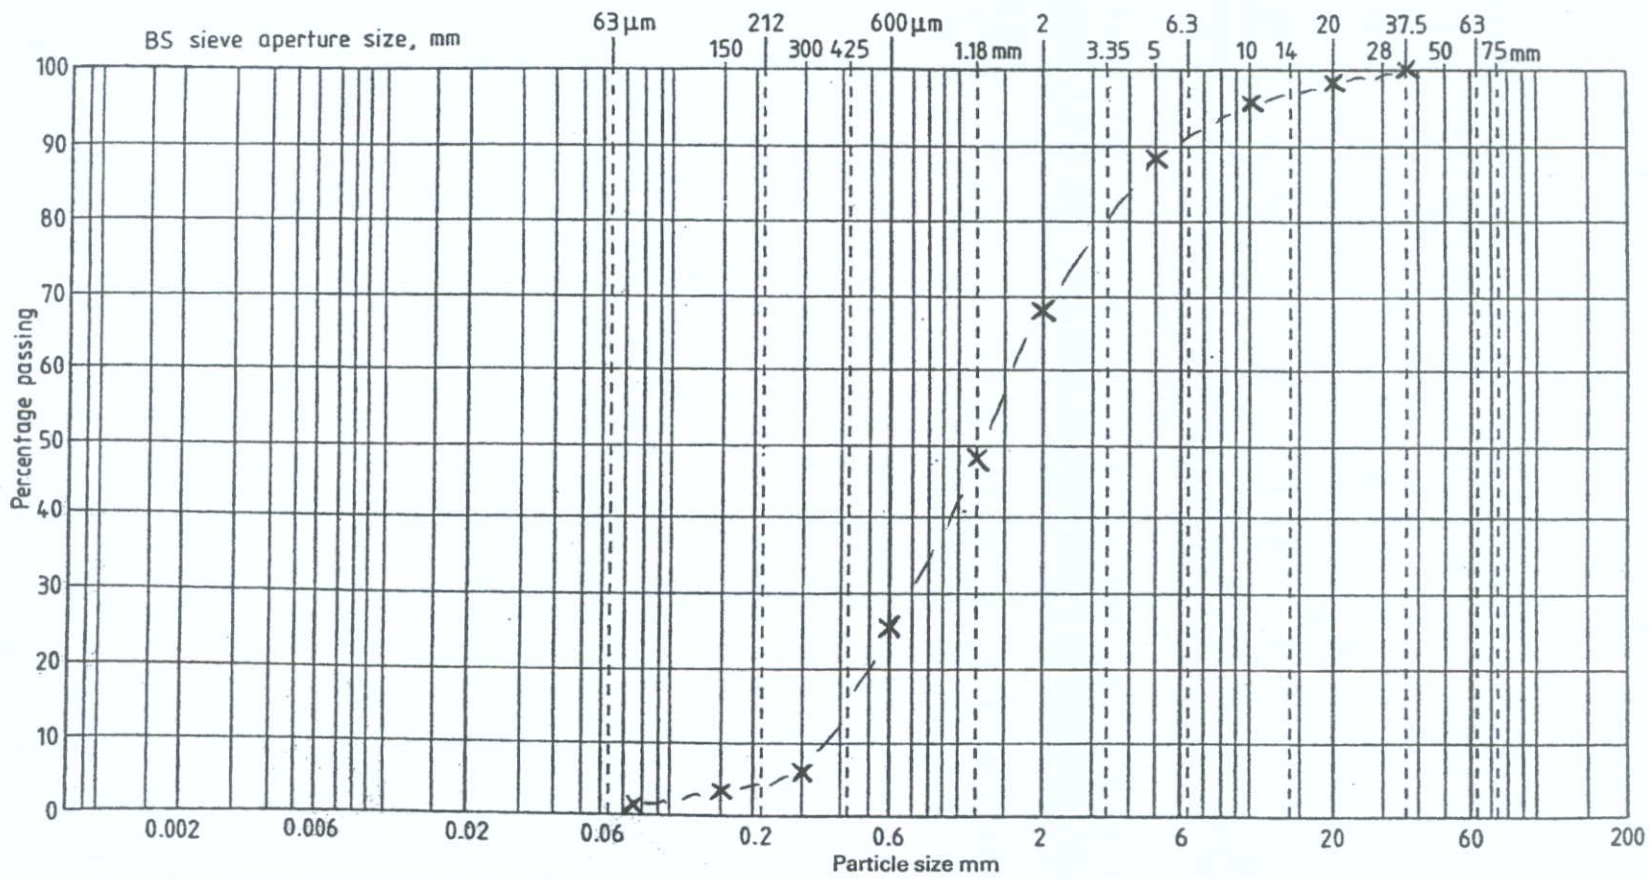
Locati WEST GATE	Soil desc. <i>tion</i>	Job ref.	Sample no.
		Borehole no. 3	Depth 10.0 m
Test method BS 1377 : Part 2 : 1990 : 9.2/9.3/9.4/9.6/9.7 *		Date	11/1/06

CLAY	Fine	Medium	Coarse	Fine	Medium	Coarse	Fine	Medium	Coarse	COBBLES	BOULDERS
	SILT			SAND			GRAVEL

Appendix G contains laboratory testing carried out as part of the investigation. Laboratory testing included atterburg tests, moisture content tests, PSD grading curves and sulphate/ pH testing.

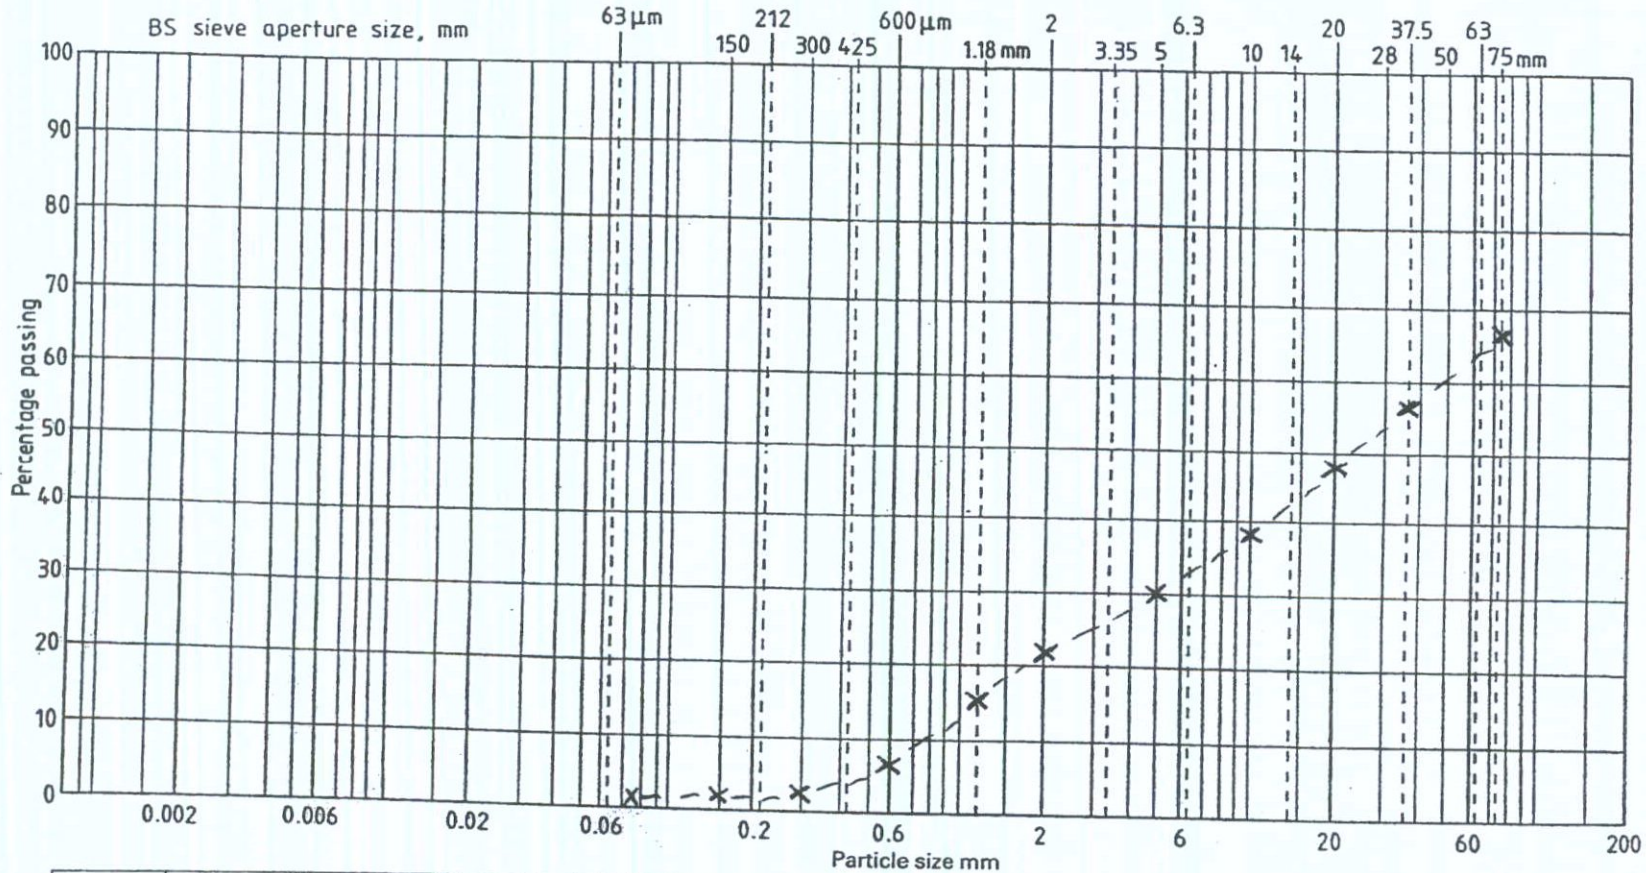
Loca WESTGATE	Soil description	Job ref.	Sample no.
		Borehole/ Pit no. 7A	Depth 5.0 m
Test method BS 1377 : Part 2 : 1990 : 9.2/9.3/9.4/9.6/9.7*			Date 11/1/06

CLAY	Fine	Medium	Coarse	Fine	Medium	Coarse	Fine	Medium	Coarse	COBBLES	BOULDERS
	SILT			SAND			GRAVEL

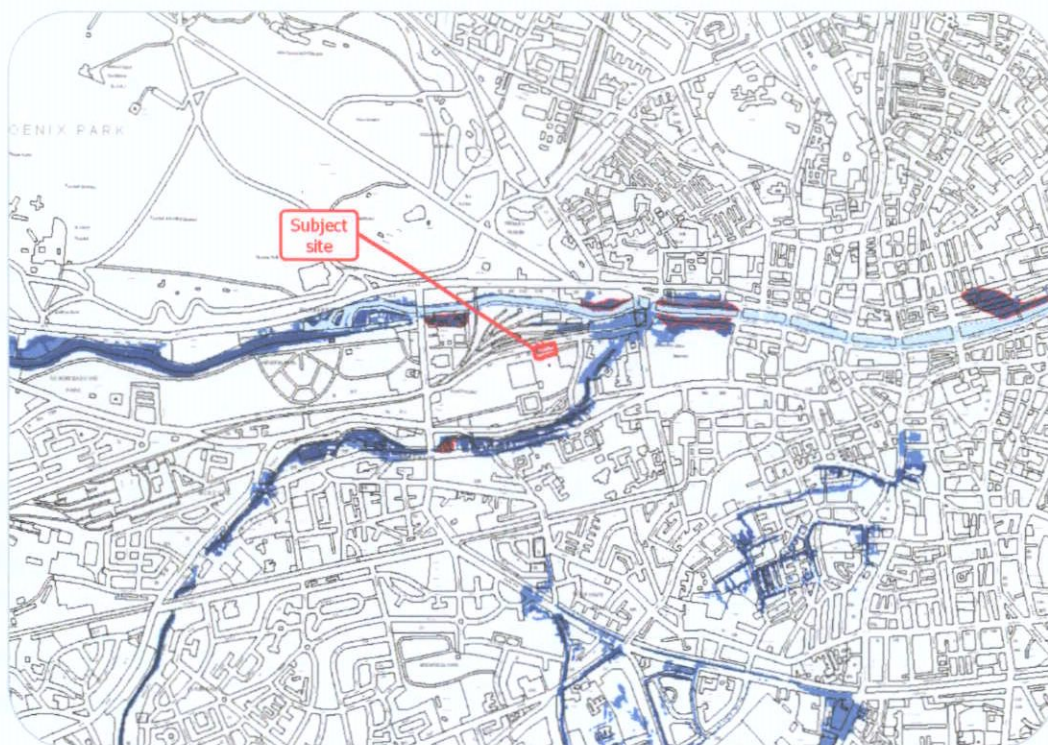
Figure 4 – Extract of DCC composite flood risk mapping
(background imagery source: Dublin City Council)

A review of DCC flood risk mapping shows the subject site to be located in **Flood Zone C**. See **Appendix B** and **Figure 4**.

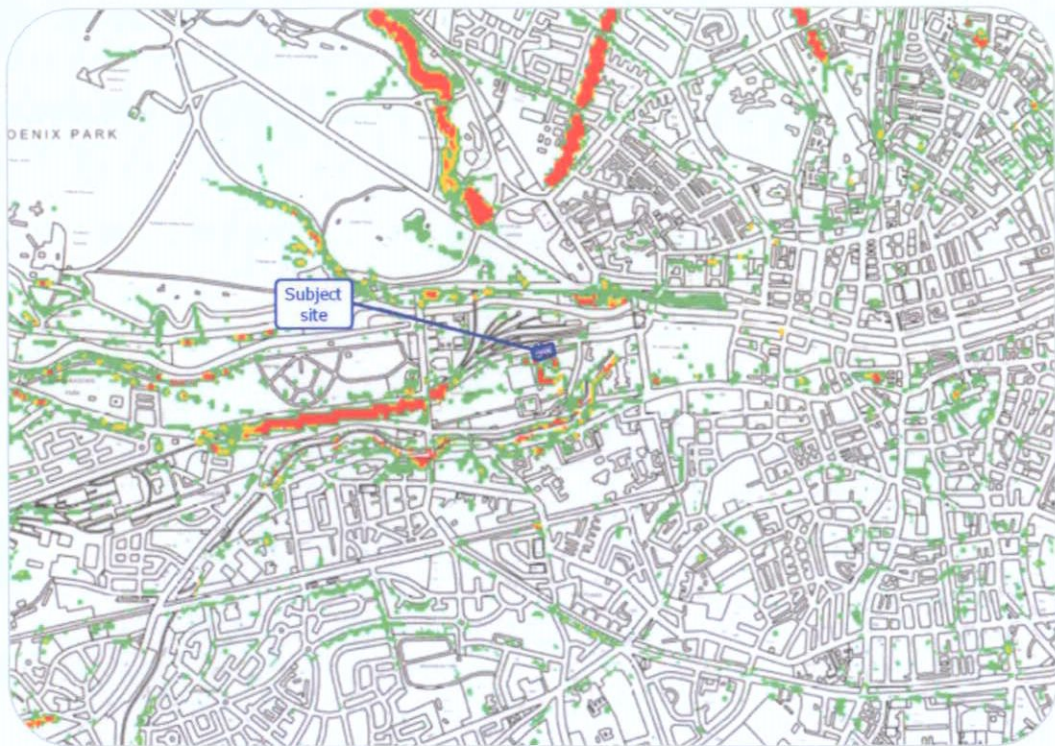
Figure 8 – Extract of DCC pluvial flood hazard mapping
(background imagery source: DCC)

Pluvial flooding is flooding which has originated from overland flow resulting from high intensity rain fall. A high-level pluvial flood map has been produced by both Dublin City Council & the OPW, but it is of benefit as a high-level tool rather than for a specific site. Previous flood events in the area can be reviewed on the Office of Public Works web site (www.floodmaps.ie). Refer to **Figure 6** and to **Appendix A** for the historical flood mapping in the area, and to **Appendix D** for the DCC pluvial flood map.
