# The Donore Project

Part 10 Application  
Infrastructure Report

The Land Development Agency

STG-AEC-S1b-00-00-RE-C-0000001\_Infrastructure\_Report

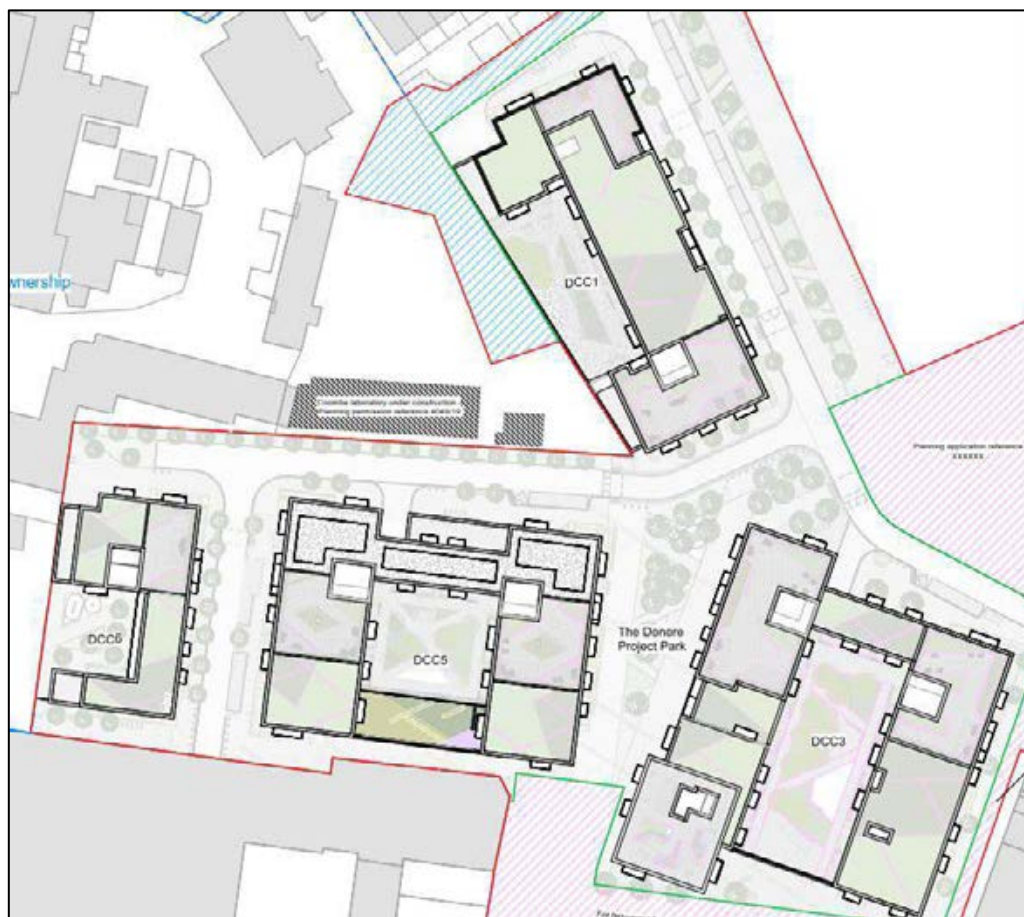
Refer to Figure 1.2 for the proposed site layout. The proposed development consists of the construction of 543 no. residential units, distributed over 4 no. proposed apartment blocks (DCC1, DCC3, DCC5 and DCC6). Table 1.1 summarises the current schedule of accommodation, per block.

Figure 1.2: Extract from drawing STG-MW-S1b-00-RF-DR-A-1100002 – Site Layout Plan Proposed

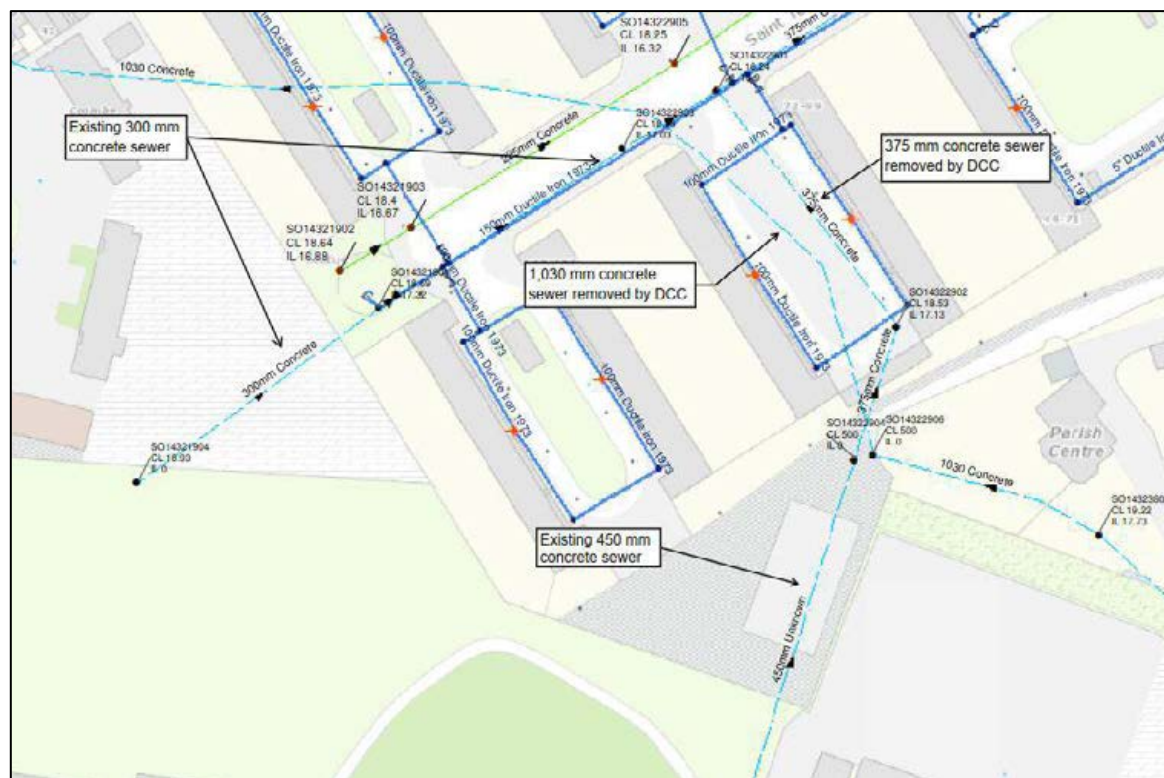
There are several existing surface water pipes present throughout the subject site and the DCC lands, as seen on the utility survey (refer to Appendix A) and the records (refer to Figure 4.1 below and Appendix G for full records).

**Figure 4.1: Surface Water sewers recorded within the Donore Project Site**

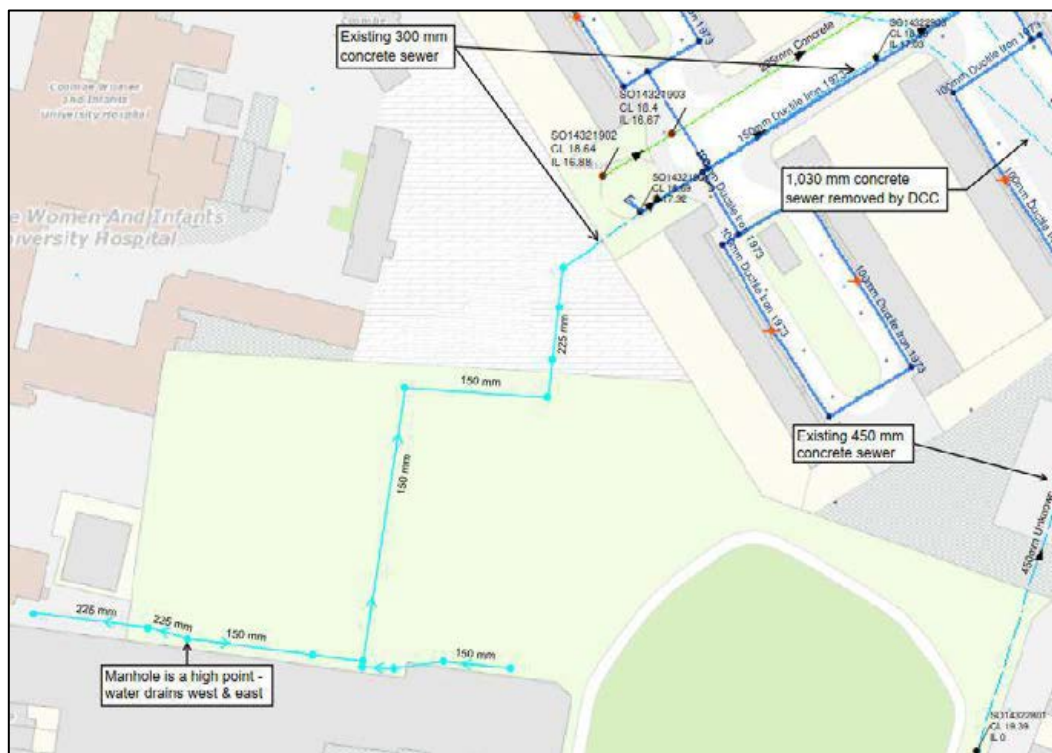
- discussions with the Contractor and Design Engineer for The Coombe Women & Infants University Hospital,
- and a CCTV Survey to determine the upstream extent of the 300 mm coming from the Bailey Gibson site which was unknown. This survey confirmed there are connections from the existing Bailey Gibson warehouse draining to this line. Refer to Appendix H for the CCTV survey report.

**Figure 4.2: Existing surface water network following investigations**

1. A portion of the Bailey Gibson warehouse drains to a 150 mm surface water line within the Donore Project site, and drains north towards The Coombe Women & Infants University Hospital car park and then joins a 300 mm sewer which drains east, which enters the Donore Project site from The Coombe Women & Infants University Hospital lands, traverses the location of the proposed DCC1 Block and continues along the site of the former St. Teresa's Gardens flats (the line upsizes to a 375 mm sewer in this area), before discharging to a 1 m stormwater culvert in Donore Avenue.

2. A 450 mm concrete sewer running parallel to the west of the Player Wills warehouse (which drains north), reduces in size to a 375 mm pipe and previously connected to the 375 mm pipe described in the bullet point above, via a 60 m run of pipe as shown in records (refer to Appendix G). This 60 m run of 375 mm pipe was removed by DCC in 2019 during demolition of St. Teresa's Gardens flats, meaning the 450 mm pipe does not join this network which discharges to the culvert in Donore Avenue. The 450 mm was not diverted to another outfall location and DCC previously noted that there was no indication of flooding as result of the lack of a downstream connection.

3. A 1,030 mm surface water concrete culvert which is shown on the records to drain from Donore Avenue, northwest across the SDRA site, entering The Coombe Women & Infants University Hospital lands. The sewer is noted to be obsolete and removed in the area where the St. Teresa's Gardens flats once existed. Northwest beyond this area, within The Coombe Women & Infants University Hospital lands, the sewer remains as a live asset. The portion of culvert within the St. Teresa's Church grounds acts as storage, permanently filled with water. The inflow to this 'storage' is from an overflow from Donore Avenue 700 mm above its invert. The outflow from this 'storage' is a 225 mm pipe which connects into the 450 mm sewer described in the bullet point above, which does not have an outfall location and DCC had noted there is no indication of flooding issues at this location. It is not proposed to divert this overflow, as the potential volume from the Donore

As can be seen from Figure 4.2 and drawing STG-AEC-S1b-00-00-DR-C-0000500\_DrainageLayoutOverall, there are existing surface water sewers traversing locations of proposed buildings. Therefore, these sewers are required to be diverted.

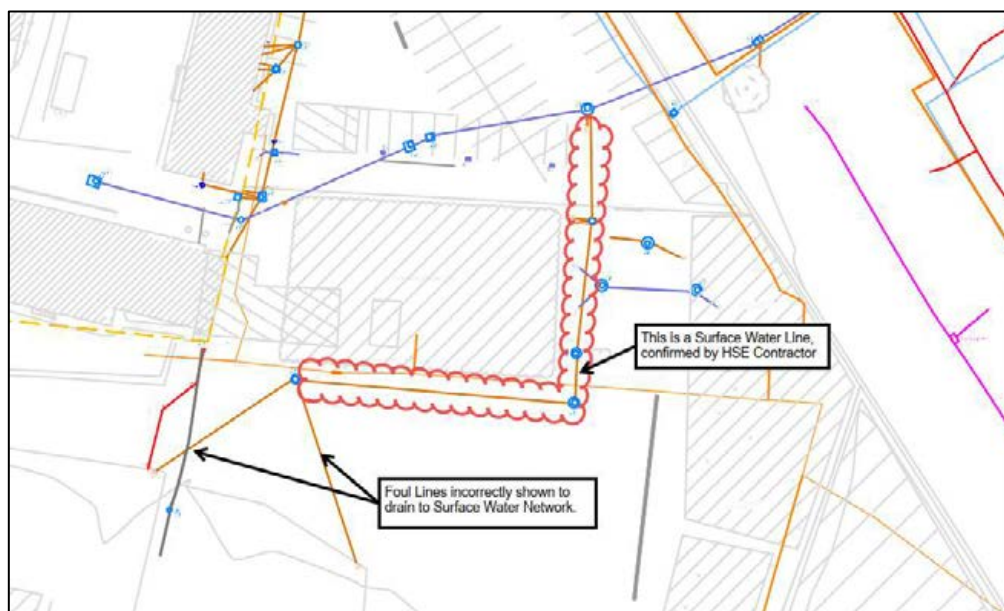
The utility survey carried out by Murphy Geospatial, shows that there are foul connections south of The Coombe Women & Infants University Hospital car park which discharge from the site compound into the separate 300 mm surface water sewer. It has been confirmed from The Coombe Women & Infants University Hospital's contractor that foul connections from the site compound do not drain to this network, despite what the utility survey shows, refer to Figure 4.3.

**Figure 4.3: Corrections to Utility Survey, confirmed by HSE Contractor**

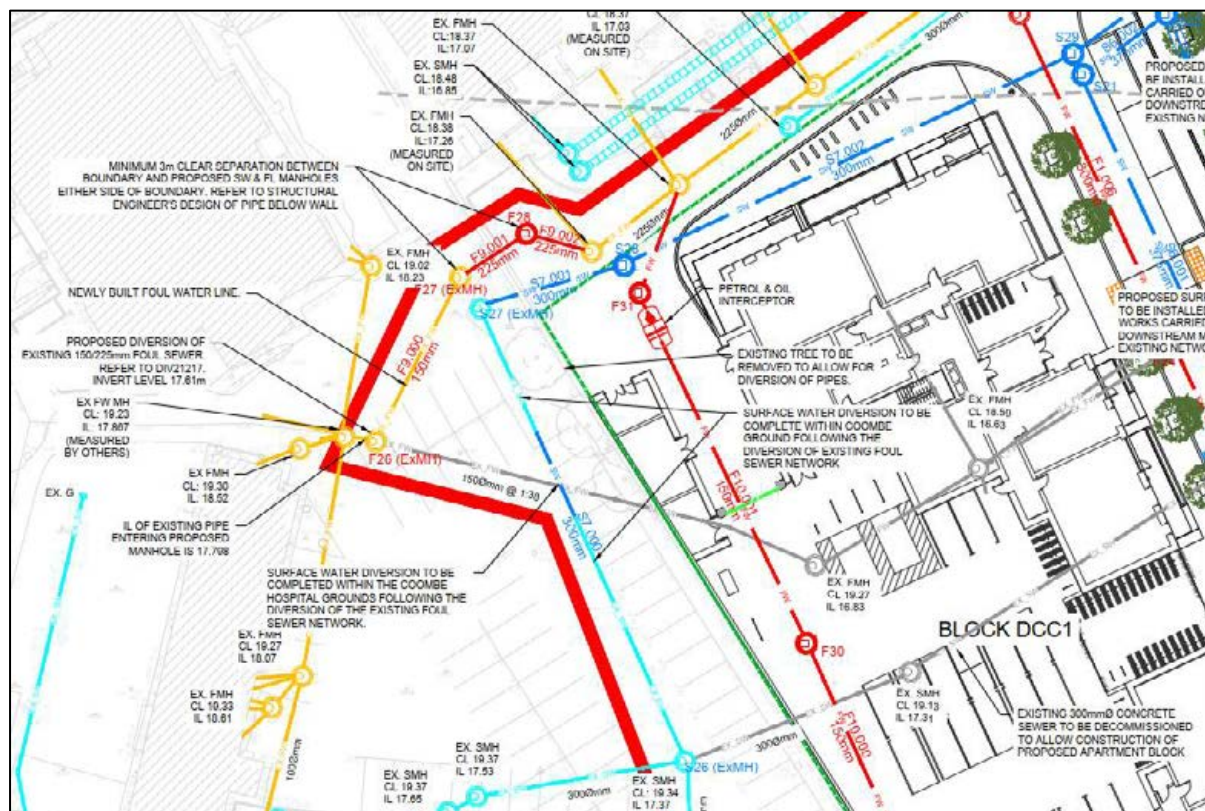
### **Diversion 3 (Future Diversion)**

It is not proposed under this application to divert/remove the overflow from Donore Avenue into the 1,030 mm culvert 'storage', this is instead proposed under a separate application for development within the SDRA. This application proposed to retain the current scenario regarding the overflow and 'storage'. It is noted however the diversion of the 450 mm line described above does reduce the flow to this dead end, thus allowing more 'storage'. The future application to divert / remove the overflow from Donore Avenue into the 1030mm culvert storage will be a standalone upgrade and does not impact this application.

**Figure 4.4: Proposed Wastewater & Surface Water Diversions**

The initial portion of the diversion is within The Coombe Women & Infants University Hospital car park. To allow the surface water diversion to be completed, a foul diversion must be completed first. The existing foul water line (the grey 'FW' line shown in Figure 4.4) will remain live until the diversion shown in red has been constructed as far as the Margaret Kennedy Road. The surface water line shown in blue would clash with the exiting foul line shown in grey, which couldn't be avoided due to levels constraints. Therefore, the surface water line can only be

As described in Section 4.3, the existing foul water line (grey 'FW' line) will remain live until the full diversion, shown in red in Figure 4.4, has been constructed as far as Margaret Kennedy Road. Manhole F29, was constructed as part of The Coombe Women & Infants University Hospital works (Diversion 1 - Phase 1), however the foul wastewater still flows southeast in the existing foul line (grey 'FW' line), until Diversion 1 - Phase 2 is completed and the manhole benching at F29 is altered so the wastewater flows northeast as per the diversion route.

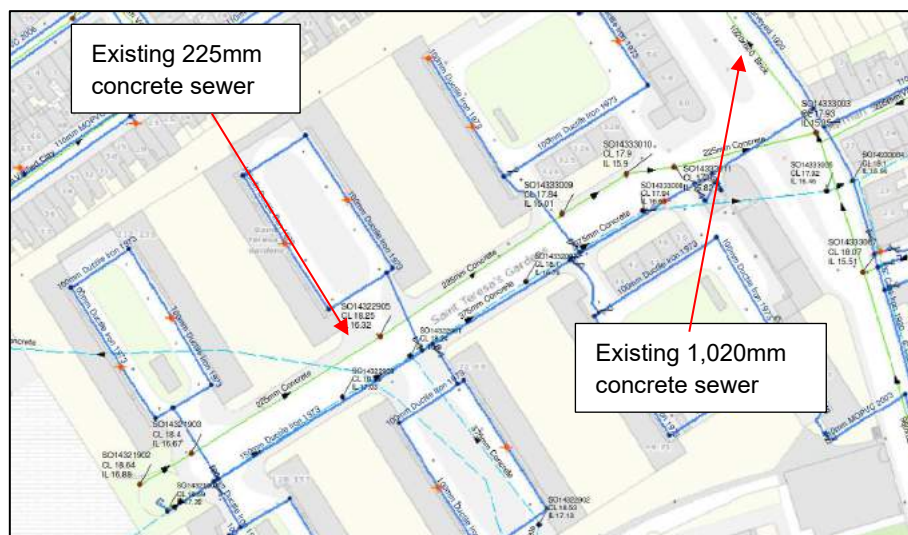
There is an existing 225 mm combined sewer which drains east, collecting the wastewater flow from The Coombe Women & Infants University Hospital (west of the site) and flowing eastwards, connecting to the existing 1,020 mm combined sewer running along Donore avenue. Please refer to Figure 5.1 for the extract of the Irish Water records map showing the identified foul sewers.

### Figure 5.1: Existing Irish Water Foul Water Records

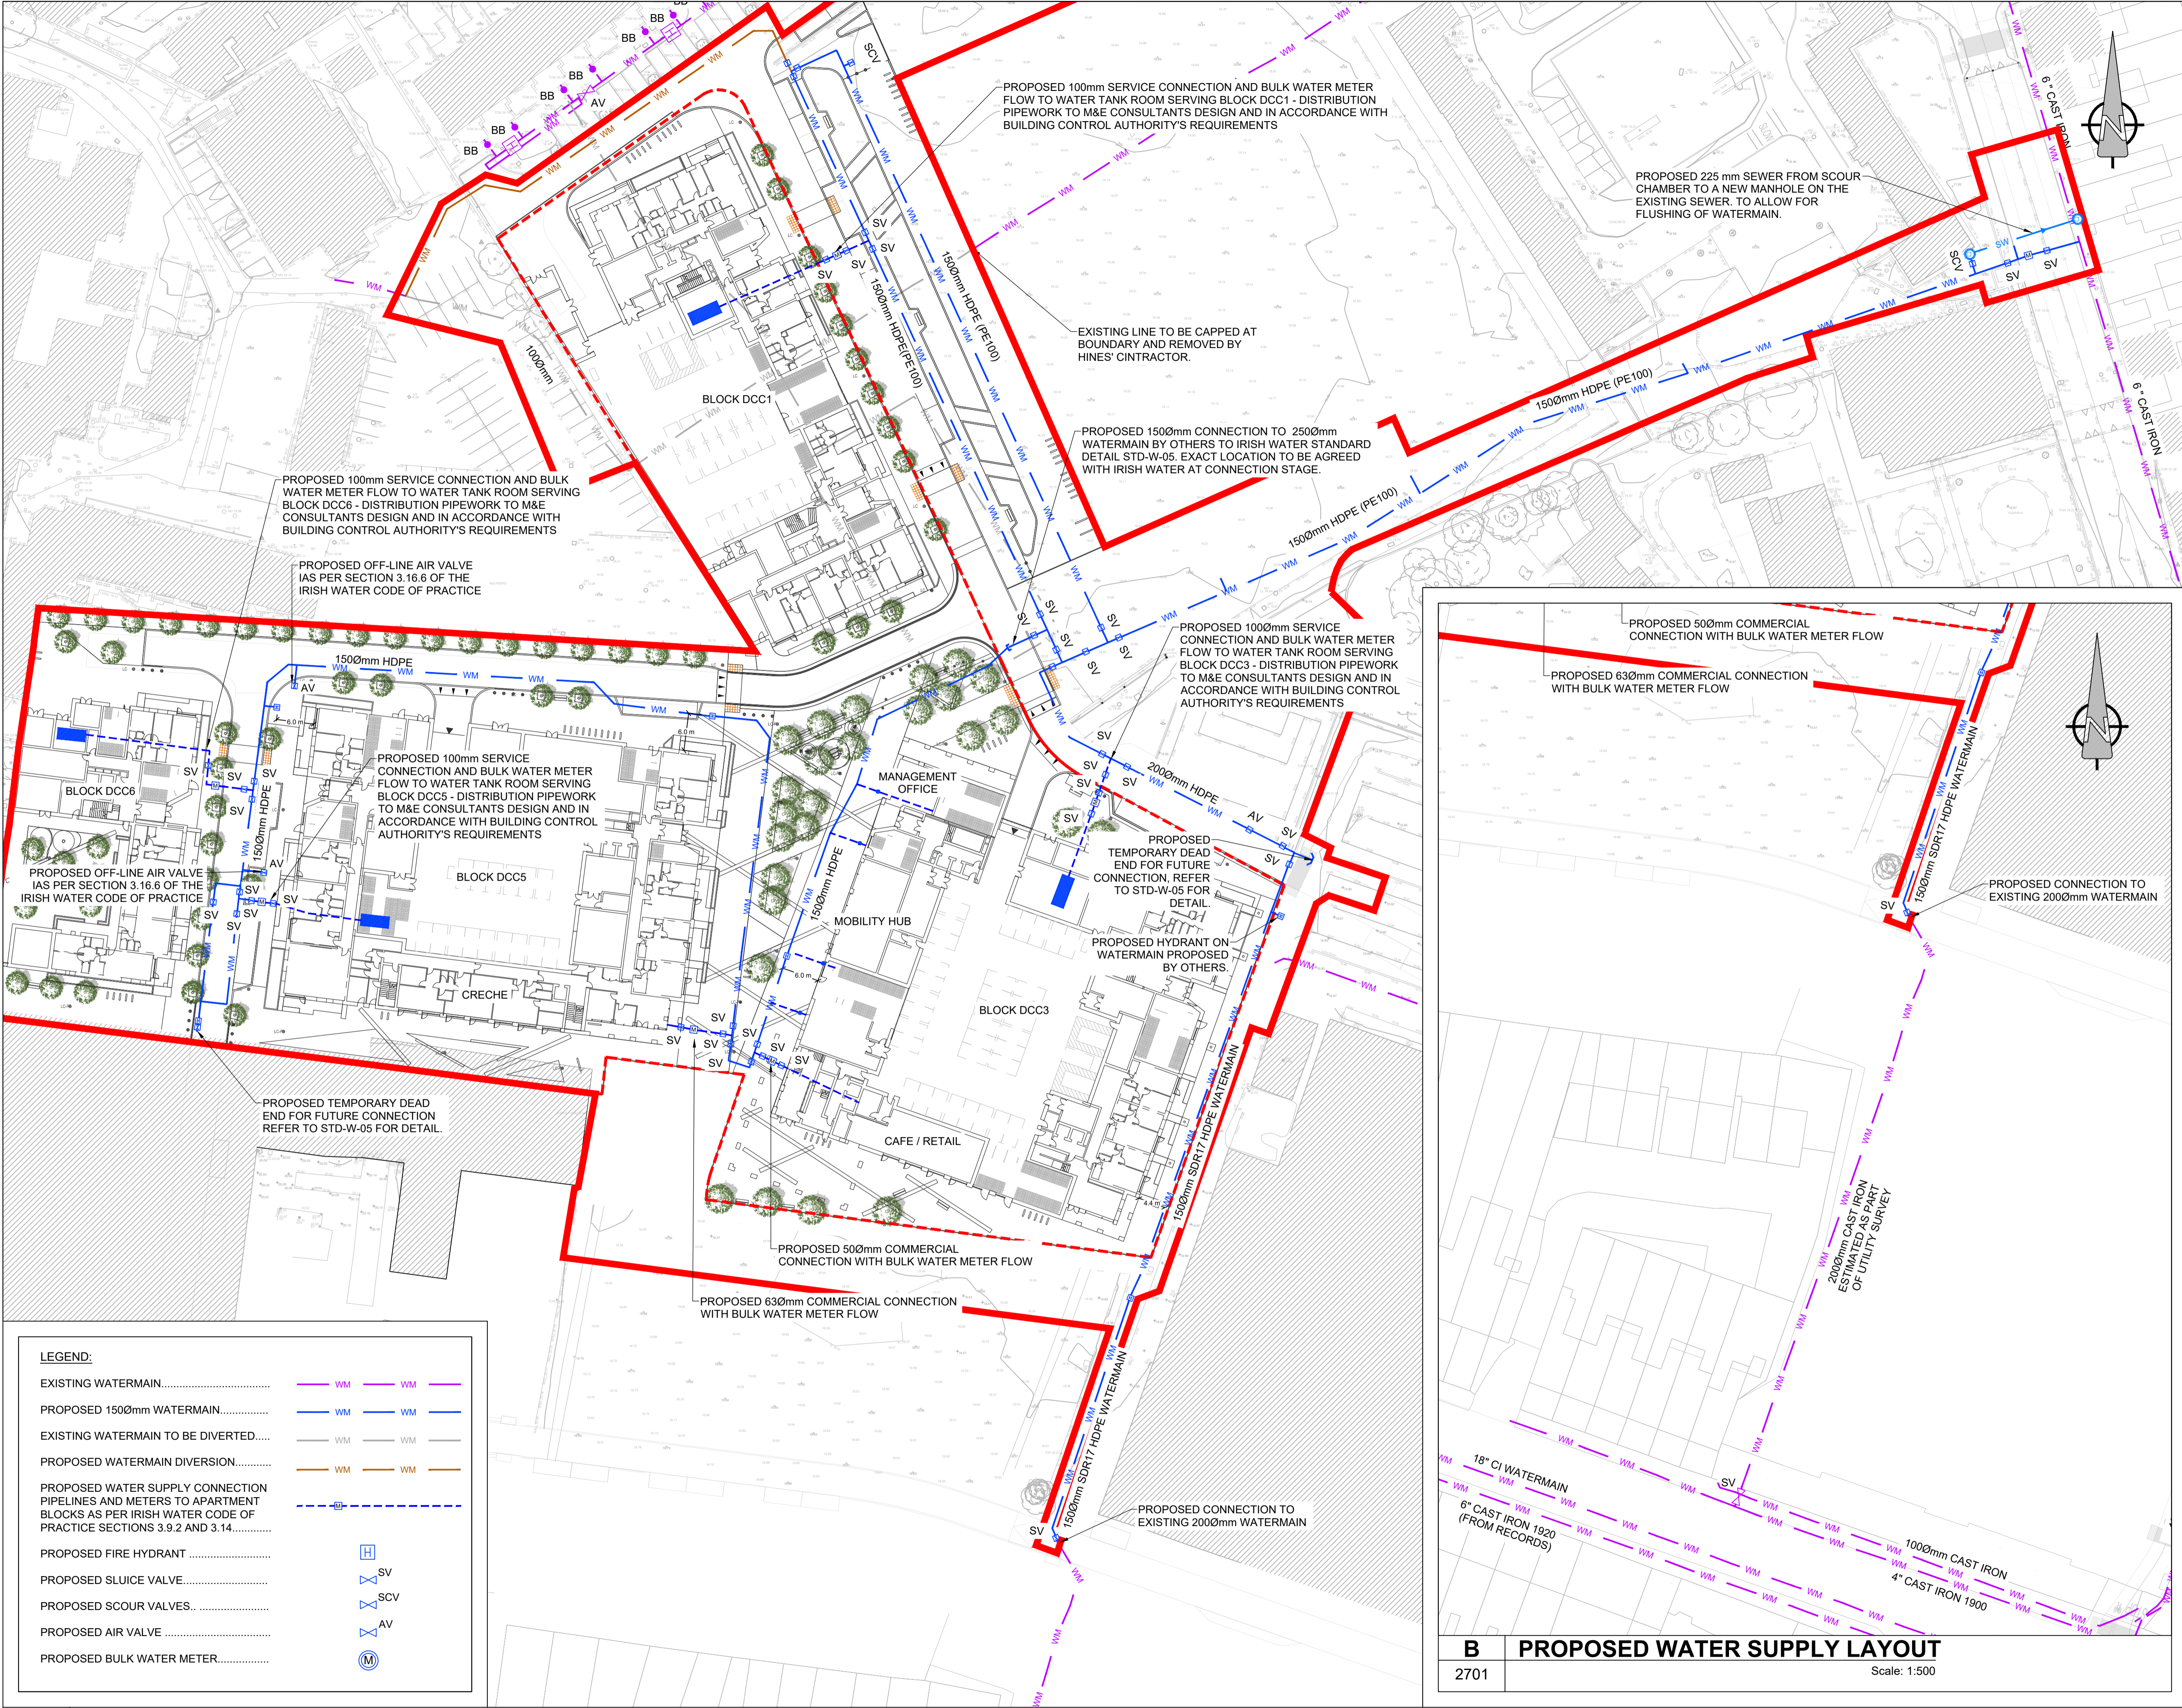
STG-AEC-S1b-00-00-DR-C-0002701

LEGEND:

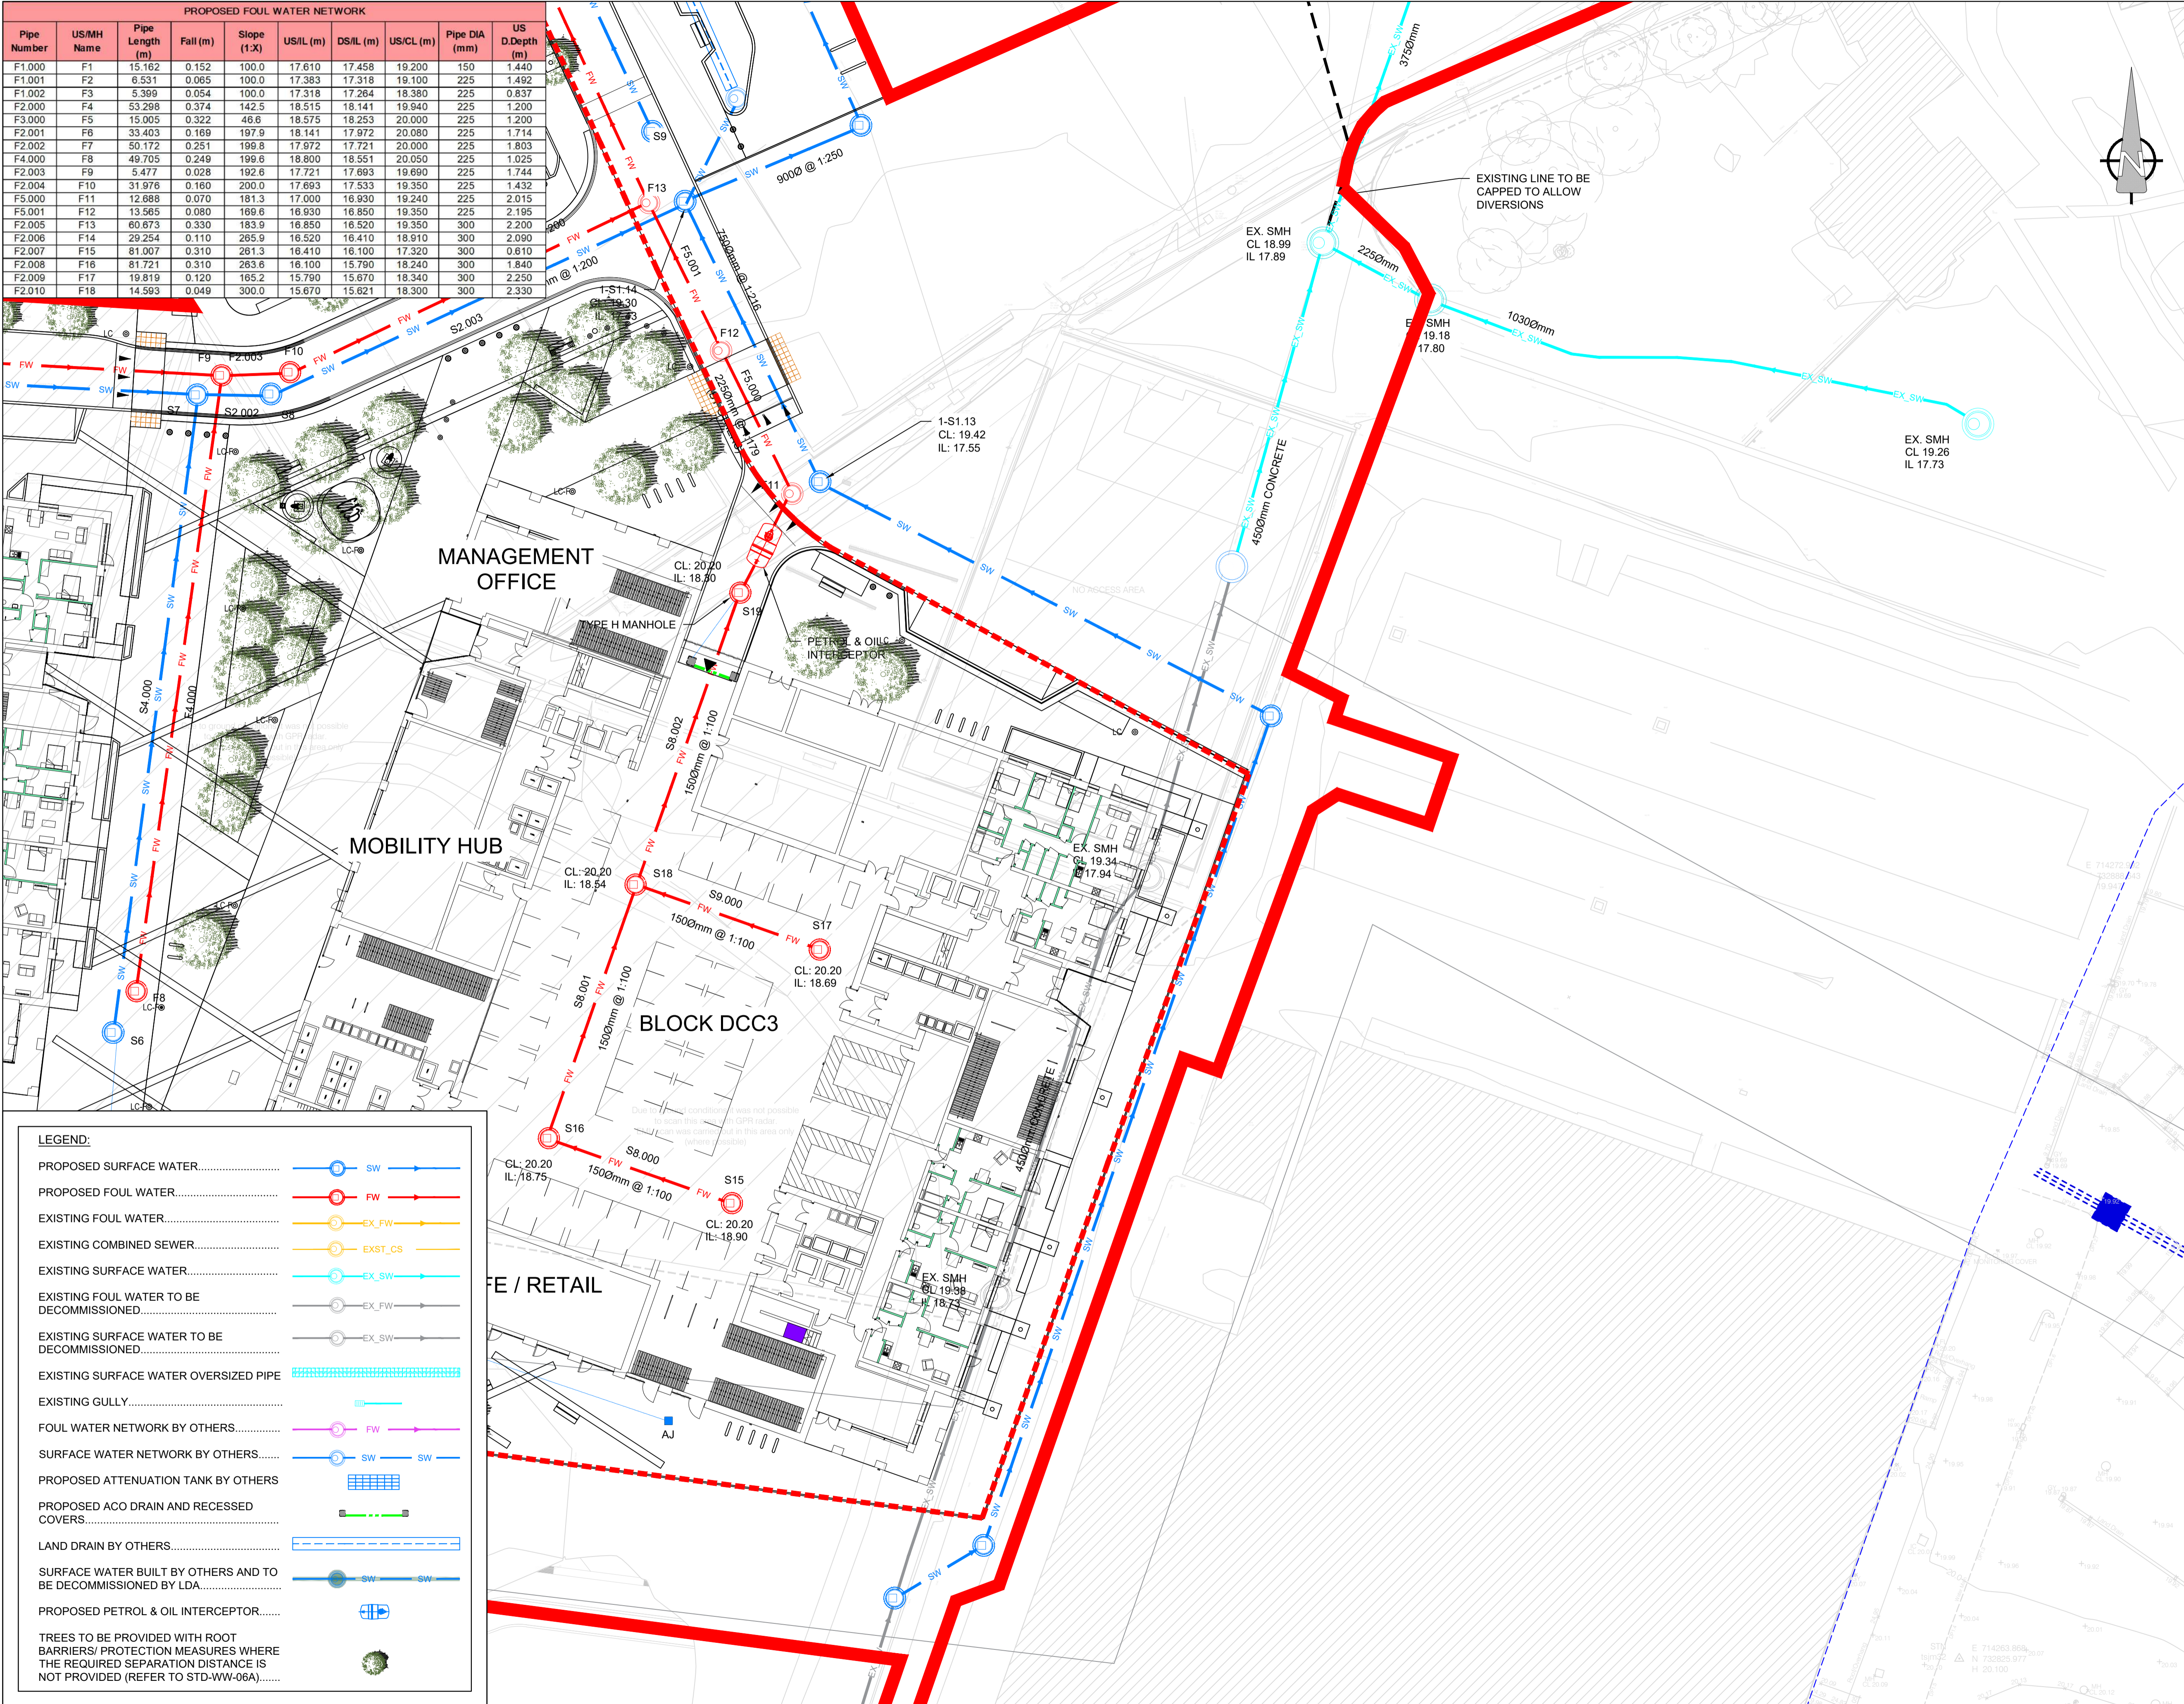
STG-AEC-S1b-00-00-DR-C-0000504

**LEGEND:**

PROPOSED SURFACE WATER.....

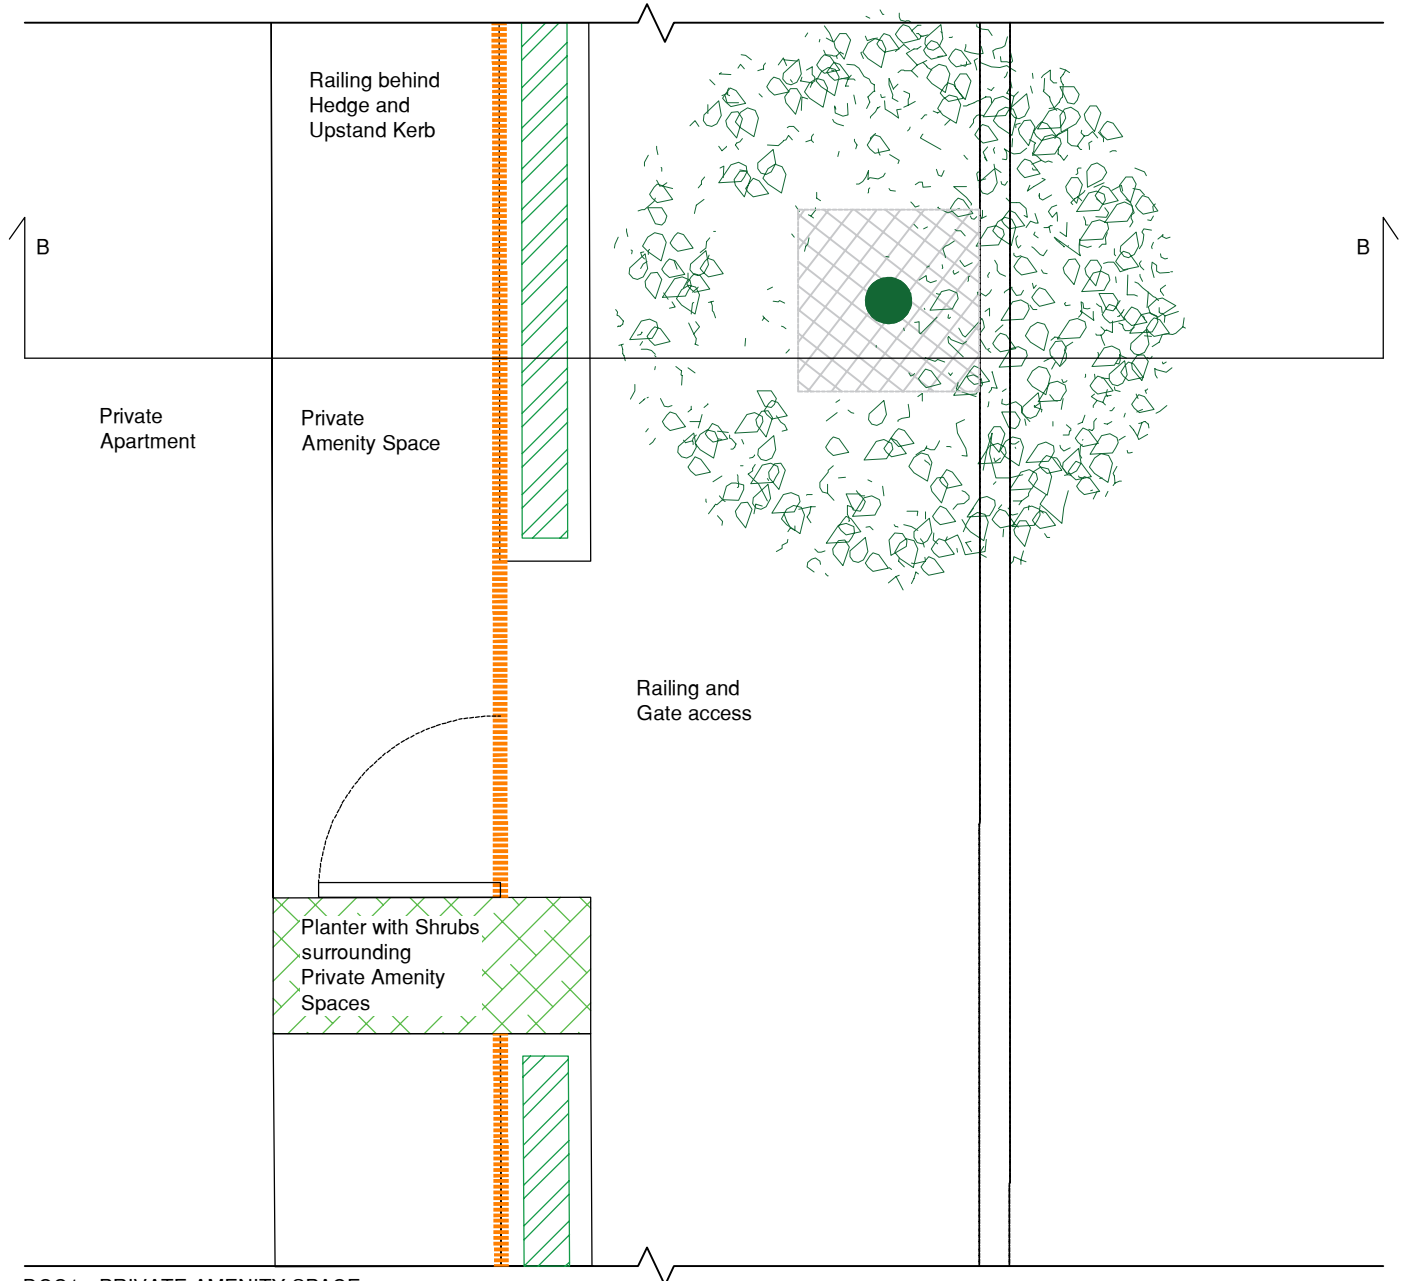
DCC1 - PRIVATE AMENITY SPACE  
1.1M HIGH RAILING AND HEDGE  
PLAN 1:50

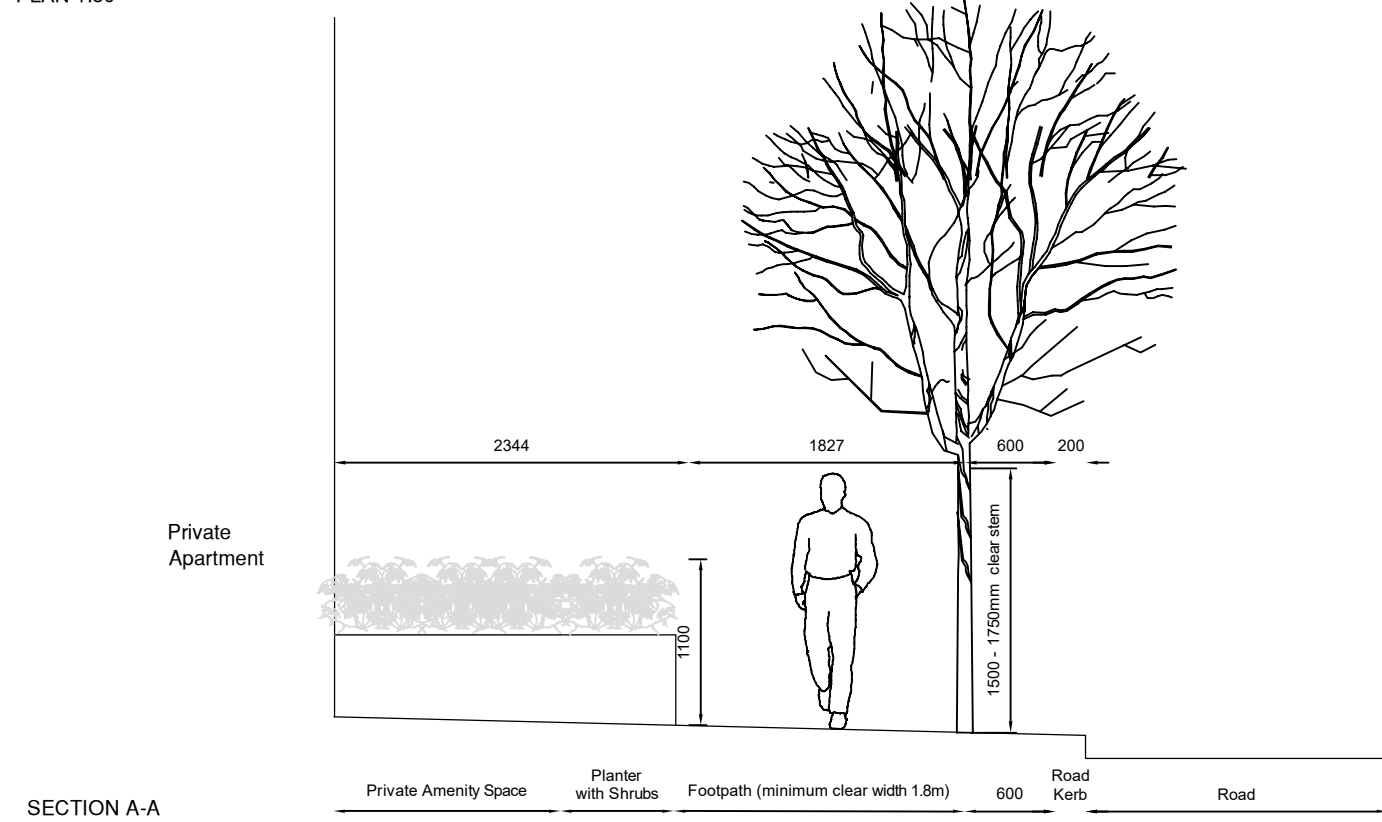
SECTION A-A

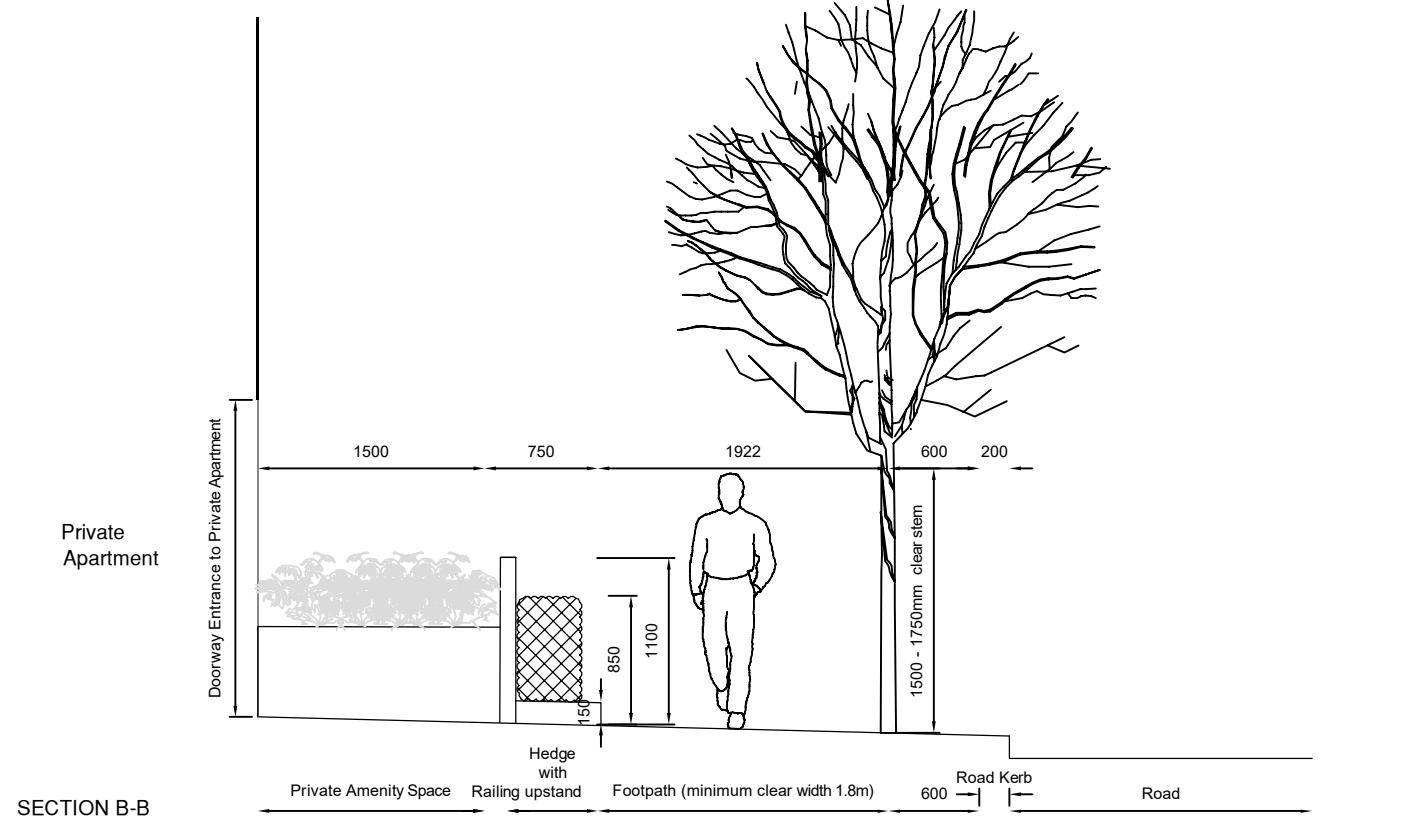
SECTION B-B

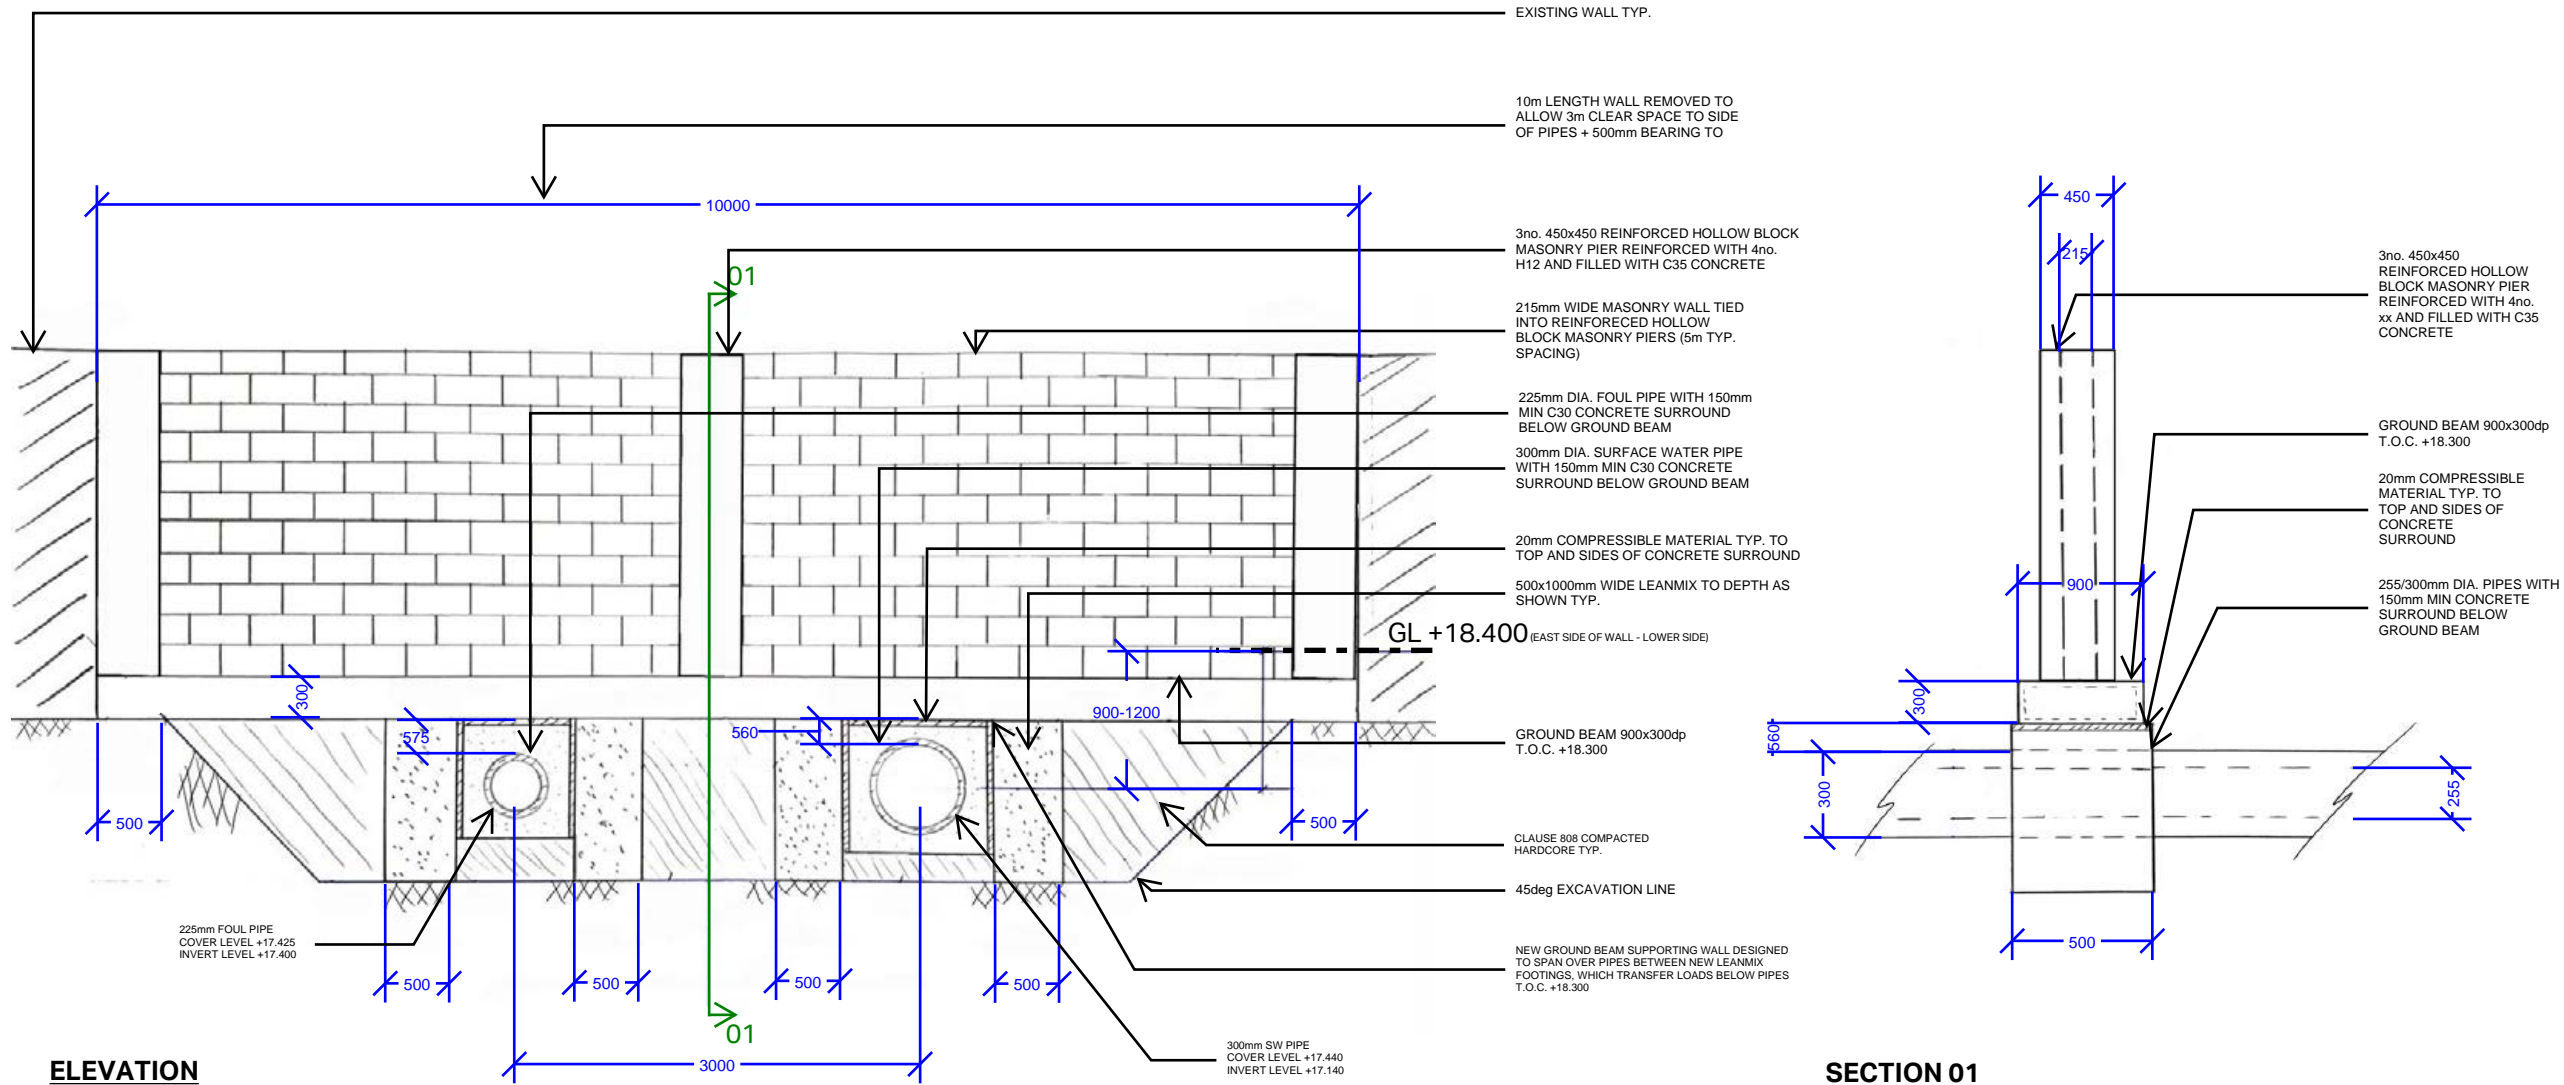
1. DEMOLISH 10m LENGTH OF WALL CENTERED ON NEW PIPE LAYOUT. MOVE 500mm OFF ENDS OF EXISTING WALL AND EXCAVATE AT 45DEG BERM TO DESIRED LEVEL

NOTE: LEVELS OF NEW FOUNDATION TO MATCH EXISTING AND ARE SUBJECT TO ADJUSTMENT

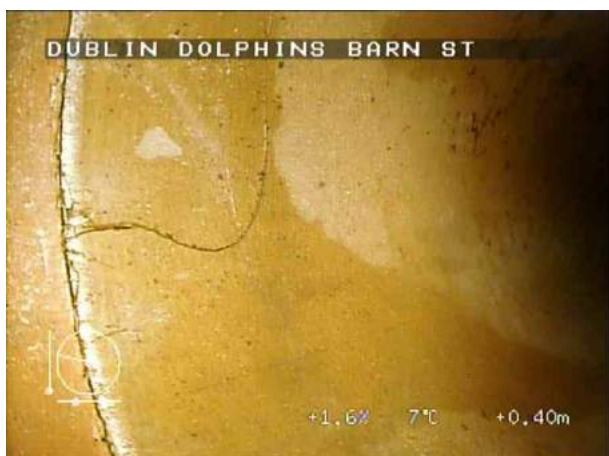
SMH4X\_4b387c41-09cd-4717-b066-db1a2cc7a6cd\_20220408\_124648\_682.jpg, 00:00:11, 0.40 m  
Roots, fine

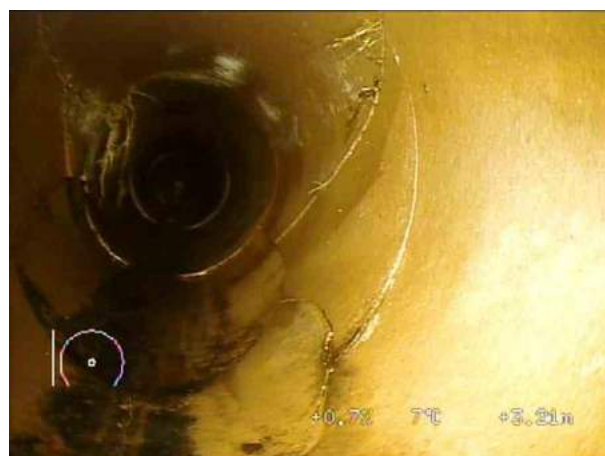
SMH4X\_adab20d6-bcc8-4224-b896-5e7e801ac00a\_20220408\_124732\_423.jpg, 00:00:38, 3.21 m  
Crack, circumferential from 4 o'clock to 8 o'clock, CRACKS AND ROOTS

Crack, circumferential from 4 o'clock to 8 o'clock: CRACKS AND ROOTS

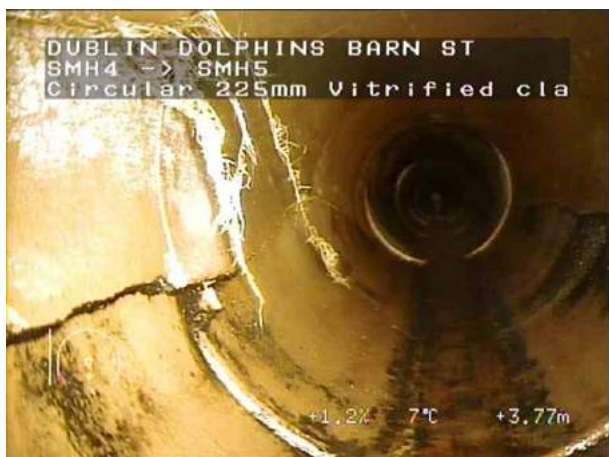
SMH4X\_2da0b000-1b7d-41b2-8540-e041eeb42d3d\_20220408\_124806\_045.jpg, 00:00:53, 3.77 m  
Fracture, circumferential from 8 o'clock to 10 o'clock

Fracture, circumferential from 8 o'clock to 10 o'clock

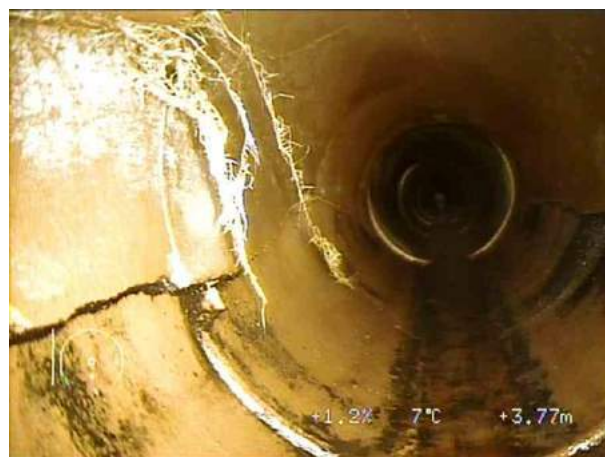
SMH4X\_3e775cd6-07bf-448a-b8af-f02383adeace\_20220408\_124815\_187.jpg, 00:00:56, 3.77 m  
Broken pipe at 9 o'clock

Broken pipe at 9 o'clock

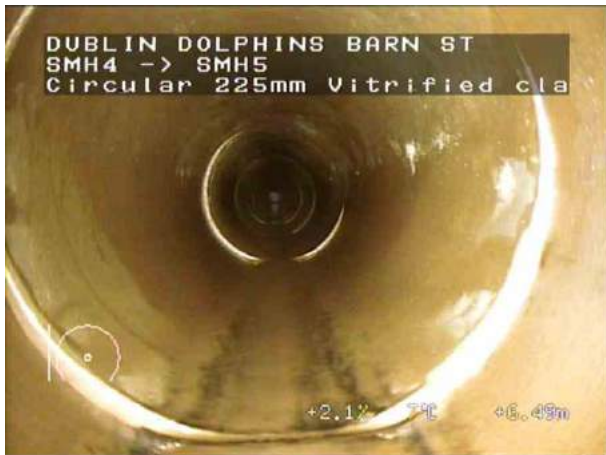
SMH4X\_0e795d9c-b08d-47e2-a26b-d0cceace6cc8\_20220408\_124844\_255.jpg, 00:01:20, 6.49 m  
Joint displaced, medium
