# The Donore Project

Part 10 Application  
Infrastructure Report

The Land Development Agency

STG-AEC-S1b-00-00-RE-C-0000001\_Infrastructure\_Report

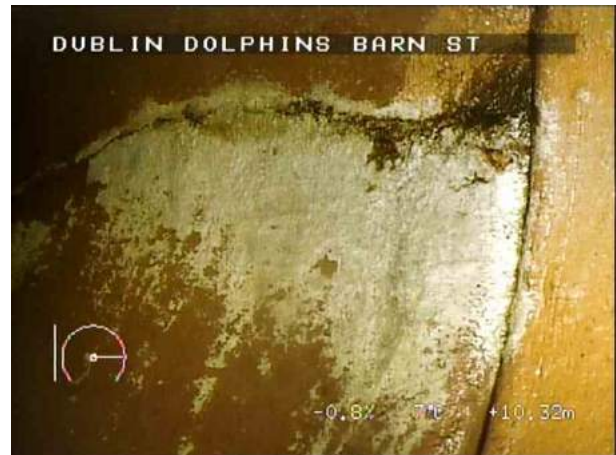
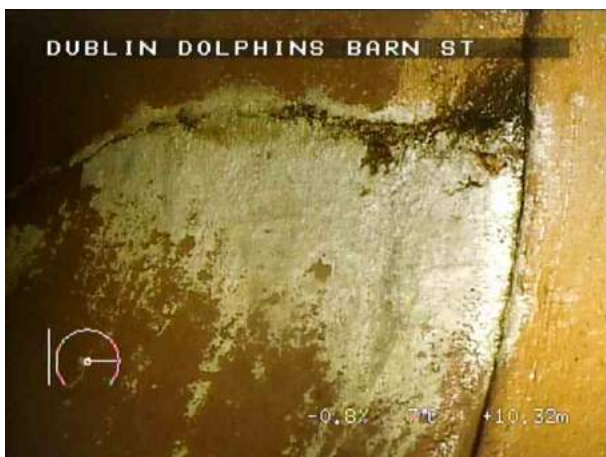
SMH4X\_92a2a218-7c0a-4af8-a8bc-a1bf08f2b202\_20220408\_124933\_070.jpg, 00:01:58, 10.32 m  
Fractures, radiating from 3 o'clock to 4 o'clock

SMH4X\_9f0fee19-06ee-4eac-a4d9-c5c9cc5831d0\_20220408\_124933\_278.jpg, 00:01:58, 10.32 m  
Fractures, radiating from 3 o'clock to 4 o'clock

Fractures, radiating from 3 o'clock to 4 o'clock

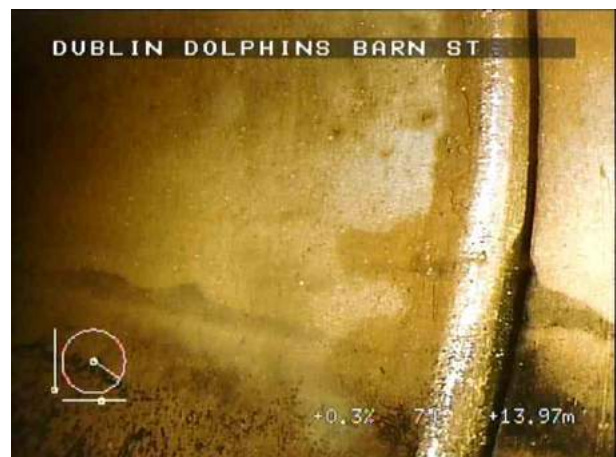
SMH4X\_f82a13ab-69c4-45fd-8f68-8b0b8f6aada8\_20220408\_125015\_918.jpg, 00:02:34, 13.97 m  
Open joint, medium

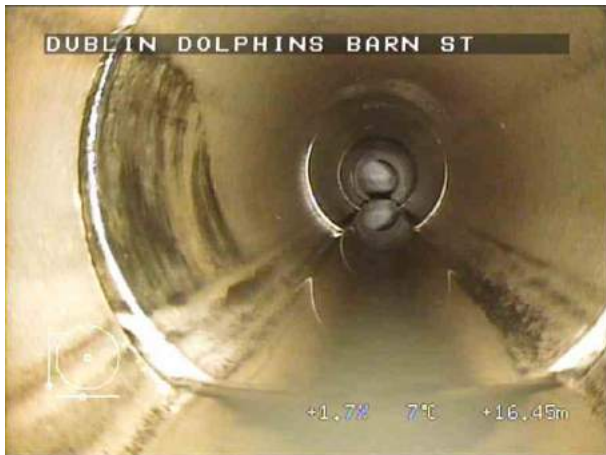
SMH4X\_640e99a1-0852-4f0b-bc90-f30d2a366878\_20220408\_125041\_365.jpg, 00:02:54, 16.45 m  
 Joint displaced, large

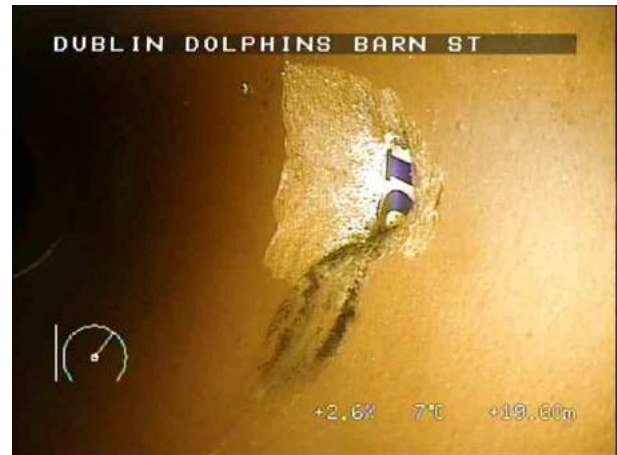
SMH4X\_81fbdfc0-ff1d-458a-a526-edb992863217\_20220408\_125119\_158.jpg, 00:03:20, 19.60 m  
 Hole in drain or sewer from 1 o'clock to 2 o'clock

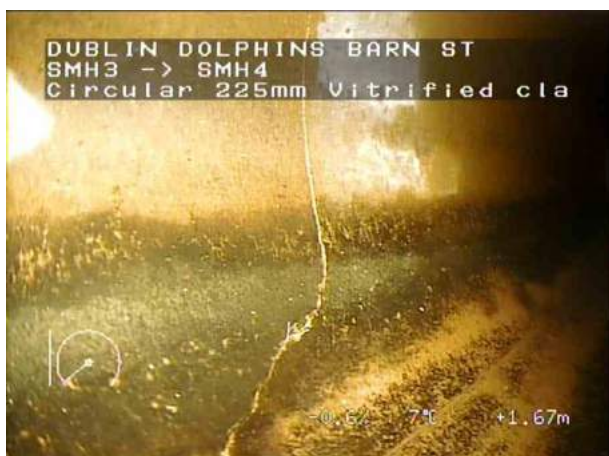
SMH3X\_5d898e02-e1ea-4f7e-bf14-5680b51cd7bd\_20220408\_124241\_795.jpg, 00:00:49, 1.67 m  
Cracks, radiating from 8 o'clock to 10 o'clock

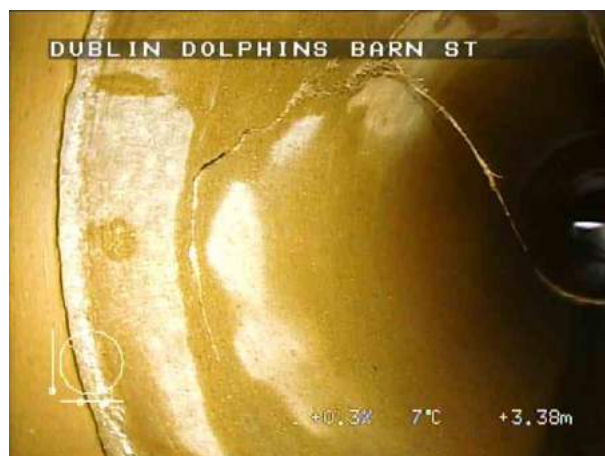
SMH3X\_b86fdd8e-a315-41cf-9ab9-d544ffdc3481\_20220408\_124314\_235.jpg, 00:01:12, 3.38 m  
Fractures, radiating from 8 o'clock to 11 o'clock

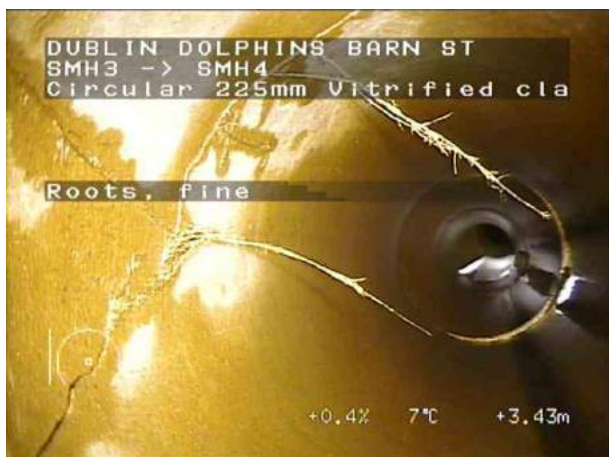
SMH3X\_f6659471-79aa-4ef4-a5ee-c77b76d7ee39\_20220408\_124332\_580.jpg, 00:01:24, 3.43 m  
Roots, fine

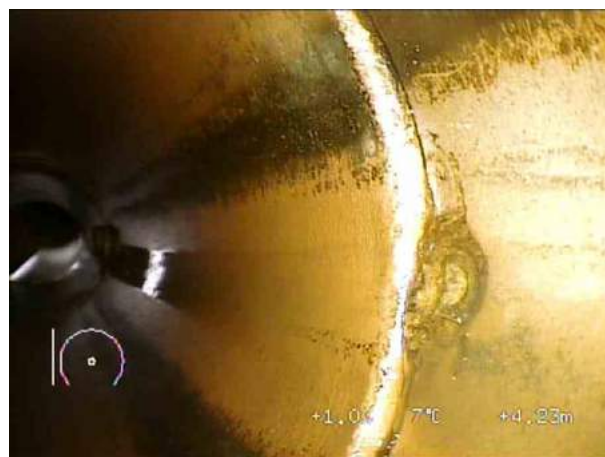
SMH3X\_f19e9c9c-3e15-4058-b30f-a15ba3ec114a\_20220408\_124410\_857.jpg, 00:01:49, 4.23 m  
Hole in drain or sewer at 6 o'clock

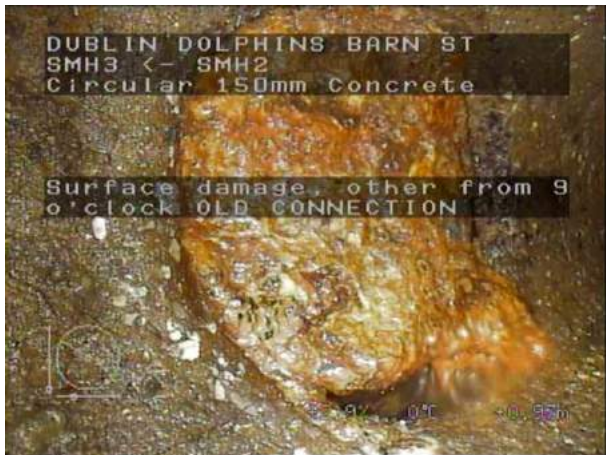
SMH3X\_3048078d-313b-4a0c-b62f-0b3dfd6fad3e\_20220408\_101131\_664.jpg, 00:00:26, 0.97 m  
Surface damage, other from 9 o'clock to 11 o'clock, OLD CONNECTION

0.00	S01	DEZ Attached deposits, other from 12 o'clock to 12 o'clock, 5% cross-sectional area loss, start: SILT	00:00:04		3
		0.97	SZ	Surface damage, other from 9 o'clock to 11 o'clock: OLD CONNECTION	00:00:26	SMH3X_3 048078d-3 13b-4a0c-

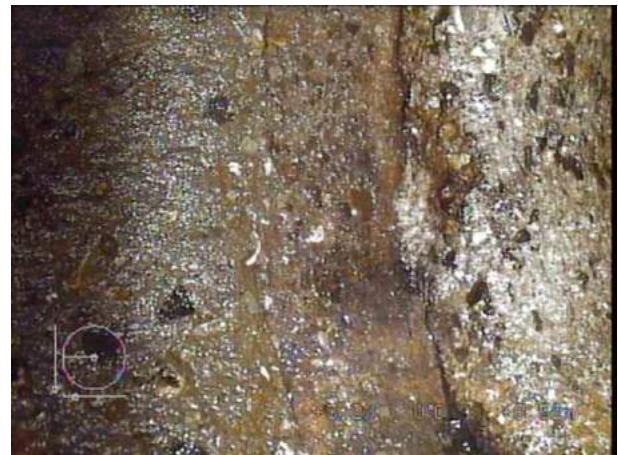
SMH3X\_f949510e-b4f6-4394-8afe-2daf860bfc1d\_20220408\_101348\_771.jpg, 00:02:23, 8.52 m  
Open joint, large

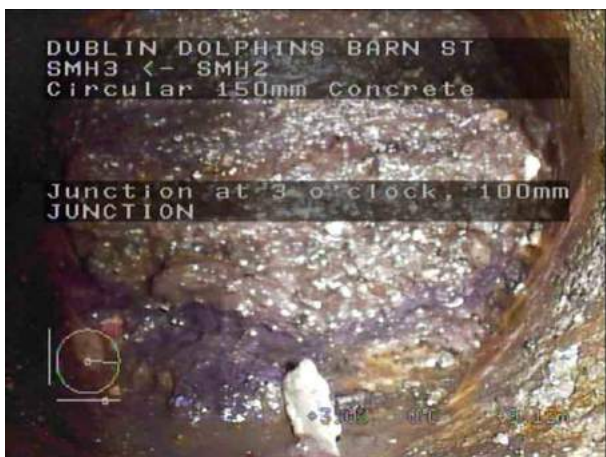
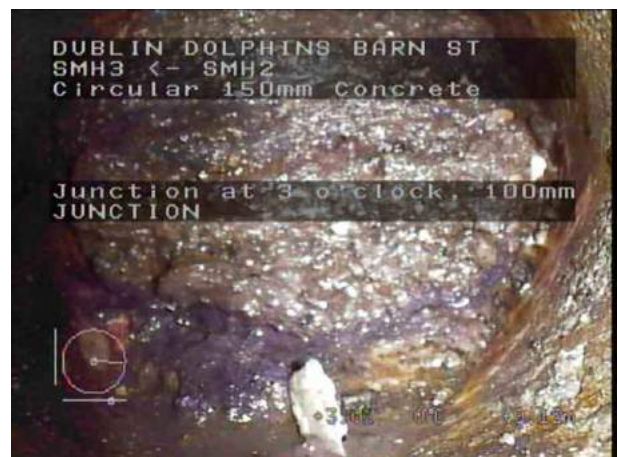
SMH3X\_a0c2e369-32cc-4cbc-b45b-fe9c2527e042\_20220408\_101438\_189.jpg, 00:02:50, 9.12 m  
Junction at 3 o'clock, 100mm dia, OLD JUNCTION

SMH3X\_97c281b6-352d-4a2b-aacf-9862c78501cb\_20220408\_101439\_675.jpg, 00:02:50, 9.12 m  
Junction at 3 o'clock, 100mm dia, OLD JUNCTION

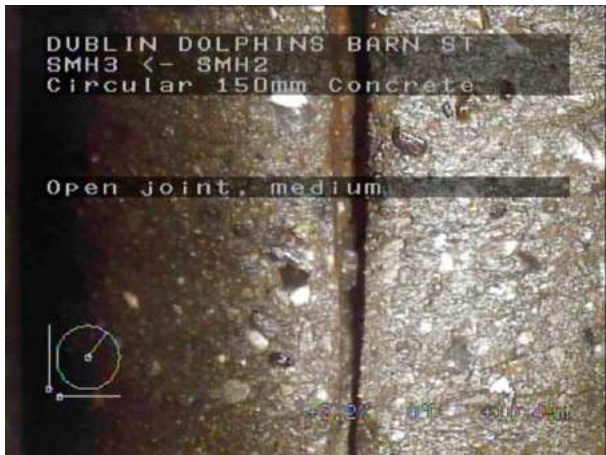
SMH3X\_ee8eff8b-ef12-4309-8494-48da32b7e79d\_20220408\_101528\_559.jpg, 00:03:34, 10.49 m  
Open joint, medium

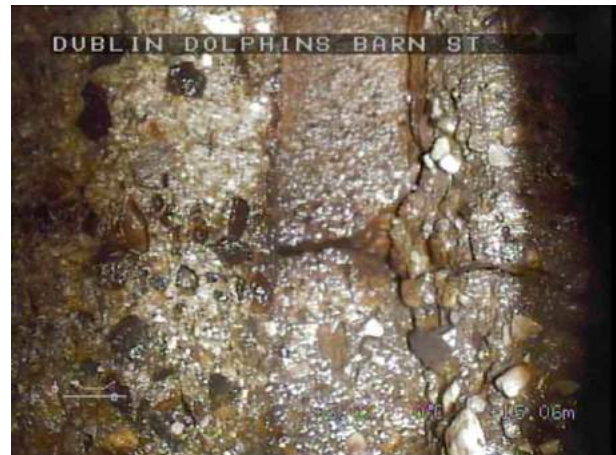
SMH3X\_191414e8-b719-45b2-aca3-856292a3ef3b\_20220408\_101720\_789.jpg, 00:04:57, 15.06 m  
Open joint, large, CRANCK ON JOINT

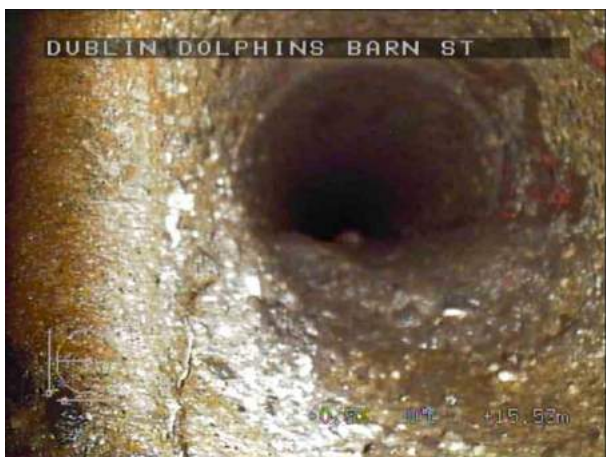
SMH3X\_53077791-5ac5-4dee-879f-715ab5cb6e64\_20220408\_101811\_303.jpg, 00:05:13, 15.53 m  
Junction at 9 o'clock, 100mm dia

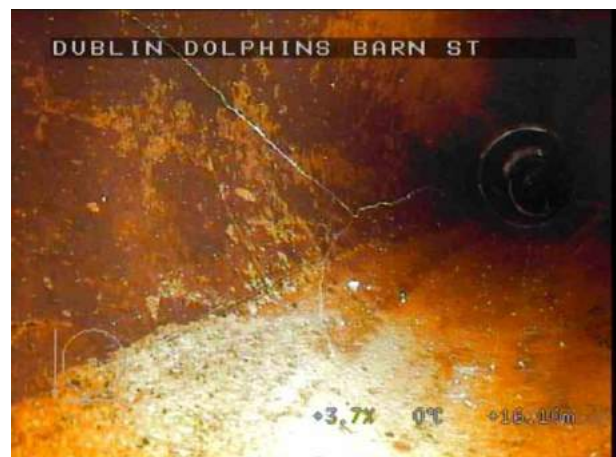
SMH3X\_fe378036-504c-4eea-937a-ddab3fadaa73\_20220408\_102006\_609.jpg, 00:05:54, 16.10 m  
Cracks, radiating from 8 o'clock to 10 o'clock

16.10	CR	Cracks, radiating from 8 o'clock to 10 o'clock	00:05:54	SMH3X_fe 378036-50 4c-4eea-9	3 / 2
		17.22	FCJ	Fracture, circumferential at joint from 10 o'clock to 12 o'clock	00:06:36	SMH3X_2 856e269-1 400-4a1e-	3 / 2

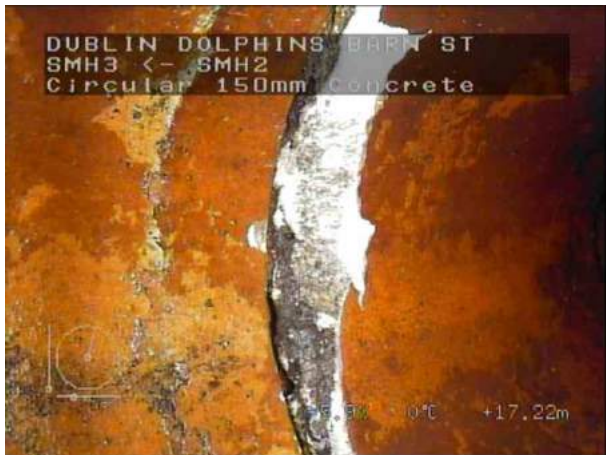
SMH3X\_2856e269-1400-4a1e-880a-86ee3f0c09ed\_20220408\_102207\_967.jpg, 00:06:36, 17.22 m  
Fracture, circumferential at joint from 10 o'clock to 12 o'clock

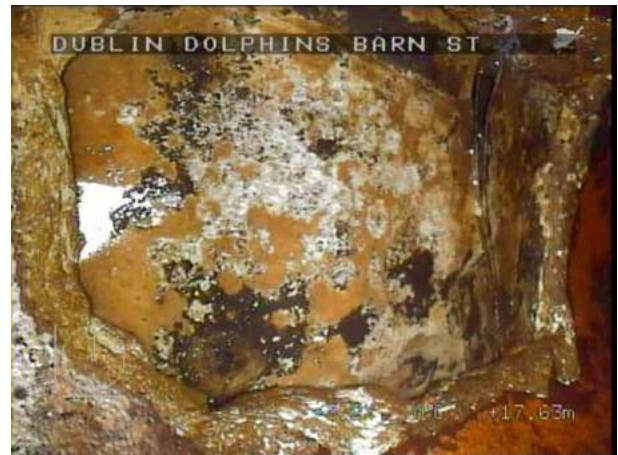
SMH3X\_4bc7a12c-afa4-49e1-a5d1-6b8698e8d898\_20220408\_102308\_252.jpg, 00:06:54, 17.63 m  
Deformed sewer or drain, 10%, OLD CONNECTION

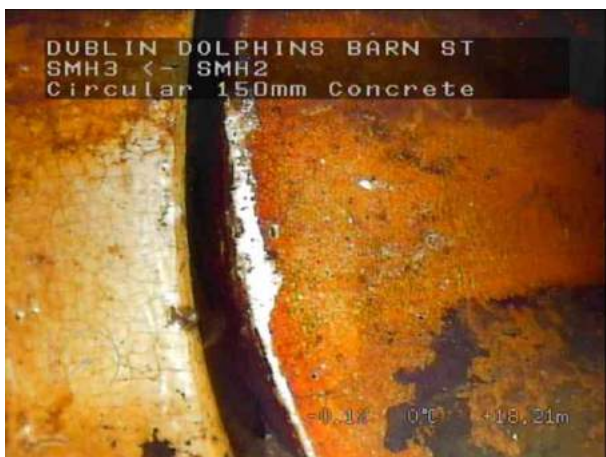
SMH3X\_4560511f-a8a0-4761-b103-2ad8f21897b7\_20220408\_102426\_372.jpg, 00:07:51, 18.21 m  
Open joint, medium

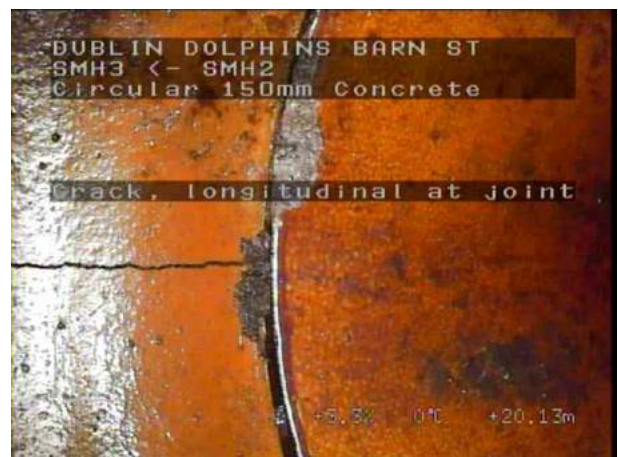
SMH3X\_0ac6157f-b4ab-4ad9-8172-19cf6c224f8e\_20220408\_102755\_481.jpg, 00:08:26, 20.13 m  
Crack, longitudinal at joint at 12 o'clock

20.13	CLJ	Crack, longitudinal at joint at 12 o'clock	00:08:26	SMH3X_0 ac6157f-b 4ab-4ad9-	2 / 2

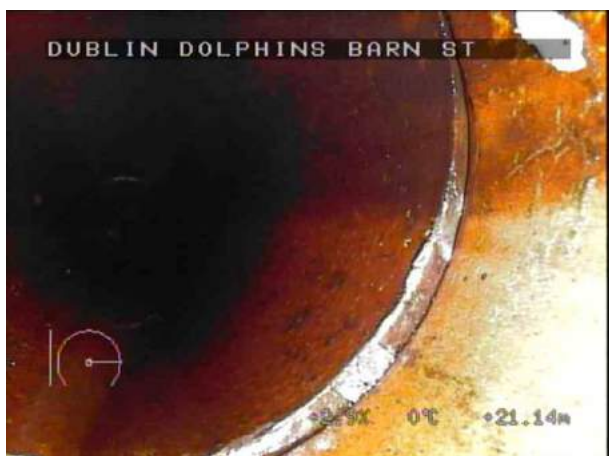
SMH3X\_b2ac8f39-db7c-4314-b07c-01876c25bebb\_20220408\_102842\_873.jpg, 00:08:54, 21.14 m  
Joint displaced, large

21.14	JDL	Joint displaced, large	00:08:54	SMH3X_b 2ac8f39-d b7c-4314-	1 / 4
		21.20	D	Deformed sewer or drain, 5%	00:09:18	SMH3X_d 48bc823-7 a6c-4735-	2 / 2

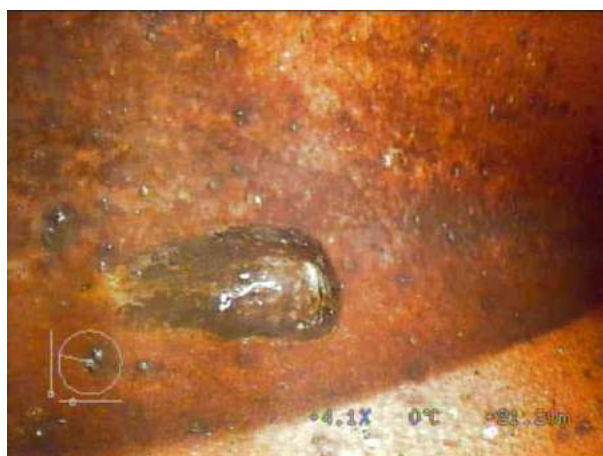
SMH3X\_d48bc823-7a6c-4735-a61d-b64428dd3433\_20220408\_102923\_372.jpg, 00:09:18, 21.20 m  
Deformed sewer or drain, 5%

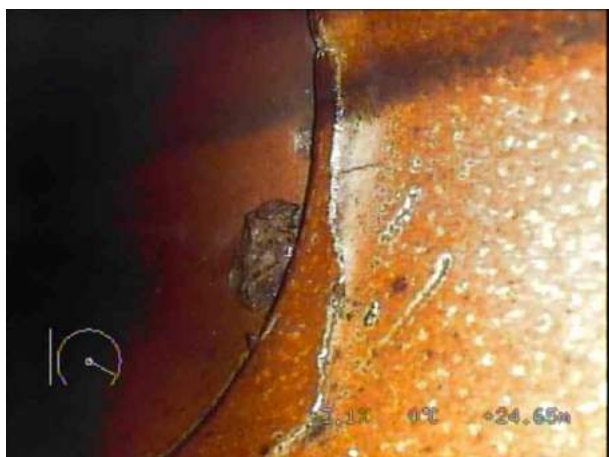
SMH3X\_0ebb6a48-de9d-4969-8cc3-2cbcd6f102d8\_20220408\_103035\_844.jpg, 00:10:19, 24.65 m  
Crack, circumferential from 3 o'clock to 4 o'clock

24.65	CC	Crack, circumferential from 3 o'clock to 4 o'clock	00:10:19	SMH3X_0 ebb6a48-d e9d-4969-	2 / 2
		27.19	SR	Sealing ring intruding at 6 o'clock	00:11:01		1 / 1

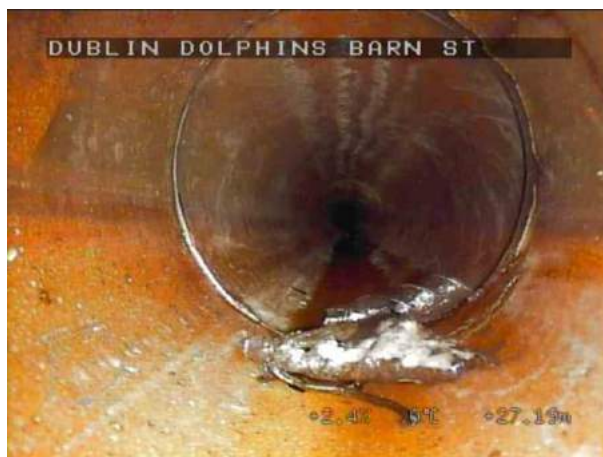
SMH3X\_4f6e492a-5e77-4b84-8bf2-9b37f8e05a1e\_20220408\_103145\_695.jpg, 00:11:01, 27.19 m  
Sealing ring intruding at 6 o'clock

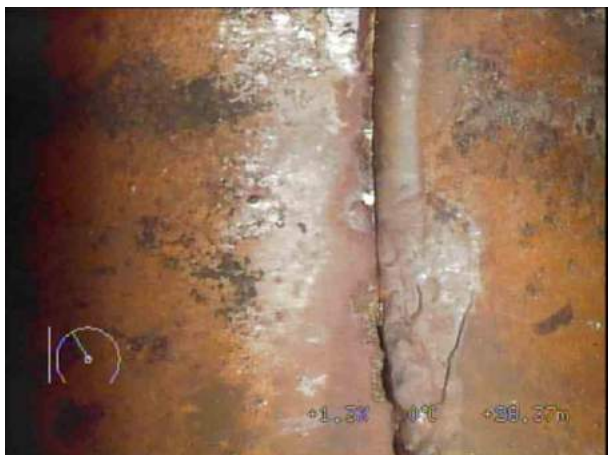
SMH3X\_2d4f37a4-ef05-4947-9a4c-4fce43f26fed\_20220408\_103232\_340.jpg, 00:11:25, 28.37 m  
Deformed sewer or drain, 10%

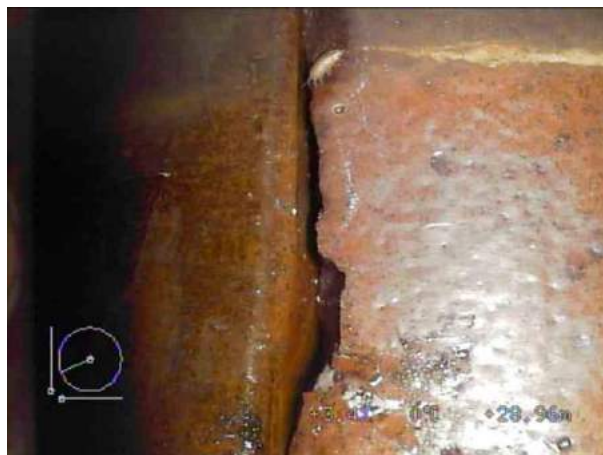
SMH3X\_c4e3b749-1326-407f-856d-6befd816f5e4\_20220408\_103324\_828.jpg, 00:12:01, 28.96 m  
Open joint, large

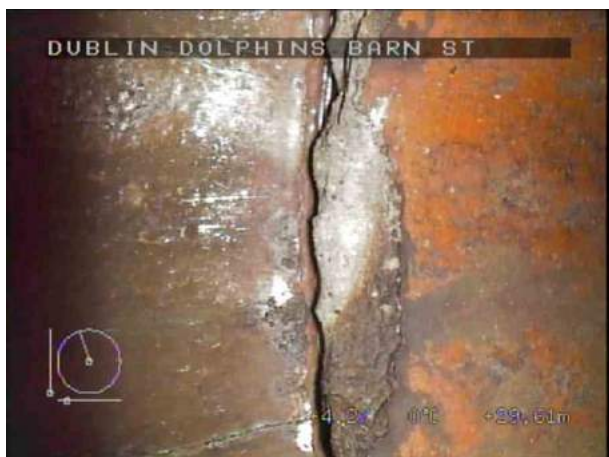
SMH3X\_e097369b-9d07-4f80-b9f6-642262c70cb6\_20220408\_103357\_091.jpg, 00:12:25, 29.61 m  
Open joint, large

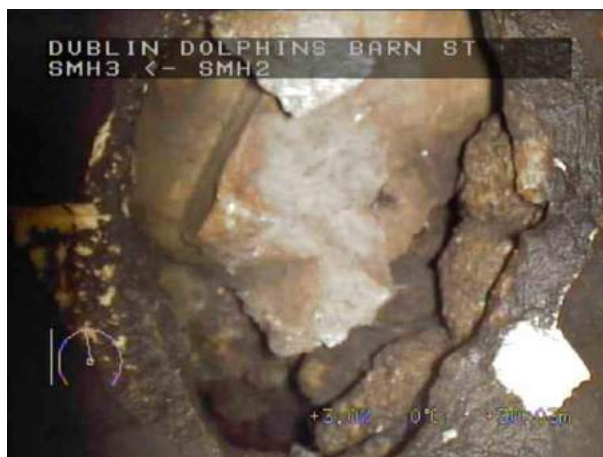
SMH3X\_31bada83-1254-45d7-9f25-eaef24bba3c3\_20220408\_103439\_621.jpg, 00:12:44, 30.03 m  
Hole in drain or sewer from 11 o'clock to 1 o'clock

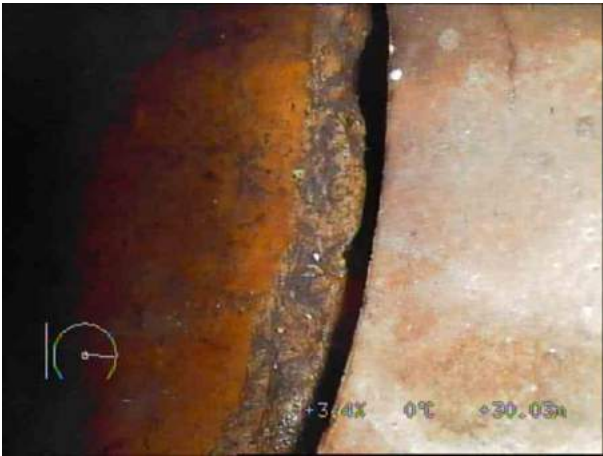
SMH3X\_0aac7fce-5a23-446e-884d-486e70784976\_20220408\_103502\_848.jpg, 00:13:00, 30.03 m  
Open joint, large

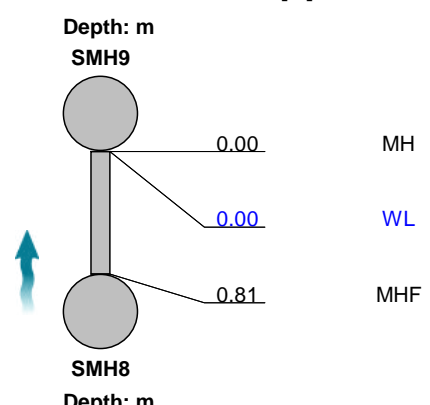
0.00	MH	Start node, manhole, reference: SMH9	00:00:00		
		0.00	WL	Water level, 5% of the vertical dimension	00:00:00		
		0.81	MHF	Finish node, manhole, reference: SMH8	00:00:12

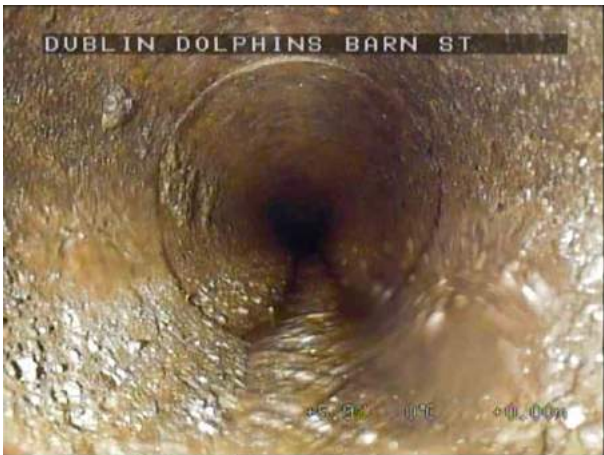
SMH2X\_8c149130-048c-446d-86a1-1400bc3ca565\_20220412\_123830\_327.jpg, 00:00:05, 0.00 m  
Attached deposits, other from 12 o'clock to 12 o'clock, 5% cross-sectional area loss, finish, SILT

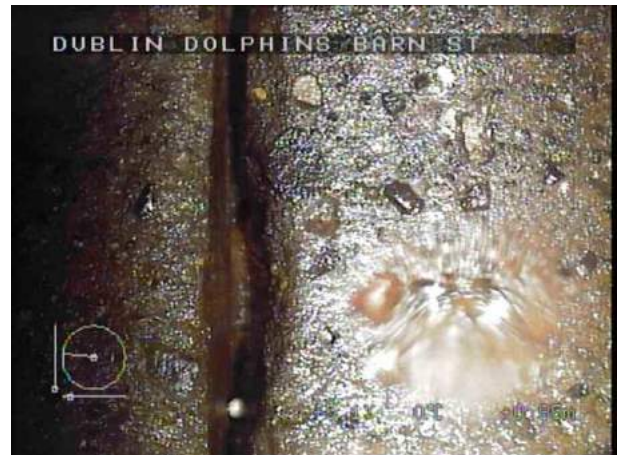
SMH2X\_0889b6b3-45e6-4b41-bbfa-a42acf304ac4\_20220408\_100034\_943.jpg, 00:00:27, 0.85 m  
Open joint, medium

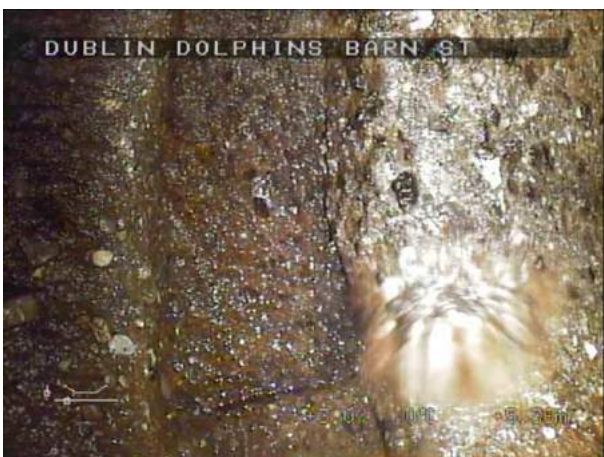
SMH2X\_148e6317-0075-47a9-90ec-1b057ce0a7c8\_20220408\_100212\_773.jpg, 00:01:52, 5.38 m  
Open joint, large

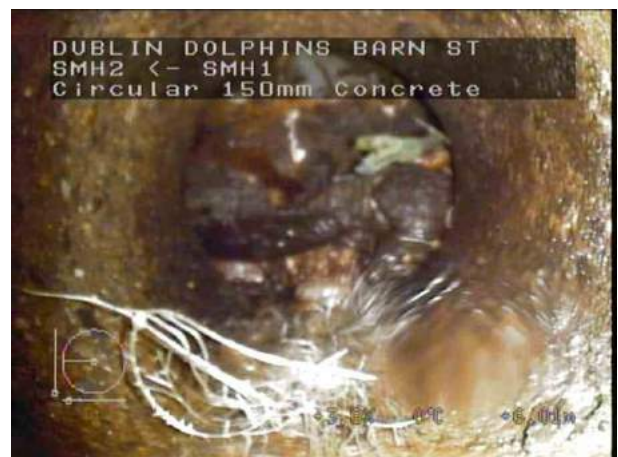
SMH2X\_d3a5553c-1358-44da-8de2-f74cbf6eea60\_20220408\_100312\_296.jpg, 00:02:22, 6.01 m  
Junction at 9 o'clock, 100mm dia

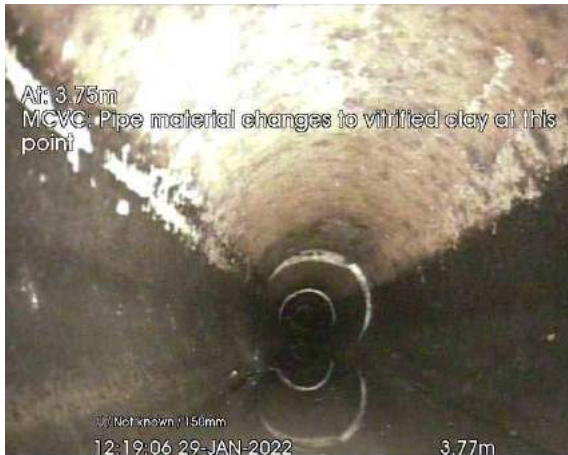
MH2 TO MH1\_3-77m\_121906.jpg, 00:00:24, 3.77 m  
Pipe material changes to vitrified clay at this point

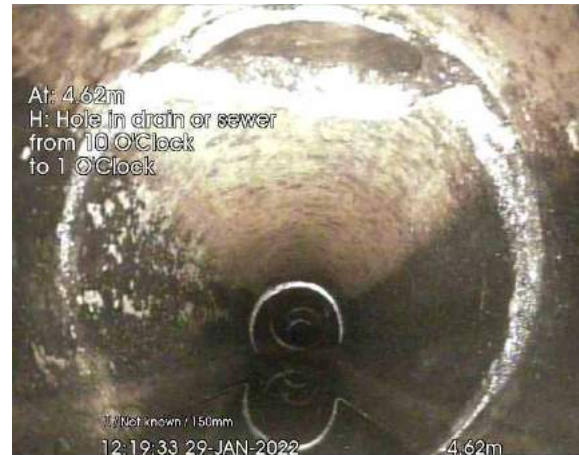
MH2 TO MH1\_4-62m\_121933.jpg, 00:00:43, 4.62 m  
Hole in drain or sewer from 10 o'clock to 1 o'clock

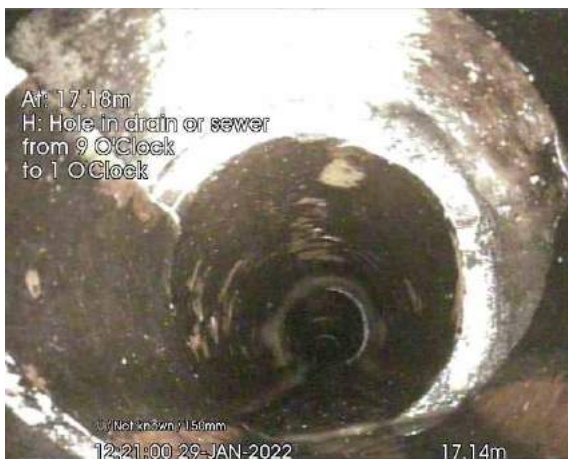
MH2 TO MH1\_17-14m\_122100.jpg, 00:01:56, 17.14 m  
Hole in drain or sewer from 9 o'clock to 1 o'clock

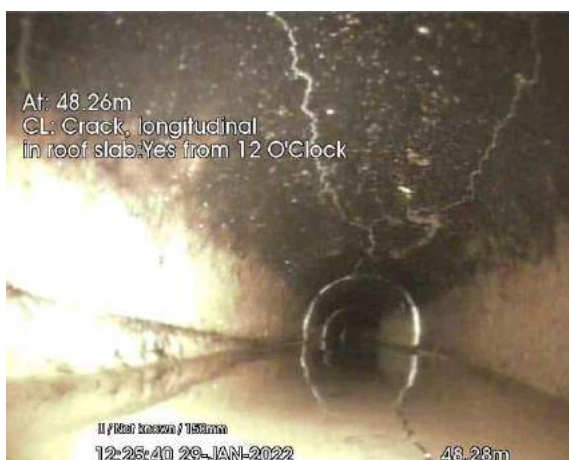
MH2 TO MH1\_48-28m\_122540.jpg, 00:04:41, 48.28 m  
Crack, longitudinal, in roof slab at 12 o'clock

46.51	CM	Cracks, multiple, in roof slab at 12 o'clock	00:04:25	MH2 TO MH1_46-5 1m_12251	3 / 2		
		48.28	CL	Crack, longitudinal, in roof slab at 12 o'clock	00:04:41	MH2 TO MH1_48-2 8m_12254	2 / 2

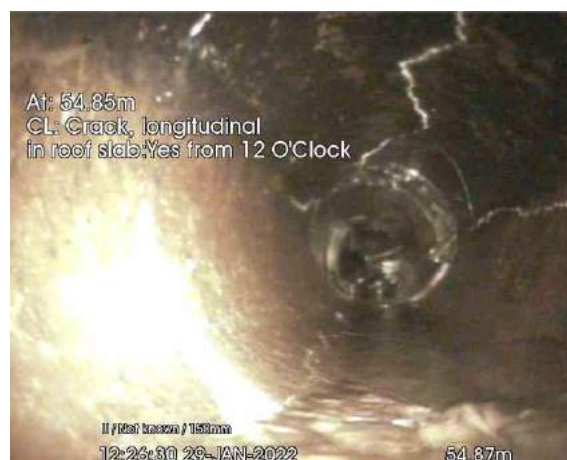
MH2 TO MH1\_54-87m\_122630.jpg, 00:05:14, 54.87 m  
Crack, longitudinal, in roof slab at 12 o'clock

51.01	WL	Water level, 30% of the vertical dimension	00:04:54				
		54.87	CL	Crack, longitudinal, in roof slab at 12 o'clock	00:05:14	MH2 TO MH1_54-8 7m_12263	2 / 2

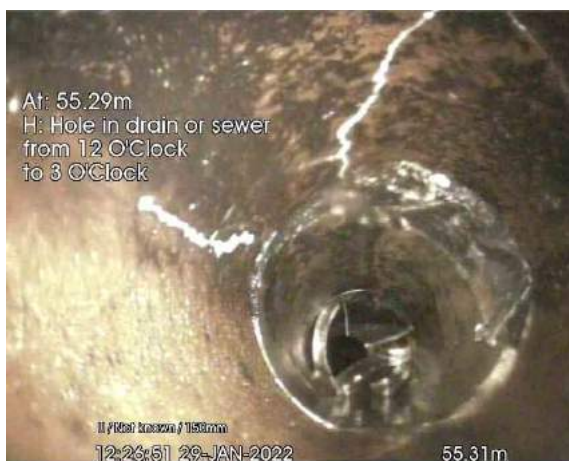
MH2 TO MH1\_55-31m\_122651.jpg, 00:05:26, 55.31 m  
Hole in drain or sewer from 12 o'clock to 3 o'clock

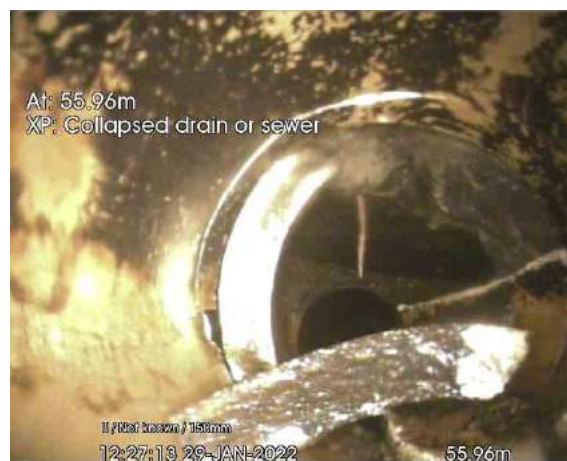
MH2 TO MH1\_55-96m\_122713.jpg, 00:05:34, 55.96 m  
Collapsed drain or sewer

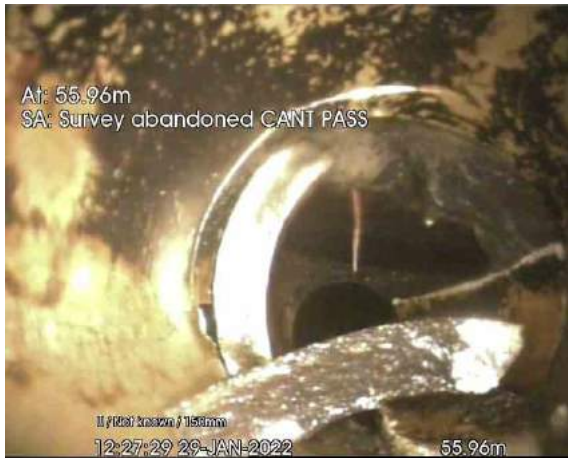
MH2 TO MH1\_55-96m\_122729.jpg, 00:05:38, 55.96 m  
Survey abandoned, CANT PASS

55.96	SA	Survey abandoned: CANT PASS	00:05:38	MH2 TO MH1_55-9 6m_12272			
	Construction Features					Miscellaneous Features			
Structural Defects					Service & Operational Observations				
STR No. Def	STR Peak	STR Mean	STR Total	STR Grade	SER No. Def	SER Peak	SER Mean	SER Total	SER Grade
10	175.0	14.3	802.0	5.0	5	2.0	0.1	7.0	3.0

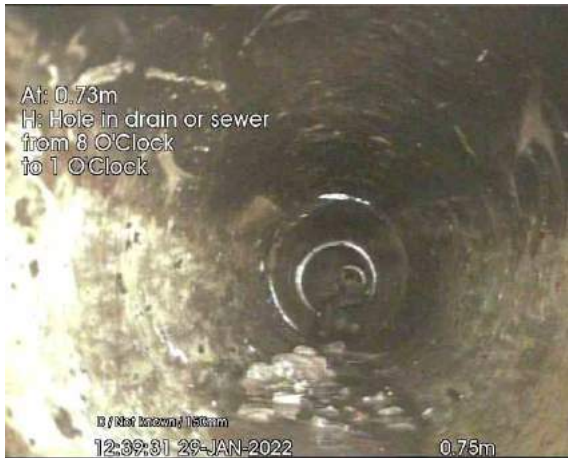
MH1 TO MH2\_0-75m\_123931.jpg, 00:00:09, 0.75 m  
Hole in drain or sewer from 8 o'clock to 1 o'clock

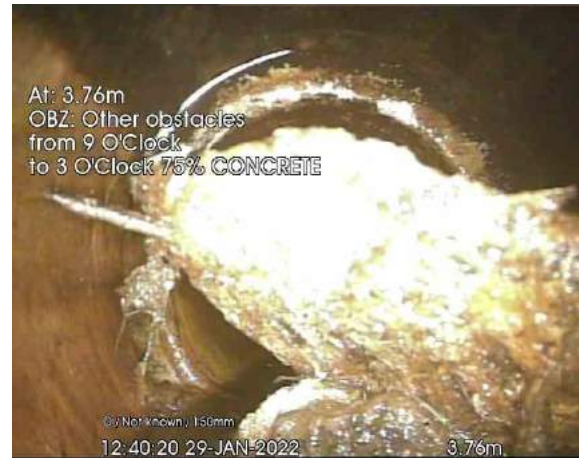
MH1 TO MH2\_3-76m\_124020.jpg, 00:00:27, 3.76 m  
Other obstacles from 9 o'clock to 3 o'clock, 75% cross-sectional area loss, CONCRETE

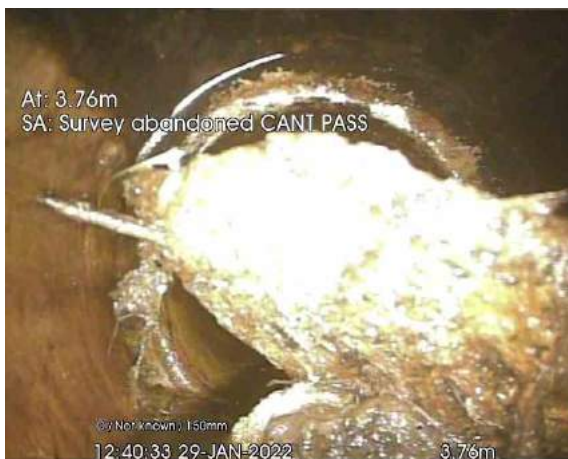
MH1 TO MH2\_3-76m\_124033.jpg, 00:00:30, 3.76 m  
Survey abandoned, CANT PASS

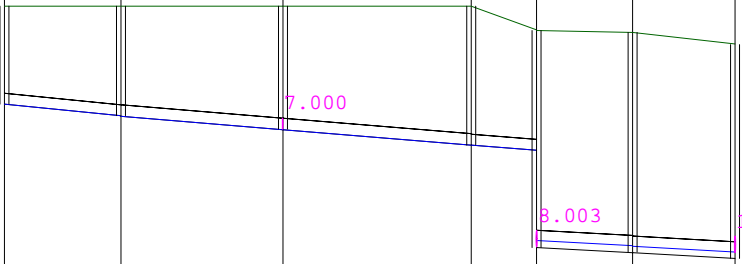
MH Name		F12	F13	F15		F21	F22	F23
<p>Hor Scale 1000</p> <p>Ver Scale 100</p> <p>Datum (m)15.000</p>

PN		F6.000	F6.001	F6.002		F6.004	F6.005	
Dia (mm)		150	150	150		225	225	
Slope (1:X)		100.0	120.0	120.0		181.3	169.6	
Cover Level (m)		20.200	20.200	20.200	20.200	19.880	19.850	19.690
Invert Level (m)		18.900	18.746	18.567	18.359	17.000	16.930	16.850
Length (m)		15.398	21.430	24.970		12.688	13.565

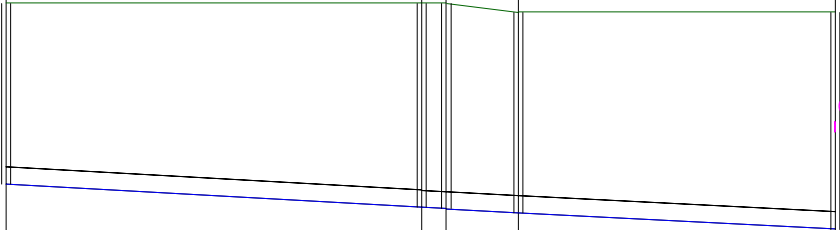
MH Name		F17		F20	F21
<div> <div>Hor Scale 1000</div> <div>Ver Scale 100</div> <div>Datum (m)15.000</div> </div>

PN		F8.000		F8.003	
Dia (mm)		225		225	
Slope (1:X)		178.4		190.5	
Cover Level (m)		20.000		19.880	19.880
Invert Level (m)		17.600	17.292	17.274	17.000
Length (m)		54.962		41.911

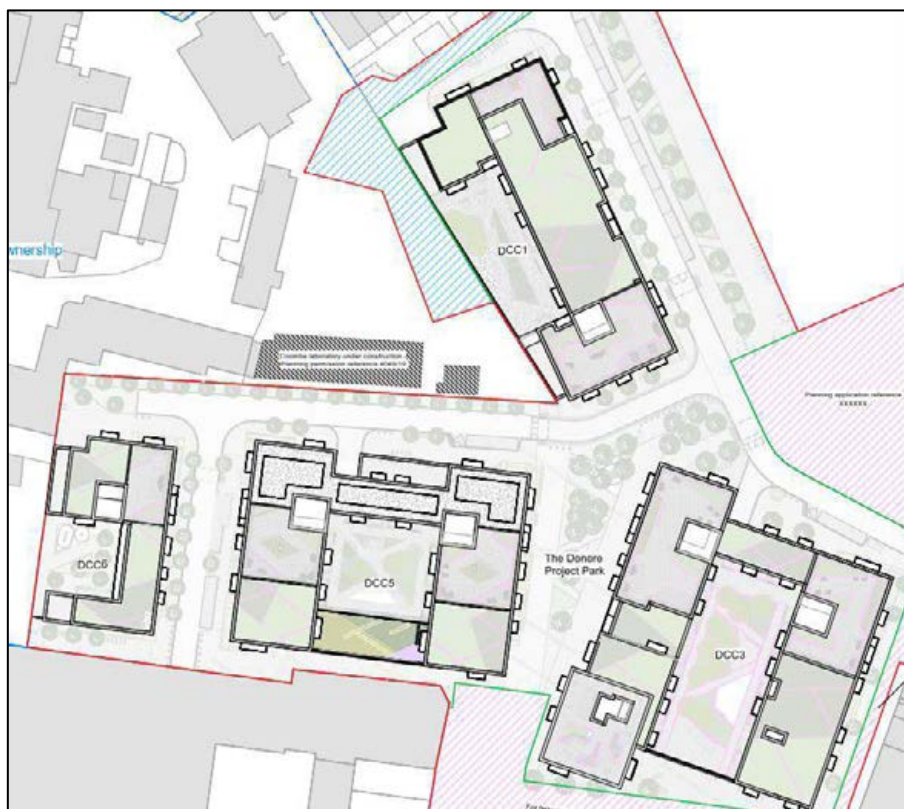
Figure 1.2: Extract from drawing STG-MW-S1b-00-RF-DR-A-1100002 – Site Layout Plan Proposed

Refer to Figure 1.2 for the proposed site layout. The proposed development consists of the construction of 543 no. residential units, distributed over 4 no. proposed apartment blocks (DCC1, DCC3, DCC5 and DCC6). Table 1.1 summarises the current schedule of accommodation, per block.

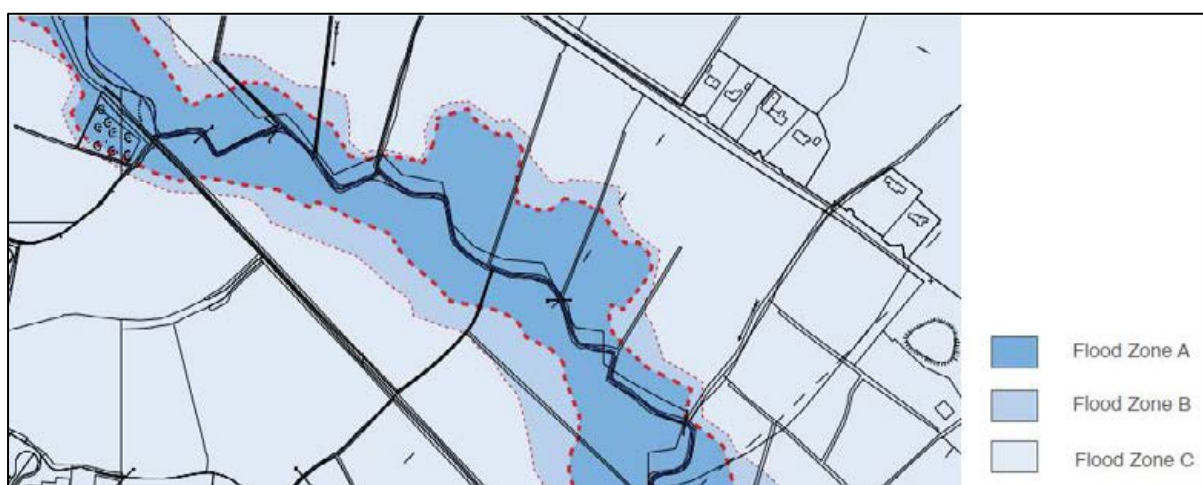
**Figure 2.1: Indicative Flood Zone Map (Extract from The Guidelines)**

This approach is based on the identification of flood zones for river and coastal flooding. “Flood Zones” are geographical areas used to identify areas at various levels of flood risk. It should be noted that these do not consider the presence of flood defences, as risks remain of overtopping and breach of the defences. There are three flood zones defined:

**Zone B** (moderate probability of flooding) refers to lands where the probability of flooding is moderate (between 0.1% or 1 in 1,000 and 1% or 1 in 100 for river flooding and between 0.1% or 1 in 1,000 and 0.5% or 1 in 200 for coastal flooding).

**Zone C** (low probability of flooding) refers to lands where the probability of flooding is low (less than 0.1% or 1 in 1,000 for both river and coastal flooding).

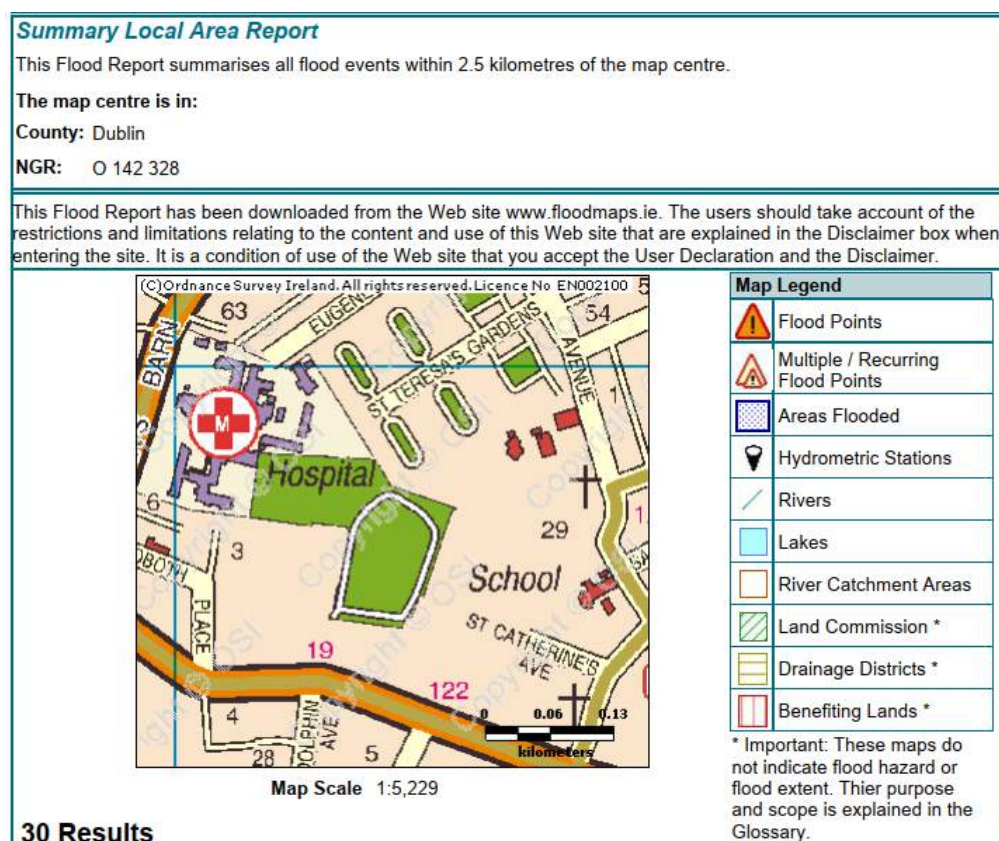
Figure 3.1: Historic Flood Events in the Vicinity of the Subject Site

The Office of Public Works (OPW) collates available reports of flooding from all sources (e.g. fluvial, pluvial, coastal, etc.) on a nationwide basis and provide mapping for the historical flooding events in specific areas. Figure 3.1 is an extract from the historical flooding report, showing the area in the vicinity of the development site and notes on reported instances of flooding within or around the frontage of the development site. Please refer to Appendix A for the OPW Past Flood Summary Report.

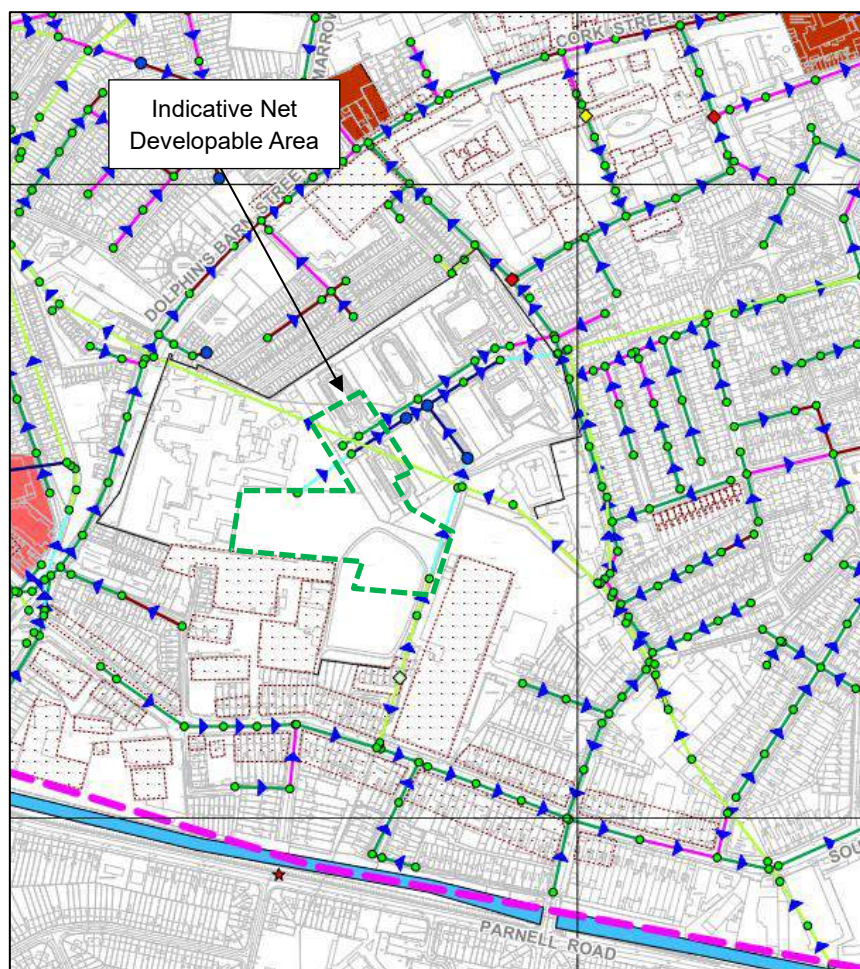
**Figure 3.2: Extract from the GSDS Existing Hydraulic Performance Map 2013**

The Greater Dublin Strategic Drainage Study (GSDS) provides significant information regarding the existing surface water and foul water infrastructure within the subject site. Performance Maps give flooding predictions and cataloguing existing hydraulic deficiencies in the network area. Refer to Figure 3.2.

The colouring coding is as follows:

The sewer shown in light green, traversing the site, is noted to be obsolete (refer to Section 4.2 *Existing Surface Water Drainage*, of the STG-AEC-S1b-00-00-RE-C-0000001\_Infrastructure\_Report enclosed with this application for further information) and will be removed as part of the overall future developments within the SDRA.

As shown in Figure 3.2: Extract from the GDSDS Existing Hydraulic Performance Map 2013 (Section 3.3), there are 2 sewers which are noted to surcharge from the 1 or 2 year event. Both of these sewers are being diverted; one sewer is being diverted into the proposed network, which has been modelled and no flooding occurs for 100 year events with a 20% climate change allowance, and the other sewer is being diverted and as noted in Section 3.3 includes attenuation located within The Coombe Women & Infants University Hospital, which will reduce maximum flows draining to the sewer.

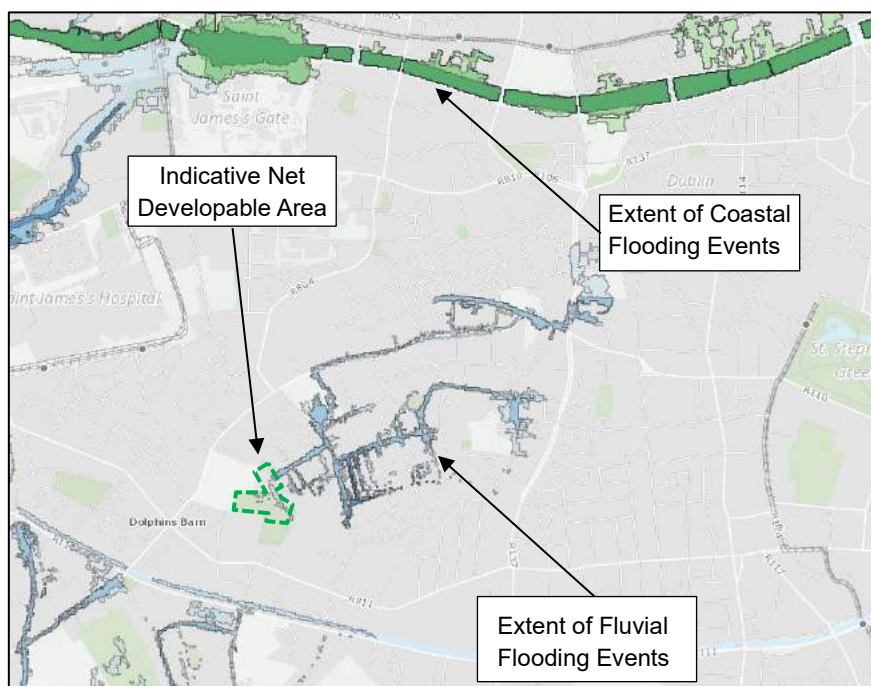
**Figure 3.3: Fluvial Flood Zones at The Donore Project site, as defined by the CFRAM Mapping ([www.floodinfo.ie](http://www.floodinfo.ie))**

The CFRAM mapping available for the area surrounding the development indicates that the site is within a predicted fluvial flooding area. The subject site is located approx. 1.2 km from the predicted coastal flood extent. Refer to Figure 3.3 and Figure 3.4.

As shown in Figure 3.3, tidal flooding is not predicted to affect the subject site.

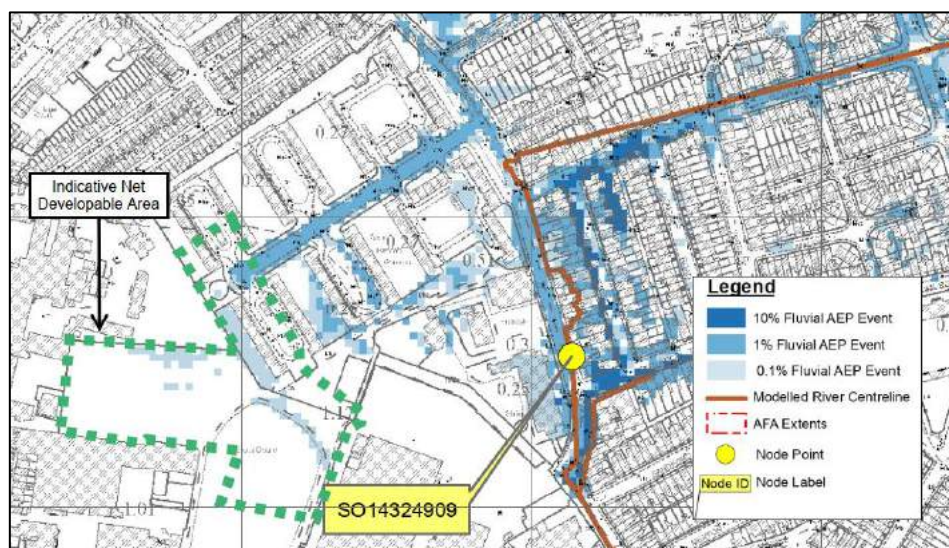
Figure 3.4: Extract from CFRAM Fluvial Flood Extents

An extract from the Eastern CFRAM map Drawing No. E09POD\_EXFCD\_F0\_05 is illustrated in Figure 3.4. Refer to Appendix B for these CFRAM flood extent and flood depth maps.

On the outdated CFRAM mapping, fluvial flooding is predicted on the subject site, for the 1:100 year flood event (a minimal flood extent area, with 0 - 0.25 m flood depth predicted) and for the 1:1000 year event (a larger flood extent area with a 0 - 0.25 m flood depth predicted). Based on this mapping, approx. 90% of the site is located within Flood Zone C, 10% within Flood Zone B and <1% situated within Flood Zone A. Given a portion of the site is in Flood Zone A/B, it would be prudent to carry out a Justification Test, refer to Section 5.3.

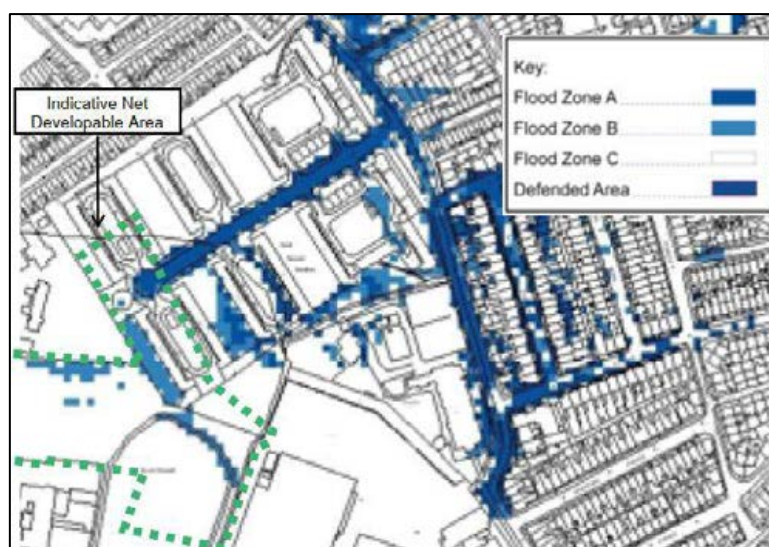
Figure 3.5: Site 13: Poddle – Inside Canal, from DCC Development Plan 2016-2022 SFRA

The Strategic Flood Risk Assessment (SFRA), published as part of the DCC Development Plan 2016-2022 is largely based on the CFRAM mapping and hence shows the same information. The subject site is within Site 13: Poddle – Inside Canal of the justification test tables in Appendix 3 of the DCC SFRA. Refer to Figure 3.5.

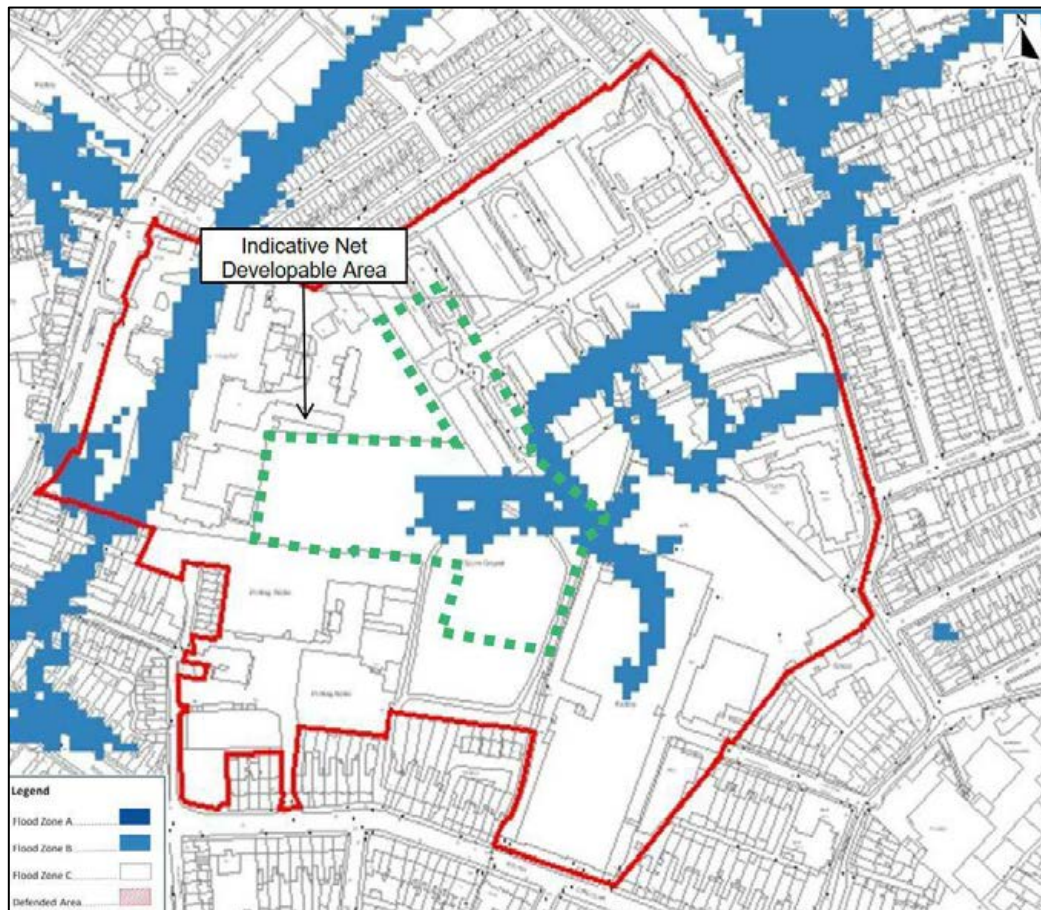
Figure 3.6: Flood Zones at SDRA 11 (DCC Development Plan 2022-2028 SFRA)

The Strategic Flood Risk Assessment (SFRA), published as part of the DCC Development Plan 2022-2028, includes SDRA Screening & Justification Tests for each SDRA. The subject site is within SDRA 11 of the 2022-2028 Development Plan and the Flood Zones for the SDRA (refer to Figure 3.6) show a larger Flood Zone B extent than the previous SFRA (2016-2022).

Furthermore, it appears the flood extent shown in the SFRA is incorrect, relative to the OS (Ordnance Survey) Mapping, when comparing topographical levels. In addition to levels, it appears the flooding is mistakenly shown approx. 50 m southeast relative to the OS Mapping when comparing with the CFRAM mapping and the previous SFRA. (And as expected, the flood extents should generally be within roadways).

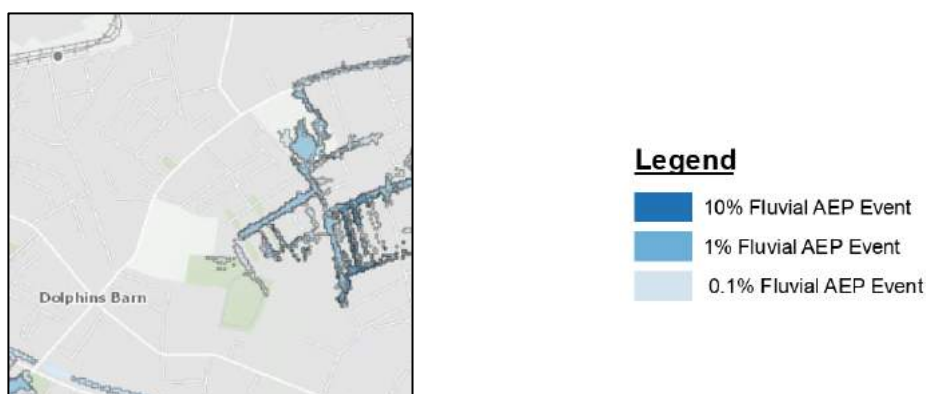
Figure 4.1: Current Scenario - Fluvial Flooding

The 10% AEP flood extent involves large increases through the scenarios. The 0.1% AEP flood extent within the subject site is minorly increased; the majority of the site remains as Flood Zone C (approx. 85%), with approx. 15% of the site within Flood Zone B and <1% of the site within Flood Zone A.

However, as described, the flood routes are likely via Donore Avenue and Brown Street, due to the altered topography.
