# The Donore Project

Part 10 Application  
Infrastructure Report

The Land Development Agency

STG-AEC-S1b-00-00-RE-C-0000001\_Infrastructure\_Report

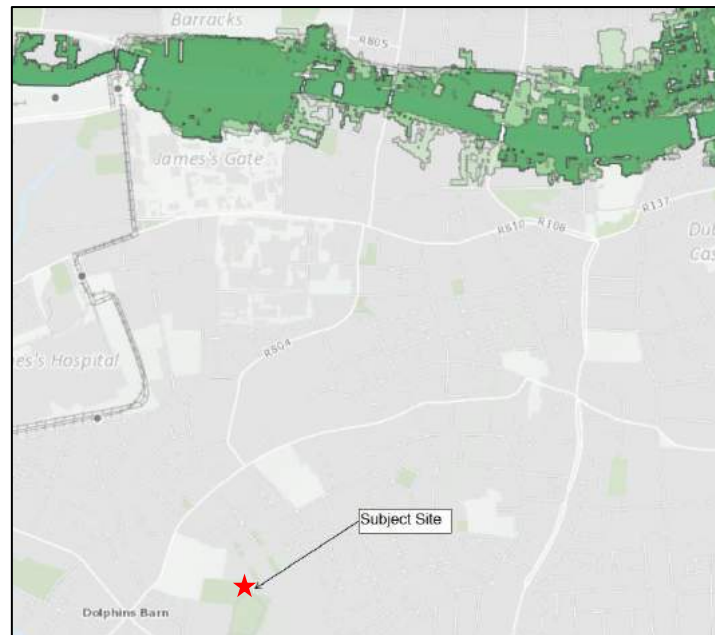
Figure 4.4: HEFS Coastal Flooding

Figure 4.4 shows the High-End Future Scenario (1 m mean sea level rises). As shown in the figure, the site is not predicted to be impacted by coastal flooding when climate change is considered.

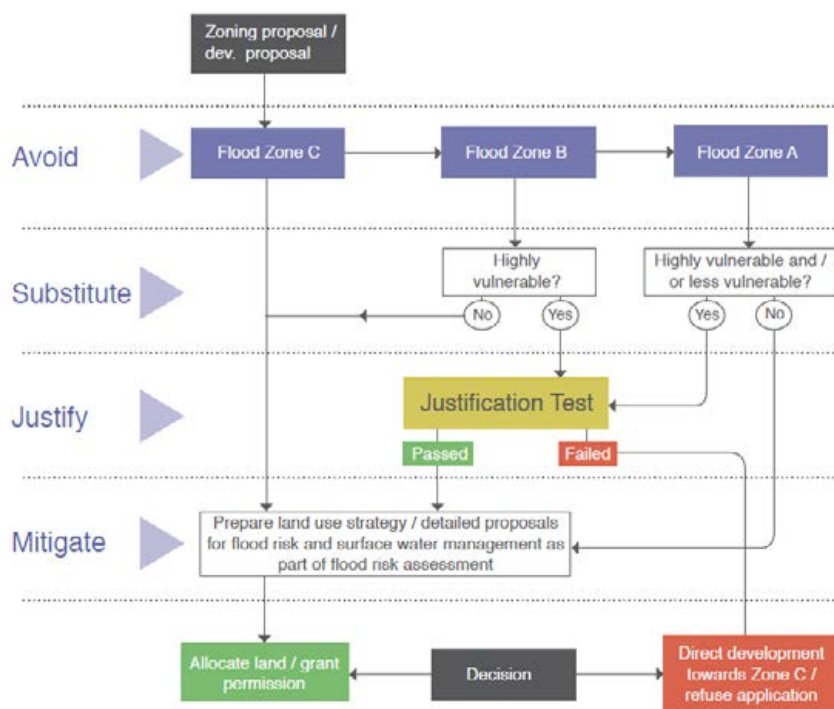
Figure 5.1: Sequential Approach Mechanism in the Planning Process

Chapter 3 of the Planning System and Flood Risk Management Guidelines (DEHLG/ OPW, 2009) describes the key principles of a risk based sequential approach to managing flood risk. The sequential approach is aimed at directing development toward land that is at low risk of flooding. Figure 5.1 is extracted from The Guidelines and illustrates the sequence in which a site must be assessed from a flood risk standpoint. Specifically, the order in which the planning authority must be satisfied from a flood risk perspective is to *Avoid* (locate in an area that is not prone to flooding), then *Substitute* (if in a flood risk zone, then substitute the type of development), *Justify* (if substitution does not reduce flood risk sufficiently, then perform Justification Test) and *Mitigate*. This section discusses the sequential approach recommended in The Guidelines with regard to the proposed development.

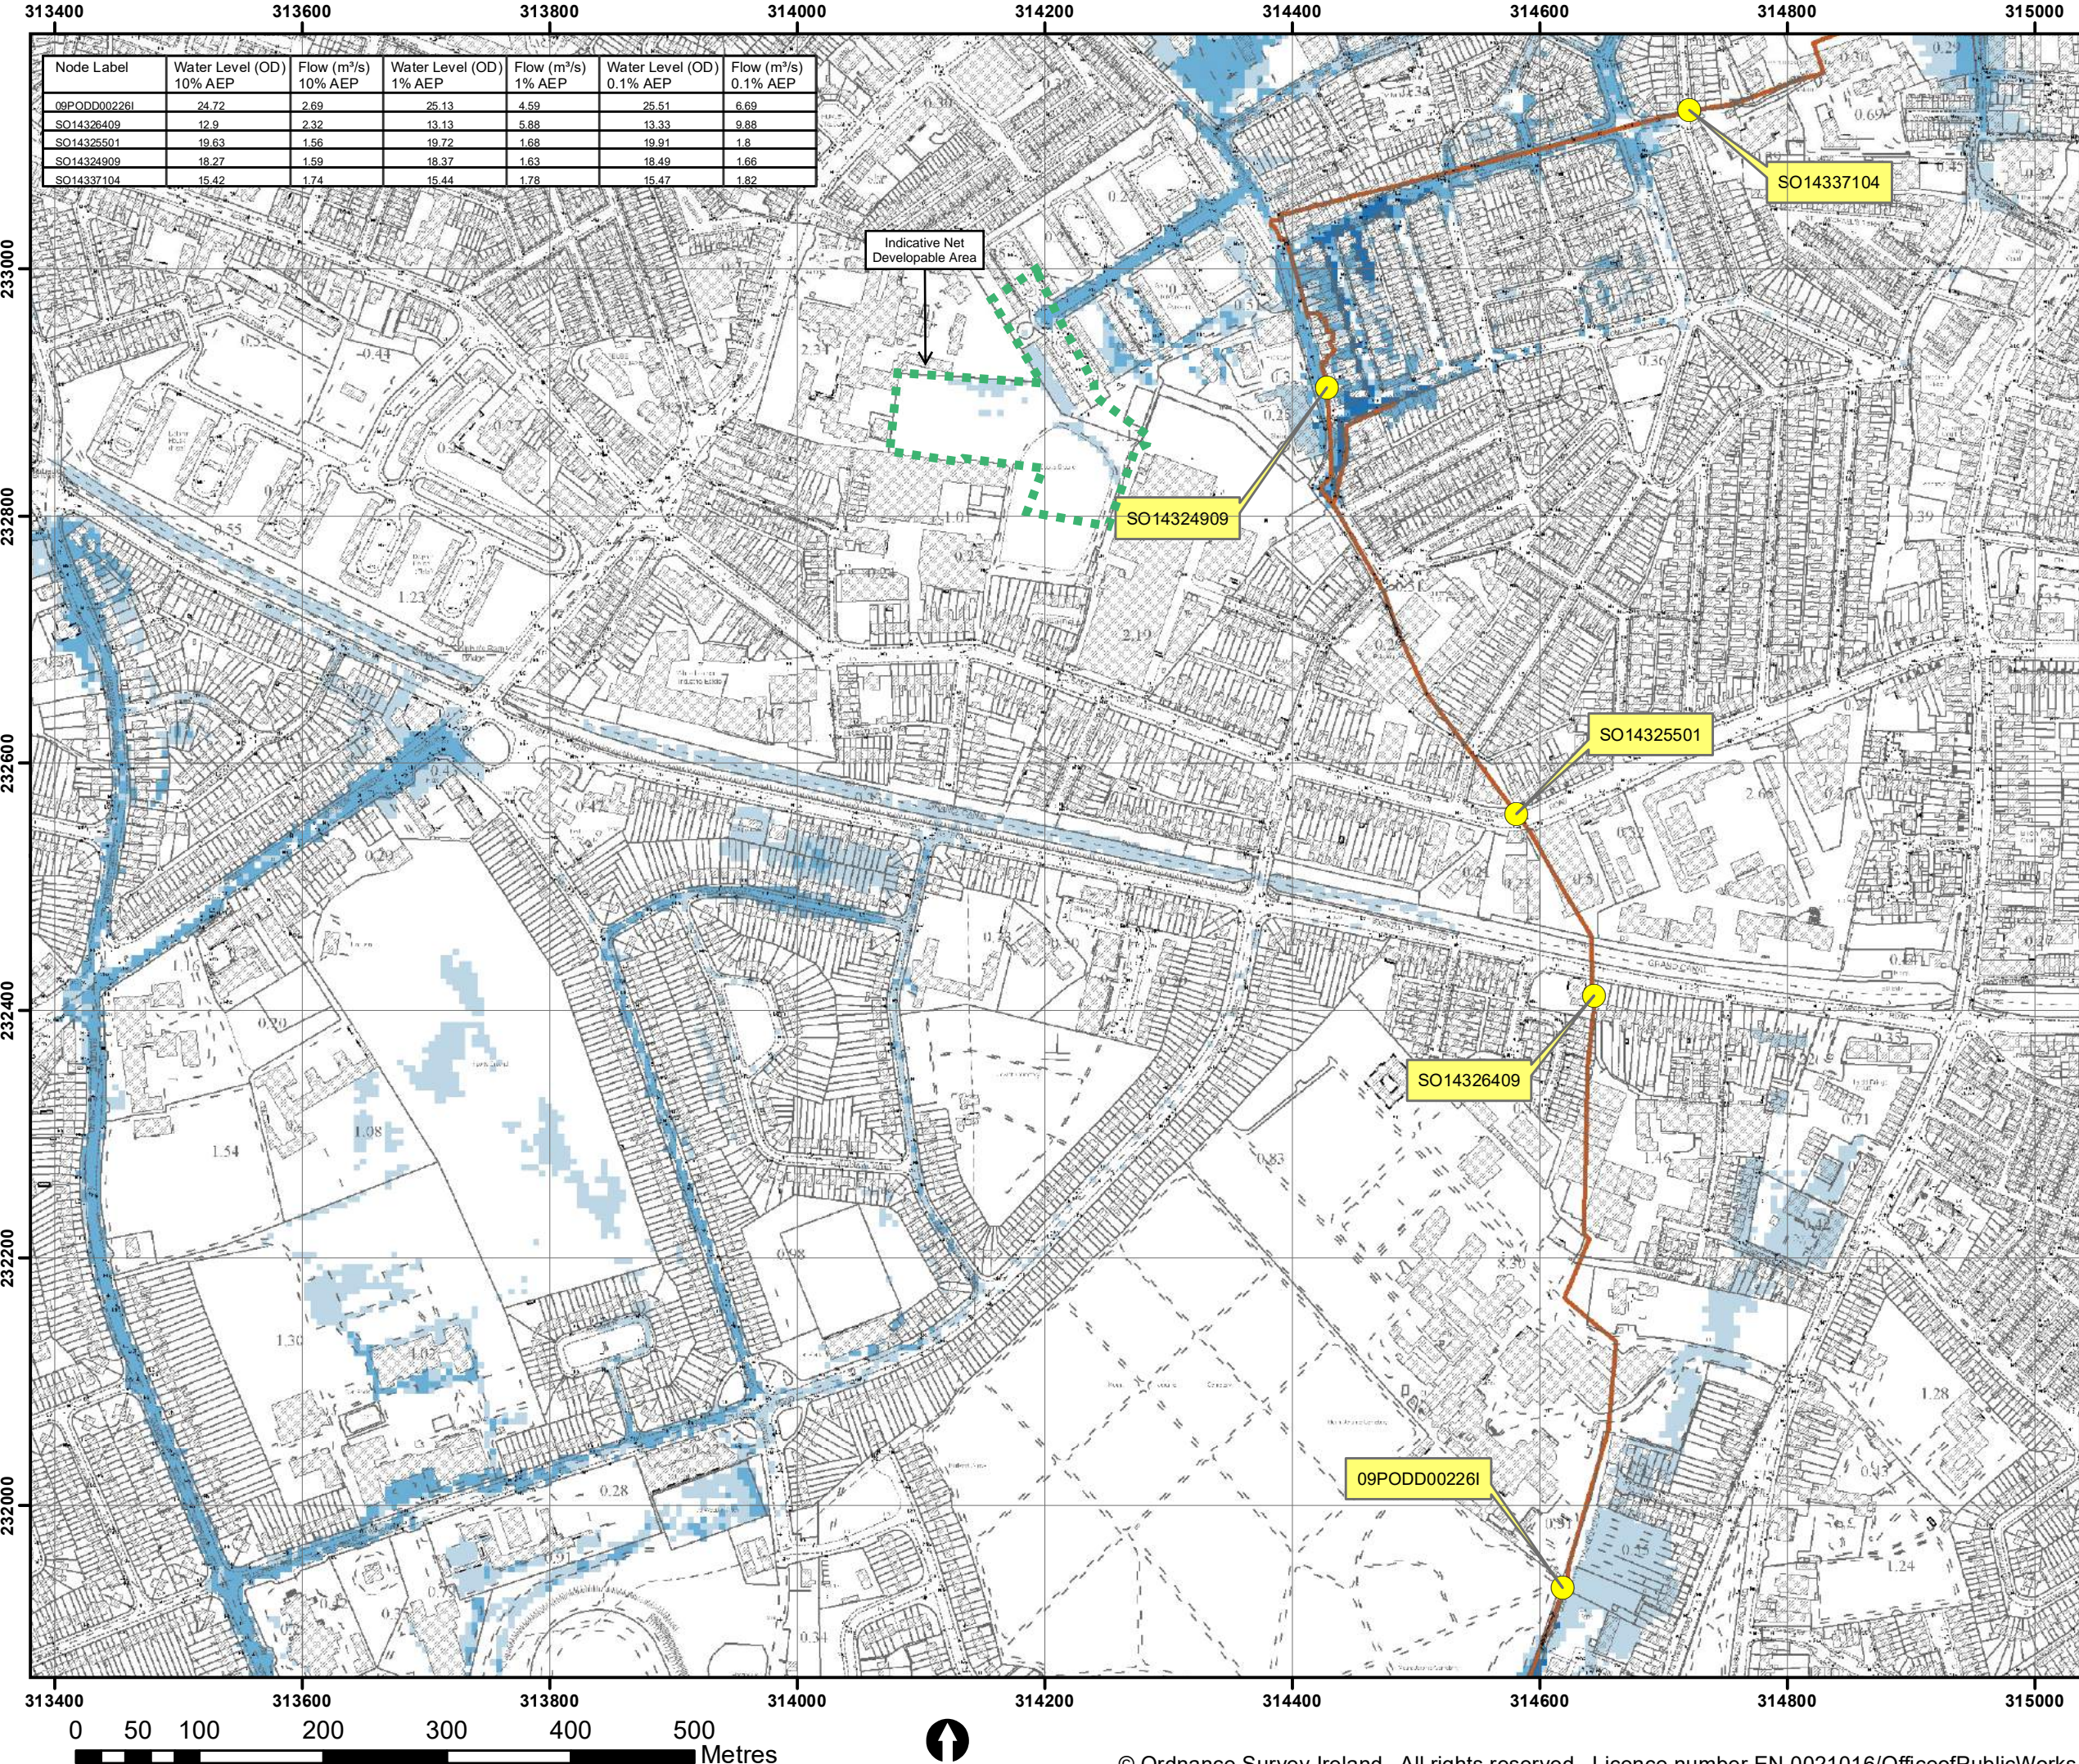
Node Label	Water Level (OD) 10% AEP	Flow (m³/s) 10% AEP	Water Level (OD) 1% AEP	Flow (m³/s) 1% AEP	Water Level (OD) 0.1% AEP	Flow (m³/s) 0.1% AEP
09PODD00226I	24.72	2.69	25.13	4.59	25.51	6.69
SO14326409	12.9	2.32	13.13	5.88	13.33	9.88
SO14325501	19.63	1.56	19.72	1.68	19.91	1.8
SO14324909	18.27	1.59	18.37	1.63	18.49	1.66
SO14337104	15.42	1.74	15.44	1.78	15.47	1.82

Map:
Poddle River Fluvial Flood Extents
Map Type: EXTENT
Source: FLUVIAL
Map Area: HPW
Scenario: CURRENT
Drawn By : F.M.C. Date : 11 August 2016
Checked By : A.S. Date : 11 August 2016
Approved By : S.P. Date : 11 August 2016
Drawing No. : E09POD_EXFCD_F0_05
Map Series : Page 5 of 6
Drawing Scale : 1:5,000 @A3

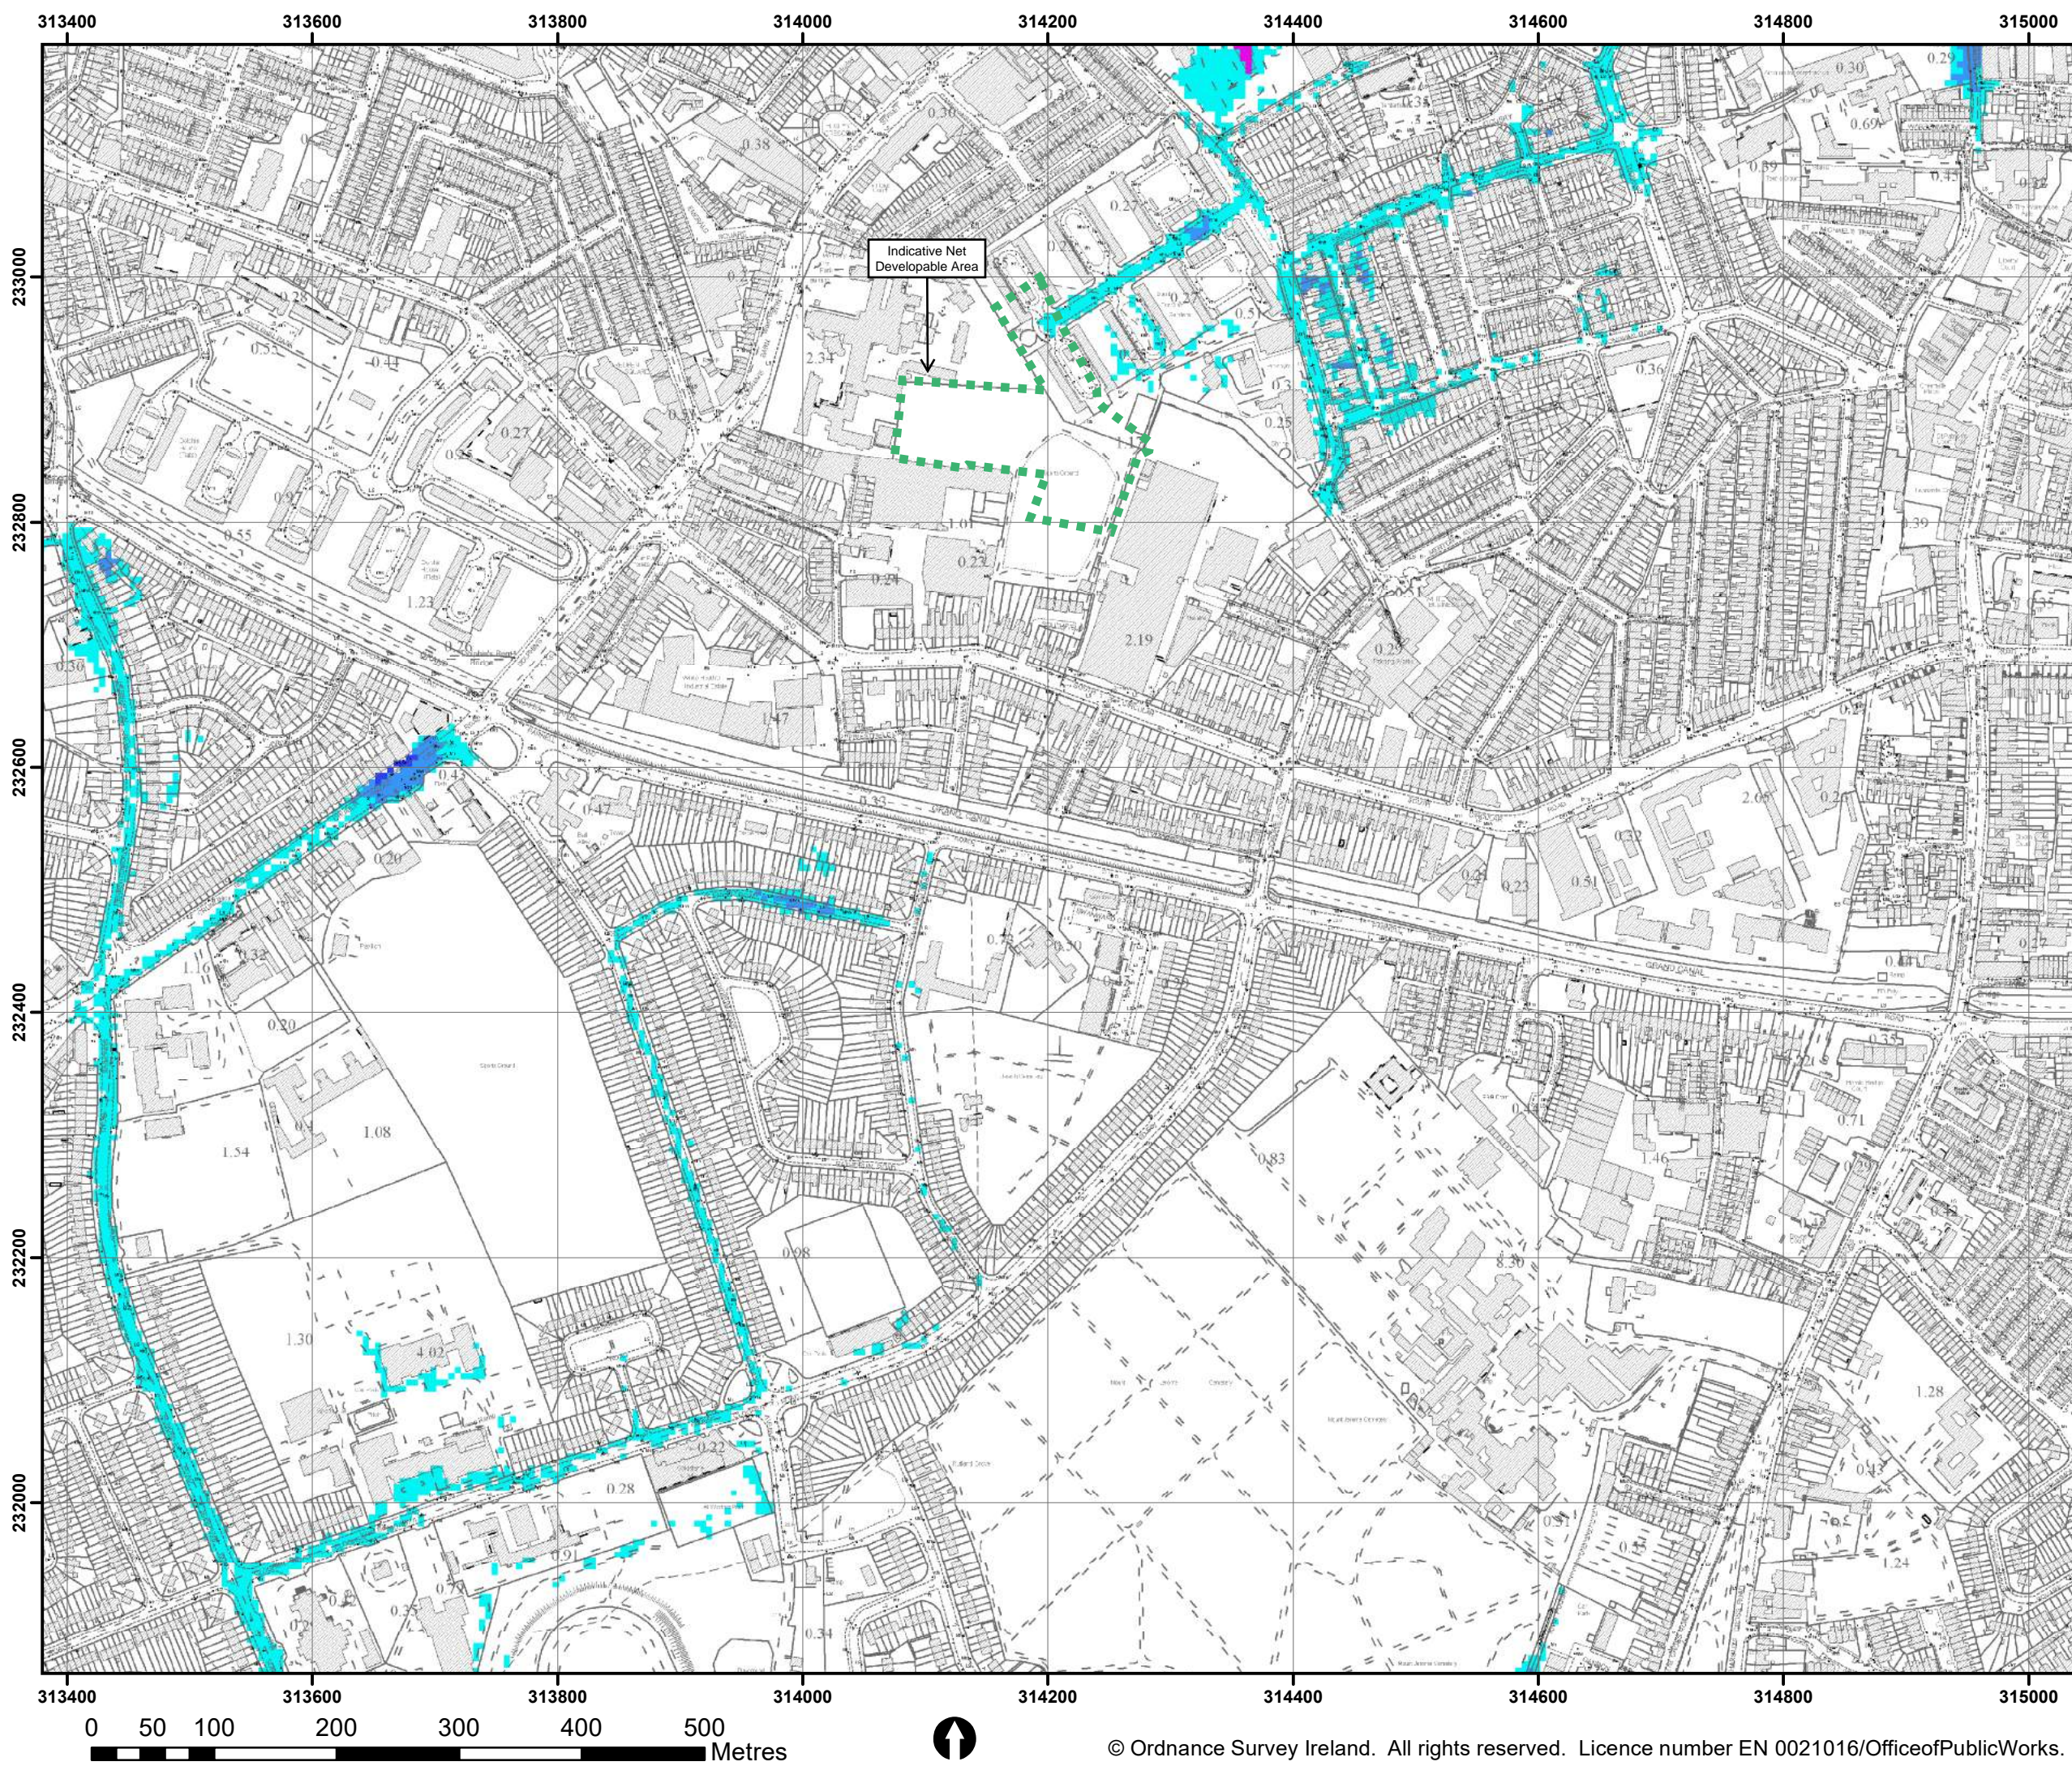
<b>Map:</b>	
<b>Poddle River Fluvial Flood Depths</b>	
<b>Map Type:</b> DEPTH	
<b>Source:</b> FLUVIAL	
<b>Map Area:</b> HPW	
<b>Scenario:</b> CURRENT	
<b>Drawn By :</b> F.M.C.	<b>Date :</b> 20 October 2016
<b>Checked By :</b> A.S.	<b>Date :</b> 20 October 2016
<b>Approved By :</b> S.P.	<b>Date :</b> 20 October 2016
<b>Drawing No. :</b>	
<b>E09POD_DPFCD010_F0_05</b>	
<b>Map Series :</b> Page 5 of 6	
<b>Drawing Scale :</b> 1:5,000 @ A3

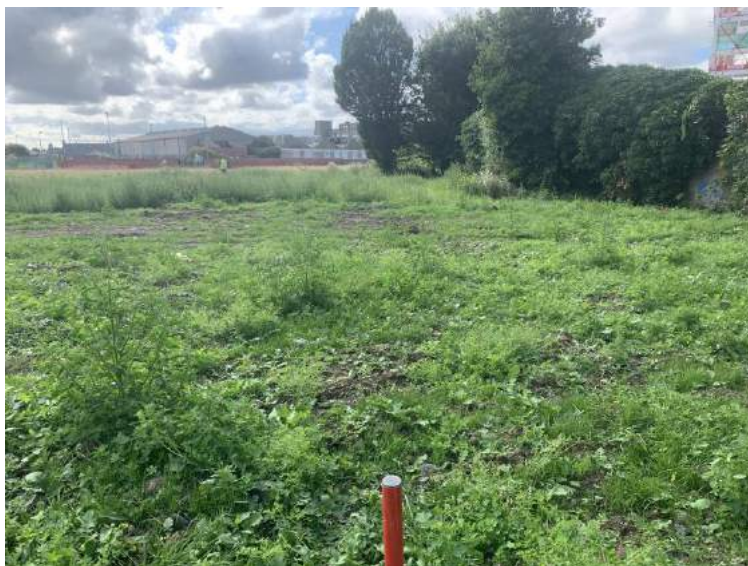
Plate 3 Test Trench 1, pre excavation, facing south

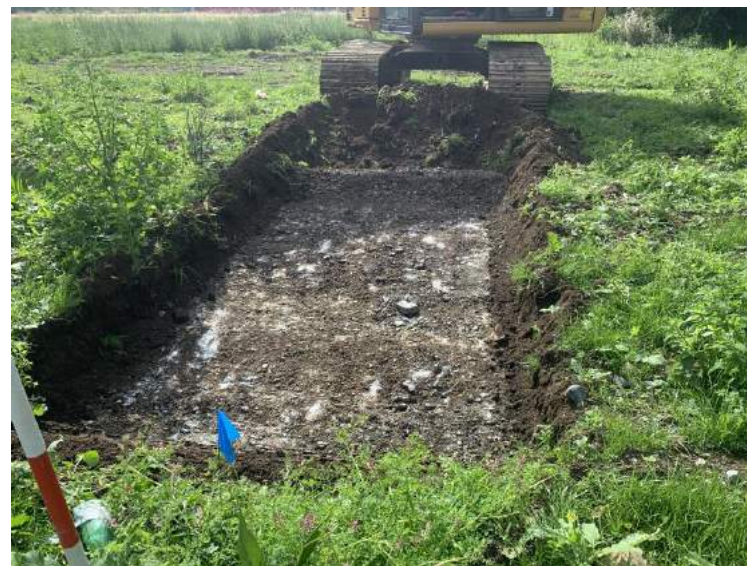
Plate 4 Test Trench 1, former compound surface, facing south

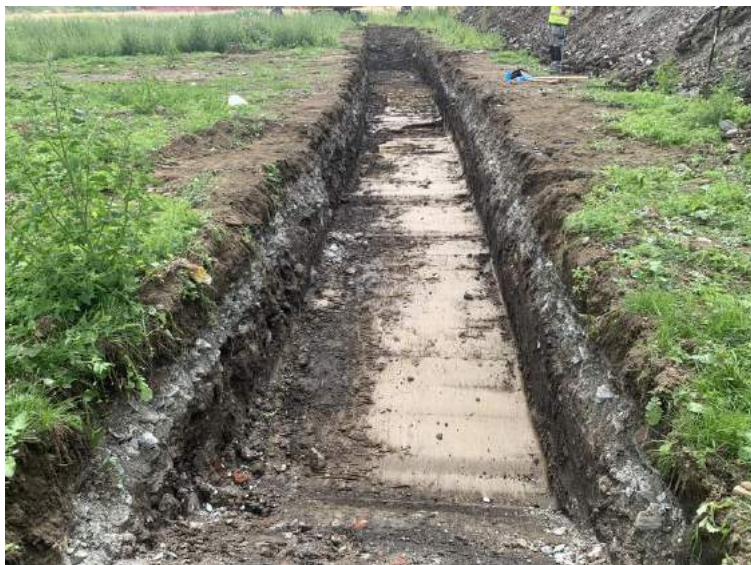
Plate 5 Test Trench 1, post excavation, facing south

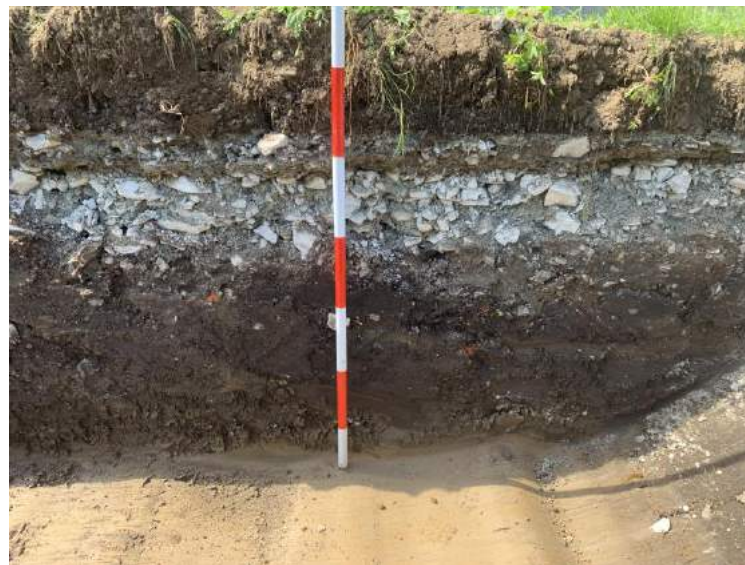
Plate 6 Test Trench 1 stratigraphy, facing west

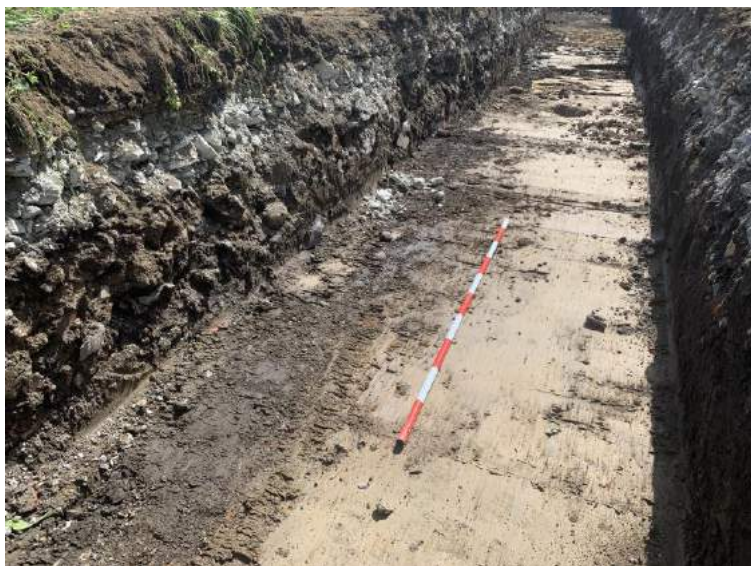
Plate 7 Test Trench 1, modern disturbance, facing southeast

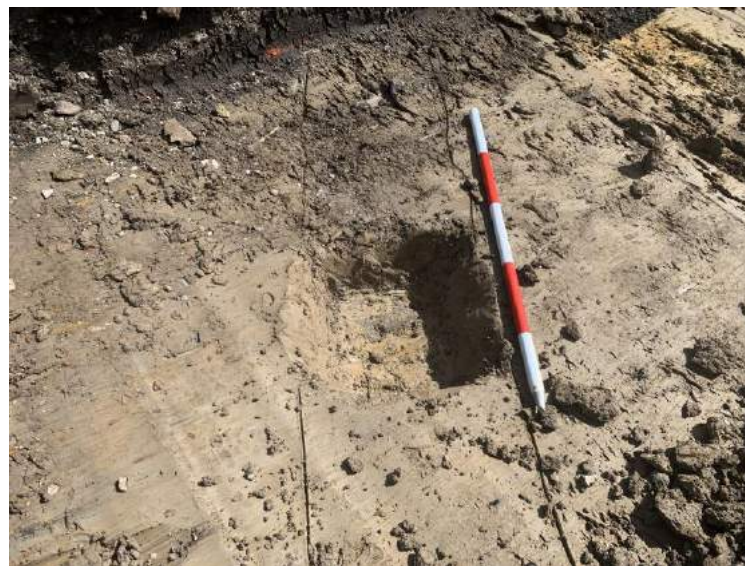
Plate 8 Test Trench 1, C4, facing east

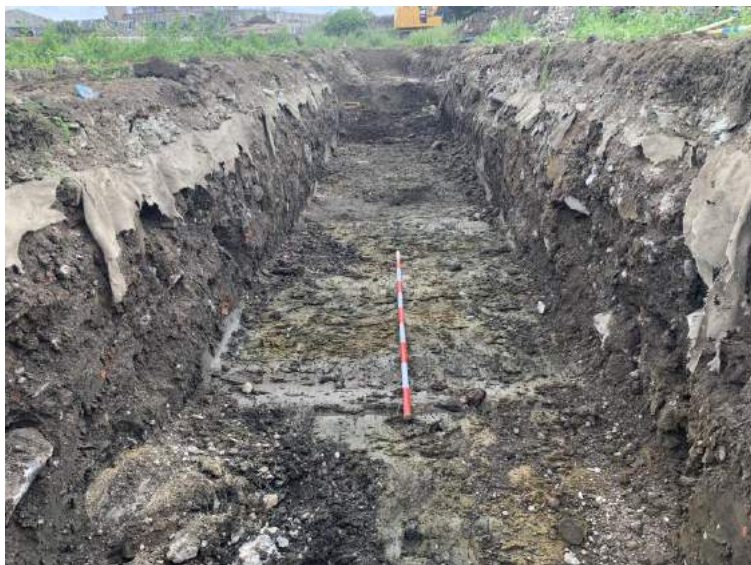
Plate 9 Test Trench 2, post excavation, facing south

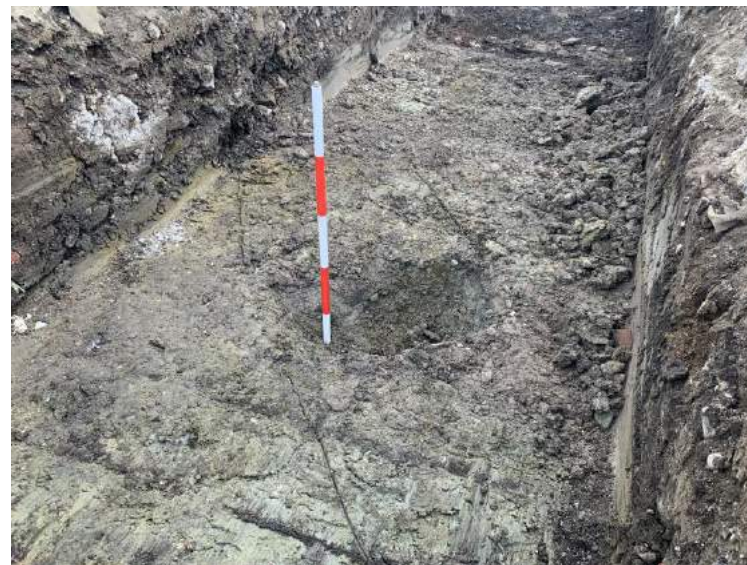
Plate 10 Test Trench 2, C6, facing southeast

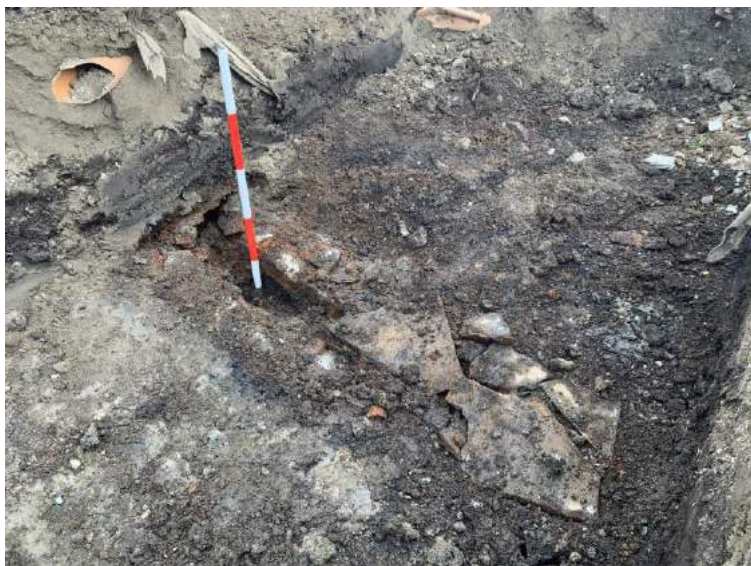
Plate 11 Test Trench 2, C8, facing southeast

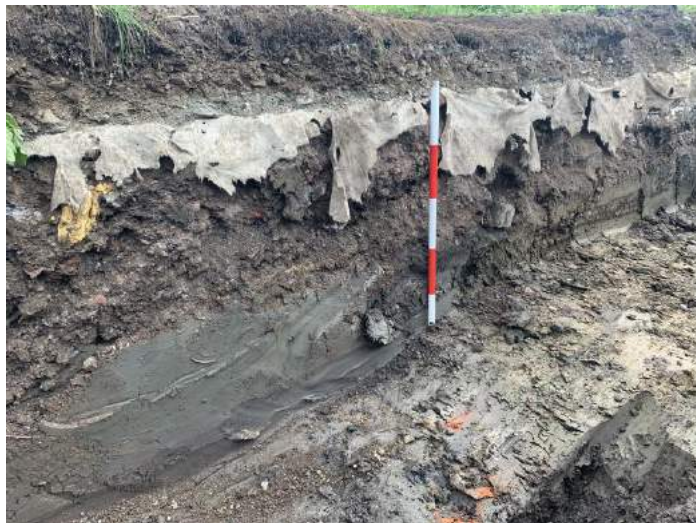
Plate 14 Test Trench 3 stratigraphy, facing southeast

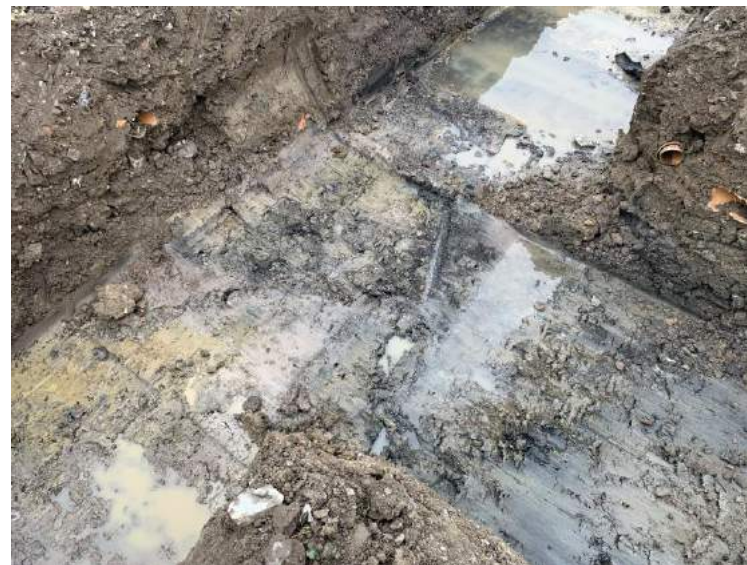
Plate 21 Test Trench 4, waterlogging, facing southwest

TRENCH	LENGTH (m)	WIDTH (m)	DEPTH (m)	ORIENTATION	DETAILS
					extending north-south, 1.25m in width, 0.55m in maximum depth, with V shaped sides and a flat base. The fill material (C20) was recorded as analogous with C14 and C16
4	30	2	1.6	North-south	One linear feature was recorded extending northeast-southwest across the trench (Plates 21-29). The cut (C21) of the feature was recorded as 1.25m in width, 0.6m in observable depth, with gradually sloping sides on western side. The feature was heavily waterlogged, and only one fill (C22) consisting of a dark grey clay. Four wooden elements (C23) were recovered from C22, which were identified as two oval profile stake, a post with a tapered end, and a plank element. The wooden elements were all considered to be part of a disturbed superstructure to a water channel.
5	5	2	1.9	Northwest-southeast	Nothing of archaeological significance (Plate 30).

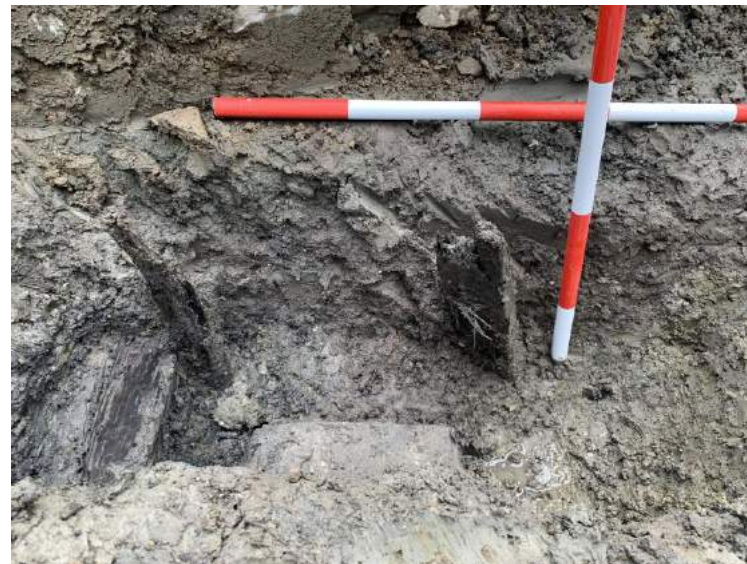
Plate 23 Test Trench 4, C21 mid excavation facing northeast

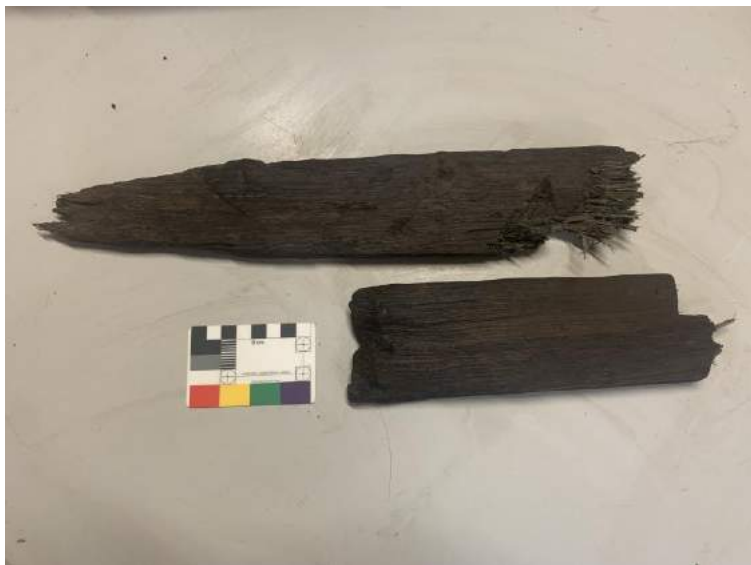
Plate 28 Test Trench 4, C23 axe marks on post element

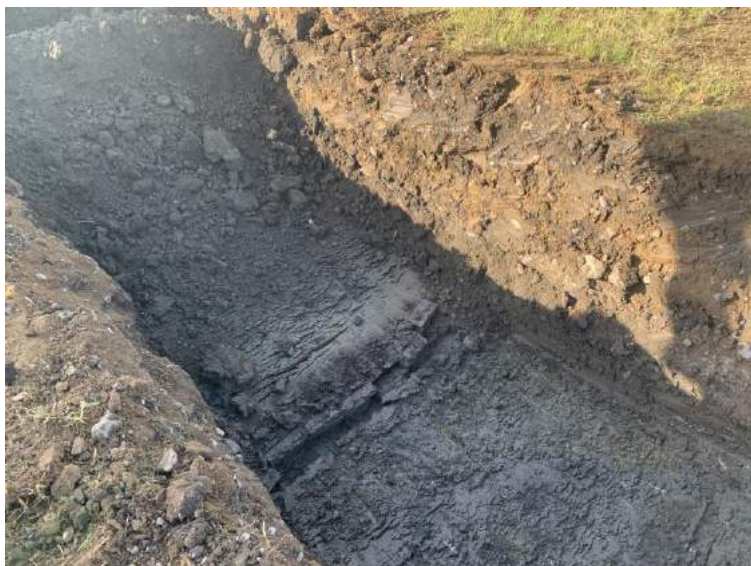
Plate 30 Test Trench 5, post excavation, facing southwest

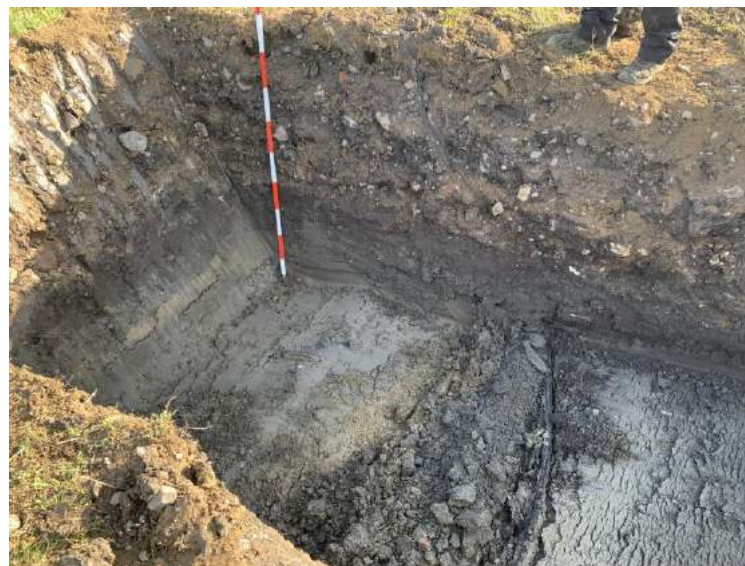
Plate 31 Test Trench 6, post excavation, facing southwest

6	6	2	1.85	Northwest-southeast	Nothing of archaeological significance (Plate 31).
7	7	2	1.85	Northwest-southeast	Nothing of archaeological significance (Plate 32).
8	6	2	1.87	Northwest-southeast	One linear feature was recorded extending east-west across the trench (Plate 33). The cut (C24) could not be full explored due to the depth of the trench but the fill material (C25) was recorded as analogous with C14 and C16
9	6	2	1.25	Northeast-southwest	Nothing of archaeological significance (Plate 36)
10	8	2	1	Northeast-southwest	Nothing of archaeological significance (Plate 37).
11	6	2	1.2	Northwest-southeast	Nothing of archaeological significance (Plate 38).
12	6	2	1	Northwest-southeast	Nothing of archaeological significance (Plate 39)
13	6	2	1	Northwest-southeast	Nothing of archaeological significance (Plate 40).
14	6	2	1	Northwest-southeast	Nothing of archaeological significance (Plate 41).

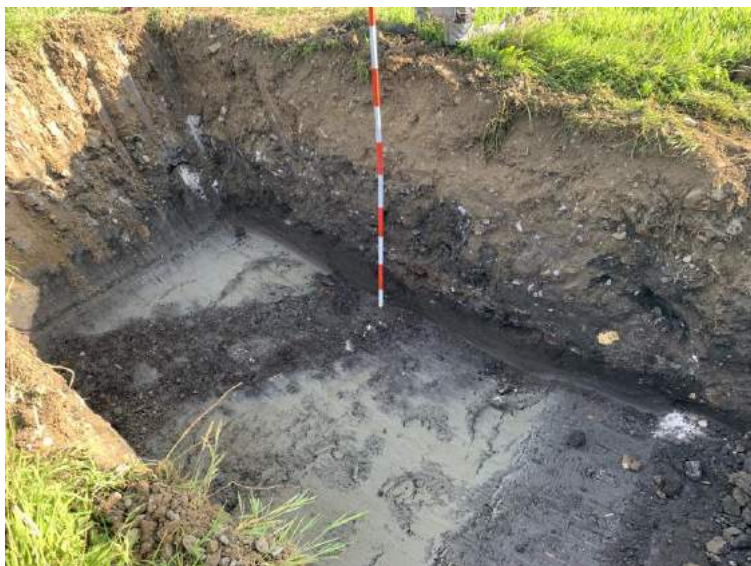
Plate 32 Test Trench 7, post excavation, facing southwest

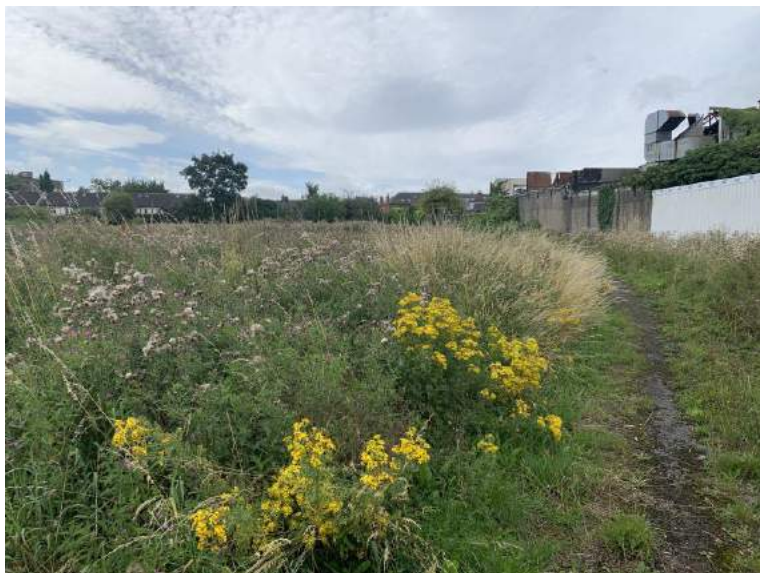
Plate 34 Concrete and tarmacadam area of test area, facing east

The site is owned by Dublin City Council and comprises an area of ground 170m to the southwest of Donore Avenue, 120m to the east of Dolphin's Barn Street and 160m to the north of South Circular Road (ITM 714124, 732899; Figure 1). The north extent was previously occupied by the 1950s residential development of St. Teresa's Gardens (now partially demolished; Plate 1) while the southern extent comprised a former sports and recreational area (Plates 34 and 35).
