Dyrick Hill Wind Farm

Abnormal Indivisible Load Route Survey

December 2021

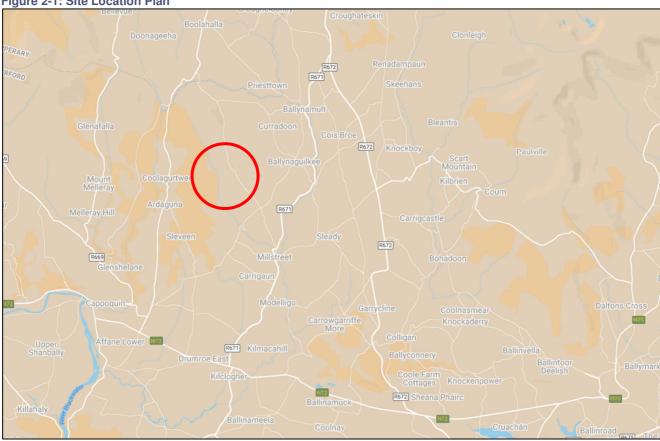
The development site located to the west of Curradoon, County Waterford, Ireland. Figure 2-1 illustrates the general site location.

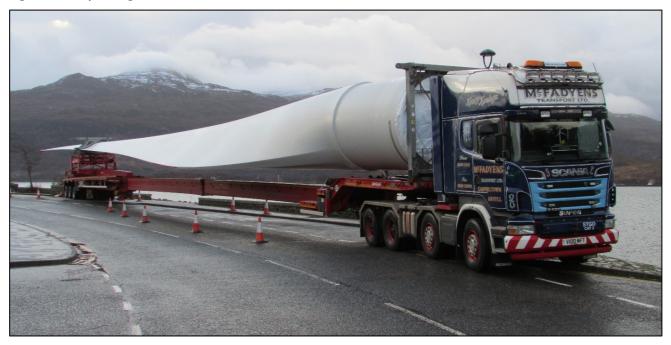
Figure 2-2: Superwing Carrier Trailer

To provide a robust assessment scenario based upon the known issues along the access route, it has been assumed that all blades would be carried on a Superwing Carrier trailer to reduce the need for mitigation in constrained sections of the route.

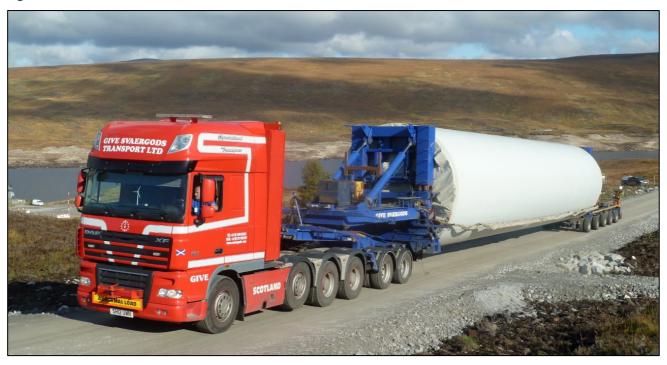
Figure 2-3: Tower Trailer

The base and mid towers would be carried on a 4+7 clamp trailer. The hub, nacelle housing, and top towers would be carried on a six-axle step frame trailer.

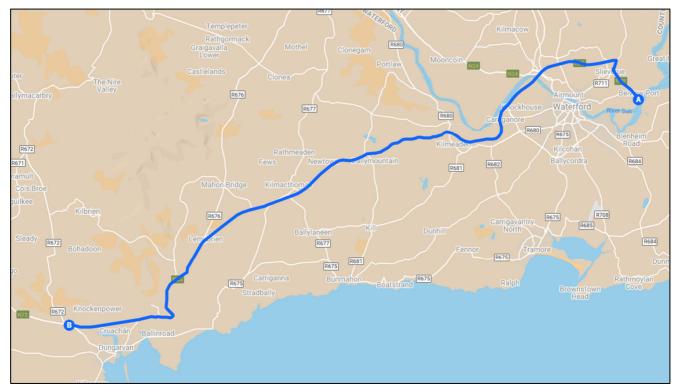
Figure 3-1: Shared Access Route

The proposed shared route from Waterford Port is detailed below:

- Loads would depart the port and join the N29 travelling north west;
- Loads will turn left and join the westbound N25; and
- Loads will turn right onto the N72 and continue west to Ballymacmague.

The proposed access route is illustrated below.

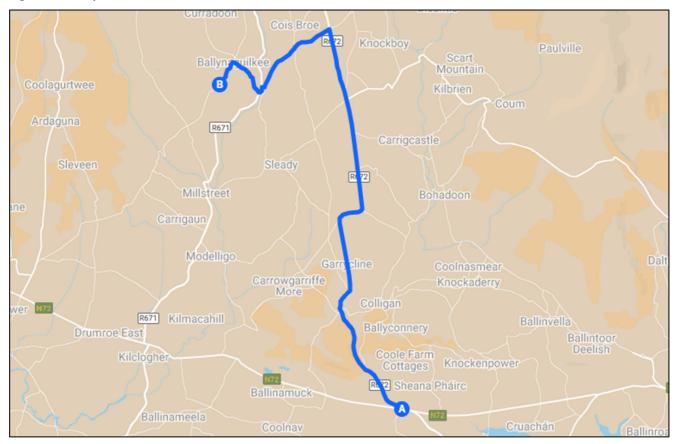
Figure 3-2: Proposed Access Route 1

The proposed eastern access route to site is detailed below:

- Loads will turn right onto the R672 and travel north west;
- Loads would turn left onto the L5071 leading west; and
- Loads will turn right and follow the unclassified road to the proposed site entrance.

The proposed access route is illustrated below.

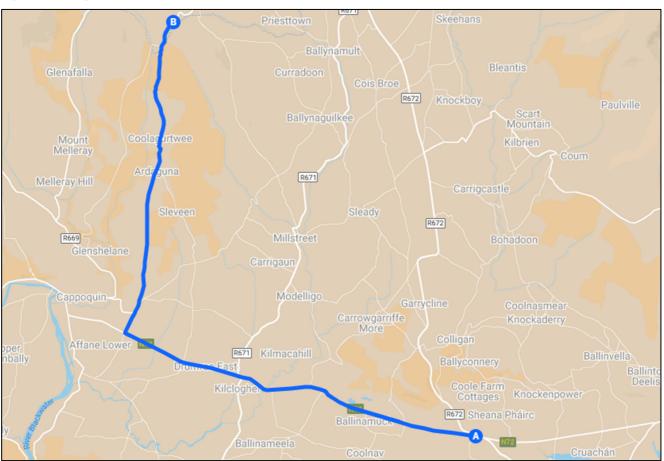
Figure 3-3: Proposed Access Route 2

The proposed western access route to site is detailed below:

- Loads will continue west on the N72 to Affane and turn right onto the L1027; and
- Loads will continue north to the proposed site entrance.

The proposed access route is illustrated in Figure 3-3.

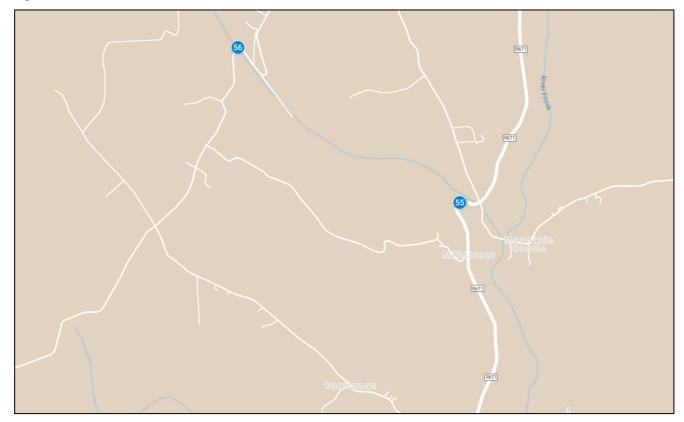
Figure 3-4: Alternative Route Constraint Points

The client identified two further constraint points for assessment on two alternative access routes. Initial swept path assessments have been completed at these locations to identify whether either route is potentially suitable for further assessment. The locations are shown in Figure 3-4 below and detailed in Table 3-4. Due to the extreme works required on the swept path assessments, no further assessment of these have been completed as part of this study.

Farnane Upper, Cappagh Loads would be required to negotiate two hairpin bends in order to utilise this route. It was not possible to negotiate the vehicles through the initial right bend without substantial third party land and significant earth works and as such no further assessment of this route is considered physically or financial possible.
