Arboricultural Impact Assessment

National Transport Authority

Bus Connects Route 11 Kimmage the City Centre

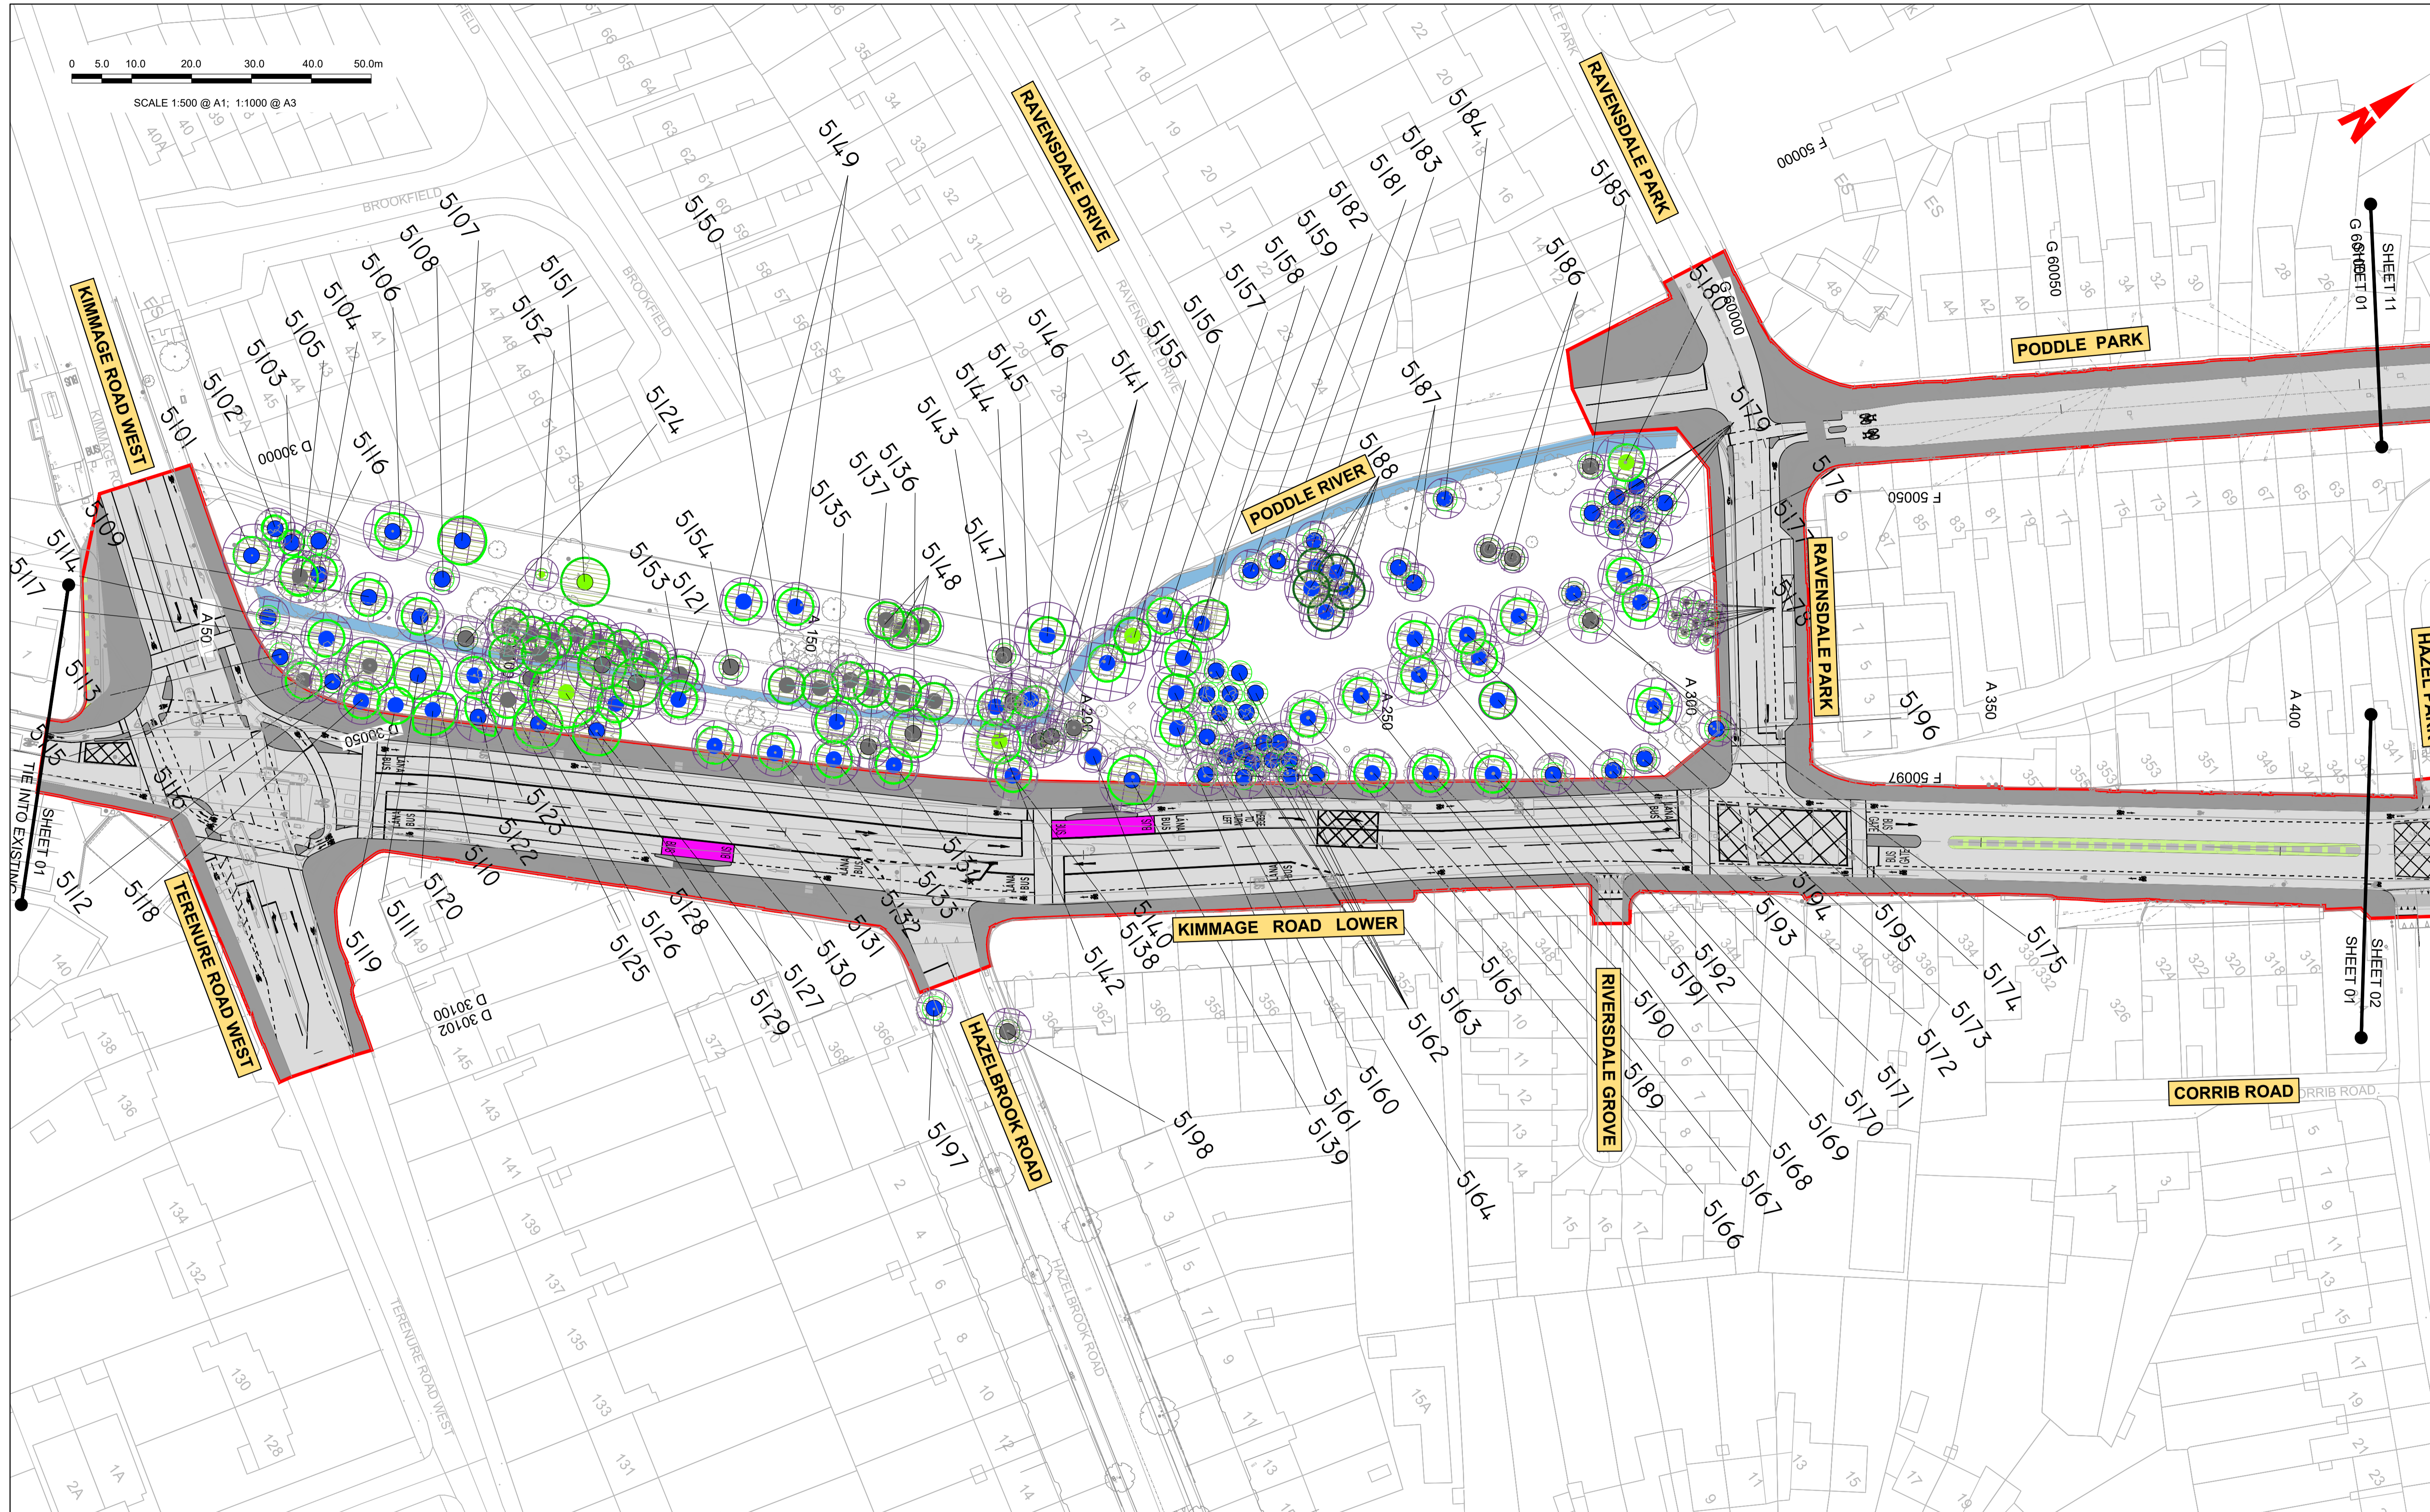
- 1 EXISTING TREE CANOPY BASED ON DIMENSIONS GATHERED ON SITE IN 4 DIRECTIONS, NORTH, SOUTH, EAST AND WEST
- 2 ROOT PROTECTION ZONE BASED ON 12 TIMES THE (DBH) AT CHEST HEIGHT
- 3 TREE TAG NUMBER
- 4 TREE TO BE RETAINED
- 5 TREE TO BE REMOVED
- 6 TREE CATEGORY BASED ON BS:5837 2012 CRITERIA
- 7 DECIDUOUS TREE CANOPY
- 8 EVERGREEN TREE CANOPY
