Appendix D
Arboricultural Impact
Assessment Report

Arboricultural Impact Assessment

Bus Connects Route 11 Kimmage the City Centre

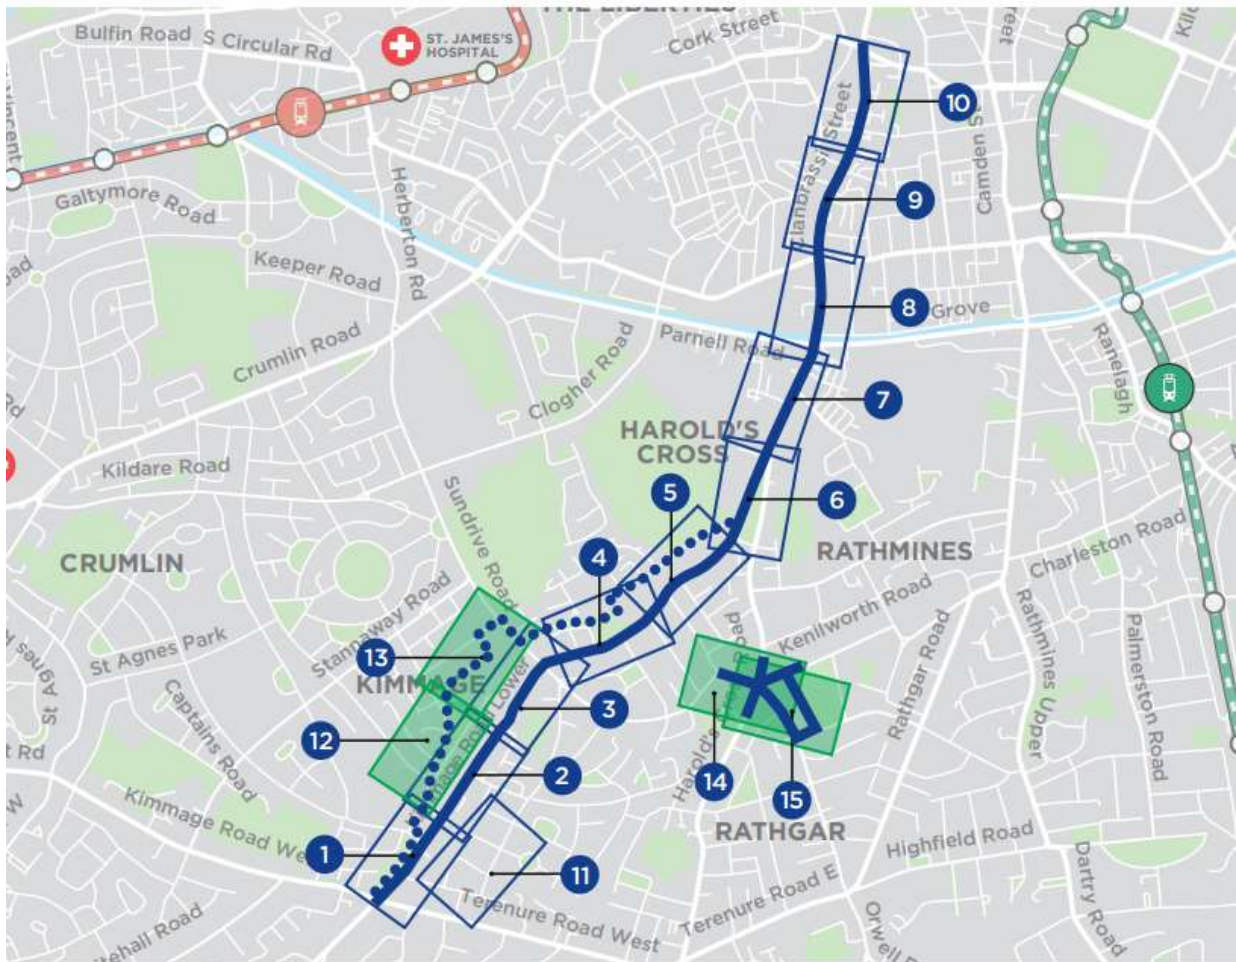
Figure 1.0 Proposed Route corridor (Source: www.busconnects.ie)

The survey was undertaken between the 26th and 30th of June 2020. The survey commenced at location 1 and finished at location 10 of figure 1 below of the Proposed Scheme.

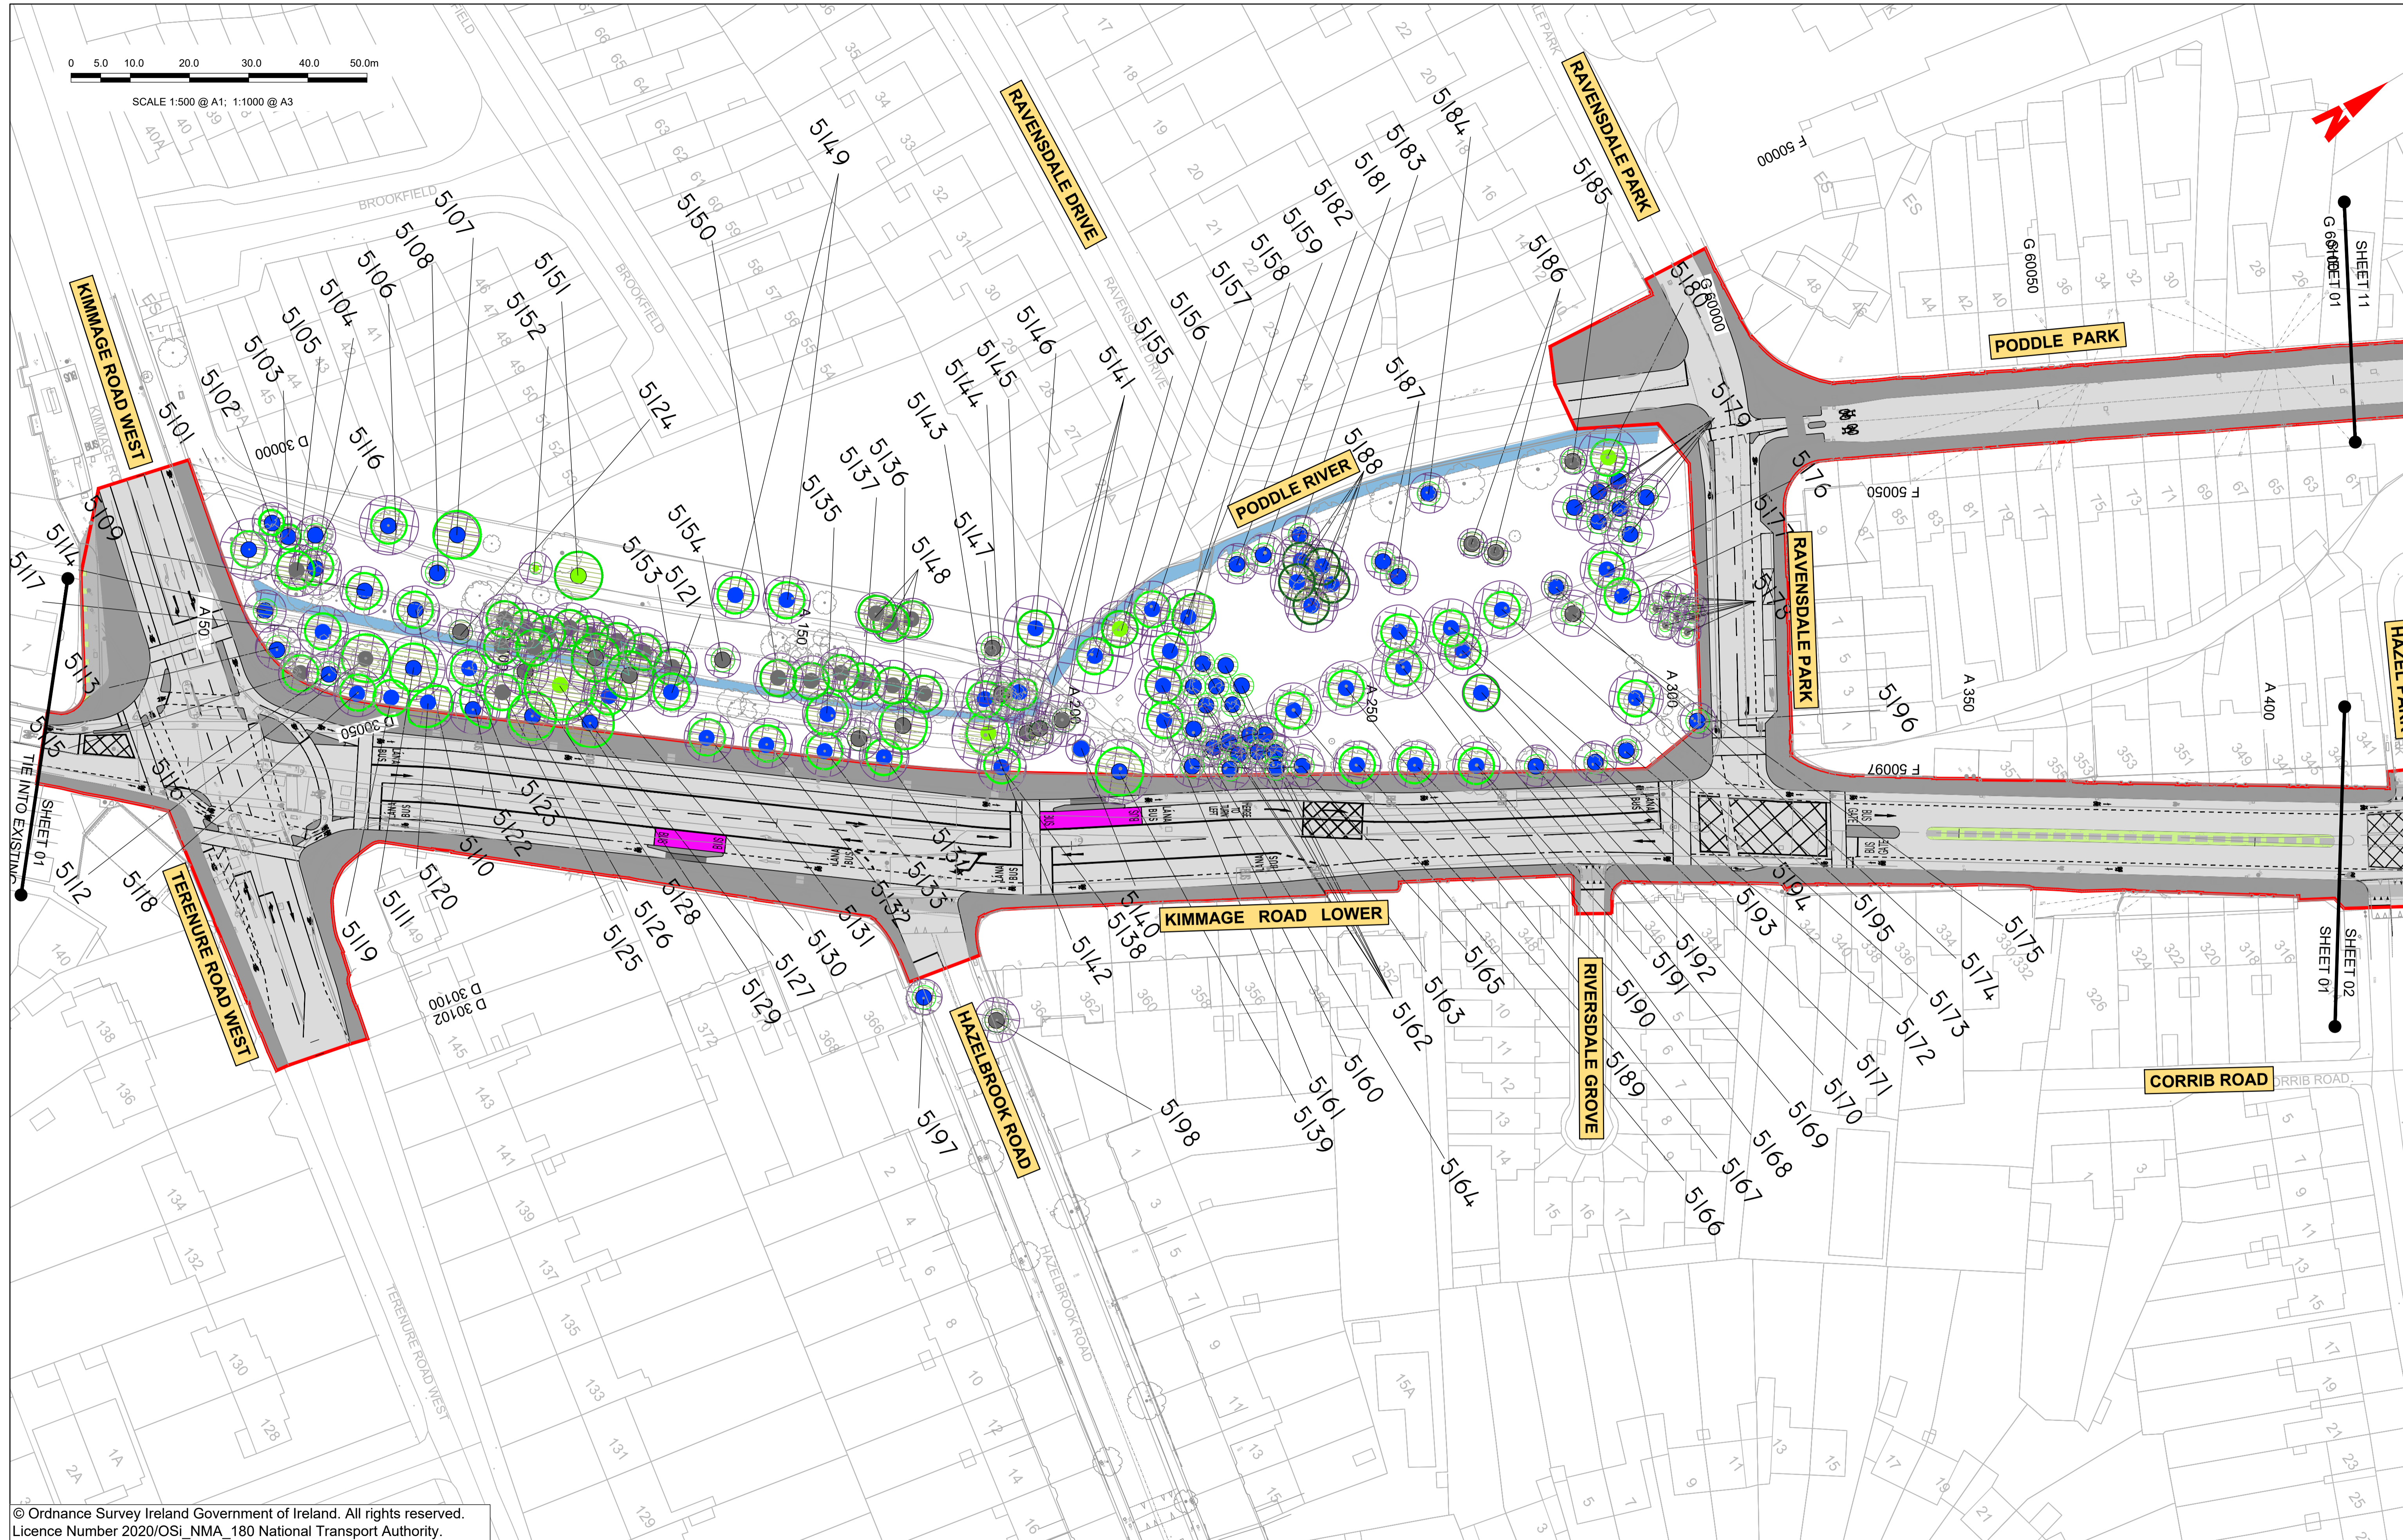
- 1 EXISTING TREE CANOPY BASED ON DIMENSIONS GATHERED ON SITE IN 4 DIRECTIONS, NORTH, SOUTH, EAST AND WEST
- 2 ROOT PROTECTION ZONE BASED ON 12 TIMES THE (DBH) AT CHEST HEIGHT

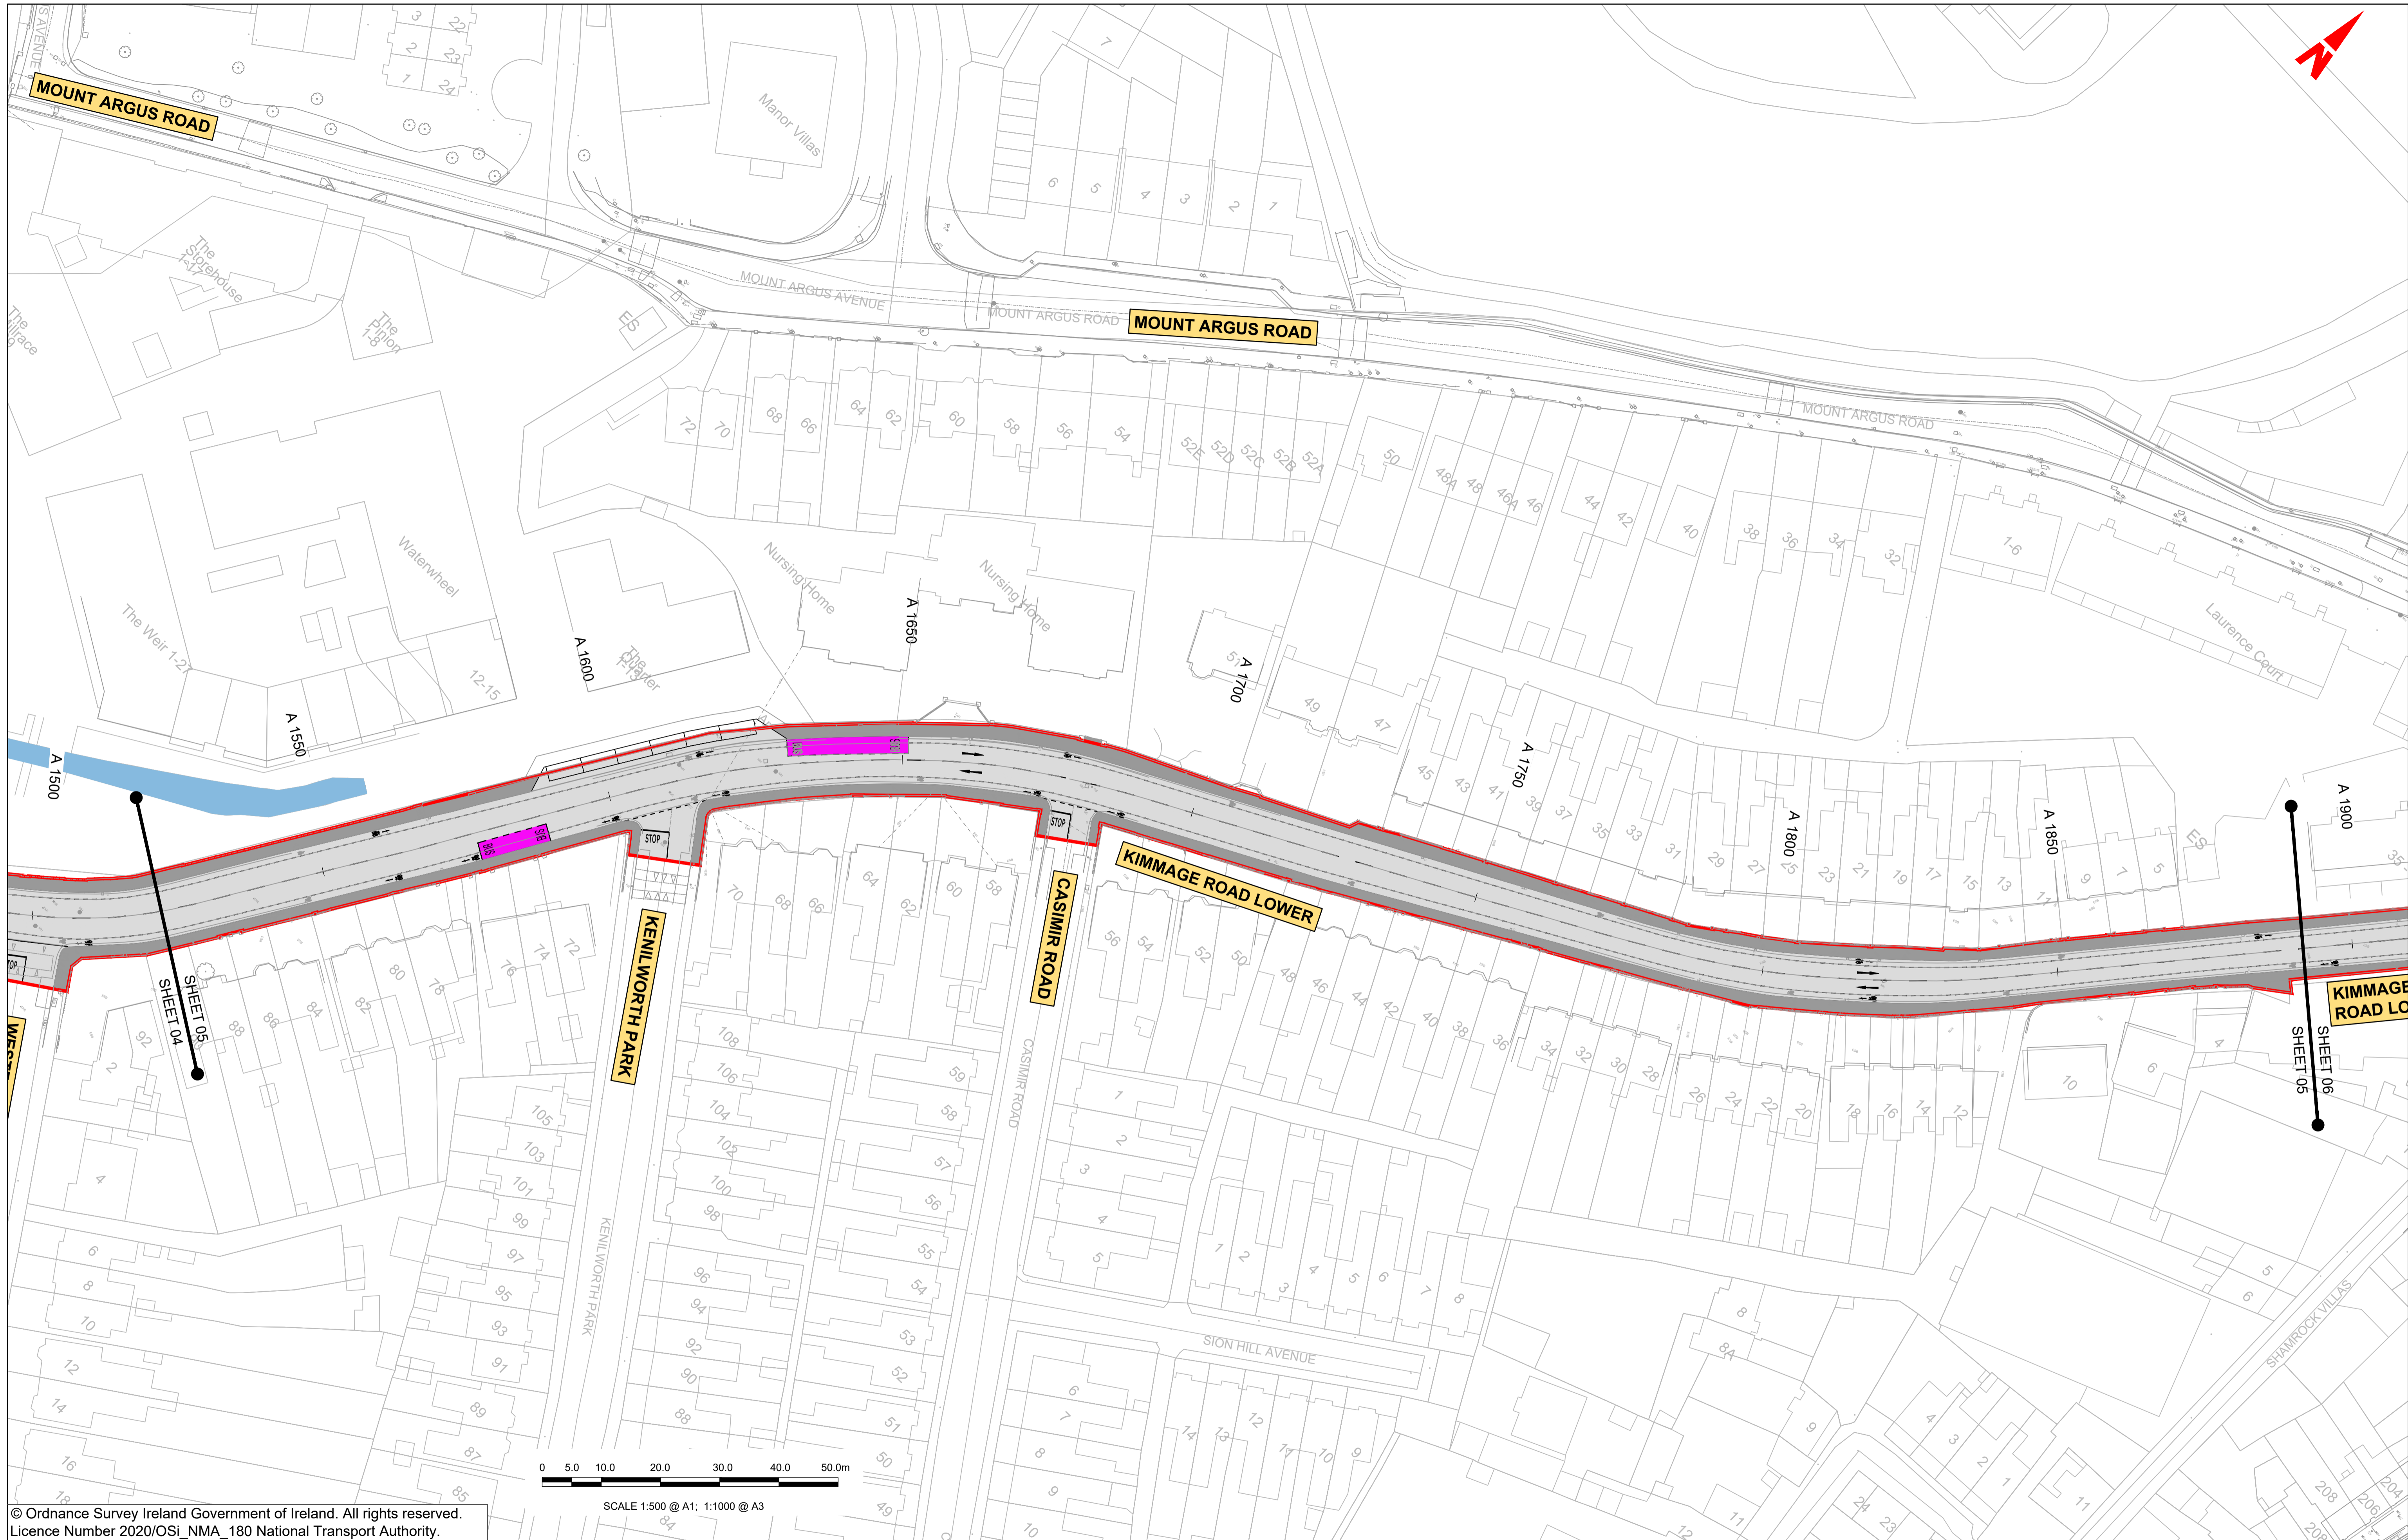
- 1 EXISTING TREE CANOPY BASED ON DIMENSIONS GATHERED ON SITE IN 4 DIRECTIONS, NORTH, SOUTH, EAST AND WEST
- 2 ROOT PROTECTION ZONE BASED ON 12 TIMES THE (DBH) AT CHEST HEIGHT
- 3 TREE TAG NUMBER
- 4 TREE TO BE RETAINED
- 5 TREE TO BE REMOVED
- 6 TREE CATEGORY BASED ON BS:5837 2012 CRITERIA
- 7 DECIDUOUS TREE CANOPY
- 8 EVERGREEN TREE CANOPY

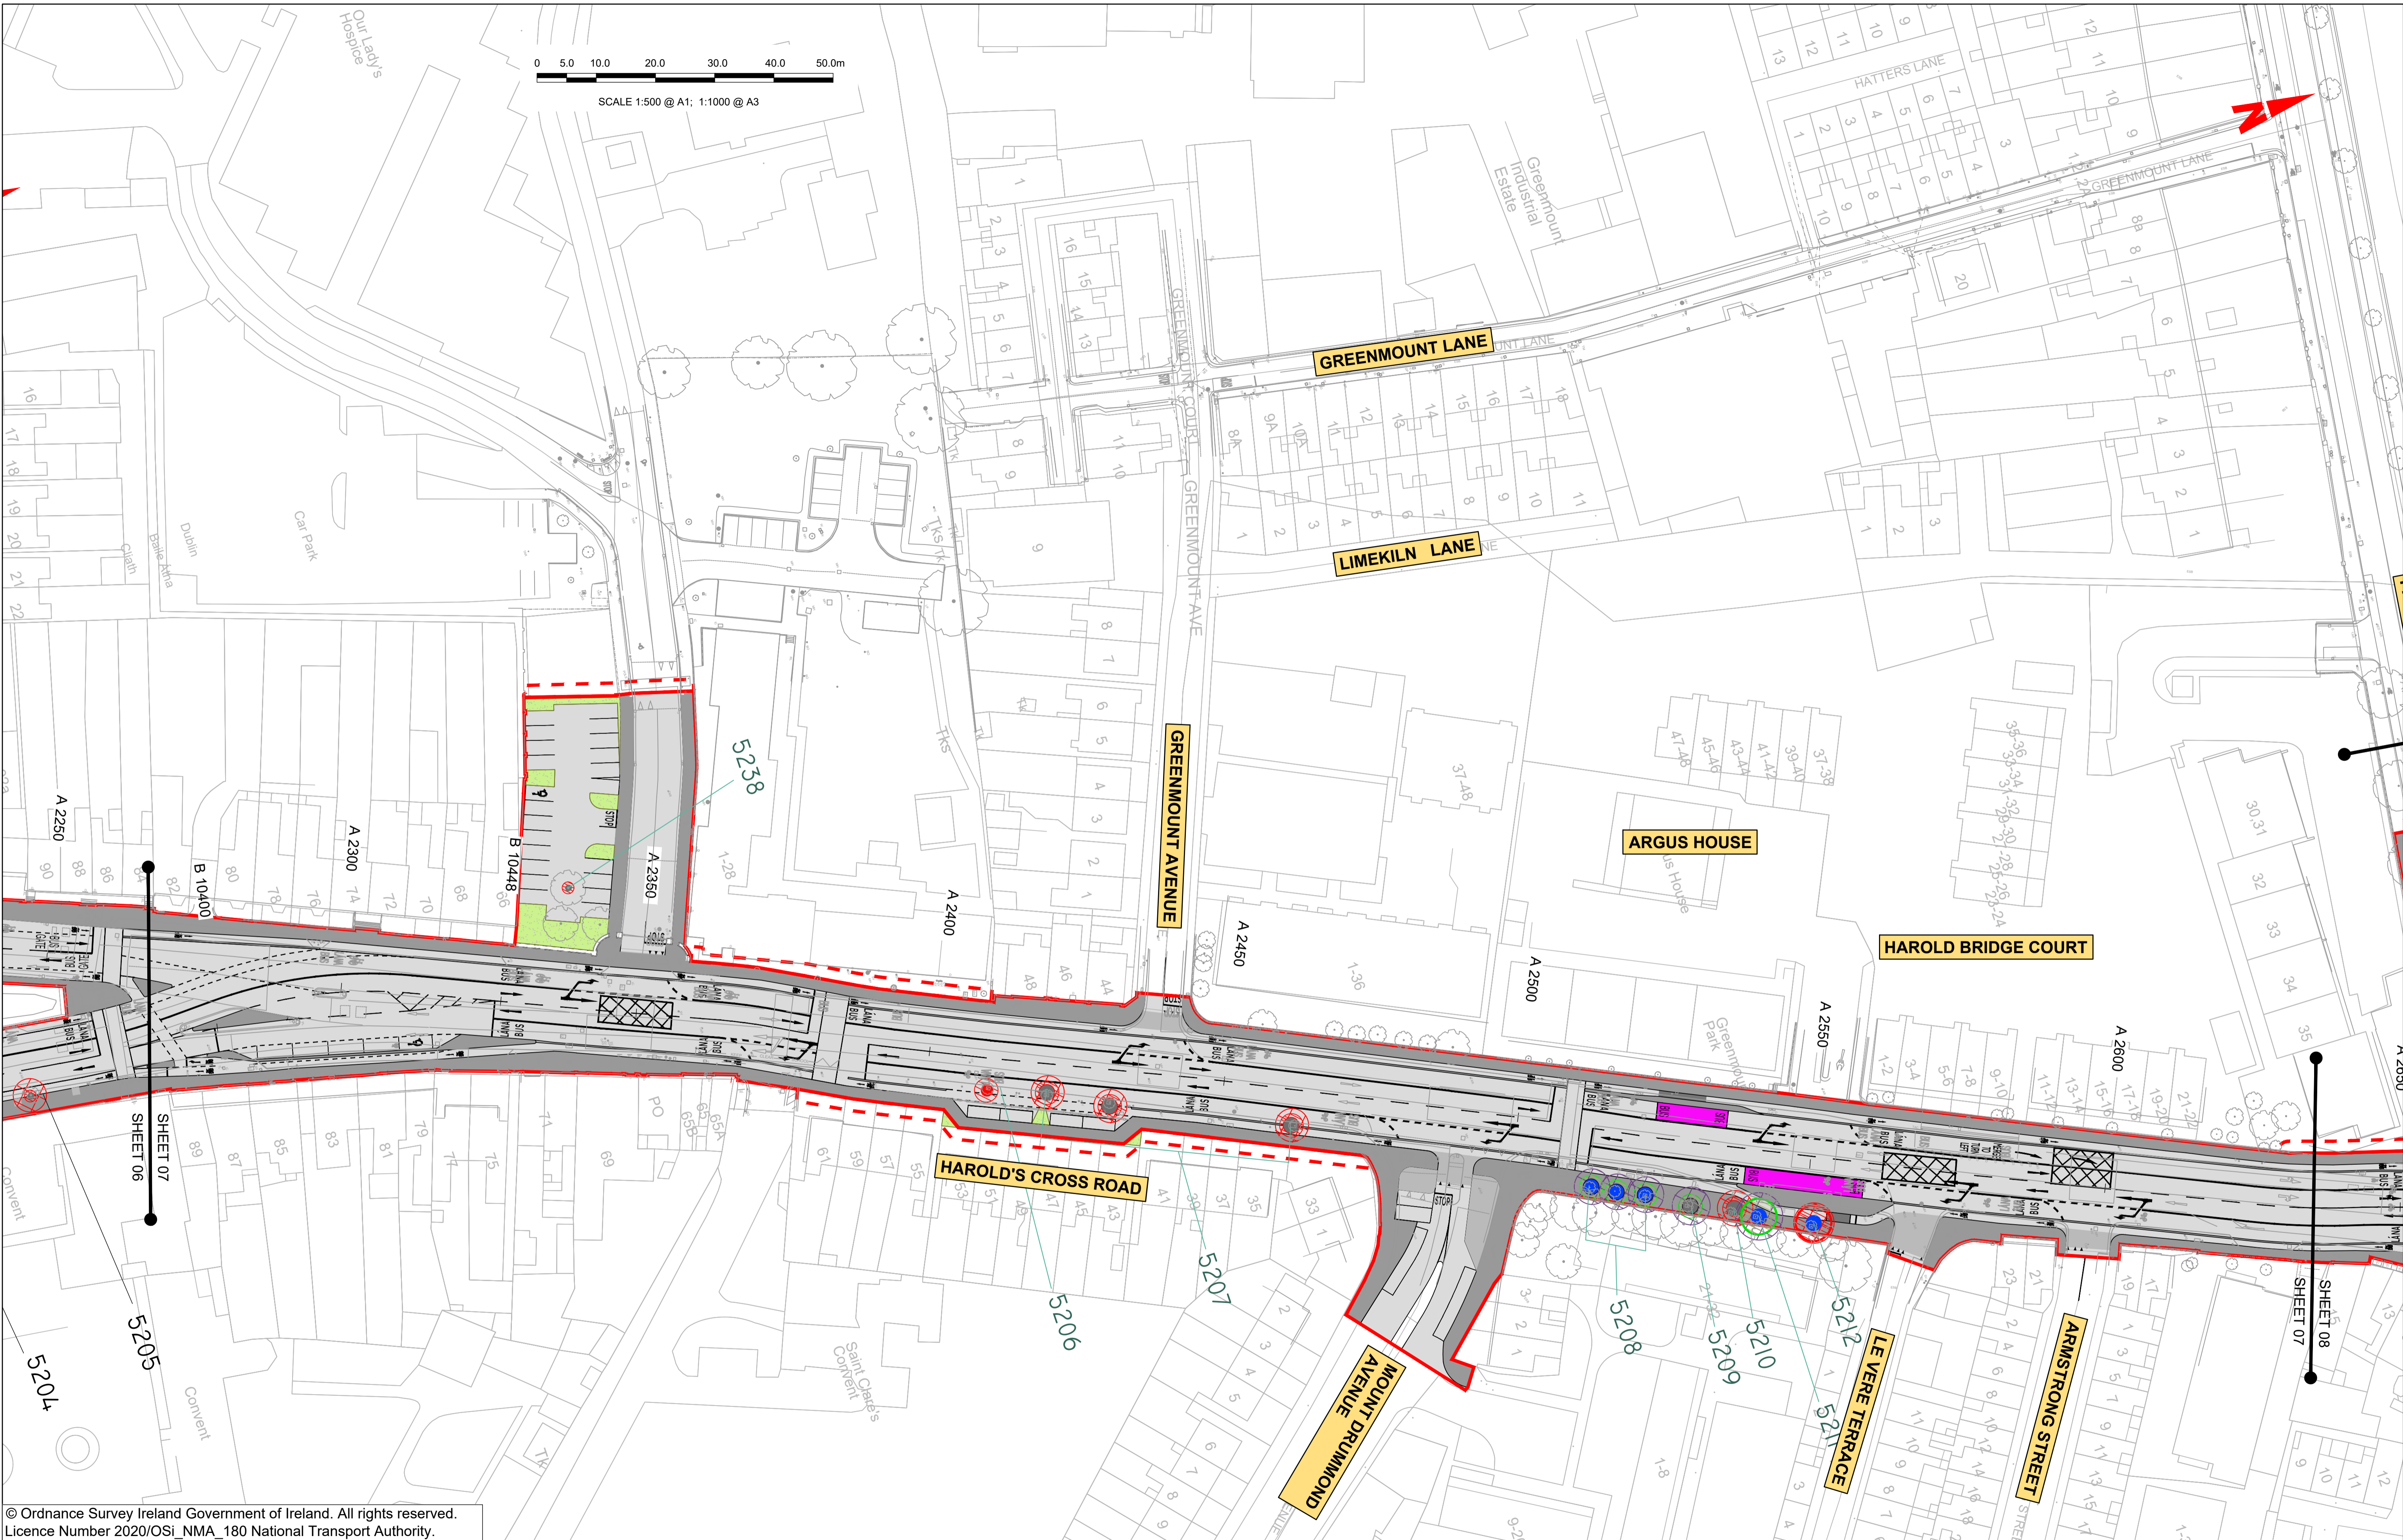
- 1 EXISTING TREE CANOPY BASED ON DIMENSIONS GATHERED ON SITE IN 4 DIRECTIONS, NORTH, SOUTH, EAST AND WEST
- 2 ROOT PROTECTION ZONE BASED ON 12 TIMES THE (DBH) AT CHEST HEIGHT
- 3 TREE TAG NUMBER
- 4 TREE TO BE RETAINED
- 5 TREE TO BE REMOVED
- 6 TREE CATEGORY BASED ON BS:5837 2012 CRITERIA
- 7 DECIDUOUS TREE CANOPY
- 8 EVERGREEN TREE CANOPY

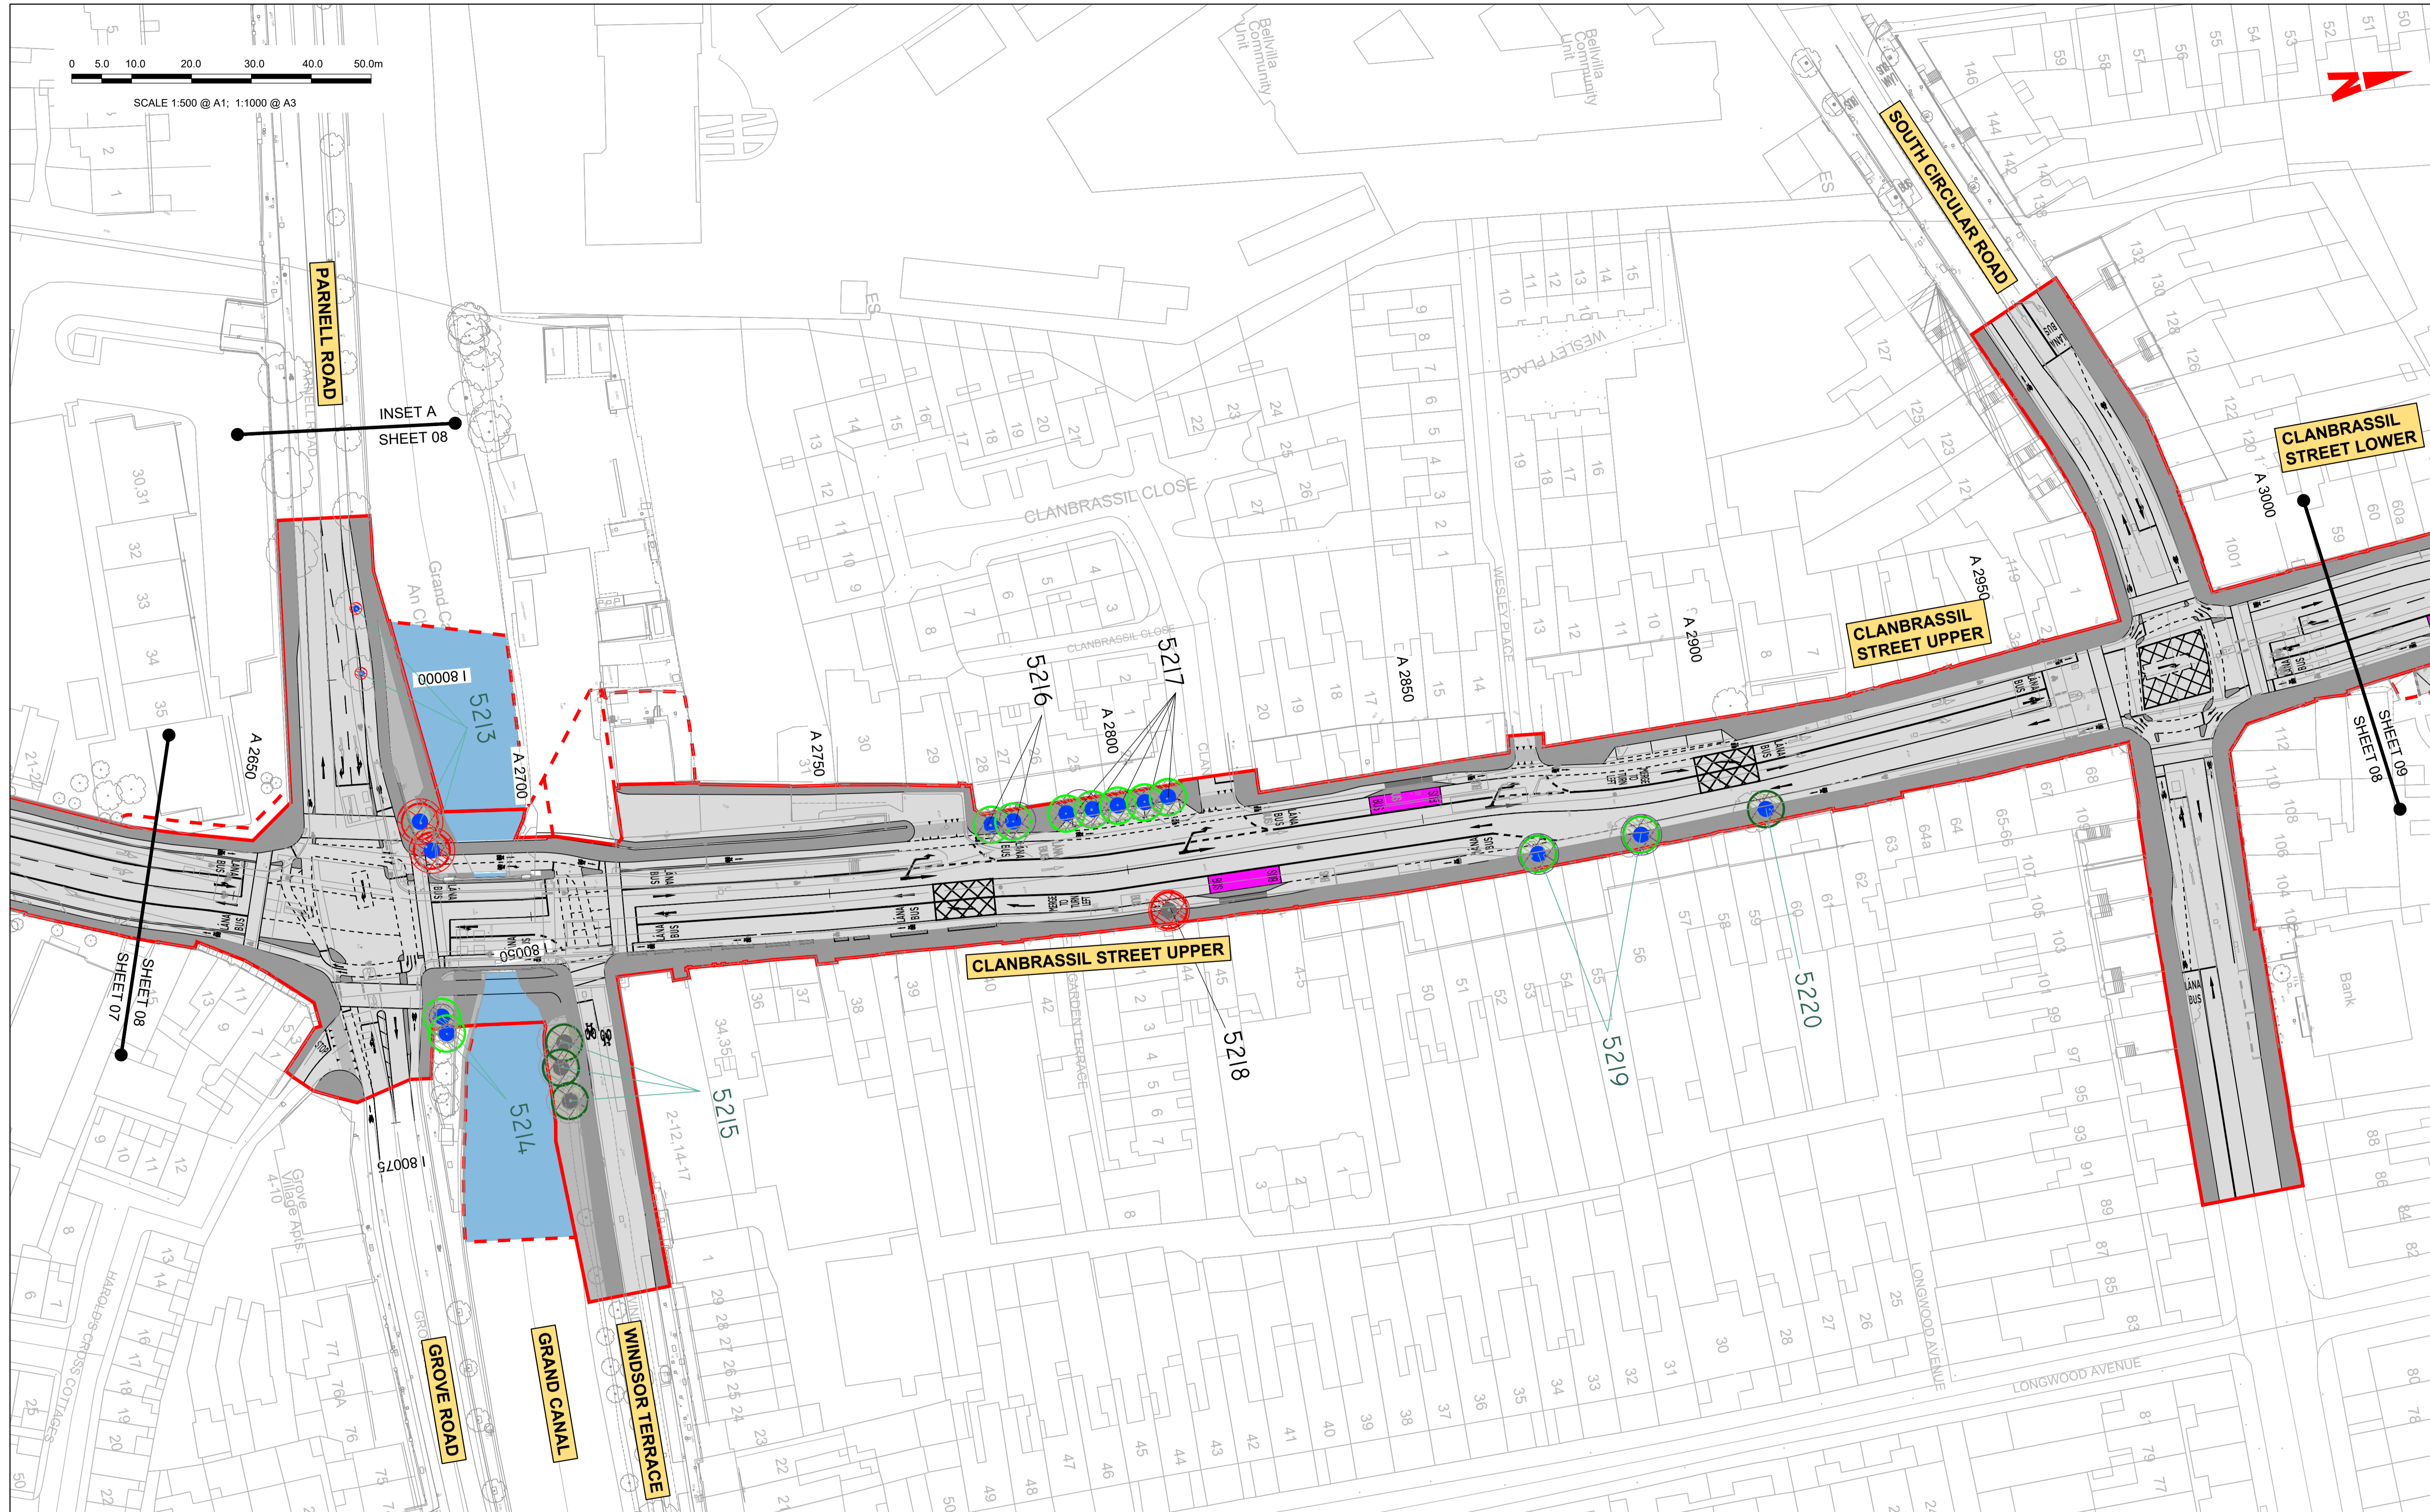
- 1 EXISTING TREE CANOPY BASED ON DIMENSIONS GATHERED ON SITE IN 4 DIRECTIONS, NORTH, SOUTH, EAST AND WEST
- 2 ROOT PROTECTION ZONE BASED ON 12 TIMES THE (DBH) AT CHEST HEIGHT
- 3 TREE TAG NUMBER
- 4 TREE TO BE RETAINED
- 5 TREE TO BE REMOVED
- 6 TREE CATEGORY BASED ON BS:5837 2012 CRITERIA
- 7 DECIDUOUS TREE CANOPY
- 8 EVERGREEN TREE CANOPY

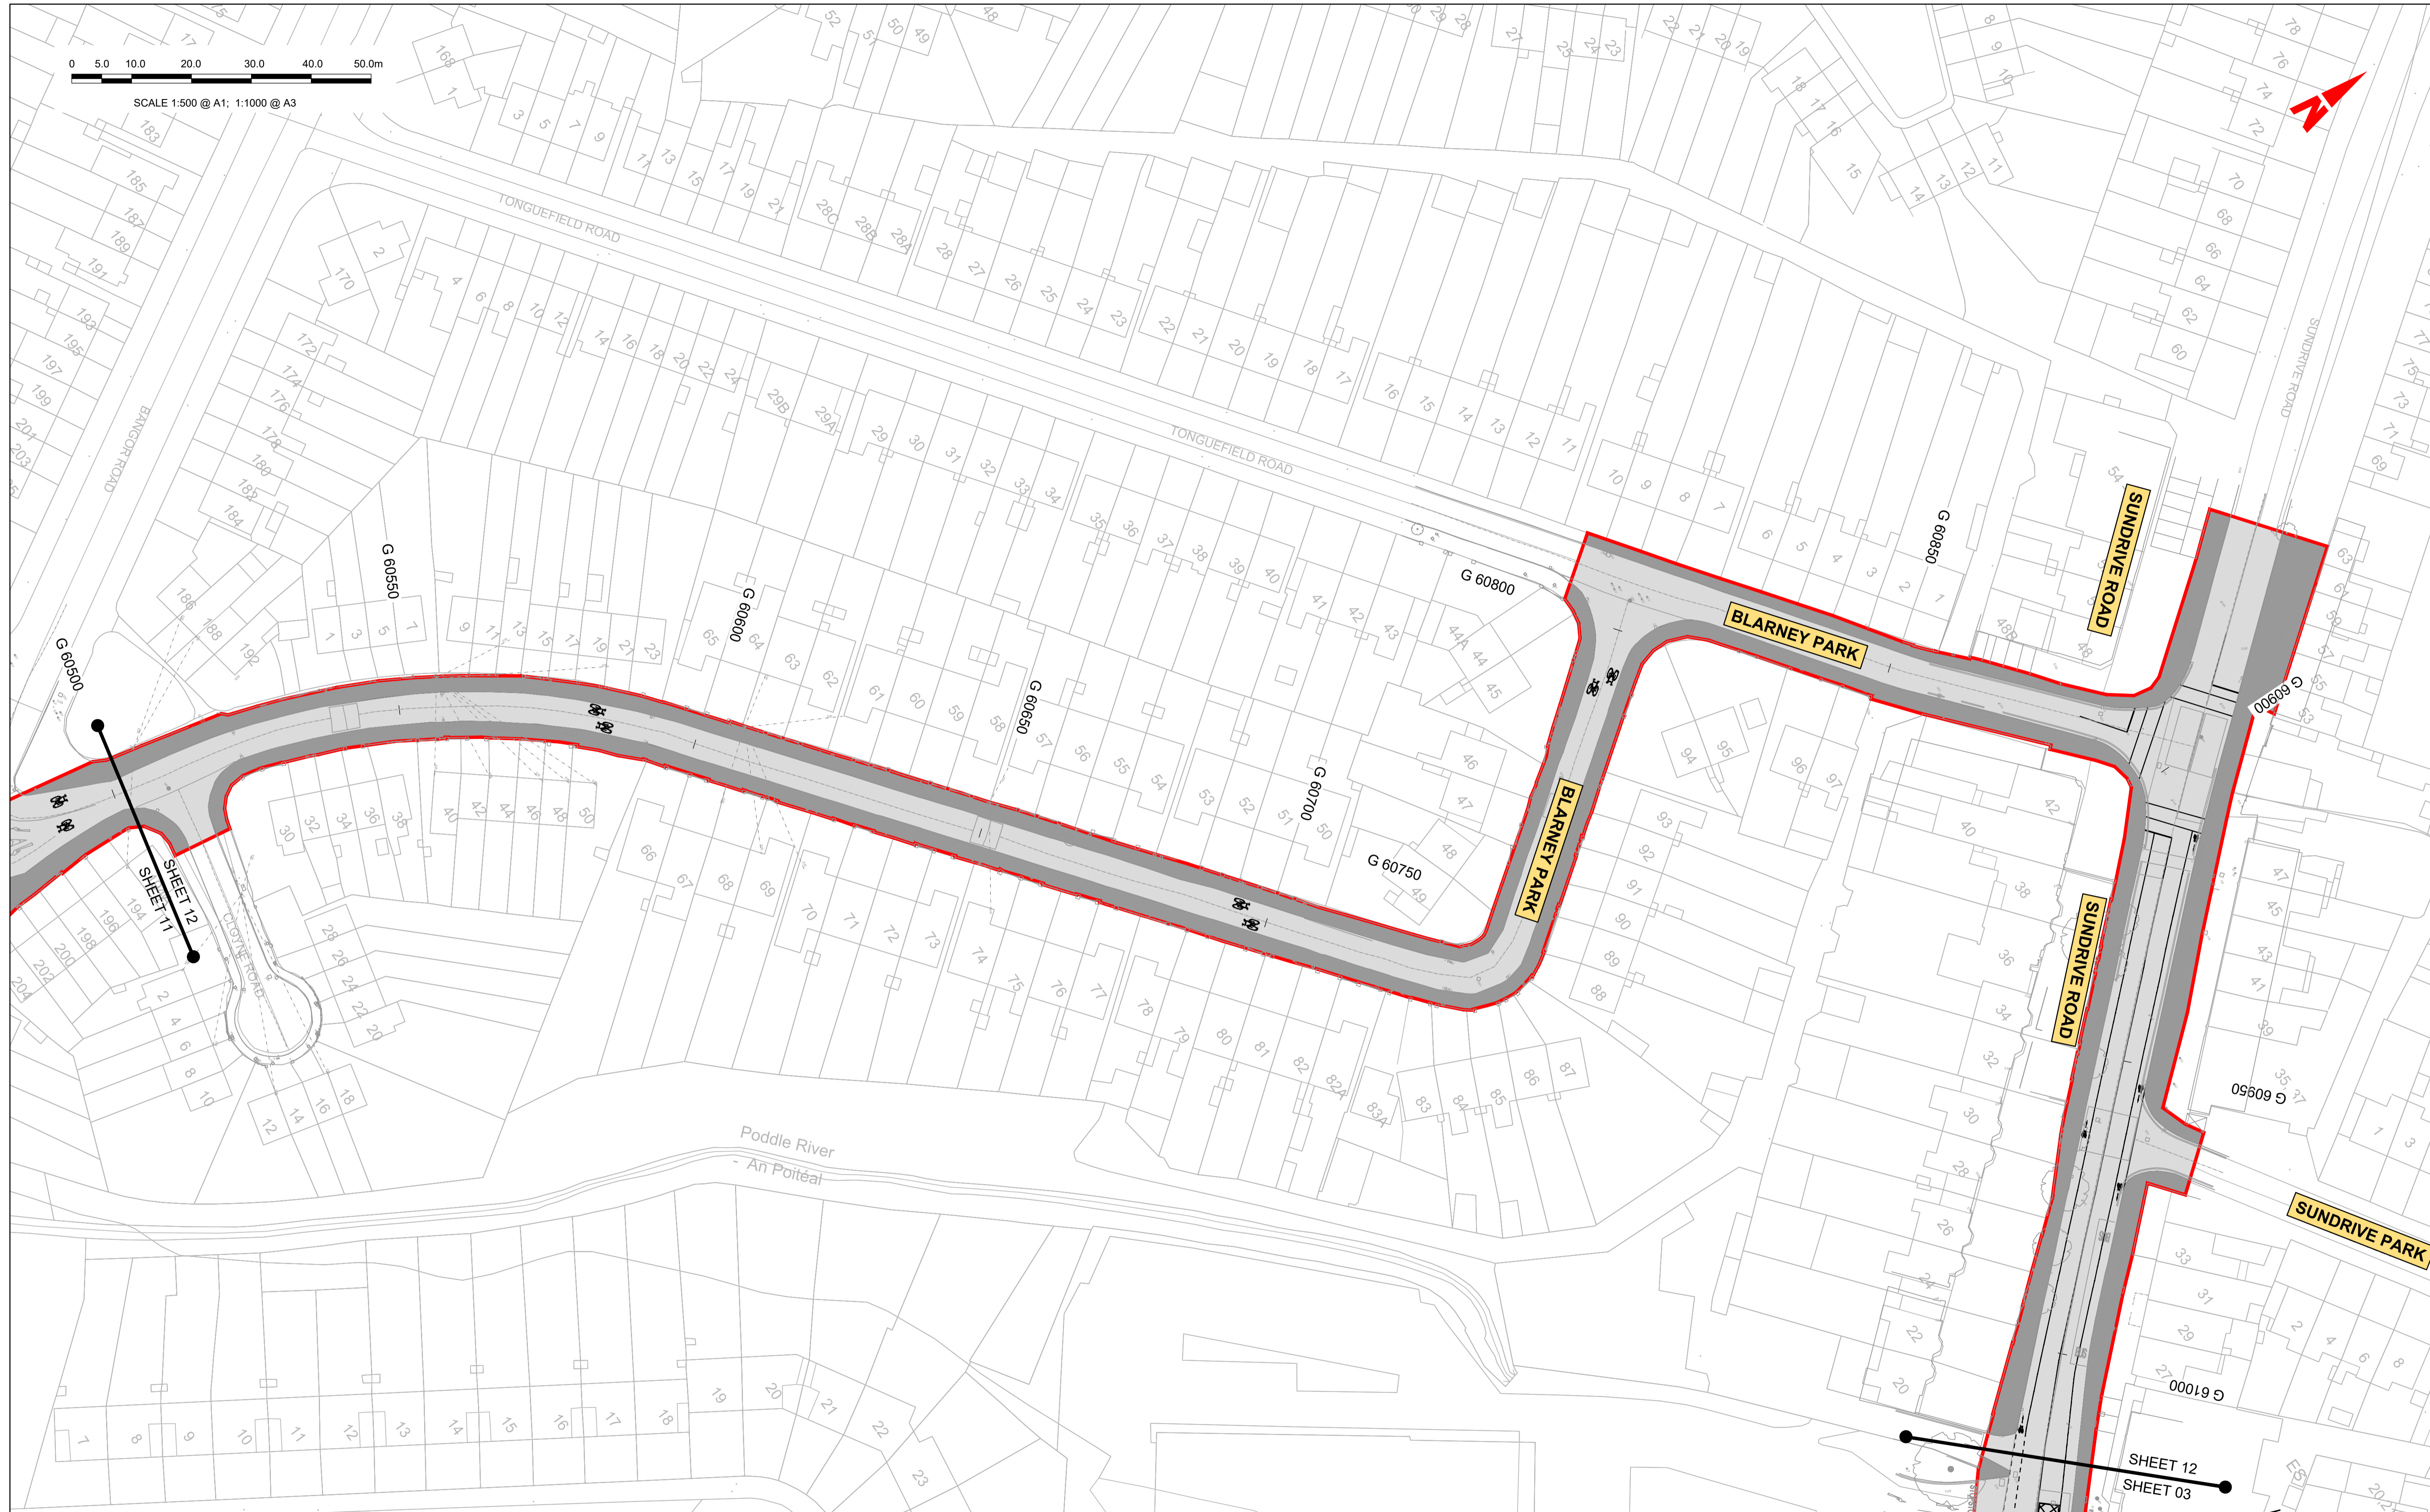
- 1 EXISTING TREE CANOPY BASED ON DIMENSIONS GATHERED ON SITE IN 4 DIRECTIONS, NORTH, SOUTH, EAST AND WEST
- 2 ROOT PROTECTION ZONE BASED ON 12 TIMES THE (DBH) AT CHEST HEIGHT
- 3 TREE TAG NUMBER
- 4 TREE TO BE RETAINED
- 5 TREE TO BE REMOVED
- 6 TREE CATEGORY BASED ON BS:5837 2012 CRITERIA
- 7 DECIDUOUS TREE CANOPY
- 8 EVERGREEN TREE CANOPY
