Appendix D
Arboricultural Impact
Assessment Report

Arboricultural Impact Assessment

Bus Connects Route 11 Kimmage the City Centre

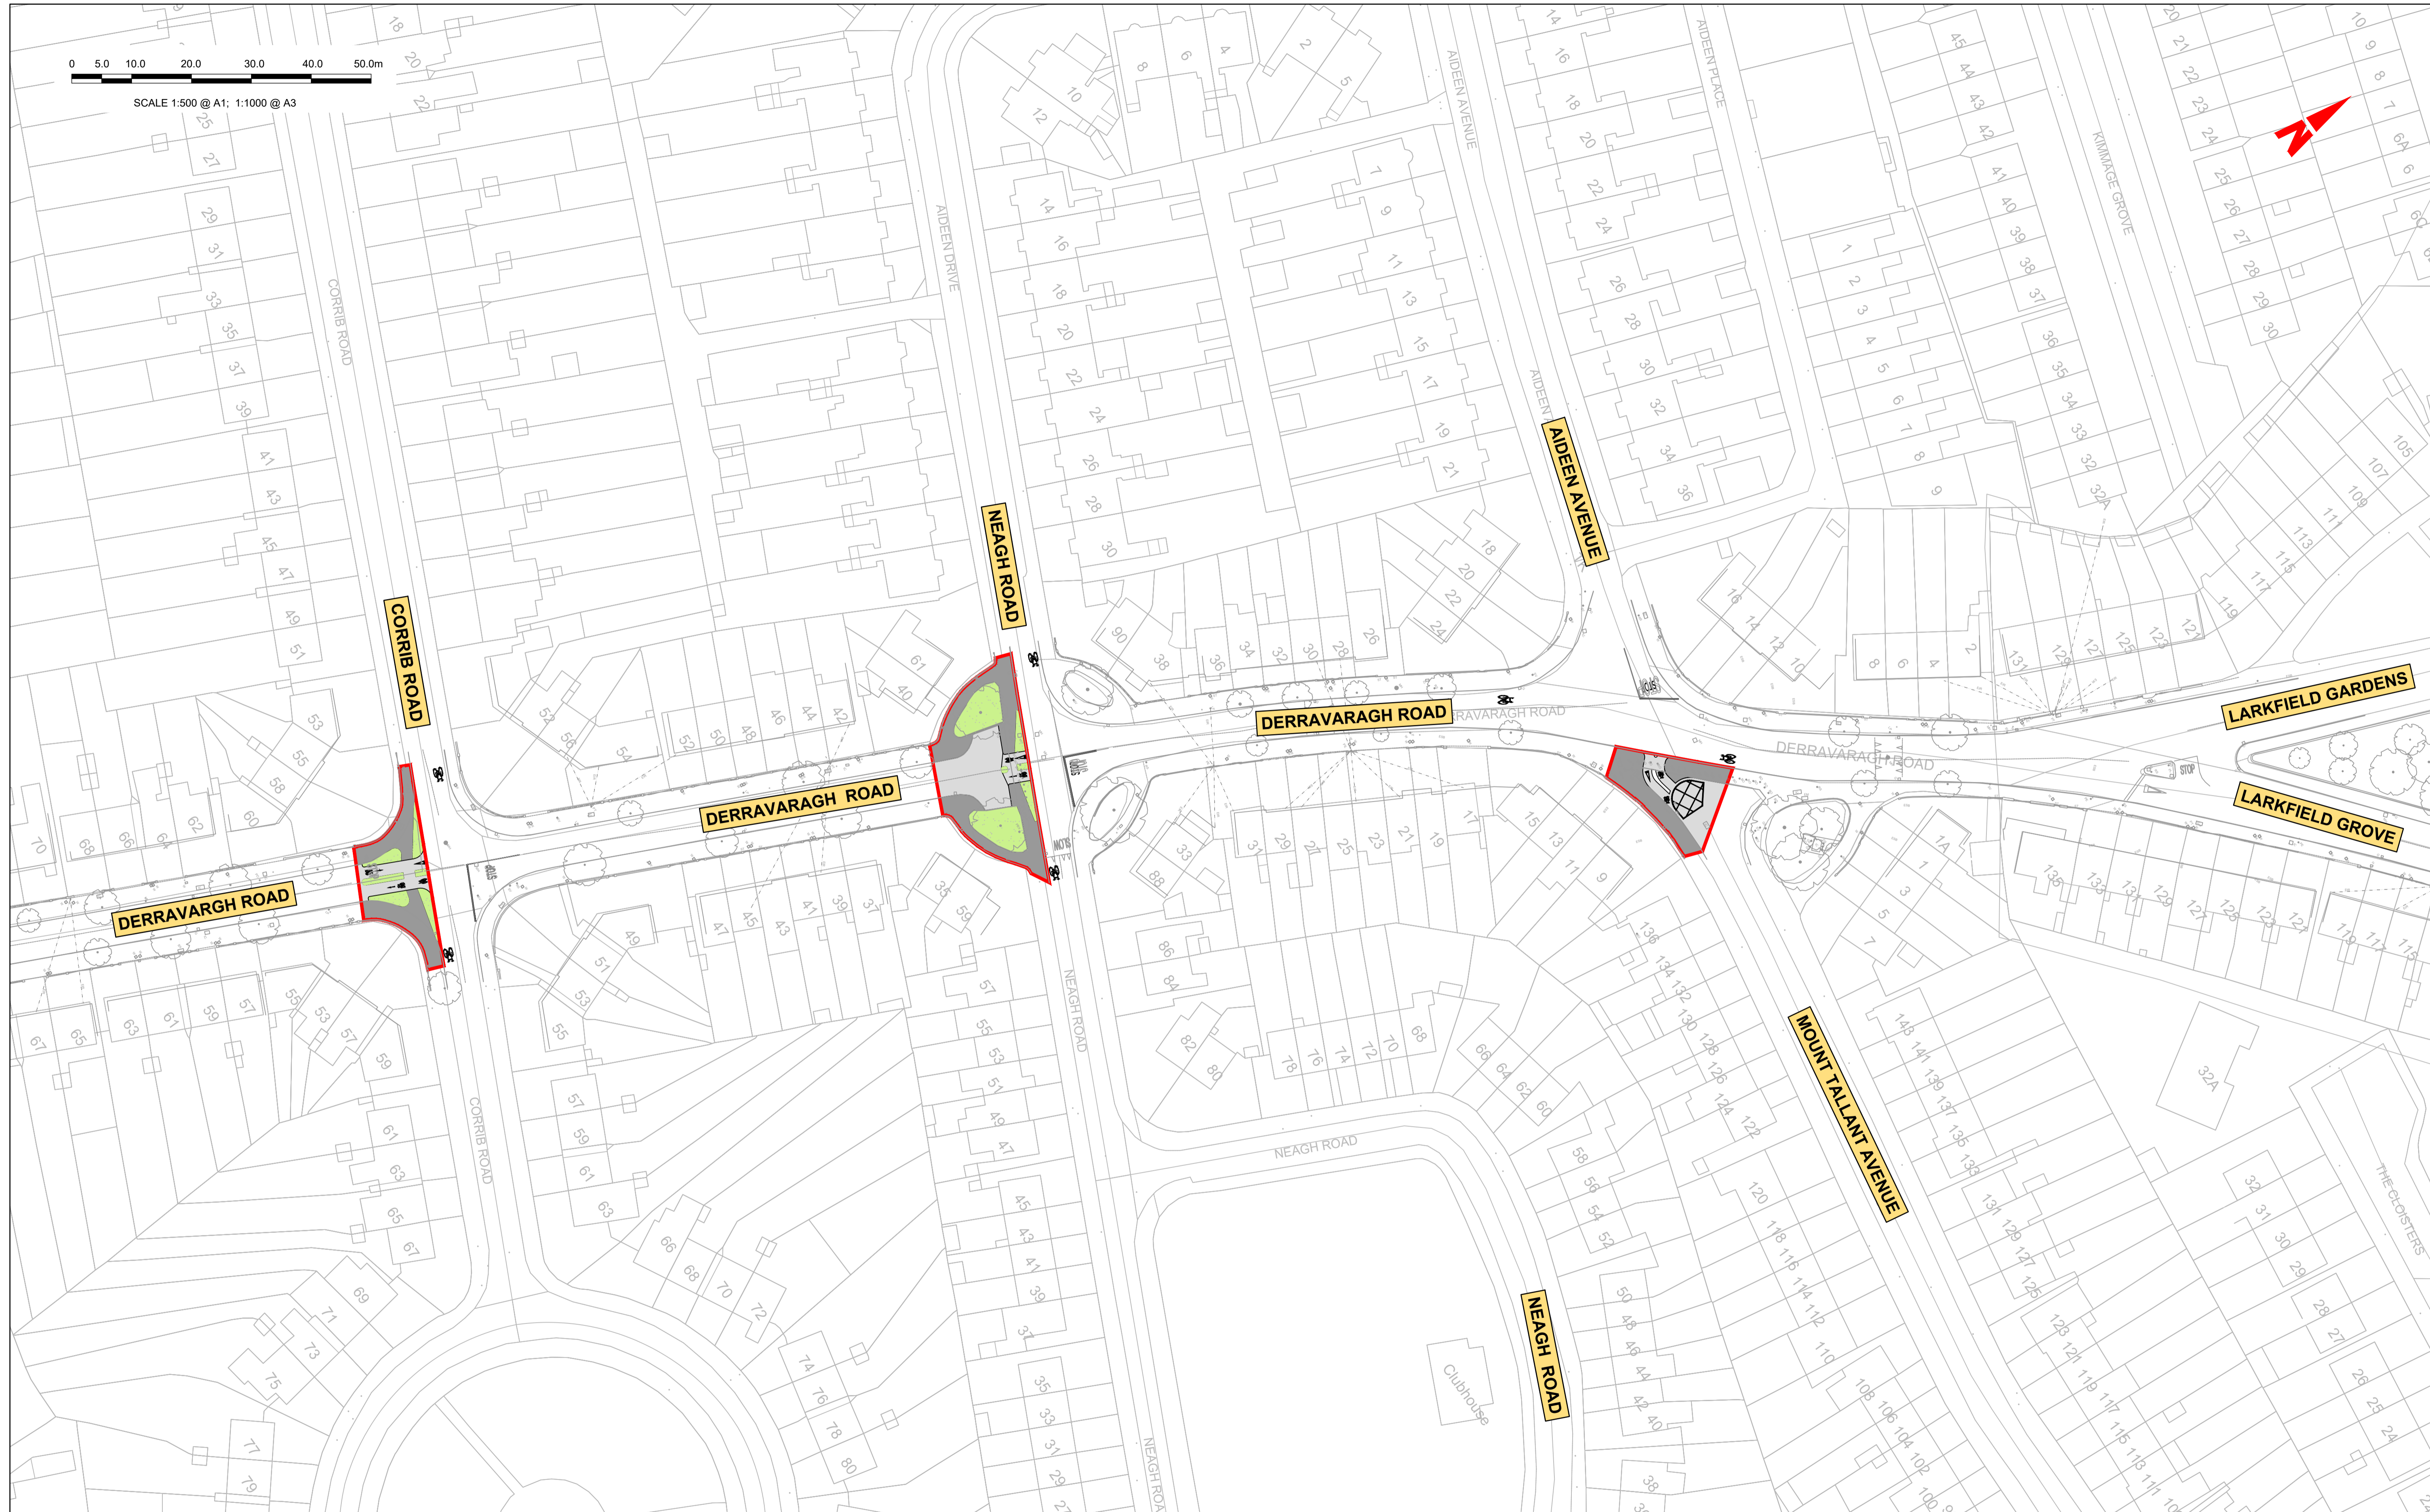
- 1 EXISTING TREE CANOPY BASED ON DIMENSIONS GATHERED ON SITE IN 4 DIRECTIONS, NORTH, SOUTH, EAST AND WEST
- 2 ROOT PROTECTION ZONE BASED ON 12 TIMES THE (DBH) AT CHEST HEIGHT
- 3 TREE TAG NUMBER
- 4 TREE TO BE RETAINED
- 5 TREE TO BE REMOVED
- 6 TREE CATEGORY BASED ON BS:5837 2012 CRITERIA
- 7 DECIDUOUS TREE CANOPY
- 8 EVERGREEN TREE CANOPY
