# Appendix A17.1

## Arboricultural Impact Assessment

National Transport Authority

Bus Connects Route 16 Ringsend to the City Centre

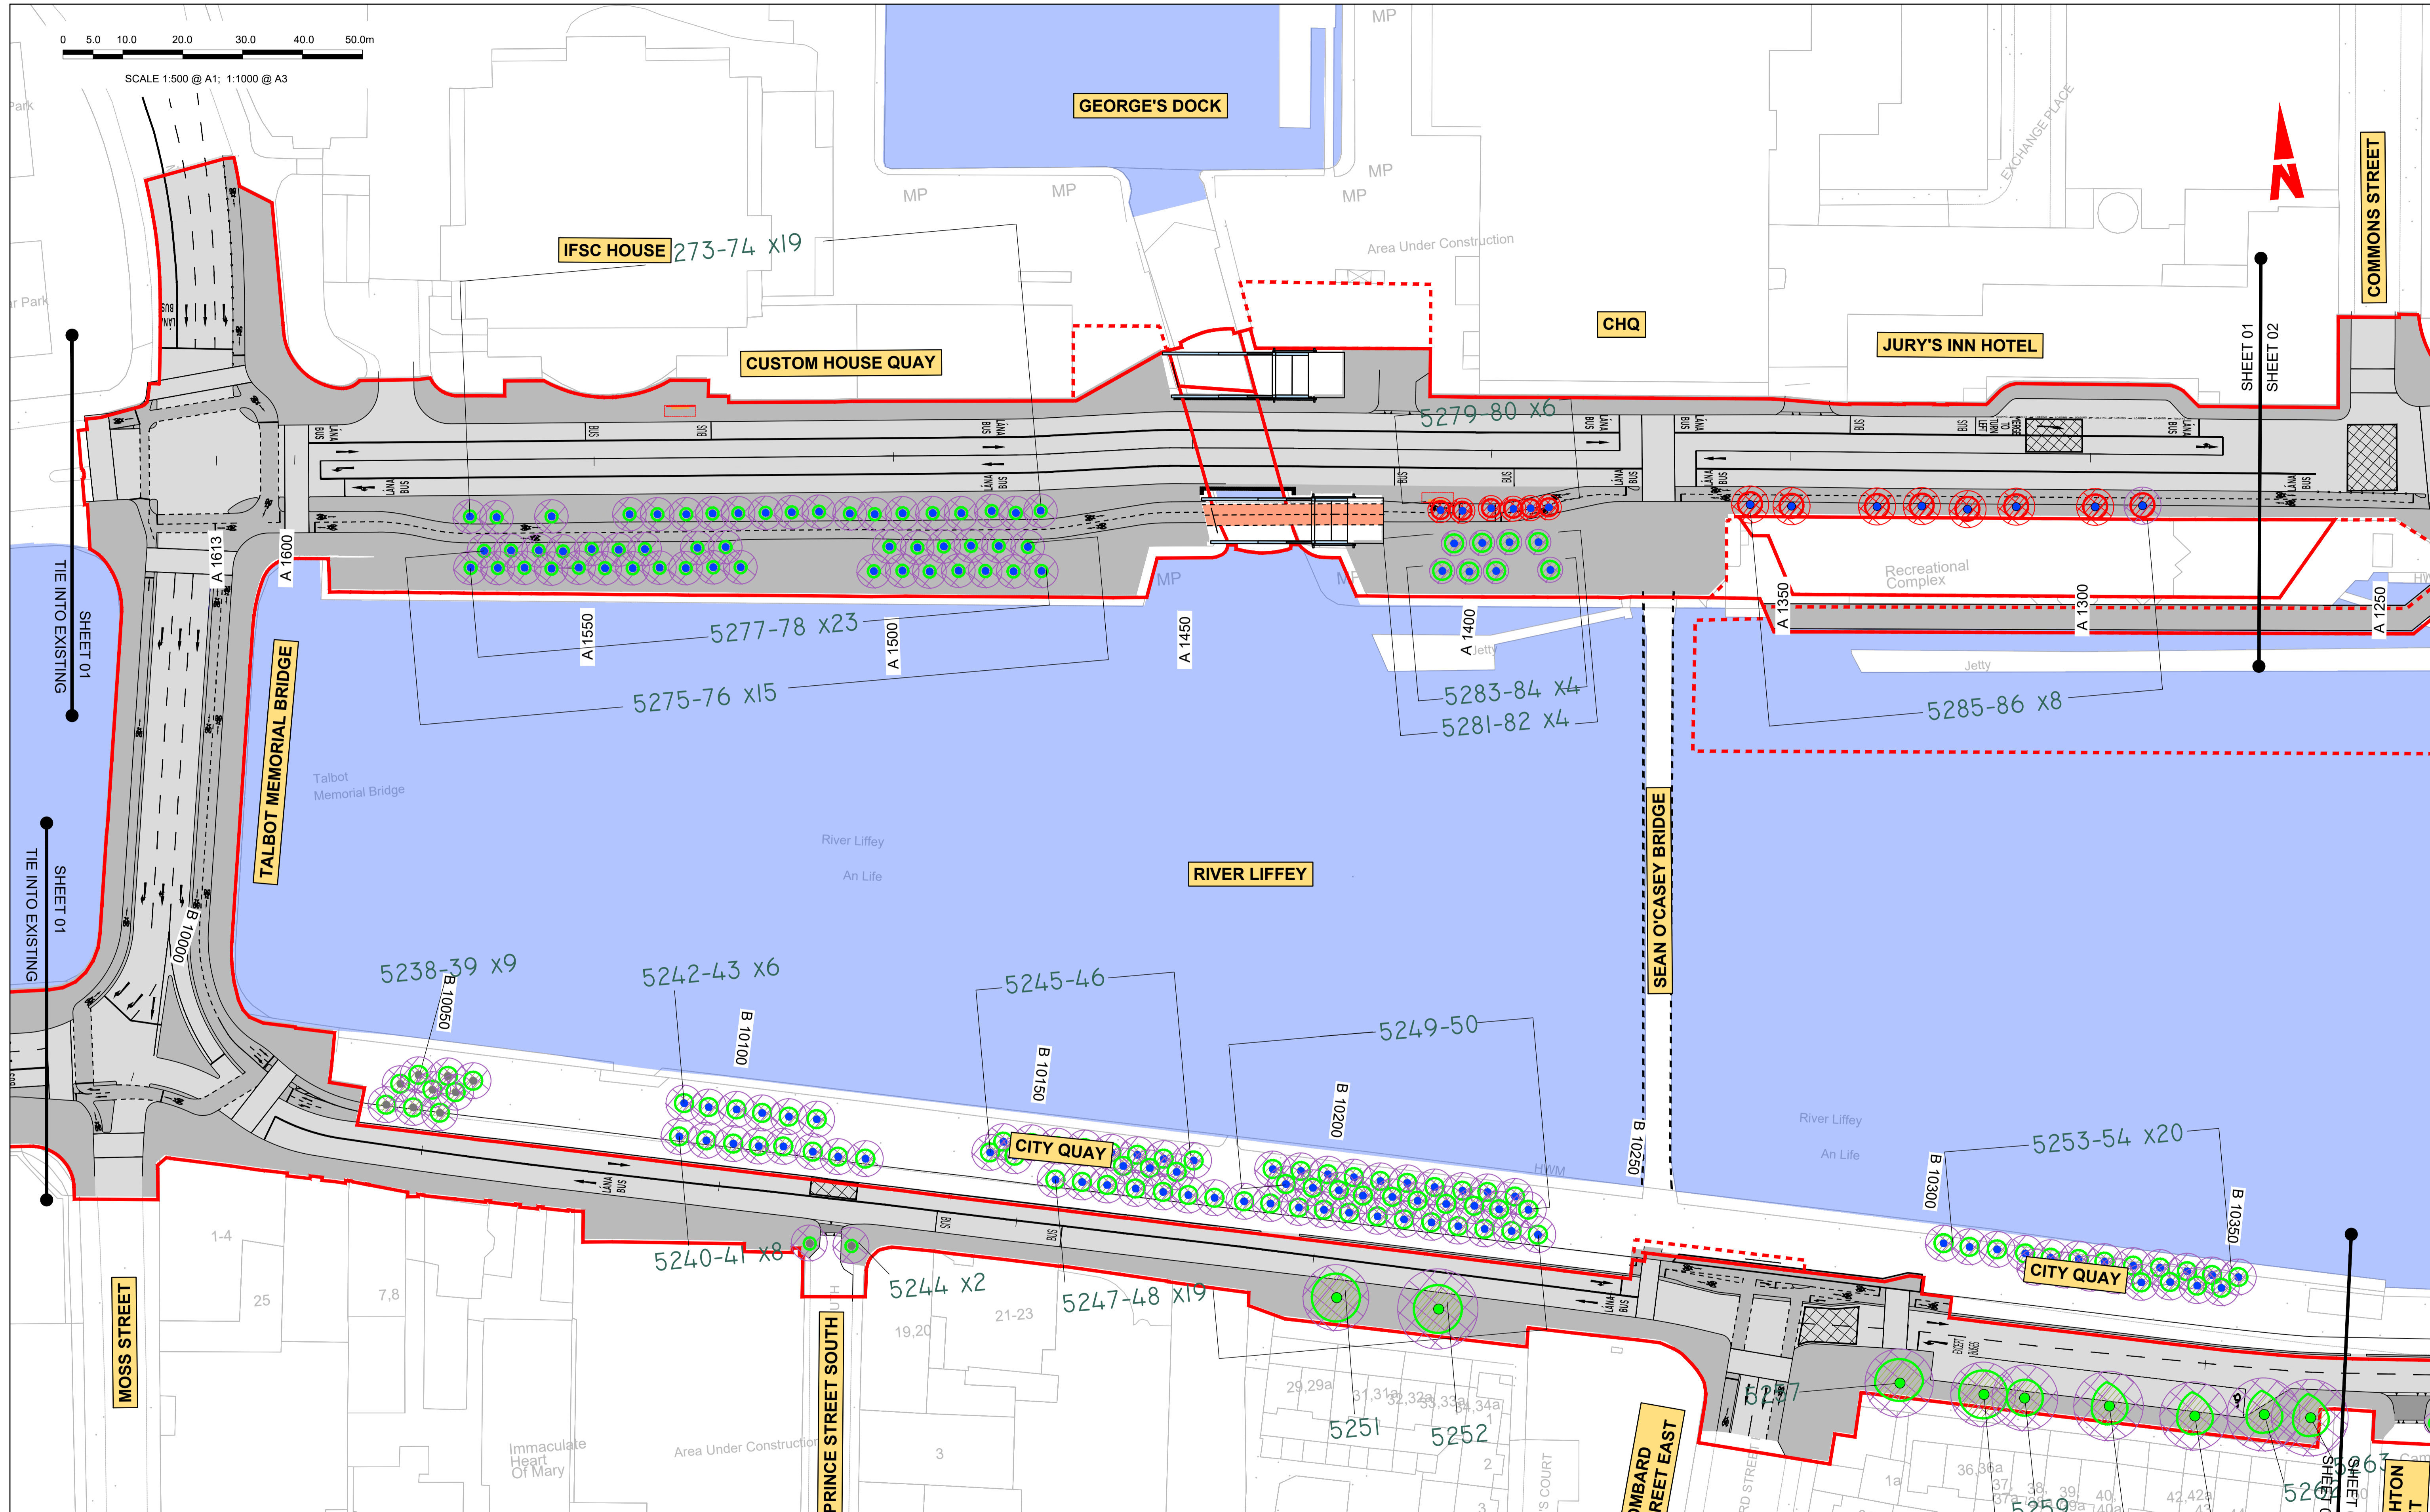
JL	MG	Sheet of 12	15/05/2021	Scale: 1:500@A1 1:1,000@A3
BCIDD-ROT-PRW_PC-0016_XX_00-DR-CR-0001.tpp.dwg				Issued For: Information
Client: BUS CONNECTS INFRASTRUCTURE, DUBLIN				
Project: ROUTE 0016 - RINGSEND TO CITY CENTER.TREE SURVEY				
Drawing Title: Tree Protection Plan

- 1 EXISTING TREE CANOPY BASED ON DIMENSIONS GATHERED ON SITE IN 4 DIRECTIONS, NORTH, SOUTH, EAST AND WEST
- 2 ROOT PROTECTION ZONE BASED ON 12 TIMES THE (DBH) AT CHEST HEIGHT
- 3 TREE TAG NUMBER
- 4 TREE TO BE RETAINED
- 5 TREE TO BE REMOVED
- 6 TREE CATEGORY BASED ON BS:5837 2012 CRITERIA
- 7 DECIDUOUS TREE CANOPY
- 8 EVERGREEN TREE CANOPY

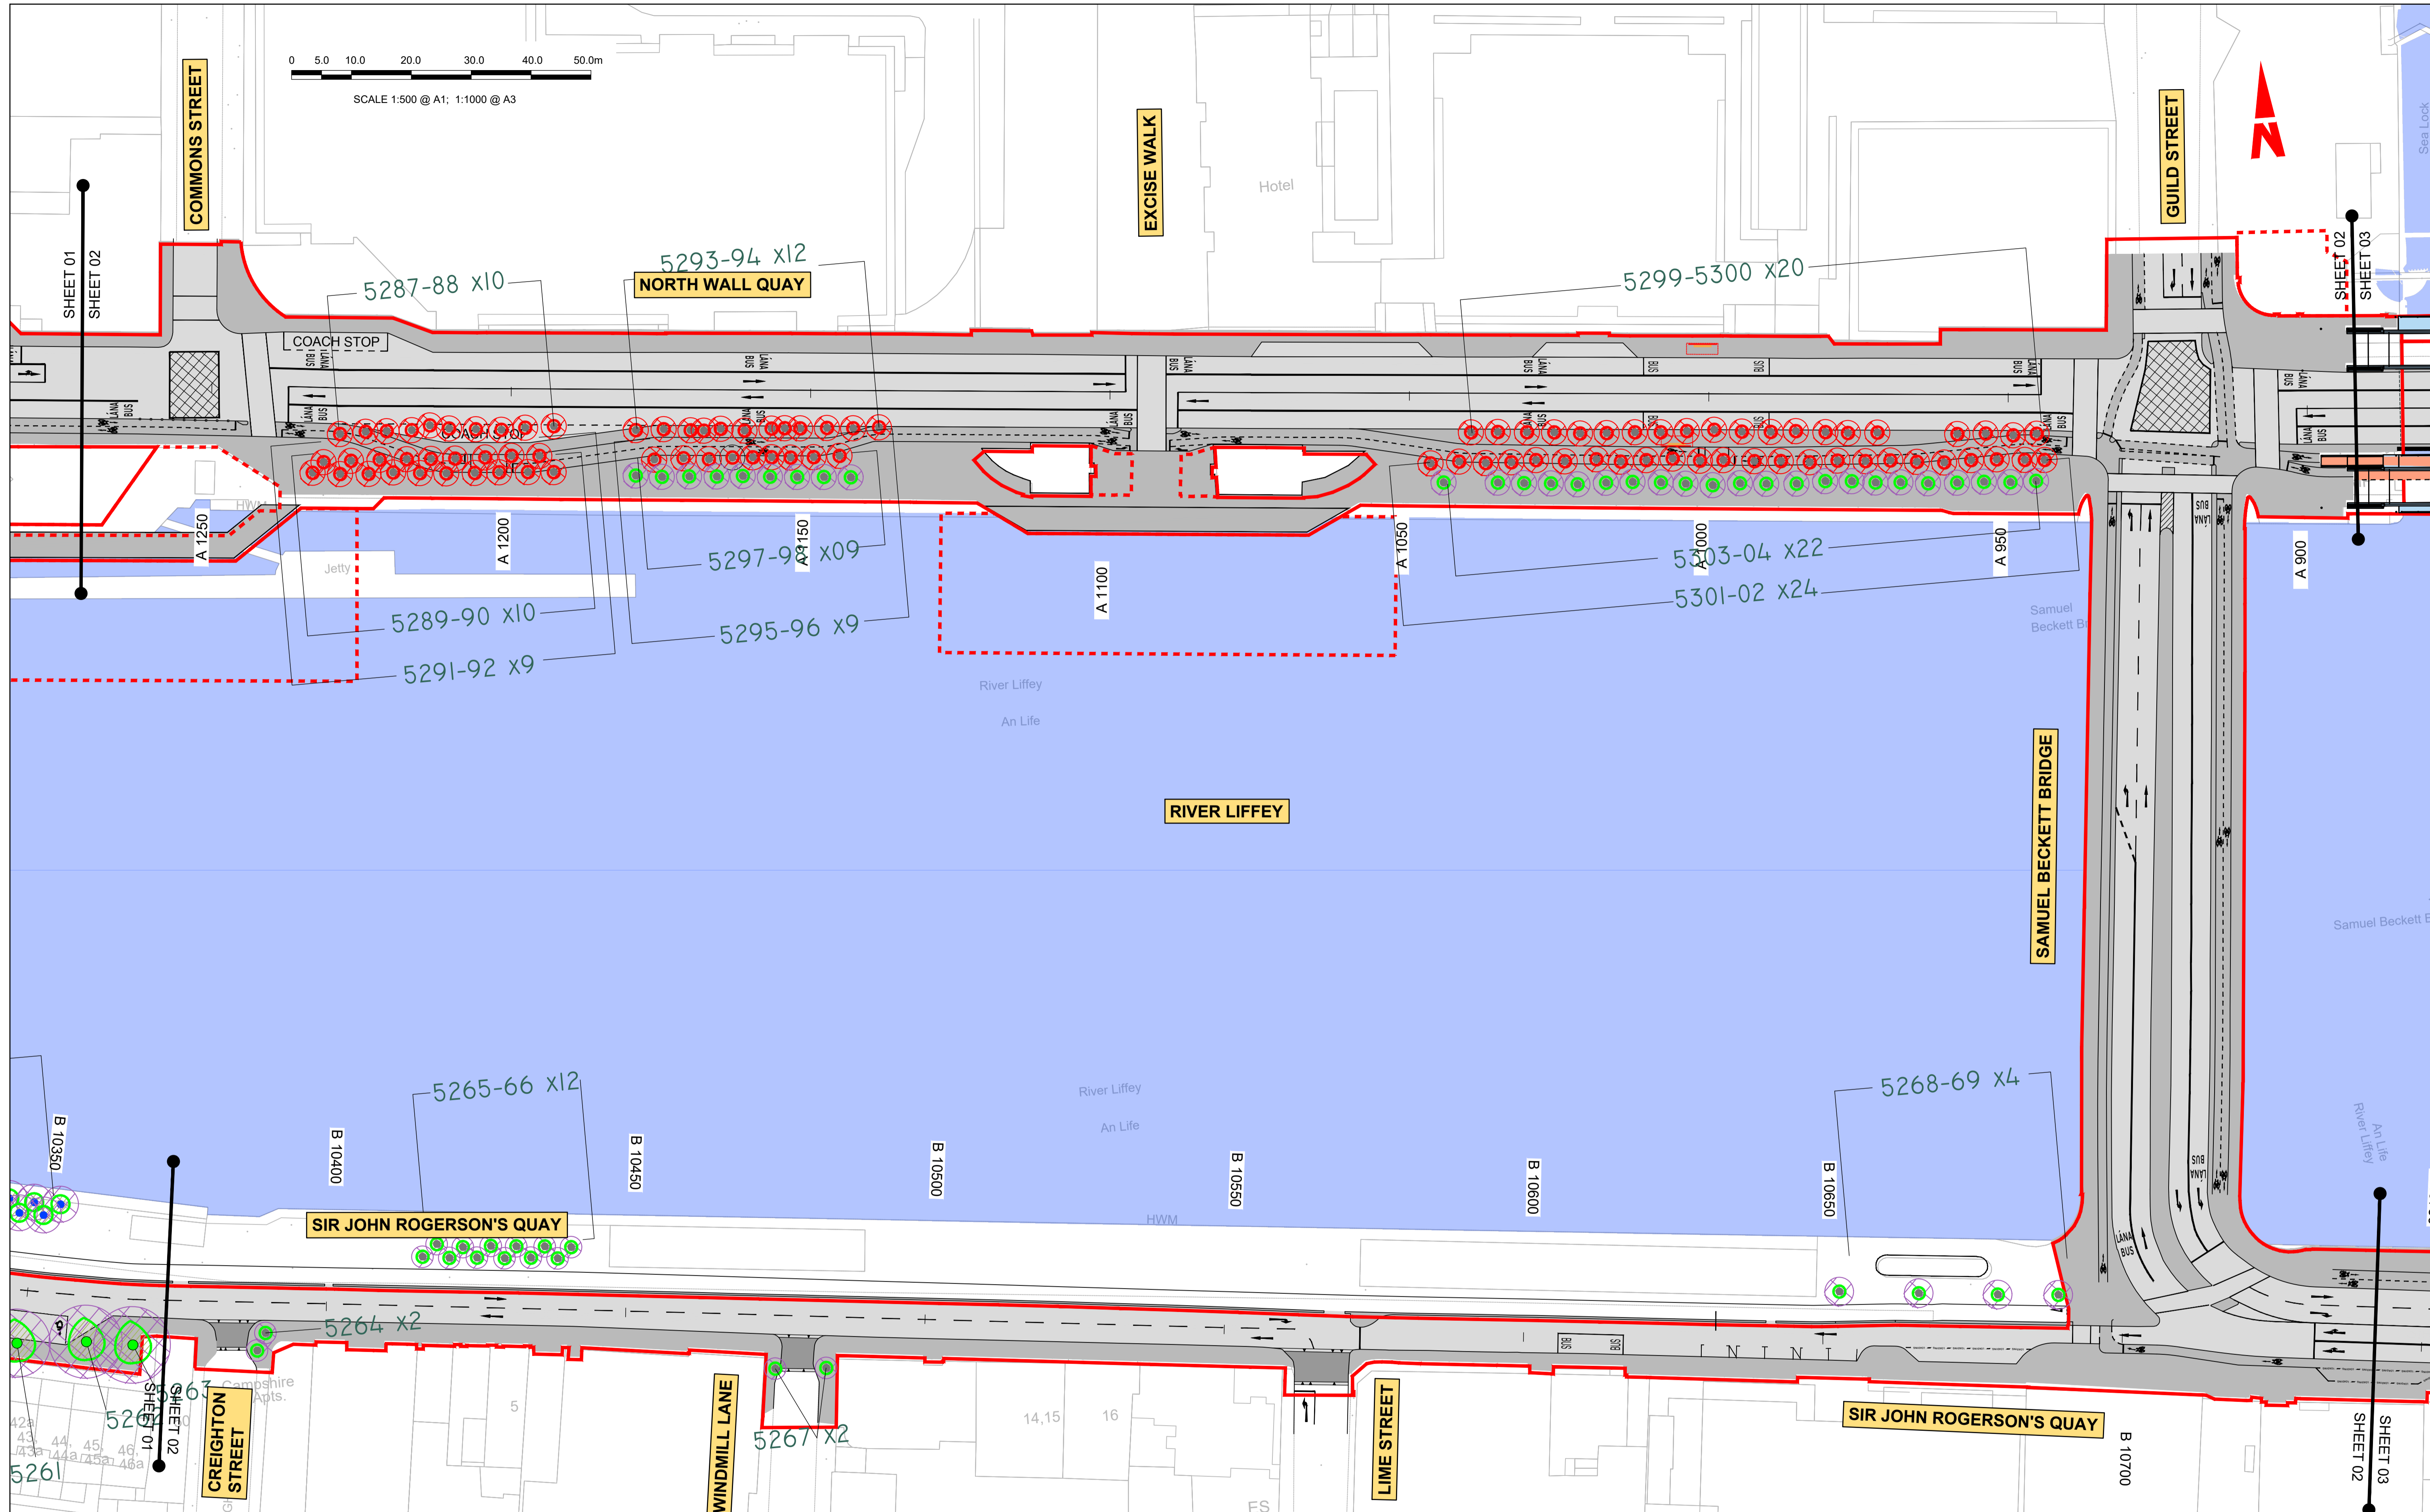
- 1 EXISTING TREE CANOPY BASED ON DIMENSIONS GATHERED ON SITE IN 4 DIRECTIONS, NORTH, SOUTH, EAST AND WEST
- 2 ROOT PROTECTION ZONE BASED ON 12 TIMES THE (DBH) AT CHEST HEIGHT

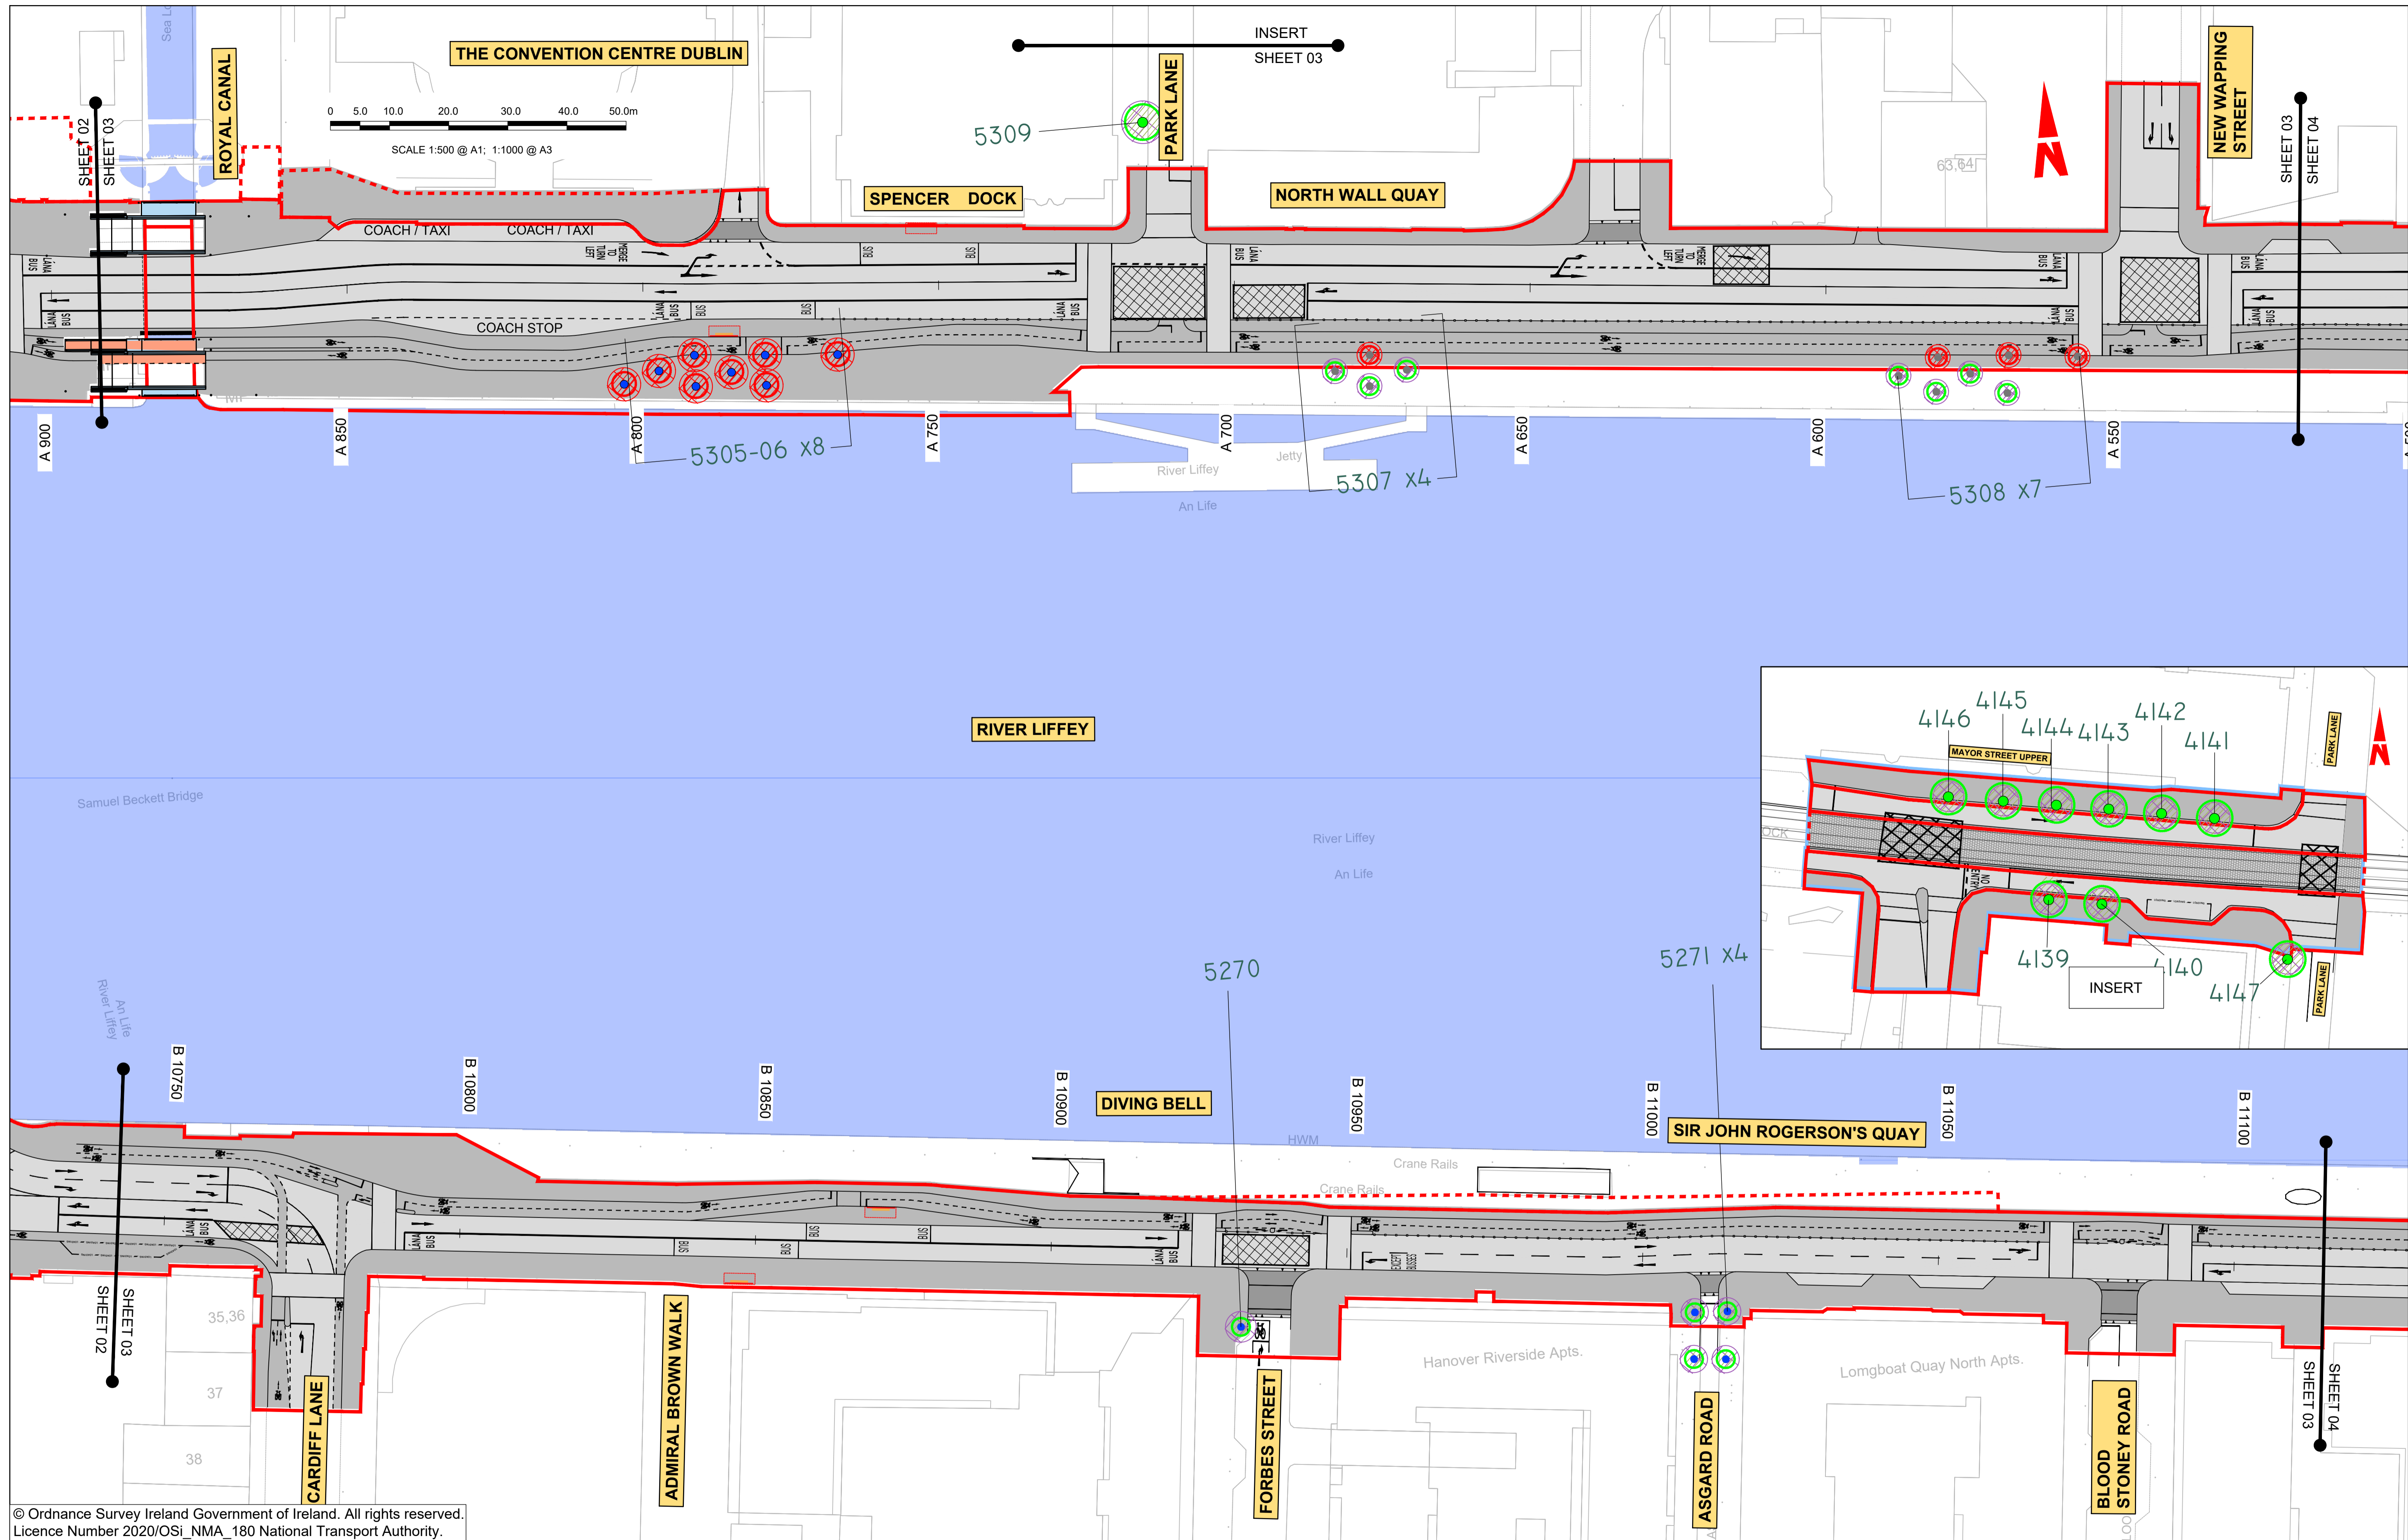
JL	MG	Sheet 3 of 12	15/05/2021	Scale: 1:500@A1 1:1,000@A3
BCIDD-ROT-PRW_PC-0016_XX_00-DR-CR-0001.tpp.dwg				Issued For: Information
Client: BUS CONNECTS INFRASTRUCTURE, DUBLIN				
Project: ROUTE 0016 - RINGSEND TO CITY CENTER.TREE SURVEY				
Drawing Title: Tree Protection Plan

- 1 EXISTING TREE CANOPY BASED ON DIMENSIONS GATHERED ON SITE IN 4 DIRECTIONS, NORTH, SOUTH, EAST AND WEST
- 2 ROOT PROTECTION ZONE BASED ON 12 TIMES THE (DBH) AT CHEST HEIGHT
- 3 TREE TAG NUMBER
- 4 TREE TO BE RETAINED
- 5 TREE TO BE REMOVED

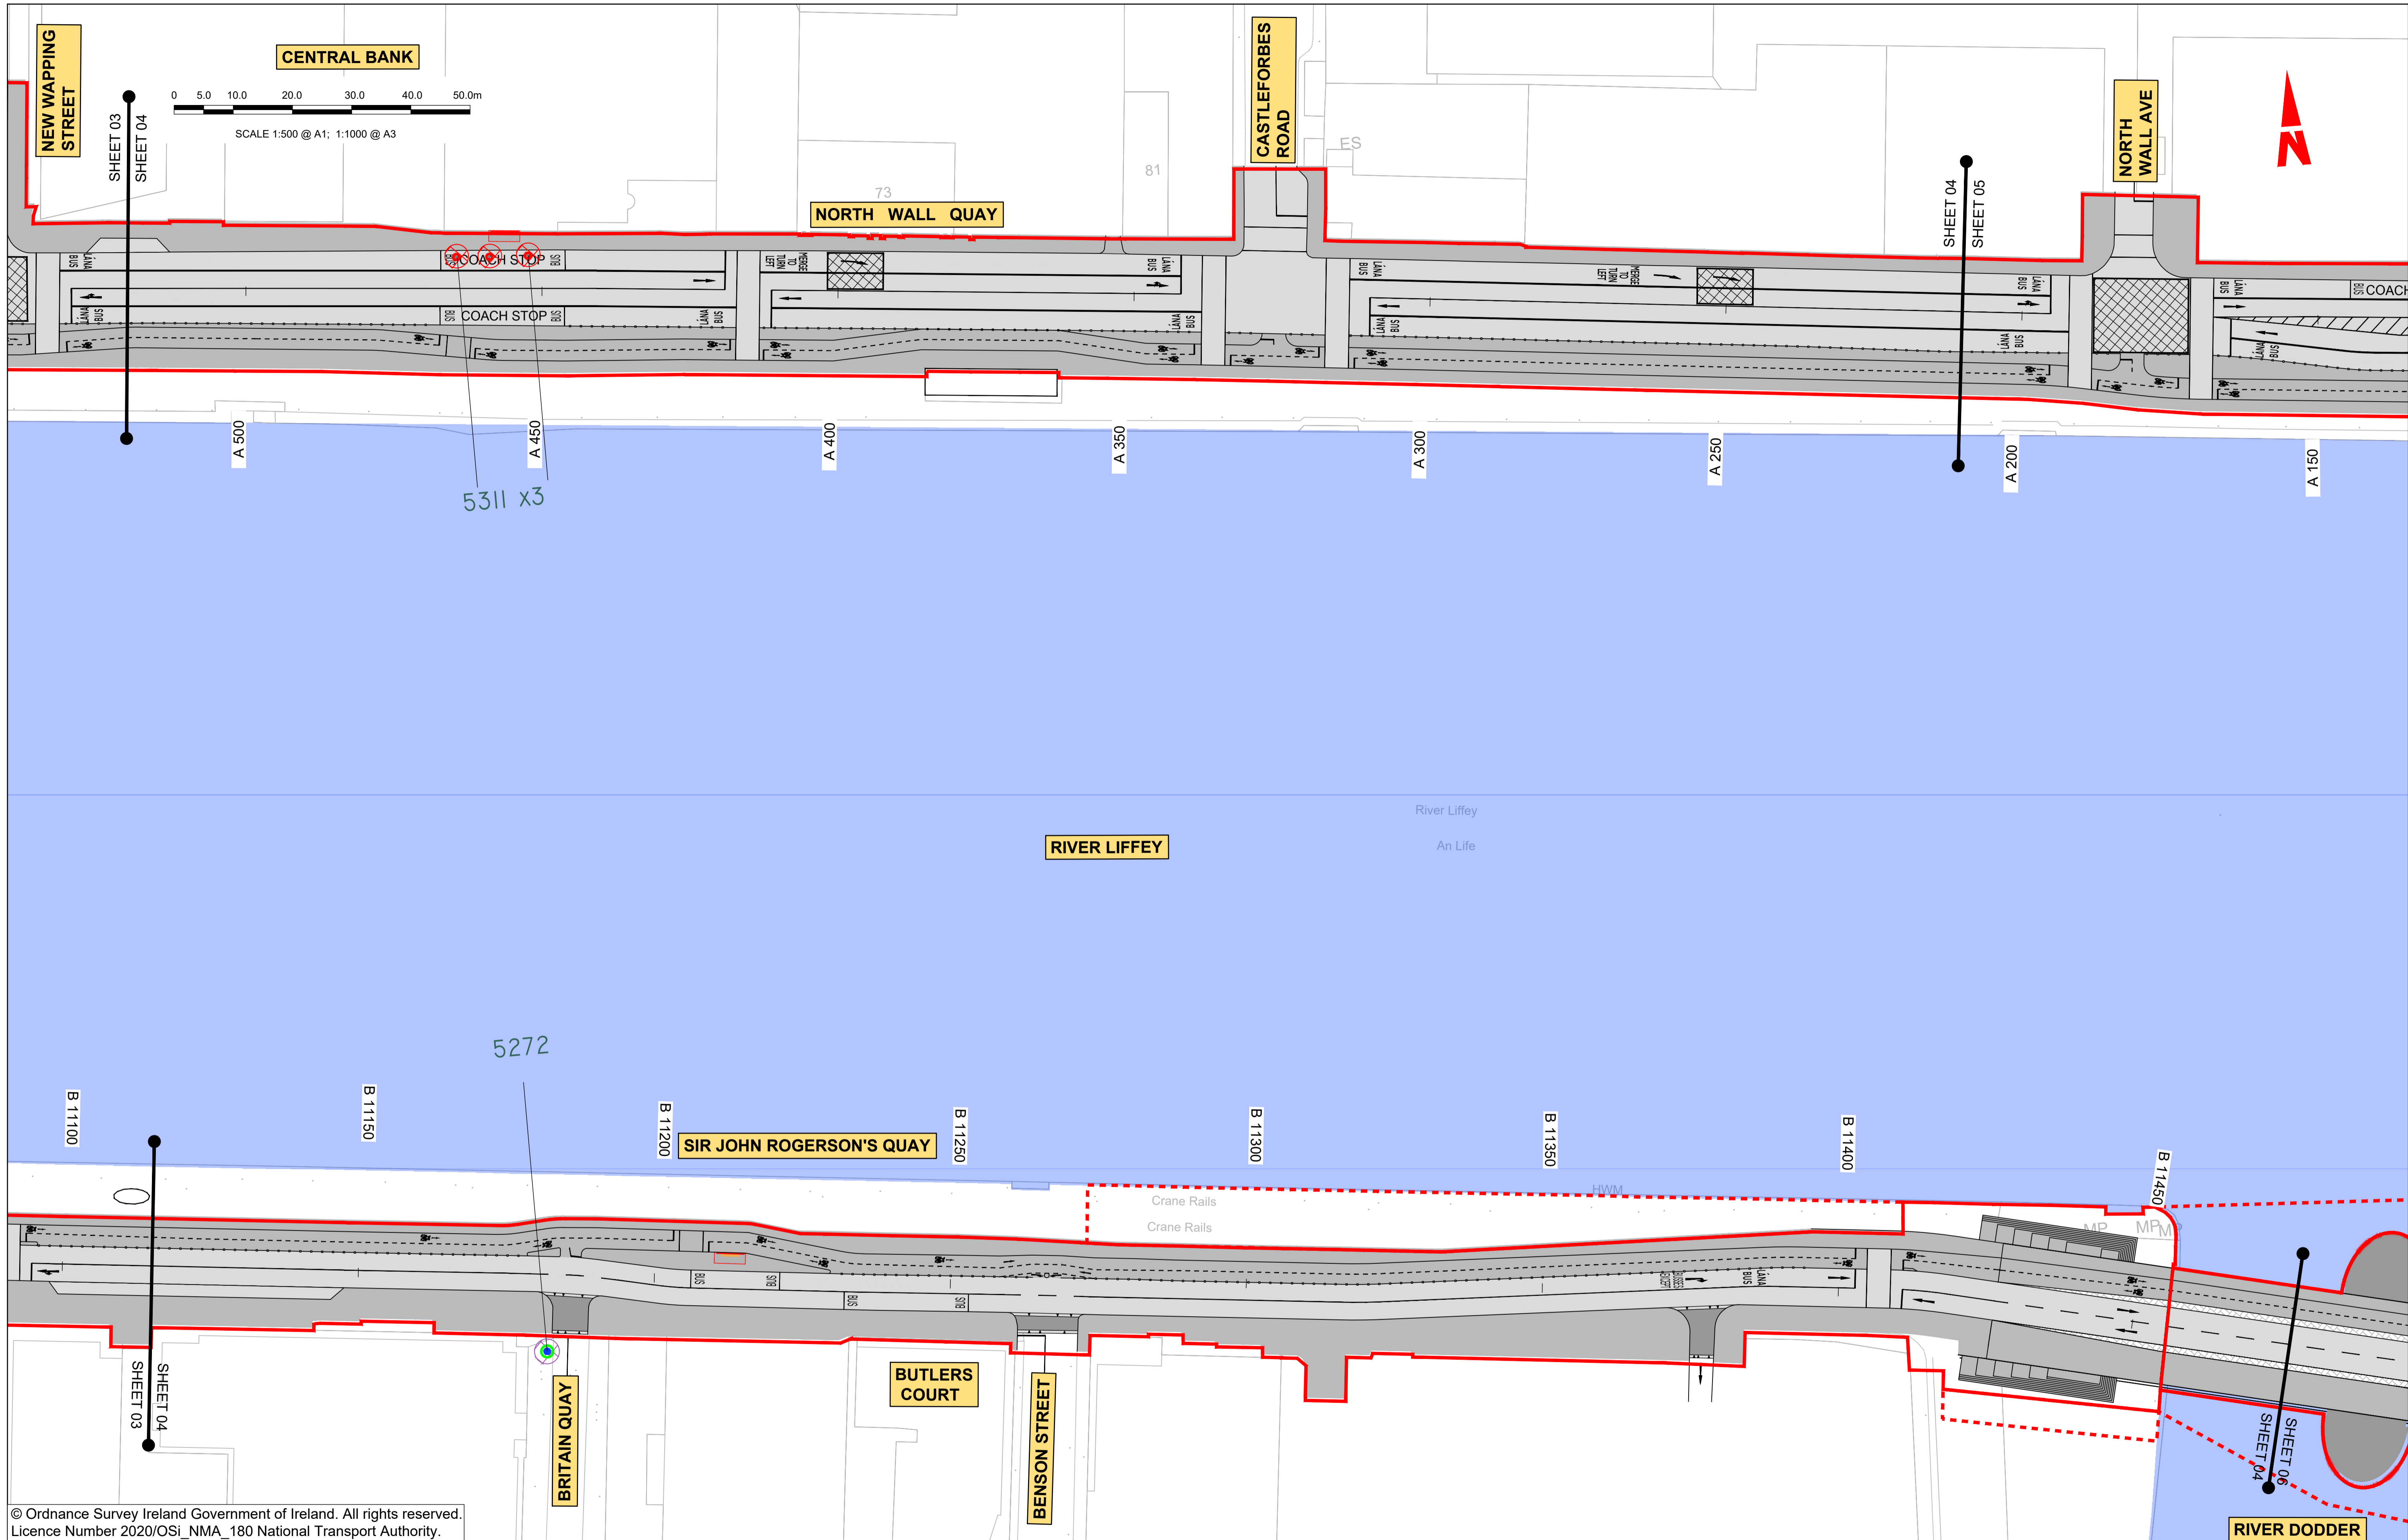
JL	MG	Sheet 4 of 12	15/05/2021	Scale: 1:500@A1 1:1,000@A3
BCIDD-ROT-PRW_PC-0016_XX_00-DR-CR-001.tpp.dwg				Issued For: Information
Client: BUS CONNECTS INFRASTRUCTURE, DUBLIN				
Project: ROUTE 0016 - RINGSEND TO CITY CENTER.TREE SURVEY				
Drawing Title: Tree Protection Plan

- 1 EXISTING TREE CANOPY BASED ON DIMENSIONS GATHERED ON SITE IN 4 DIRECTIONS, NORTH, SOUTH, EAST AND WEST
- 2 ROOT PROTECTION ZONE BASED ON 12 TIMES THE (DBH) AT CHEST HEIGHT
- 3 TREE TAG NUMBER
- 4 TREE TO BE RETAINED
- 5 TREE TO BE REMOVED

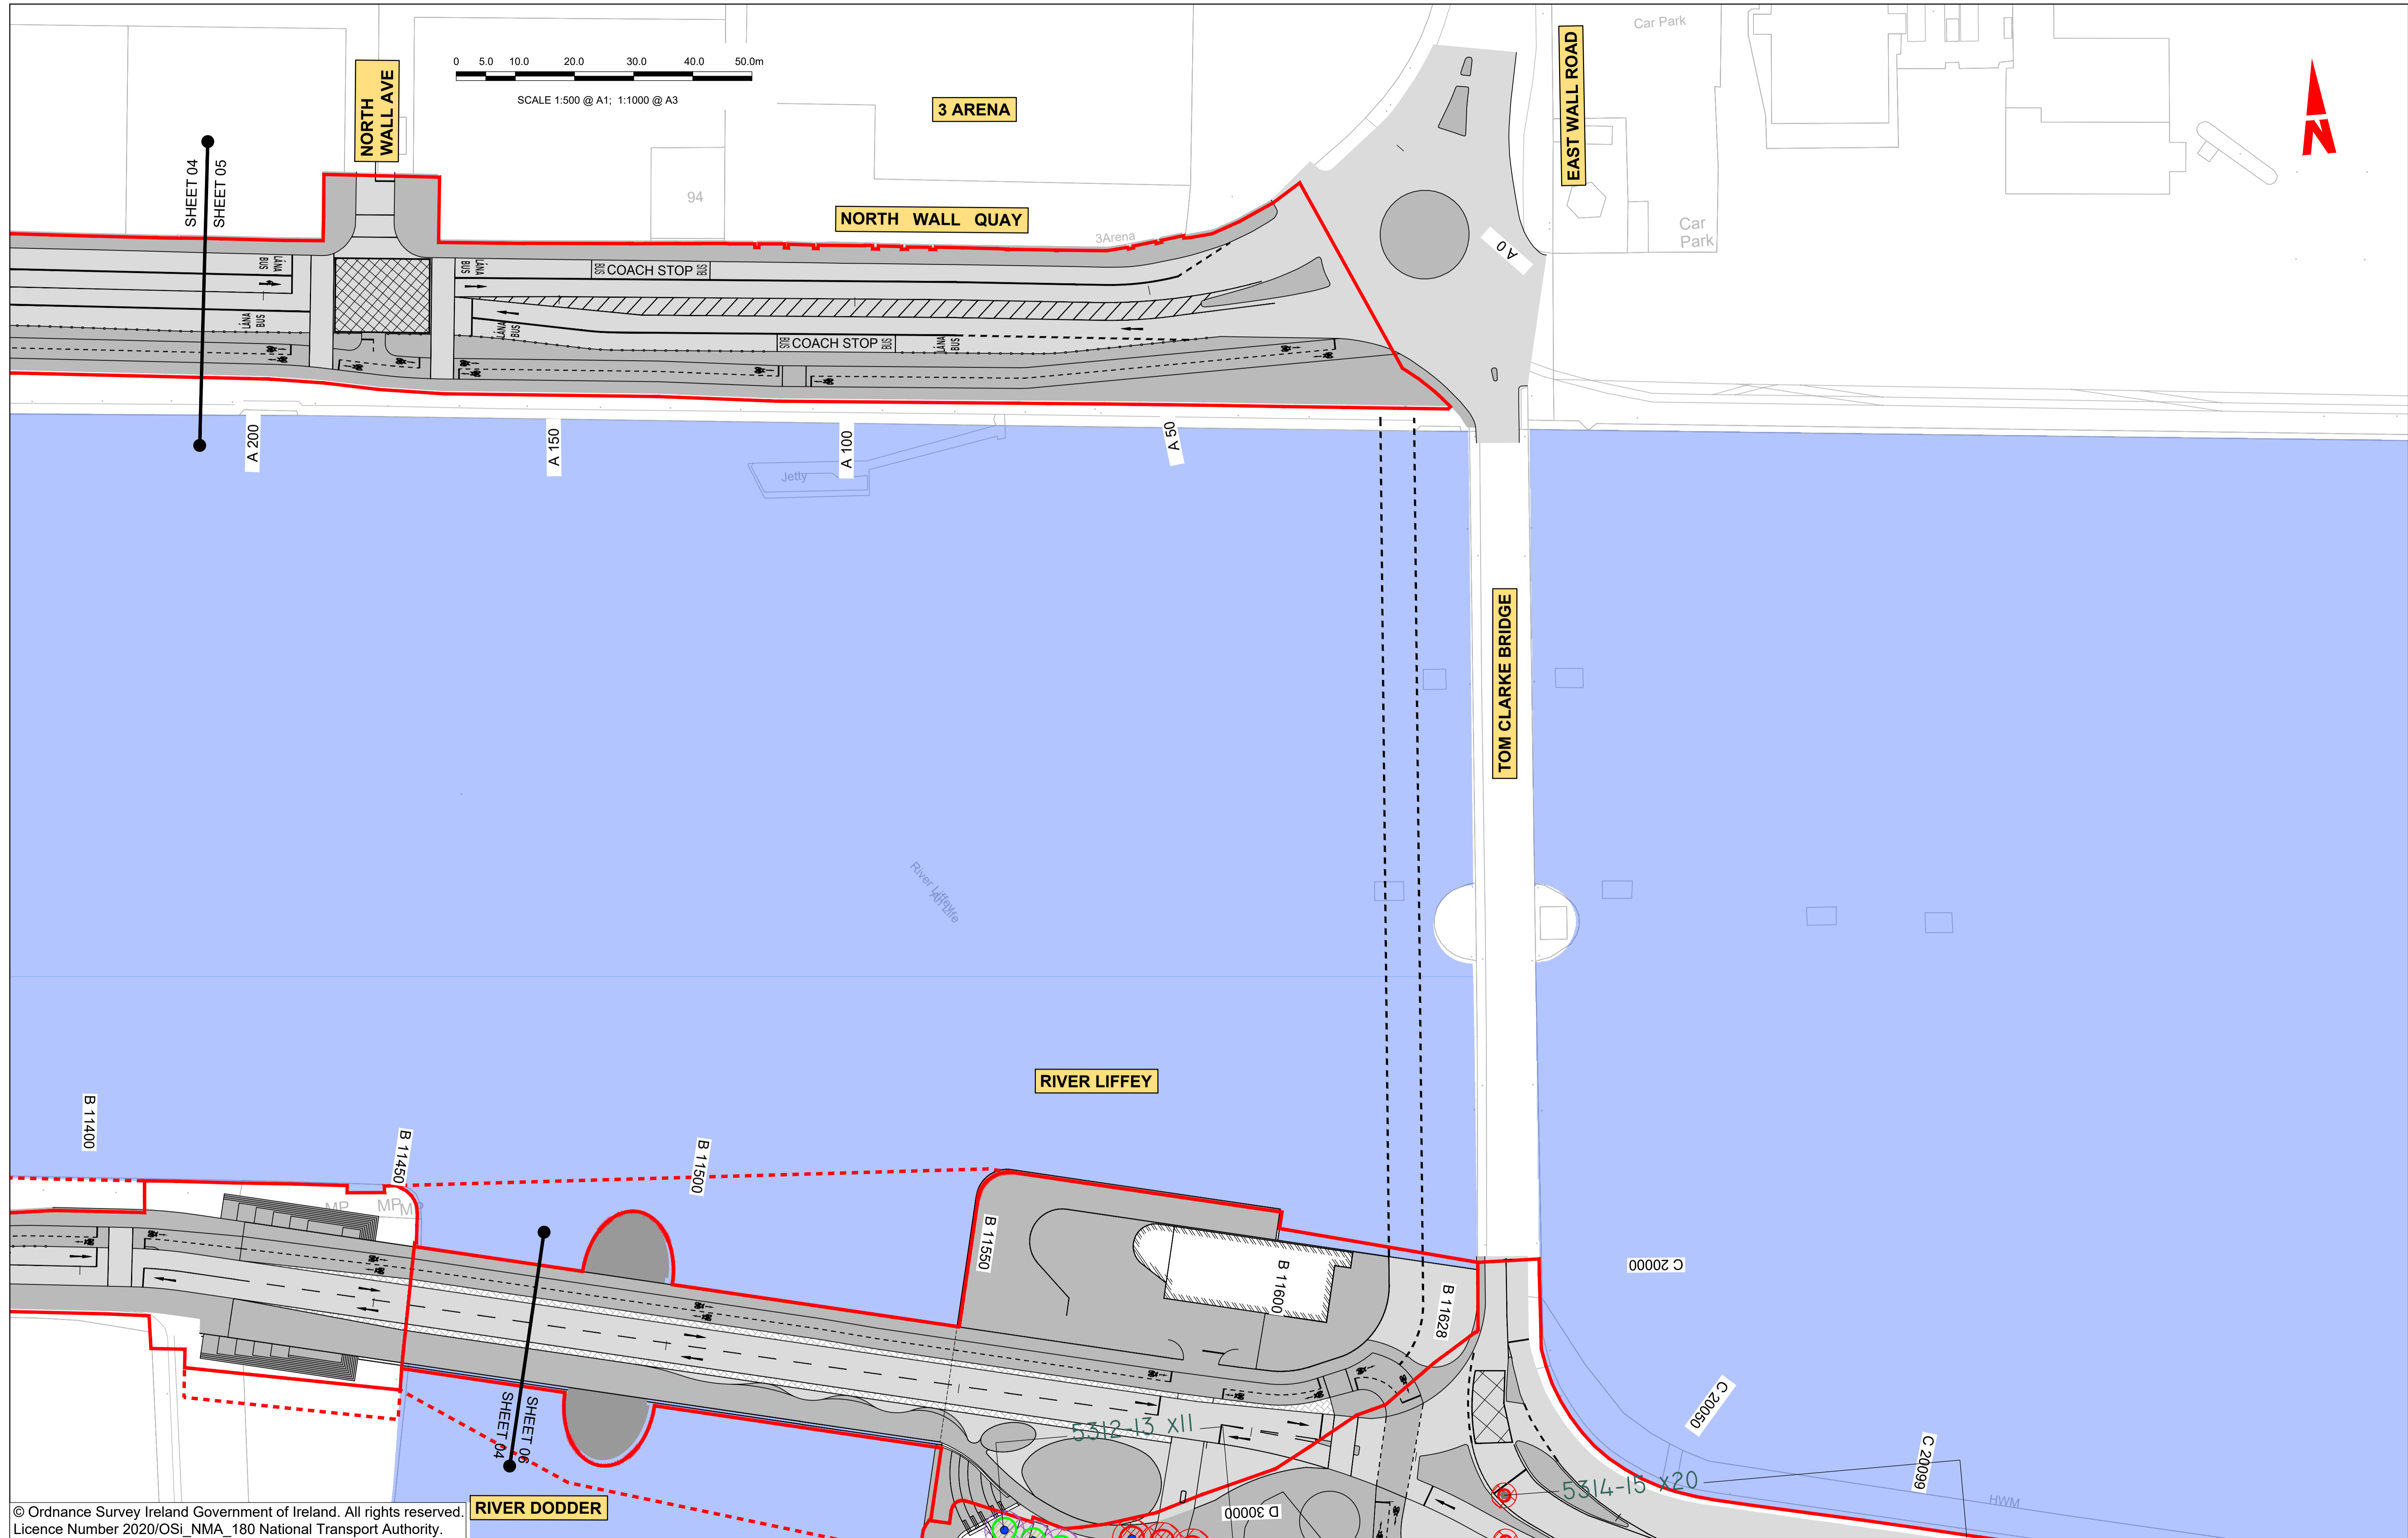
JL	MG	Sheet 9 of 12	15/05/2021	Scale: 1:500@A1, 1:1,000@A3
BCIDD-ROT-PRW_PC-0016_XX_00-DR-CR-0001.tpp.dwg			Issued For:	Information
Client: BUS CONNECTS INFRASTRUCTURE, DUBLIN				
Project: ROUTE 0016 - RINGSEND TO CITY CENTER.TREE SURVEY				
Drawing Title: Tree Protection Plan

- 1 EXISTING TREE CANOPY BASED ON DIMENSIONS GATHERED ON SITE IN 4 DIRECTIONS, NORTH, SOUTH, EAST AND WEST
- 2 ROOT PROTECTION ZONE BASED ON 12 TIMES THE (DBH) AT CHEST HEIGHT
- 3 TREE TAG NUMBER
- 4 TREE TO BE RETAINED
- 5 TREE TO BE REMOVED
- 6 TREE CATEGORY BASED ON BS:5837 2012 CRITERIA
- 7 DECIDUOUS TREE CANOPY
- 8 EVERGREEN TREE CANOPY

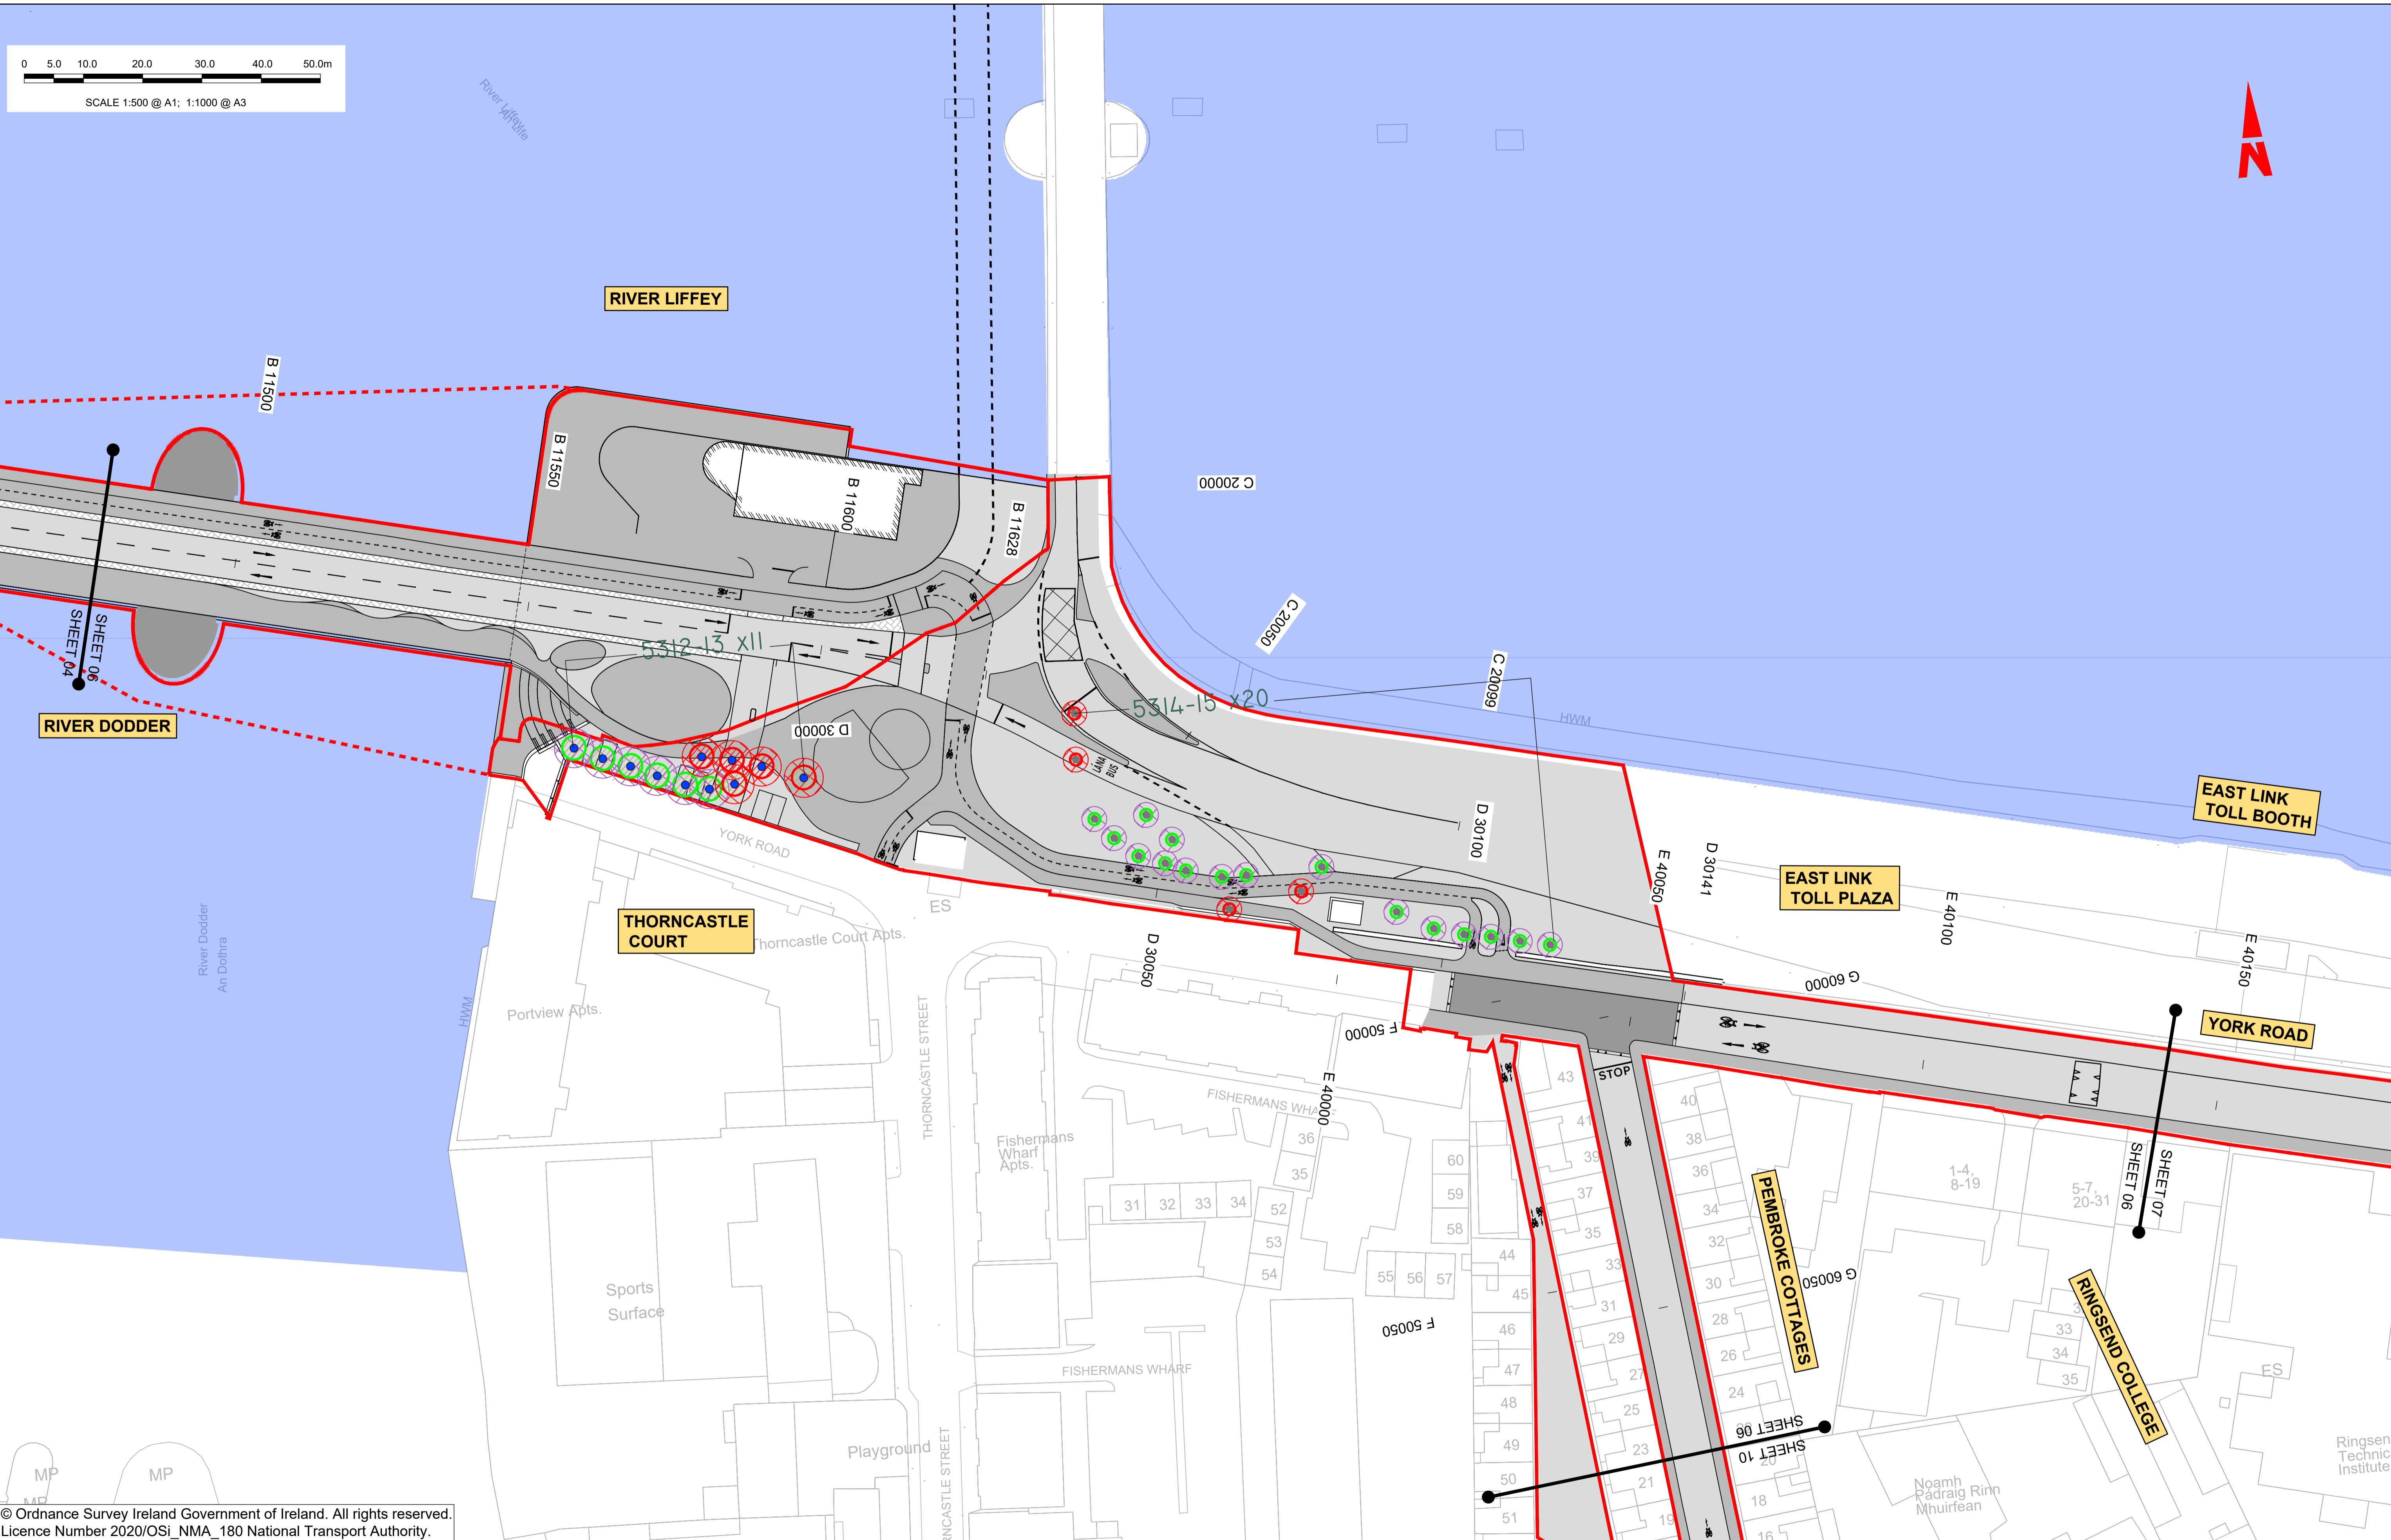
- 1 EXISTING TREE CANOPY BASED ON DIMENSIONS GATHERED ON SITE IN 4 DIRECTIONS, NORTH, SOUTH, EAST AND WEST
- 2 ROOT PROTECTION ZONE BASED ON 12 TIMES THE (DBH) AT CHEST HEIGHT
- 3 TREE TAG NUMBER
- 4 TREE TO BE RETAINED
- 5 TREE TO BE REMOVED
- 6 TREE CATEGORY BASED ON BS:5837 2012 CRITERIA
- 7 DECIDUOUS TREE CANOPY
- 8 EVERGREEN TREE CANOPY
