# Appendix A17.1

## Arboricultural Impact Assessment

National Transport Authority

Bus Connects Route 16 Ringsend to the City Centre

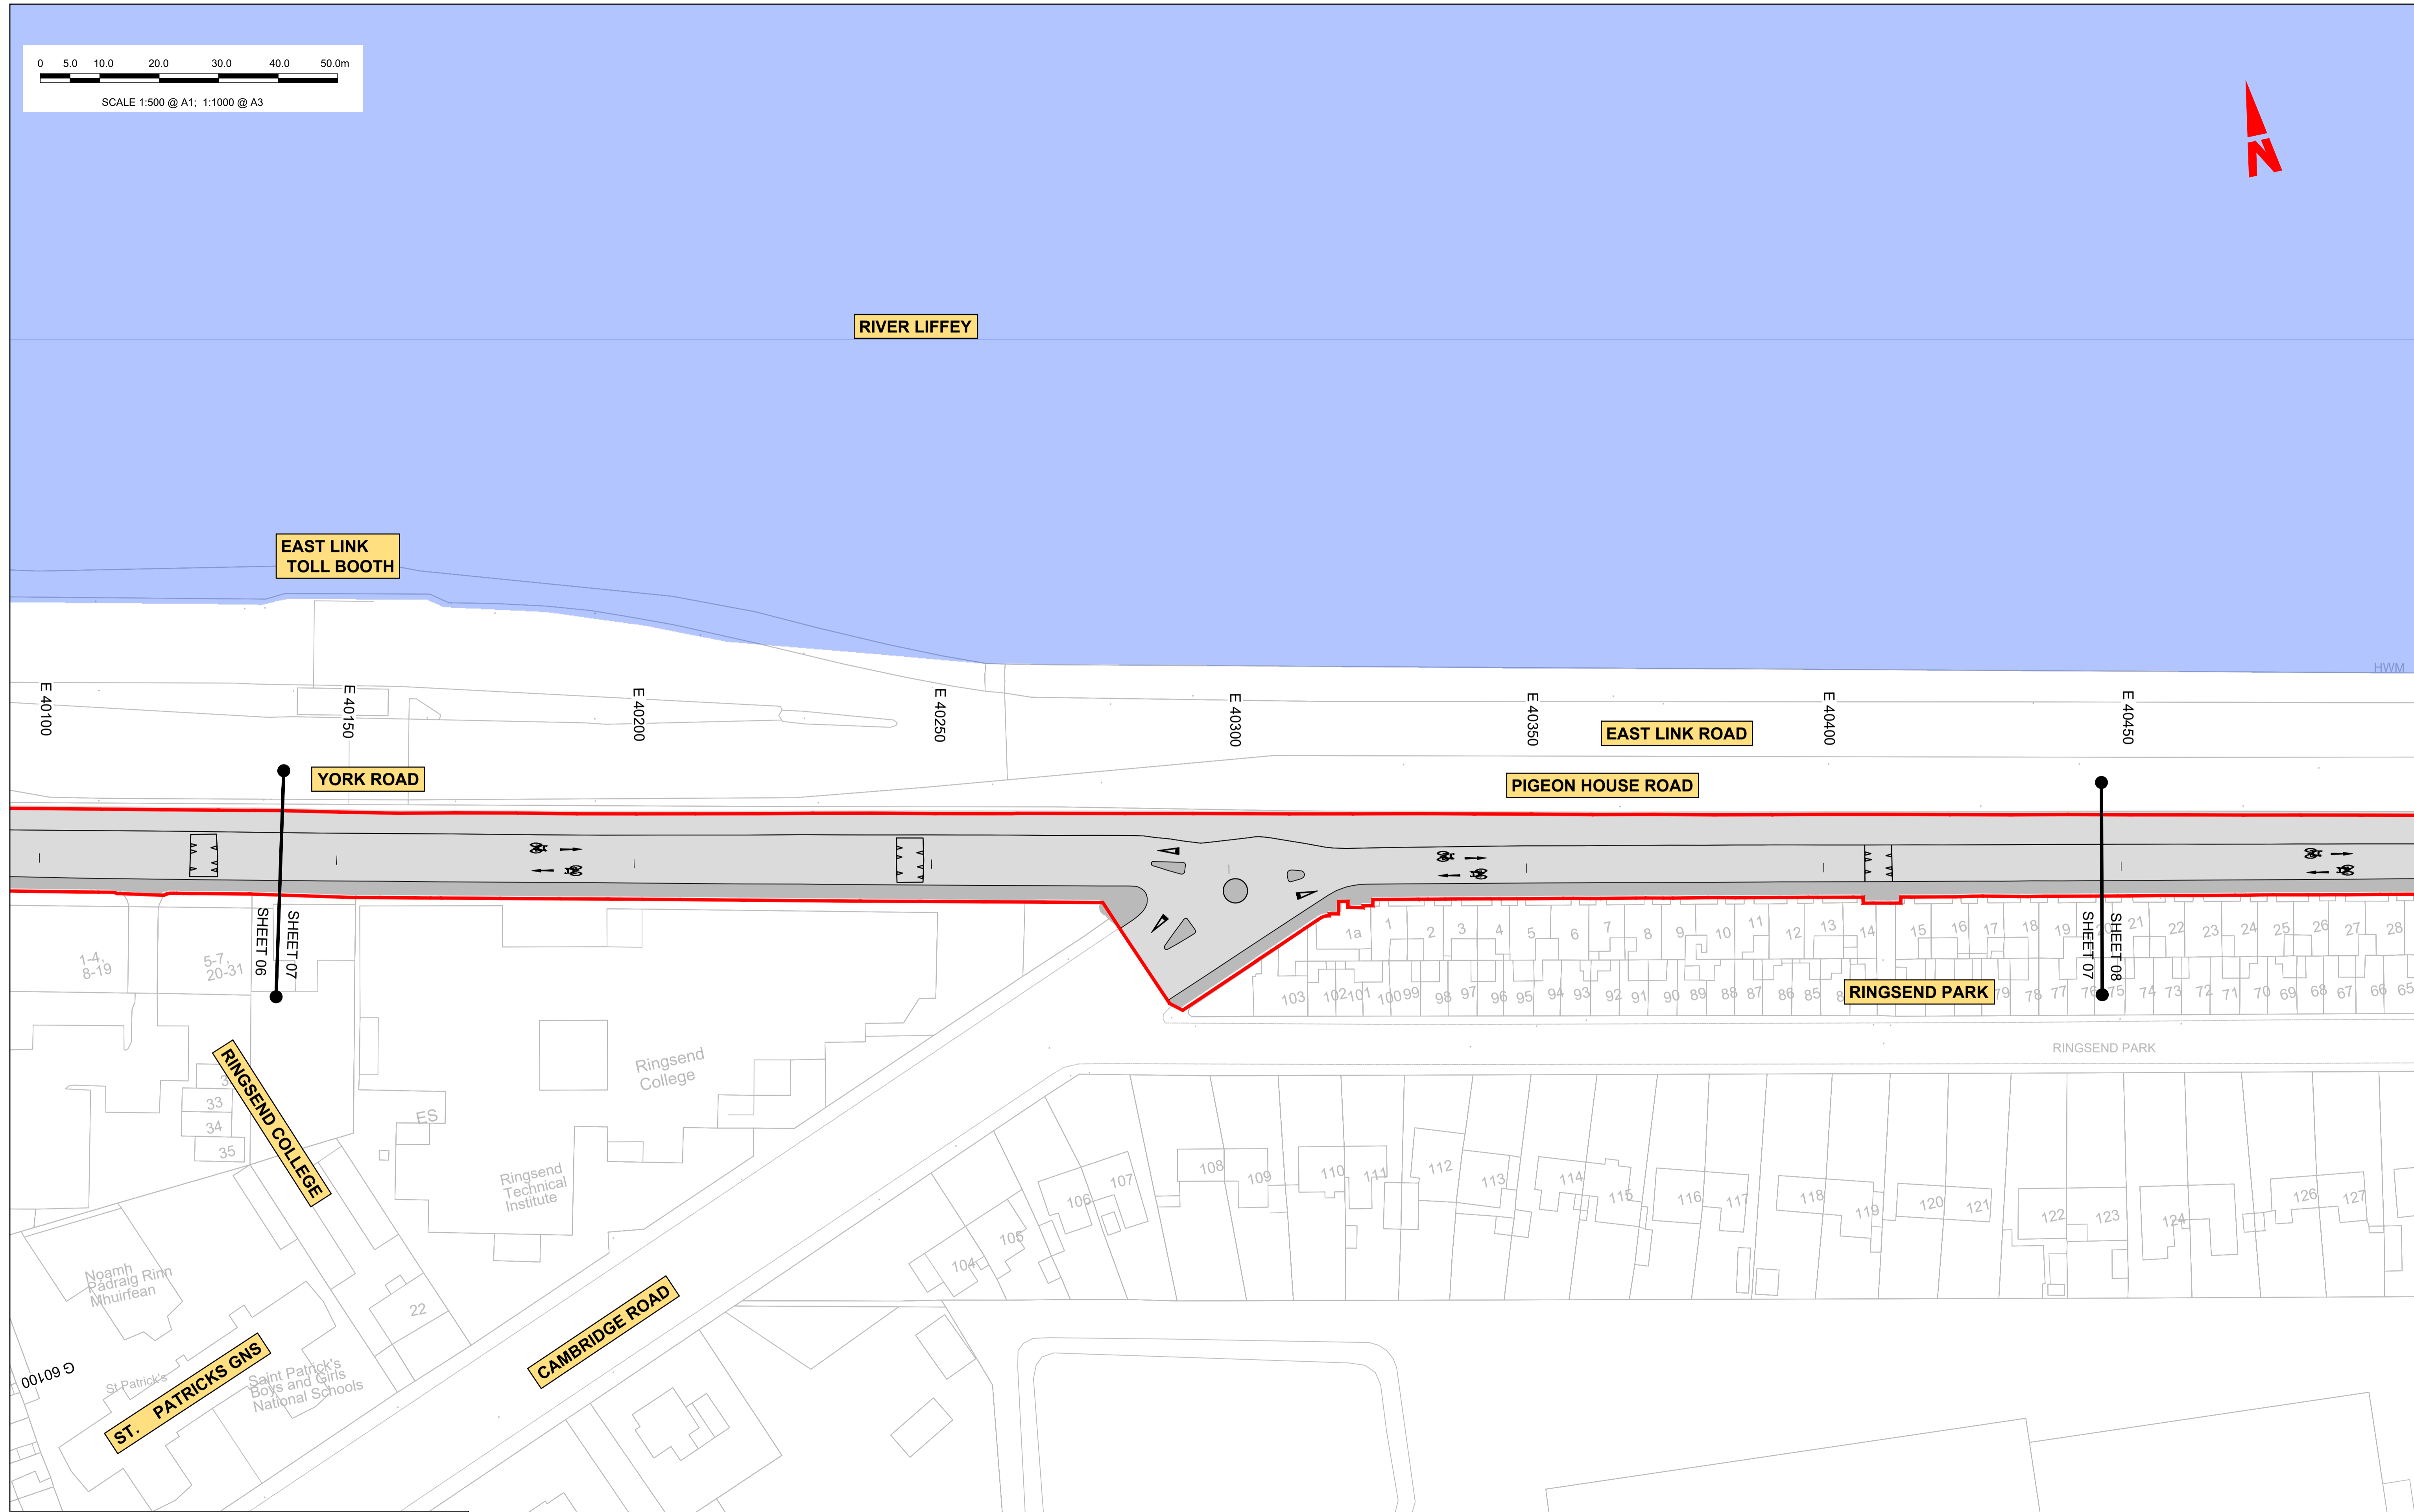
- 1 EXISTING TREE CANOPY BASED ON DIMENSIONS GATHERED ON SITE IN 4 DIRECTIONS, NORTH, SOUTH, EAST AND WEST
- 2 ROOT PROTECTION ZONE BASED ON 12 TIMES THE (DBH) AT CHEST HEIGHT
- 3 TREE TAG NUMBER
- 4 TREE TO BE RETAINED
- 5 TREE TO BE REMOVED
- 6 TREE CATEGORY BASED ON BS:5837 2012 CRITERIA
- 7 DECIDUOUS TREE CANOPY
- 8 EVERGREEN TREE CANOPY

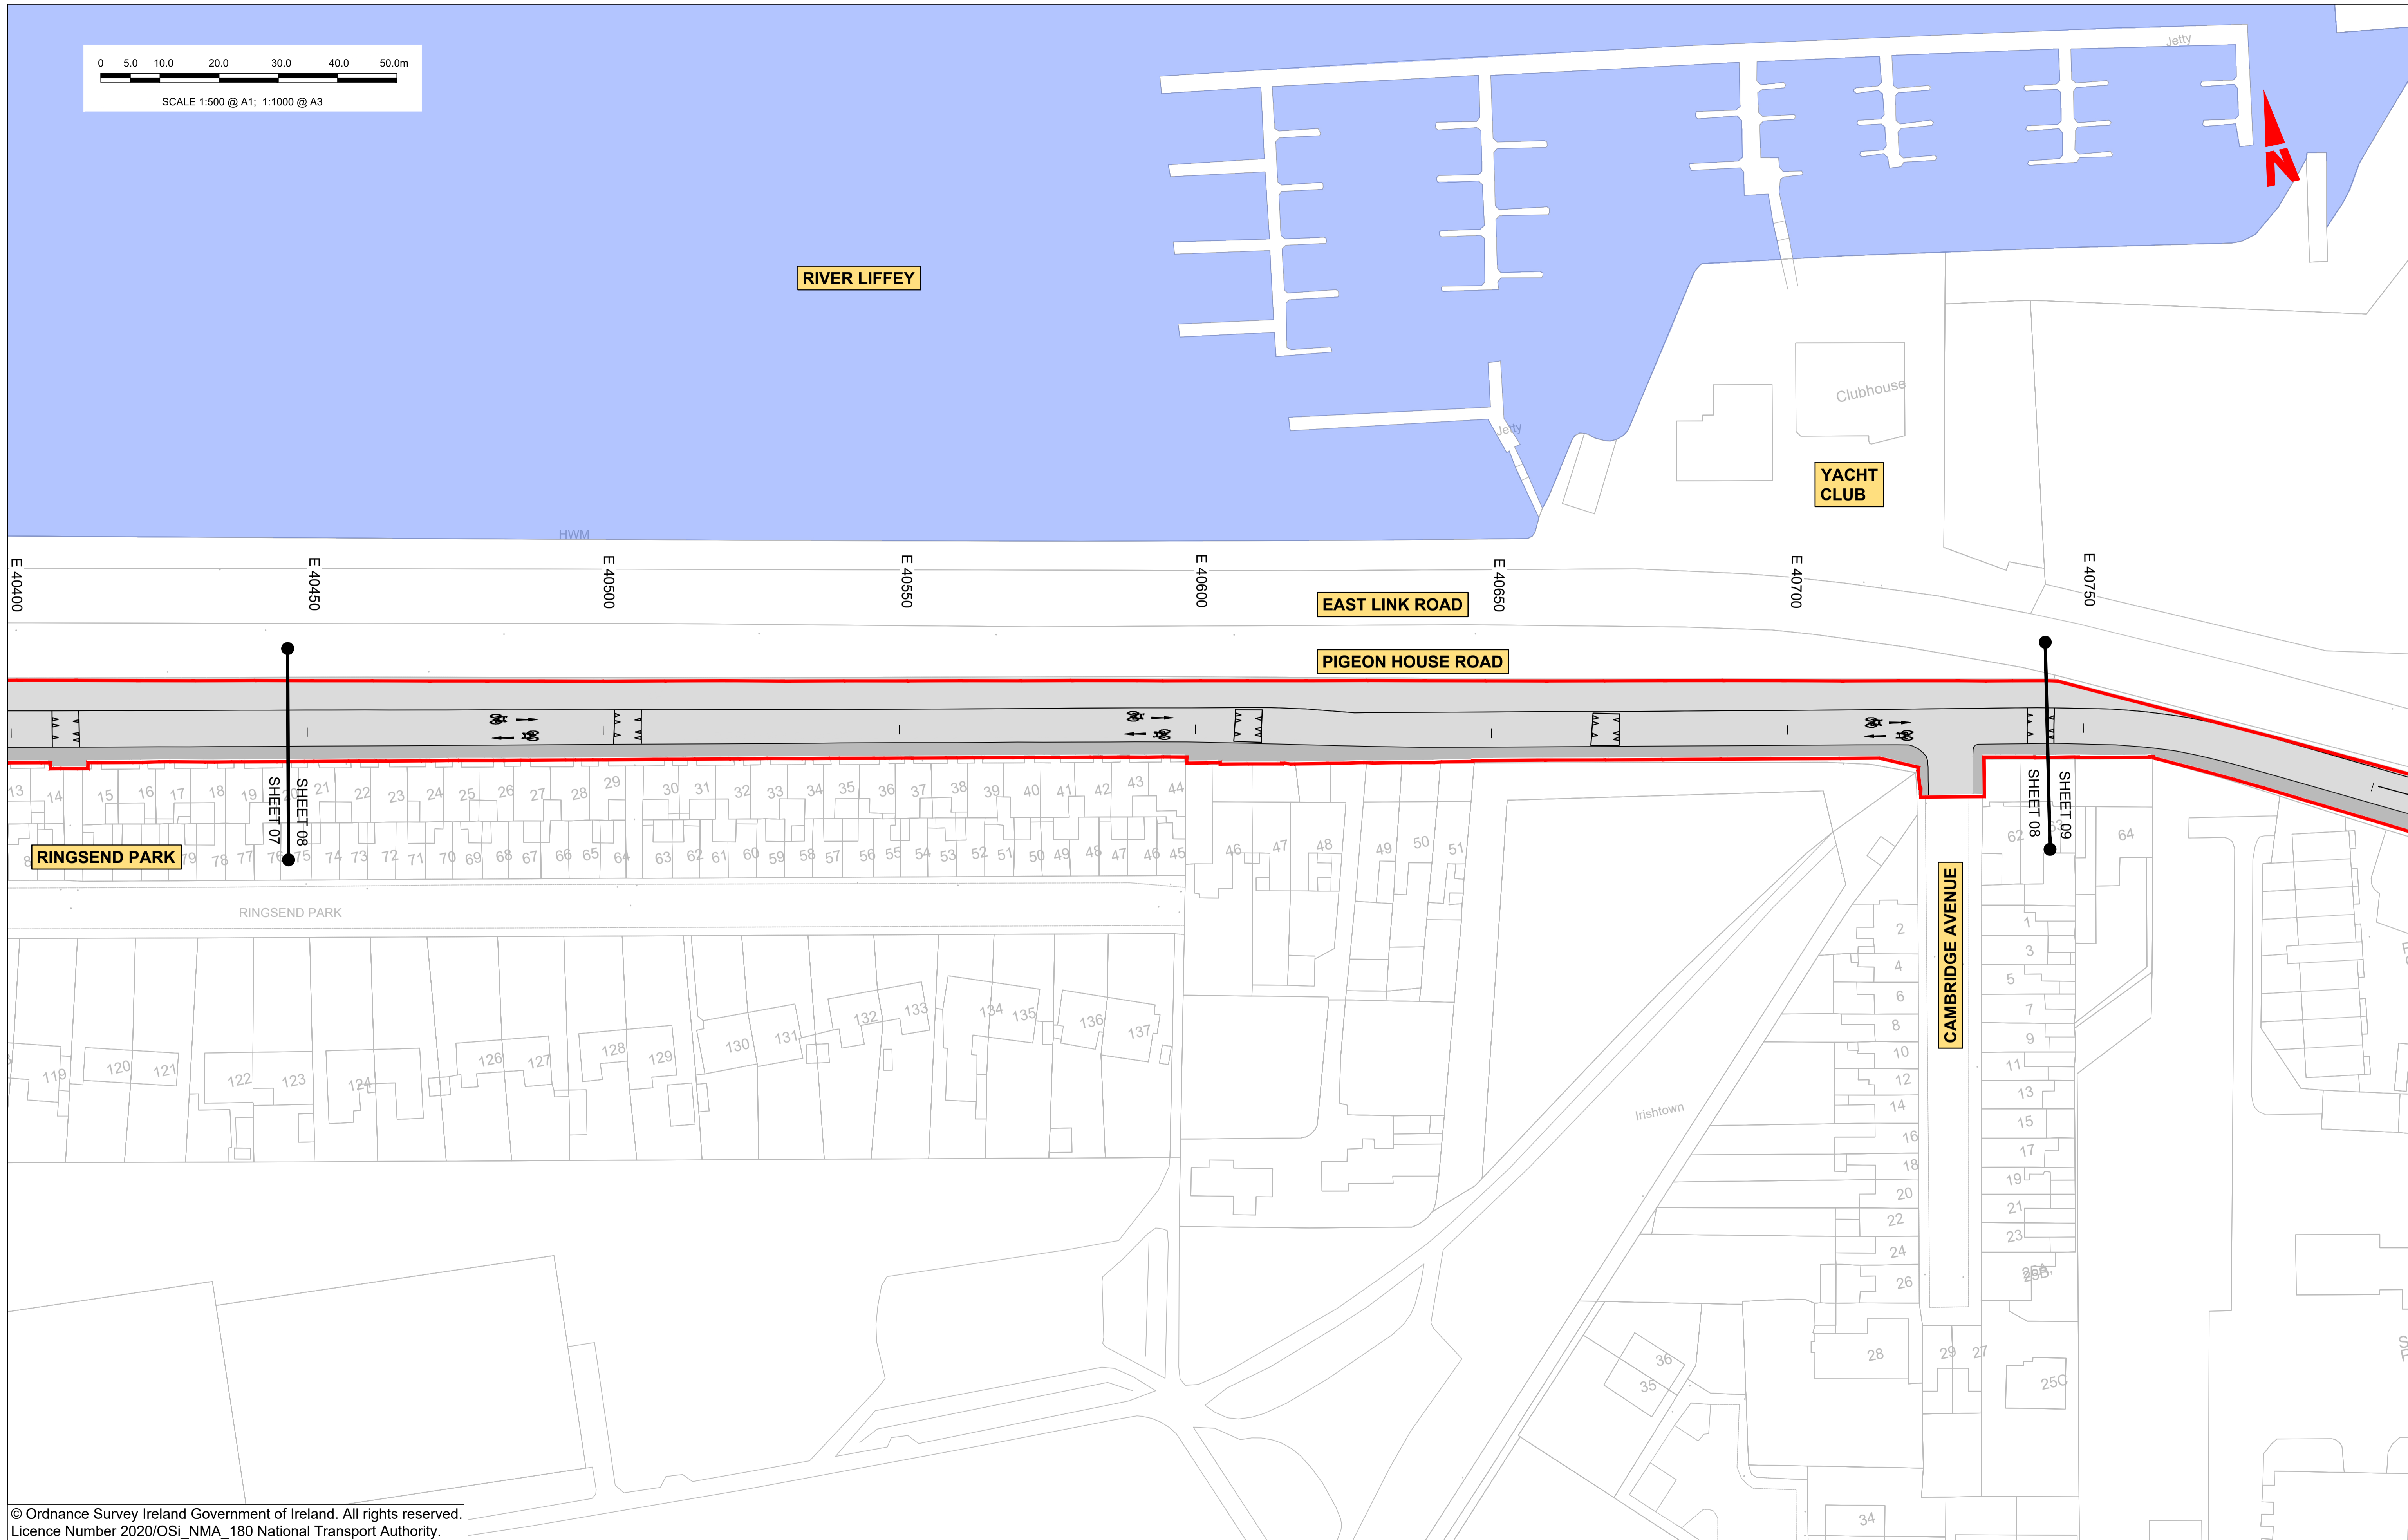
- 1 EXISTING TREE CANOPY BASED ON DIMENSIONS GATHERED ON SITE IN 4 DIRECTIONS, NORTH, SOUTH, EAST AND WEST
- 2 ROOT PROTECTION ZONE BASED ON 12 TIMES THE (DBH) AT CHEST HEIGHT
- 3 TREE TAG NUMBER
- 4 TREE TO BE RETAINED
- 5 TREE TO BE REMOVED
- 6 TREE CATEGORY BASED ON BS:5837 2012 CRITERIA
- 7 DECIDUOUS TREE CANOPY
- 8 EVERGREEN TREE CANOPY

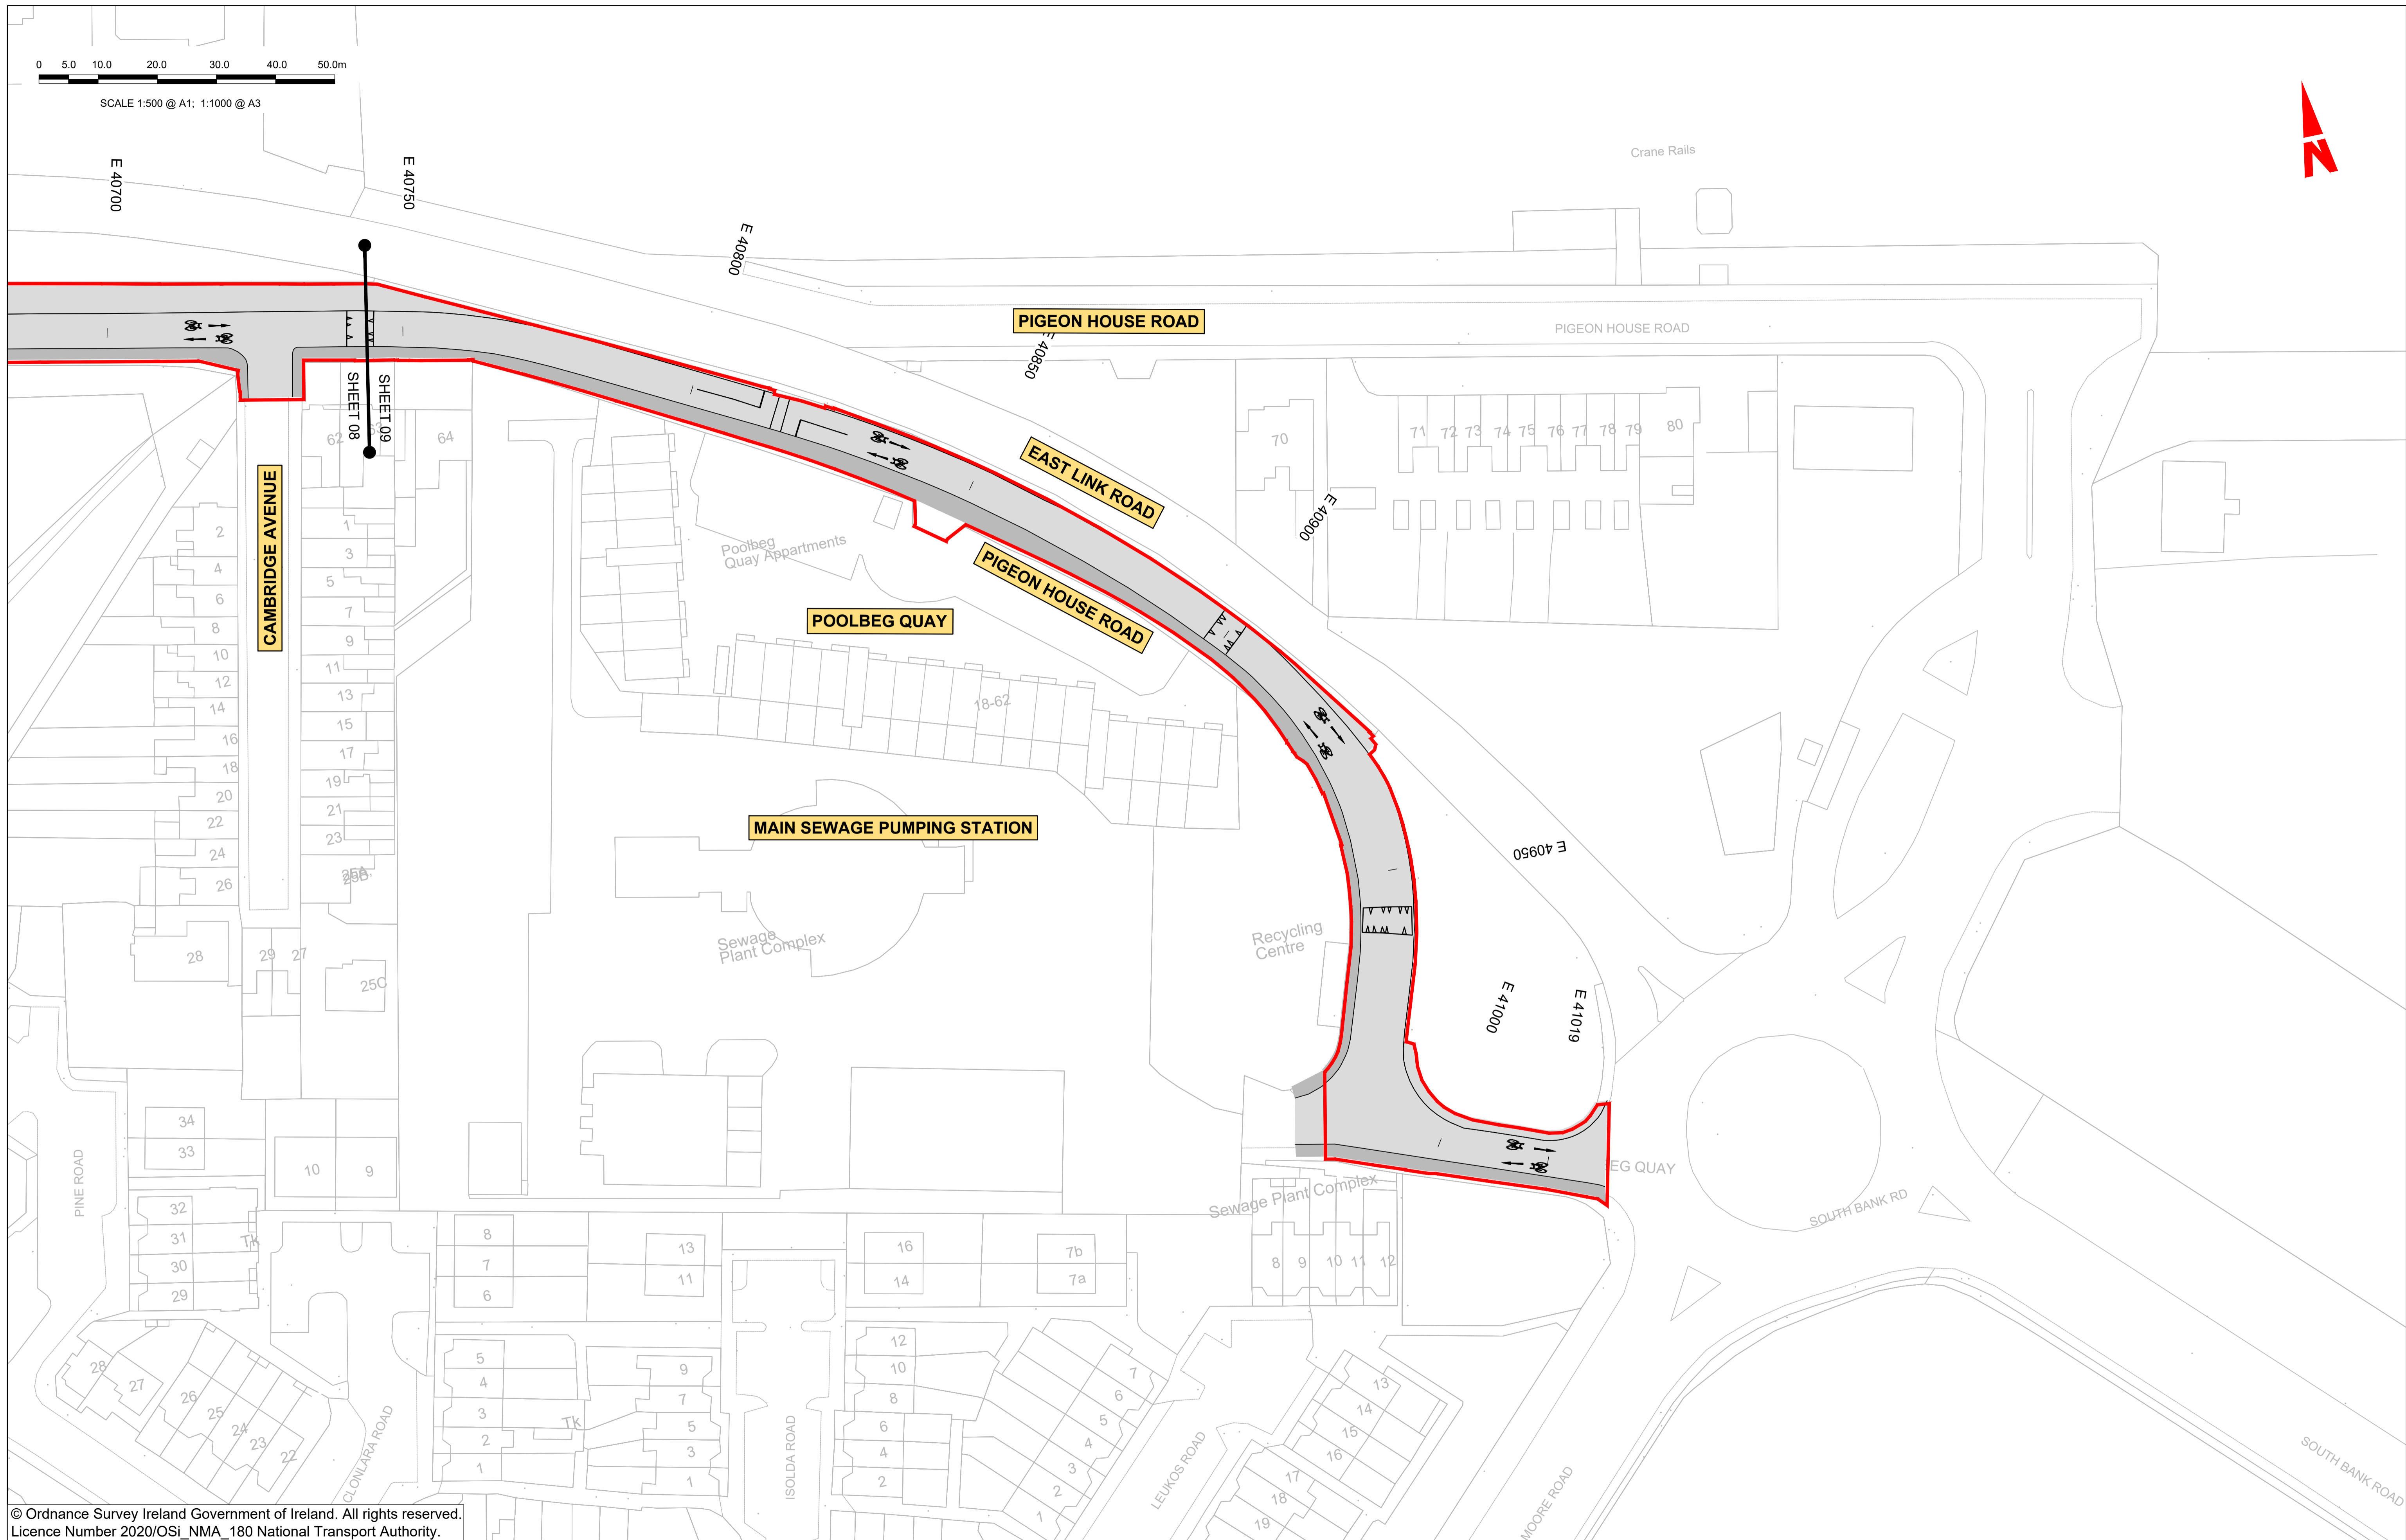
- 1 EXISTING TREE CANOPY BASED ON DIMENSIONS GATHERED ON SITE IN 4 DIRECTIONS, NORTH, SOUTH, EAST AND WEST
- 2 ROOT PROTECTION ZONE BASED ON 12 TIMES THE (DBH) AT CHEST HEIGHT
- 3 TREE TAG NUMBER
- 4 TREE TO BE RETAINED
- 5 TREE TO BE REMOVED
- 6 TREE CATEGORY BASED ON BS:5837 2012 CRITERIA
- 7 DECIDUOUS TREE CANOPY
- 8 EVERGREEN TREE CANOPY

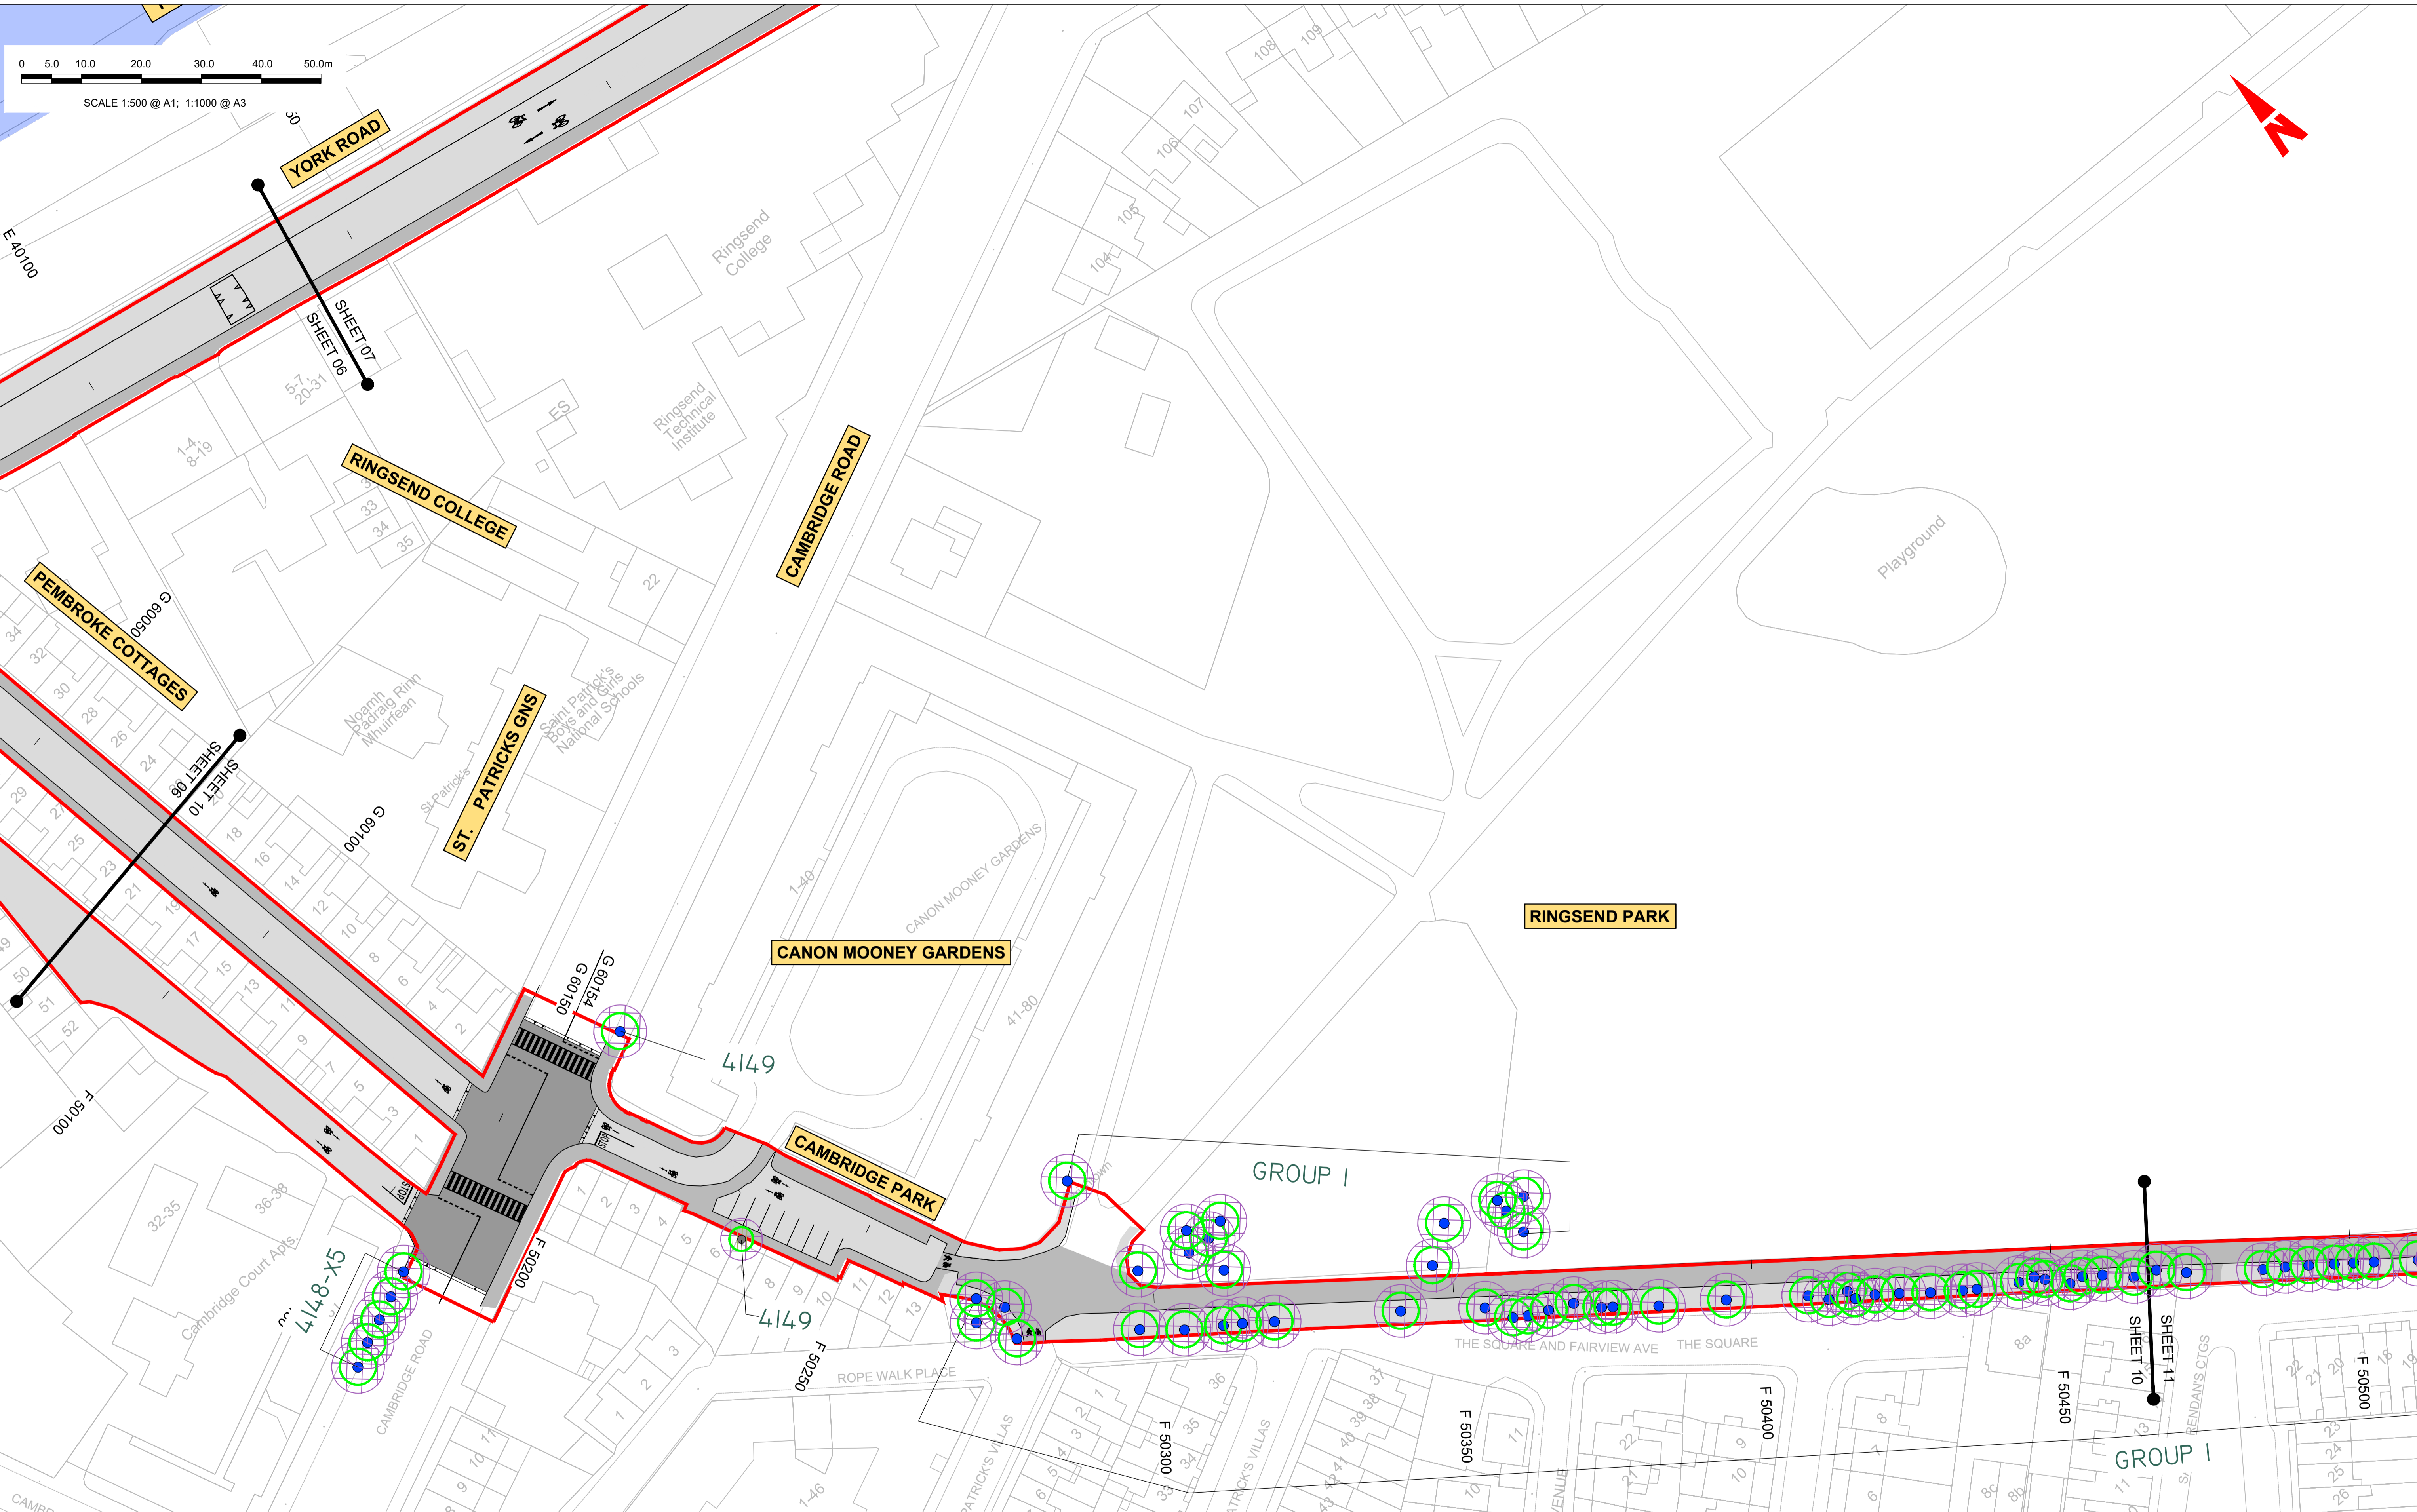
- 1 EXISTING TREE CANOPY BASED ON DIMENSIONS GATHERED ON SITE IN 4 DIRECTIONS, NORTH, SOUTH, EAST AND WEST
- 2 ROOT PROTECTION ZONE BASED ON 12 TIMES THE (DBH) AT CHEST HEIGHT
- 3 TREE TAG NUMBER
- 4 TREE TO BE RETAINED
- 5 TREE TO BE REMOVED
- 6 TREE CATEGORY BASED ON BS:5837 2012 CRITERIA
- 7 DECIDUOUS TREE CANOPY
- 8 EVERGREEN TREE CANOPY

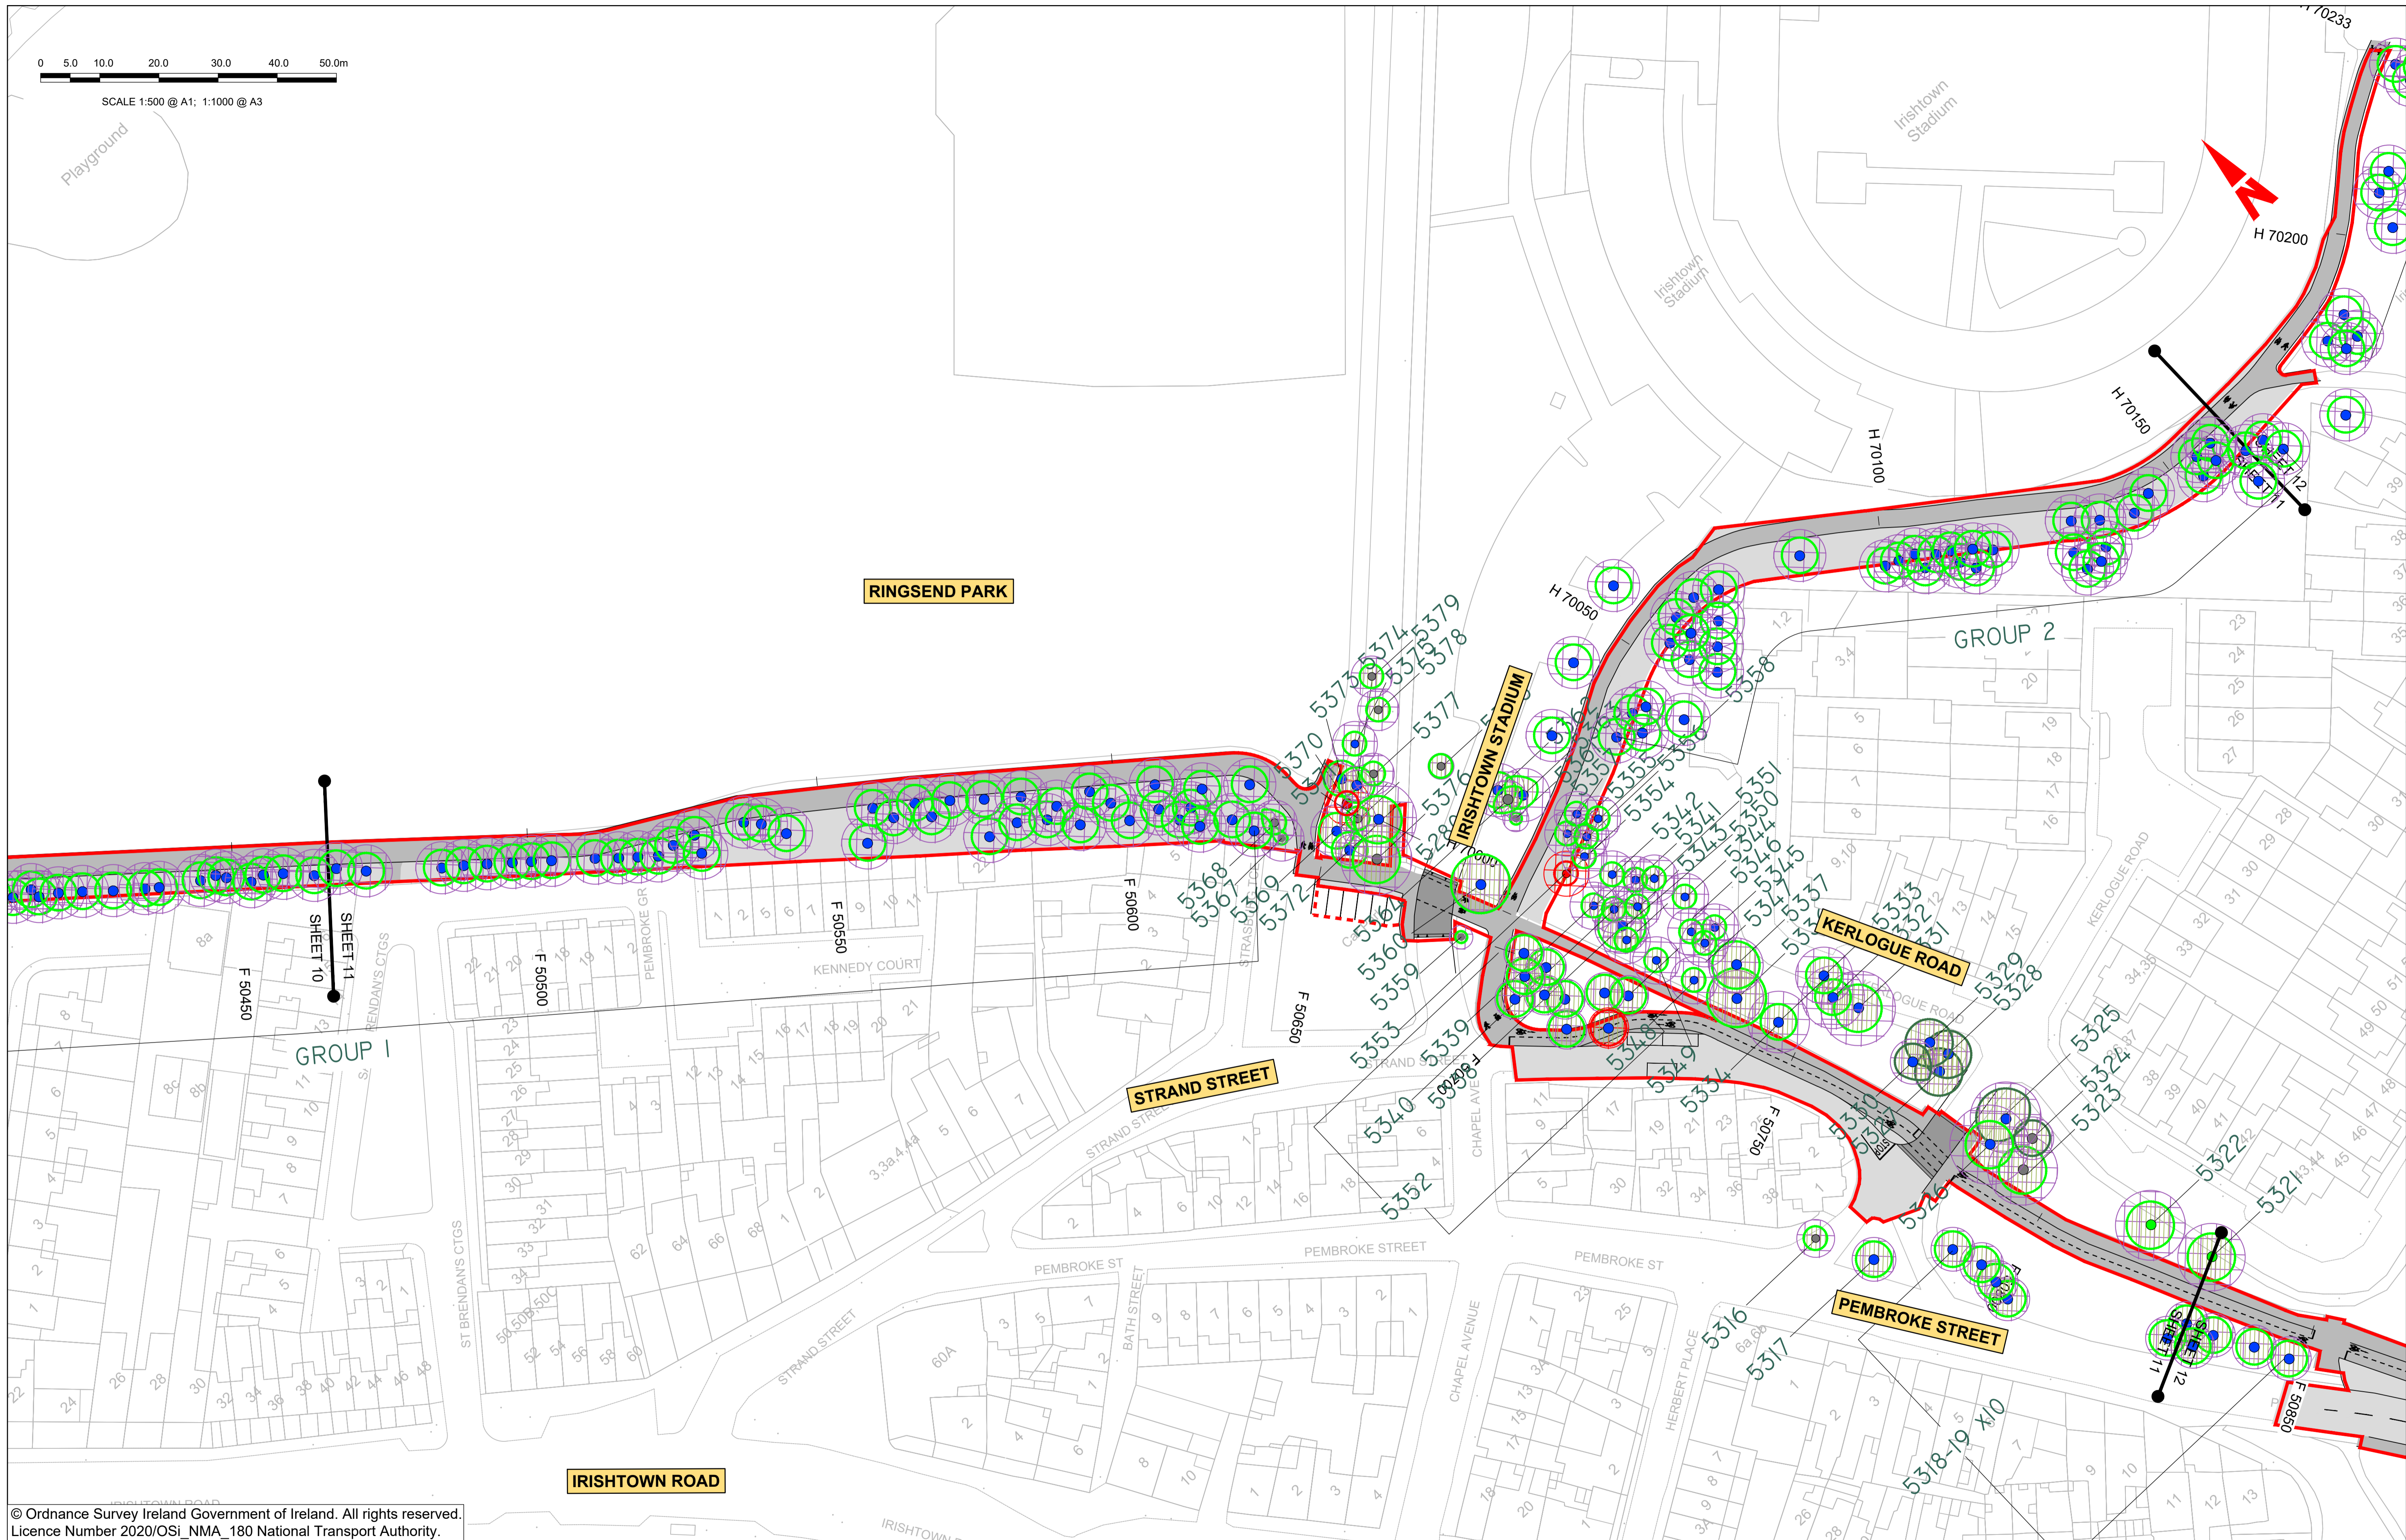
- 1 EXISTING TREE CANOPY BASED ON DIMENSIONS GATHERED ON SITE IN 4 DIRECTIONS, NORTH, SOUTH, EAST AND WEST
- 2 ROOT PROTECTION ZONE BASED ON 12 TIMES THE (DBH) AT CHEST HEIGHT
- 3 TREE TAG NUMBER
- 4 TREE TO BE RETAINED
- 5 TREE TO BE REMOVED
- 6 TREE CATEGORY BASED ON BS:5837 2012 CRITERIA
- 7 DECIDUOUS TREE CANOPY
- 8 EVERGREEN TREE CANOPY

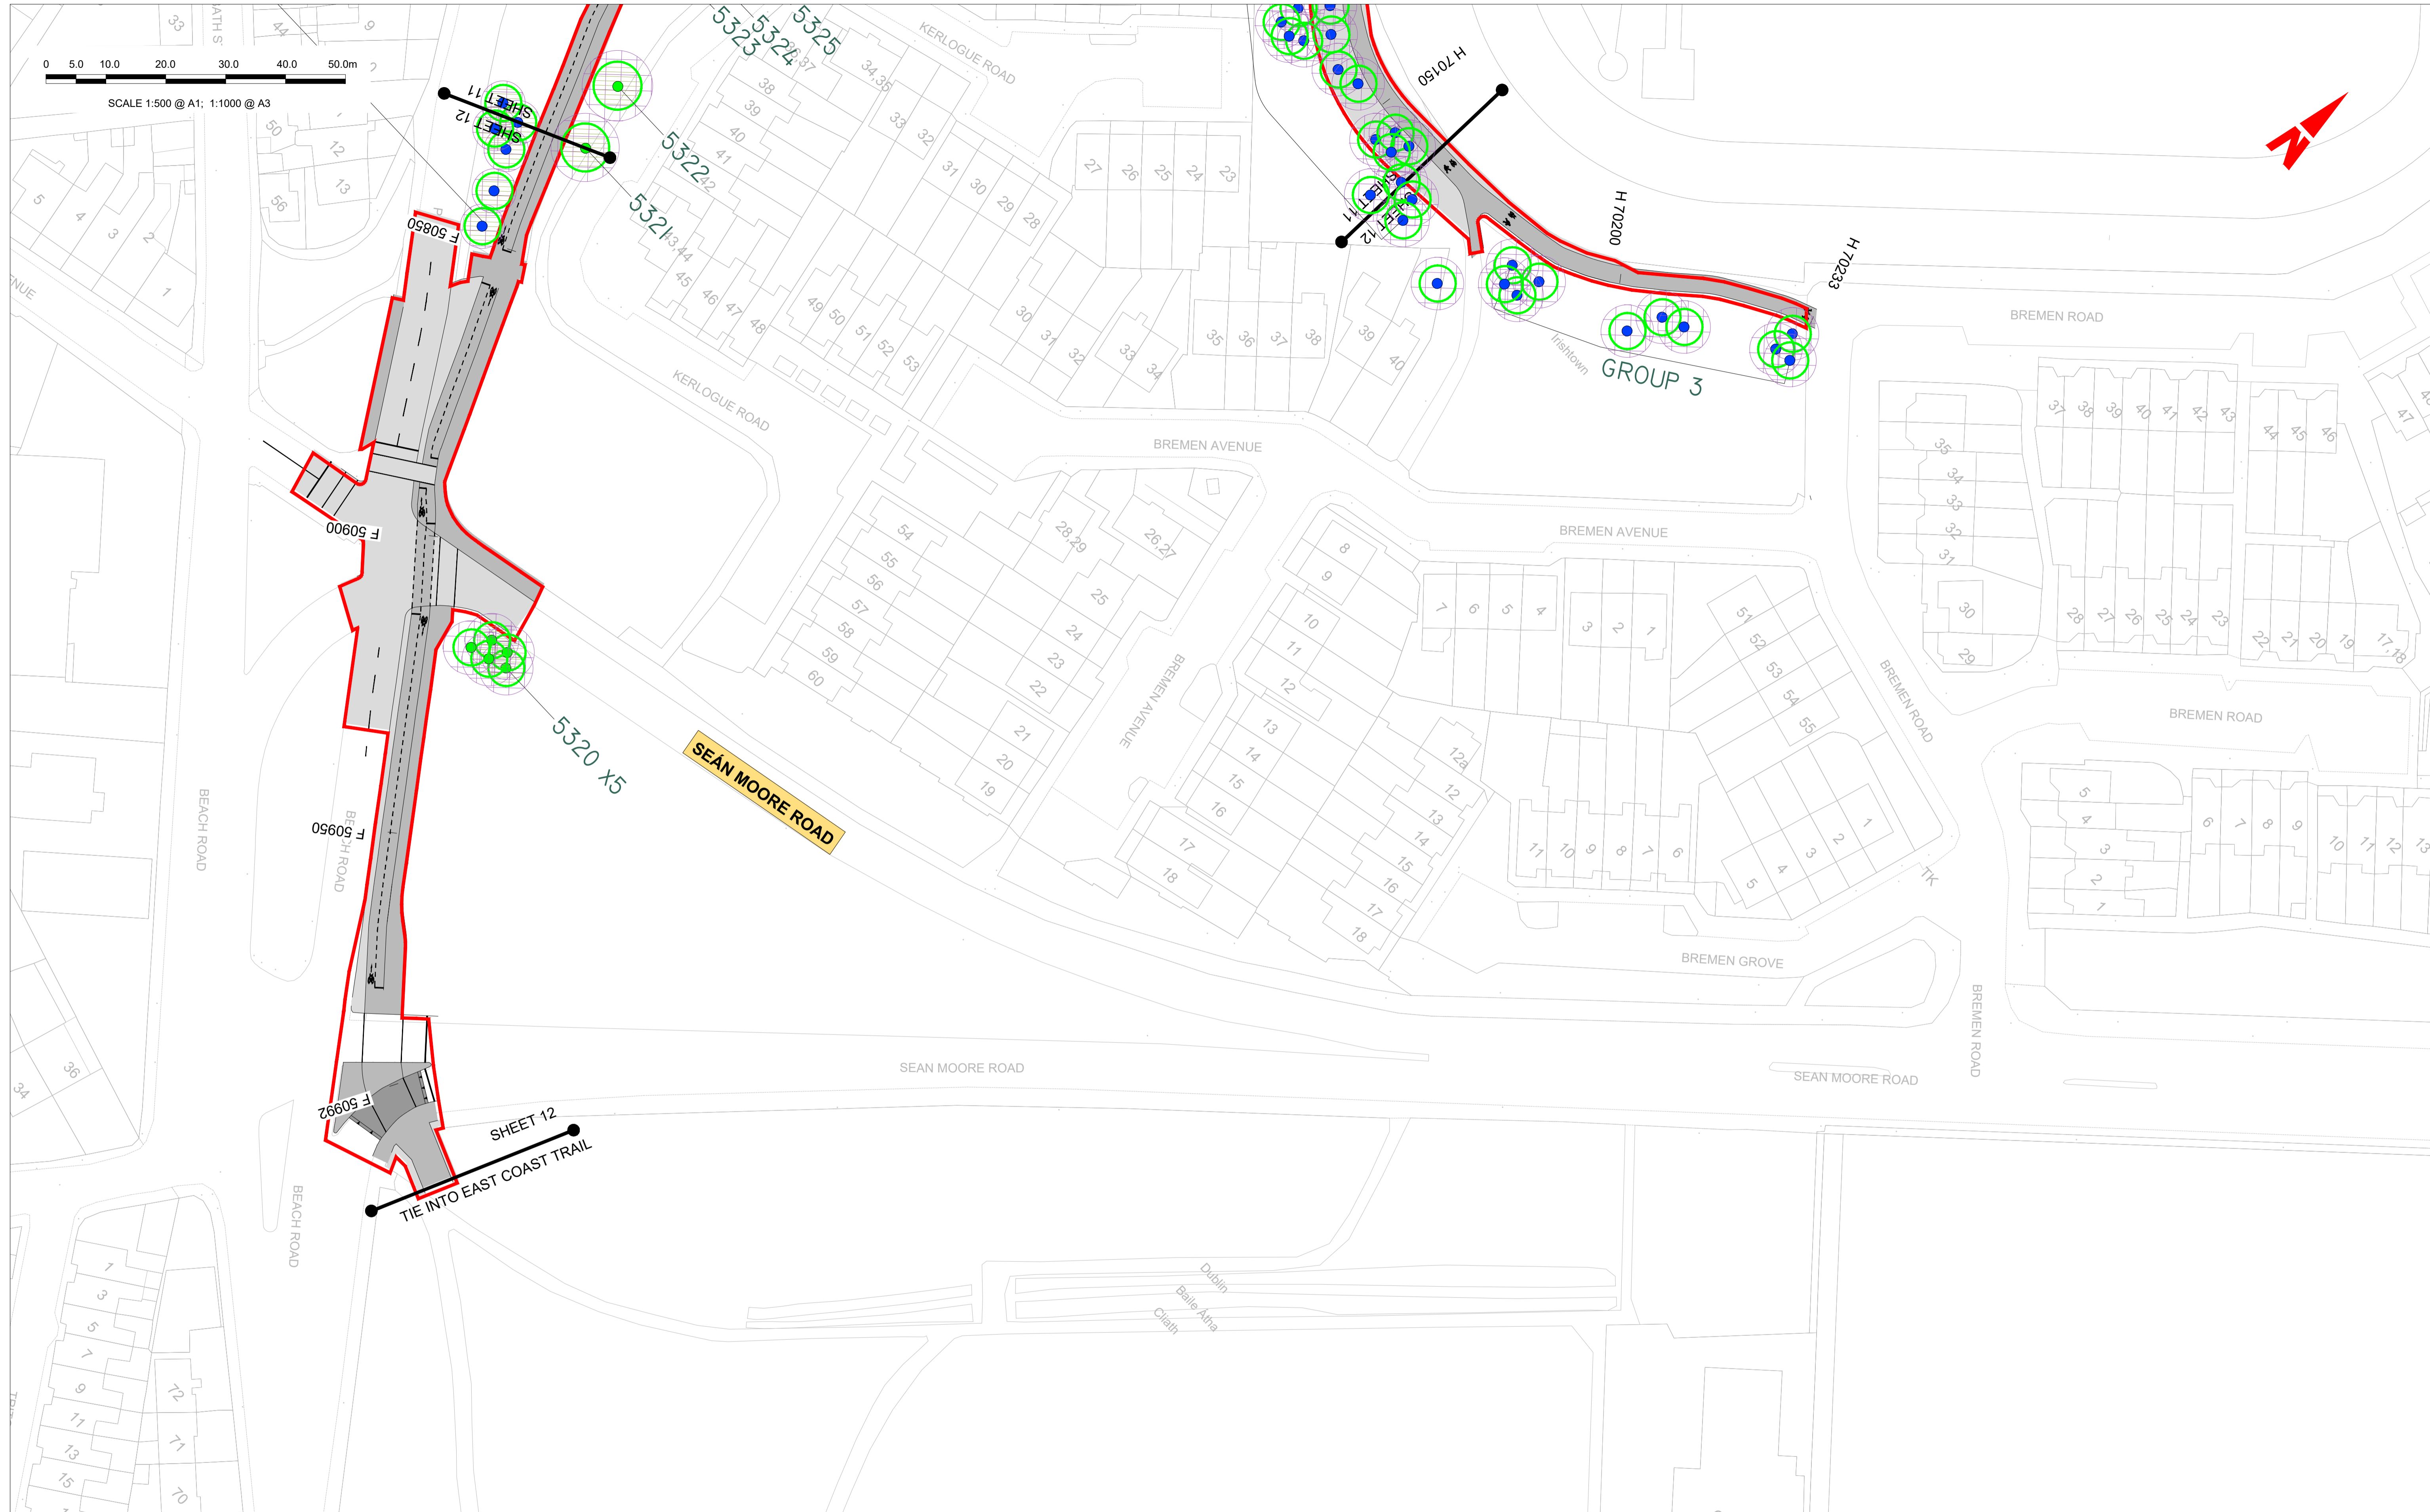
- 1 EXISTING TREE CANOPY BASED ON DIMENSIONS GATHERED ON SITE IN 4 DIRECTIONS, NORTH, SOUTH, EAST AND WEST
- 2 ROOT PROTECTION ZONE BASED ON 12 TIMES THE (DBH) AT CHEST HEIGHT
- 3 TREE TAG NUMBER
- 4 TREE TO BE RETAINED
- 5 TREE TO BE REMOVED
- 6 TREE CATEGORY BASED ON BS:5837 2012 CRITERIA
- 7 DECIDUOUS TREE CANOPY
- 8 EVERGREEN TREE CANOPY
