3.6 Overview of chronology of the Link (Building G)

MILLTOWN PARK HOUSE - EXTERNAL ELEVATIONS

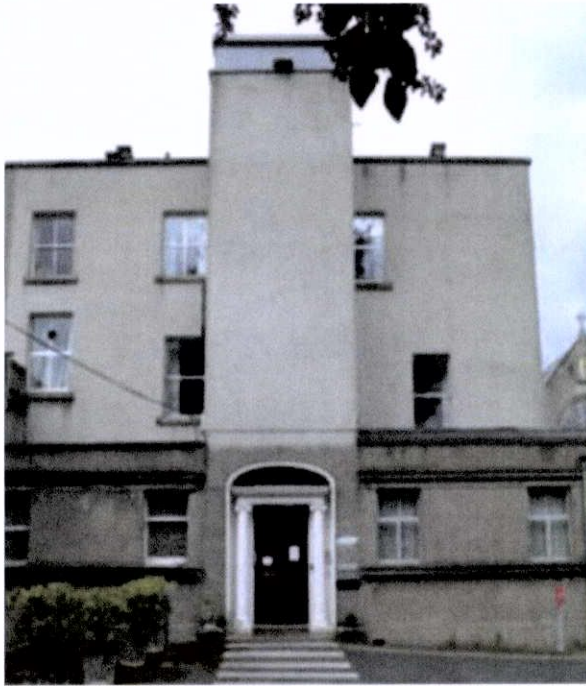
Plate 1: Milltown Park House entrance with some of its many extensions visible

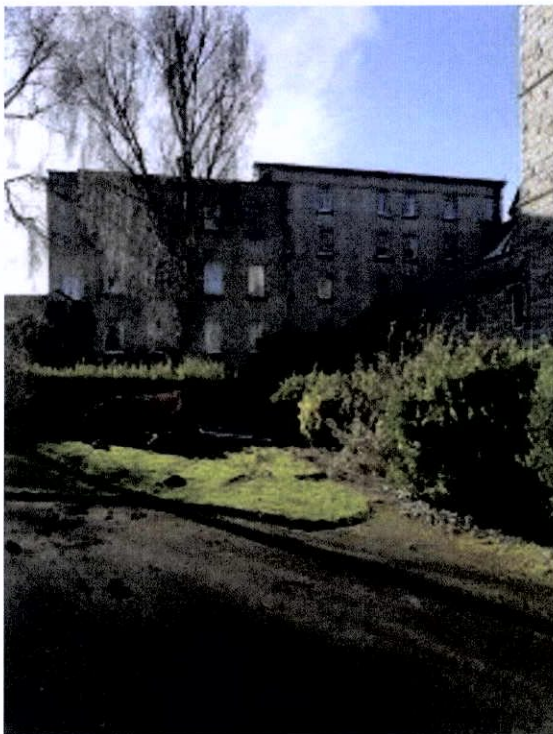
Plate 3: North east gable from drive way passing Tabor House (to right) with rear extension in context

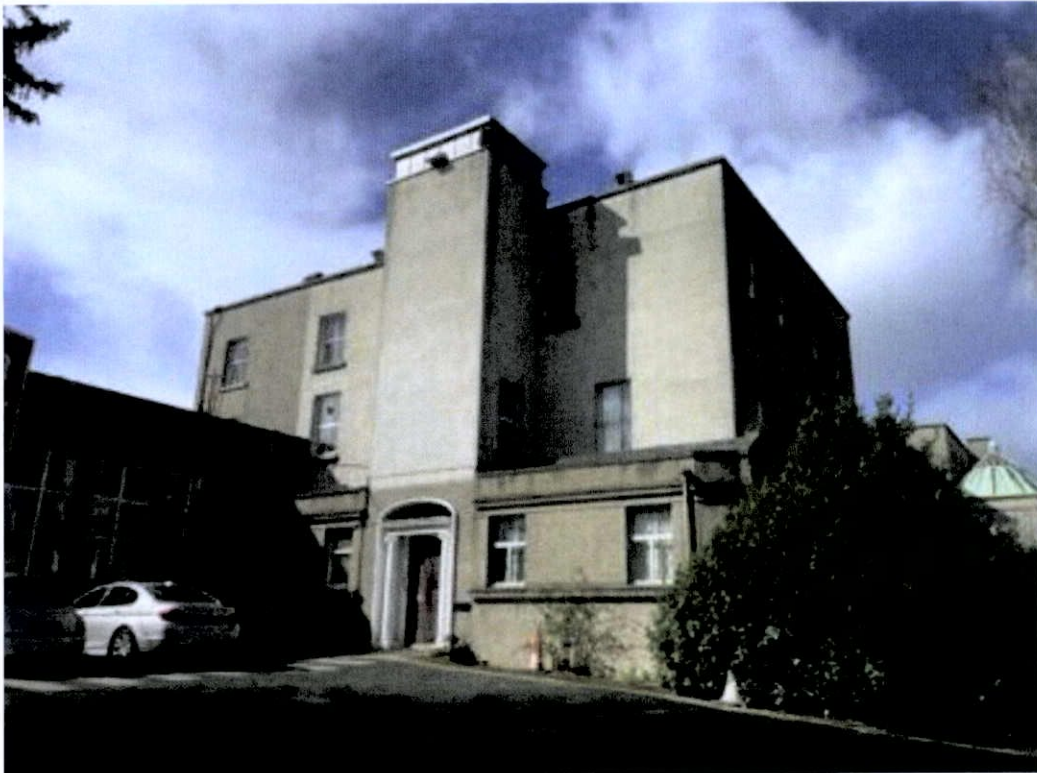
Plate 9: View of front elevation of MPH. Note later extension over entrance portico. The gable of the Finlay wing visible to the left of entrance.

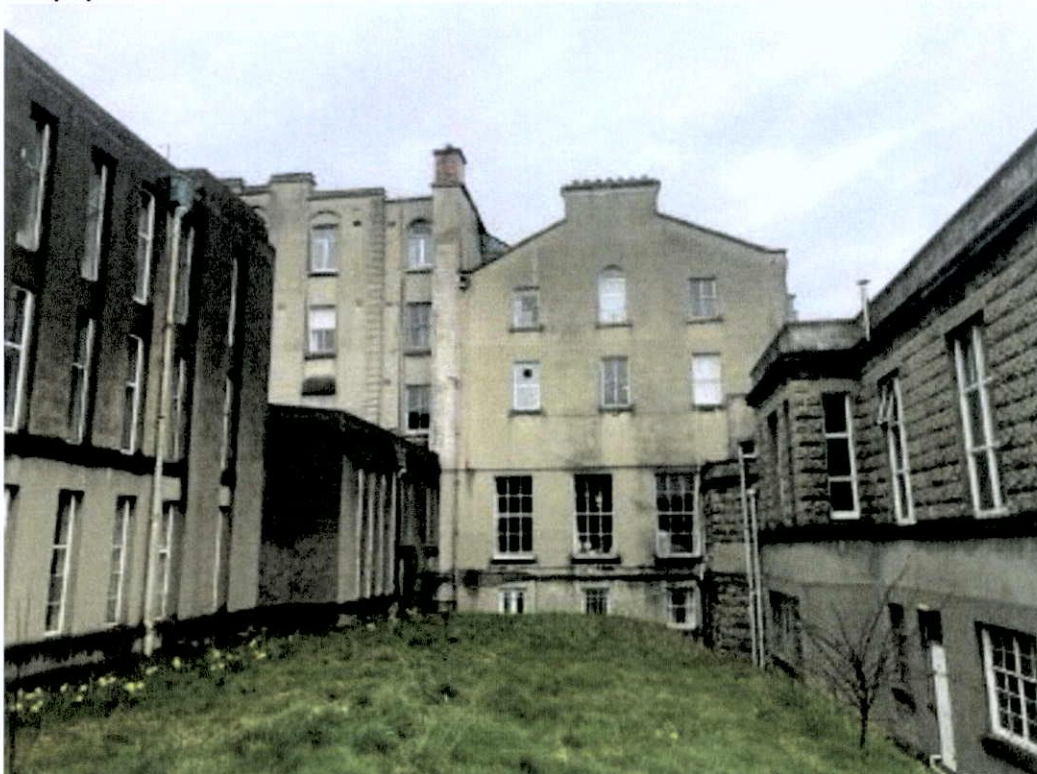
Plate 10: View on south-west elevation of MPH, positioned between the Archive (left) and the Finlay wing (right).

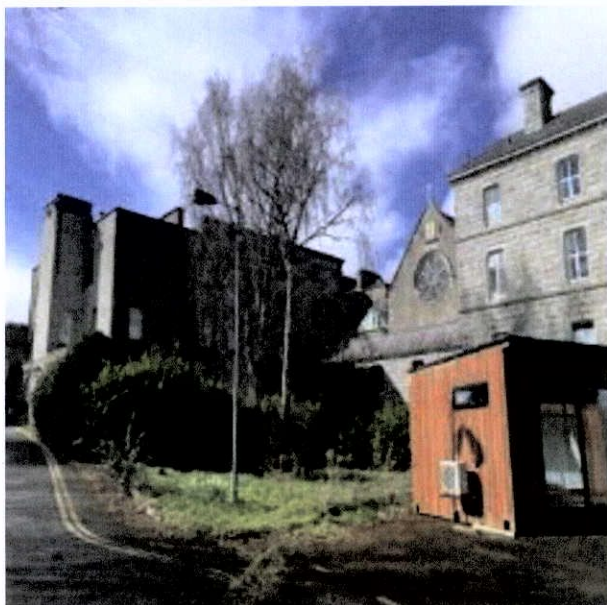
Plate 11: North east gable of rear extension block in context

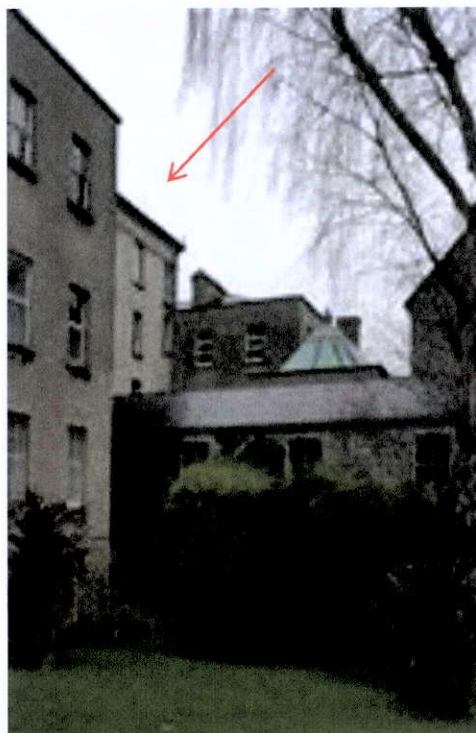
Plate 12: View west of the same elevation with the rear extension, link building and turret of small Sacred Heart Chapel (1911) in view

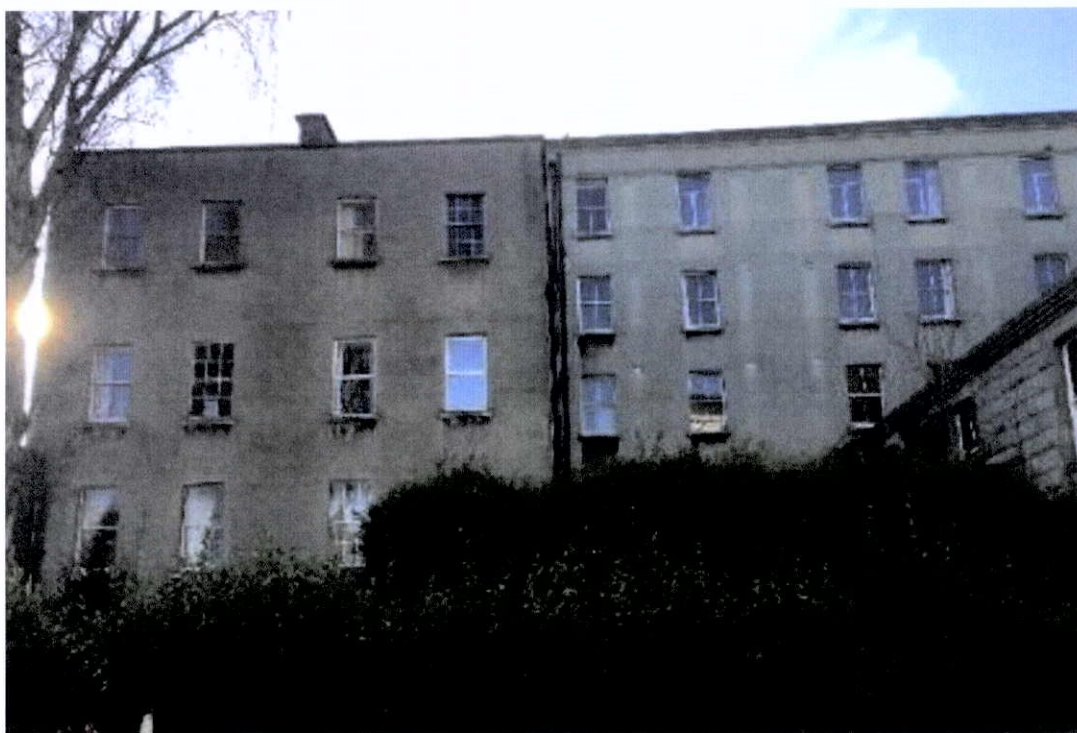
Plate 13: North elevation of Milltown Park, which was vertically extended in the late 19th century with north elevation of the higher, rear extension which was constructed in the 20th century

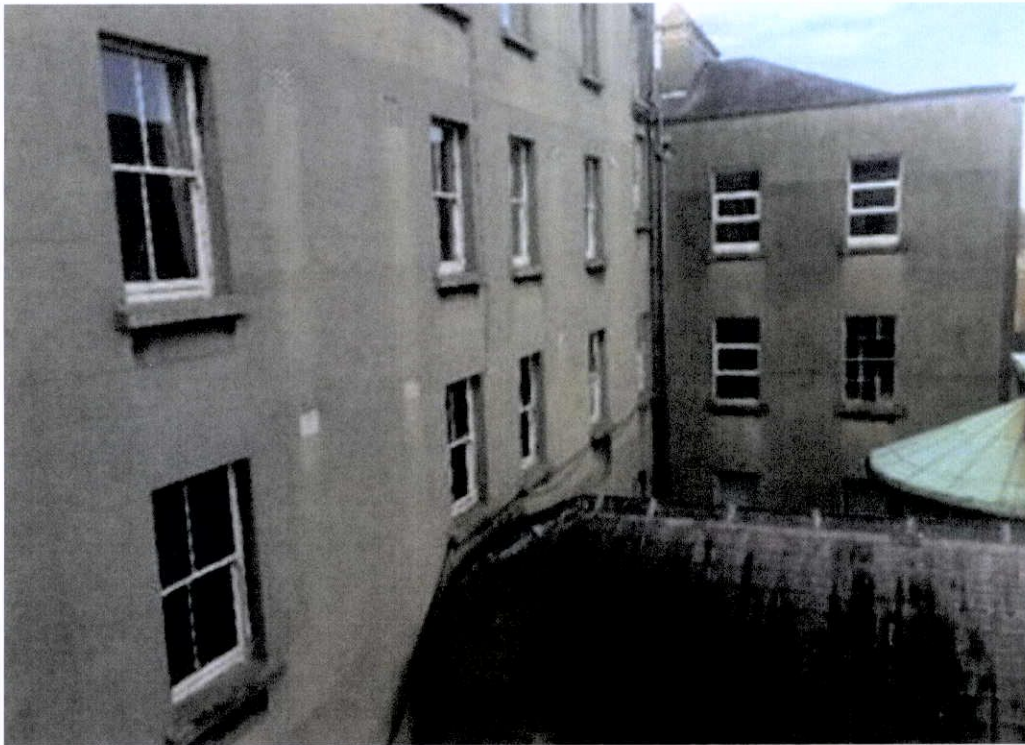
Plate 18: View of the (later) northern extension from a rear 1st floor window of Milltown Park house, towards the opposing (original) H form comprising a lower building, possibly intended to align with MPH

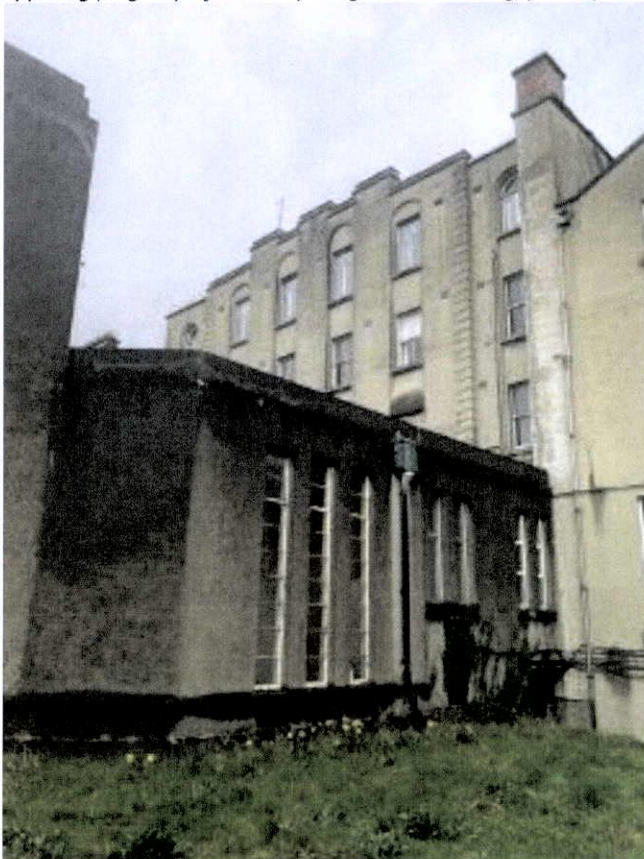
Plate 19: Southwest view of the rear extension, above the connection with the archive building.

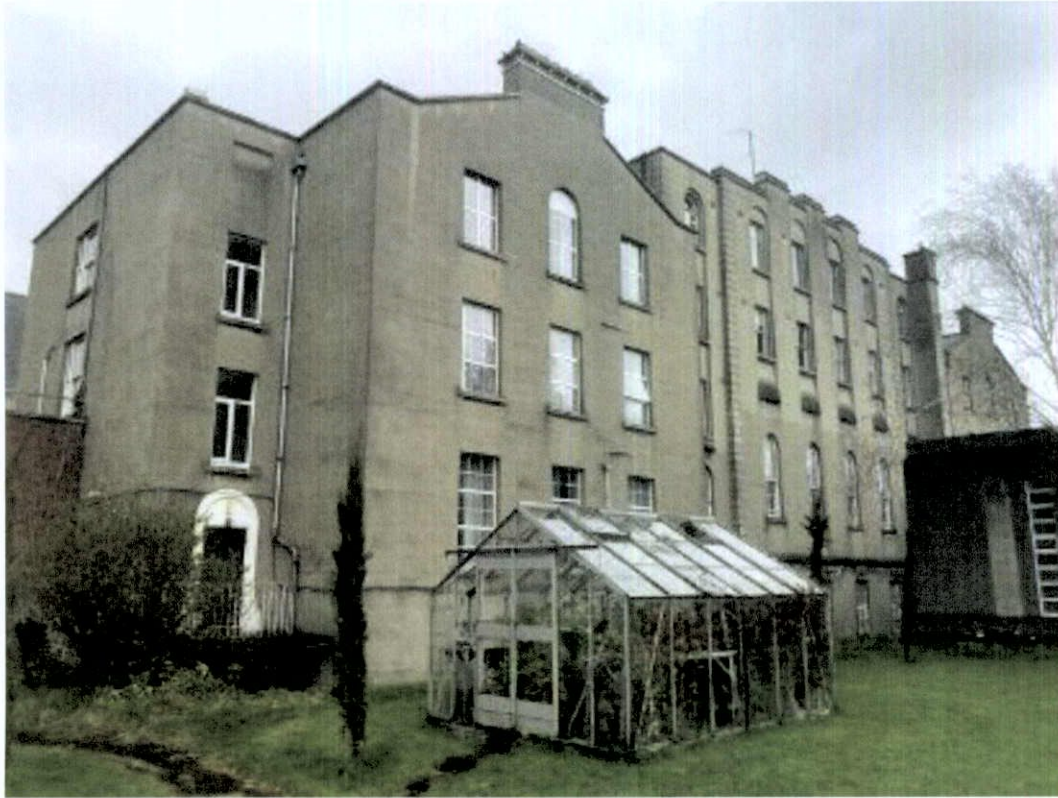
Plate 20: South-west elevation of the rear extension to MPH, with projecting gable to match that on eastern end

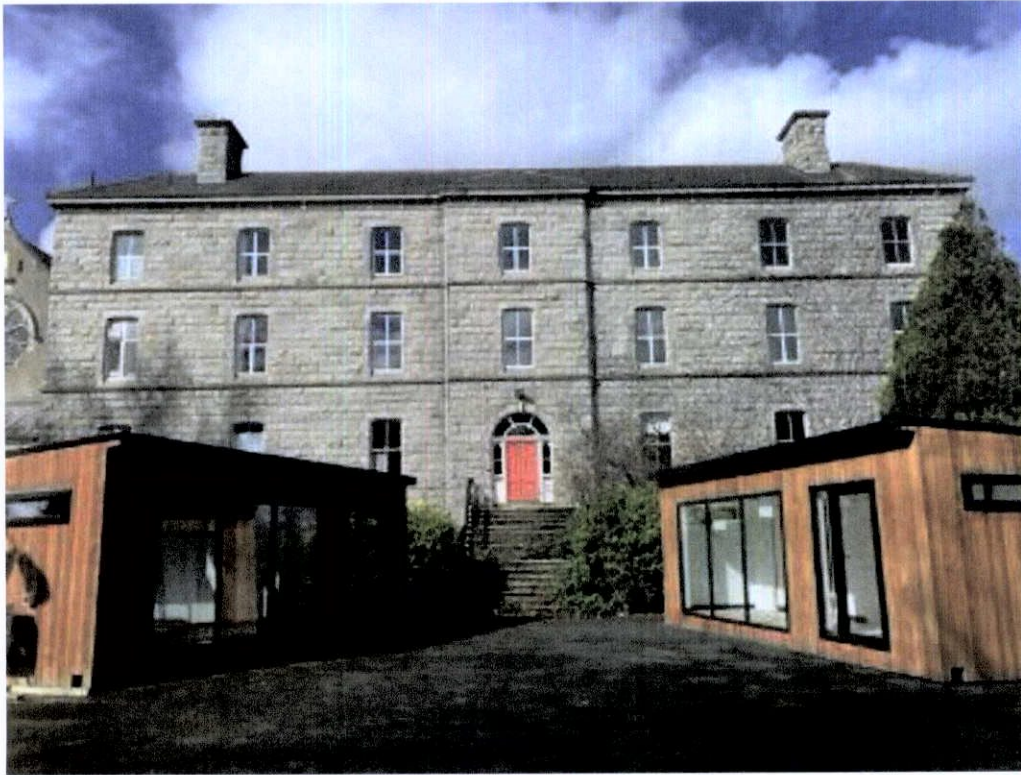
Plate 22: Symmetrical front elevation of Tabor House, a three storey over lower ground floor, 7 bay building. Temporary prefabricated structures in foreground.

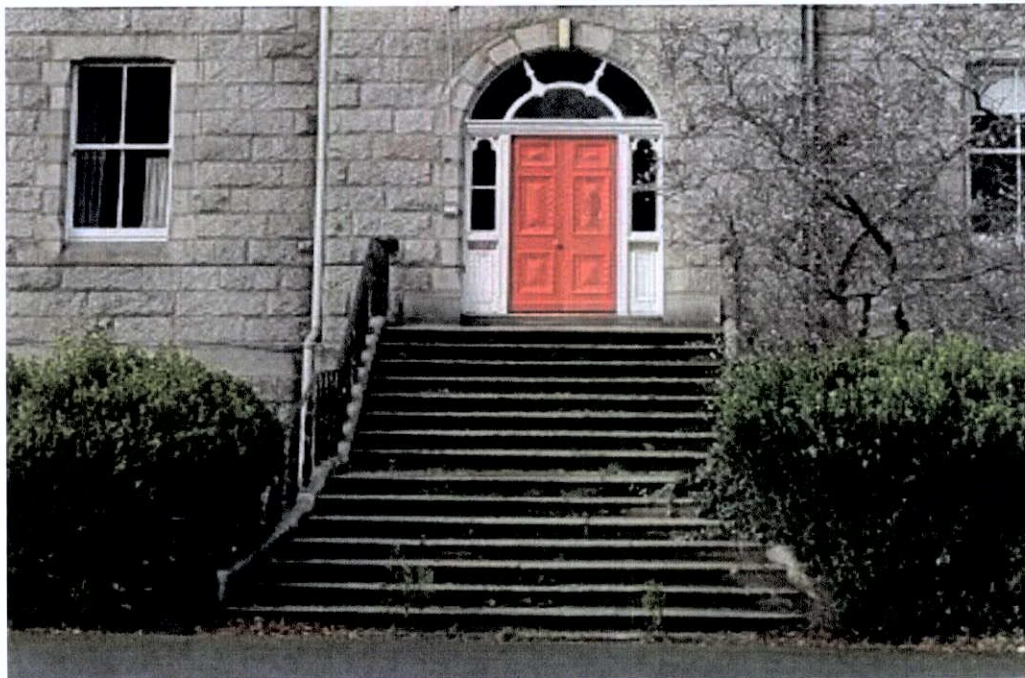
Plate 23: Original panelled front door with fanlight and granite steps to Tabor House

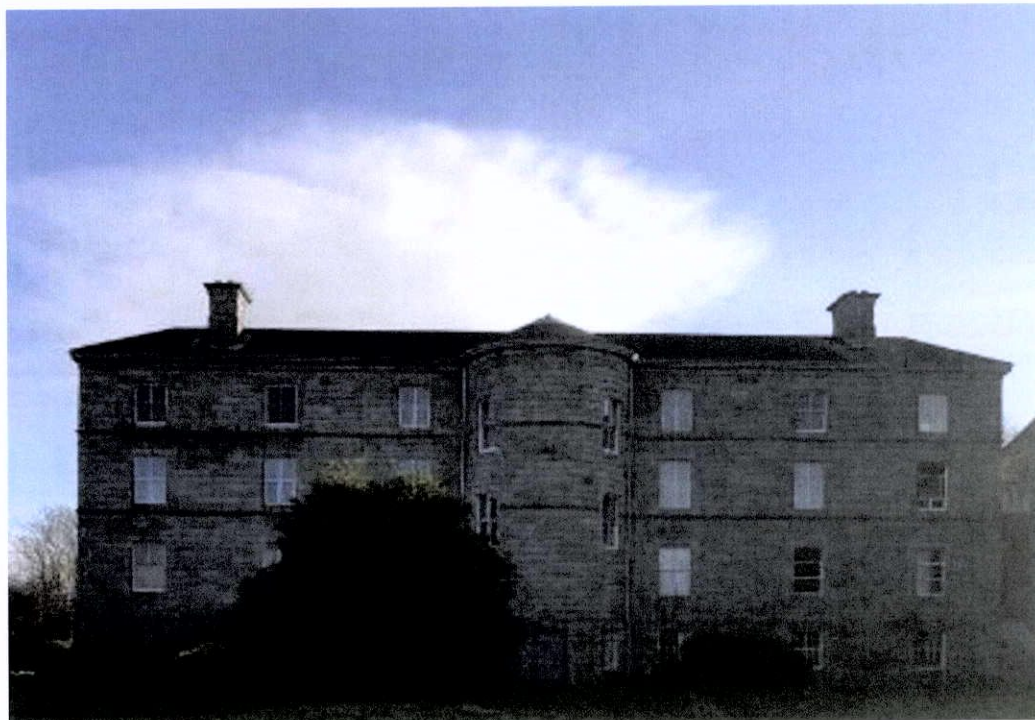
Plate 24: Tabor House rear/west elevation, with bowed bay of central staircase, note the array of fenestration types; the original 2 over 2 sashes being the most prevalent

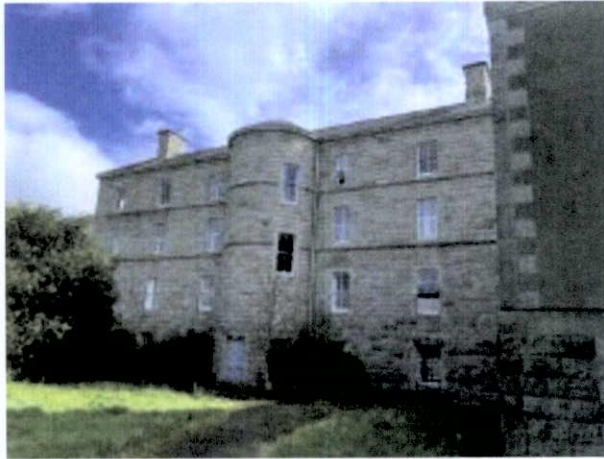
Plate 27: West elevation with bowed bay

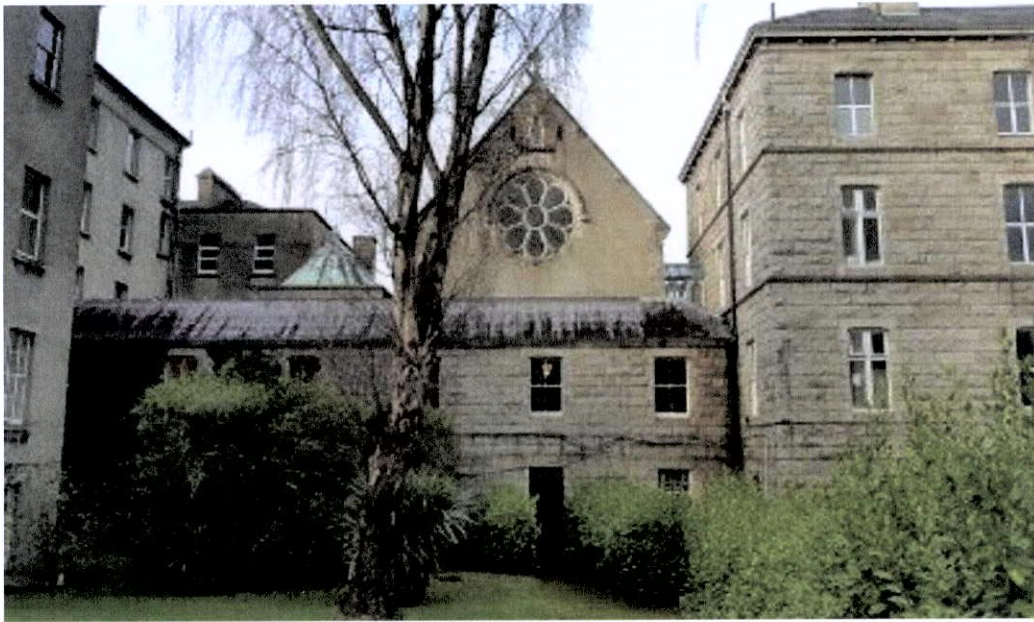
Plate 33: Front elevation of Chapel, above linking building, with stained glass Rose window on east gable with copper turret of Sacred Heart Chapel south of it. Both Chapels are accessed from within Milltown Park House

The chapel has an external form that is reflected in its entrance level interior. The building is conservable due to its strong external form that can connect with a reimagined landscape. The loose furnishings have already been removed from the interior by the Order, rendering a large volume suitable for other uses.

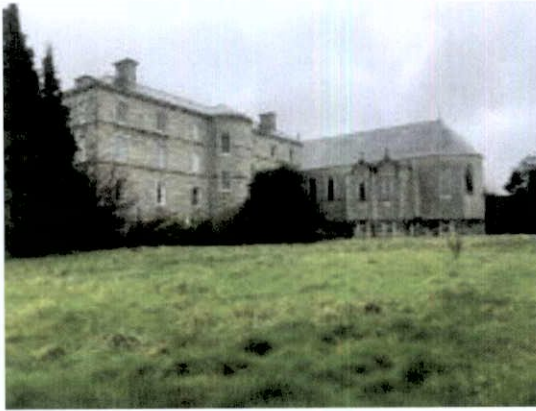
Plate 36: Rear of Chapel with Tabor House in foreground.

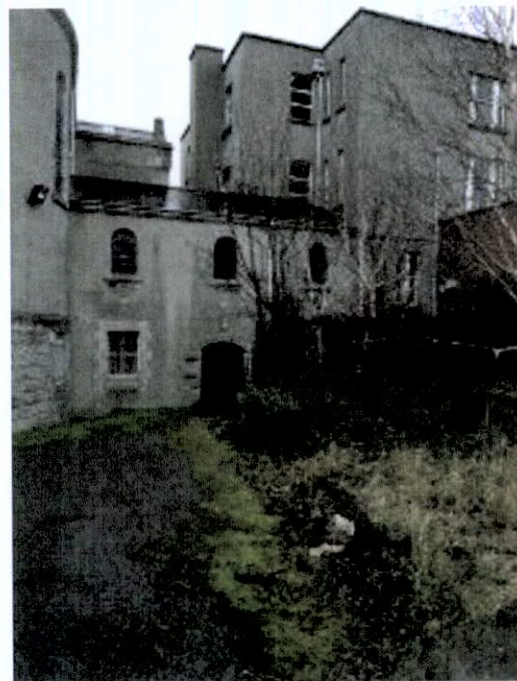
Plate 39: Rear of linking building with boundary of neighbouring property. The red brick structure was formerly part of the Milltown Park complex

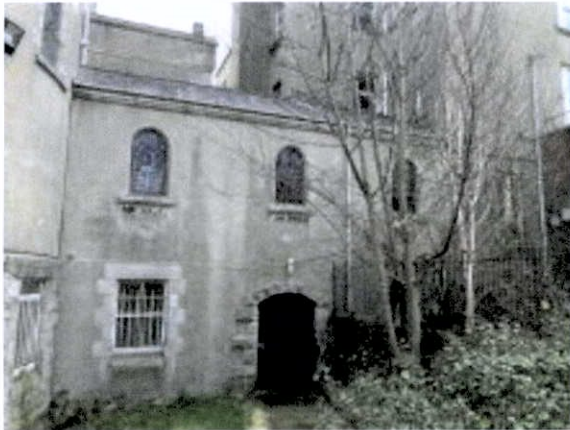
Plate 40: Gated opening to central courtyard at rear of lining structure, between Chapel and rear extension

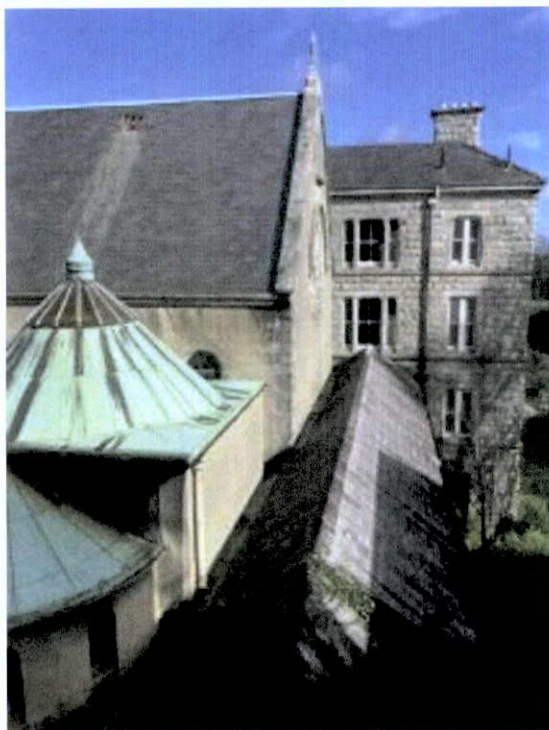
Plate 46: Roof of link building, facing towards south-west gable of Tabor House..

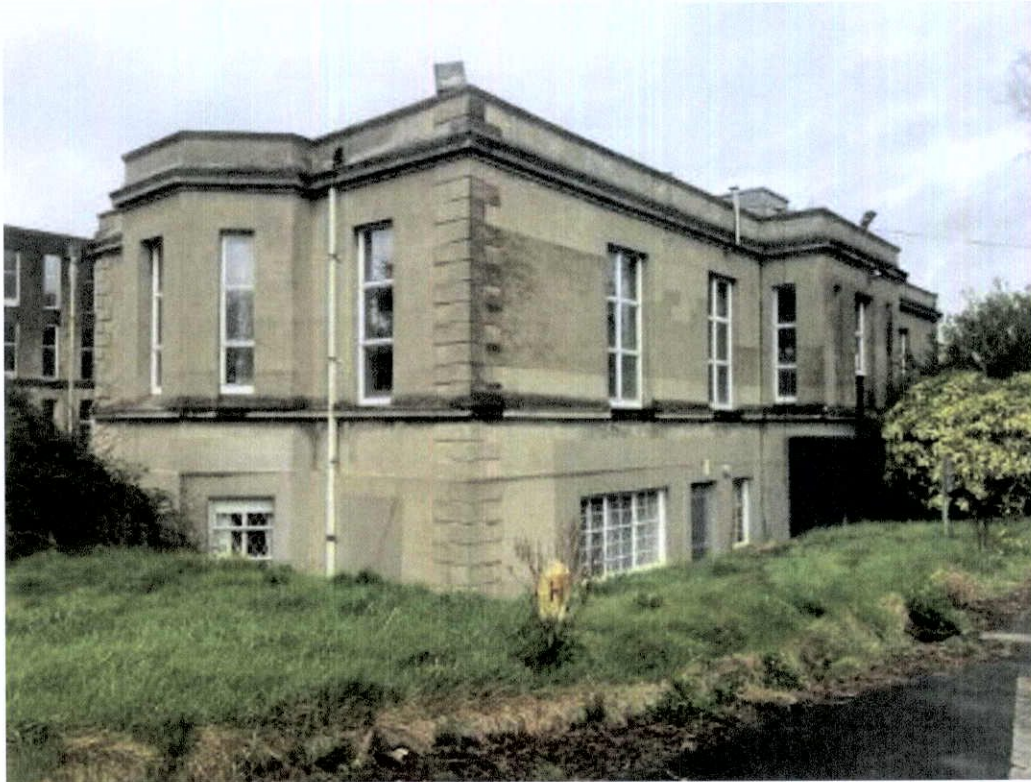
Plate 47: Finlay Wing from new Sandford Road entrance, rendered finish with raised quoins

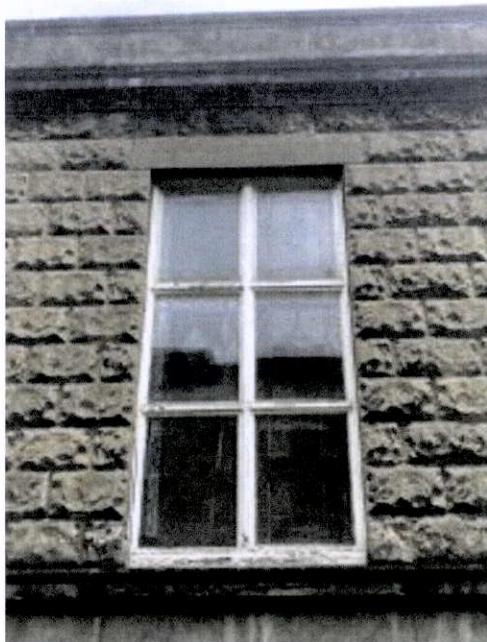
Plate 51: Leaded windows in Finlay wing. Rock-faced ashlar finish to upper ground level.

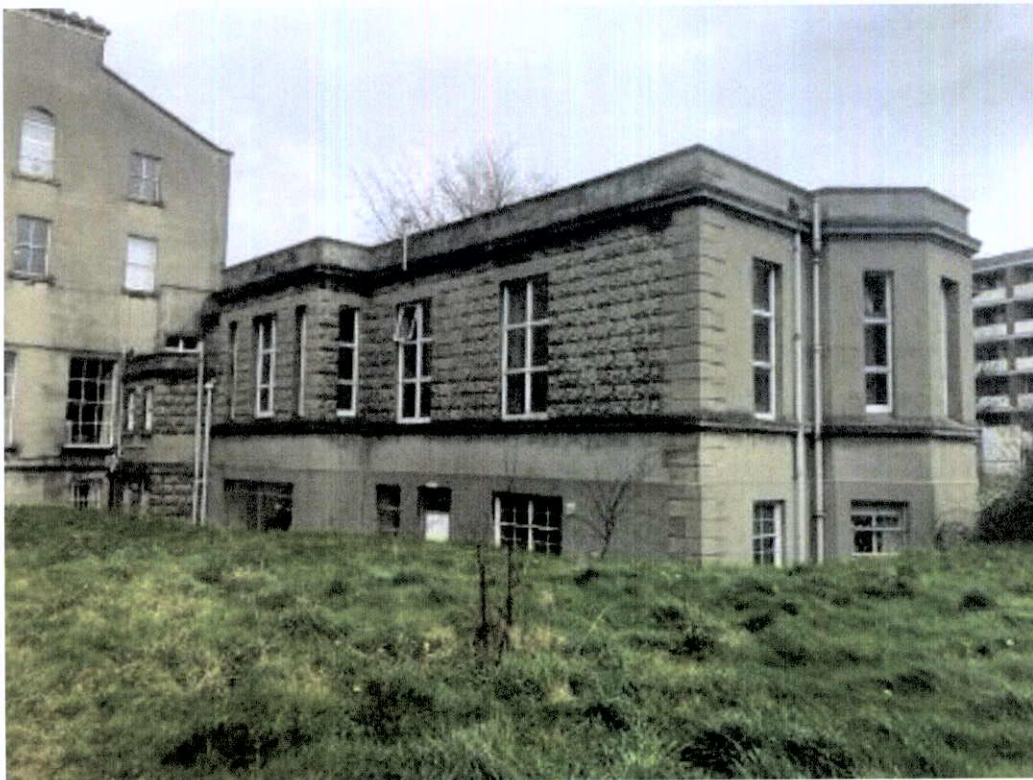
Plate 54: View of west elevation. Smooth ashlar finish to lower ground level with rock-faced finish to upper ground level.

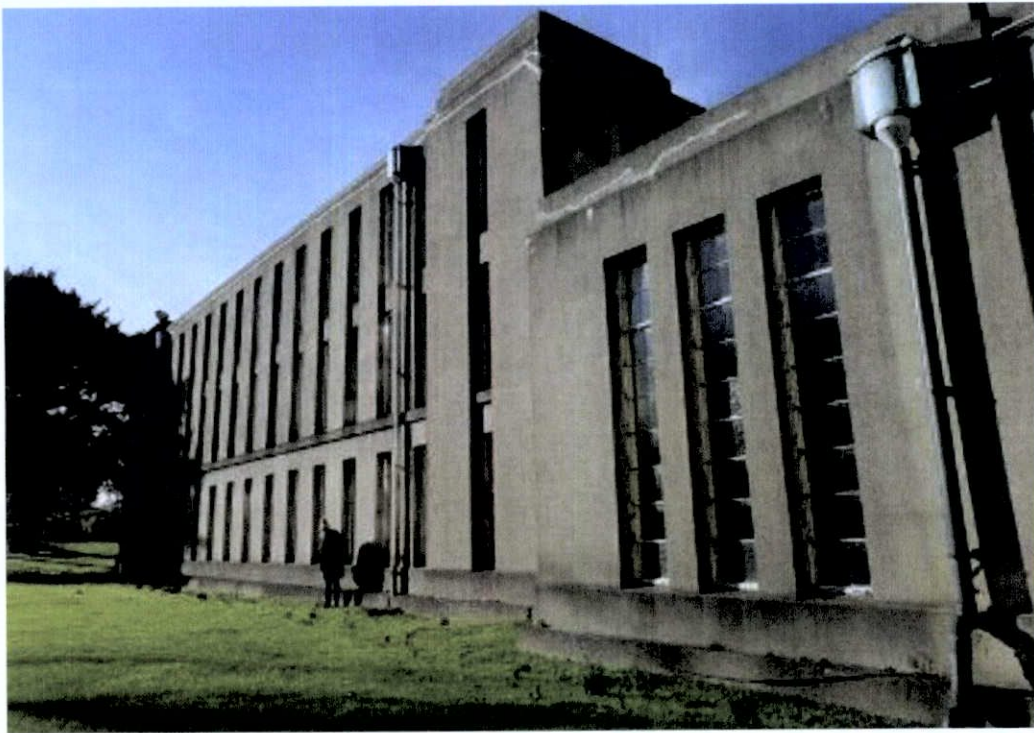
Plate 60: SE elevation of Archive wing. Original 1930's window frames. Copper hoppers to rainwater goods, Art deco detailing of parapet walls

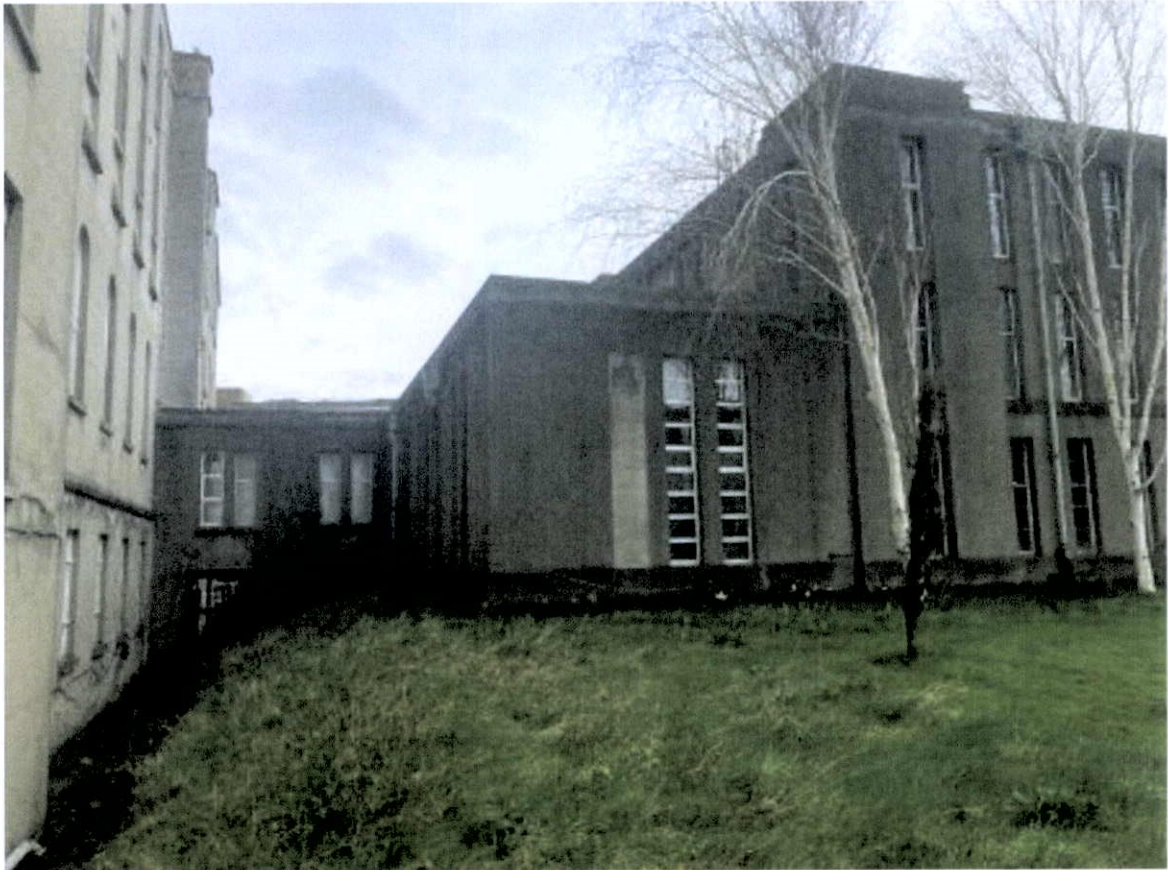
Plate 62: NW elevation of Archive wing where it joins the Rear Extension of Milltown Park House. This is the only point of entry which is internally via Milltown Park House and involves a series of level changes

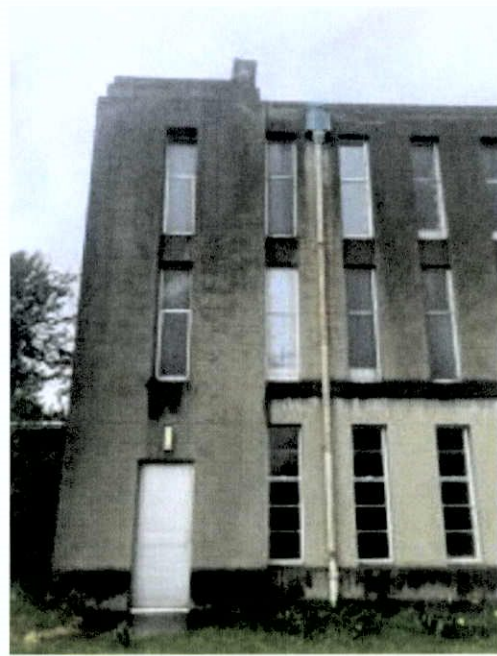
Plate 68: Art deco style parapet detail on end bay

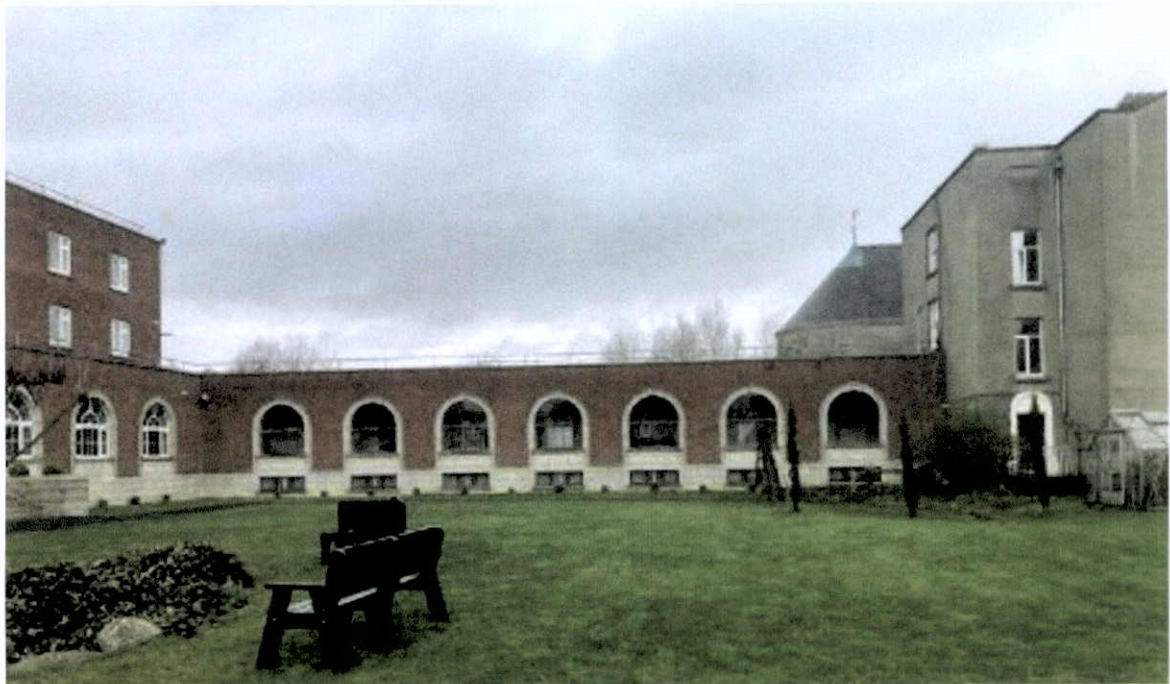
Plate 69: Building G, link, in context with the rear gable of Building B to the right of frame

Building G was constructed in the 1950s to connect the Community Building range with the subject institutional building range.

The exterior is simply composed with red brick facing having arched multi-paned windows on the south side, with rendered blockwork on the north side. The building has a flat roof with parapet upstands.

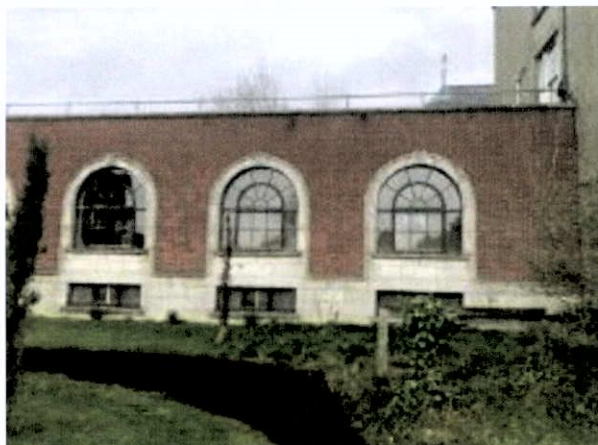
Plate 70: Arch headed windows with spoked fanlights on SW elevation.

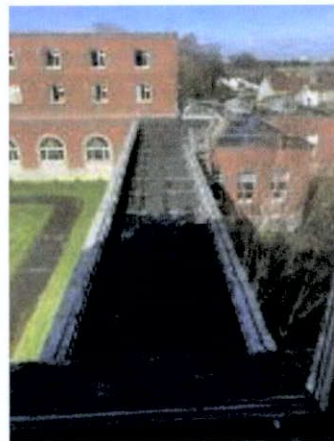
Plate 71: Roof of Building G, Link, as viewed from the rear extension of MPH

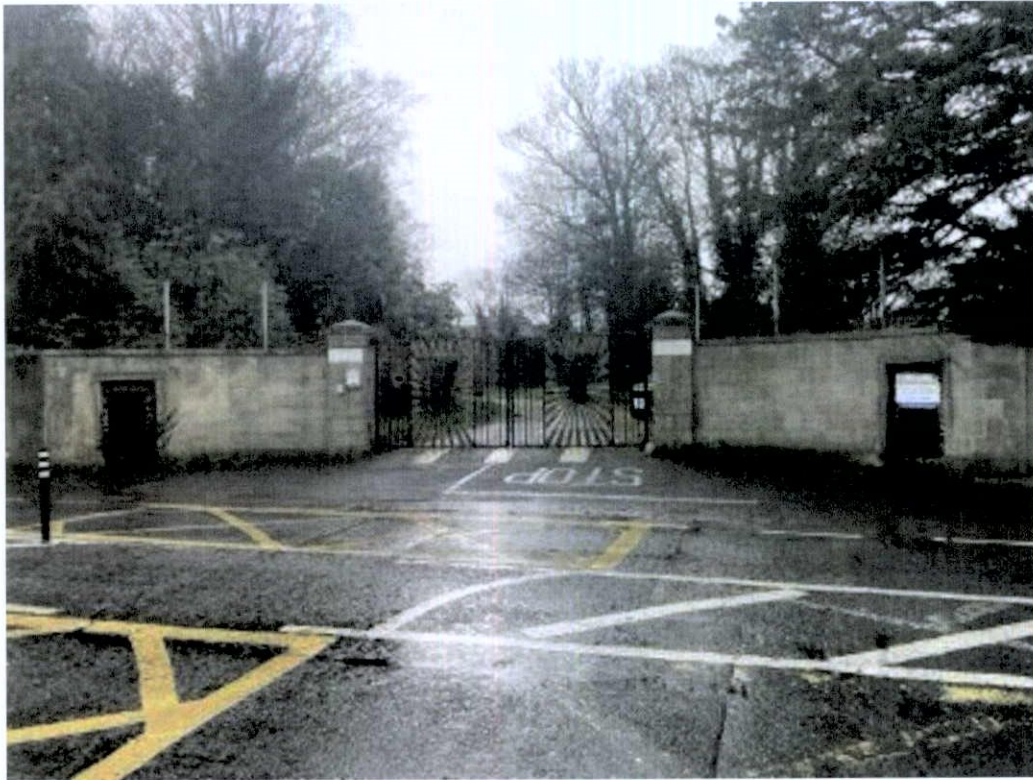
Plate 72: Vehicular entrance Milltown Park House and Jesuit Institute, with pedestrian gates in each of the flanking walls

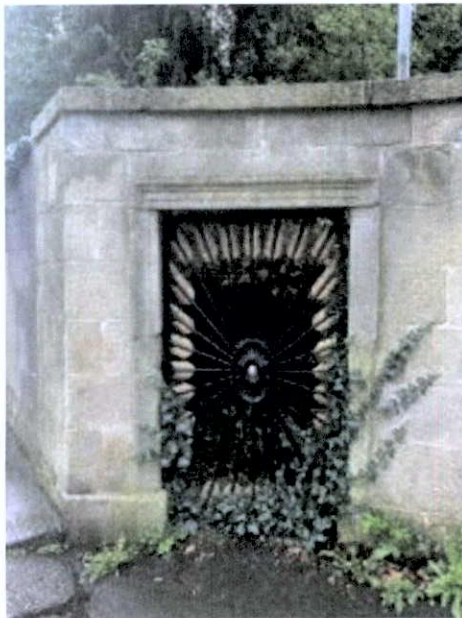
Plate 73: Detail of arrows to central bullseye on cast iron gate in flanking wall of front entrance, with carved granite architrave

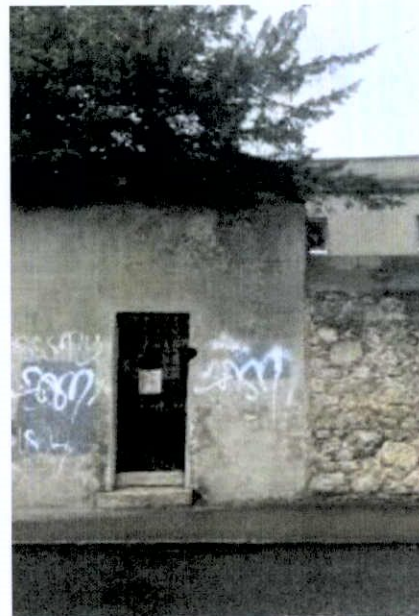
Plate 74: Side gate on Sandford Road, no longer in use, cut granite step and rendered walls

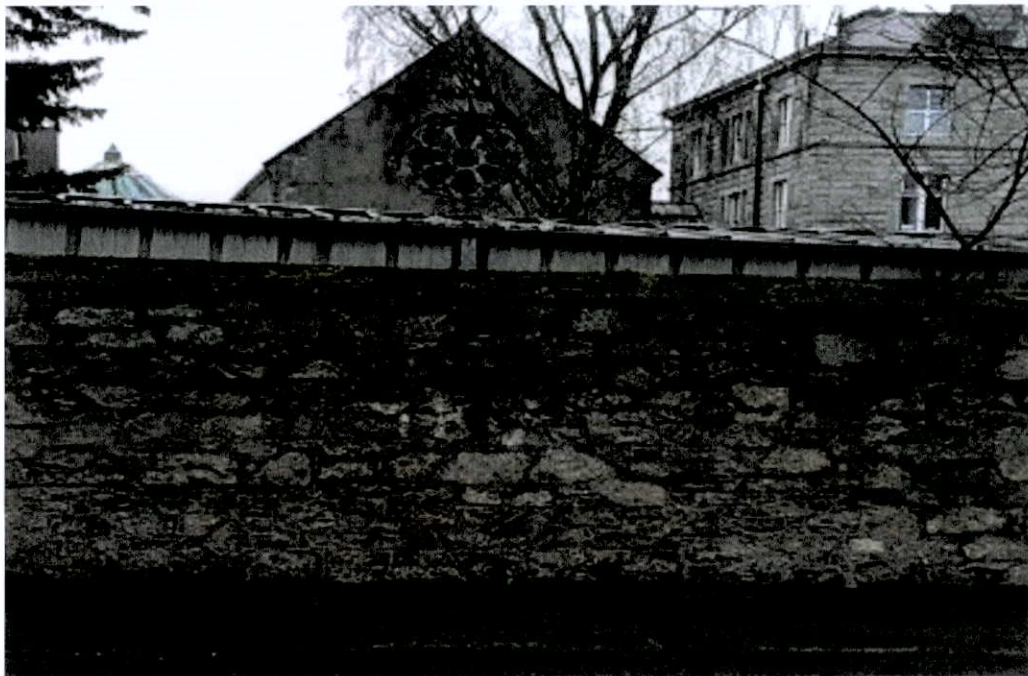
Plate 75: Perimeter rubble wall on Milltown Road with Chapel, stained glass window and Milltown Park House in background
