## Chapter 8:

## WATER

The development consists of a quarry located on a 3.45-hectare site in the rural townland of Drumbeagh. The site is located immediately north of the N56 between the villages of Mountcharles and Inver. The site is approximately 2.5 km west of Mountcharles, 3 km east of Inver and 1.7 km south of the villages of Frosses. The site is accessed off a local slip road immediately off the N56. The access road also serves the quarry owner and one other local resident. The site is surrounded by a mixture of poor-quality agricultural land, improved agricultural grassland and one-off rural houses and farmsteads. There are also peatlands and isolated forestry blocks in the surrounding area. The subject site location is outlined in Figure 8.1 below.

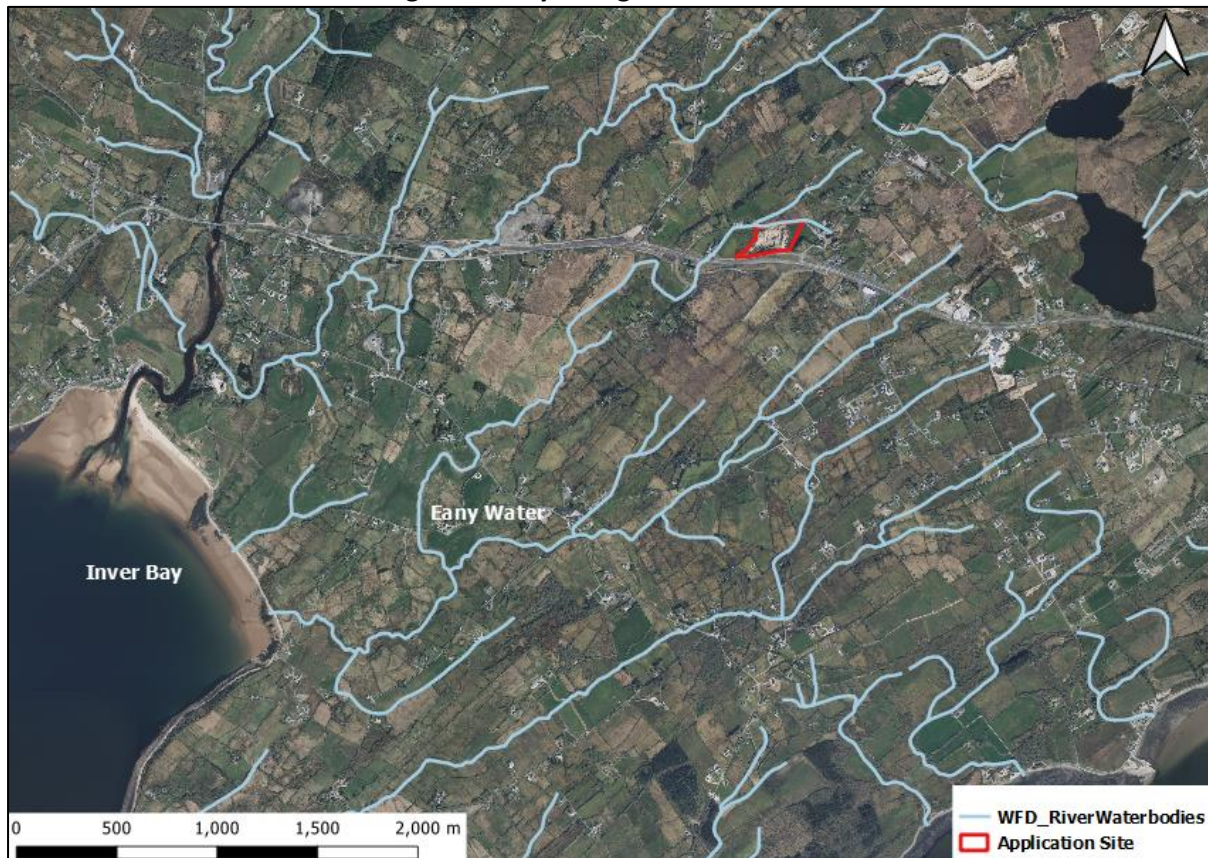
**Figure 8.4: Hydrological Connections**

The subject site is located within the Water Framework Directive (WFD) Catchment 37 Donegal Bay North (GBNIIENW) and the WFD sub catchment Eany (Water)\_SC\_010. A tributary of the Eany Water River flows (EPA code: IE\_NW\_37E030350) flows along the northern boundary of the site, and through the southern boundary of the site. The site is located in the Eany Water sub basin catchment. The Eany Water River flows into the sea at Inver Bay approximately 3 km southwest of the subject site. The hydrological distance from the site to Inver Bay is approximately 4.67 km. Hydrological connections are shown in Figure 8.4 below.

The subject site is located within the Water Framework Directive (WFD) Catchment 37 Donegal Bay North (GBNIIENW) and the WFD sub catchment Eany (Water)\_SC\_010. A tributary of the Eany Water River flows (EPA code: IE\_NW\_37E030350) flows along the northern boundary of the site and an un-named tributary of the Eany water flows through the southern edge of the site. The site is located in the Eany Water sub basin catchment. The Eany Water River flows into the sea at Inver Bay approximately 3 km southwest of the subject site. The hydrological distance from the site to Inver Bay is approximately 4.67 km. Hydrological connections are shown in Figure 8.4 . The

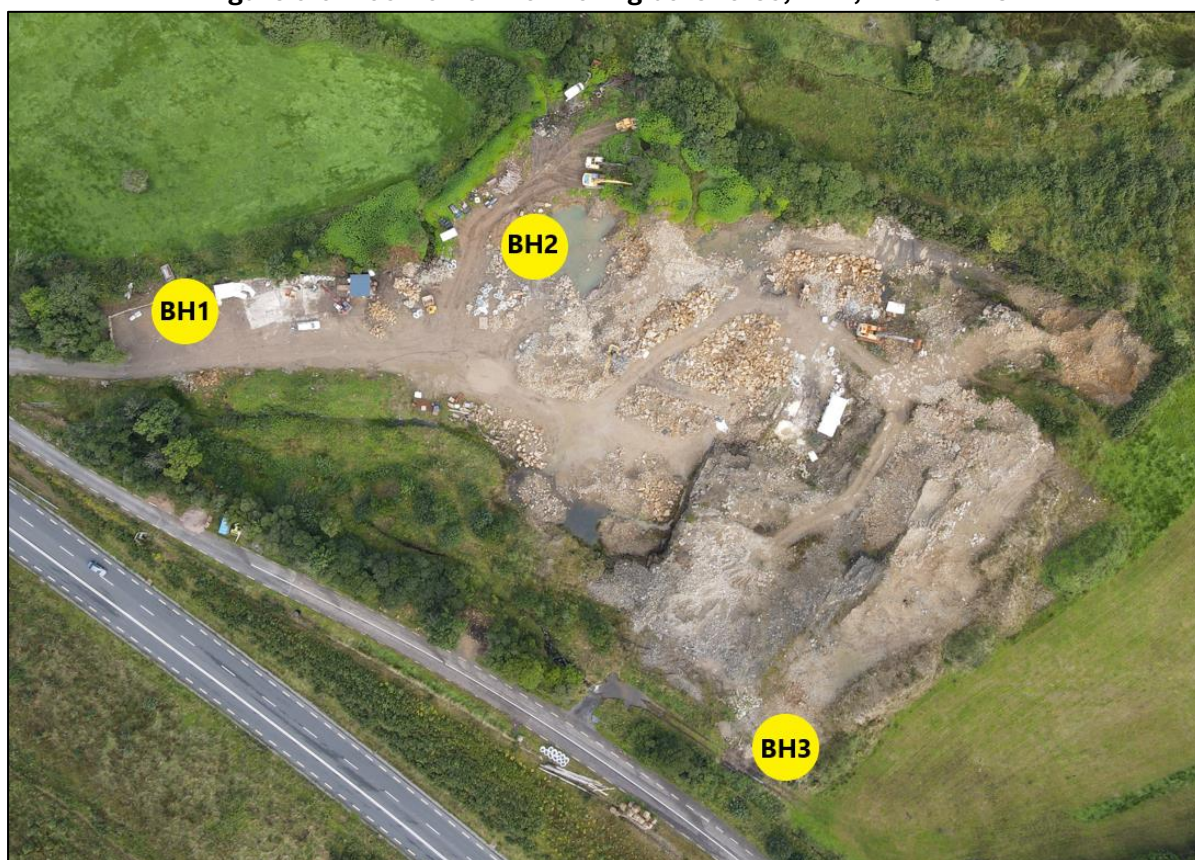
**Figure 8.6: Position of monitoring boreholes, BH1, BH2 & BH3**

To assess the current hydrogeological regime on site, three monitoring boreholes were drilled and installed in August 2023. The position of the three wells (BH1, BH2 & BH3) is shown in Figure 8.6 below.

These were drilled on 17<sup>th</sup> august 2023 and the borehole logs are presented in Appendix 8.2. The approximate position of the boreholes is shown in Figure 8.6 below. A brief water level monitoring program was commenced when the boreholes had been established to assess the water table levels and assess any likely impact. Two of the boreholes (BH1 & BH2) were located within the current extraction footprint and the third borehole (BH3) was located outside the quarry void. BH1 and BH2 were drilled to 13m and 12m depth respectively and BH3 was drilled to 31m depth.

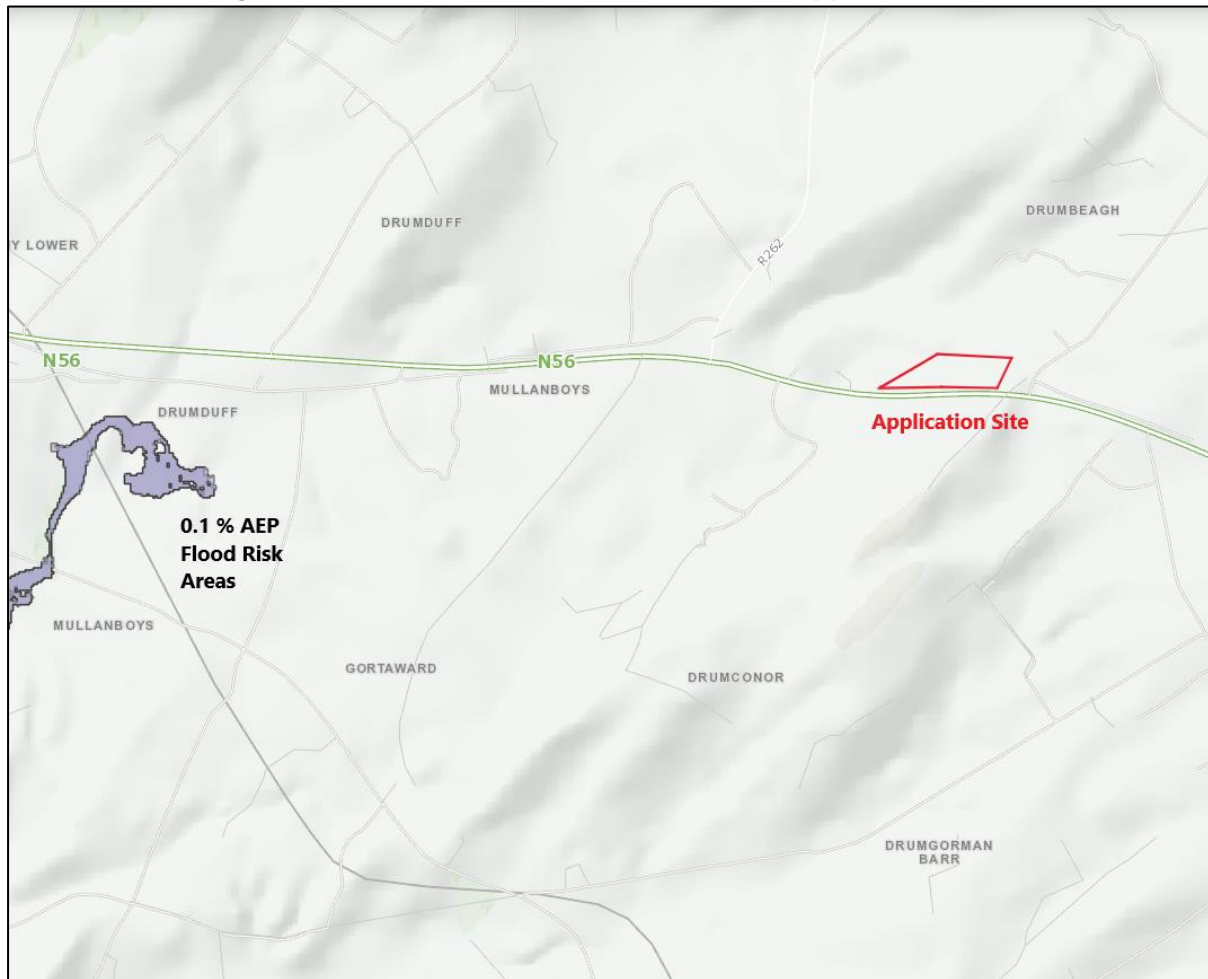
**Figure 8.8: Flood Risk in the area around the application site**

An appraisal of the available flood maps was made to determine if there was any flood risk at the site or if any of the extraction and processing activities had been likely to increase the risk of flooding either at the site or elsewhere. An examination of the flood maps (floodinfo.ie) for the area show the application site and surrounding area to be at low risk of river flooding events. The flood risk map in relation to the application site is shown below in Figure 8.8. The layers active are the low probability of flooding, 0.1% AEP (1 in a 1000 chance of occurring) and the high-end future scenario is also modelled. This takes in the potential effects of climate change modelling an increase in rainfall of 30% and sea level rise of 1,000mm.

There is only one recorded flood events within 2.5 km of the application site. The closest recorded flood event is a recurring flood event in the village of Frosses approximately 2 km to the northwest of the site. There are no details to the source of the flooding. There is no hydrological connection between this flood event and the application site.
