APPENDIX 6-4

***BIODIVERSITY
MANAGEMENT AND
ENHANCEMENT PLAN***

This Biodiversity Management and Enhancement Plan (BMEP) has been prepared in support of the Environmental Impact Assessment Report (EIAR) produced for the proposed Borrisbeg Renewable Energy Development.

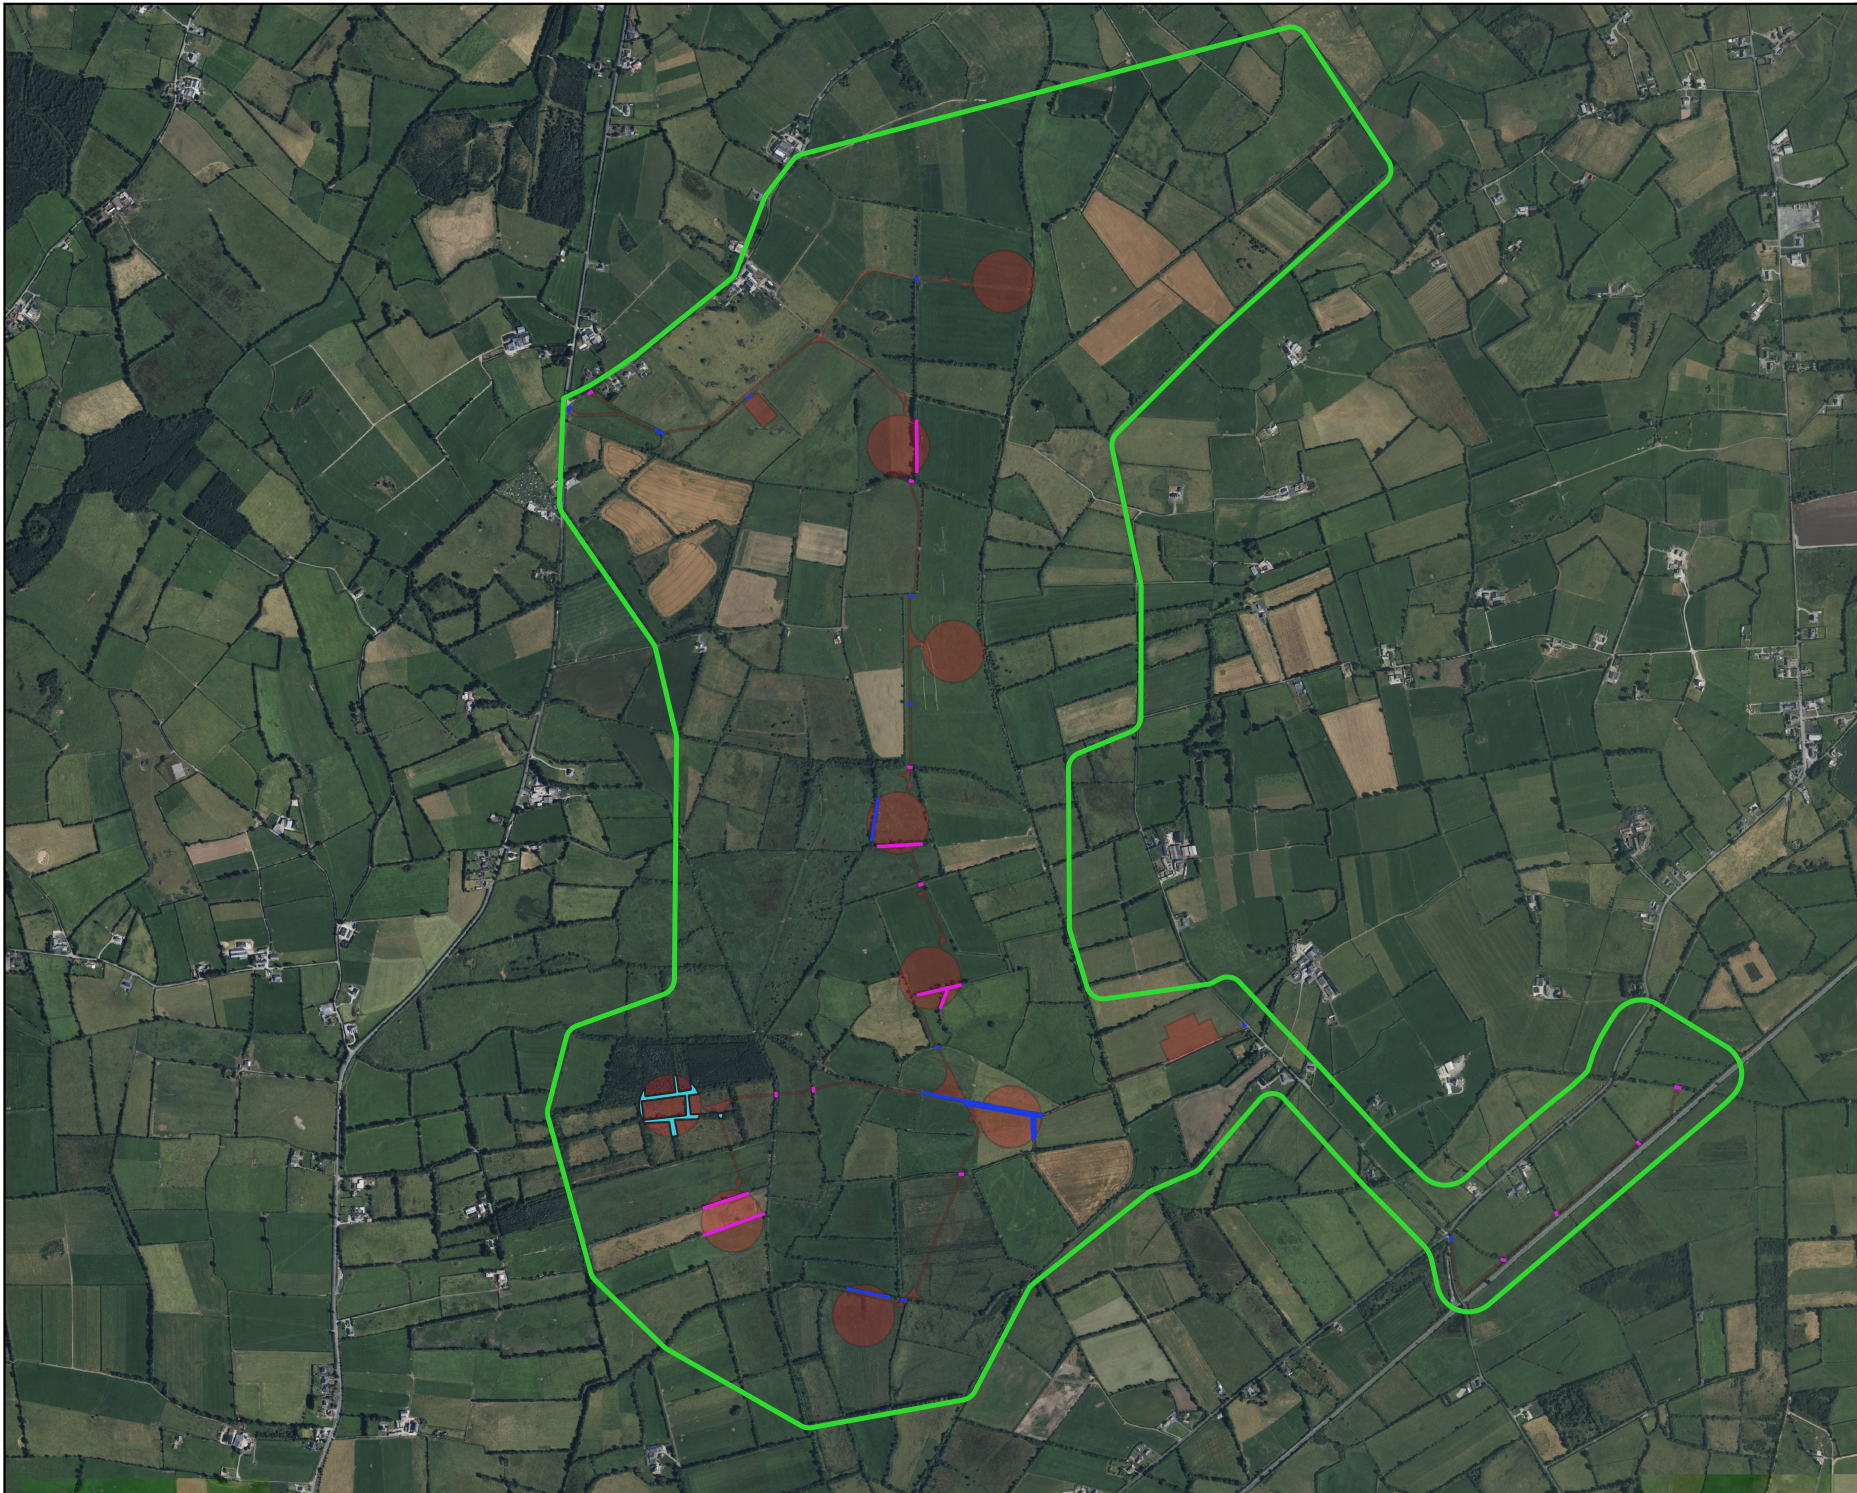
- Eiar Study Boundary
- Infrastructure Footprint and Bat Felling Buffers
- Hedgerow (WL1) to be Felled
- Treeline (WL2) to be Felled
- (Mixed) Broadleaved Woodland (WD1) to be Felled

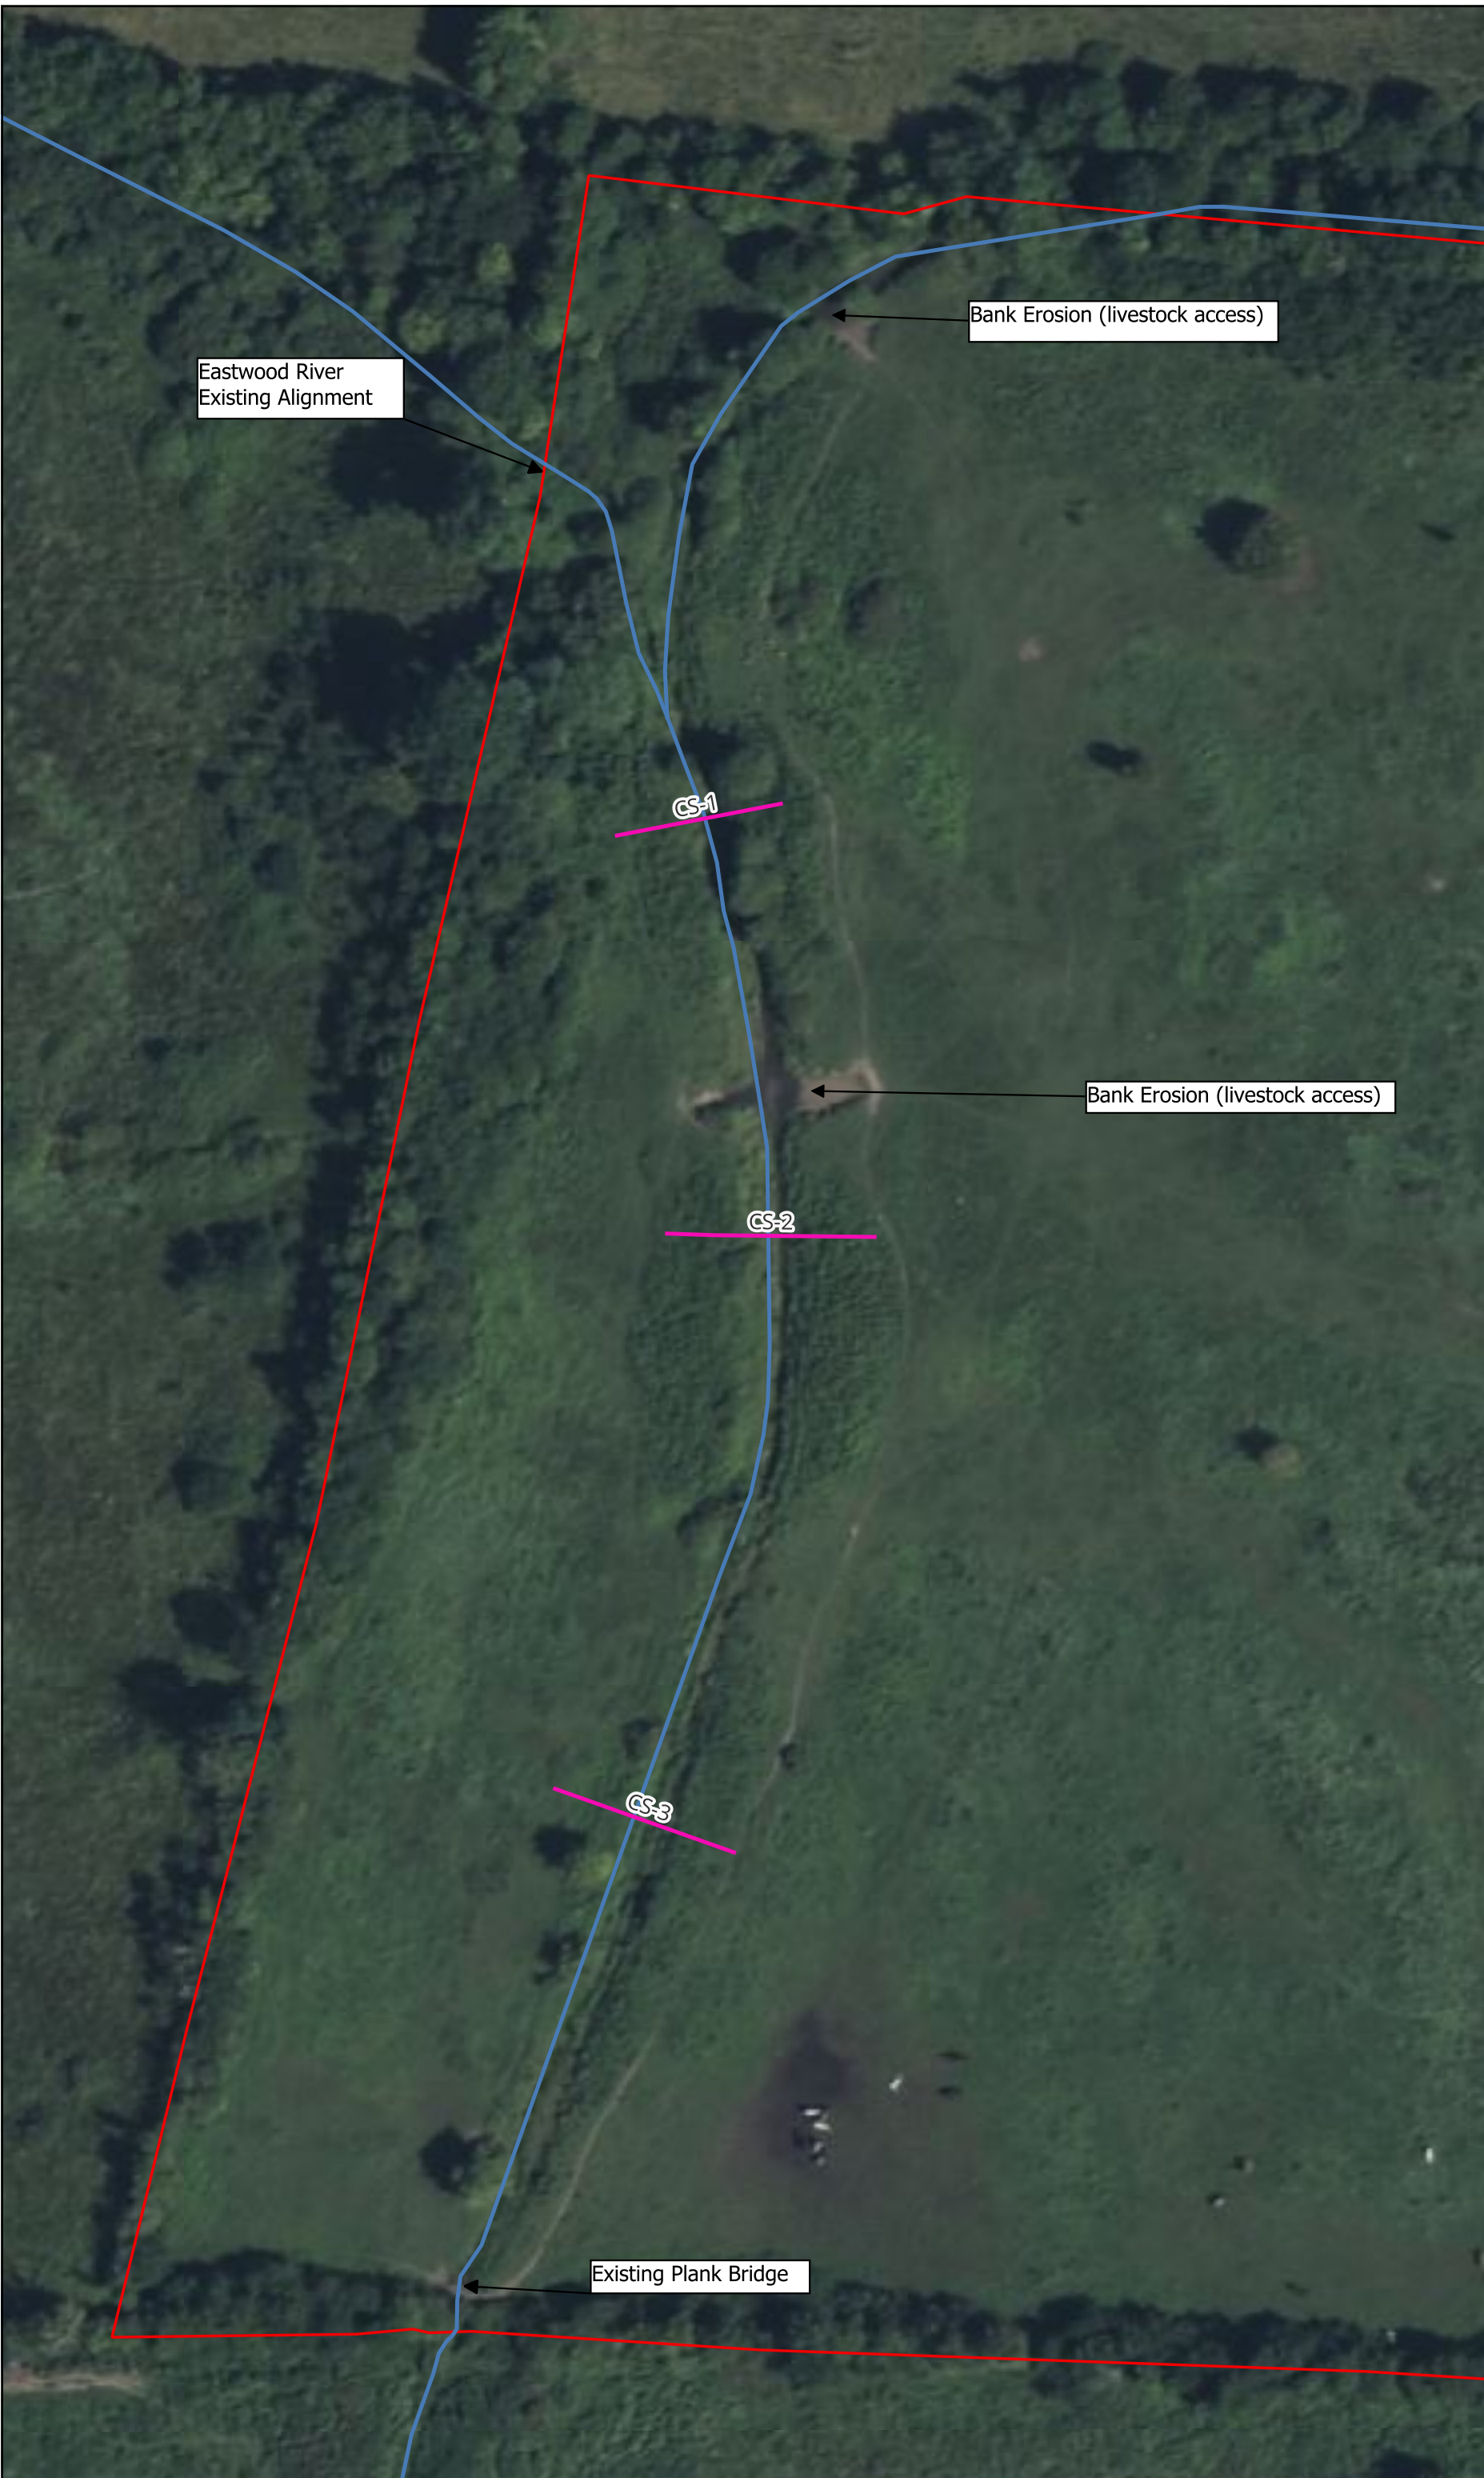
- EIA Study Area
- Cross section Location
- Existing Rivers

The riparian area is dominated by wet grassland with small areas of scrub. In general, there are few woody plants within the riparian zone and little channel shading. Photographs of the proposed restoration reach are included in Appendix 1: Plates 1 to 6. Cross-section and pebble count data are included in Appendix 2.

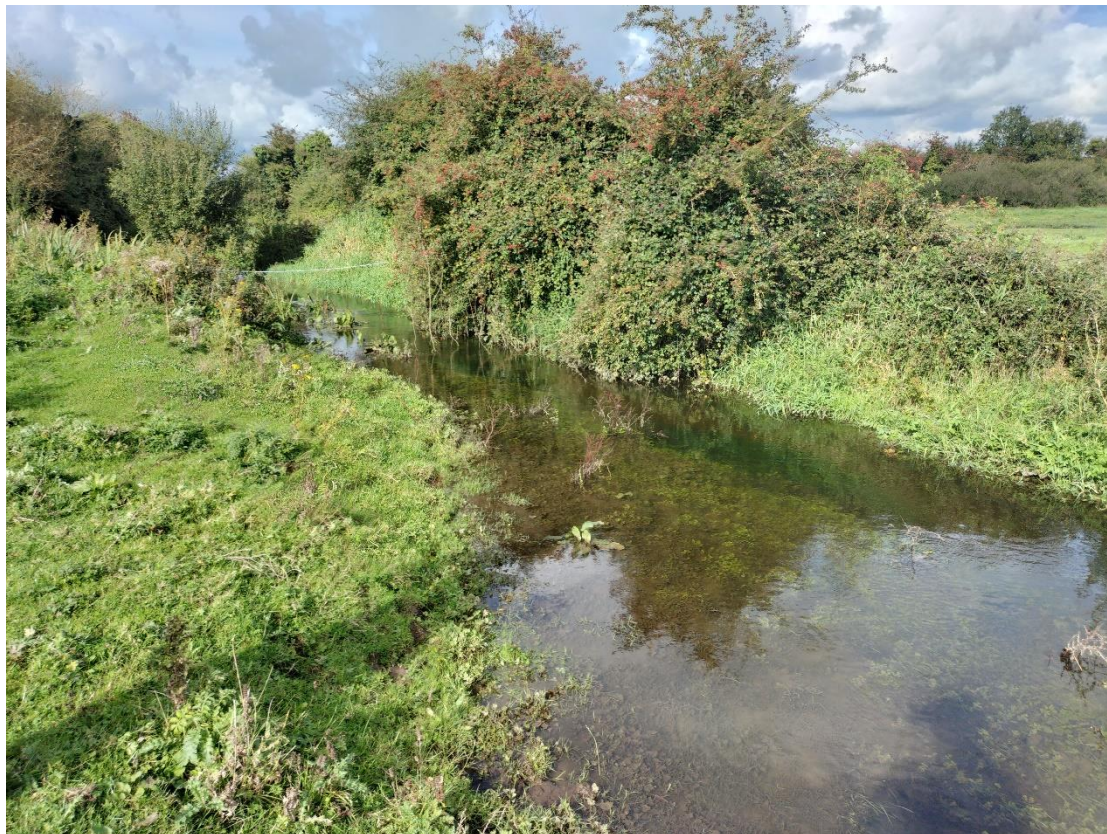
Plate 1. View of Eastwood River, facing upstream towards CS-1

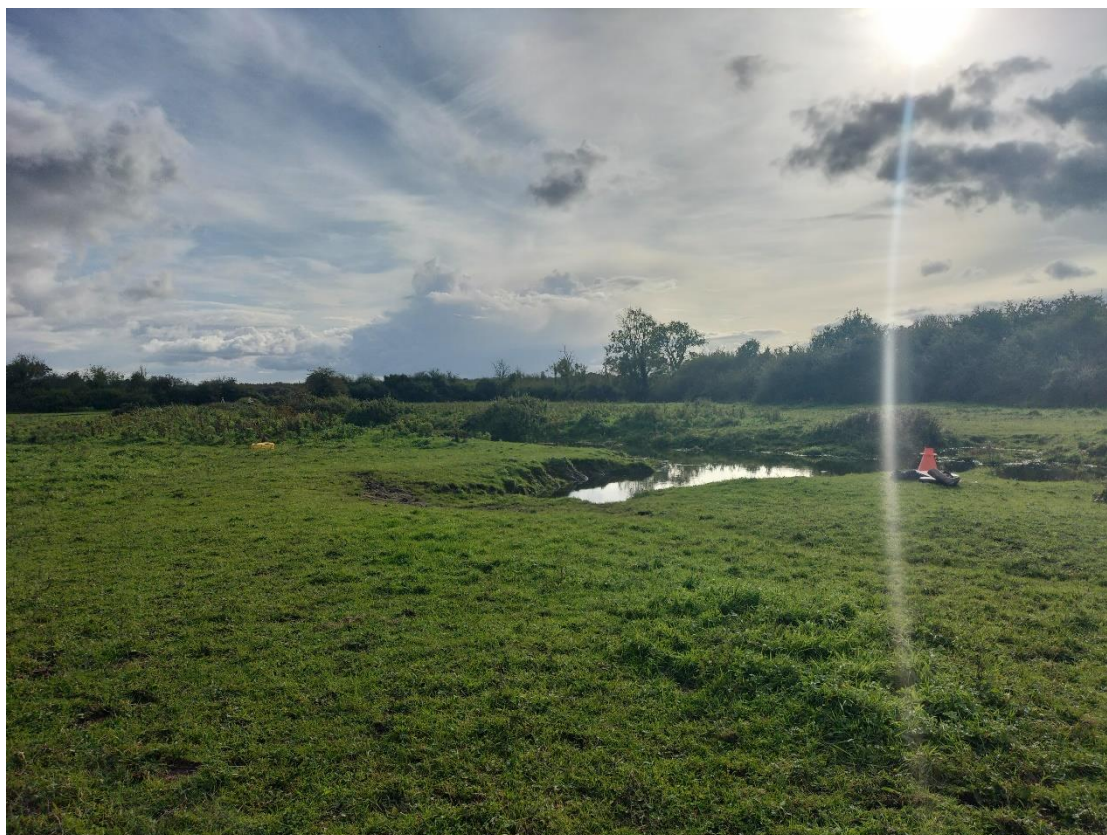
Plate 2. View of livestock access on Eastwood River, facing downstream.

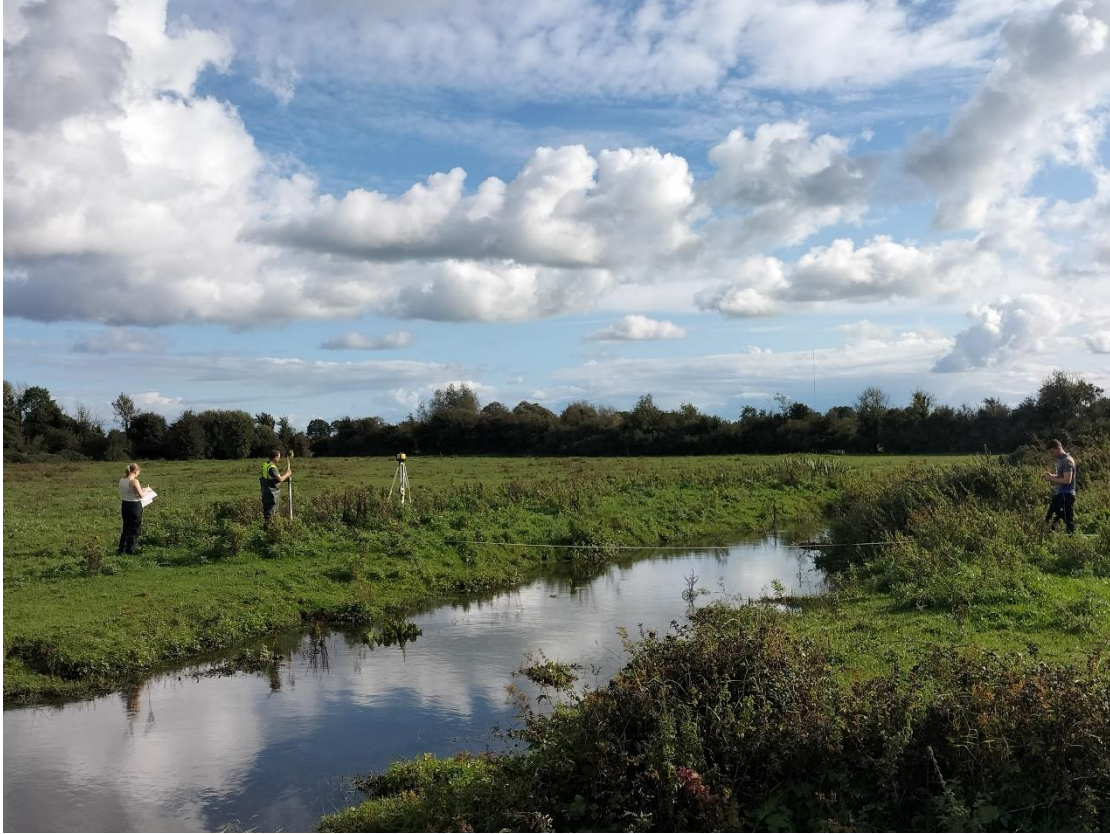
Plate 3. View of Eastwood River, facing downstream towards CS-2

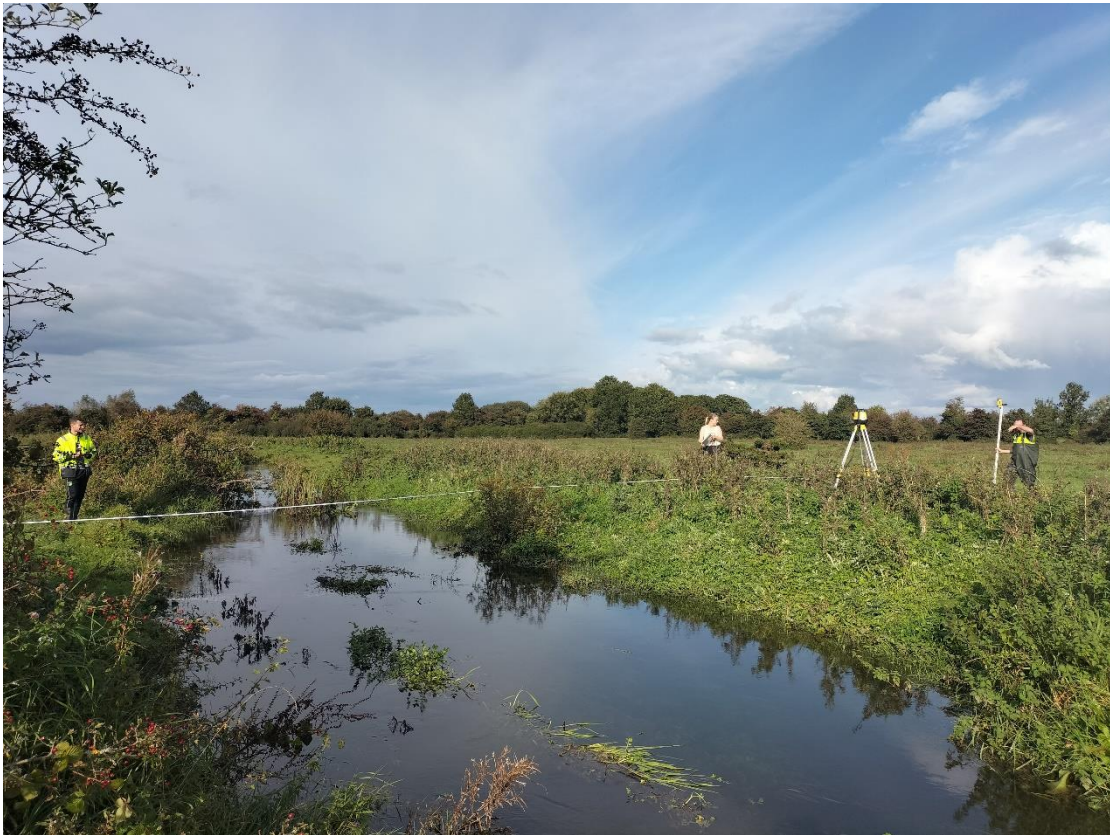
Plate 4. View of Eastwood River, facing upstream towards CS-3

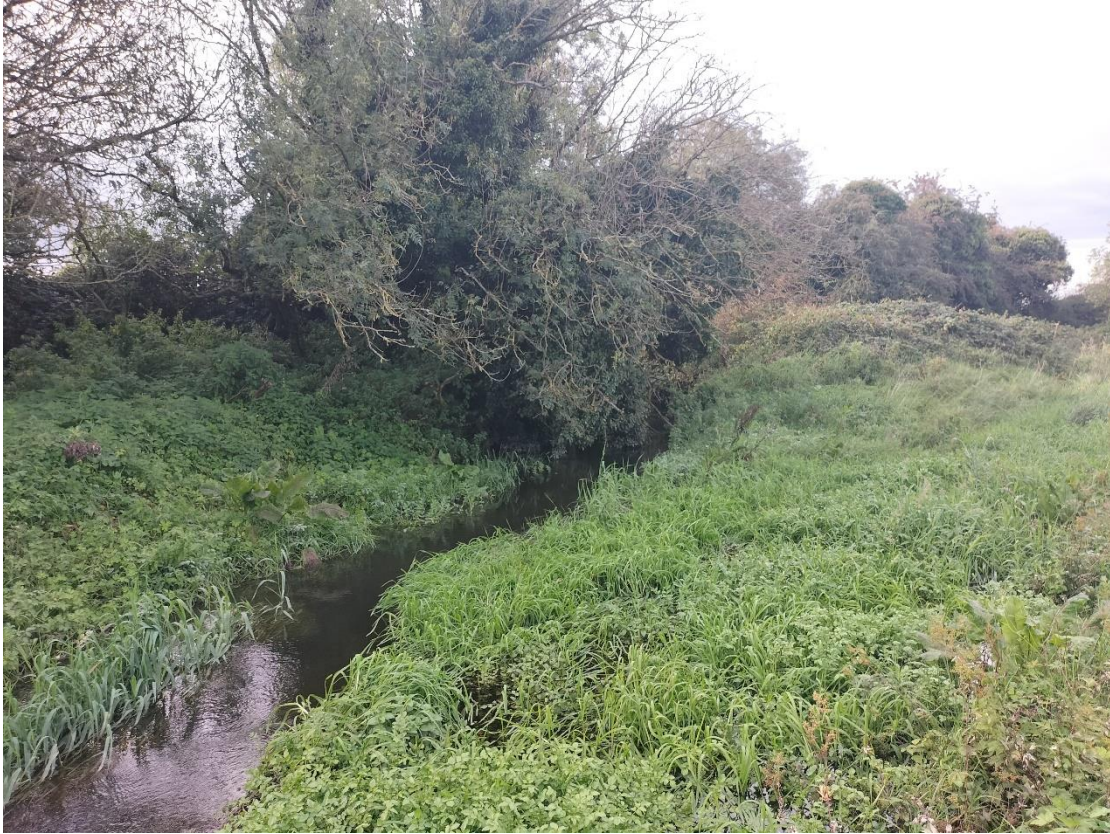
Plate 5. View of Eastwood River, facing upstream at upstream end of proposed restoration reach

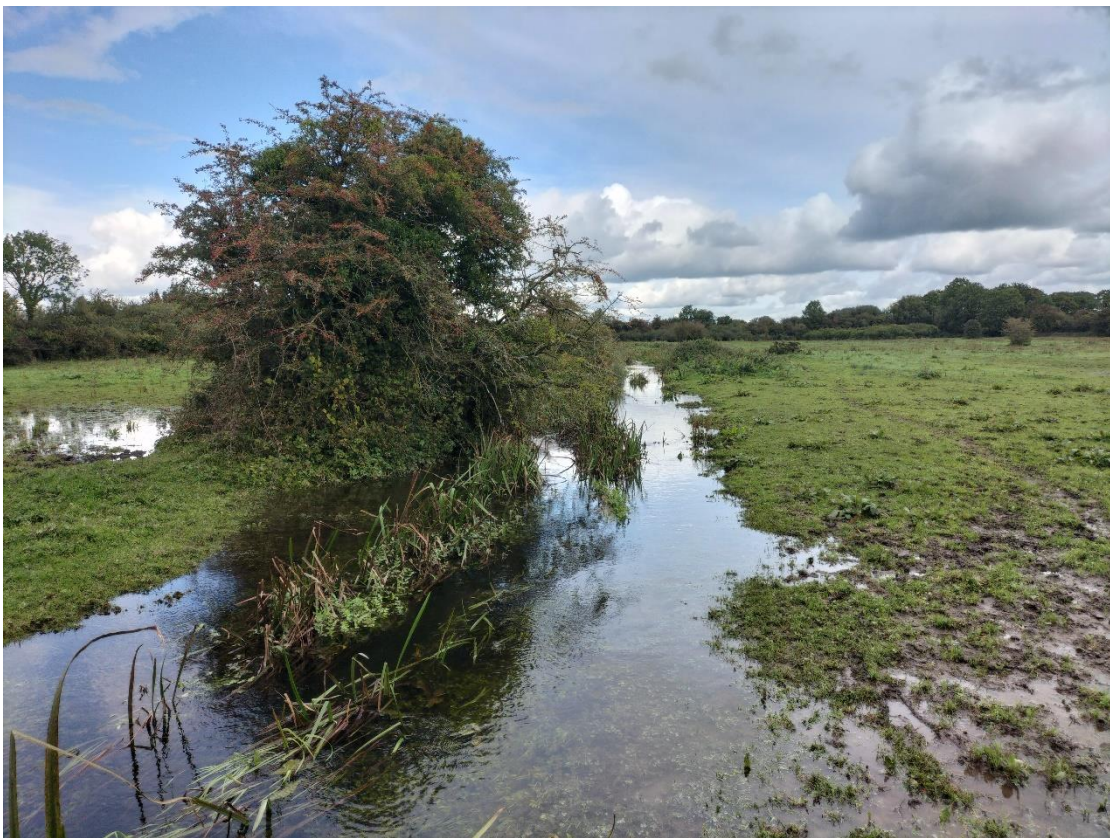
Plate 6. View of Eastwood River, facing upstream from downstream end of proposed restoration reach

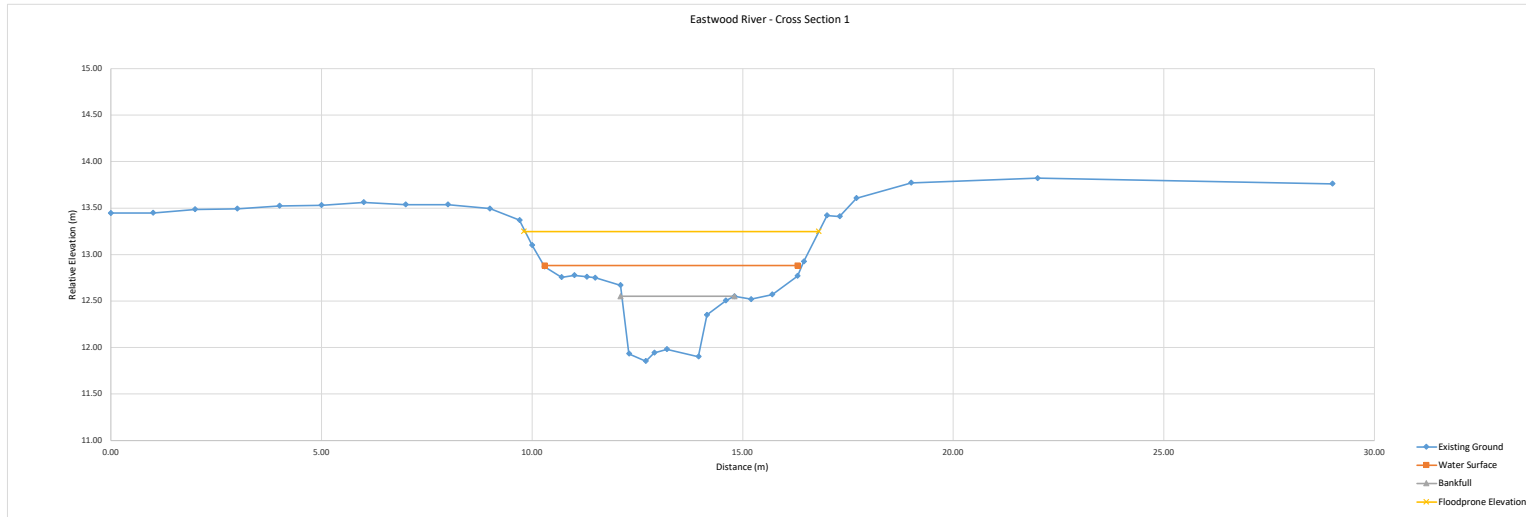
CROSS-SECTION: CS1
Project Name: Borrisbeg
Project Location: Templemore, Tipperary
Date: 21.09.23

low bank height	1.64	m.
Sinuosity	1.06	m.
LBFK	12.10	m.
RBKF	14.80	m.
Bankfull WIDTH (Wbkf)	2.70	m.
Mean DEPTH (dbkf)	0.46	m.
Bnkfl. X-Section AREA (Abkf)	1.23	Sq. Ft.
W/D RATIO (Wbkf/dbkf)	5.91	m/m
Max DEPTH (dmbkf)	0.70	m.
WIDTH of Flood Prone Area (7.00	m.
Entrenchment Ratio (ER)	2.59	m/m
Slope	0.0052	m/m
Channel Substrate	1.00	(D50)
Rosgen Classification	G/B	
Bank Height Ratio	2.34

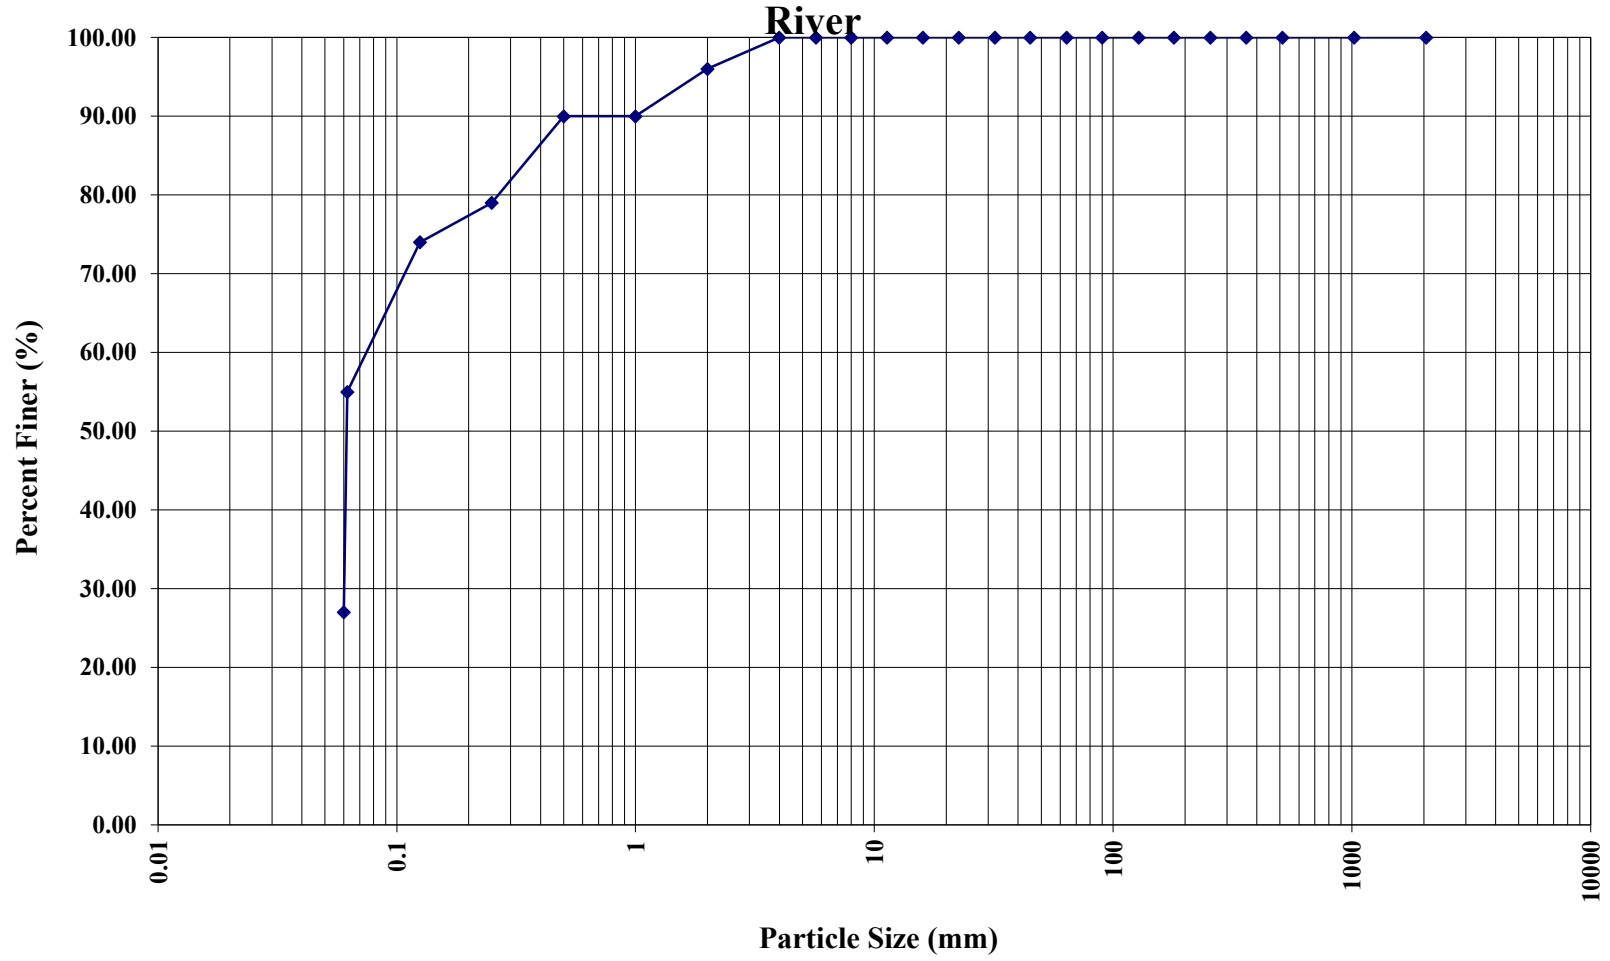
Wolman Reachwide Pebble Count Particle Size Distributions - Eastwood

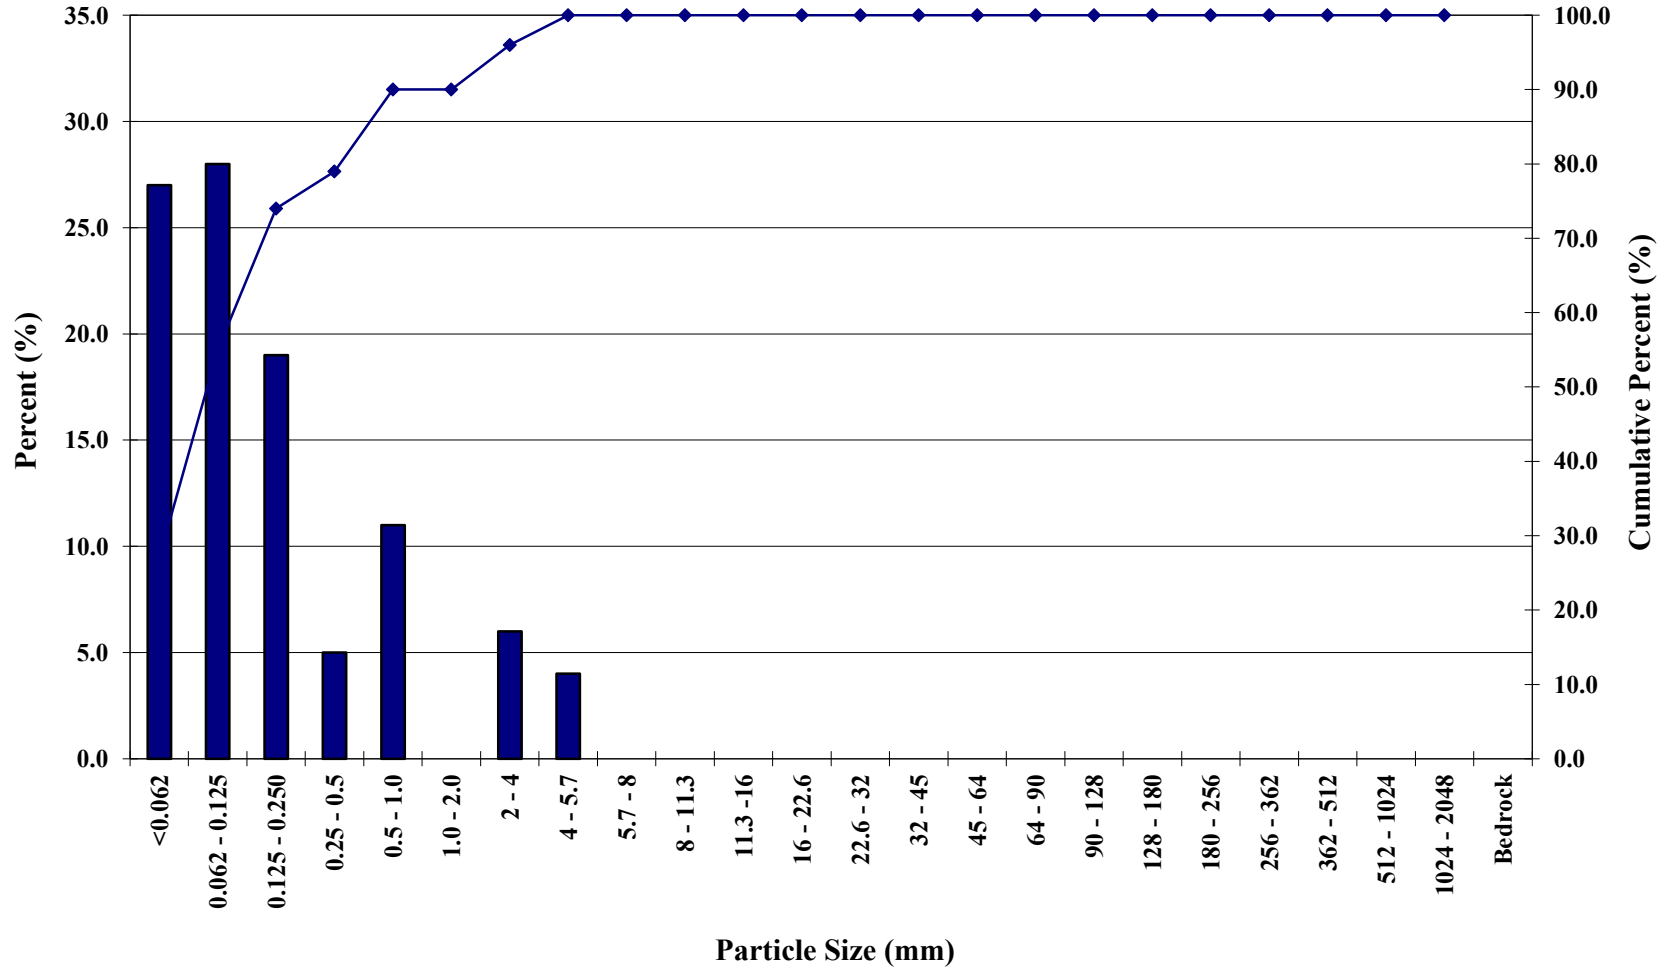
Wolman Reachwide Pebble Count Analysis - Eastwood River
