**SITE SPECIFIC FLOOD RISK ASSESSMENT
REPORT FOR PLANNING**

**STRATEGIC HOUSING DEVELOPMENT AT
ST. JOSEPH'S HOUSE AND ADJOINING PROPERTIES,
LEOPARDSTOWN**

19.236-FR-01

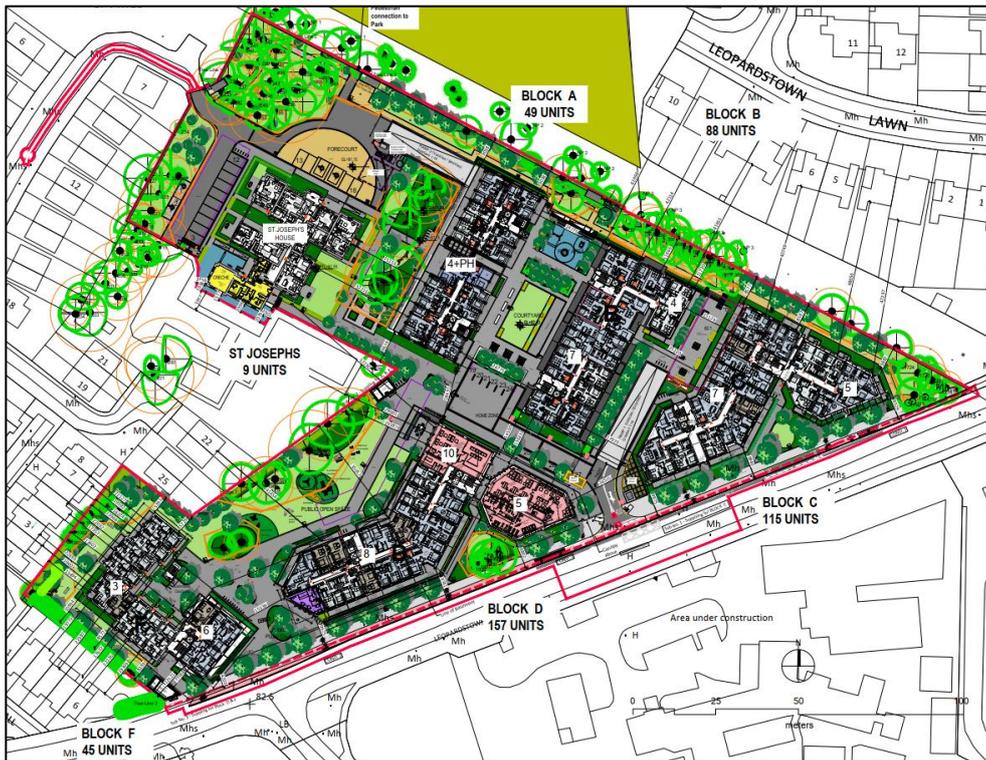
Figure 1.3 – Proposed Development

The development will consist of a new residential and mixed use scheme to include apartments, residential amenity space, a café and a childcare facility as follows:

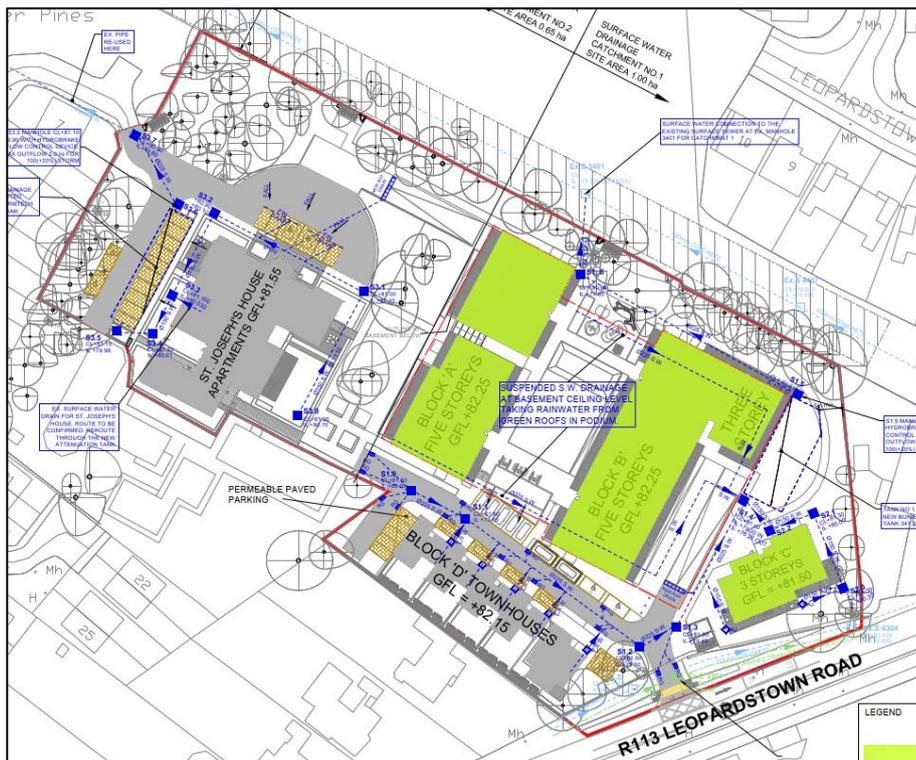
Figure 1.4 – Phase 1 (permitted scheme) drainage layout Scope of this Report

Planning permission was granted for a residential development consisting of 122 no. units by An Bord Pleanála on 28th August 2017 (Ref: PL 06D.249248) on part of the planning application site, refer to figure 1.4.

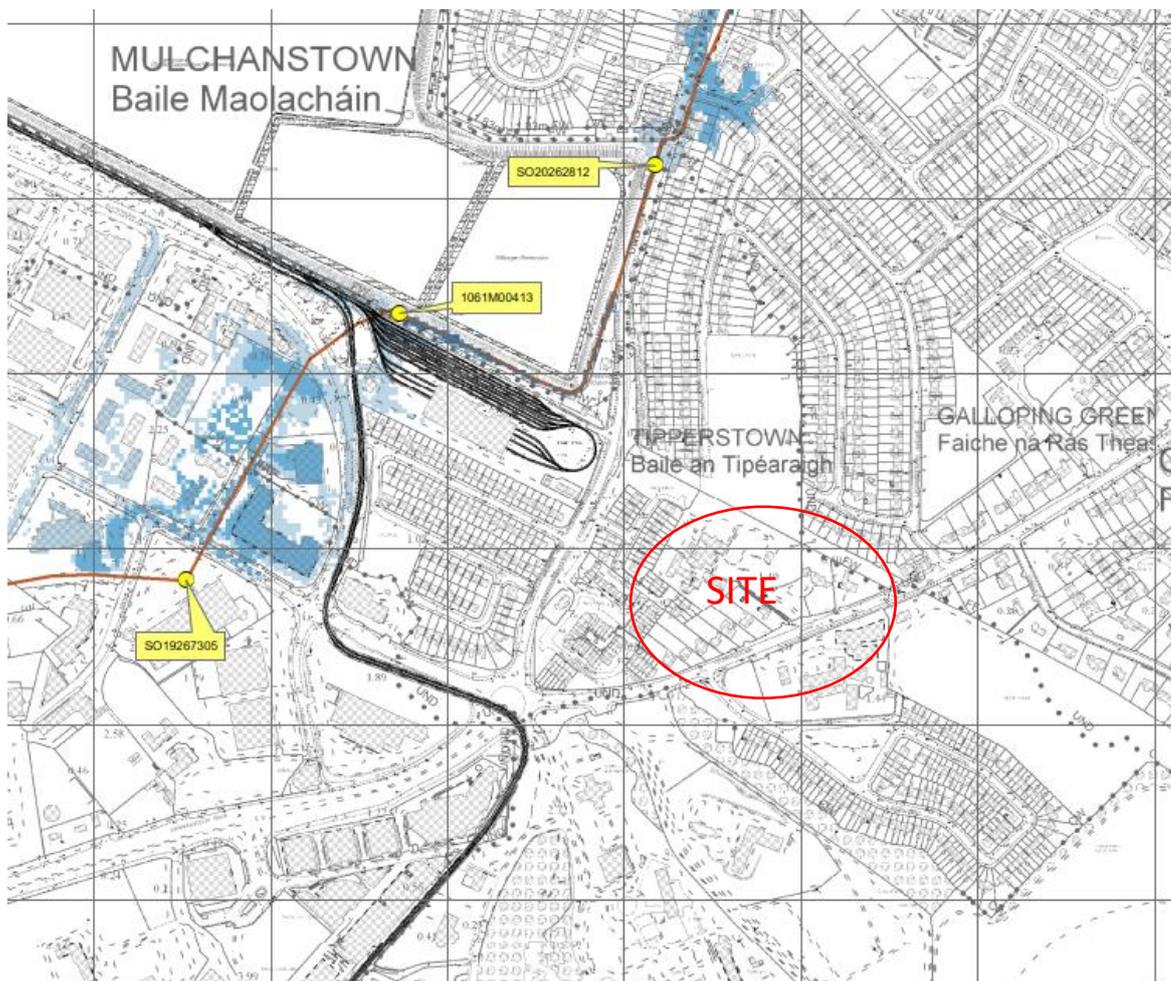
Figure 2.1 – Extent Fluvial Map

Information is available on possible flooding of the area surrounding the site in the Eastern CFRAM Study by the OPW. The study is a requirement of the EU 'Floods' Directive (2007/60/EC). The PFRA (Preliminary Flood Risk Assessment) map is also available and considers flood risk arising from any major source of flooding, including natural sources such as river, sea, groundwater and rainfall as well as infrastructural sources such as urban drainage systems, reservoirs, water supply systems ESB and Waterways Ireland Infrastructure. The tidal flood risk is not assessed in this study, as the nearest seashore coastline is 3.3km away from the site.

The relevant maps are contained in Appendix III and show that the site is located outside of the Flood Risk Areas.

The fluvial flooding maps do not show any flood risk in the vicinity of the site due to river or sea flooding. i.e. the site is in Flood Zone C. Further information can be found in Appendix III.

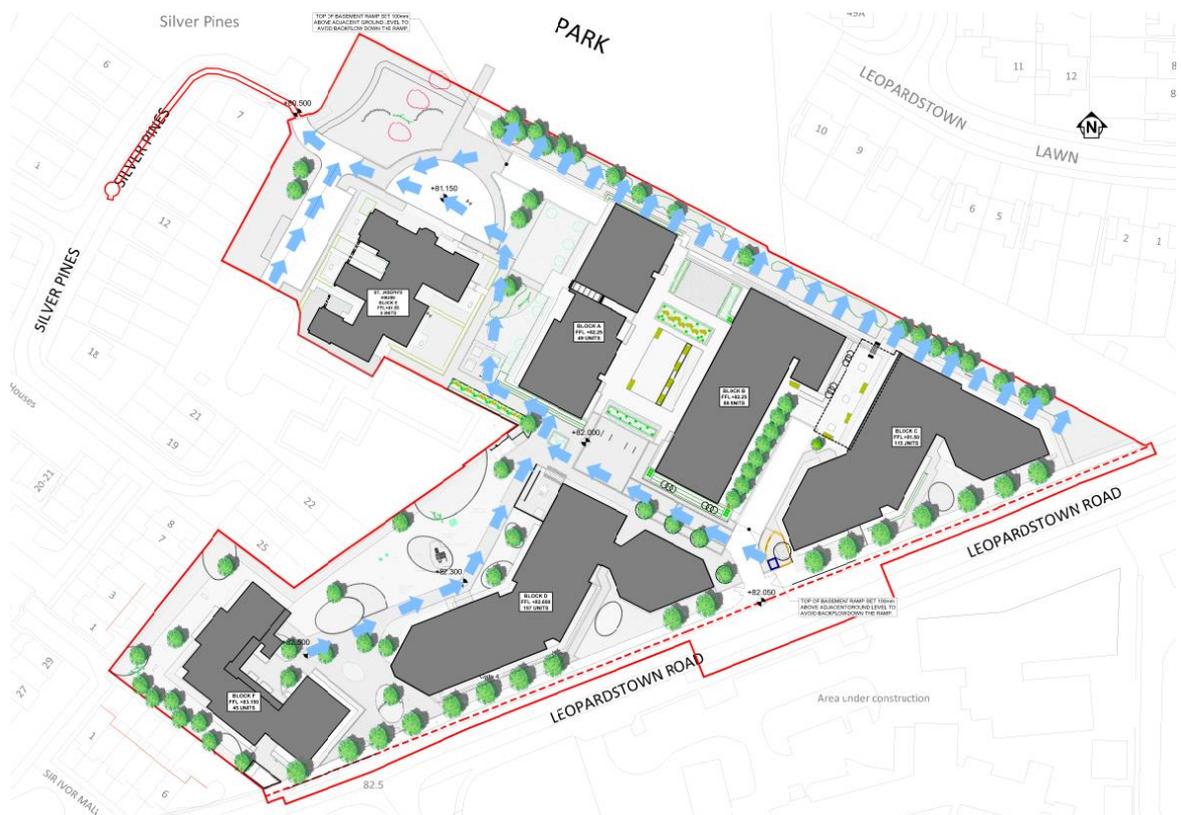
Figure 2.2 – Overland Flow Routes

The unlikely event of a complete blockage of the surface water drainage system on site will lead to overland flow in the site from the point of blockage. Figure 1.2 below shows the flow routes.

These routes are onto the surrounding public roads and not into third party lands, refer to Appendix IV. Extract below.

In the unlikely event of a full blockage of the surface water system before or during a storm event then water will build up in the pipe system and discharge back into the ground level SuDS devices – permeable paved & porous surfaced areas & soft landscaping. Given the building levels & ground levels on site, any residential overland flow will occur in the site towards Silverpines as shown in the Figure 2.2 above (Appendix IV).

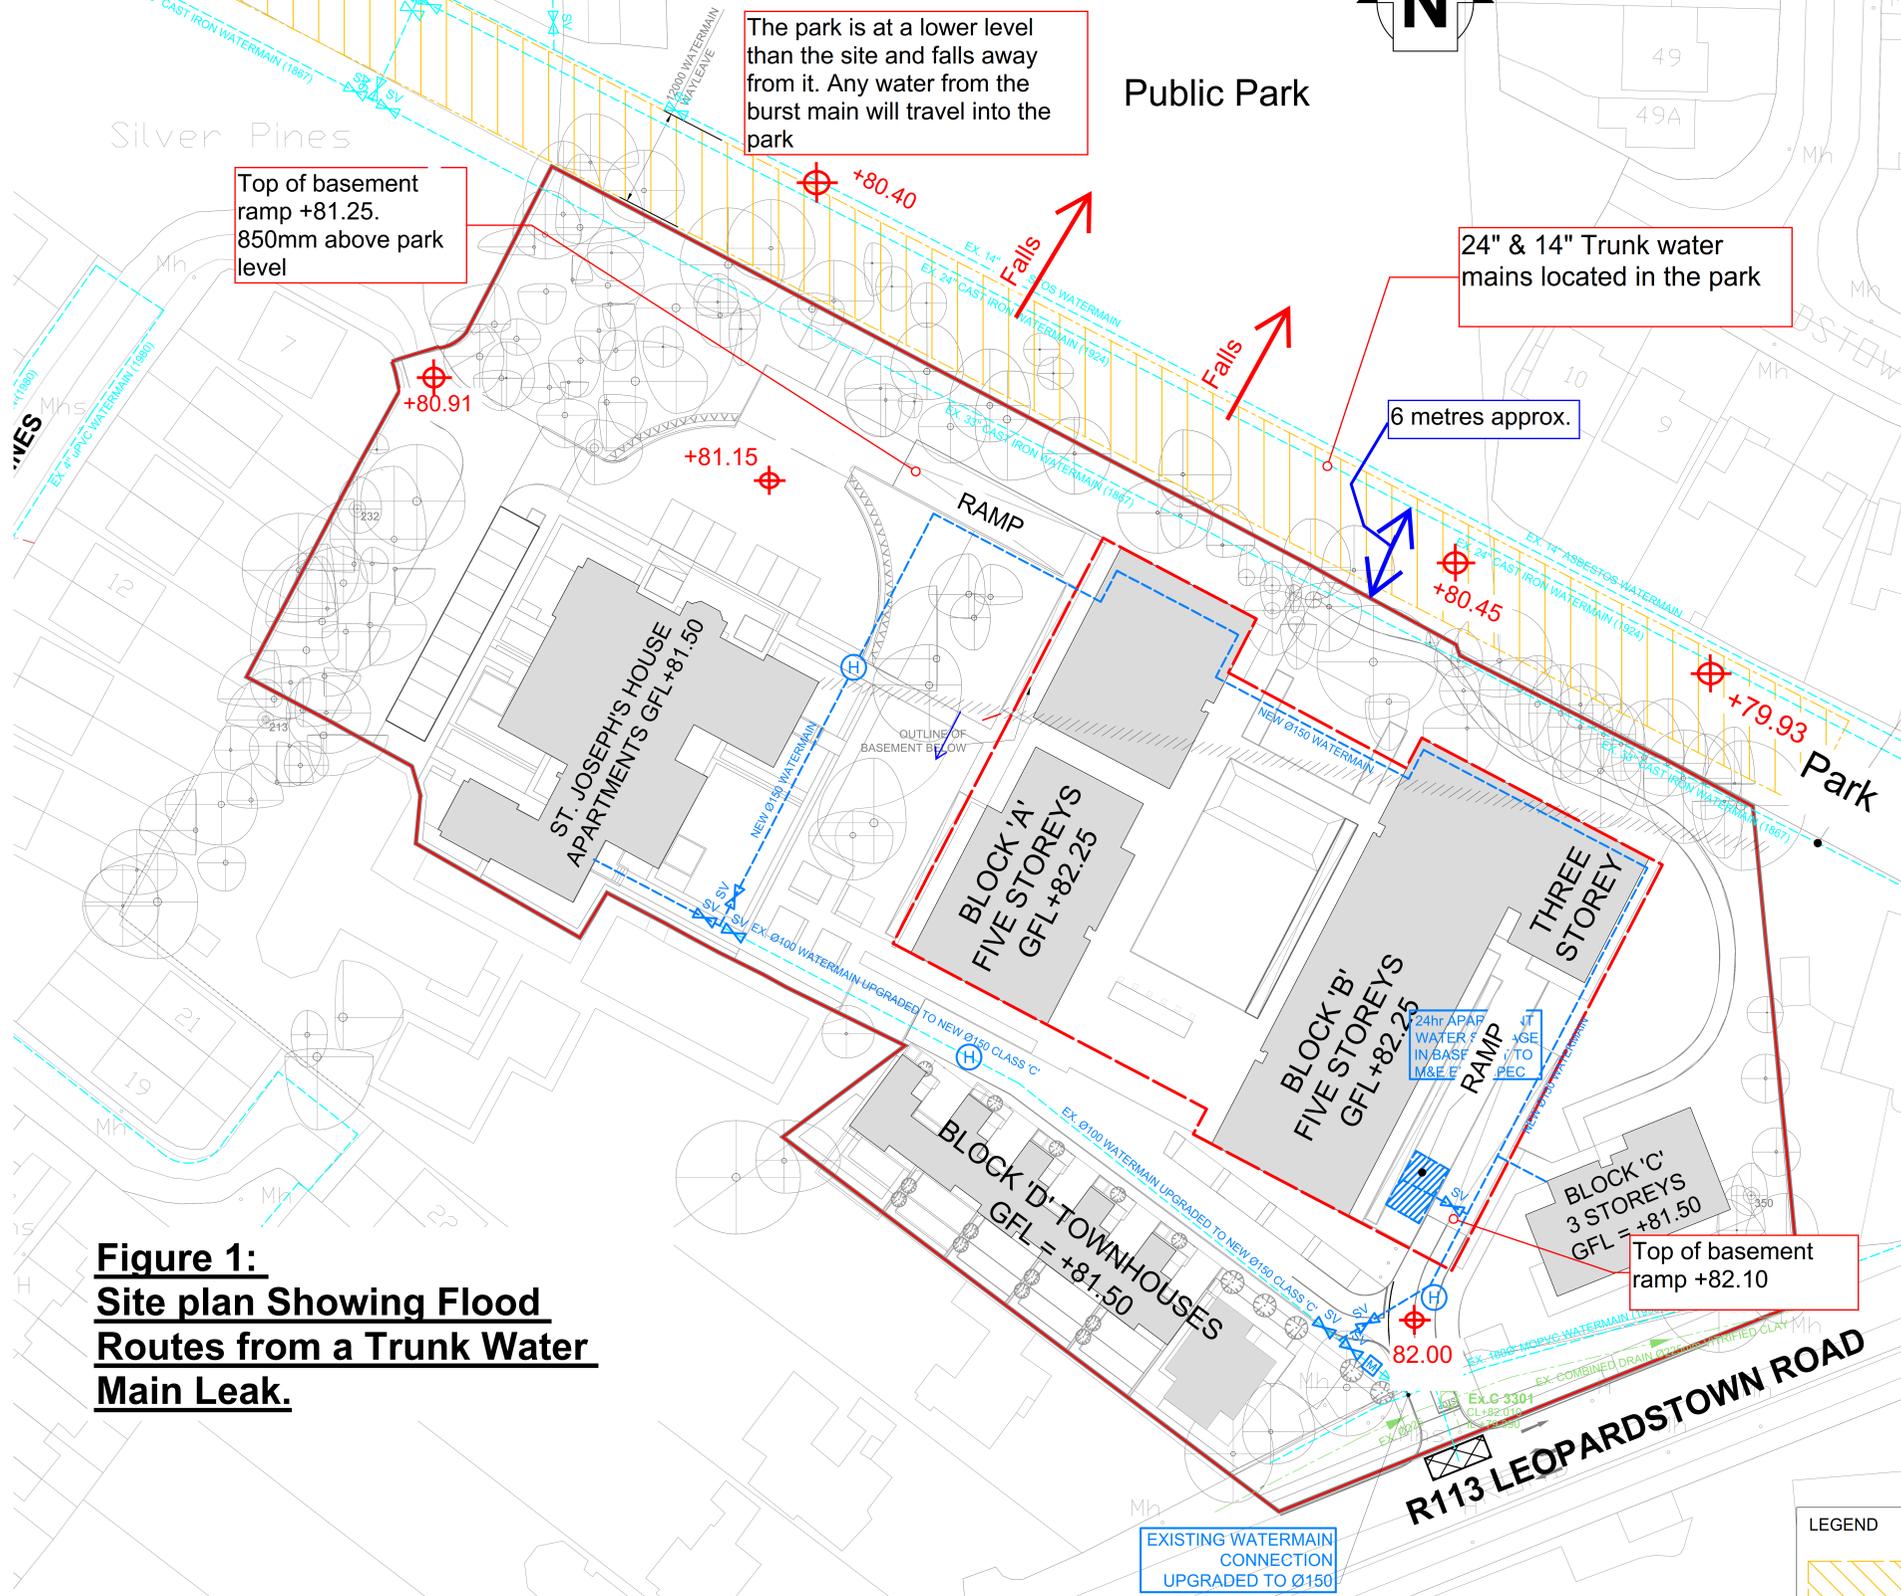
Figure 1:
Site plan Showing Flood
Routes from a Trunk Water
Main Leak.

The park is at a lower level than the site and falls away from it. Any water from the burst main will travel into the park

1. The ground level in the public park, along the watermain route, is 500 to 900mm below the general level of the subject site & between 900 & 2300mm below the proposed floor levels in the development. The park falls away from the site towards the northeast (towards the sea). Escaping water will travel northwards. Any leaking water is therefore very unlikely to enter the site.
2. The top of the two ramps to the basement car park are at +81.25 and +82.10 respectively, which is significantly above the public park level of between +79.90 & +80.40. The top of ramp level is set 100mm above the adjacent ground level to eliminate the risk of any overland flow of water entering the car park. The risk of any water from a burst main entering the basement is therefore deemed to be negligible.

The two points above are explained diagrammatically in Figure 1 attached to this letter. We trust that this is satisfactory but please do not hesitate to contact us if you have any queries.

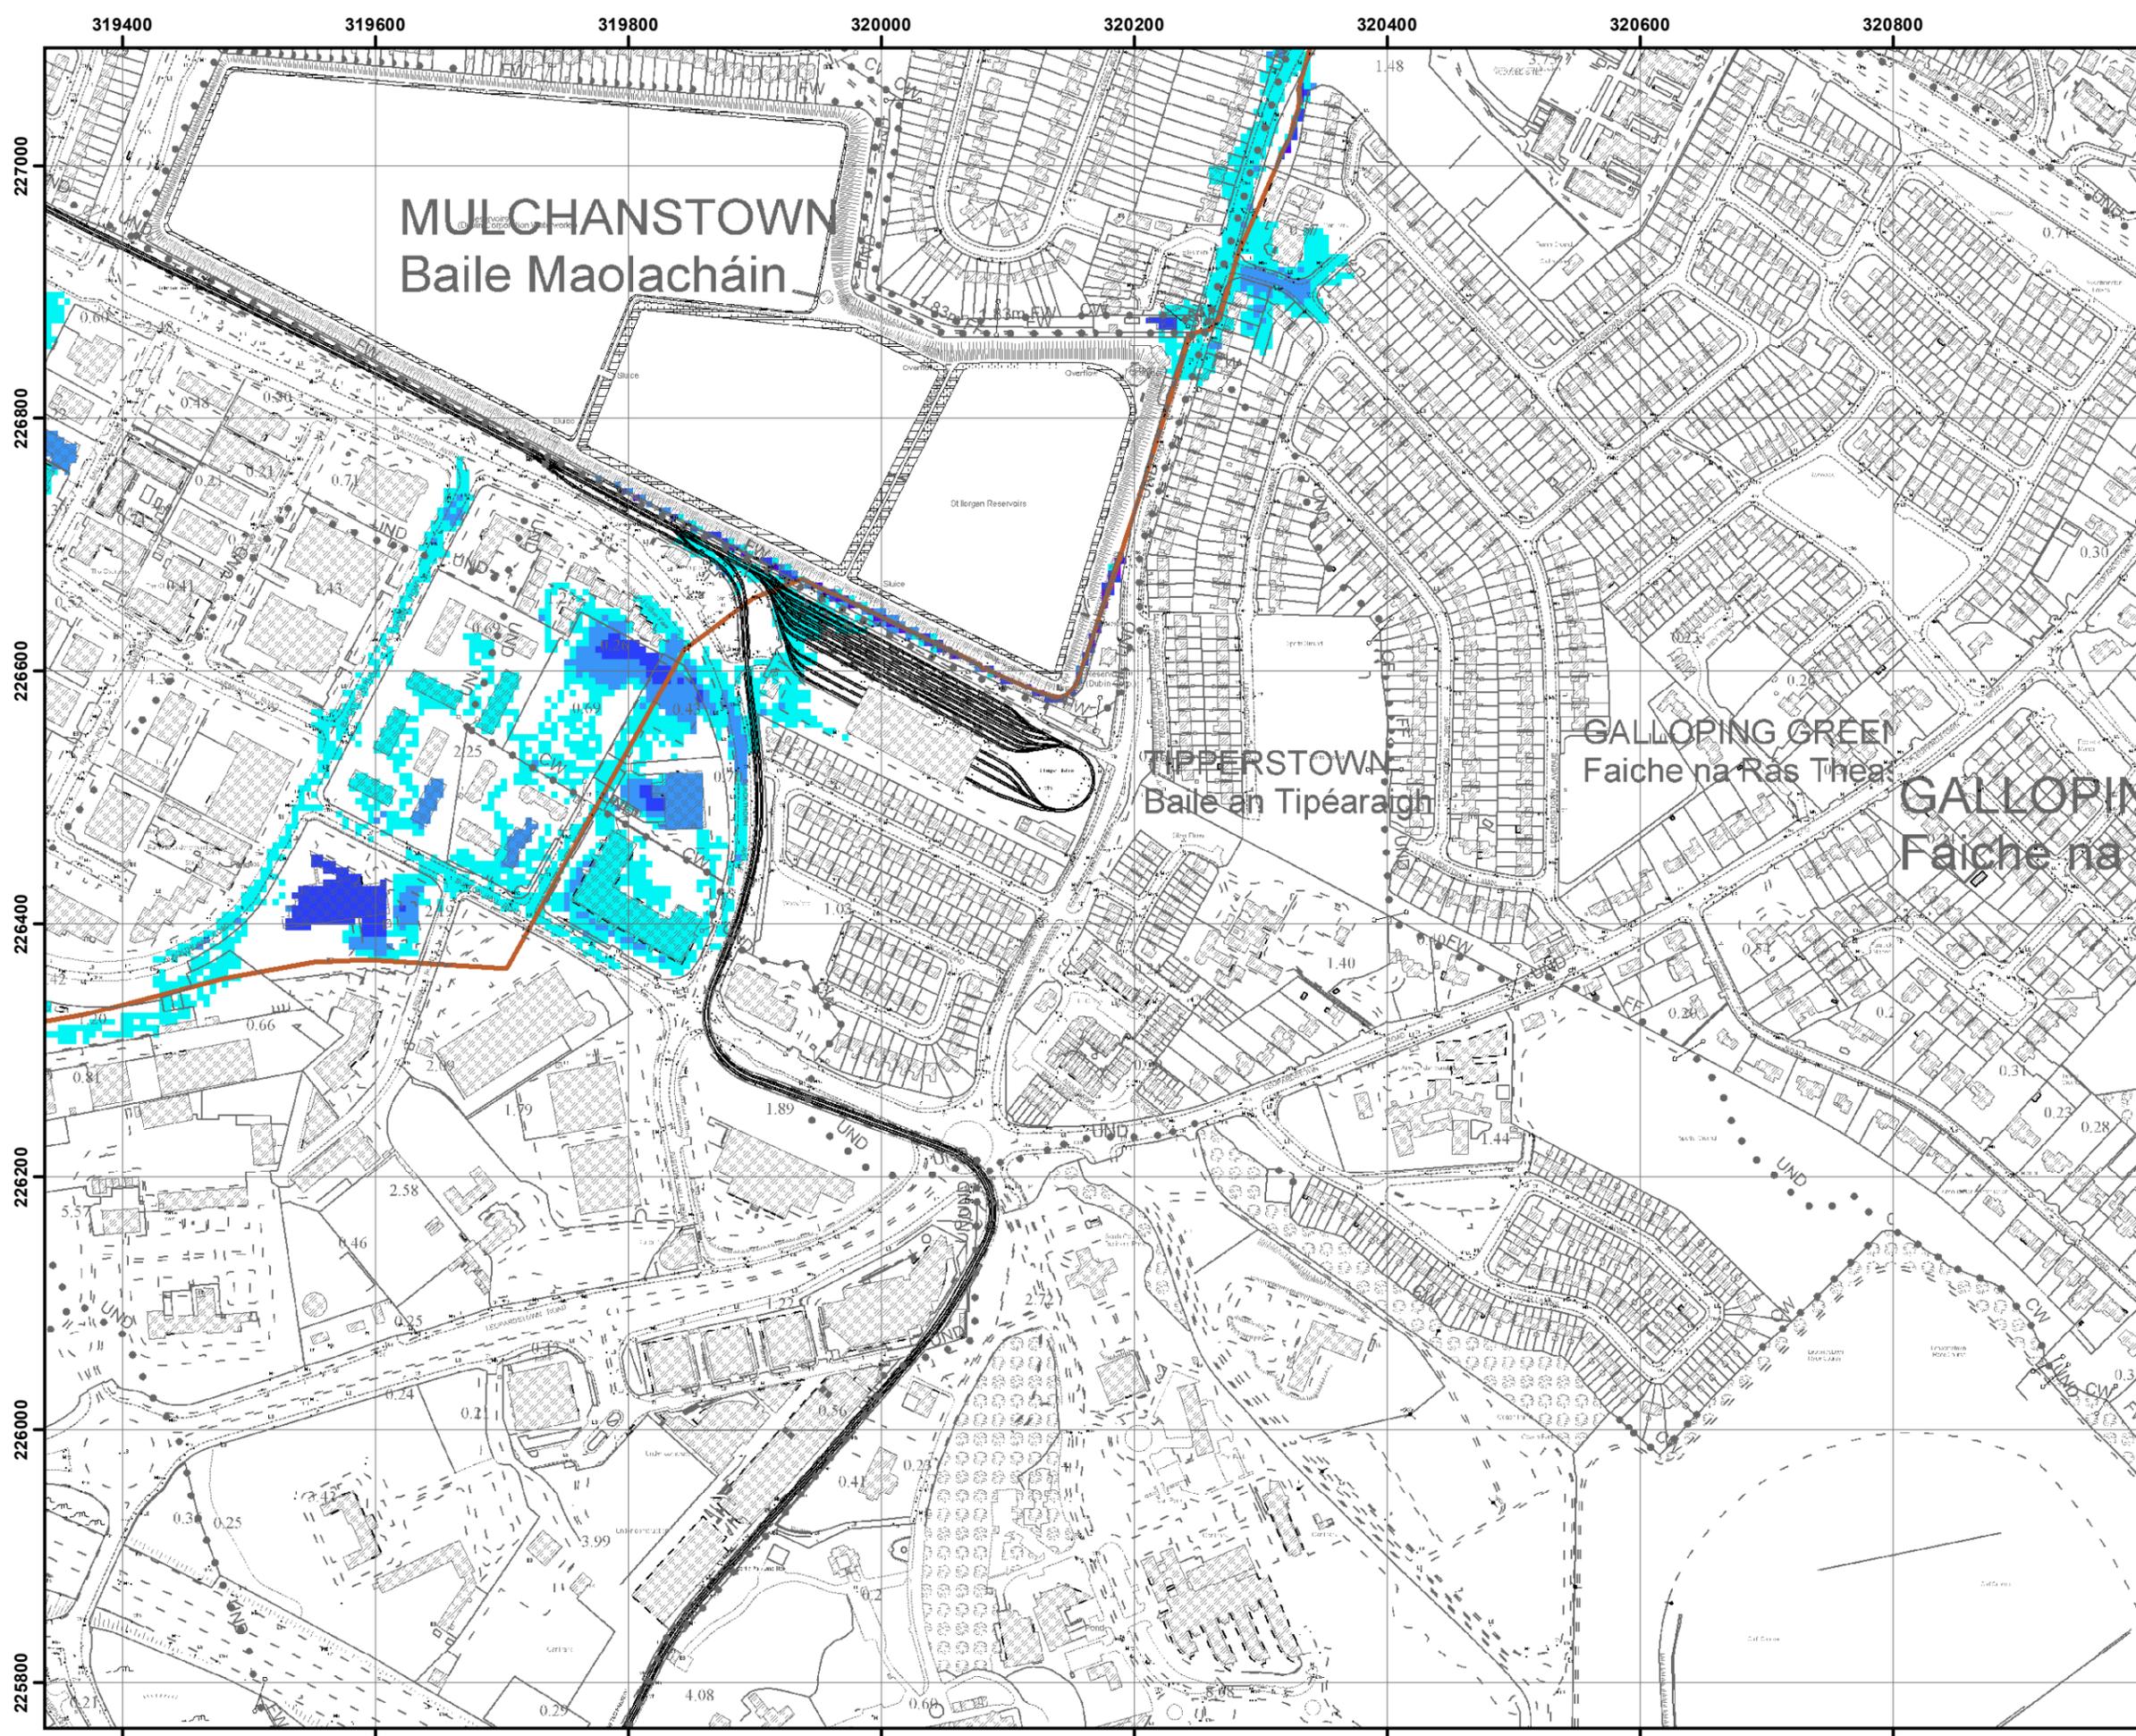
Map Type:	DEPTH
Source:	FLUVIAL
Map Area:	HPW
Scenario:	CURRENT
Drawn By:	C.McG. Date: 27 October 2017
Checked By:	A.S. Date: 27 October 2017
Approved By:	G.G. Date: 27 October 2017
Drawing No.:	E09CAR_DPFCD001_F2_05
Map Series:	Page 5 of 7
Drawing Scale:	1:5,000 @A3

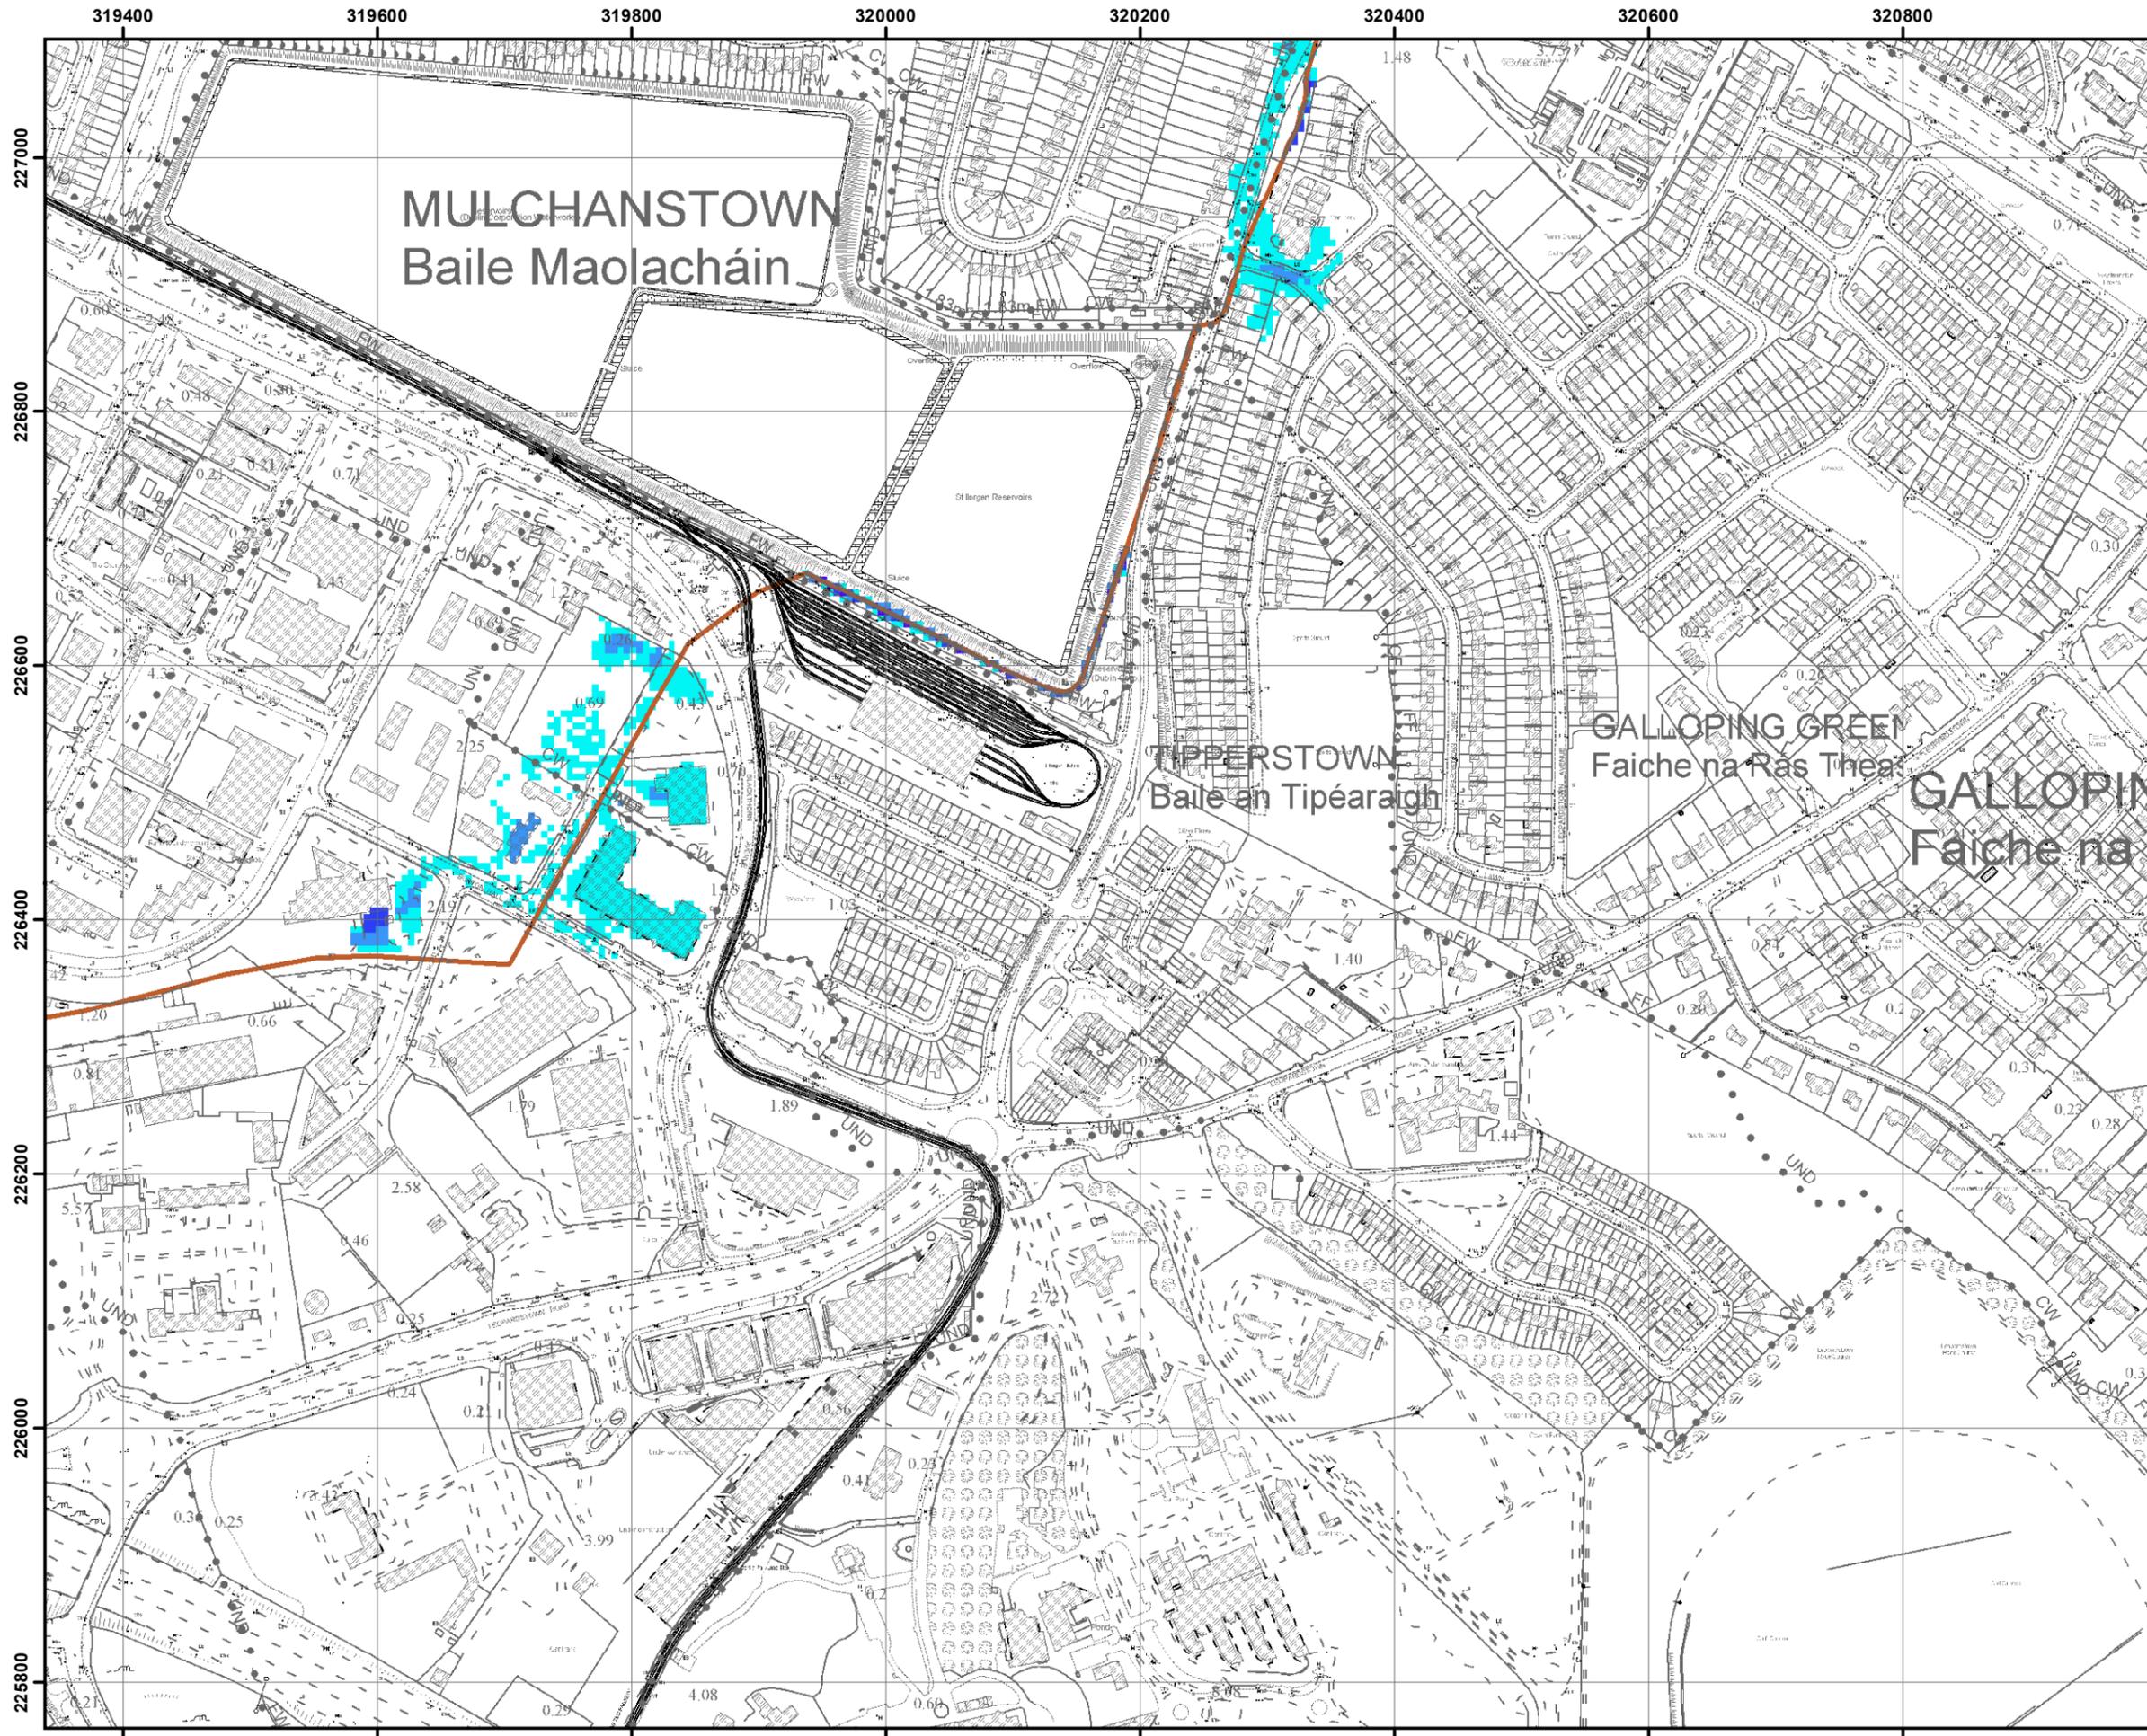
Map Type: DEPTH
Source: FLUVIAL
Map Area: HPW
Scenario: CURRENT
Drawn By: C.McG. Date: 27 October 2017
Checked By: A.S. Date: 27 October 2017
Approved By: G.G. Date: 27 October 2017
Drawing No.: E09CAR_DPFCD010_F2_05

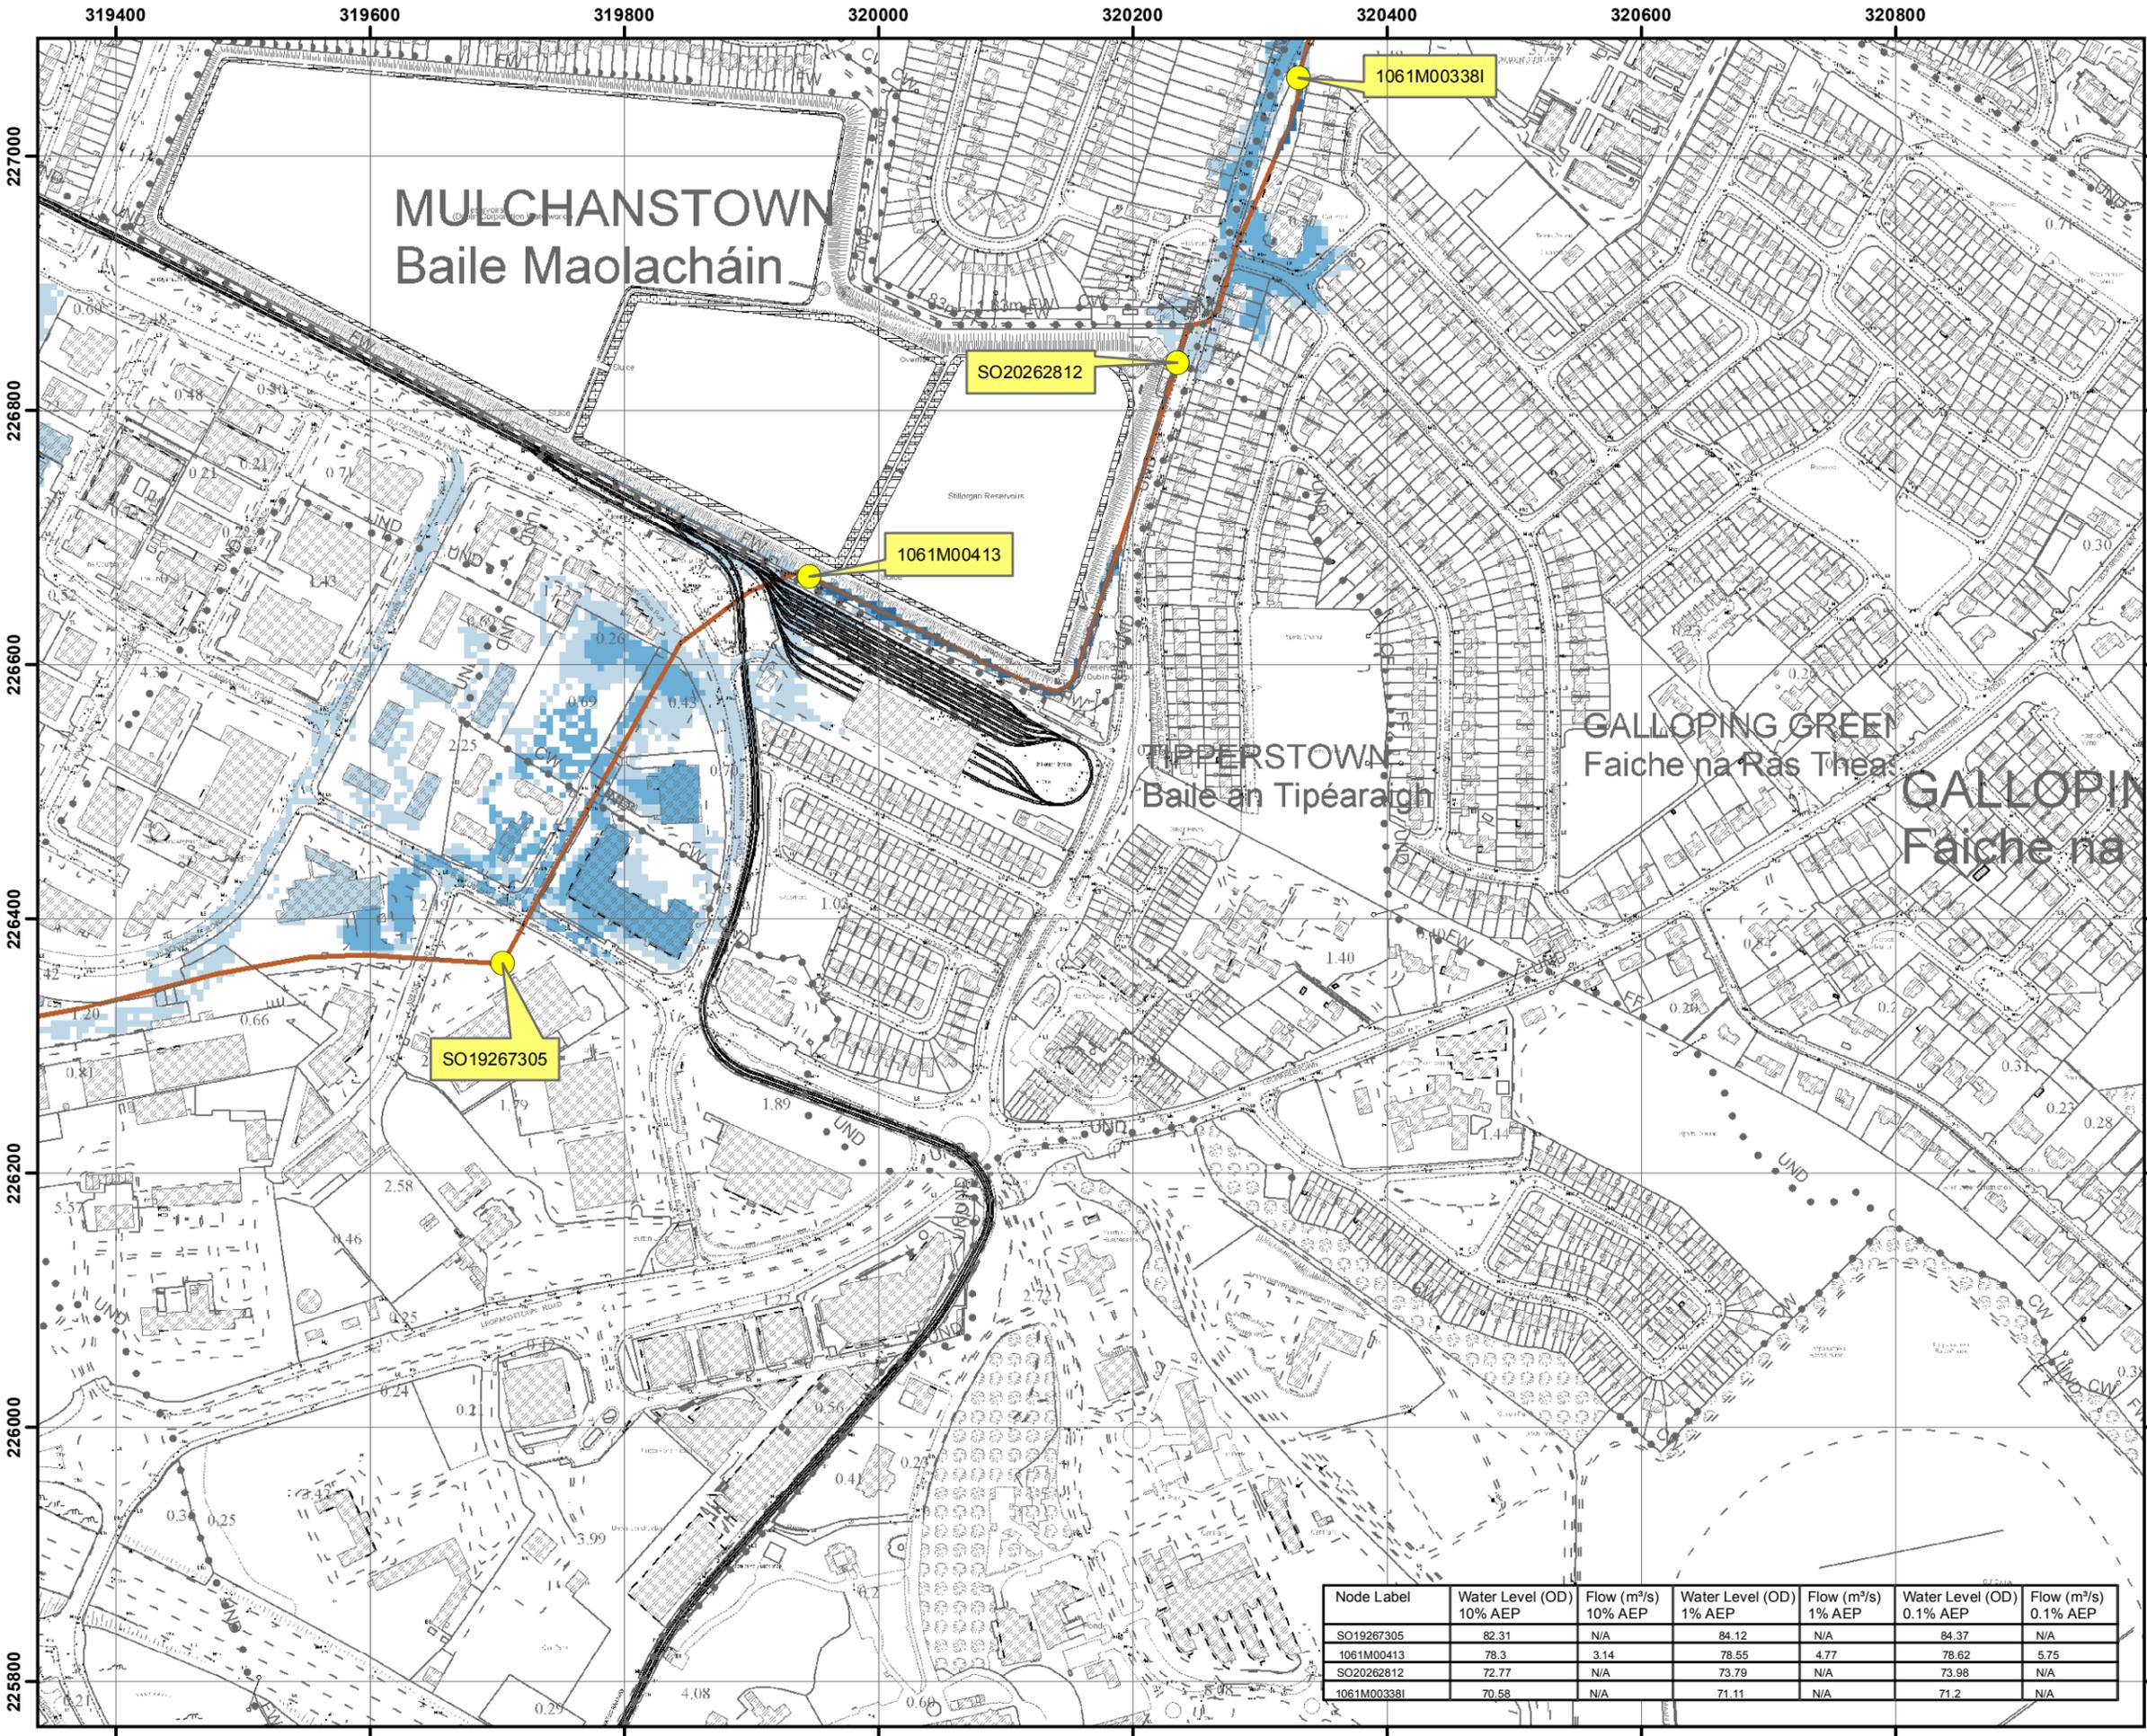
Node Label	Water Level (OD)		Flow (m³/s)		Water Level (OD)		Flow (m³/s)	
	10% AEP	10% AEP	1% AEP	1% AEP	0.1% AEP	0.1% AEP	0.1% AEP	0.1% AEP
SO19267305	82.31	N/A	84.12	N/A	84.37	N/A	N/A	N/A
1061M00413	78.3	3.14	78.55	4.77	78.62	5.75	N/A	N/A
SO20262812	72.77	N/A	73.79	N/A	73.98	N/A	N/A	N/A
1061M003381	70.58	N/A	71.11	N/A	71.2	N/A	N/A	N/A

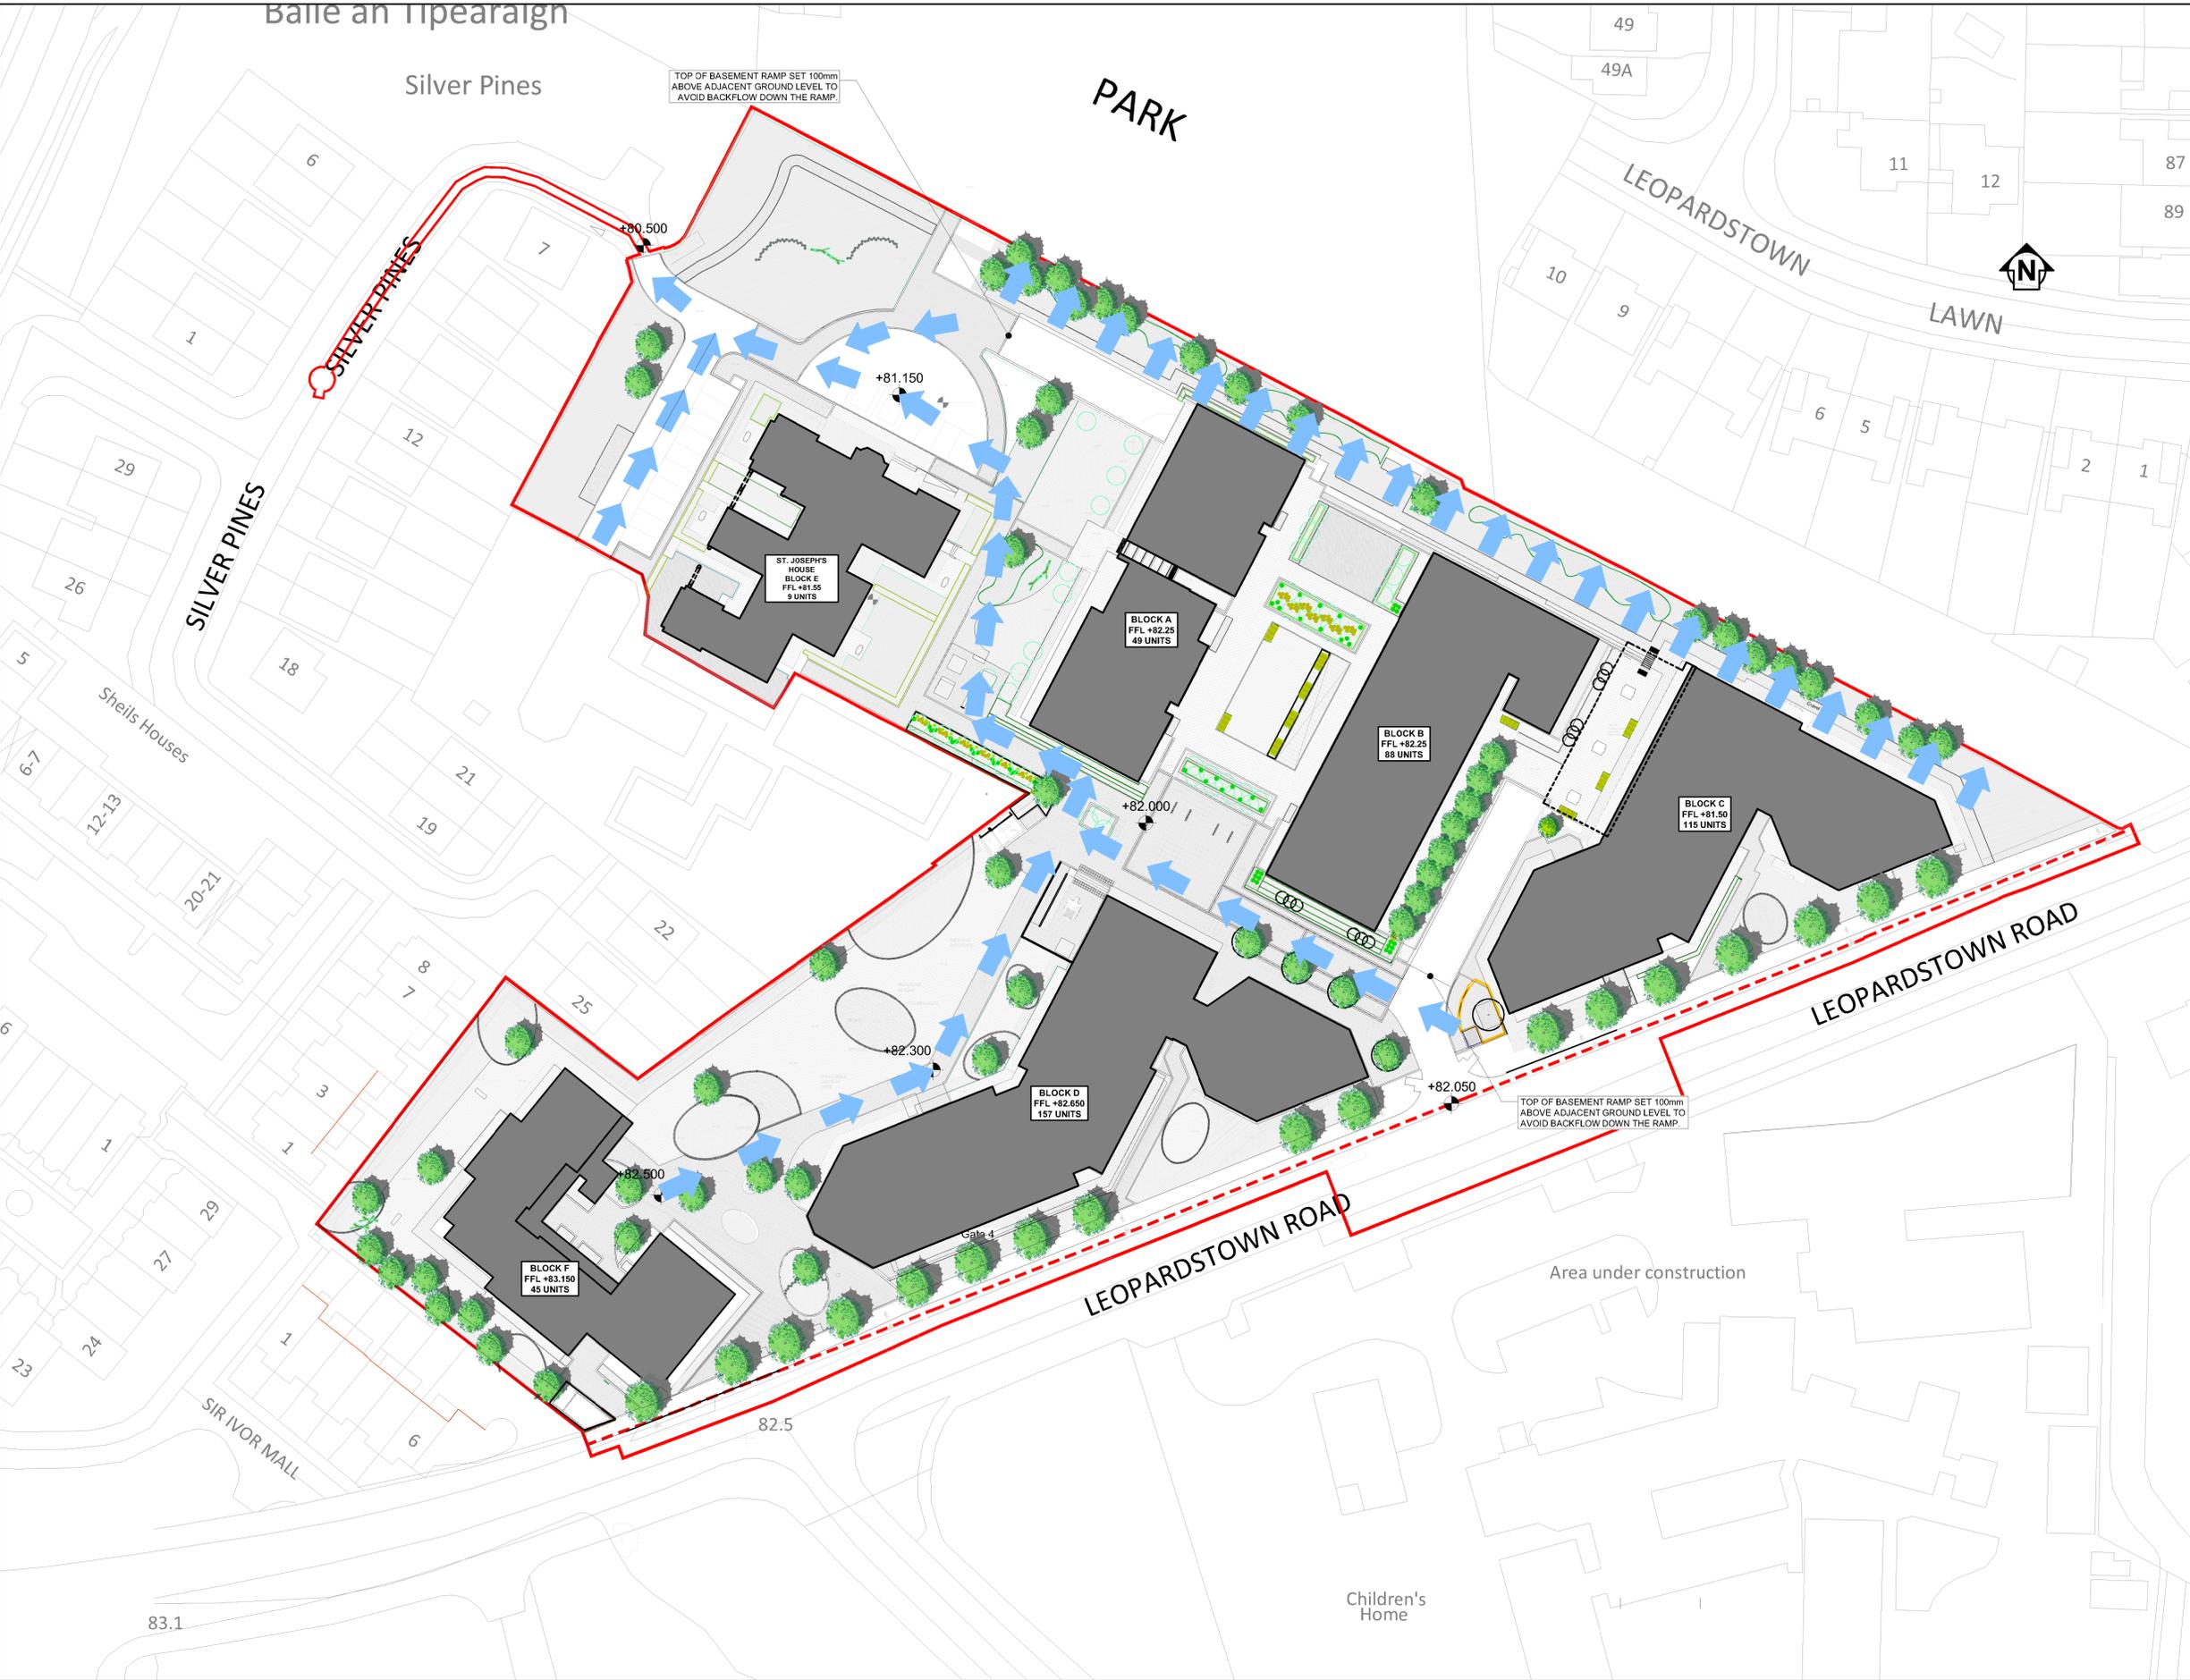
OVERLAND FLOOD
ROUTE

* NOTE: THIS ROUTE APPLIES IN THE UNLIKELY EVENT OF A FULL SCALE BLOCKAGE OR BLOCKAGES IN THE SURFACE WATER DRAINAGE SYSTEM
