**White Pines East Residential Development,  
Stocking Avenue, Dublin 16.**

**Site Specific Flood Risk Assessment**

**Ardstone Homes Limited**

**March 2021**

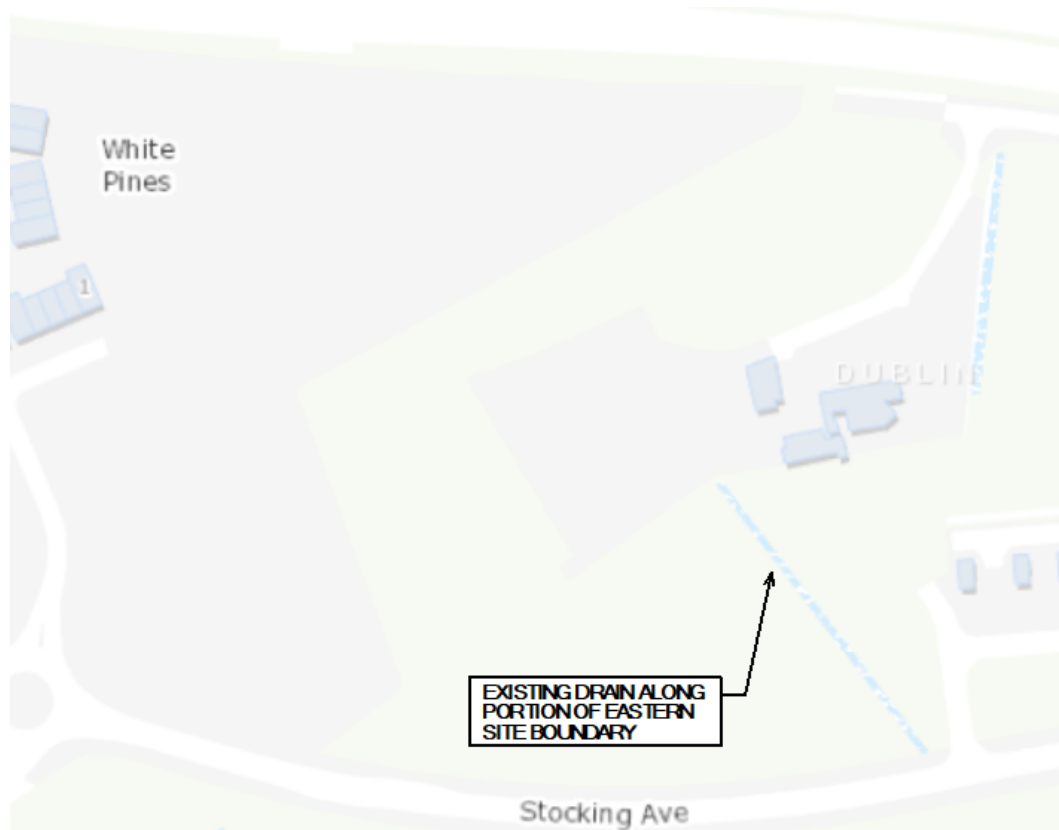
Figure 3.1 Existing Ditch Along Eastern Boundary– Extract from EPA Online Mapping

- Walkover survey – An existing open drain is located along a portion of the site's eastern boundary. (refer to Figure 3.1). This appears to be a dry ditch as there's no piped inlet at the head of the drain and it terminates approx. halfway along the eastern boundary at an existing wall. A number of large trees are located along this boundary which are being retained as part of the proposed development, therefore, this existing dry ditch will remain in place and be unaffected by the proposed development.
