## 15 Architectural Built Heritage

<b>15</b>	<b>ARCHITECTURAL BUILT HERITAGE</b>	<b>1</b>
15.1	INTRODUCTION	2
15.2	STUDY METHODOLOGY	2
15.3	THE EXISTING RECEIVING ENVIRONMENT (BASELINE)	3
15.4	HISTORY	4
15.5	CHARACTERISTICS OF THE PROPOSED DEVELOPMENT	14
15.6	POTENTIAL IMPACT OF THE PROPOSED DEVELOPMENT	14
15.7	POTENTIAL CUMULATIVE IMPACTS	16
15.8	DO NOTHING SCENARIO	17
15.9	RISKS TO HUMAN HEALTH	17
15.10	MITIGATION MEASURES	17
15.11	PREDICTED IMPACTS OF THE PROPOSED DEVELOPMENT	23
15.12	MONITORING	24
15.13	REINSTATEMENT	24
15.14	INTERACTIONS	24
15.15	DIFFICULTIES ENCOUNTERED	24
15.16	REFERENCES	24

## 15.1 Introduction

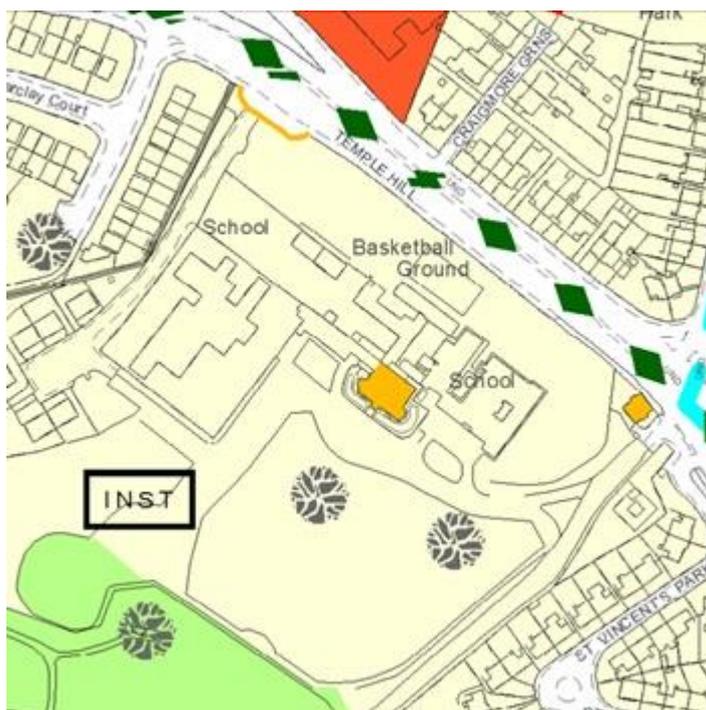
Figure 15.2 - Dun Laoghaire Rathdown Development Plan Protected Structures coloured Orange  
A: House (centre); B: Lodge (right); C: Gateway (top)

The site's buildings include three Protected Structures (main house, lodge and gateway) and these were, until recently, in the same ownership as the adjoining house known as St Catherine's. The two houses, St Teresa's and St Catherine's, were themselves built on the original curtilage of an earlier house, Rockfield, and were first known as Craigmore and Dunardagh respectively.

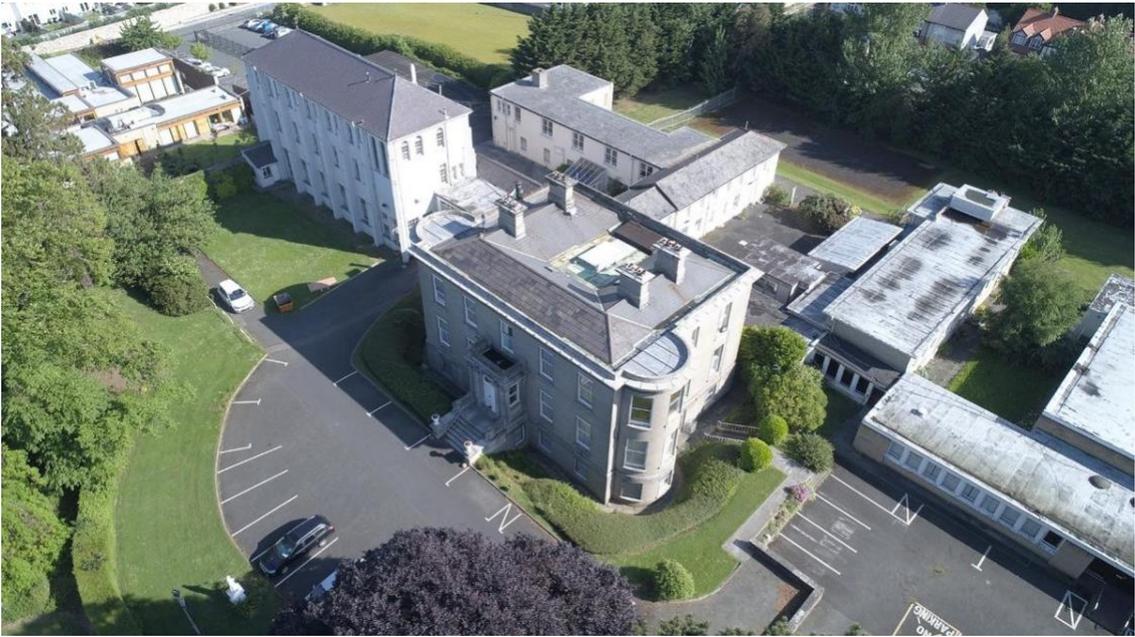
Figure 15.6 - Aerial view from South (pre-2021 demolitions)

St. Teresa's House is a two storey over basement detached country house, of five bays with central projecting granite porch, and semi-circular end-bays, and granite cornice, cills, and string course. The porch is reached via a flight of granite steps with granite flank walls. There is a pitched "A" roof having its ridge in a "U" shaped plan, with central flat-roofed area and rooflight above the stairs, and with lead roofs with rolls to the end bays with hip valleys valley gutters and parapet gutters rendered chimneys stacks. The external walls are rendered and lined, with one-over-one pane vertical sliding sash sliding windows.

The exterior of the building is in poor condition having many external service pipes, abutting later extensions, and some non-original windows. The render is cracked in places. The interior of the building has been somewhat altered to accommodate the institutional use, but the main features remain relatively intact. A room by room inventory and photographic record is attached.

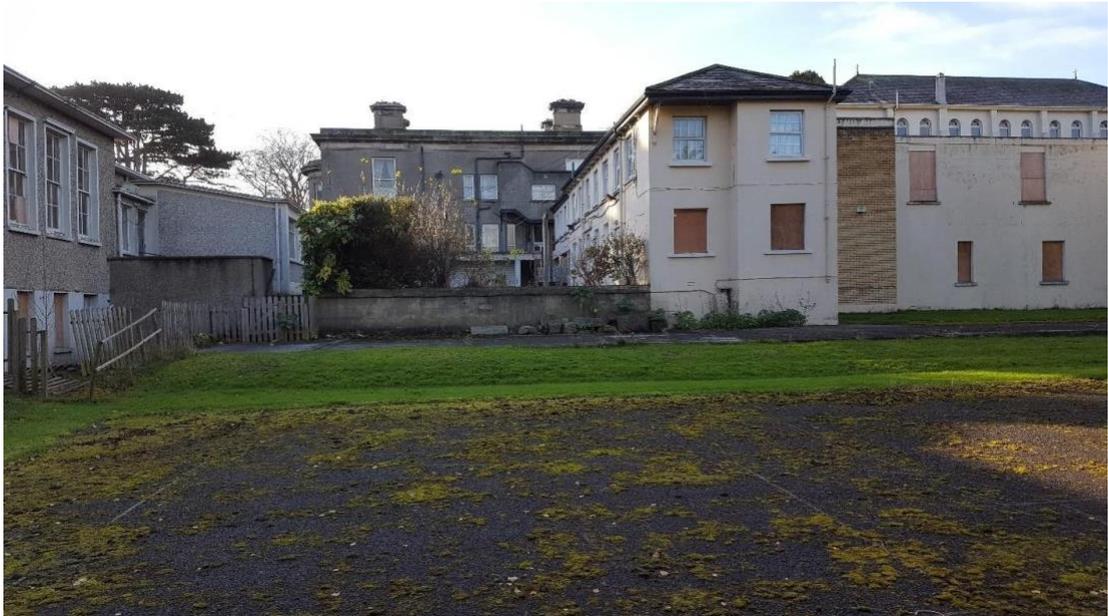
Figure 15.7 - View from North-east (pre-2021 demolitions)

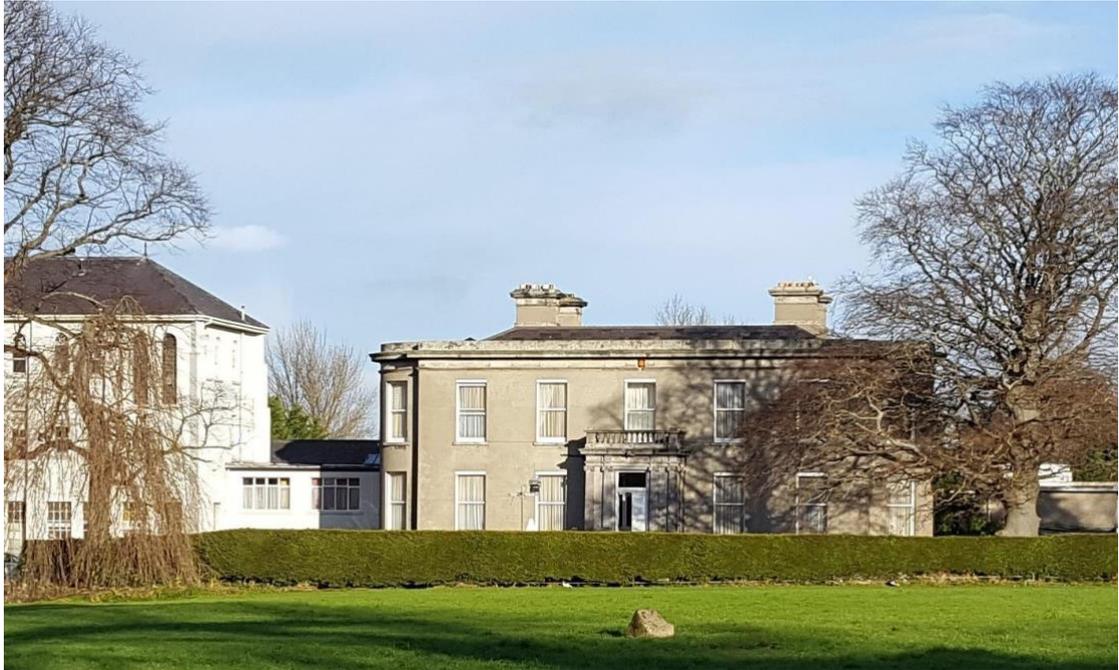
*Figure 15.8 - View from South-west (pre-2021 demolitions)*

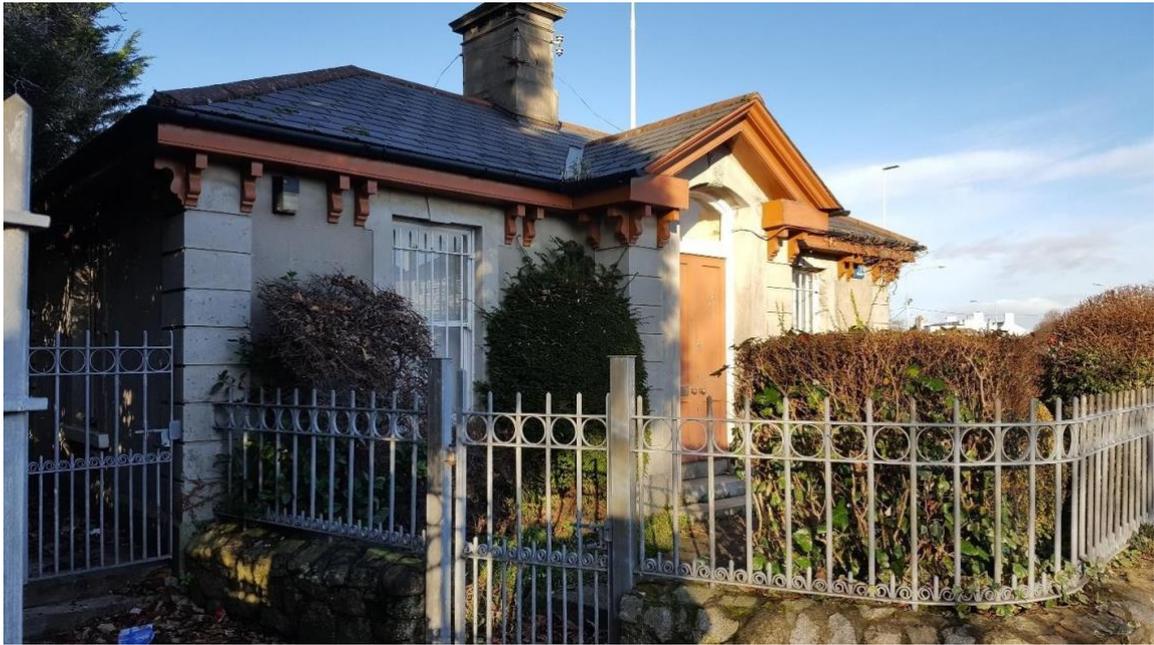
*Figure 15.8 - Gate-lodge with new (1980s) boundary treatment.*

The c.1866 gate-lodge which survives is on the new boundary wall at Temple Hill and has been unoccupied for some years. At the time of its construction, it was part of a composition which included the vast (30m wide) double gateway which served both Craigmore and Dunardagh.

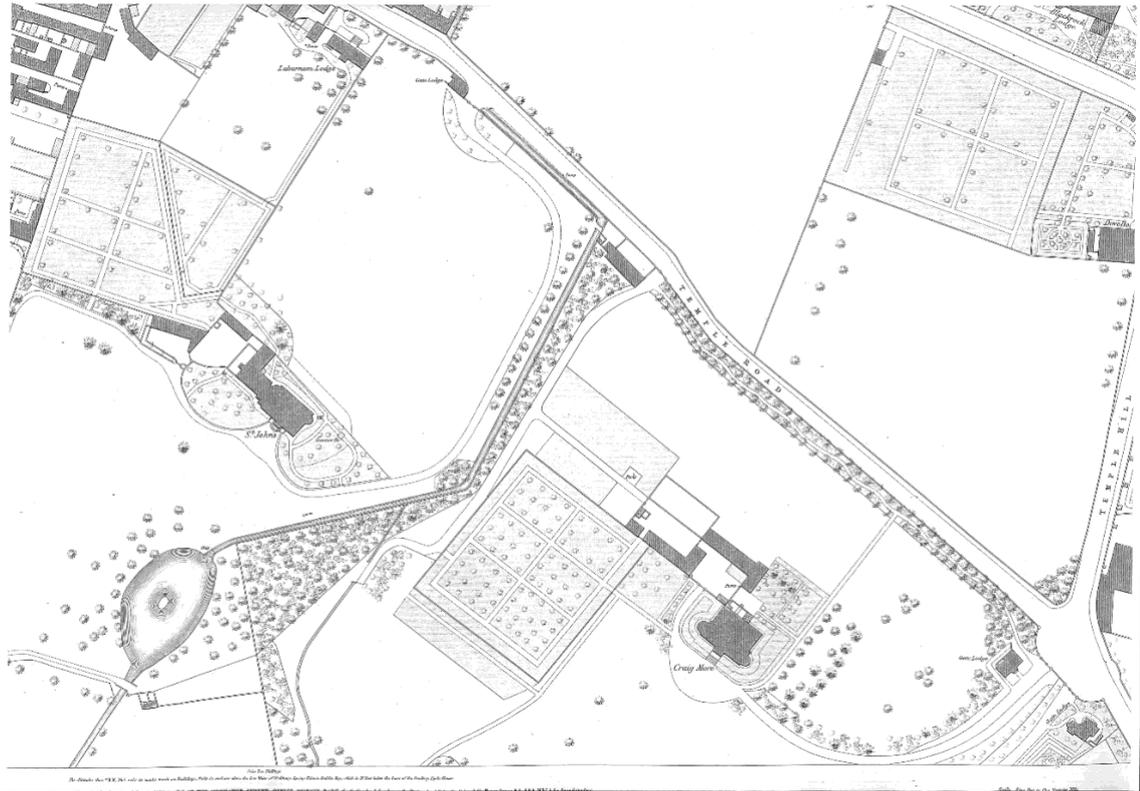
Figure 15.9 - 1867 OS Map

Note: lodge now shown as having been built since 1865 map

J.A.K. Dean<sup>5</sup>, describes this lodge as a of a pattern to be found in a number of other locations and suggests that the demolished west lodge was the only approach for more than a decade. However, the 1865 and 1867 maps do not seem to bear this out and it seems unlikely that main entrance was ever at the north corner of the site.<sup>1</sup>

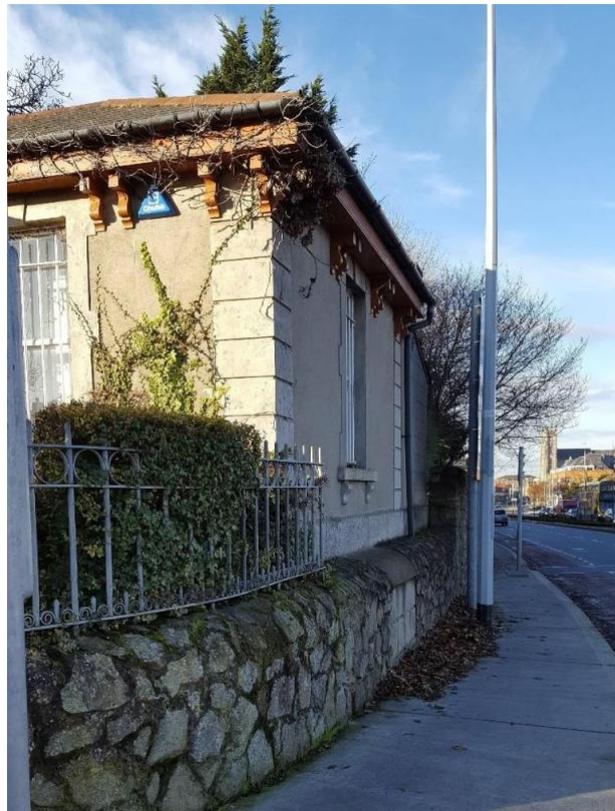
Figure 15.10 - New boundary wall

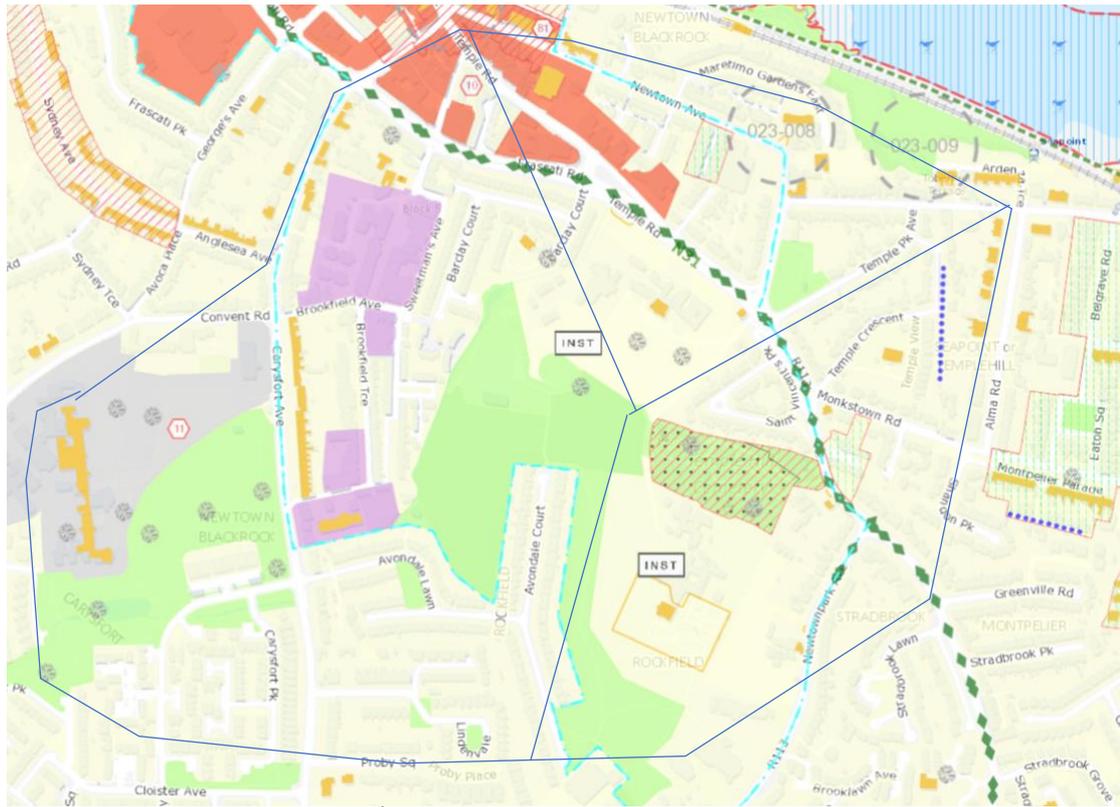
Figure 15.11 - Extract from Dun Laoghaire Rathdown Development Plan 2016 - 2022 Showing Protected Structures, cACAs and ACAs as per DLR key

The visual impact of the development on the heritage structures/areas in the environs may be broadly divided into three zones - west, north and east, and indicated on the Development Plan extract below.

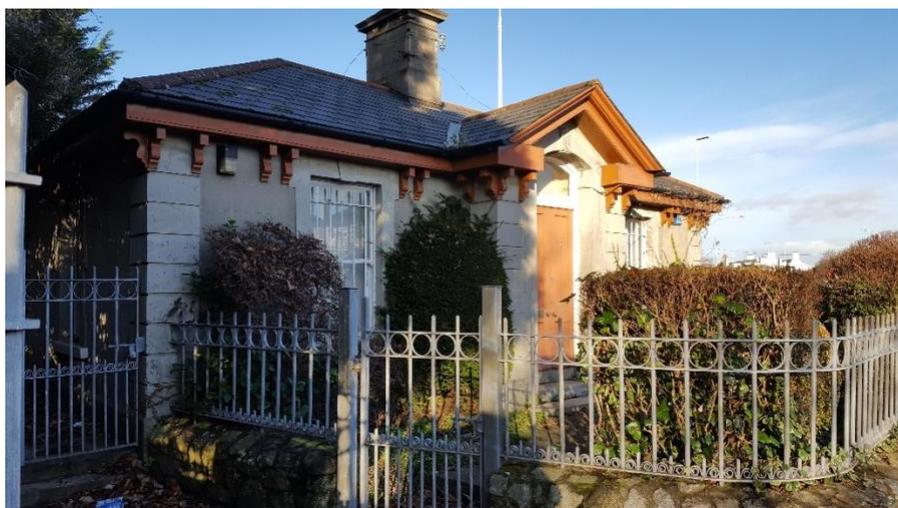
**Lodge at St Teresa's House**
