Basic Results Summary

Scenario 11: '2023 DS AM' (FG9: '2023 DS AM', Plan 1: 'Network Control Plan - AM')

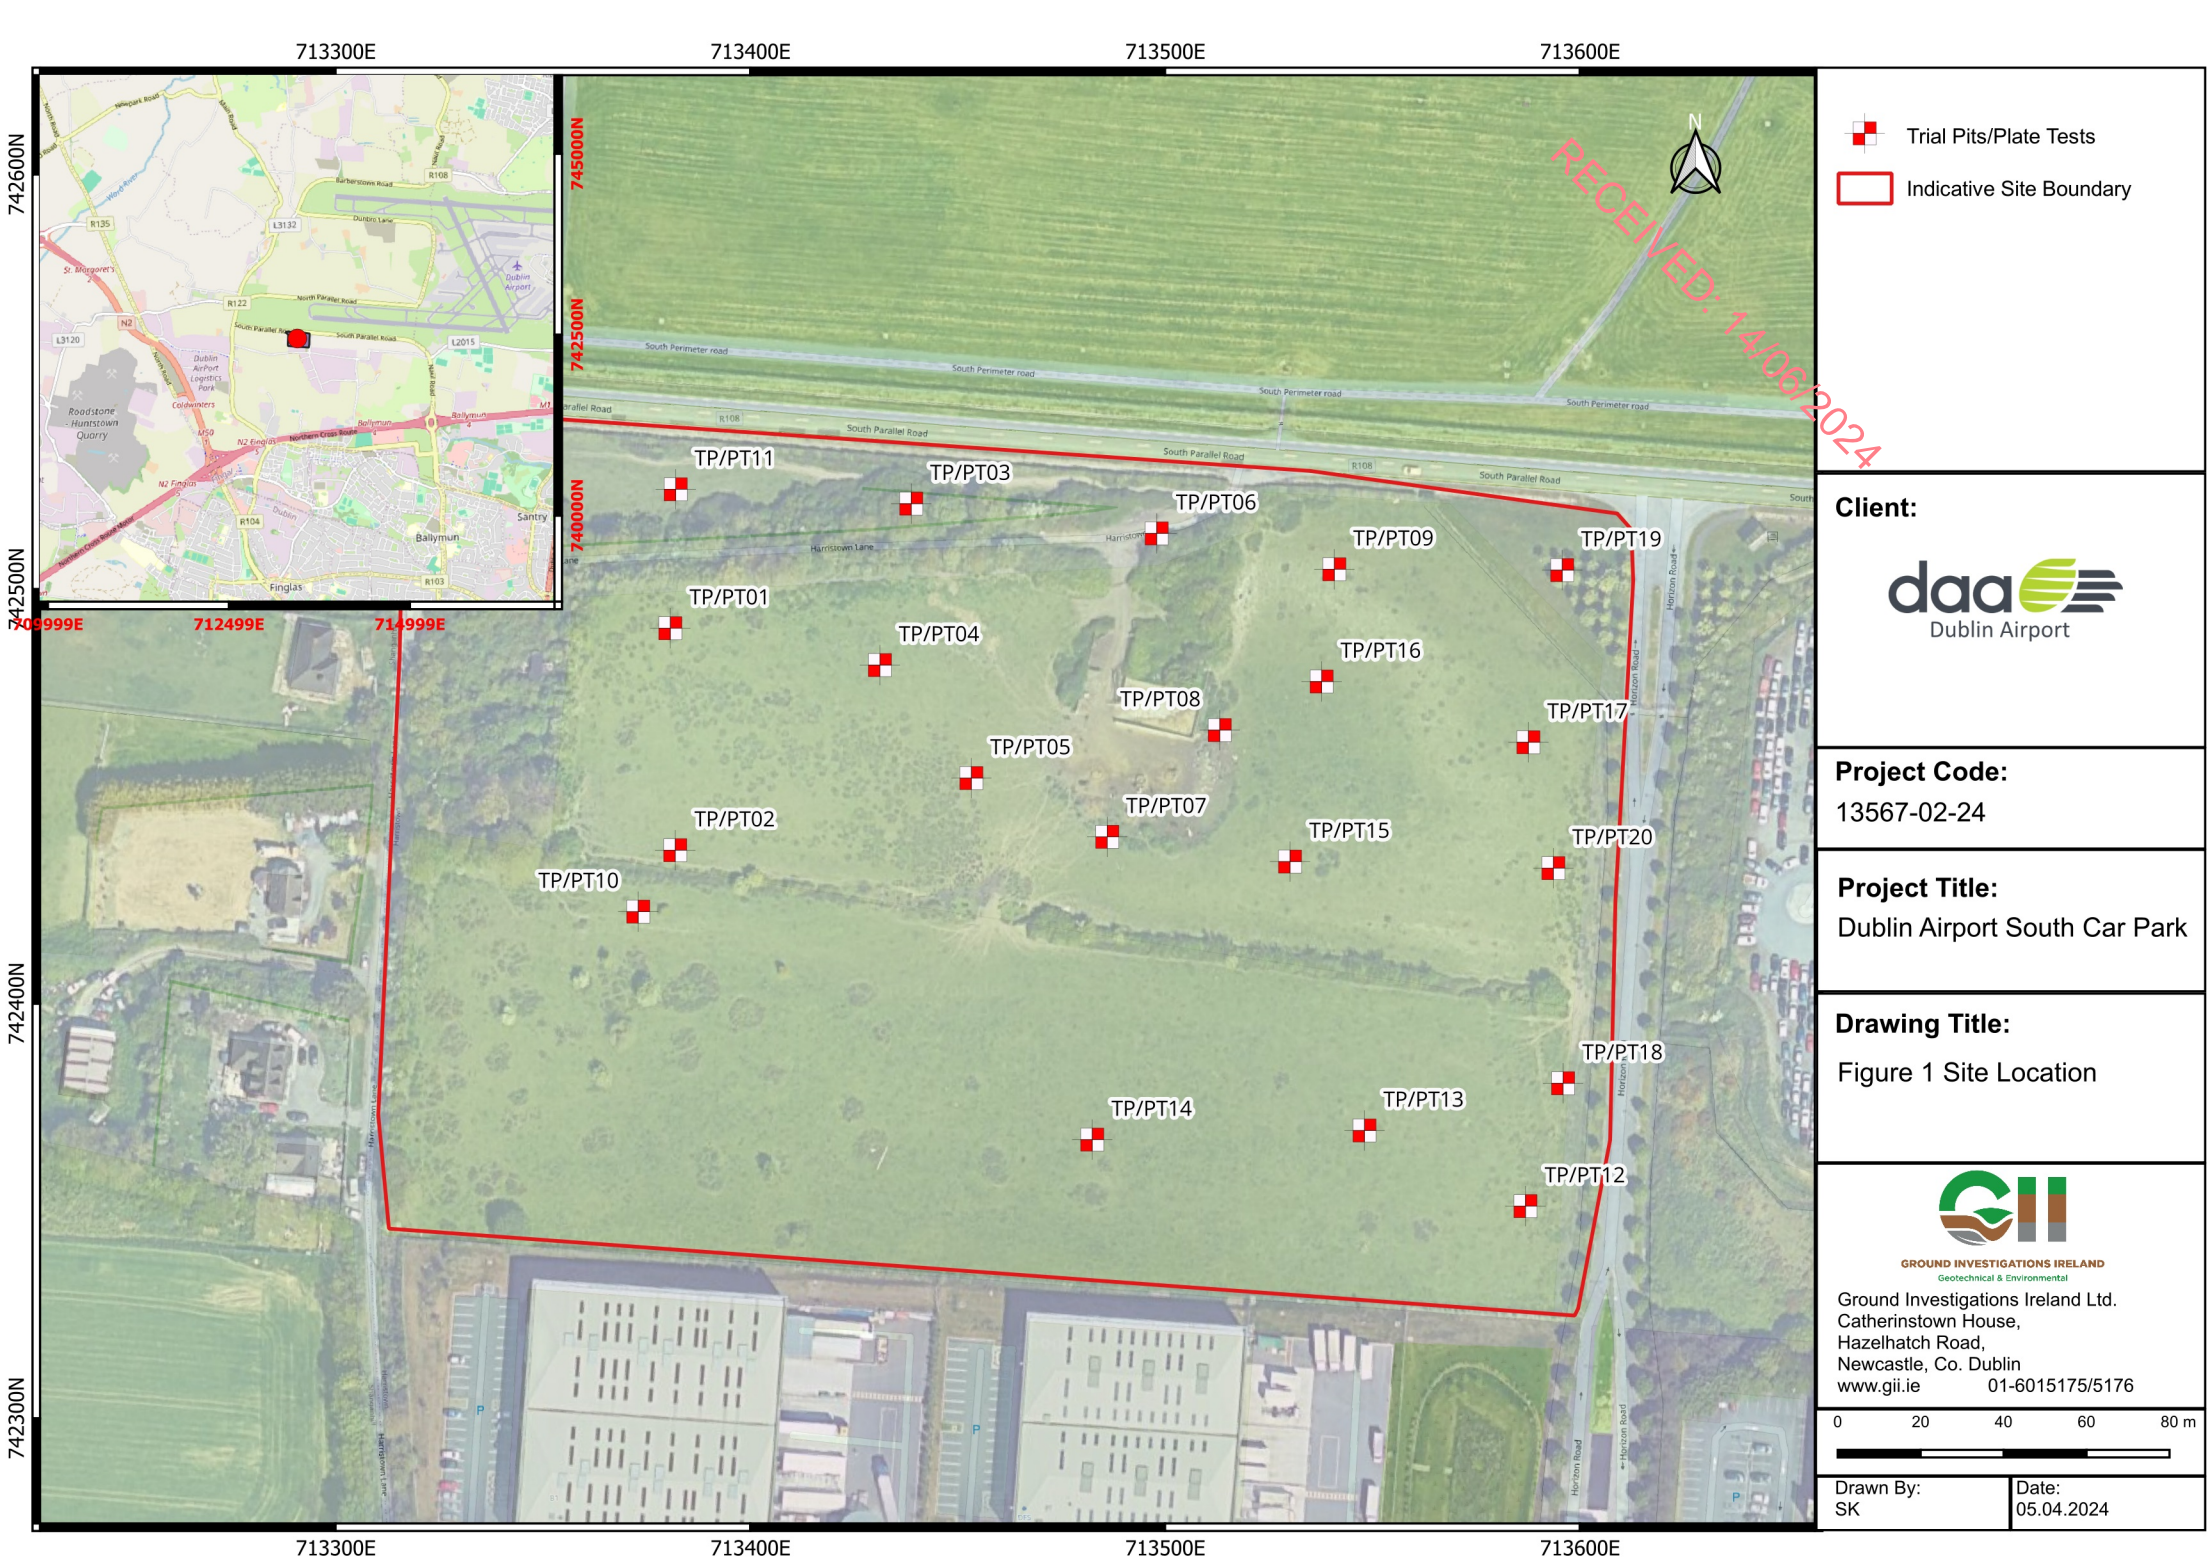
- Trial Pits/Plate Tests
- Indicative Site Boundary

- Visit project site to observe existing conditions
- Carry out 20 No. Trial Pits to a maximum depth of 3.50m BGL
- Carry out 20 No. TRL/DCP Probes to determine CBR
- Carry out 17 No. Plate Bearing Tests to determine the modulus of subgrade reaction and equivalent CBR
- Report with recommendations

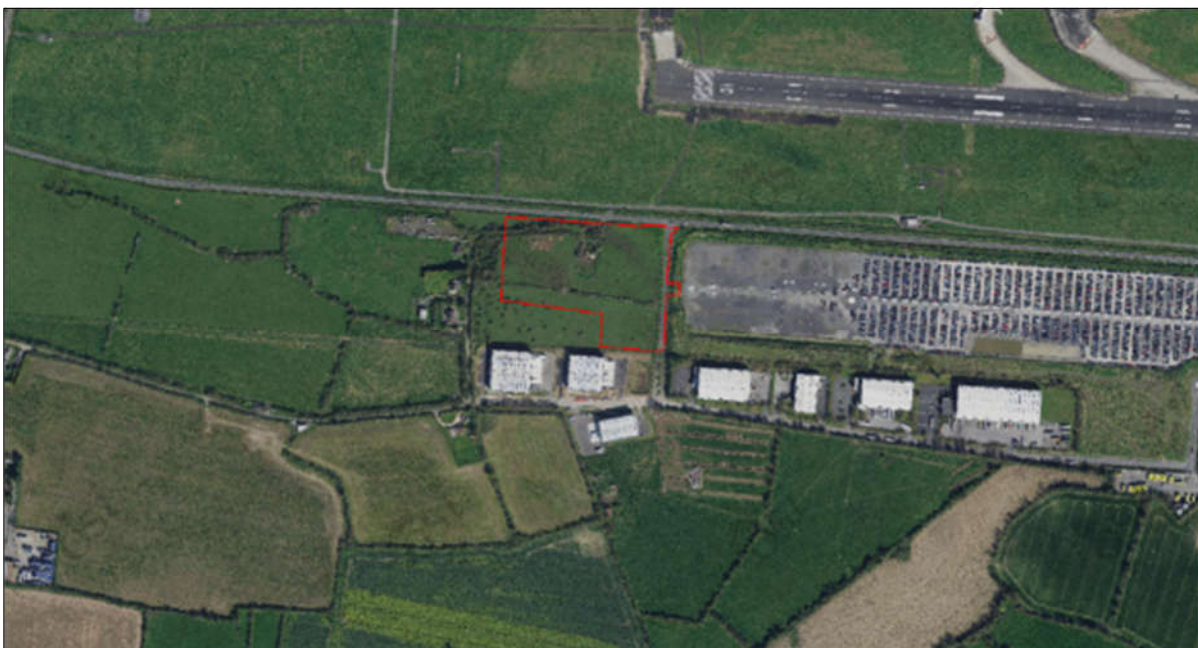
Figure 2: Location of subject site (red) (Source: Ordnance Survey Ireland/Government of Ireland)

The subject site is located within the townland of Harristown, County to the south of Dublin Airport. The site consists of a c. 4ha area of farmland containing sections of two rough pasture fields located to the south of the R108 road. The proposed development will comprise the extension of an existing daa staff car park located within the adjoining property to the east. The two fields within the site are generally level and currently in use as rough grazing lands. The centre of the northern field is occupied by a modern agricultural concrete-surfaced yard with cattle pen areas. The fields are bounded by trees and bushes on the north and west sides while modern fencing form the boundaries with the car park to the east and a commercial premises to the south.

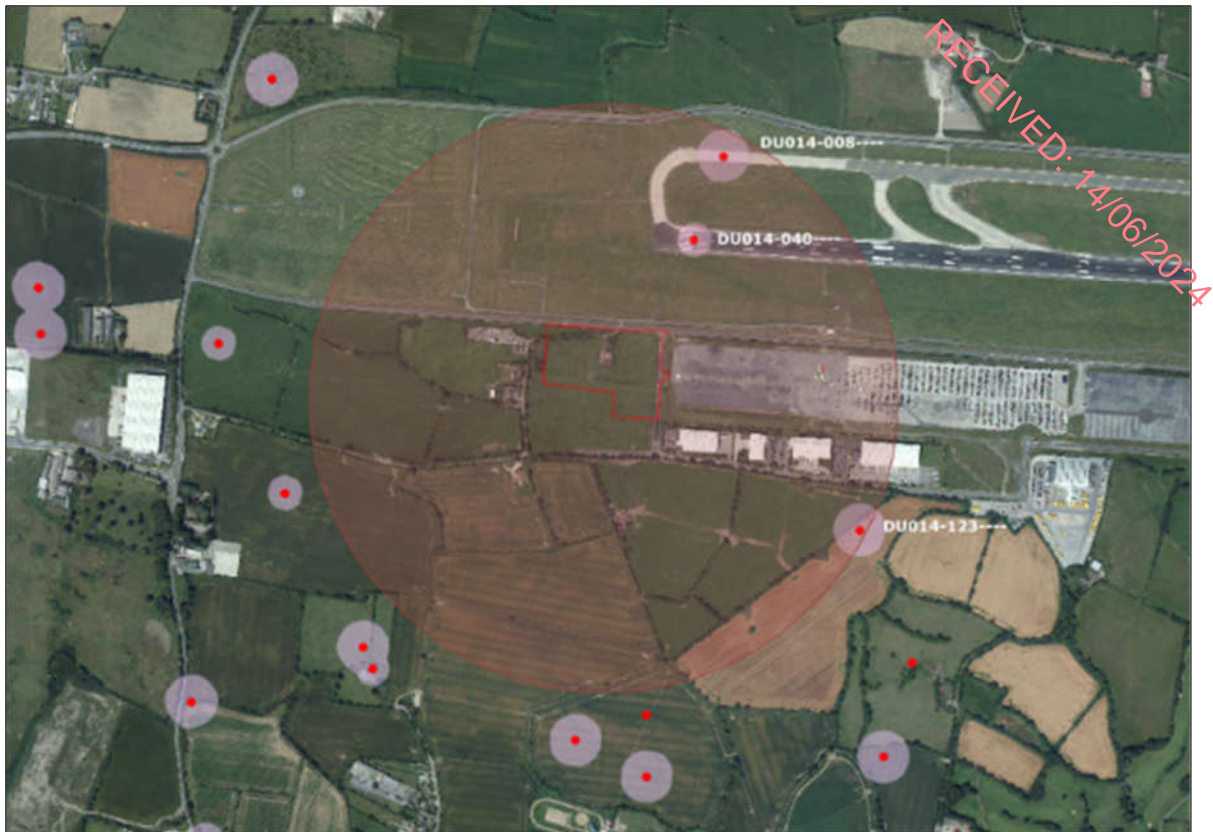
Figure 3: Recorded archaeological sites located within approximately 500m of the subject site
(Source: Government of Ireland)

There are no recorded archaeological sites within the subject site. The Historic Environment Viewer records three archaeological sites within approximately 500m (study area) of the subject site boundary (**Figure 3 & Table 1**). The wider landscape, particularly to the south and west contains a large number of recorded monuments, many of which are enclosures, field systems, ringforts, etc., indicative of likely early medieval activity.

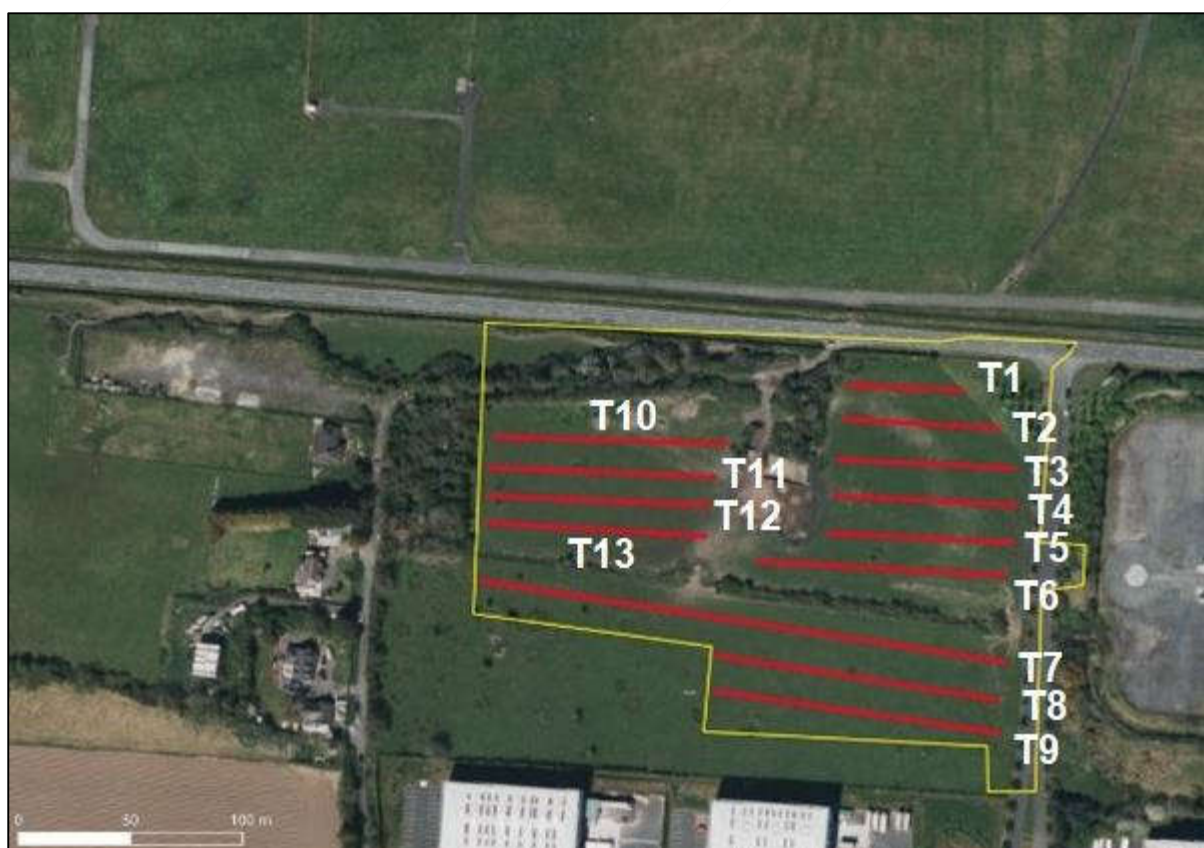
Figure 9: Location of test trenches 1-13, (yellow outline). Trench 1 and 2 not excavated due to lack of access,

Table 2: Trench details. See **Figure 9** for trench locations

All trenches were located within agricultural land used for grazing and excavated through topsoil deposits (**Figure 9**). The natural subsoil, a light grey/yellow clay was encountered at a depth of 0.25 to 0.55m below the ground surface. Two charcoal rich features, [C.003] and [C.004] interpreted as possible pits or troughs, were identified within Trench 7 and 10. No other archaeological features or deposits were uncovered. Trench 1 and 2 could not be excavated due to lack of access, and Trench 3 was shortened by 30m (**Plate 1**). Extracts from the photographic record are presented in **Appendix 3**.

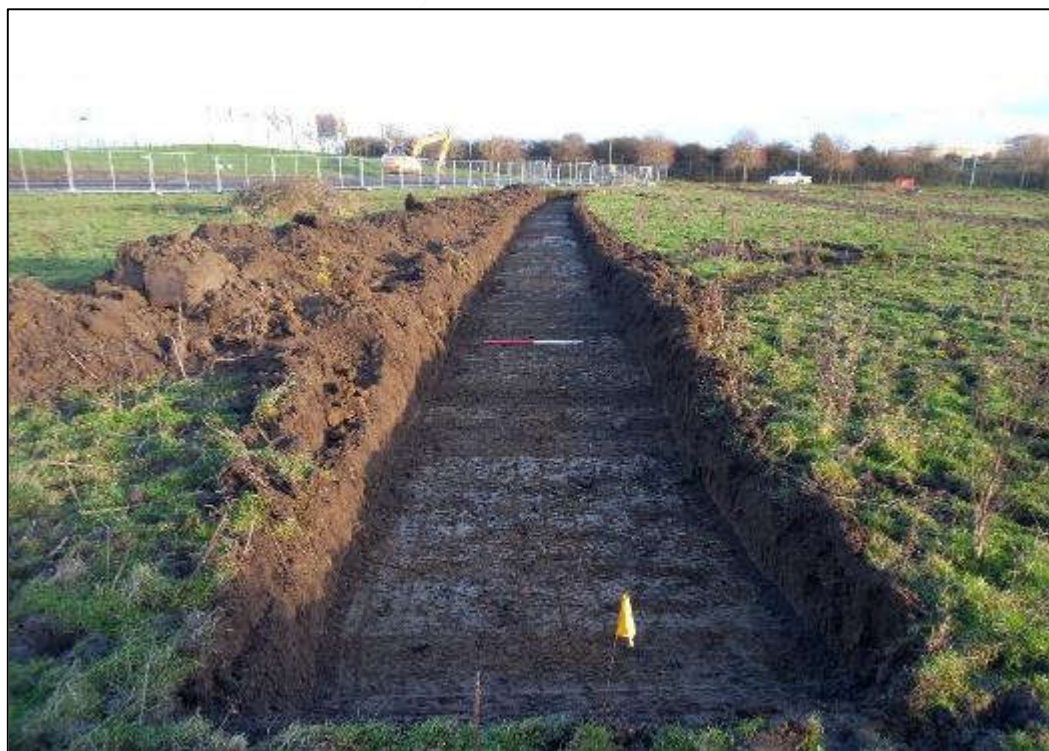
Plate 2: Trench 3 facing east

Trench ID	T3
Dimensions	W: 1.8m L: 50m D: 0.30 – 0.40m
Orientation	E-W
ITM Co-ords	713520.47 742476.33 713570.67 742475.01
Description	Test Trench 3 (T3) was excavated to a minimum depth of 0.3m and a maximum depth of 0.4m below the existing ground level. The topsoil consisted of mid greyish brown silty clay with moderate inclusions of small stones. It overlay a compact light grey/yellow clay subsoil with occasional stone inclusions. The trench was shortened by 30m due to its eastern end being unavailable for testing. Nothing of archaeological significance was encountered in this trench. Plate 2 and 3

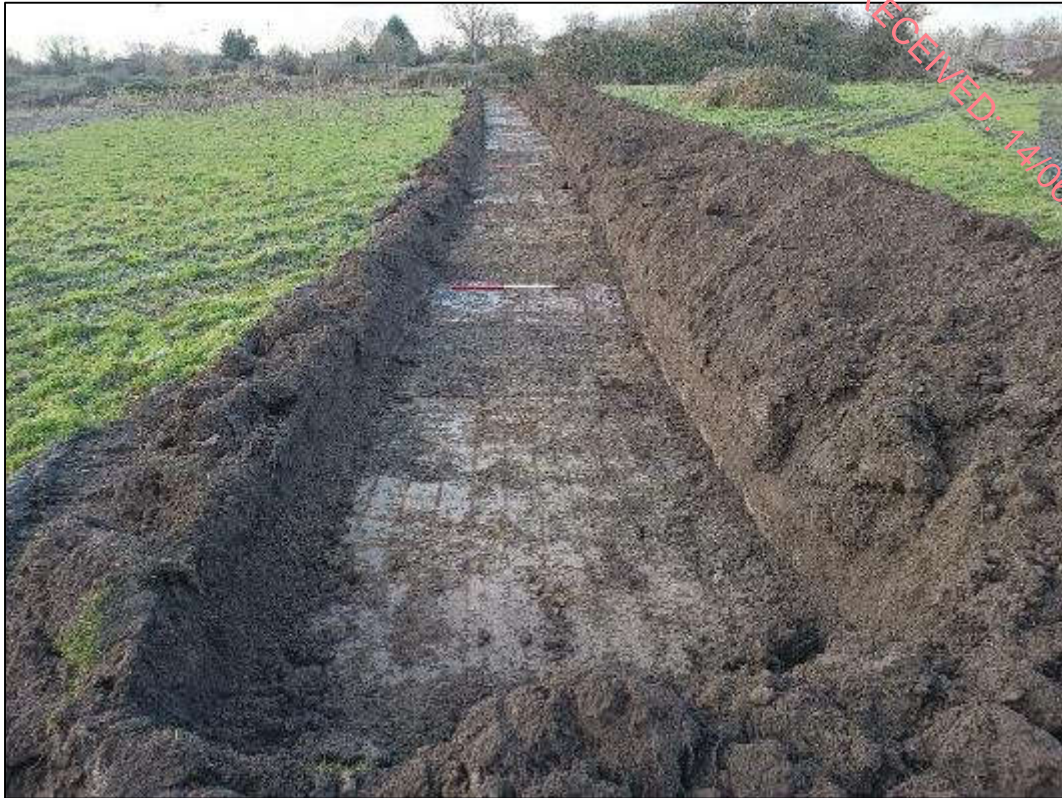
Plate 3: Trench 3 facing west

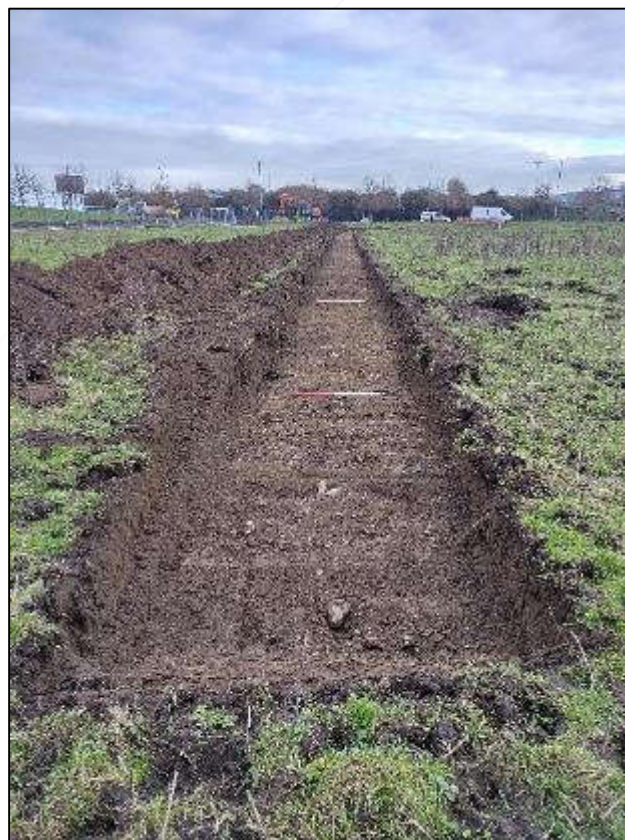
Plate 4: Trench 4 facing east

Trench ID	T4
Dimensions	W: 1.8m L: 80m D: 0.30 – 0.40m
Orientation	E-W
ITM Co-ords	713519.24 742459.70 713600.54 742456.21
Description	Test Trench 4 (T4) was excavated to a depth of 0.3 - 0.4m below the existing surface level. The topsoil consisted of mid greyish brown silty clay with moderate inclusions of small stones. It overlay a compact light grey/yellow clay subsoil with occasional stone inclusions. Nothing of archaeological significance was encountered in this trench. Plate 4 and 5

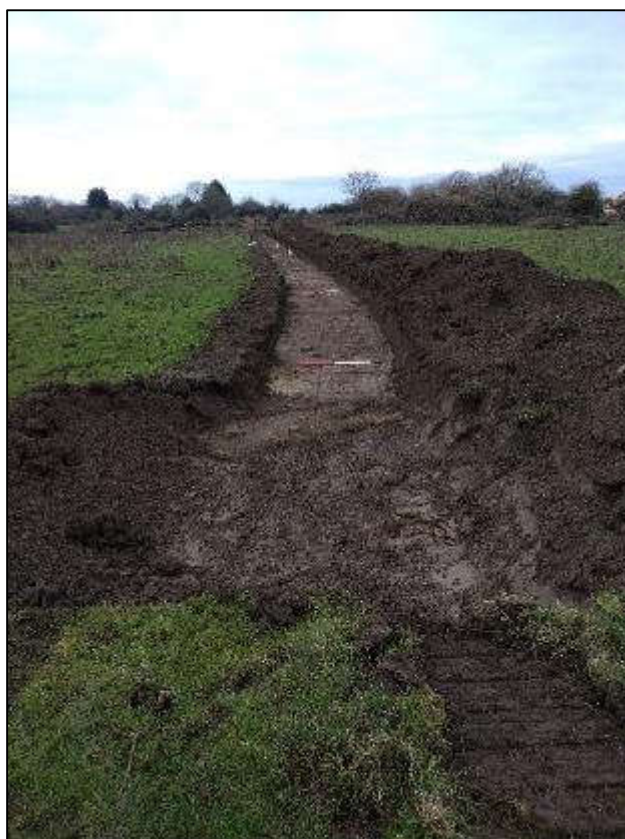
Plate 5: Trench 4 facing west

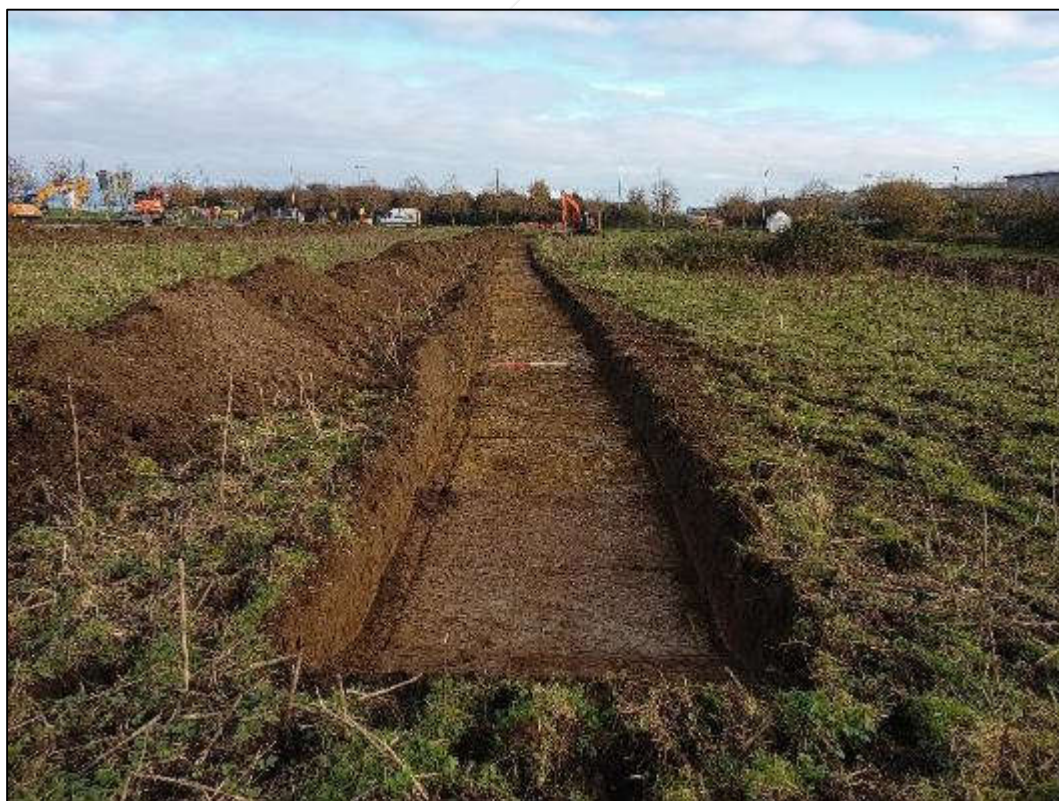
Plate 6: Trench 5 facing east

Trench ID	T5
Dimensions	W: 1.8m L: 80m D: 0.30 – 0.40m
Orientation	E-W
ITM Co-ords	713515.54 742443.07 713597.67 742439.58
Description	Test Trench 5 (T5) was excavated to a depth of 0.3 - 0.4m below the existing surface level. was excavated to a depth of 0.3 - 0.4m below the existing surface level. The topsoil consisted of mid greyish brown silty clay with moderate inclusions of small stones. It overlay a compact light grey/yellow clay subsoil with occasional stone inclusions. Nothing of archaeological significance was encountered in this trench. Plate 6 - 7

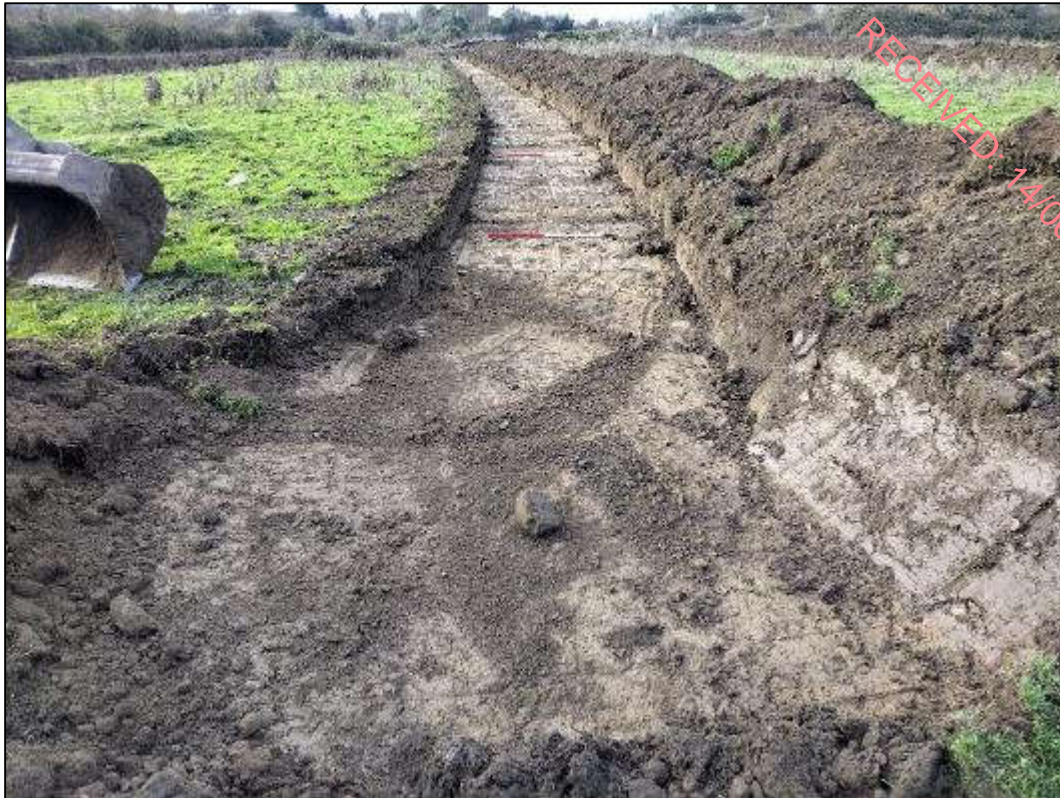
Plate 7: Trench 5 facing west

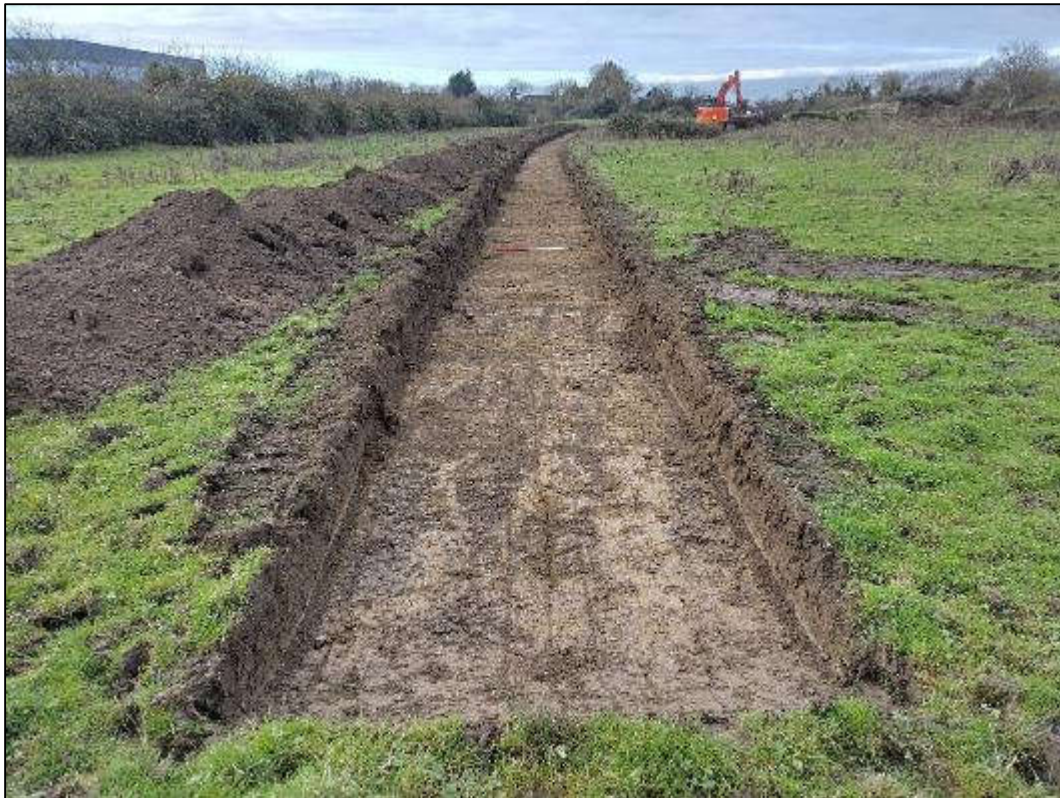
Plate 8: Trench 6 facing west

Trench ID	T6
Dimensions	W: 1.8m L: 110m D: 0.3-0.4m
Orientation	E-W
ITM Co-ords	713484.33 742430.13 713595.20 742425.00
Description	Test Trench 6 (T6) was excavated to a minimum depth of 0.3m and a maximum depth of 0.4m below the existing ground level. The topsoil consisted of mid greyish brown silty clay with moderate inclusions of small stones. It overlay a compact light grey/yellow clay subsoil with occasional stone inclusions. Nothing of archaeological significance was encountered in this trench. Plate 8 - 9

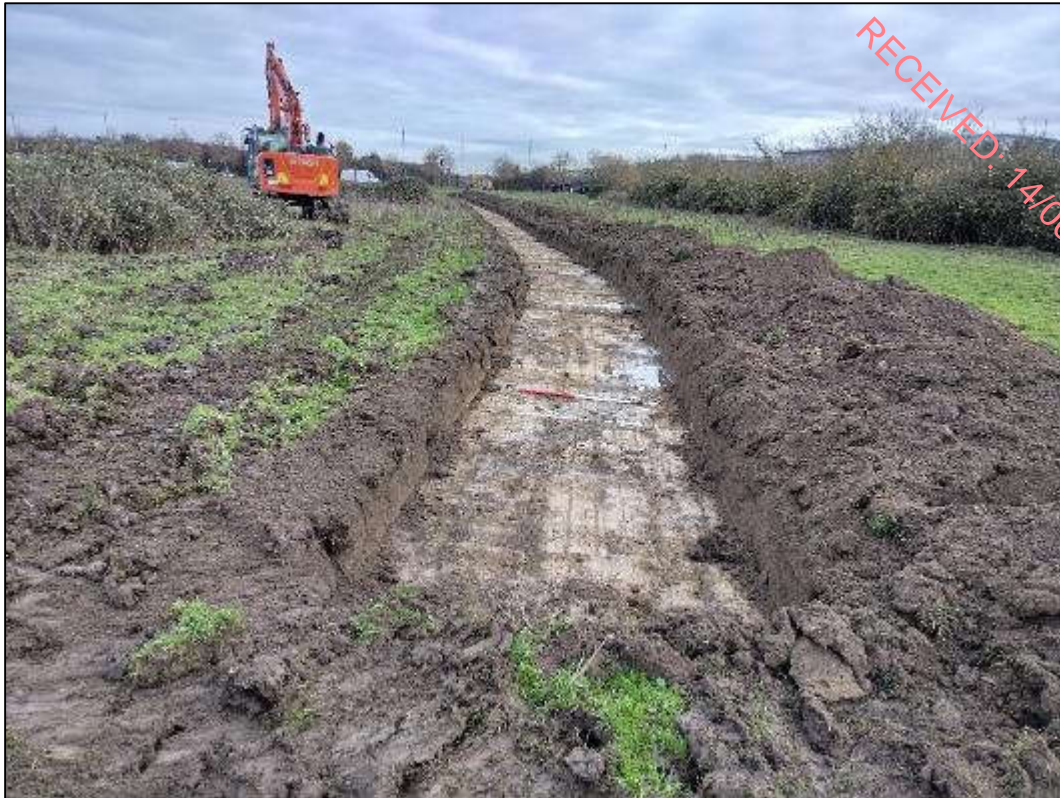
Plate 9: Trench 6 facing east

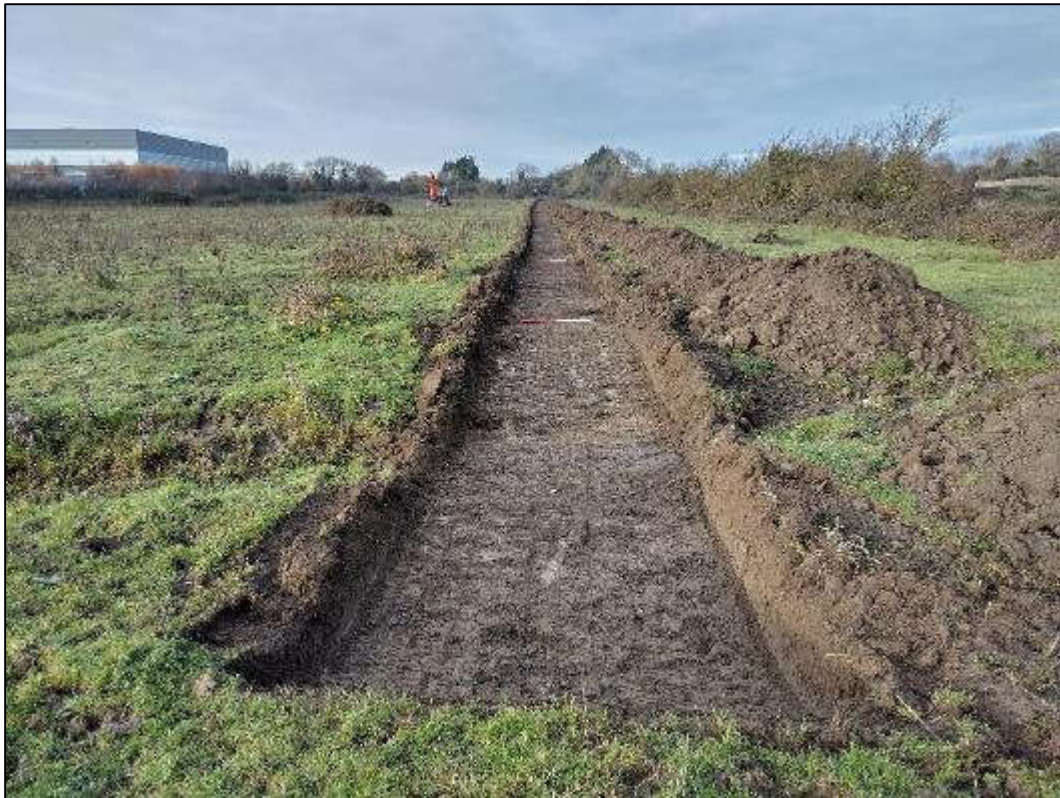
Plate 10: Trench 7 facing west-northwest

Trench ID	T7
Dimensions	W: 1.8m L: 230m D:0.25-0.4m
Orientation	ENE-WSW
ITM Co-ords	713470.78 742483.77 713367.10 742485.41
Description	Test Trench 7 (T7) was excavated to a minimum depth of 0.25m and a maximum depth of 0.4m below the existing ground level. The topsoil consisted of a mid greyish brown silty clay with occasional stone inclusions. This overlay a compact grey/yellow clay subsoil with occasional stone inclusions. One possible pit or trough feature [C.003] defined by charcoal rich silty clay and heat fractured stones was uncovered in this trench at 713496.84/742399.71 (ITM). The feature extended slightly beyond the limit of excavation to the north and south but appeared to have an oval shape in plan measuring 1.90m SE-NW by 1.50m NE-SW. A number of modern cultivation furrows orientated east – west and filled with topsoil were noted within this trench. Plate 10 - 12

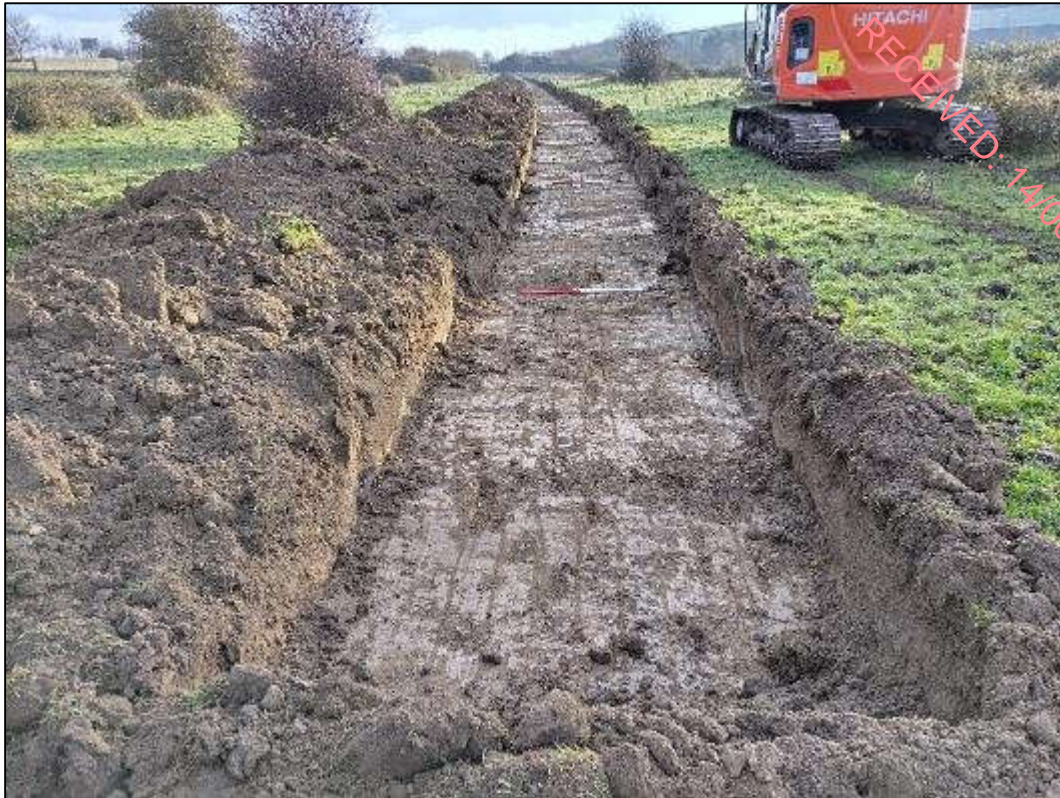
Plate 11: Trench 7 facing east-southeast

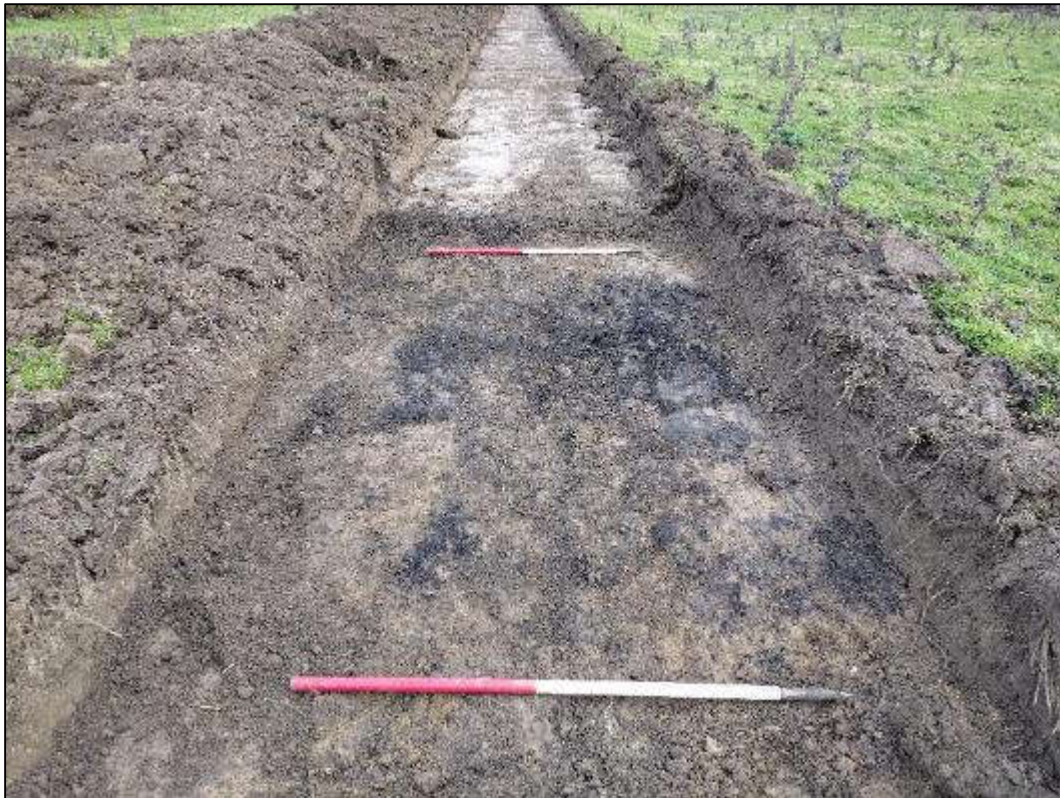
Plate 12: Trench 7, feature [C.003], facing east-southeast

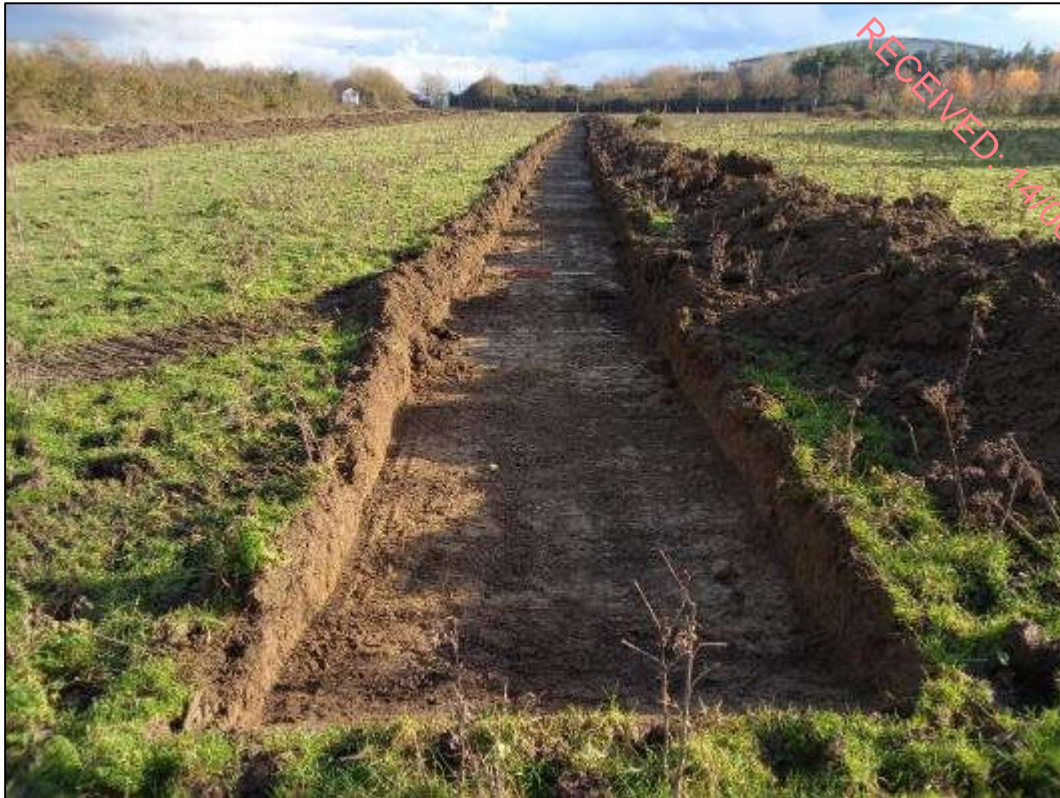
Plate 13: Trench 8 facing west-northwest

Trench ID	T8
Dimensions	W: 1.8m L: 125m D:0.3-0.5m
Orientation	ENE-WSW
ITM Co-ords	713464.62 742468.37 713365.05 742471.45
Description	Test Trench 8 (T8) was excavated to a minimum depth of 0.3m and a maximum depth of 0.5m below the existing surface level. The topsoil consisted of mid greyish brown silty clay with moderate inclusions of small stones. It overlay a compact light grey/yellow clay subsoil with occasional stone inclusions. A number of modern cultivation furrows orientated east – west and filled with topsoil were noted within this trench. Nothing of archaeological significance was encountered in this trench. Plate 13 - 14

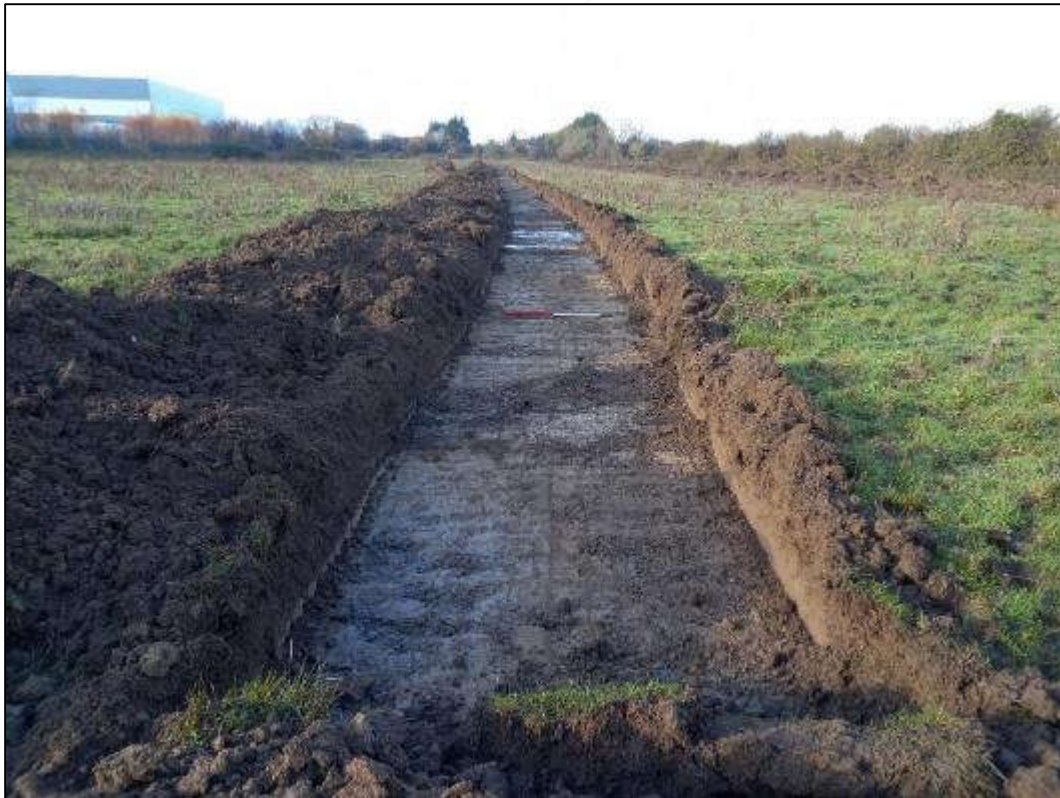
Plate 14: Trench 8 facing west-northwest

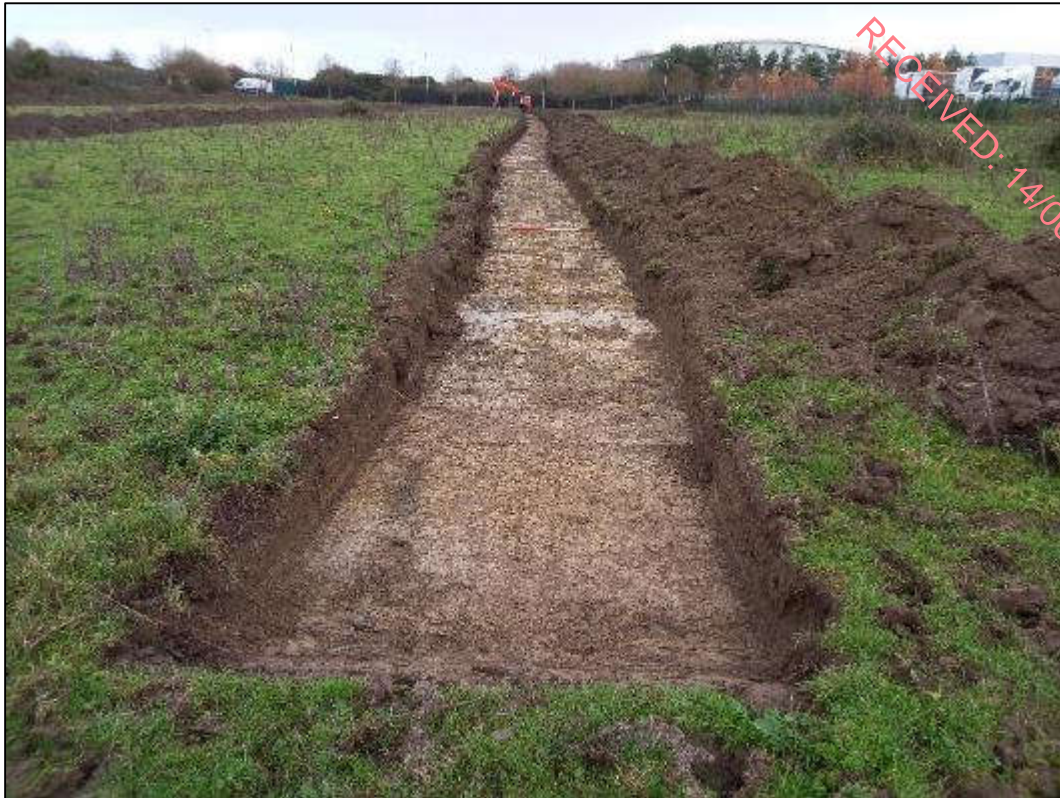
Plate 15: Trench 9 facing east-southeast

Trench ID	T9
Dimensions	W: 1.8m L: 128m D:0.3-0.4m
Orientation	ENE-WSW
ITM Co-ords	713462.57 742456.06 713364.02 742458.52
Description	Test Trench 9 (T9) was excavated to a minimum depth of 0.3m and a maximum depth of 0.4m below the existing surface level. The topsoil consisted of mid greyish brown silty clay with moderate inclusions of small stones. It overlay a compact light grey/yellow clay subsoil with occasional stone inclusions. A number of modern cultivation furrows orientated east – west and filled with topsoil were noted within this trench. Nothing of archaeological significance was encountered in this trench. Plate 15 - 16

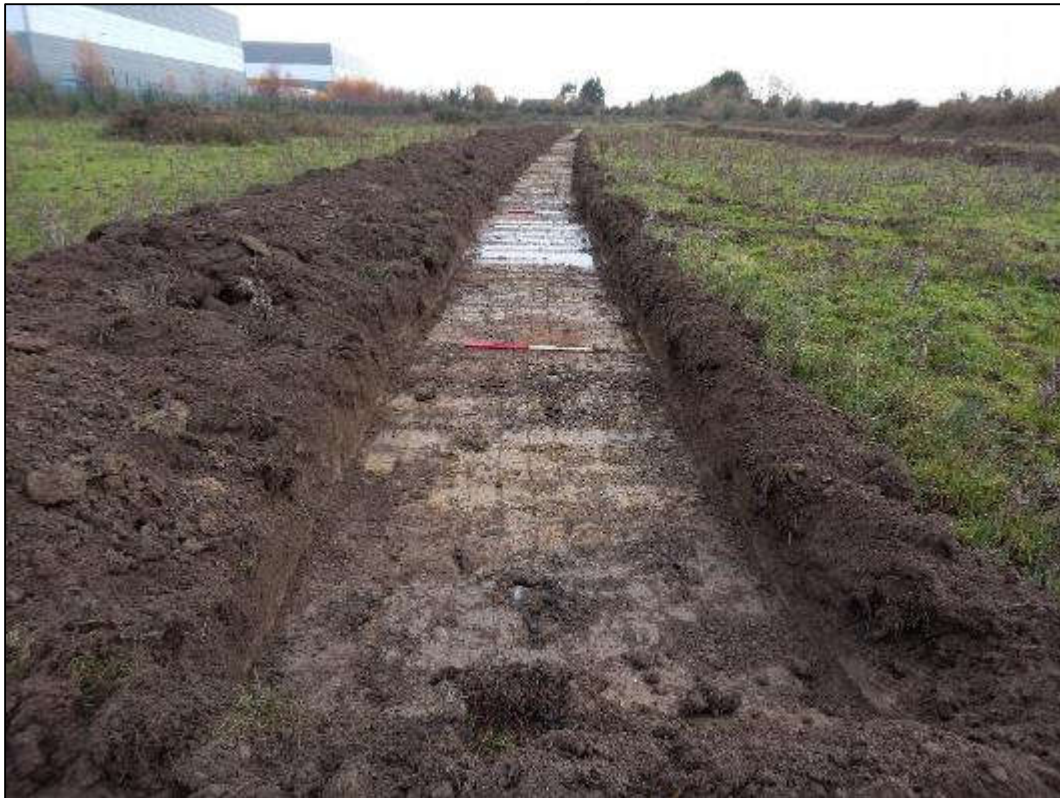
Plate 16: Trench 9 facing west-northwest

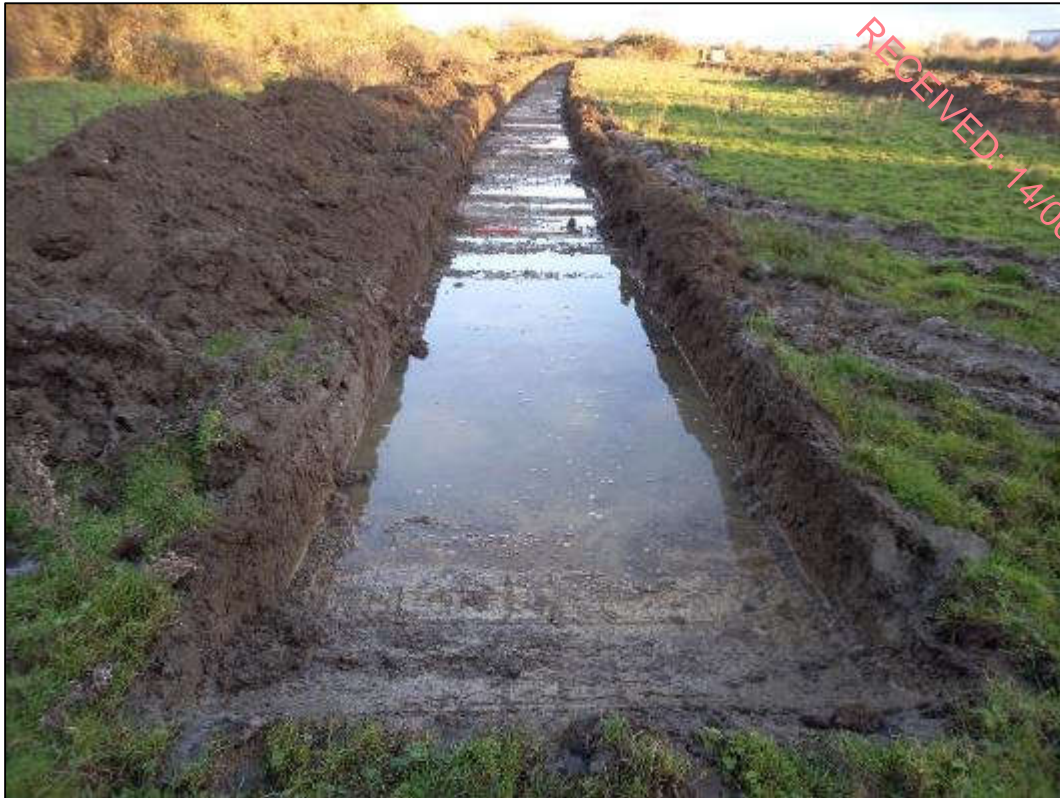
Plate 17: Trench 10 facing east

Description	Test Trench 10 (T10) was excavated to a minimum depth of 0.4m and a maximum depth of 0.5m below the existing surface level. The topsoil consisted of a mid greyish brown silty clay with occasional stone inclusions. This overlay a compact light grey/yellow clay subsoil with occasional stone inclusions. One possible pit feature [C.004] defined by charcoal rich silty clay and occasional heat fractured stones was uncovered in this trench at 713424.72/742486.80 (ITM). The feature had a circular shape in plan and a diameter of 1.15m. Plate 17 - 19
-------------	---

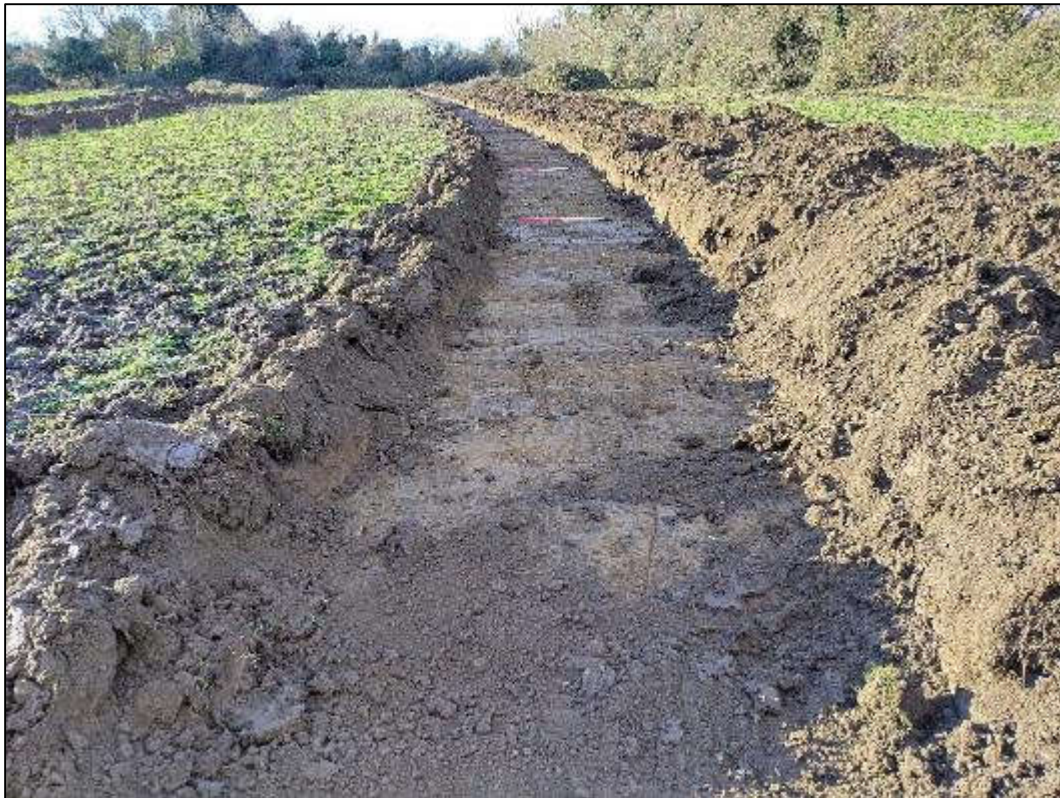
Plate 18: Trench 10 facing west
