Basic Results Summary

Scenario 11: '2023 DS AM' (FG9: '2023 DS AM', Plan 1: 'Network Control Plan - AM')

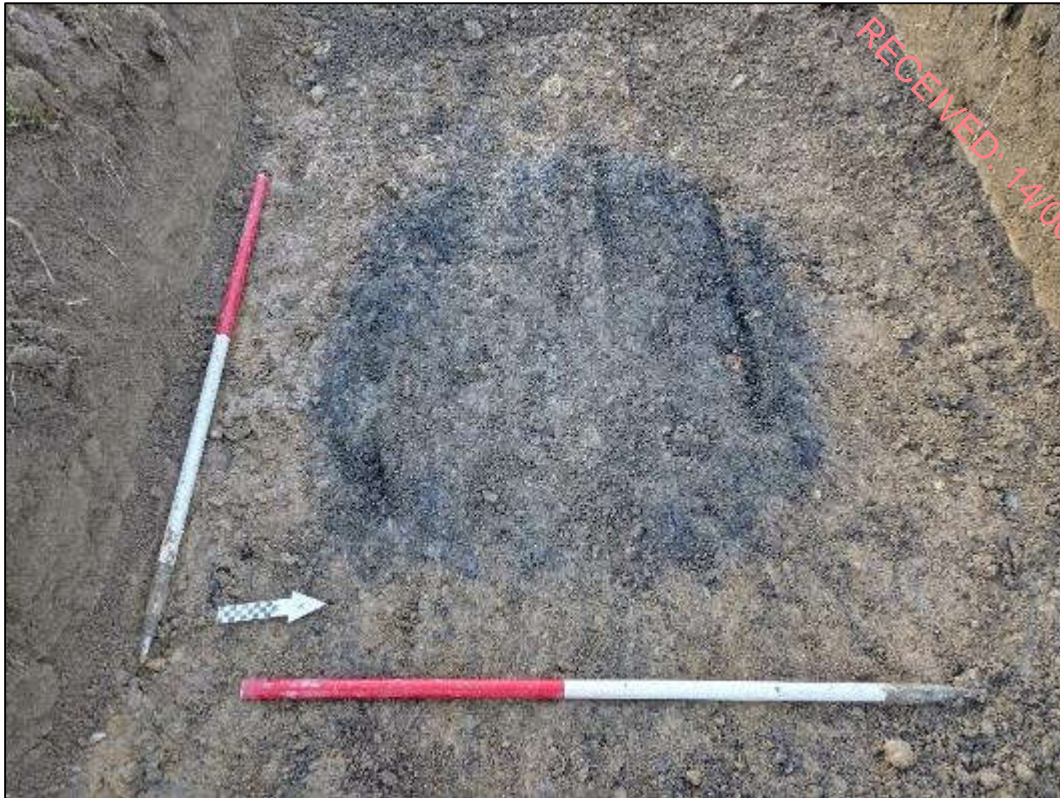
Plate 19: Close up of feature [C.004] in Trench 10 facing west

All trenches were located within agricultural land used for grazing and excavated through topsoil deposits (**Figure 9**). The natural subsoil, a light grey/yellow clay was encountered at a depth of 0.25 to 0.55m below the ground surface. Two charcoal rich features, [C.003] and [C.004] interpreted as possible pits or troughs, were identified within Trench 7 and 10. No other archaeological features or deposits were uncovered. Trench 1 and 2 could not be excavated due to lack of access, and Trench 3 was shortened by 30m (**Plate 1**). Extracts from the photographic record are presented in **Appendix 3**.

Description	Test Trench 10 (T10) was excavated to a minimum depth of 0.4m and a maximum depth of 0.5m below the existing surface level. The topsoil consisted of a mid greyish brown silty clay with occasional stone inclusions. This overlay a compact light grey/yellow clay subsoil with occasional stone inclusions. One possible pit feature [C.004] defined by charcoal rich silty clay and occasional heat fractured stones was uncovered in this trench at 713424.72/742486.80 (ITM). The feature had a circular shape in plan and a diameter of 1.15m. Plate 17 - 19
-------------	---
