12.0 LANDSCAPE

12.1 Introduction

This section of the Revised EIAR assesses the landscape & visual impact associated with the development on the surrounding landscape in the vicinity of the proposed development. Methodologies used to assess the landscape and visual impacts are outlined and mitigation measures are proposed where required. A landscaping and restoration plan is proposed which will be implemented during the operational lifetime of the development with final restoration undertaken on completion of extraction. A copy of the Revised Landscape & Restoration Plan is attached in Appendix 12.1.

This chapter has been updated on foot of Laois County Council's *Request for Further Information* (LCC Reg. Ref. 23/60390).

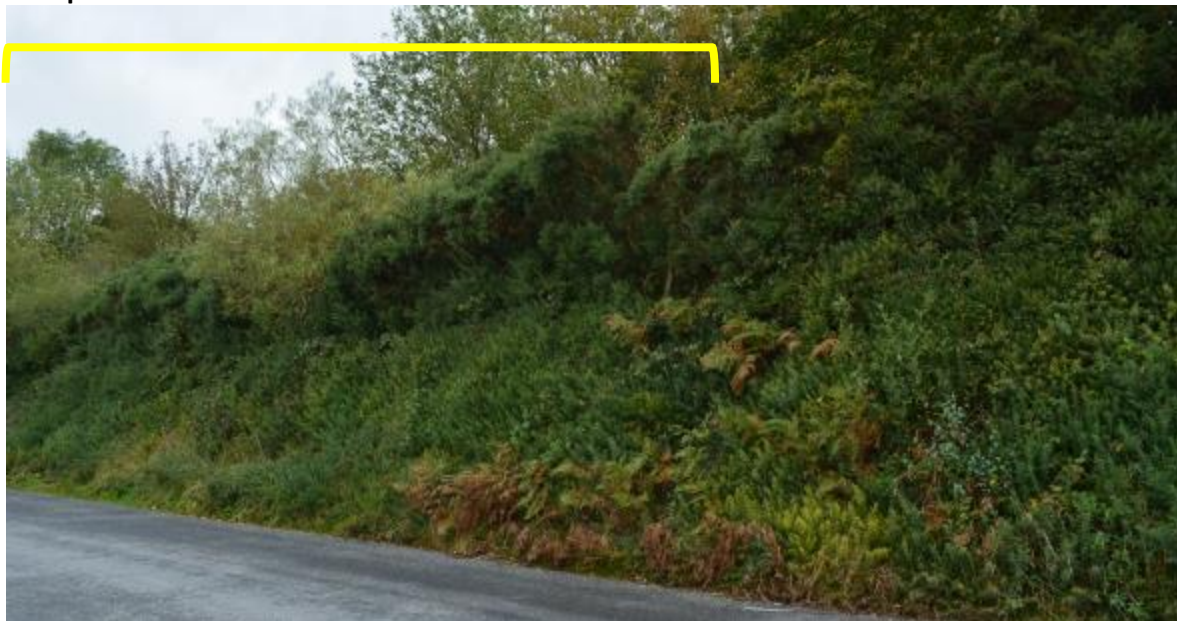
Viewpoint 1 is from a location to the south of the application site along the L-5731-25 road. The application site is not visible at this location due to the topography of the surrounding land and the field boundary hedgerows.

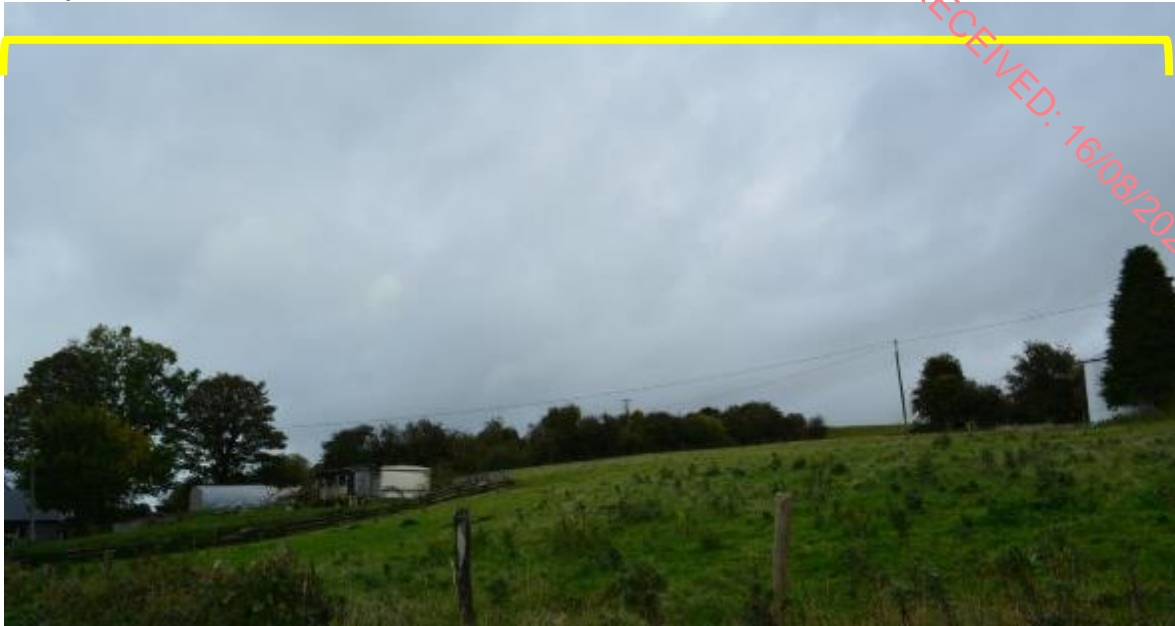
Viewpoint 2 is from a location northwest of Viewpoint 1 along the L-5731-25 local road closer to the application site. The application site is not visible due to the natural topography and vegetation located along field boundaries.

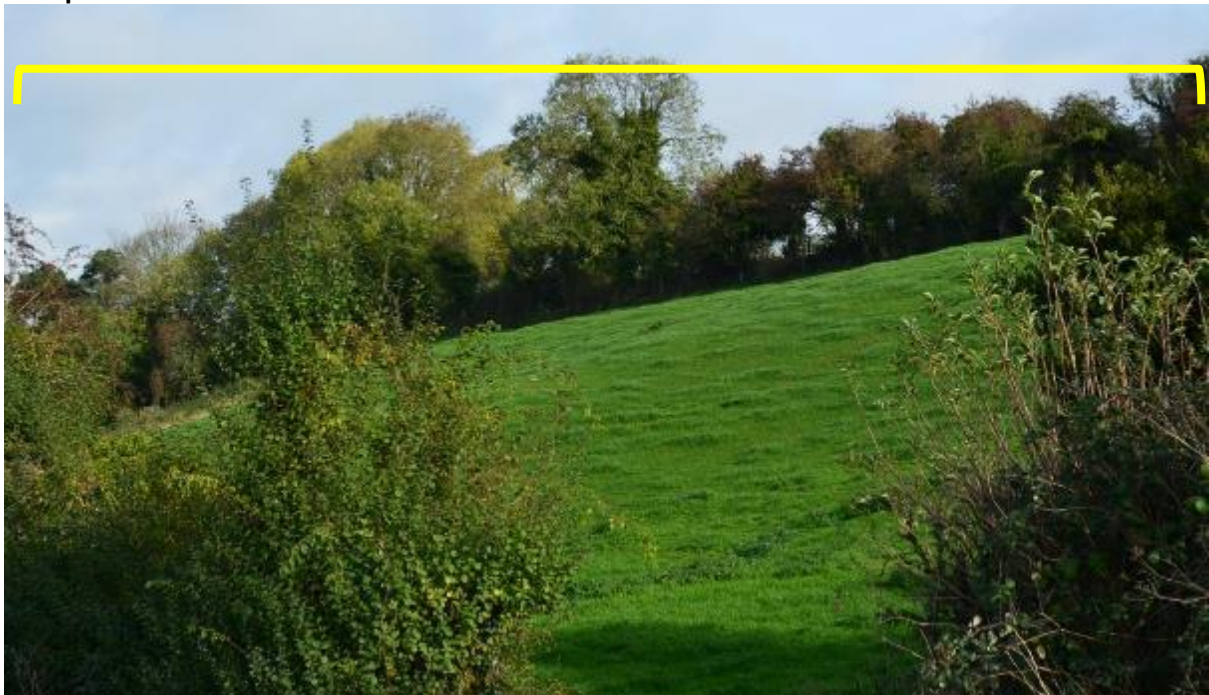
Viewpoint 3 is from a location along the boundary of the application site and the L-5731-25 local road. The site is visible along the local road due to the topography and limited boundary vegetation.

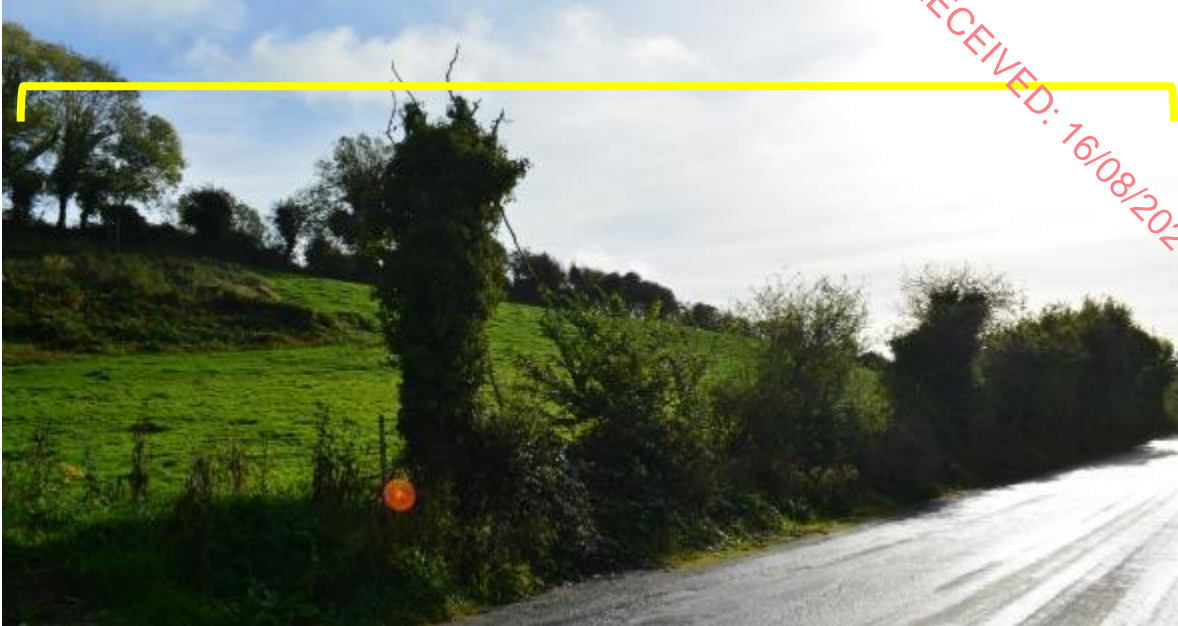
Viewpoint 4 is taken from a location to the west of the site along the L-5731-25. Similar to viewpoint 3 the application site is visible at this location.

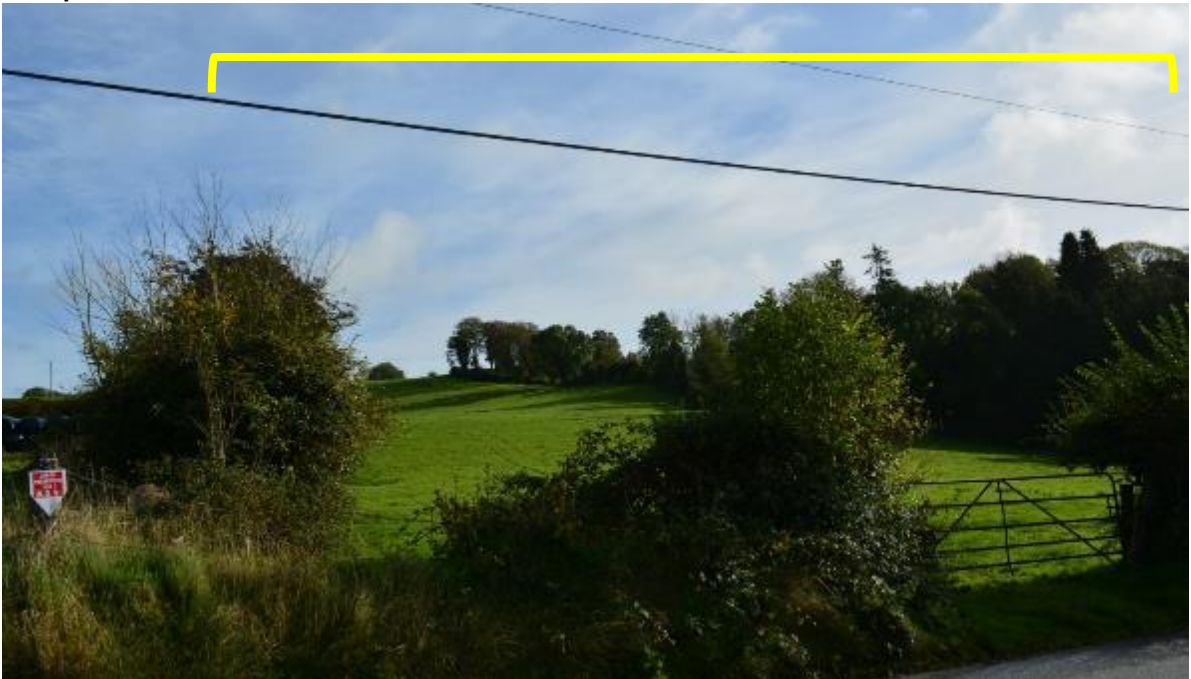
Viewpoint 5 is from a location further north along the L-5731-25. Similar to viewpoint 3 and 4 the application site is visible at this location.

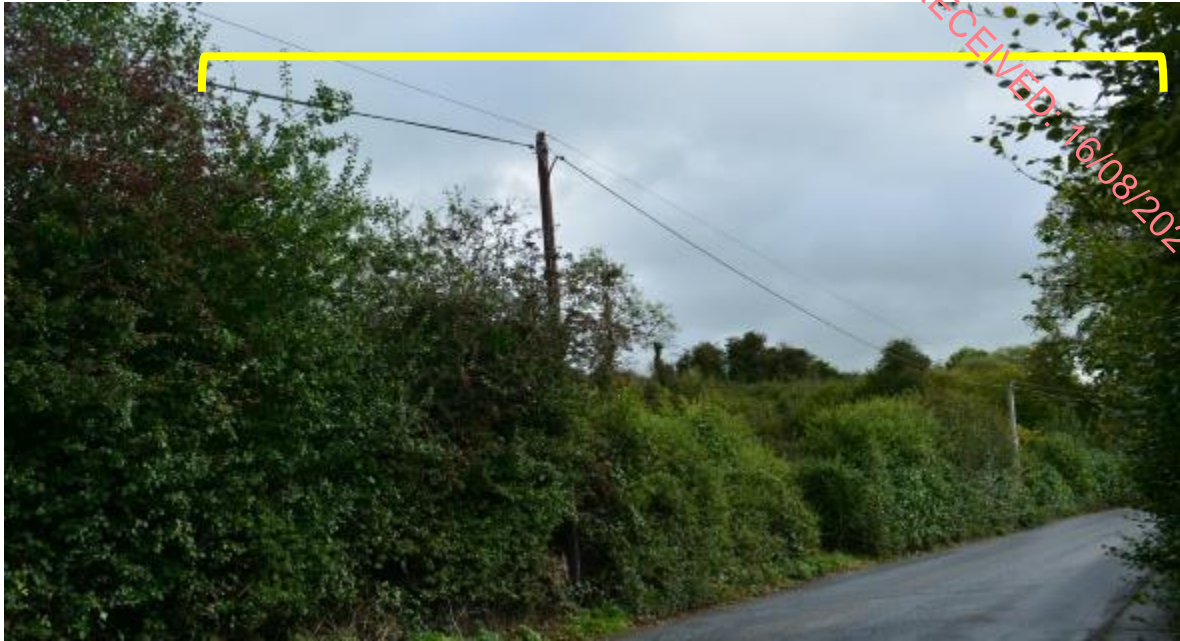
Viewpoint 6 is from a location close to Grallow Wood housing estate. The application site is not visible due to the screening provided by the natural topography and vegetation located along field boundaries.

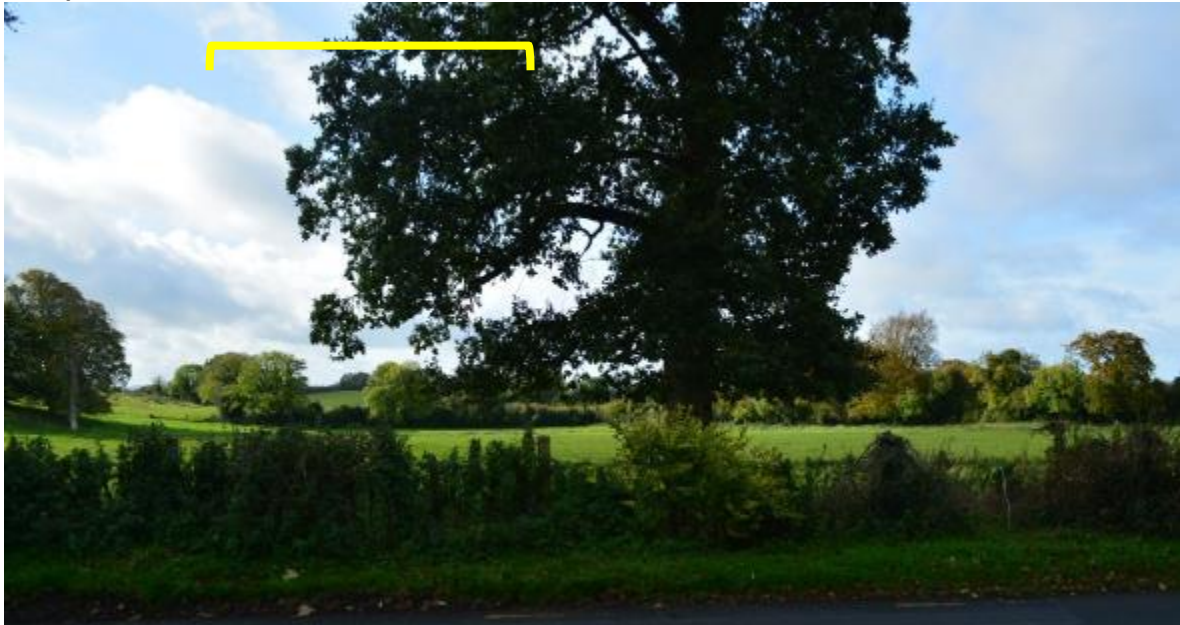
Viewpoint 7 is taken from a location along the R432 close to a housing estate on the outskirts of Abbeyleix town. The application site is not visible at this location due to the vegetation located along field boundaries.

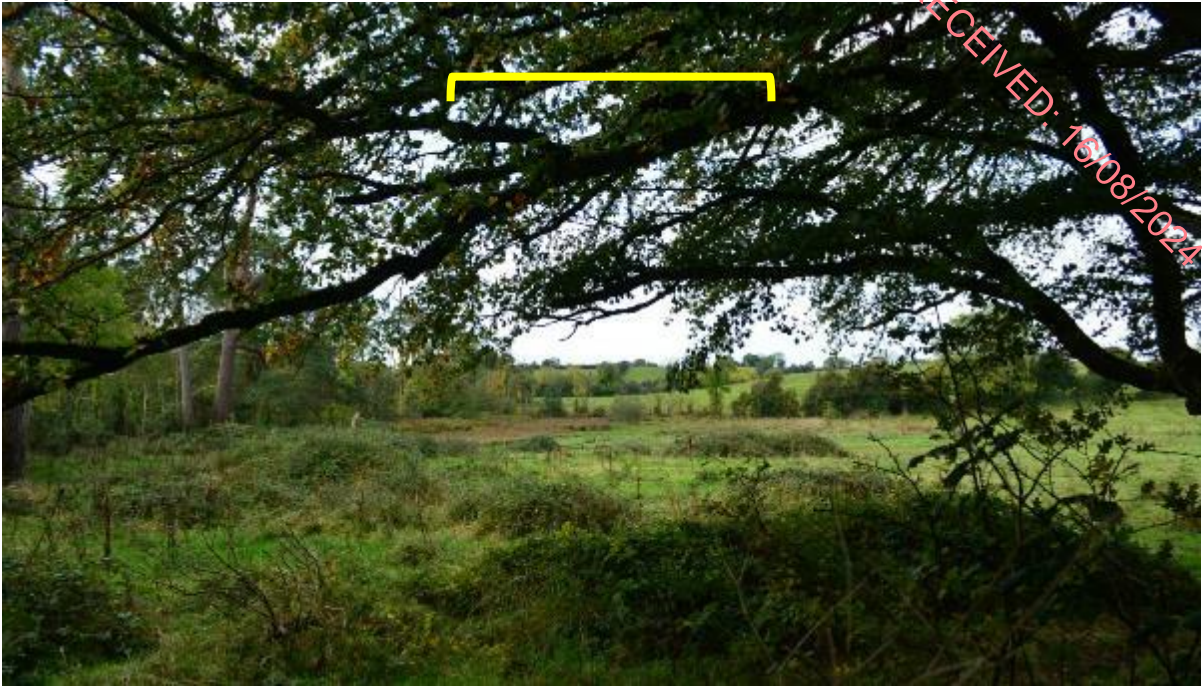
Viewpoint 8 is taken from a location further south along the R432. The application site is slightly visible at this location with vegetation along field boundaries providing significant screening.

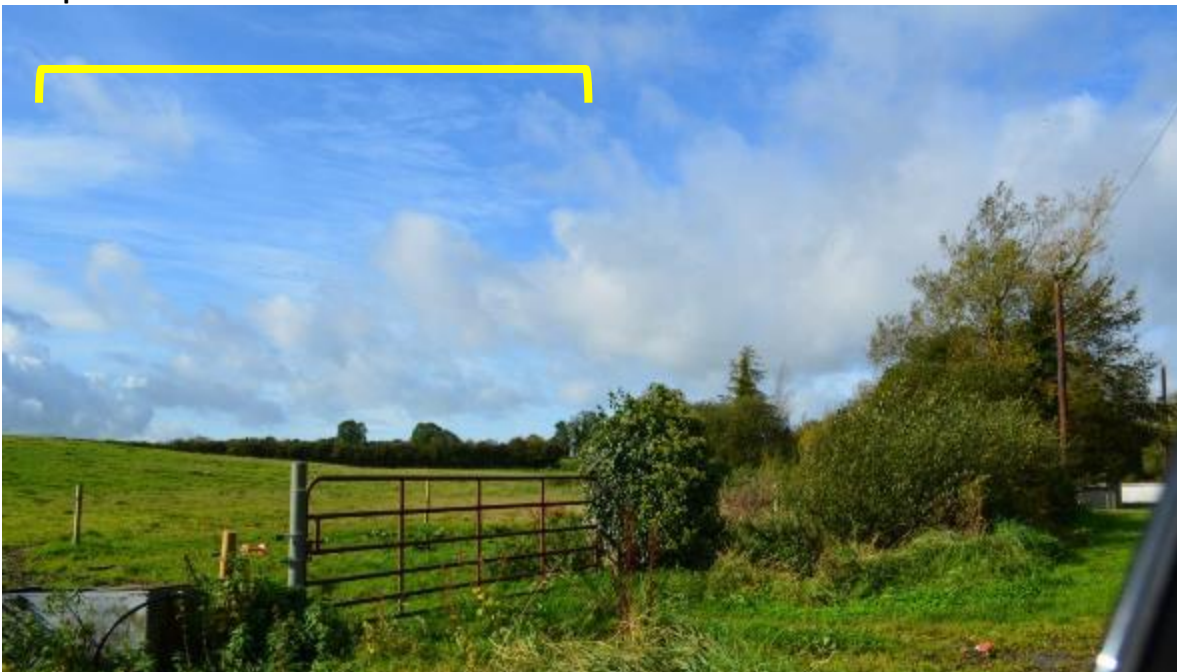
Viewpoint 9

This viewpoint is from a location further south of the R432 from viewpoint 8. The application site is not visible at this location.

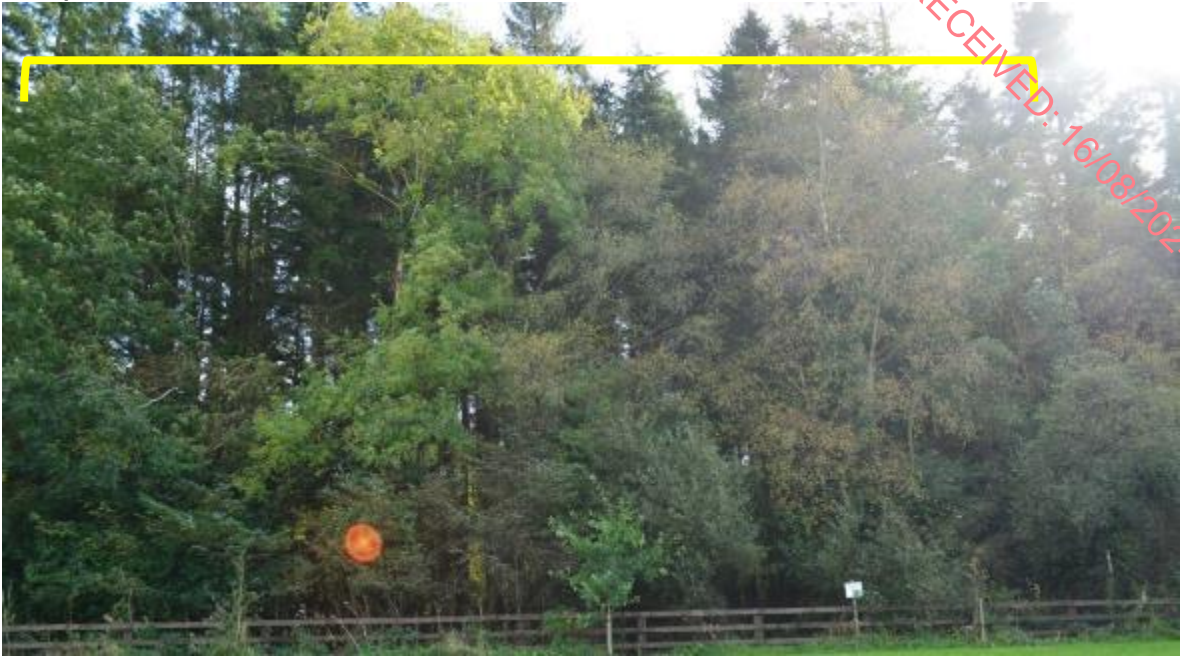
Viewpoint 10 is from a location along the N77 to the west of the site. The application site is not visible at this location due the woodland area along eastern side of the N77.

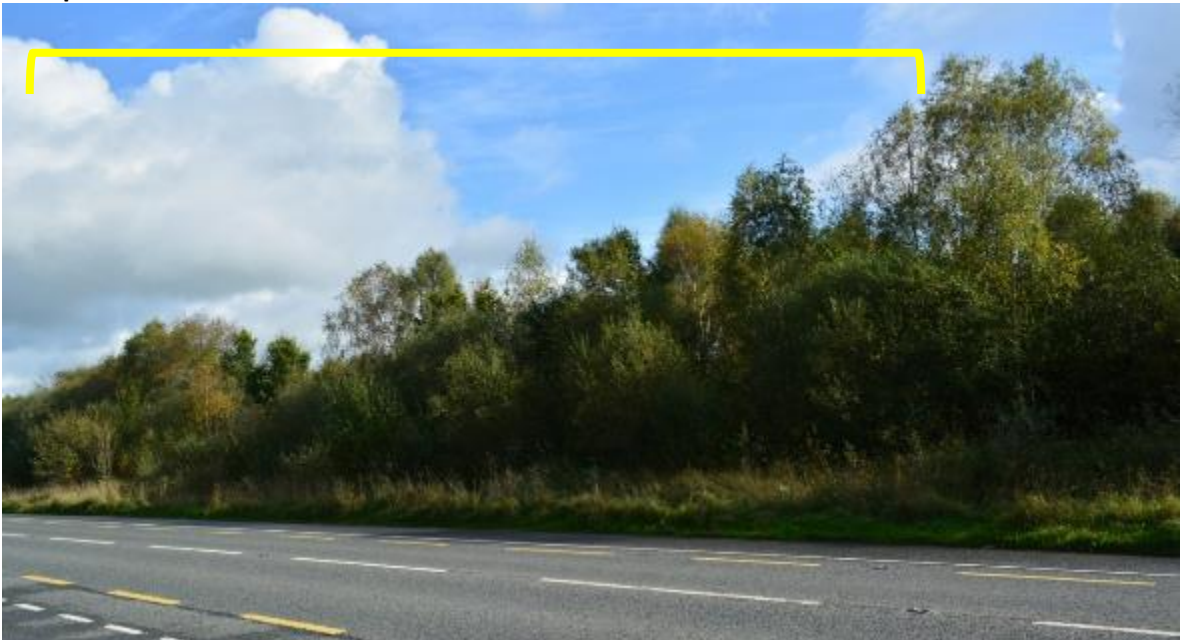
Viewpoint 11 is from a location along the N77 further south of viewpoint 10. Similar to viewpoint 10, the application site is not visible due to the woodland area along eastern side of the N77.

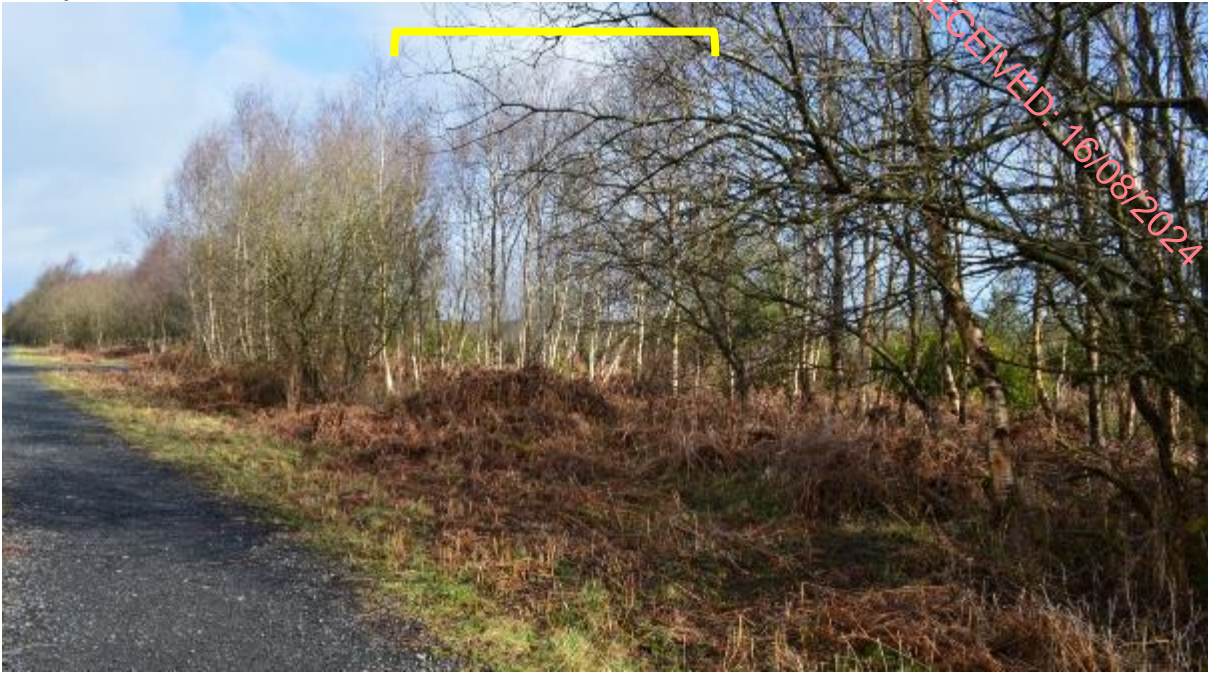
Viewpoint 12 is from a location along the main path before you proceed onto the board walk. The application site is not visible to through the existing vegetation.

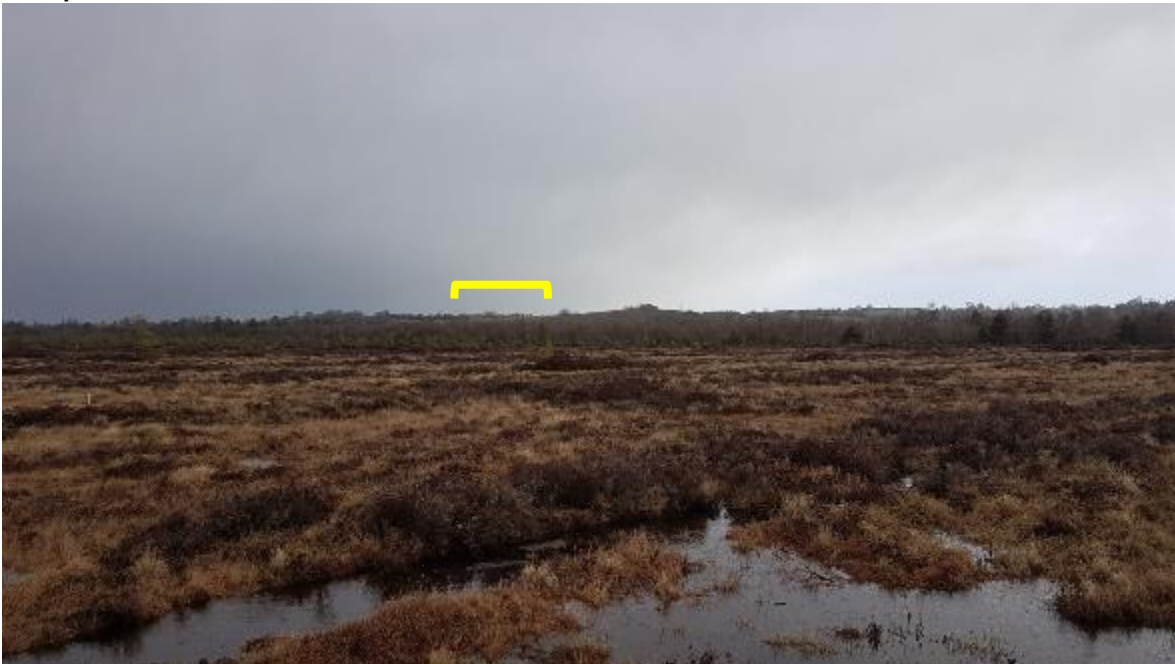
Viewpoint 13 was taken from a location along the Abbyleix Board walk. The upper part of the application site is visible at this location.

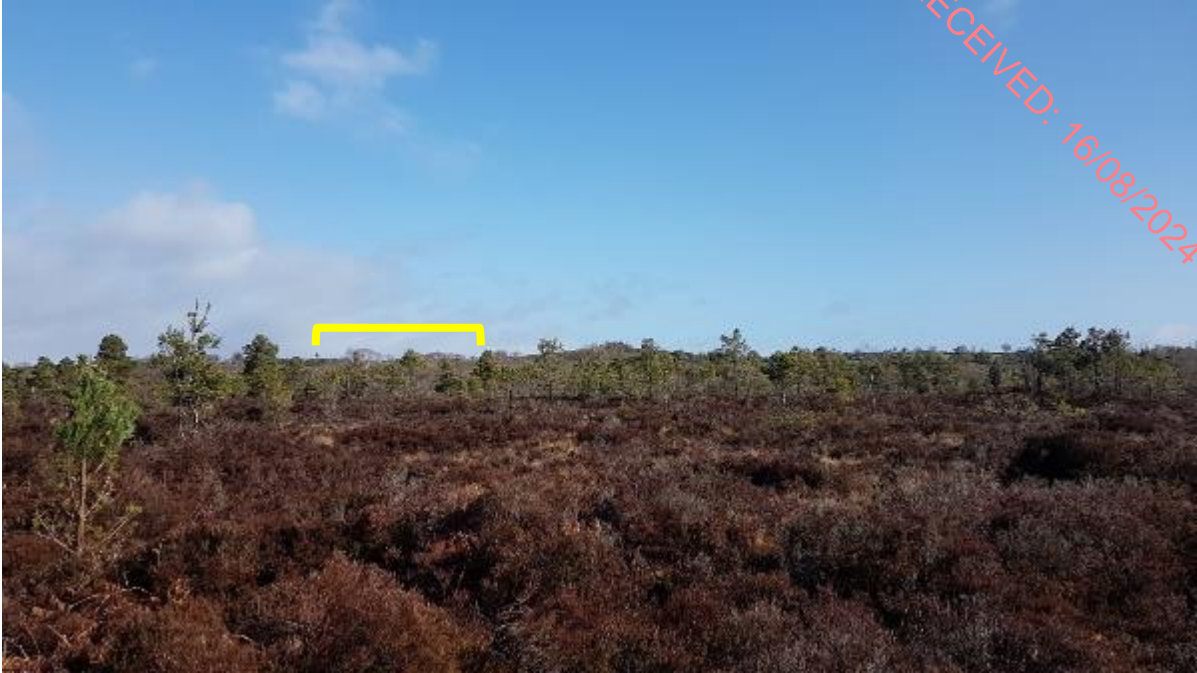
Viewpoint 14 was taken from a location along the Abbeyleix Bog walk southwest of the application site. The application site is slightly visible through the vegetation.

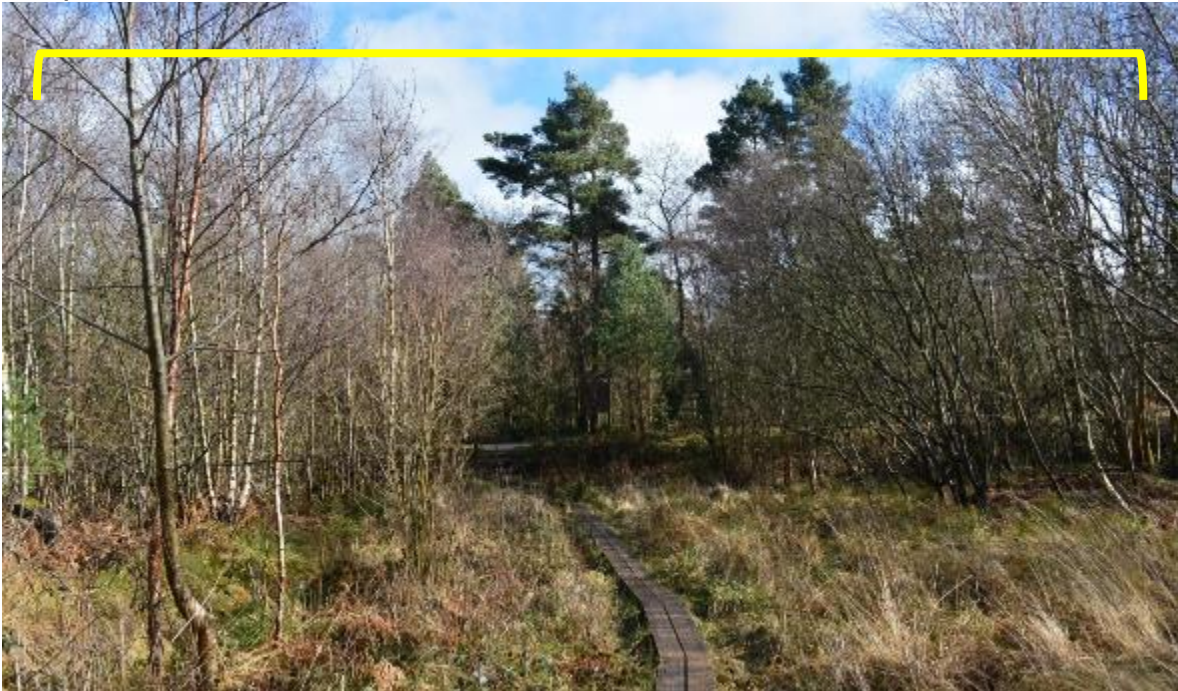
Viewpoint 15 is from a location where the boardwalk returns to meet the main track. The application site is not visible at this location.

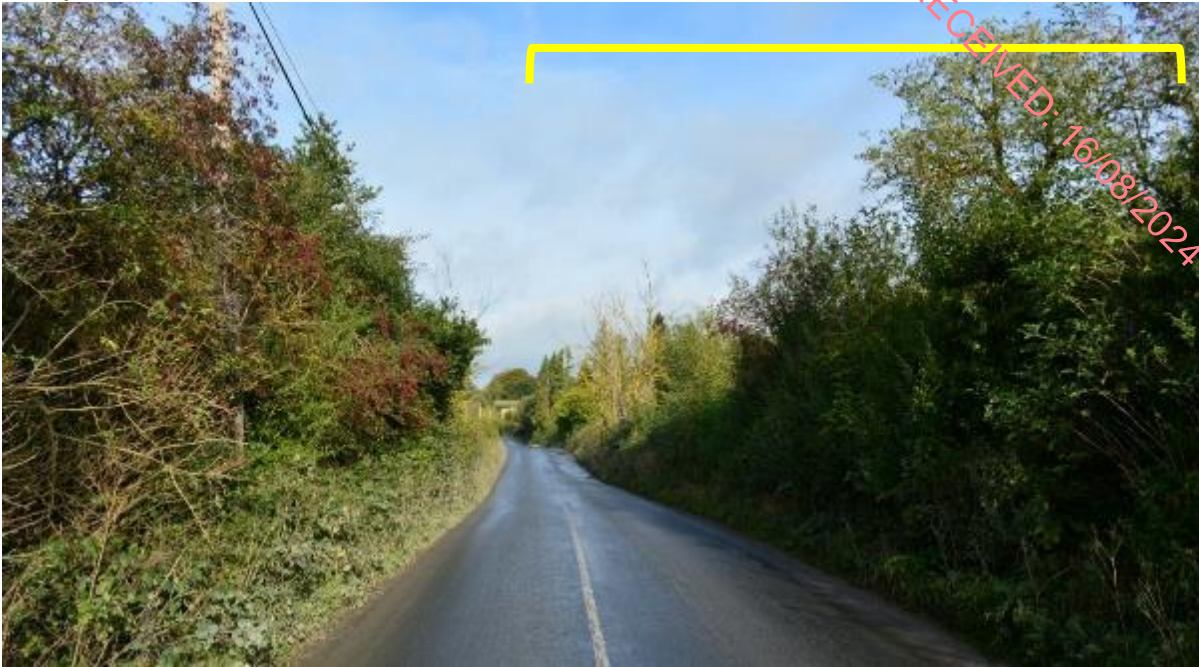
Viewpoint 16 is from a location along the L-5731-25 local road close to the south eastern boundary of the application site. The existing roadside vegetation provides screening of the site.

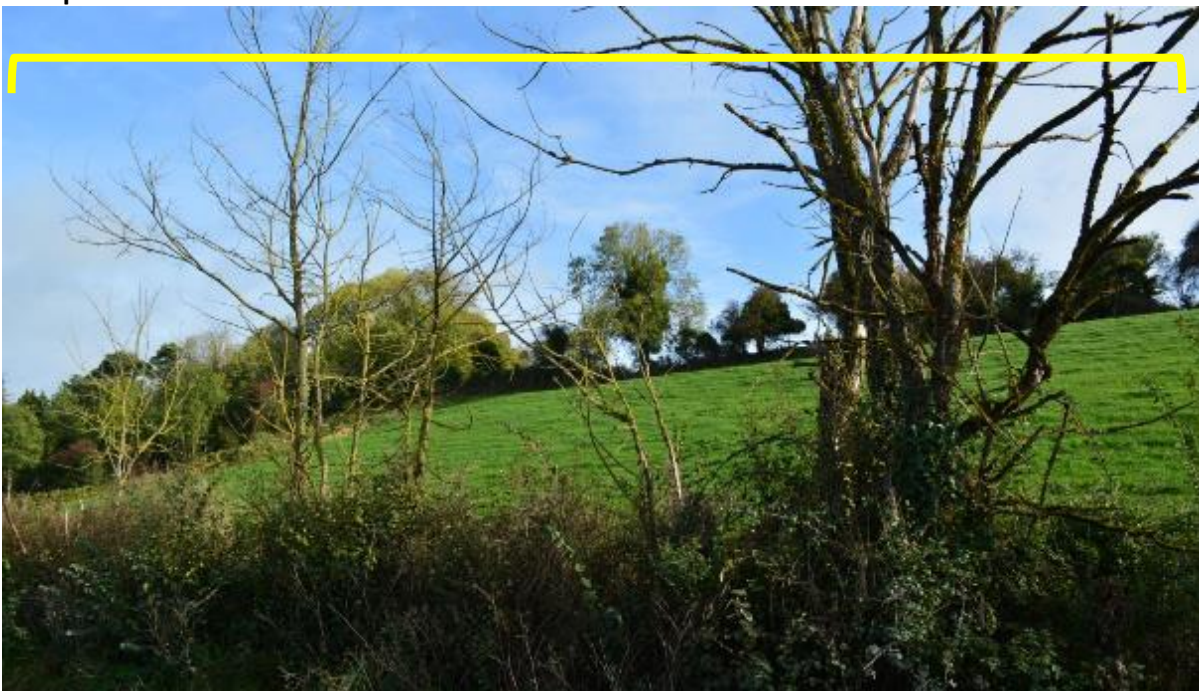
Viewpoint 17 is from a location along the L-5731-25. The application site is visible above the road side vegetation.

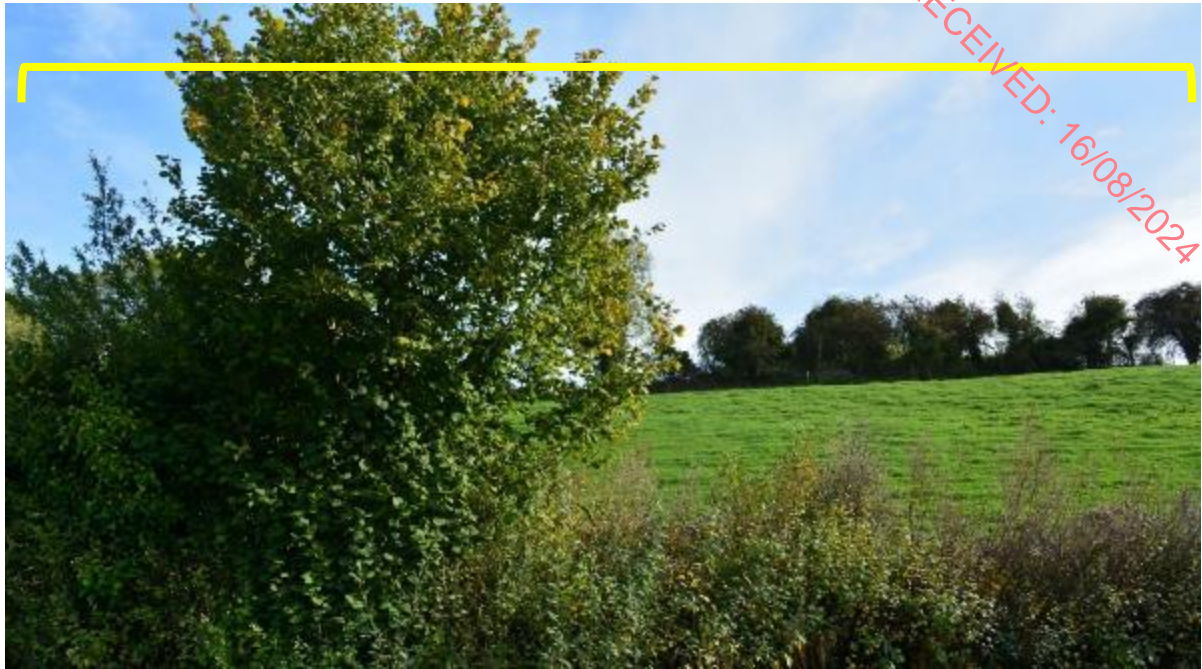
Viewpoint 18 is from a location along the L-5731-25. Similar to Viewpoint 17 the application site is visible above the roadside vegetation.

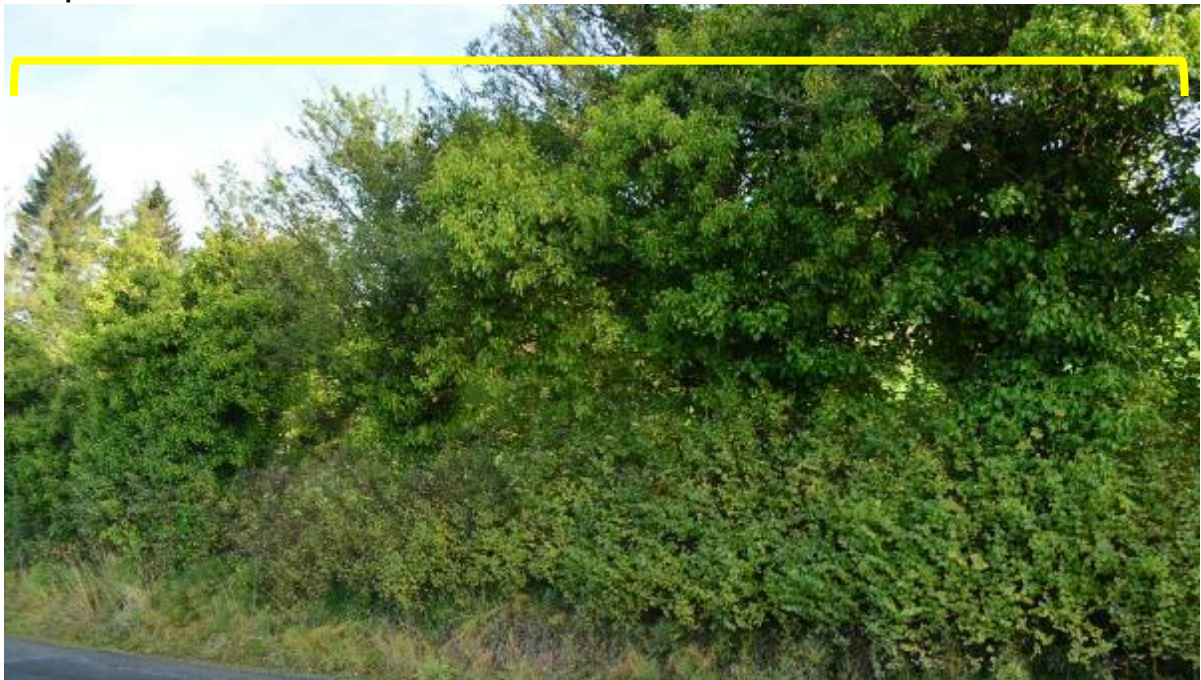
Viewpoint 19 is from a location to further north of Viewpoint 18. The application site is not visible at this location due to the roadside vegetation.

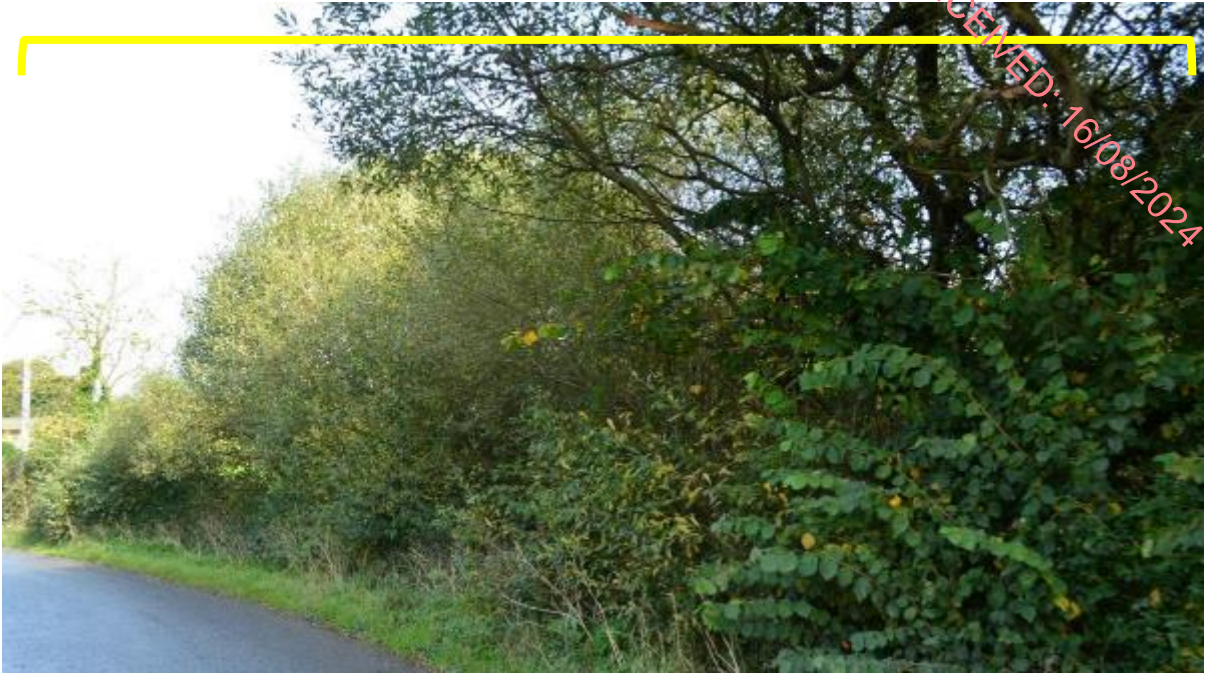
Viewpoint 20 is from a location further north of the existing site entrance. The existing roadside vegetation provides screening of the application site.

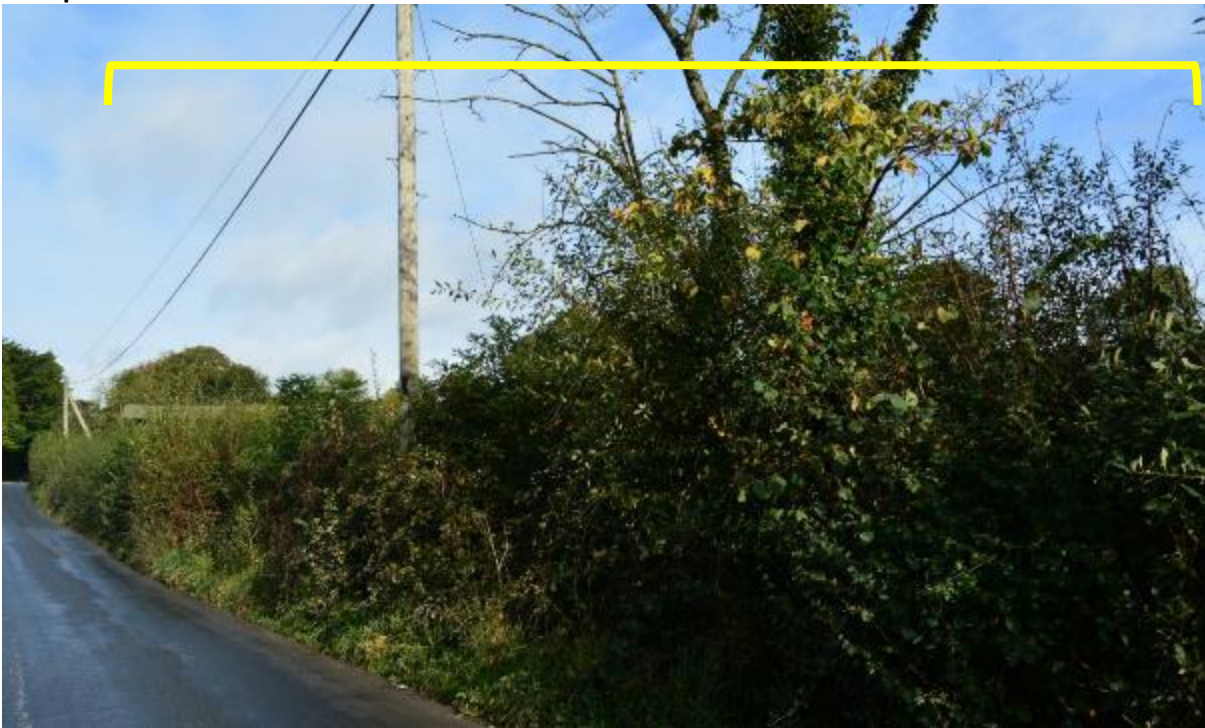
Viewpoint 21 is from a location along the northwestern boundary of the application site. The application site is not visible at this location due to the roadside vegetation.

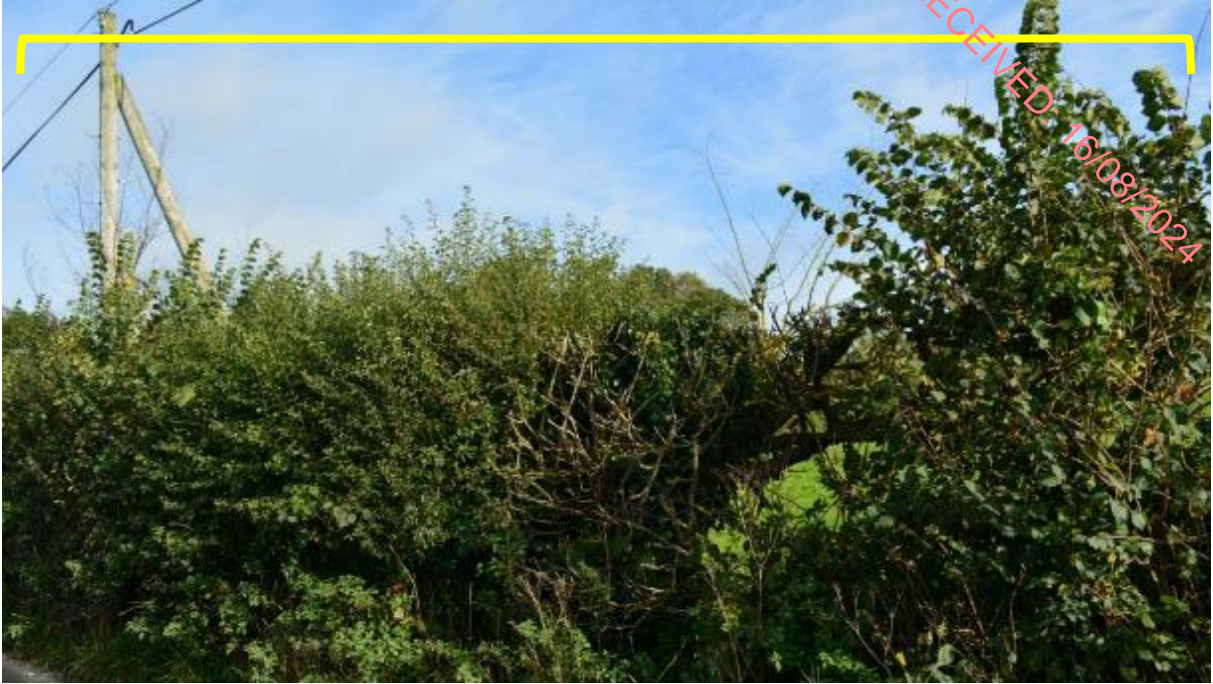
Viewpoint 22 was taken close to the northwestern corner of the application site. The application site is not visible at this location due to the roadside vegetation.

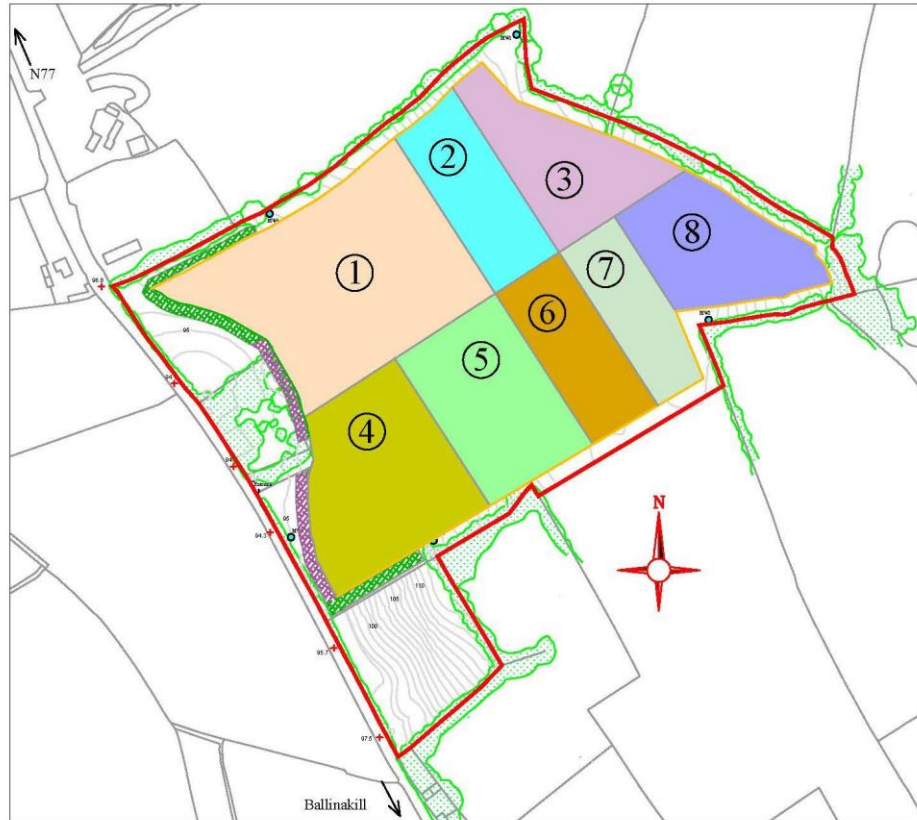
Plate 1: Proposed Extraction Plan

The applicant proposes to remove the existing woodland, vegetation and overburden and extract the underlying sand and gravel material in line with an eight-phase extraction plan as detailed on Plate 1. As illustrated in Plate 1, the extraction of material will be undertaken

over 8 phases over a 10 year period with each phases consisting on average of 12 months of material. It is proposed to implement a rolling landscape and restoration plan which will aid in reducing the visual impact associated with the proposed development. This includes the revegetating or areas, provision of berms and planting of trees and shrubs to reduce visibility of the pit. This will ensure that phases are extracted then restored on a rolling basis with only a minimum area of the site subject to activity.

It is proposed to construct a berm along the western boundary using overburden and sand and gravel material removed from Phase 1. As extraction proceeds into various phases, overburden removed from the working phase will be used to restore the previous phase where material has been extracted. This will be undertaken on a rolling basis to minimise the uncovered area of the site.
