12.0 LANDSCAPE

12.1 Introduction

This section of the Revised EIAR assesses the landscape & visual impact associated with the development on the surrounding landscape in the vicinity of the proposed development. Methodologies used to assess the landscape and visual impacts are outlined and mitigation measures are proposed where required. A landscaping and restoration plan is proposed which will be implemented during the operational lifetime of the development with final restoration undertaken on completion of extraction. A copy of the Revised Landscape & Restoration Plan is attached in Appendix 12.1.

This chapter has been updated on foot of Laois County Council's *Request for Further Information* (LCC Reg. Ref. 23/60390).

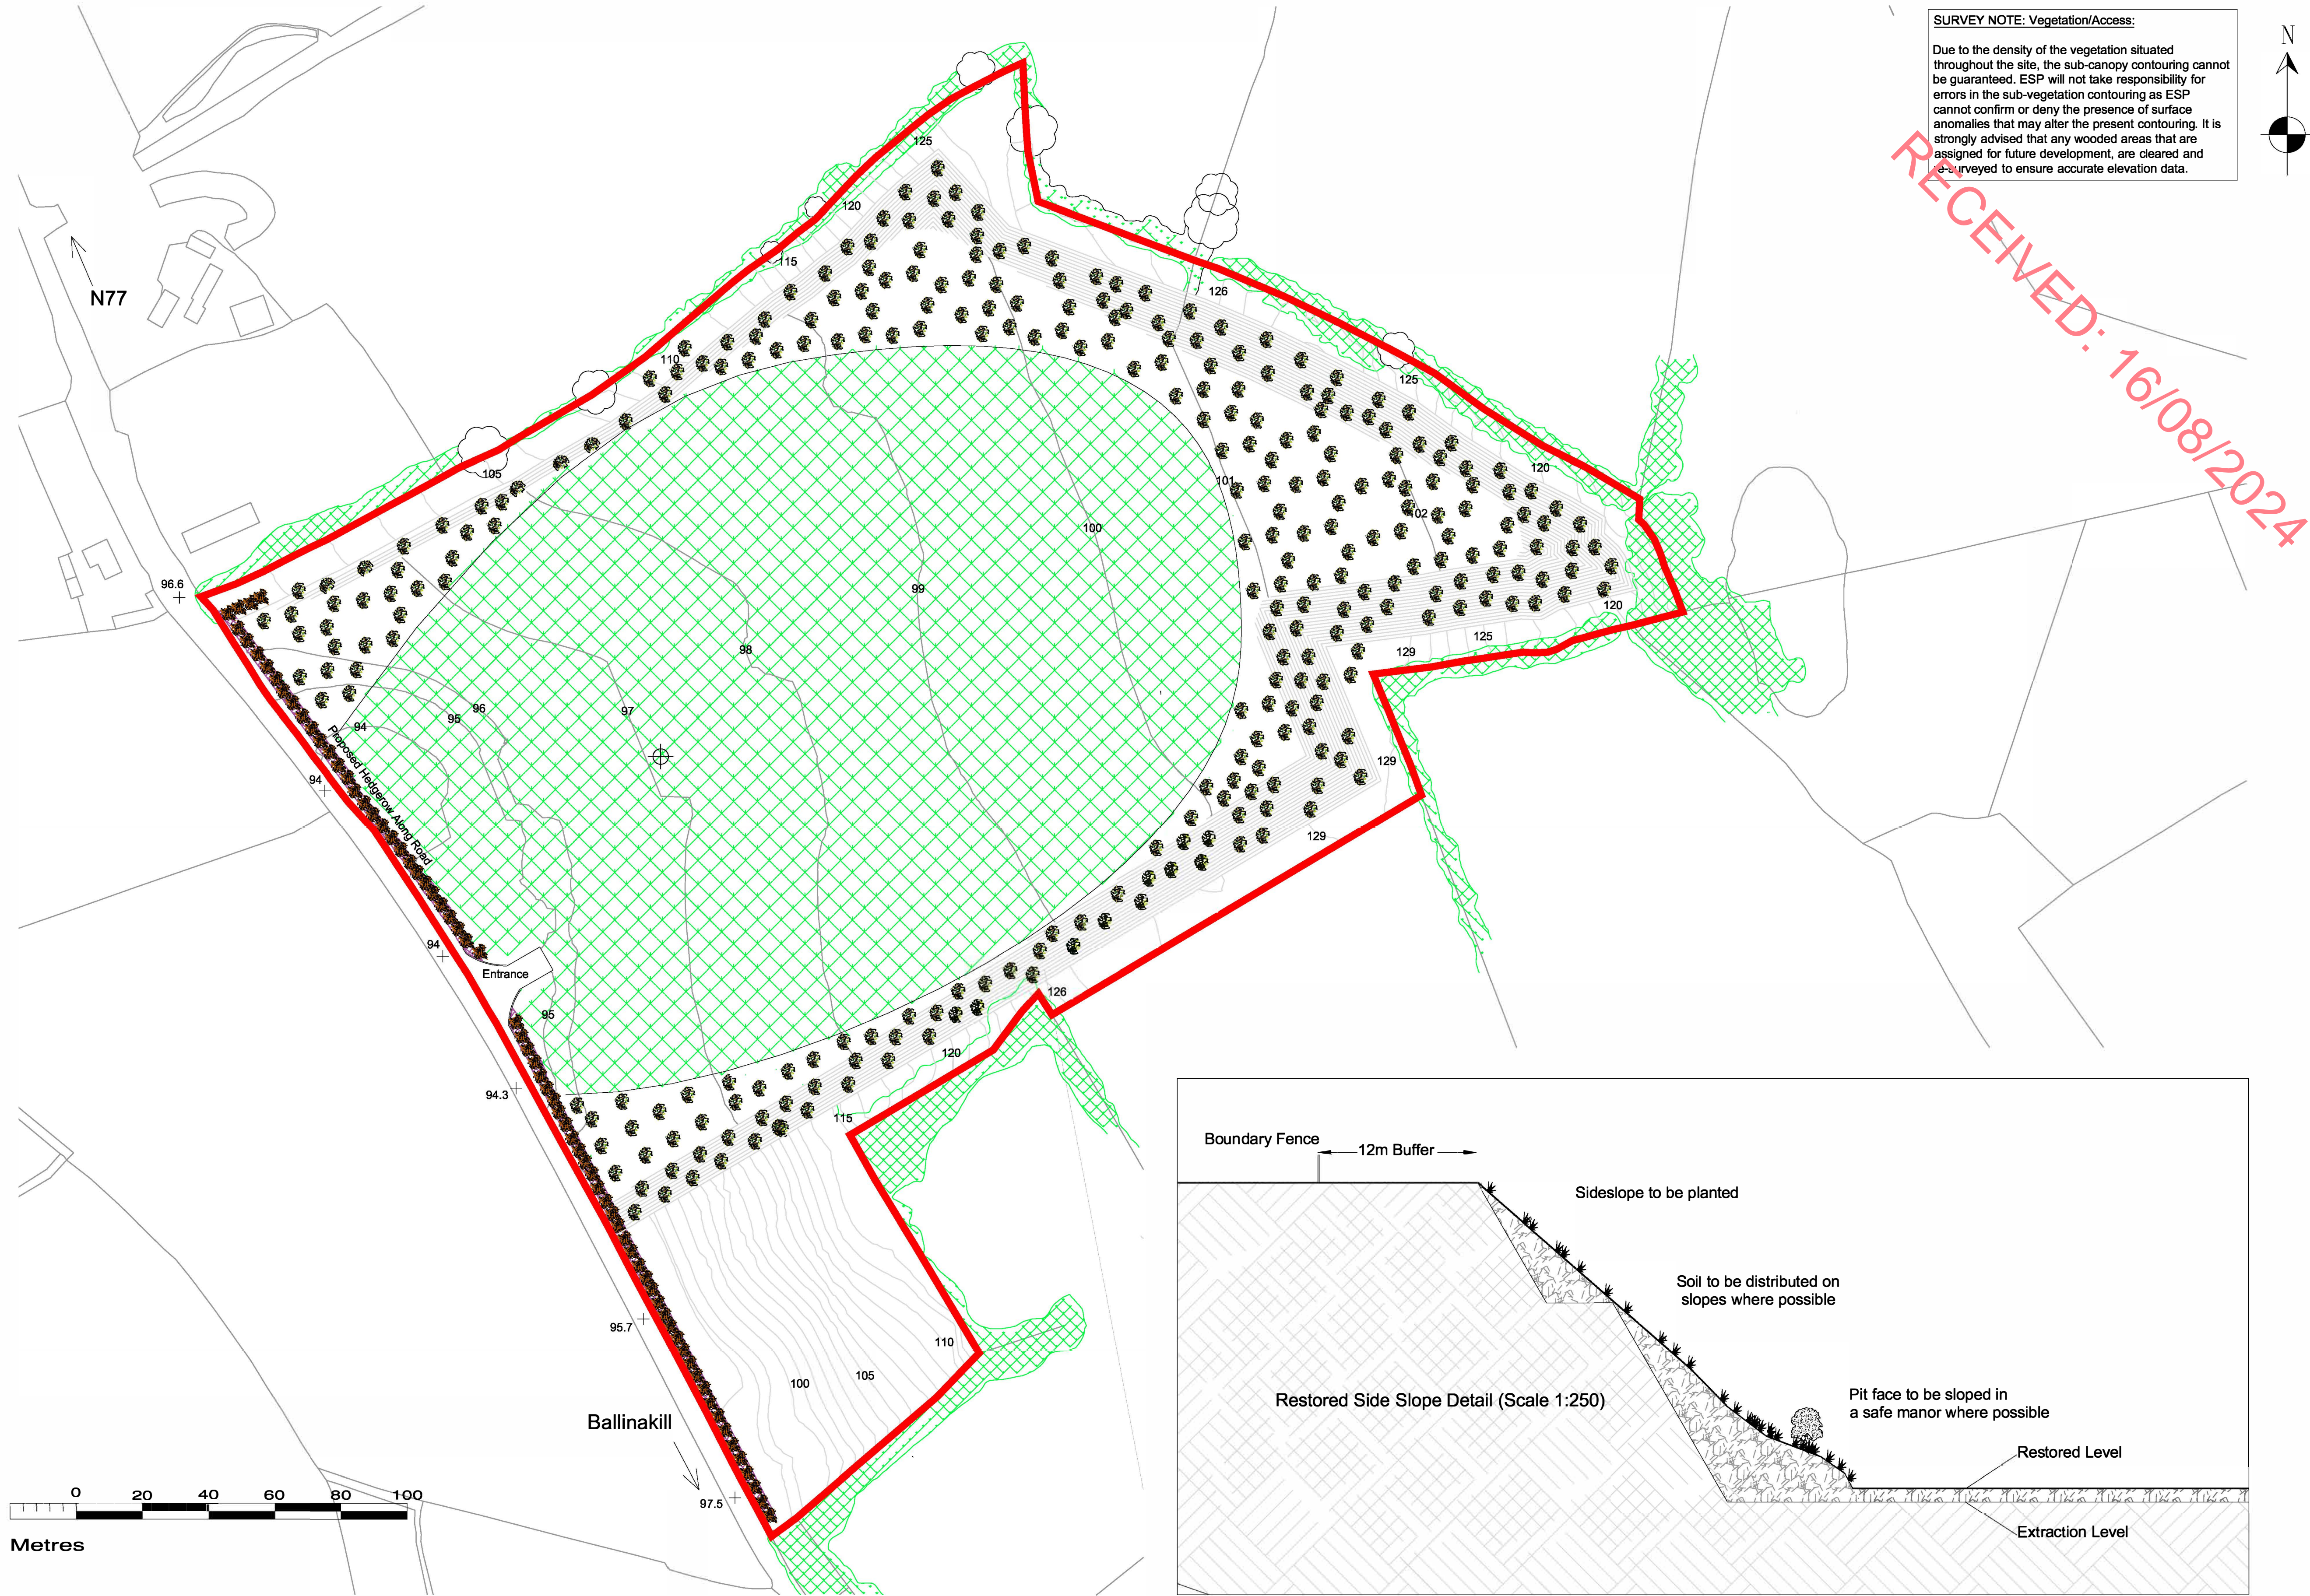
SURVEY NOTE: Vegetation/Access:
Due to the density of the vegetation situated throughout the site, the sub-canopy contouring cannot be guaranteed. ESP will not take responsibility for errors in the sub-vegetation contouring as ESP cannot confirm or deny the presence of surface anomalies that may alter the present contouring. It is strongly advised that any wooded areas that are assigned for future development, are cleared and surveyed to ensure accurate elevation data.

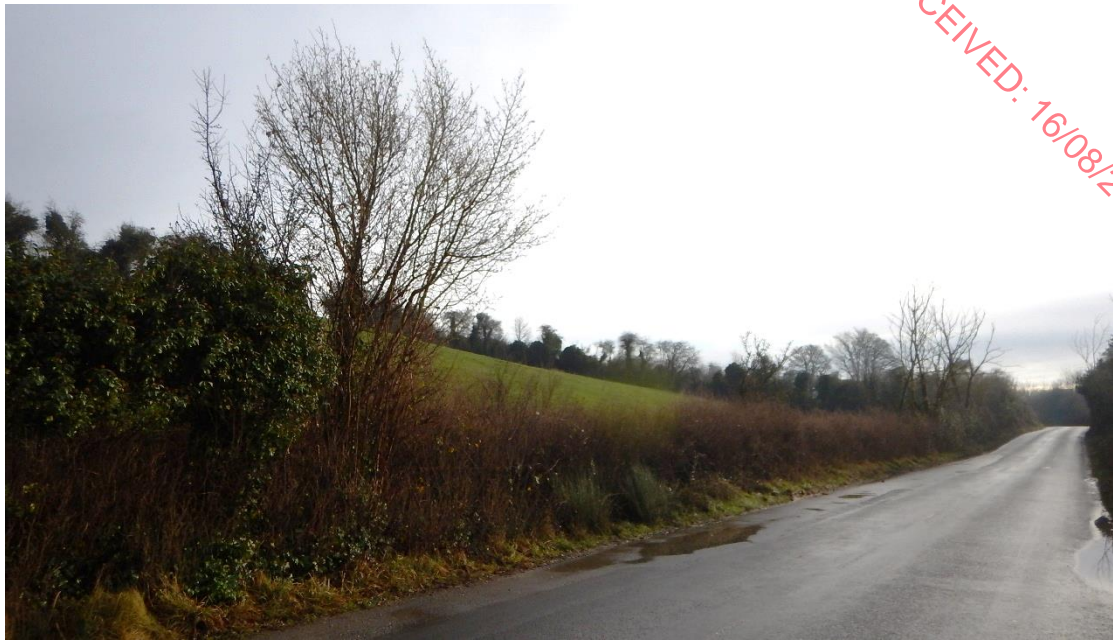
1. Southern half of the roadside hedge H1, viewed from the northwest.

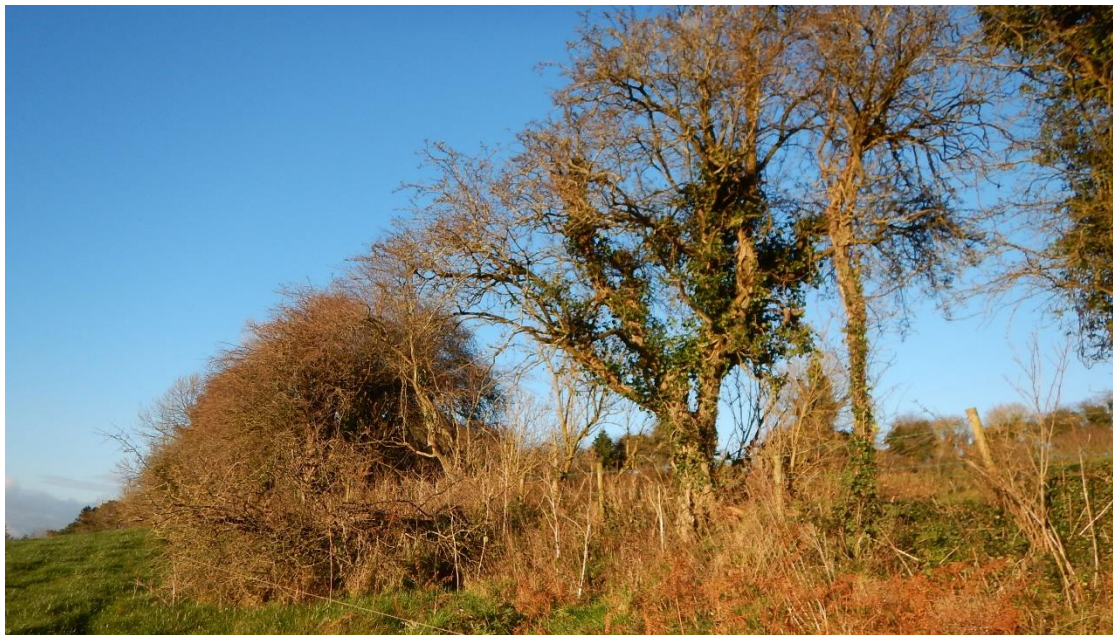
2. Over-mature Hawthorn trees in fragmented hedge-line H3 along the southern boundary area of the site.

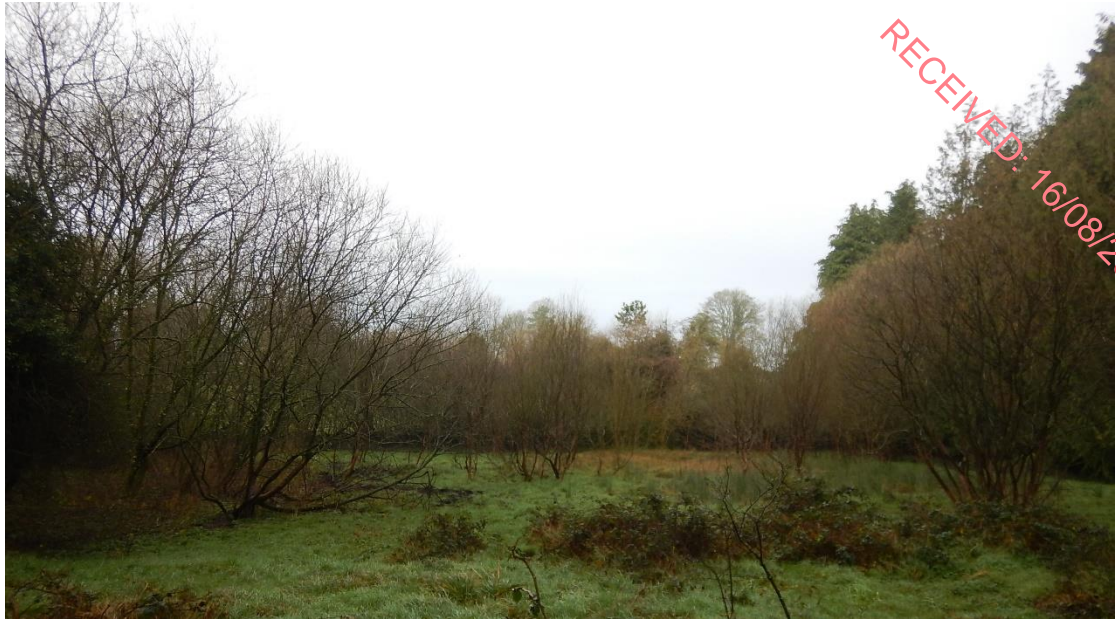
3. Willow regeneration making up group G13 encroaching across unmanaged land in the central part of the western edge of the site.

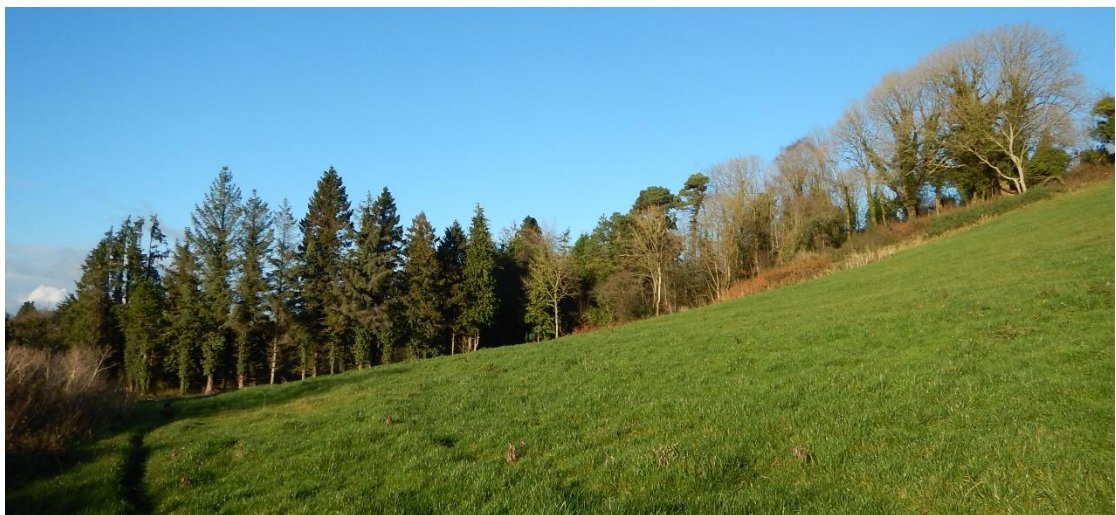
4. Central wooded part of the site seen from the south, with conifer tree group G3 to the left, woodland W1 in the centre and group G1 to the right.

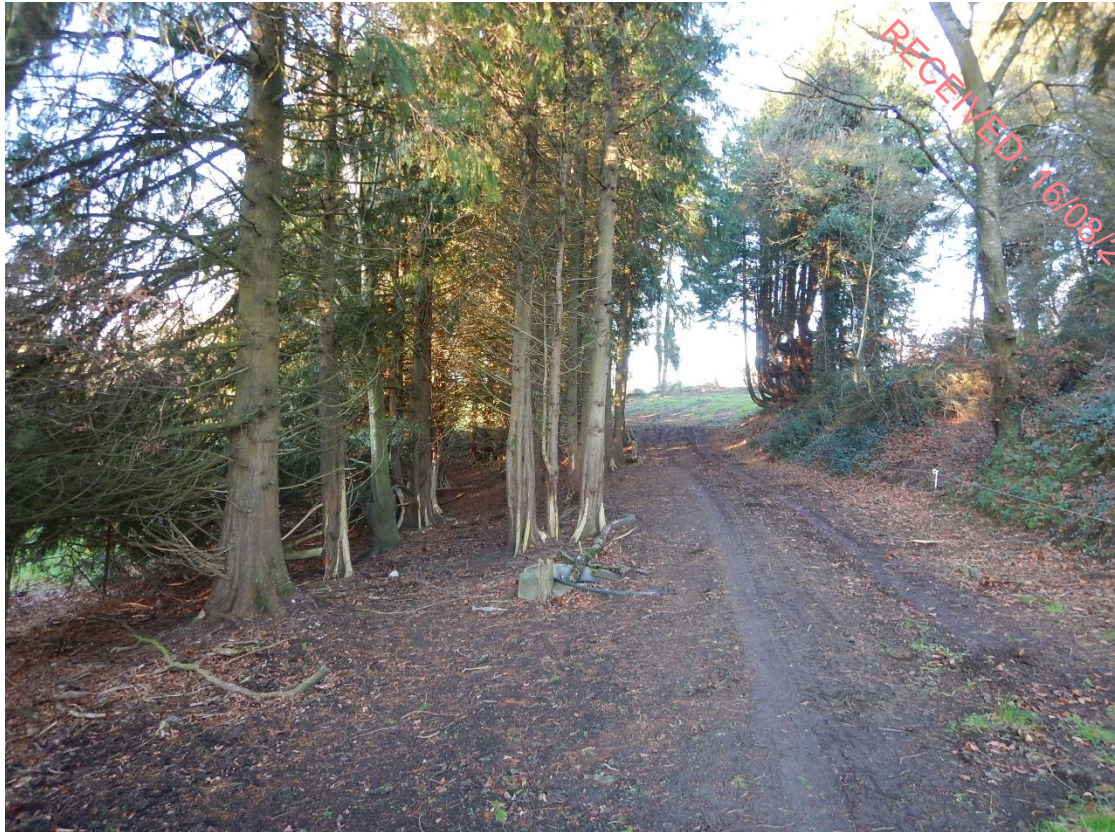
5. Mixed conifer group G4 to the left and group G7 to the right of the old track through the trees.

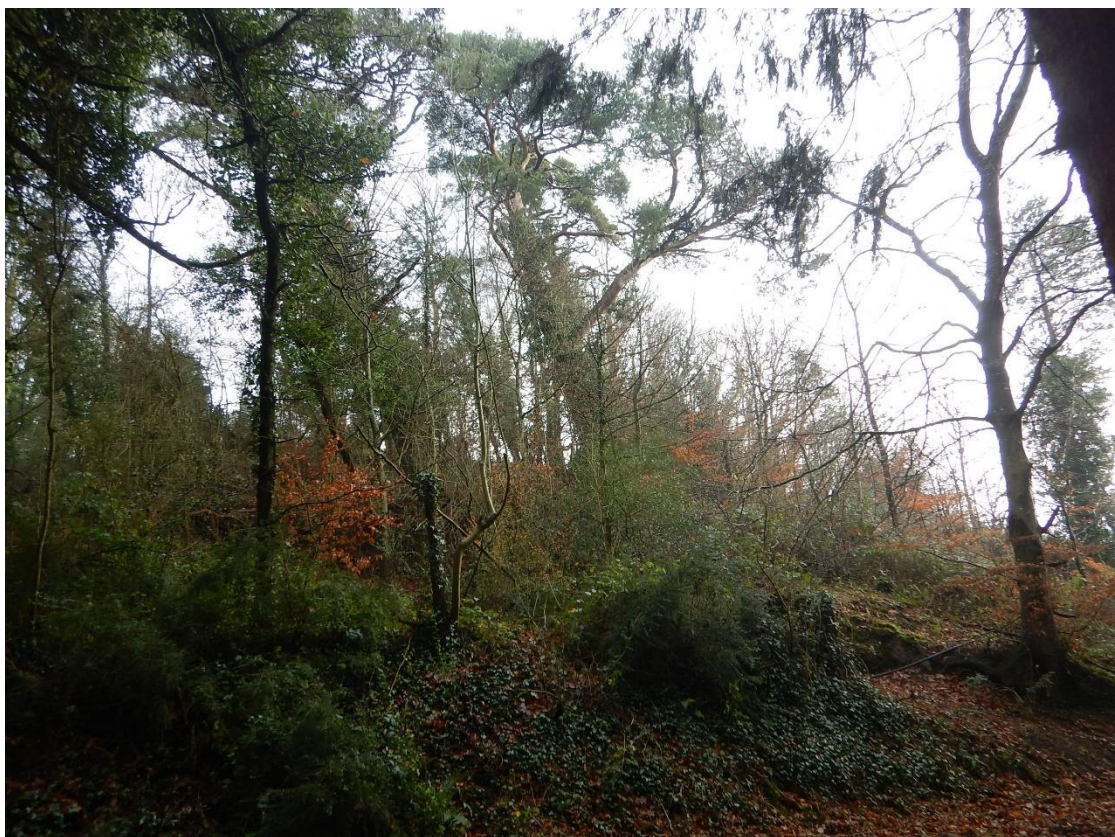
6. Woodland W1 seen from the old track at the western edge of the wood; W1 includes the mature Pine trees (G8) in the centre of the picture.

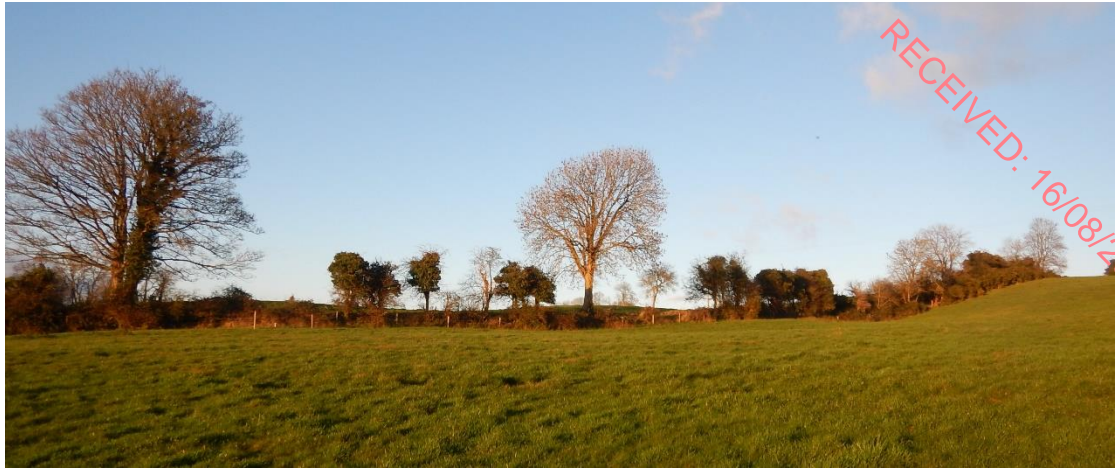
7. Emergent hedgerow trees T1 (to the left) to T5 (far right) along hedge H9 following the northern boundary of the site.

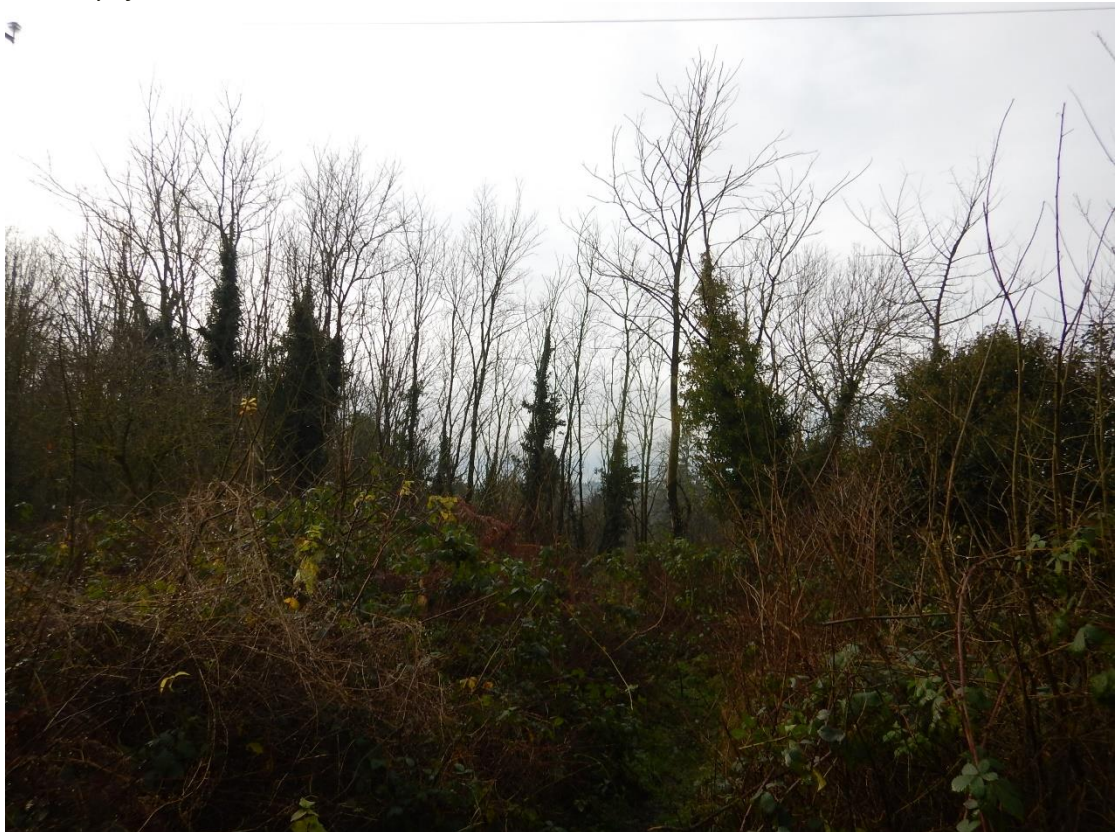
8. Young trees making up dense secondary woodland W2; many of the trees are semi-mature Elm trees now standing dead after being killed by Dutch Elm disease.

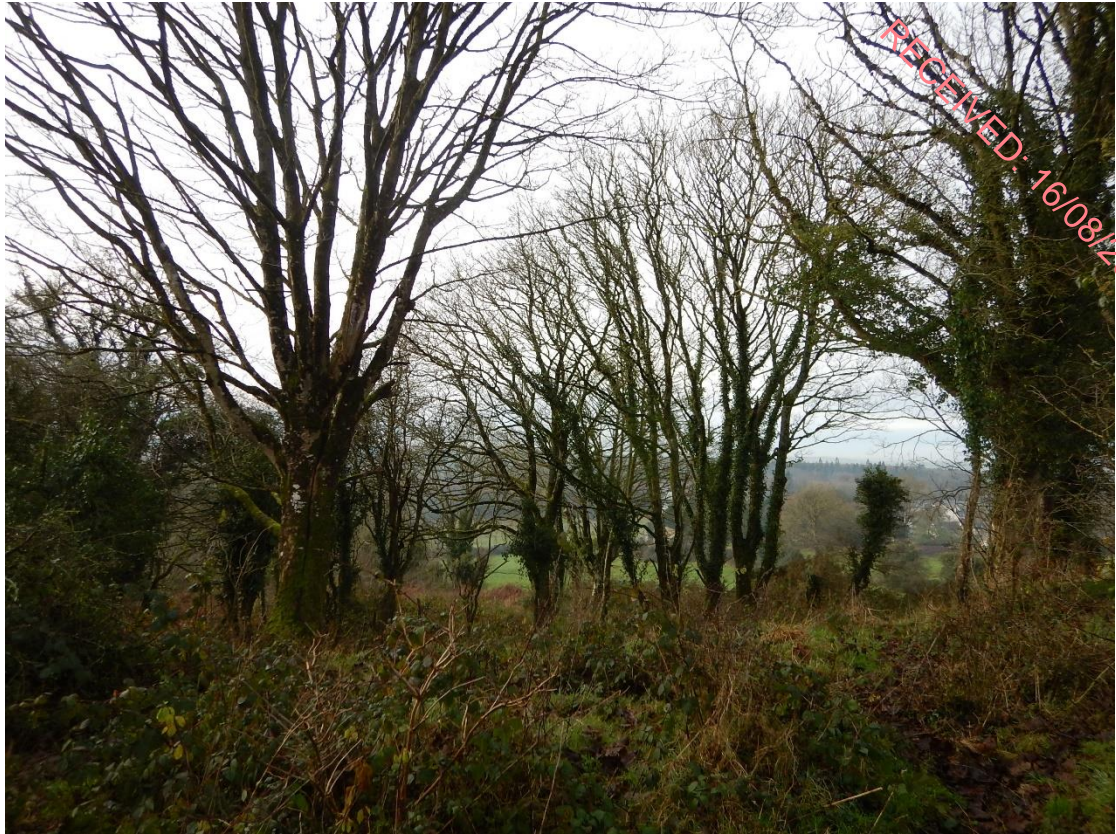
9. Cluster of mature Sycamore and Ash trees (group G9) in the north-eastern part of the wooded central area of the site.

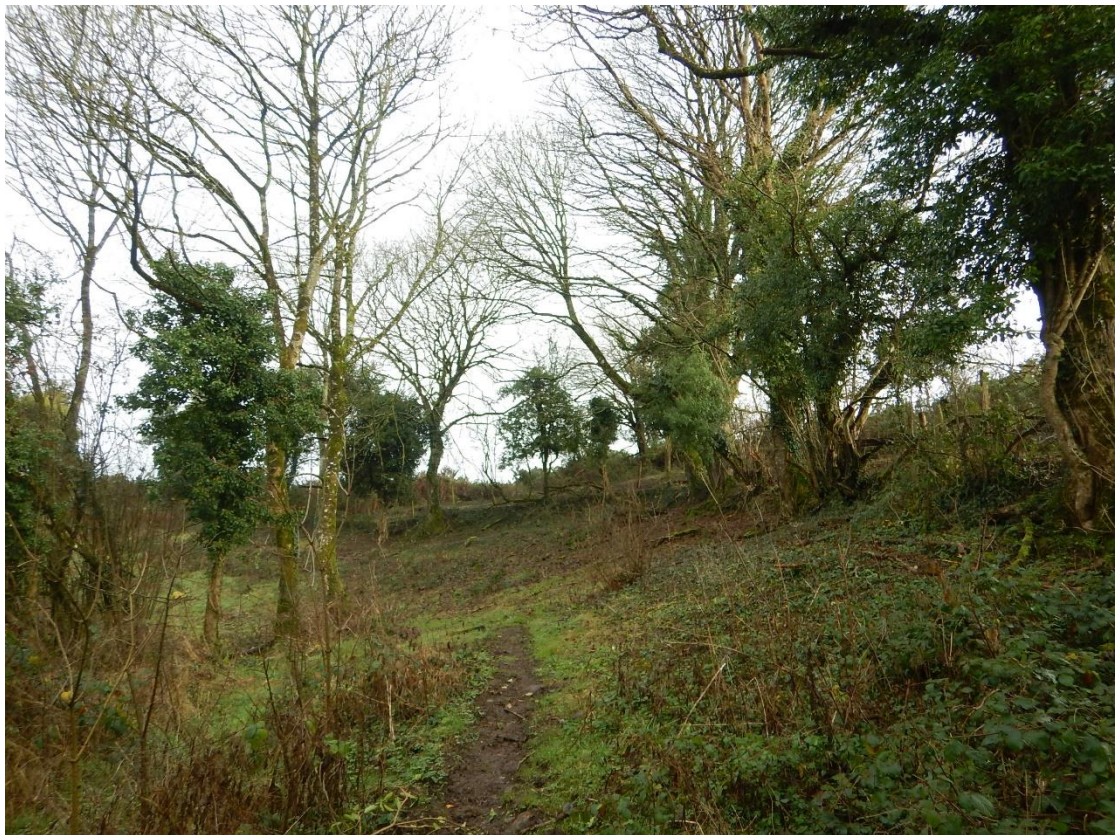
10. Mature trees (T19-T24, G11) in the south western part of the central wooded area of the site.

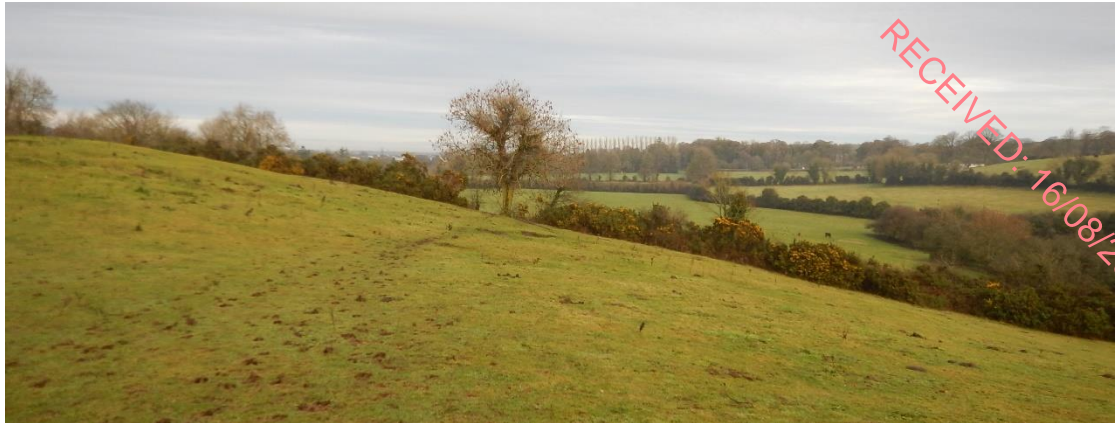
11. Solitary Ash tree (T9) on the boundary hedge H6 at the north-eastern edge of the site; most of this hedge is now made up of Gorse bushes.

T	9	Fraxinus excelsior (Ash)	SM	10	495	2	1.5	4	5.5	5	4.5	10	Fair	Fair/Poor. Smaller sized tree. Stem divides below 1.5m. Some basal decay. Major bark wounding on stem. Compression fork at tree base.	Monitor tree condition for signs of Ash Dieback disease.	5.94	C2
T	10	Fraxinus excelsior (Ash)	M	16	500	1	2	6	7	6.5	6	20+	Fair	Fair. Medium sized tree in hedge. Thick Ivy growth on tree restricts view of main branch unions. Unable to inspect stem due to undergrowth. Epicormic shoots on branching in crown.	Clear undergrowth and inspect stem base. Monitor tree condition for signs of Ash Dieback disease.	6	B2
T	11	Aesculus hippocastanum (Horse Chestnut)	OM	21.5	900	1	2	7	8	9	7	10	Poor	Poor. Large old specimen tree. Some badly storm damaged branches in crown. Recent loss of major limb. Bleeding canker lesions on stem-branches. Tree liable to further storm damage.	Crown clean and crown reduce by 2-3m.	10.8	C2
