Accessibility Audit

Inis Cealtra

Clare County Council

Evolve Technologies

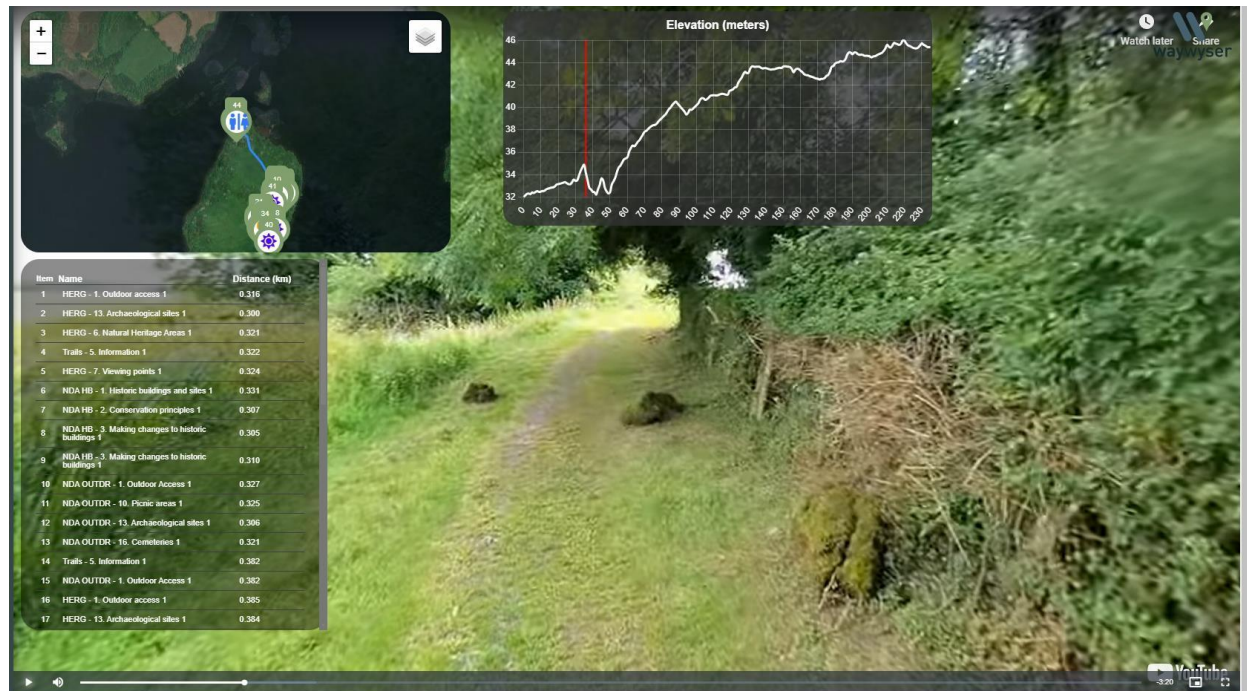
2.5 Go Pro Footage

To ensure comprehensive documentation and analysis of the island's trails and monuments, we captured 3D GoPro footage along all accessible paths and around key monuments. This approach allows us to review the site after our visit and cross-check the footage with the gradient measurements taken during our surveys. The 3D footage provides a detailed visual reference, helping us to assess trail conditions, identify potential hazards, and confirm key features such as gradient changes, surface stability, and the proximity of paths to heritage areas.

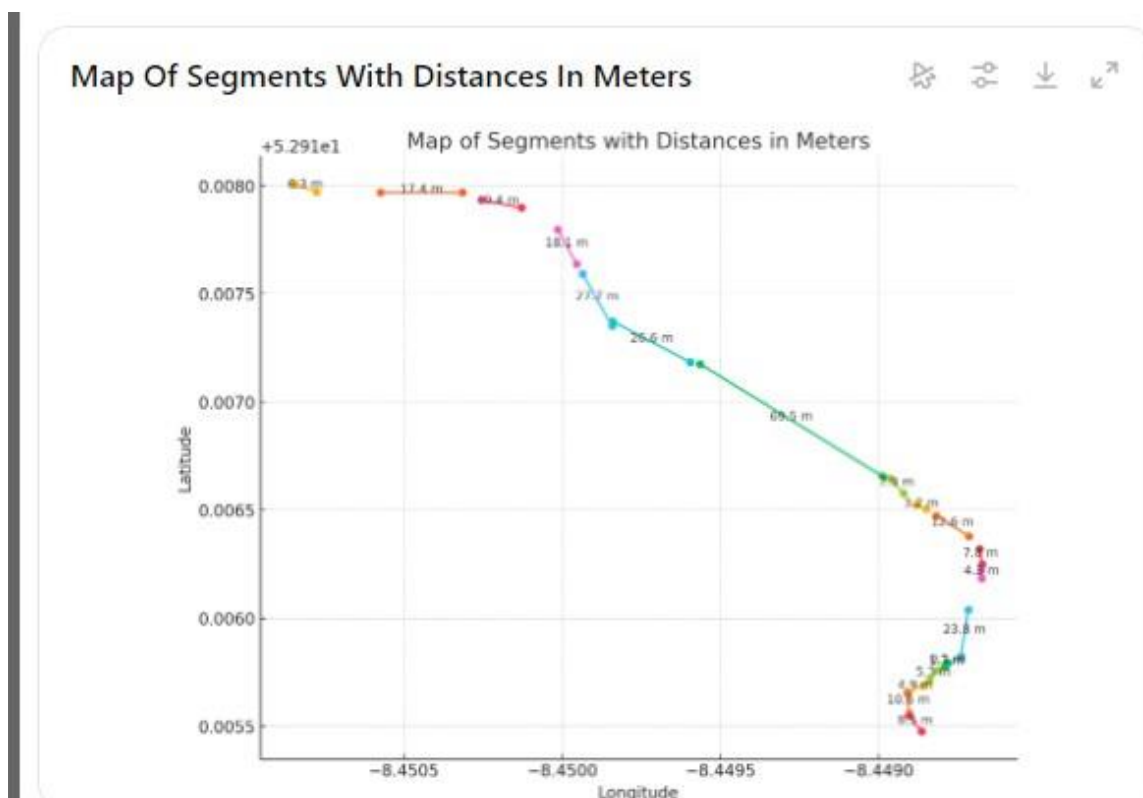
We carried out a double check to confirm the distance travelled using the go pro footage matched the gradients surveys collected while completing the survey and an example of the first section is attached below for reference.

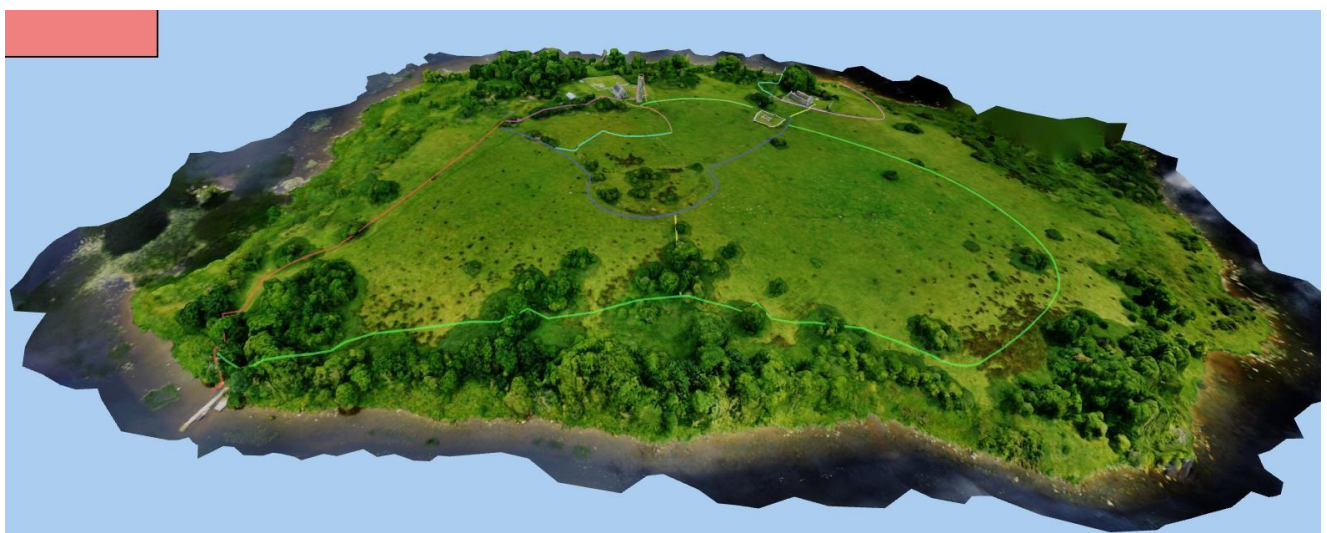
3.4 3D Model Creation

We developed a 3D model of the island to assist in our assessment, especially since some trails were either not navigable or not clearly marked. This model allowed us to remotely analyse challenging areas, assess gradient changes, and identify potential obstacles, providing a comprehensive view of the island's terrain.
