## 12.0 LANDSCAPE

### 12.1 Introduction

This section of the EIAR assesses the landscape & visual impact associated with the development on the surrounding landscape in the vicinity of the proposed development. Methodologies used to assess the landscape and visual impacts are outlined and mitigation measures are proposed where required. A landscaping and restoration plan is proposed which will be implemented during the operational lifetime of the development with final restoration undertaken on completion of extraction. A copy of the Landscape & Restoration Plan is attached in Appendix 12.1.

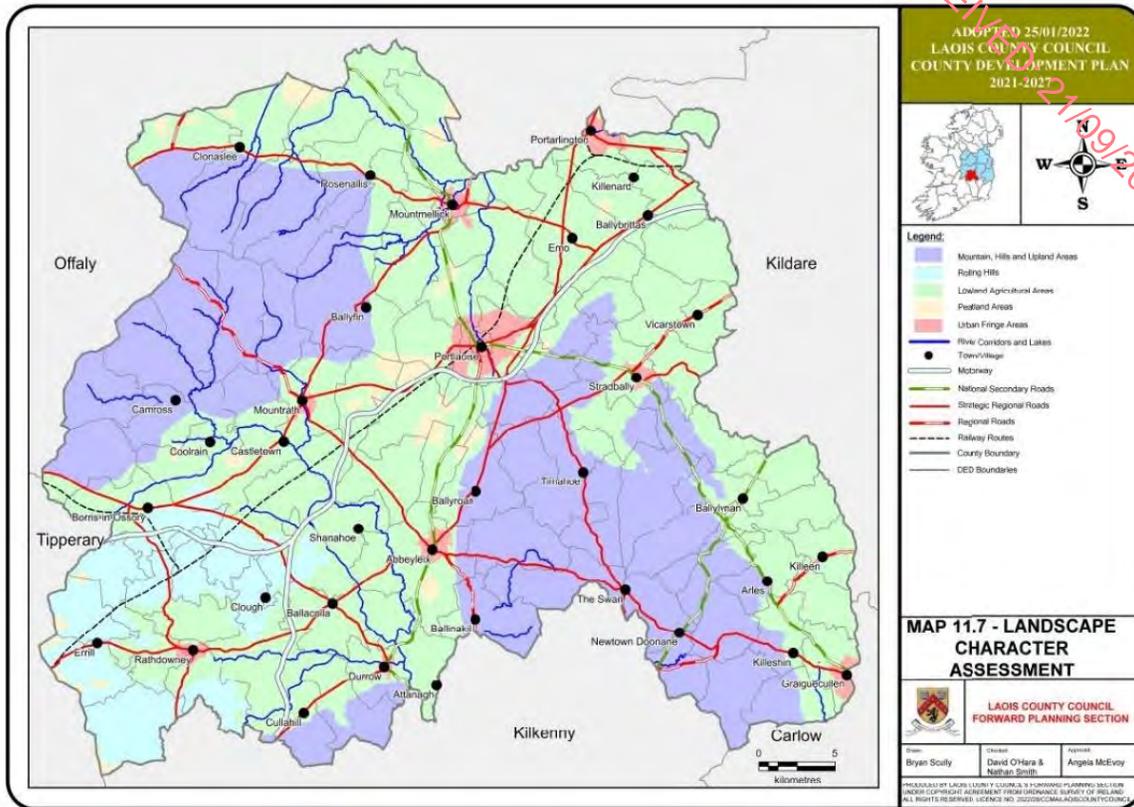
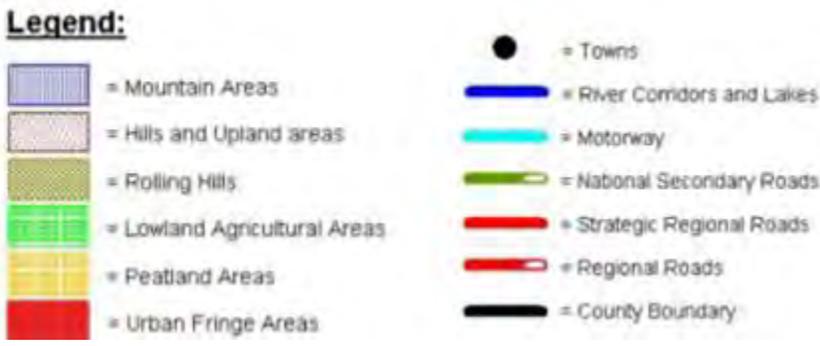
Plate 12.1: Landscape Character Assessment Extracted from Appendix 6 of *Laos County Development Plan 2021-2027*

The application site is located in the Lowland Agricultural Areas Landscape Character Type (LCT) which covers the largest proportion of County Laois. In terms of land-use, it is comprised primarily of pastoral and tillage agriculture. It is generally a flat open landscape (around Ballylynan, Barrowhouse and the environs of Graiguecullen especially) with long range views towards the upland areas. Field patterns tend to be of large scale and are generally bounded by deciduous hedgerows containing mature trees. Farm sizes are larger than average. Throughout the county there is an abundance of 18<sup>th</sup> and 19<sup>th</sup> century demesnes with extensive areas of mixed woodland and parkland bounded by original stonewalls, creating an attractive landscape setting for the numerous estate houses.

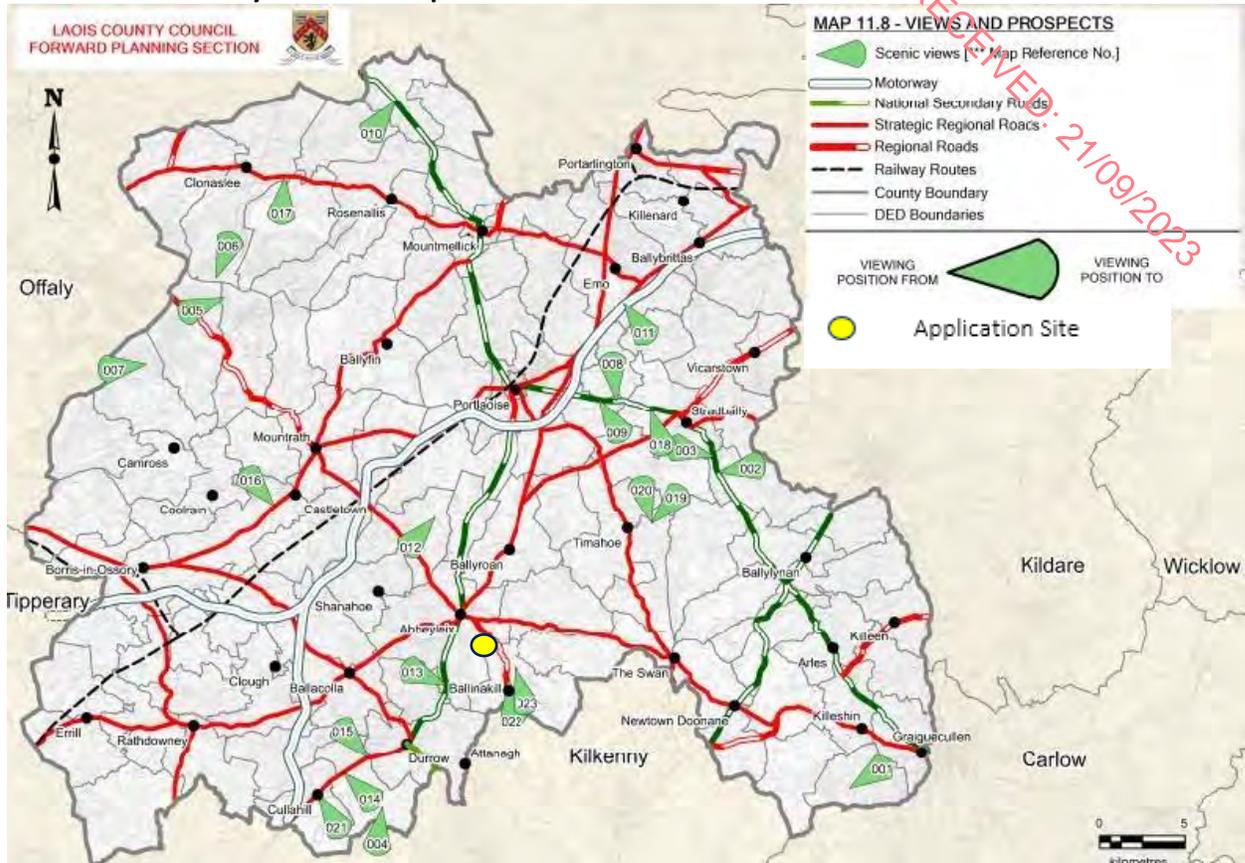
Plate 12.2: Amenity Views & Prospects Locations

County Laois contains a number of valuable views and prospects which offer a very attractive cross-sectional view and overall impression of differing landscapes as one traverses the county. The protection of these views and prospects will be done on a case-by-case basis through the development management process when considering individual planning applications. Development that would seriously hinder or obstruct such views and prospects will not be allowed. The current *Development Plan* lists a number of views for the County which are detailed on Plate 12.2. The application site is not located in the vicinity of a designated view.

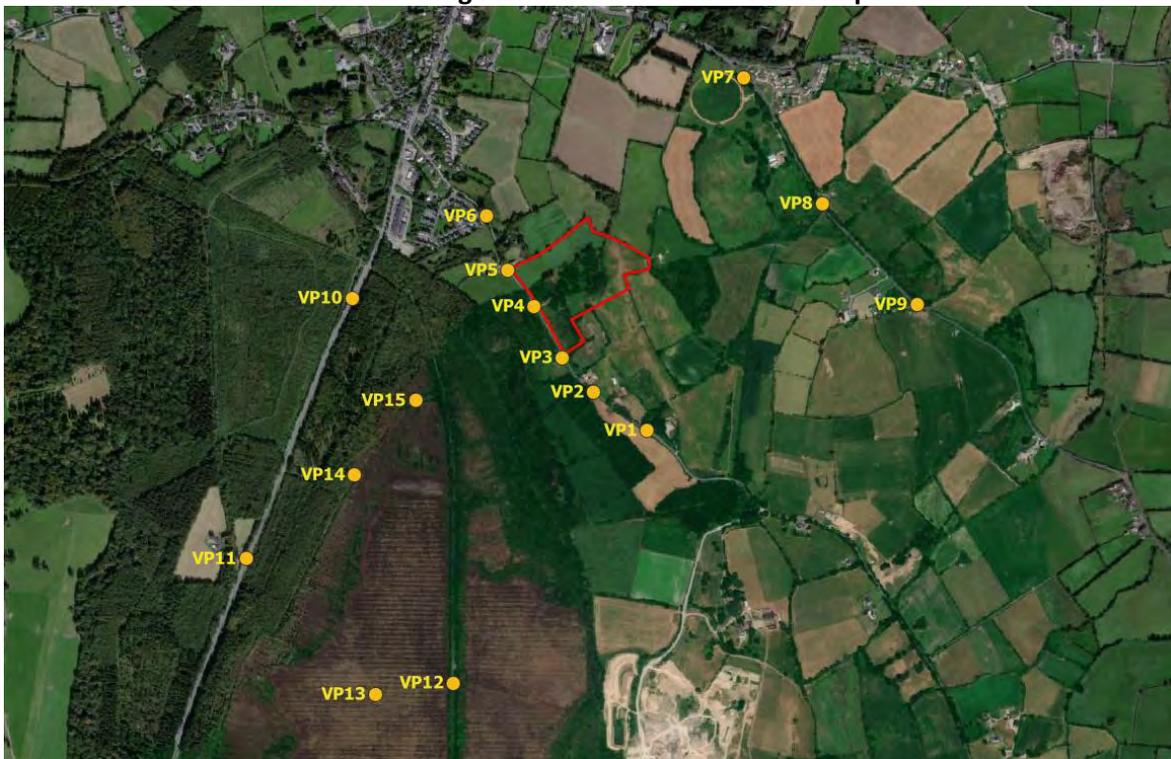
**Plate 12.3: Location of Viewing Points used to Assess Visual Impact**

A visual assessment of the application site was undertaken from a series of representative viewpoints to illustrate typical views towards the site. Fifteen viewpoints were originally chosen as part of the visual assessment which are illustrated on Plate 12.3. An additional seven locations along the public road are also assessed to demonstrate proposed landscape changes in proximity to the public road. The additional locations are labelled VPA16 to VAP22 and the locations are illustrated on Plate 12.4.

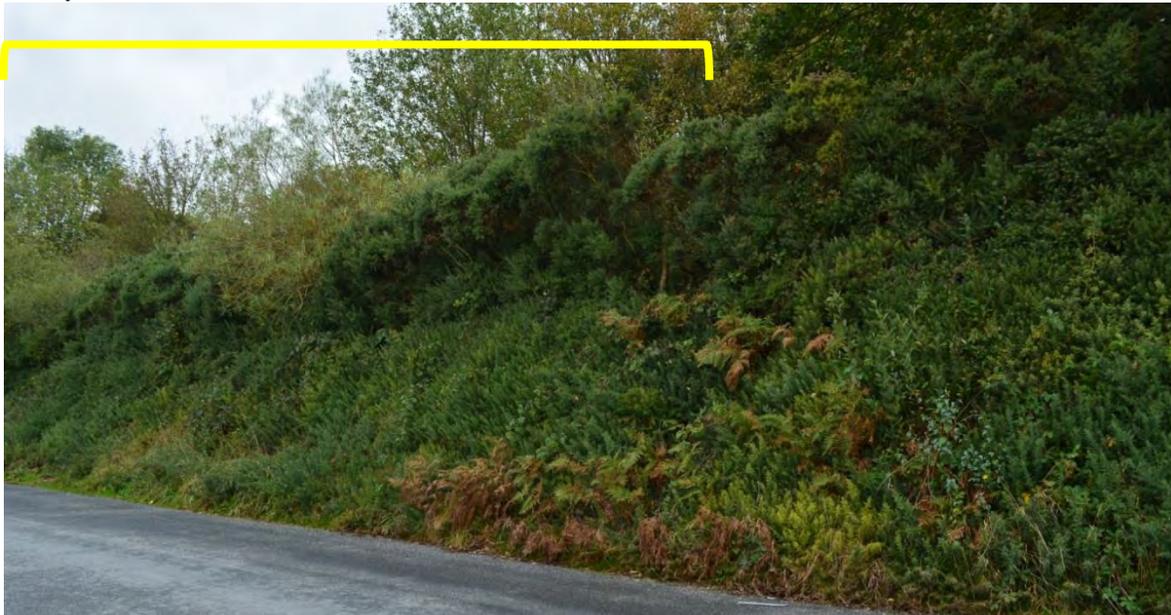
**Viewpoint 1**

Viewpoint 1 is from a location to the south of the application site along the L-5731-25 road. The application site is not visible at this location due to the topography of the surrounding land and the field boundary hedgerows.

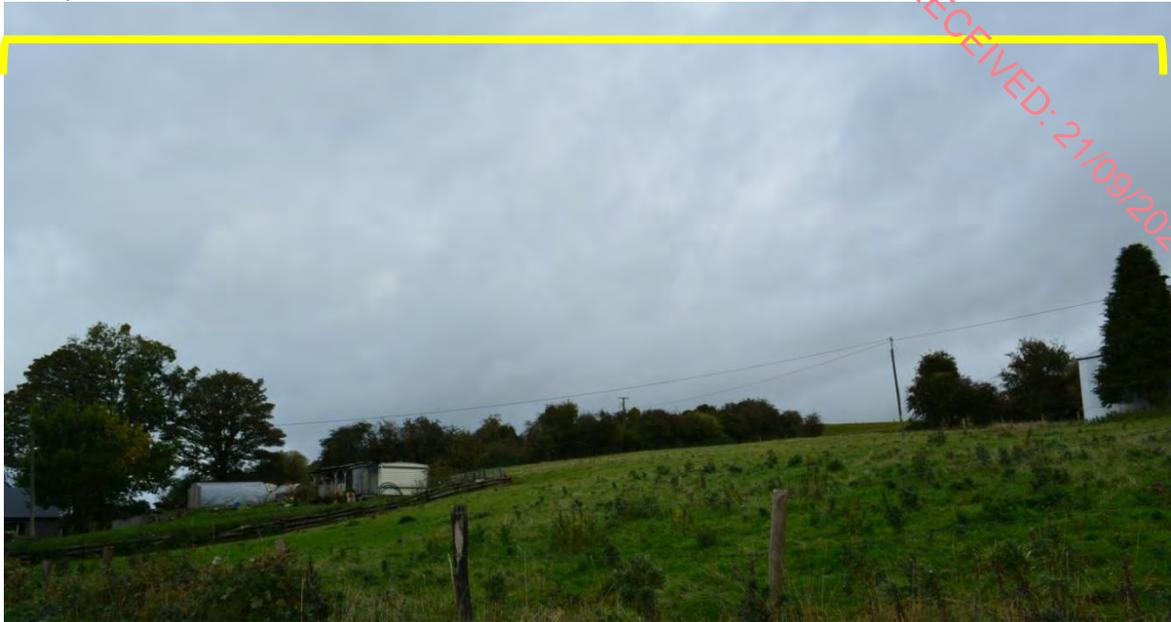
### Viewpoint 2

Viewpoint 2 is from a location northwest of Viewpoint 1 along the L-5731-25 local road closer to the application site. The application site is not visible due to the natural topography and vegetation located along field boundaries.

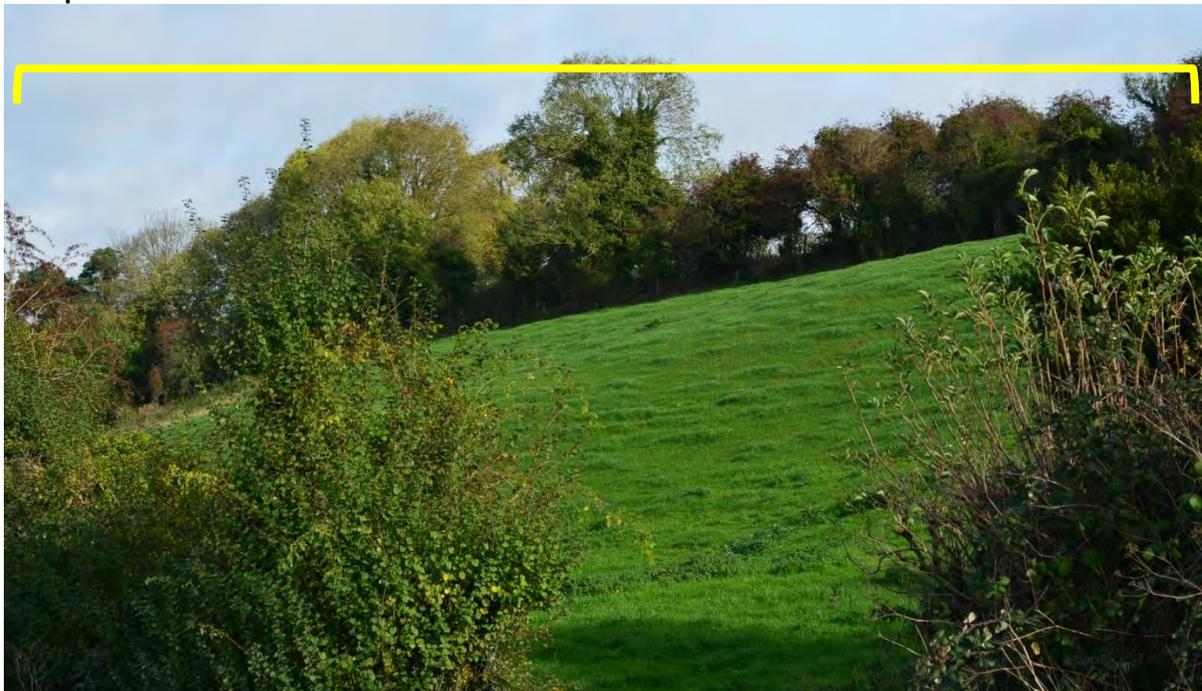
### Viewpoint 3

Viewpoint 3 is from a location along the boundary of the application site and the L-5731-25 local road. The site is visible along the local road due to the topography and limited boundary vegetation.

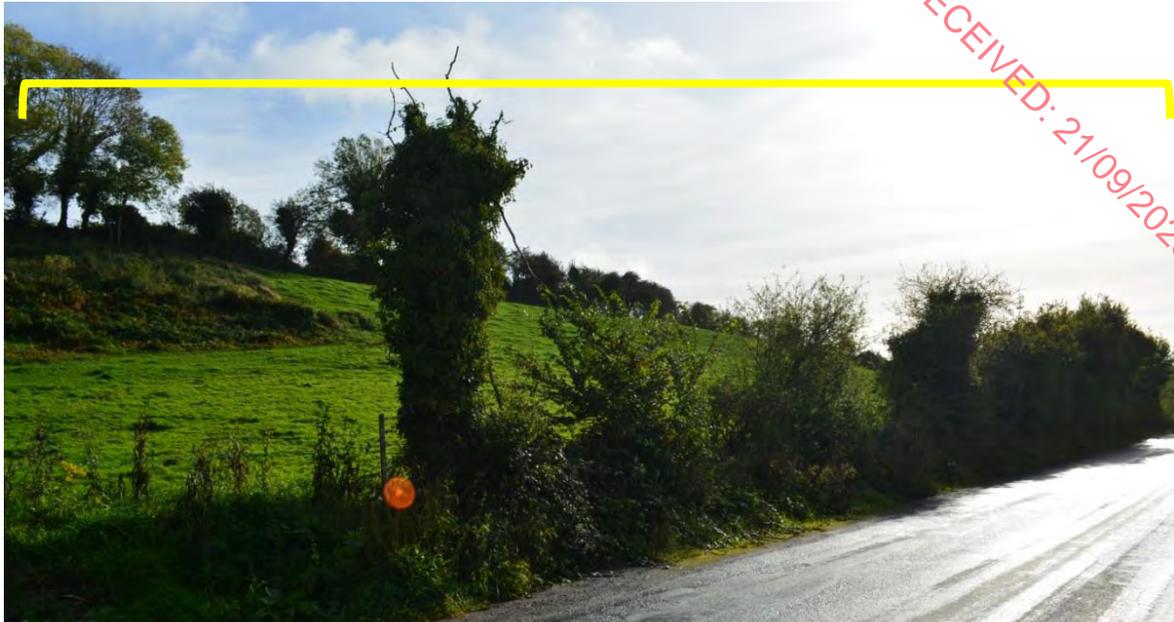
#### Viewpoint 4

Viewpoint 4 is taken from a location to the west of the site along the L-5731-25. Similar to viewpoint 3 the application site is visible at this location.

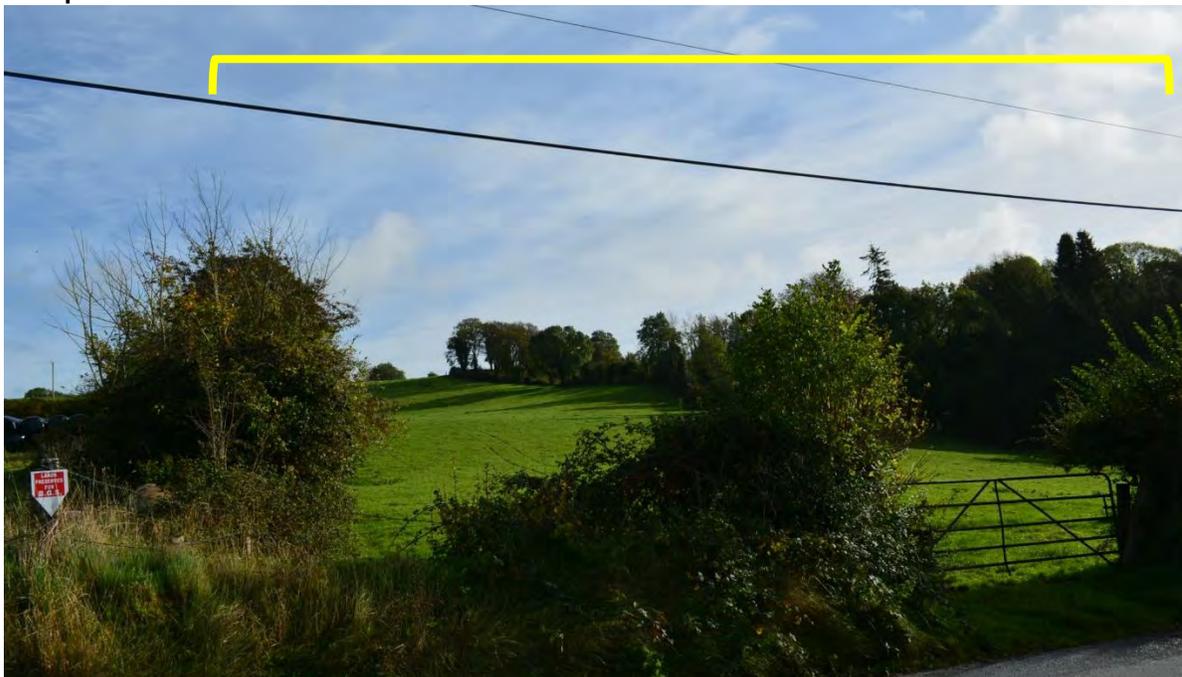
#### Viewpoint 5

Viewpoint 5 is from a location further north along the L-5731-25. Similar to viewpoint 3 and 4 the application site is visible at this location.

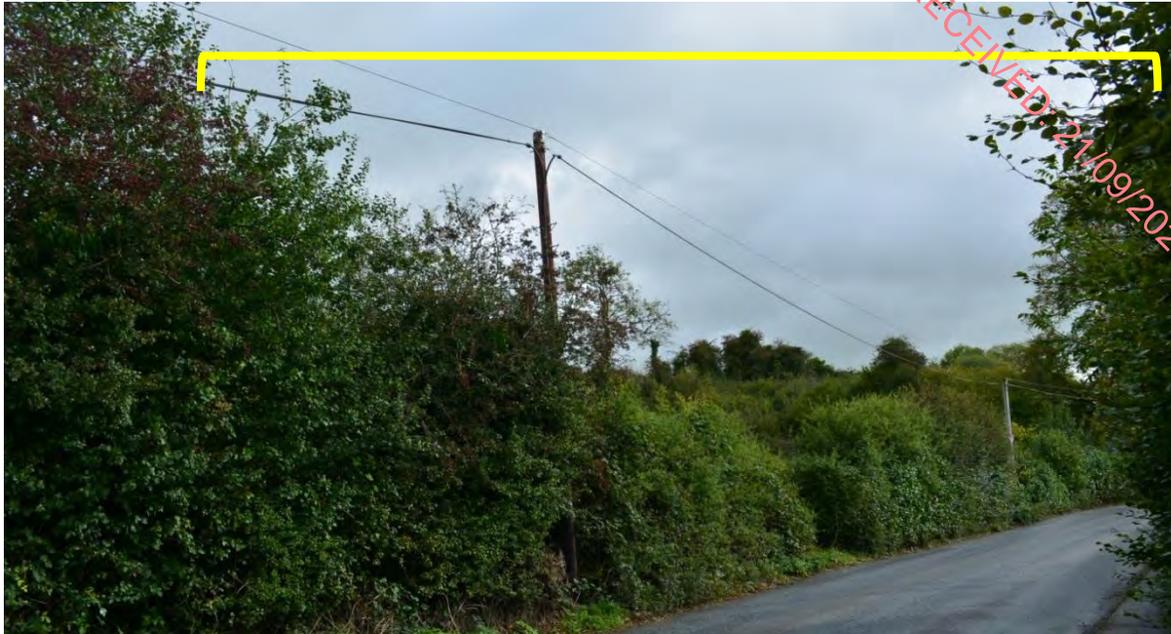
### Viewpoint 6

Viewpoint 6 is from a location close to Grallow Wood housing estate. The application site is not visible due to the screening provided by the natural topography and vegetation located along field boundaries.

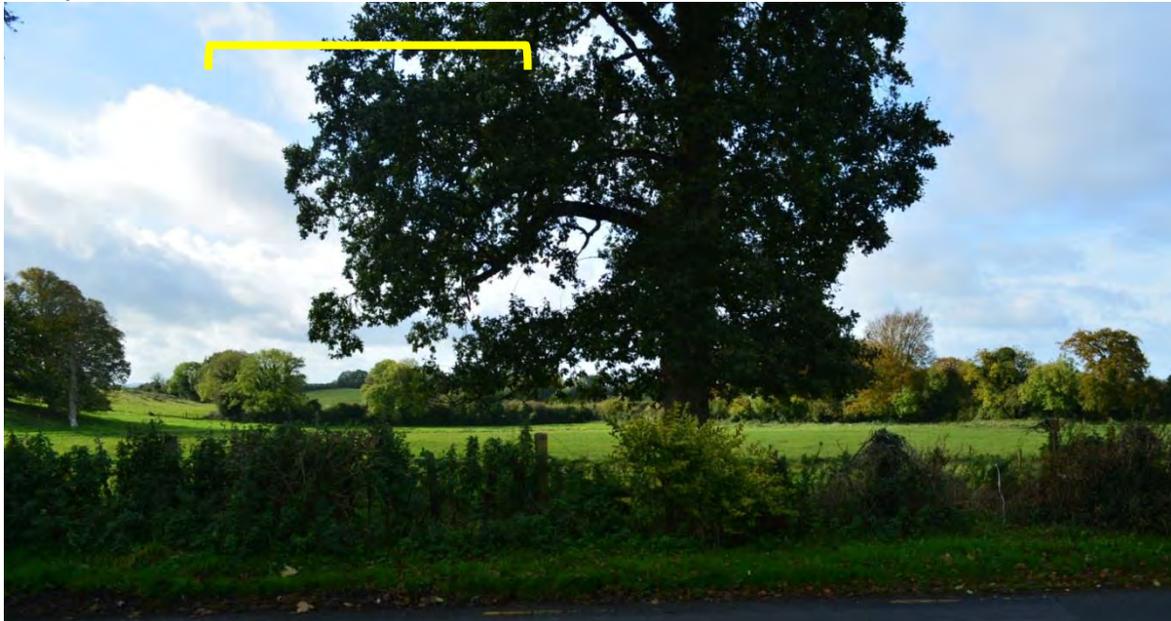
### Viewpoint 7

Viewpoint 7 is taken from a location along the R432 close to a housing estate on the outskirts of Abbeyleix town. The application site is not visible at this location due to the vegetation located along field boundaries.

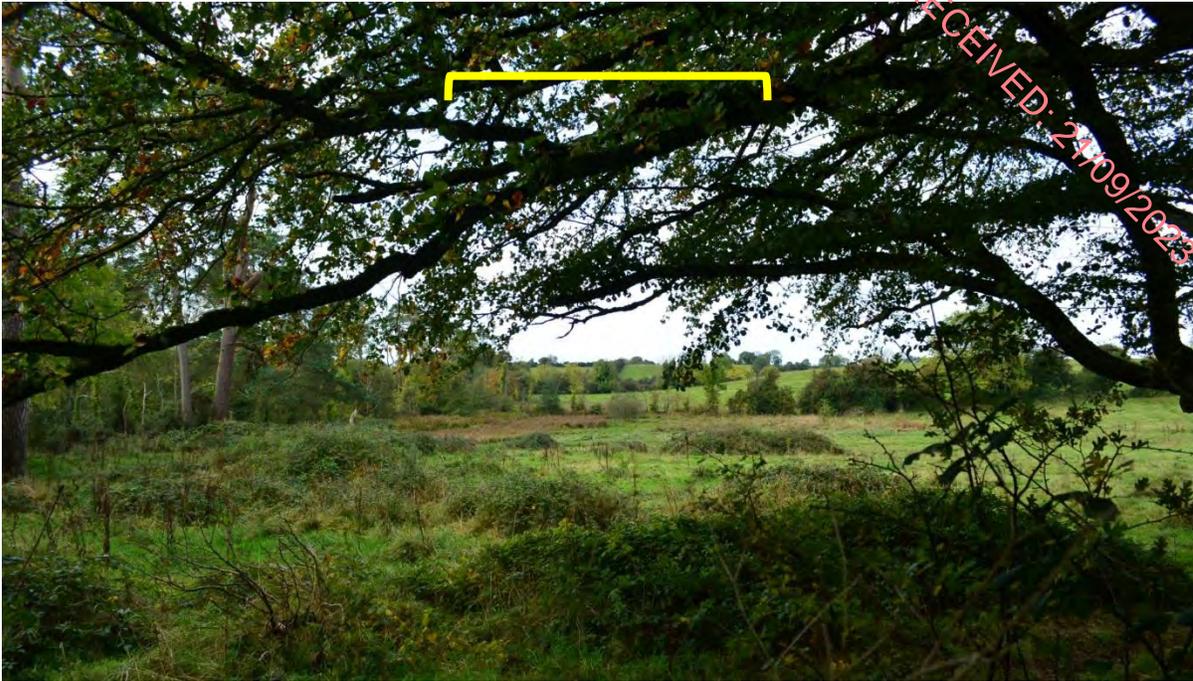
### Viewpoint 8

Viewpoint 8 is taken from a location further south along the R432. The application site is slightly visible at this location with vegetation along field boundaries providing significant screening.

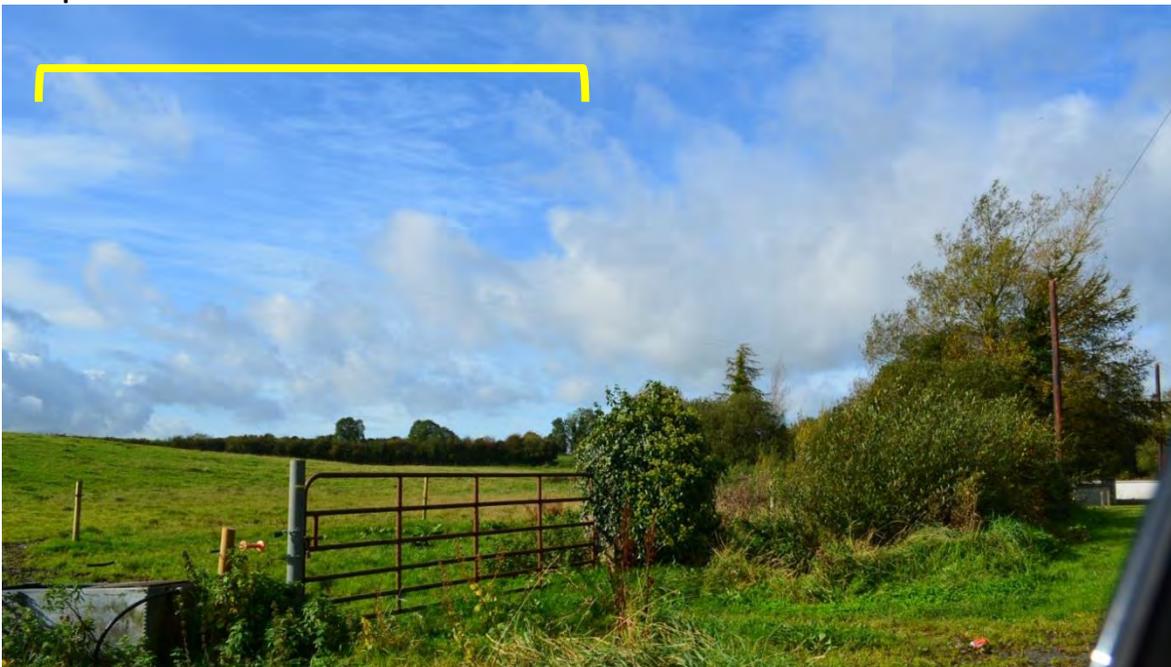
### Viewpoint 9

This viewpoint is from a location further south of the R432 from viewpoint 8. The application site is not visible at this location.

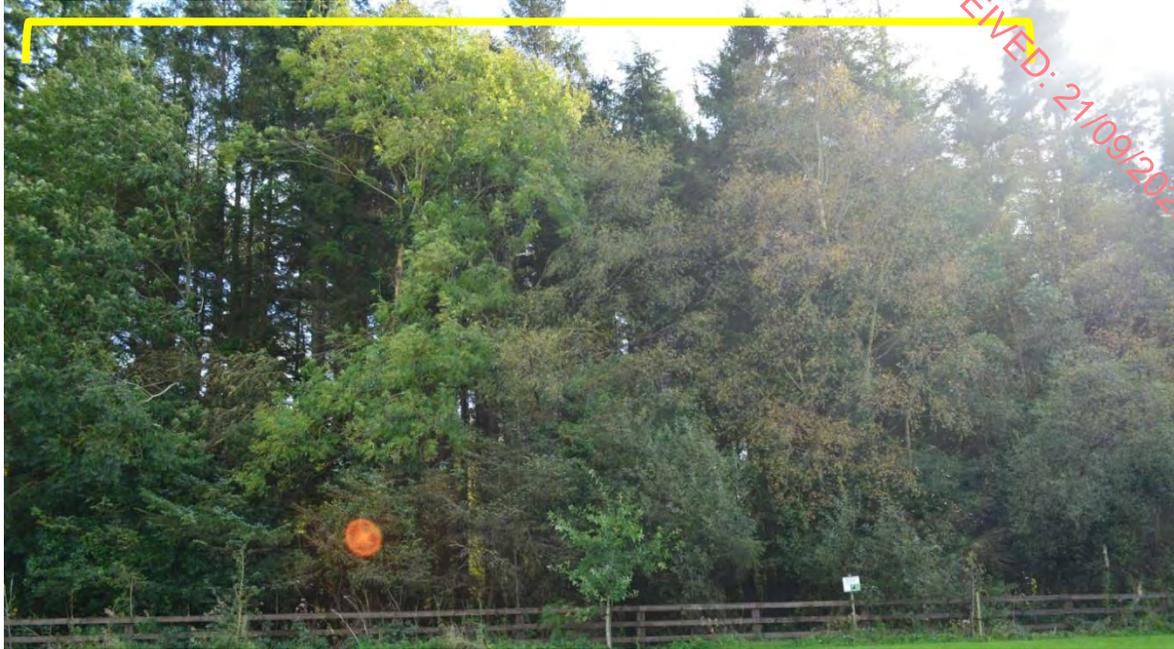
### Viewpoint 10

Viewpoint 10 is from a location along the N77 to the west of the site. The application site is not visible at this location due to the woodland area along eastern side of the N77.

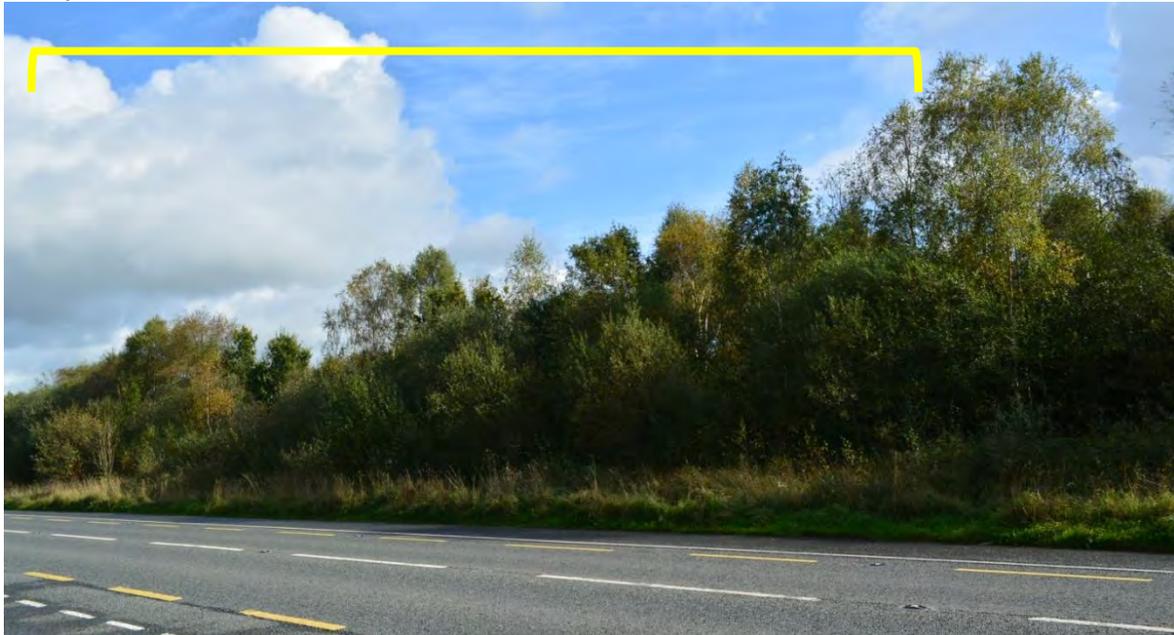
### Viewpoint 11

Viewpoint 11 is from a location along the N77 further south of viewpoint 10. Similar to viewpoint 10, the application site is not visible due to the woodland area along eastern side of the N77.

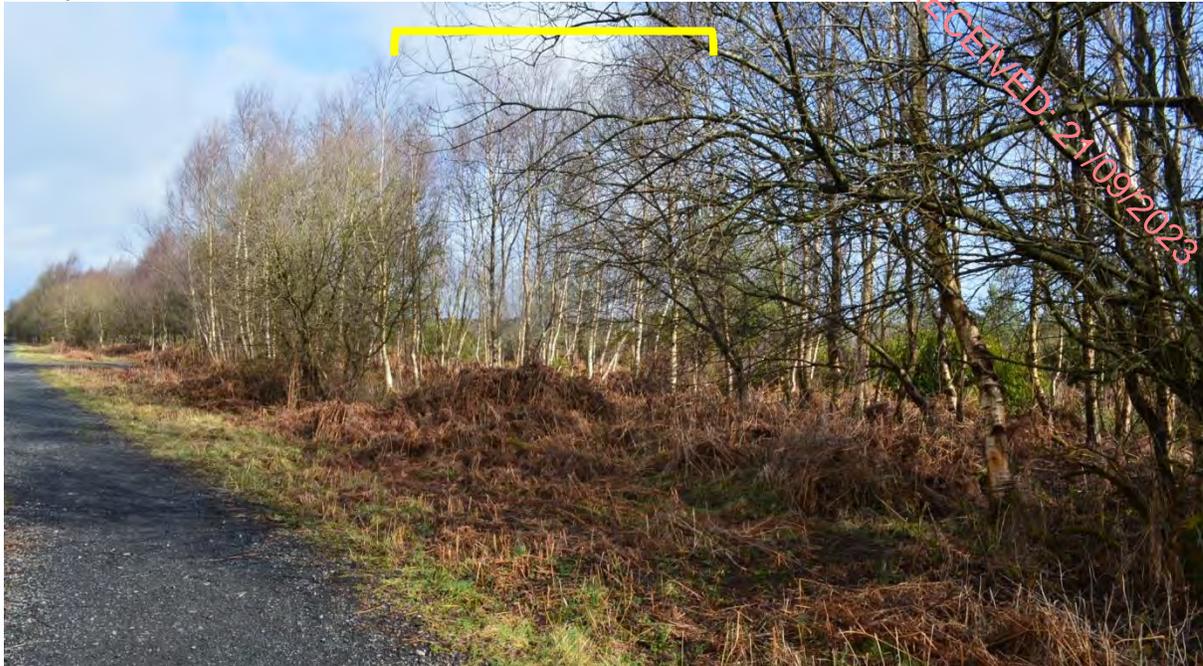
### Viewpoint 12

Viewpoint 12 is from a location along the main path before you proceed onto the board walk. The application site is not visible through the existing vegetation.

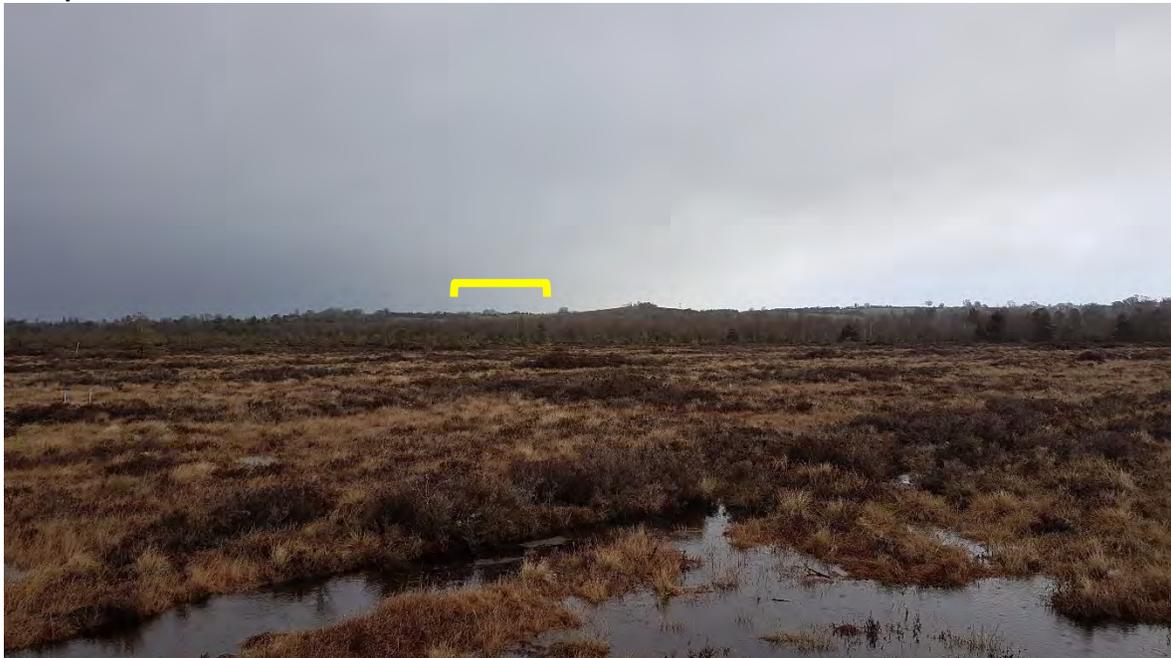
### Viewpoint 13

Viewpoint 13 was taken from a location along the Abbeyleix Board walk. The upper part of the application site is visible at this location.

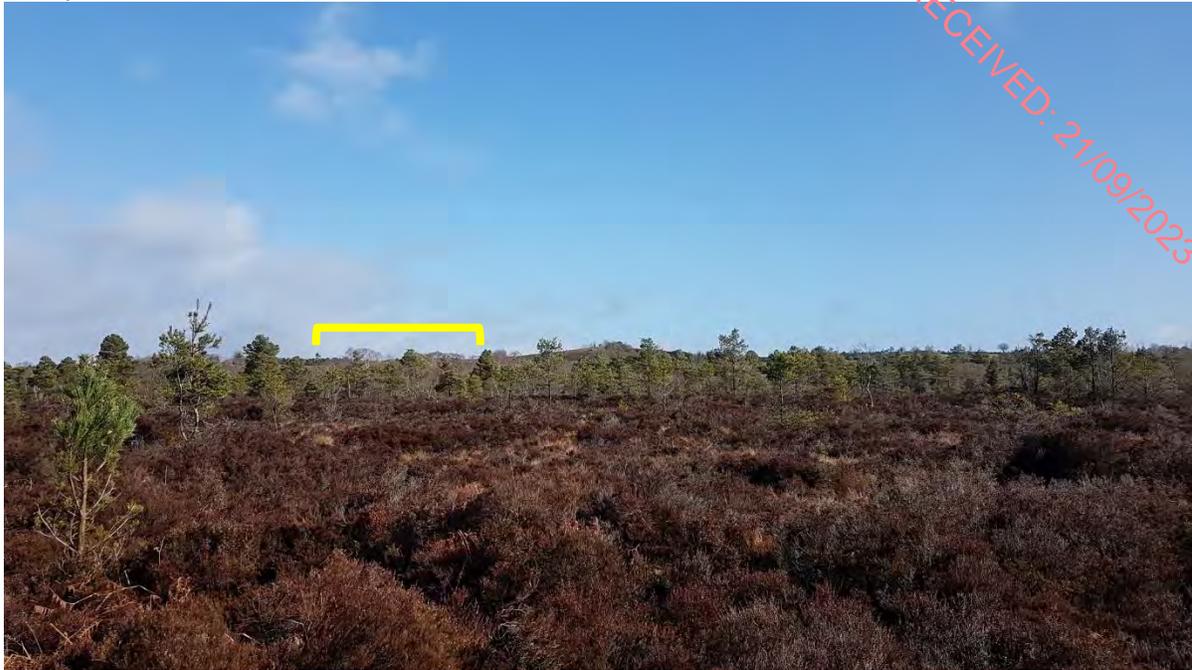
### Viewpoint 14

Viewpoint 14 was taken from a location along the Abbeyleix Bog walk southwest of the application site. The application site is slightly visible through the vegetation.

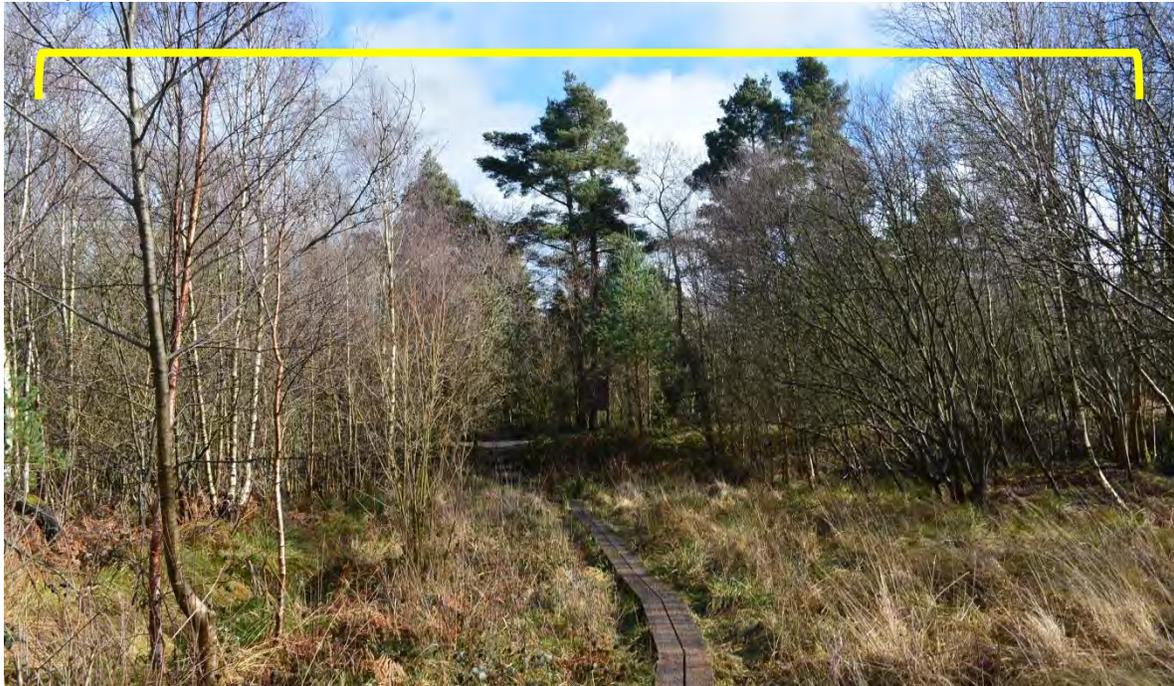
### Viewpoint 15

Viewpoint 15 is from a location where the boardwalk returns to meet the main track. The application site is not visible at this location.

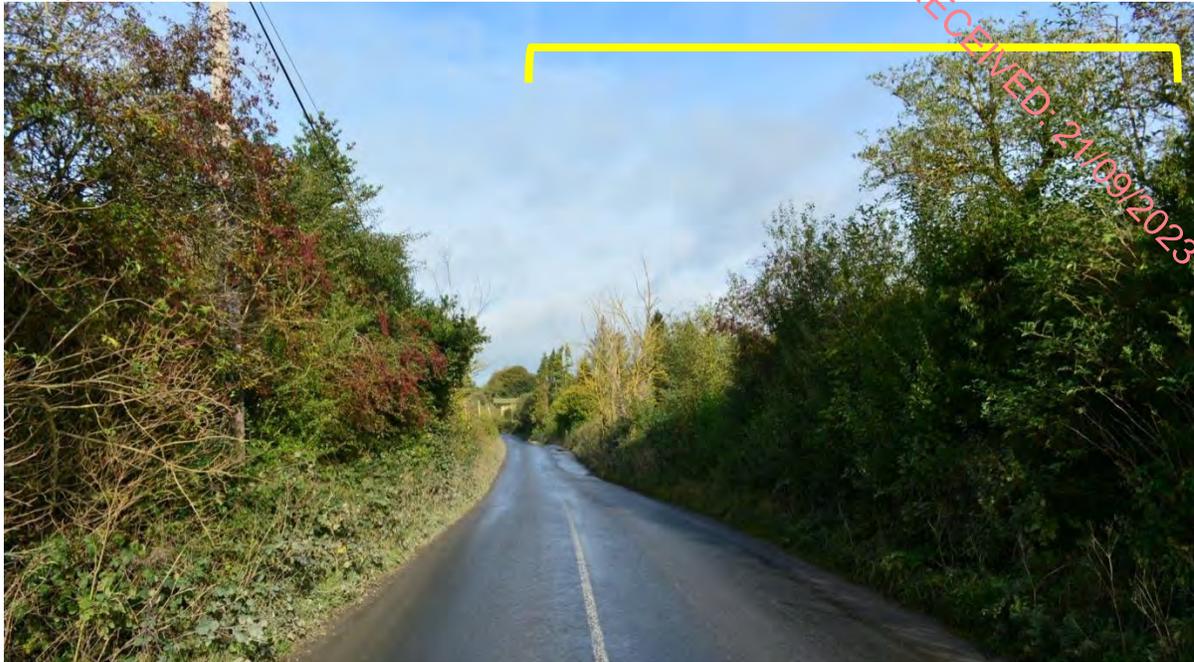
### Viewpoint 16

Viewpoint 16 is from a location along the L-5731-25 local road close to the south eastern boundary of the application site. The existing roadside vegetation provides screening of the site.

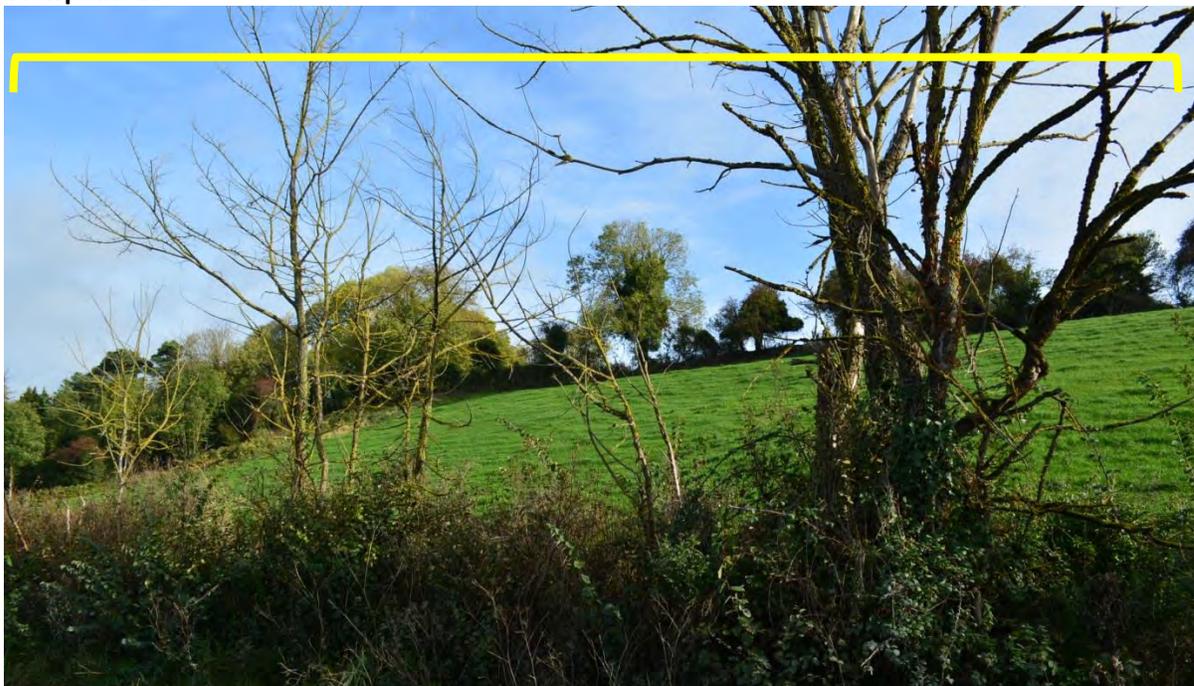
### Viewpoint 17

Viewpoint 17 is from a location along the L-5731-25. The application site is visible above the road side vegetation.

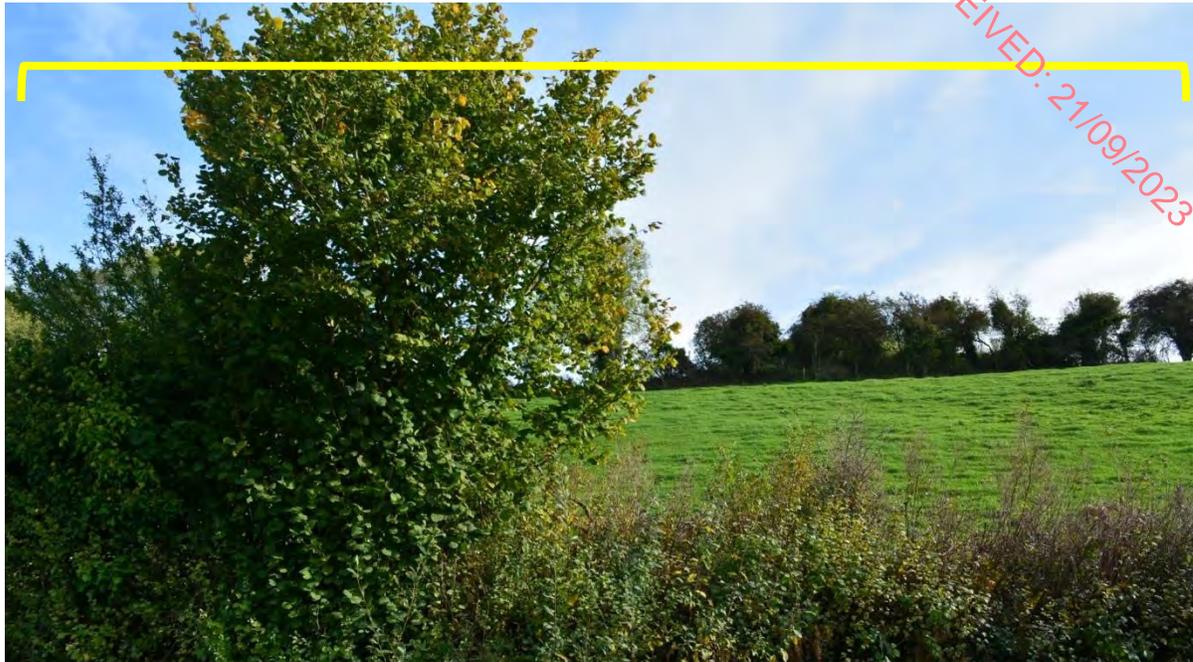
### Viewpoint 18

Viewpoint 18 is from a location along the L-5731-25. Similar to Viewpoint 17 the application site is visible above the roadside vegetation.

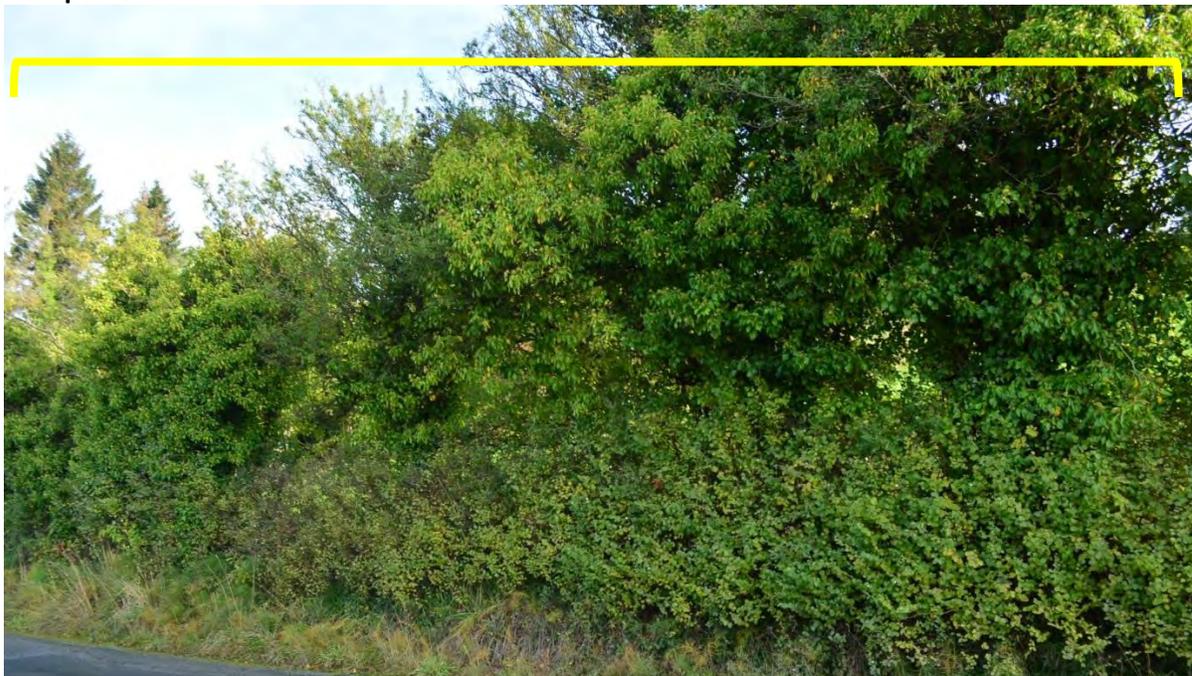
### Viewpoint 19

Viewpoint 19 is from a location to further north of Viewpoint 18. The application site is not visible at this location due to the roadside vegetation.

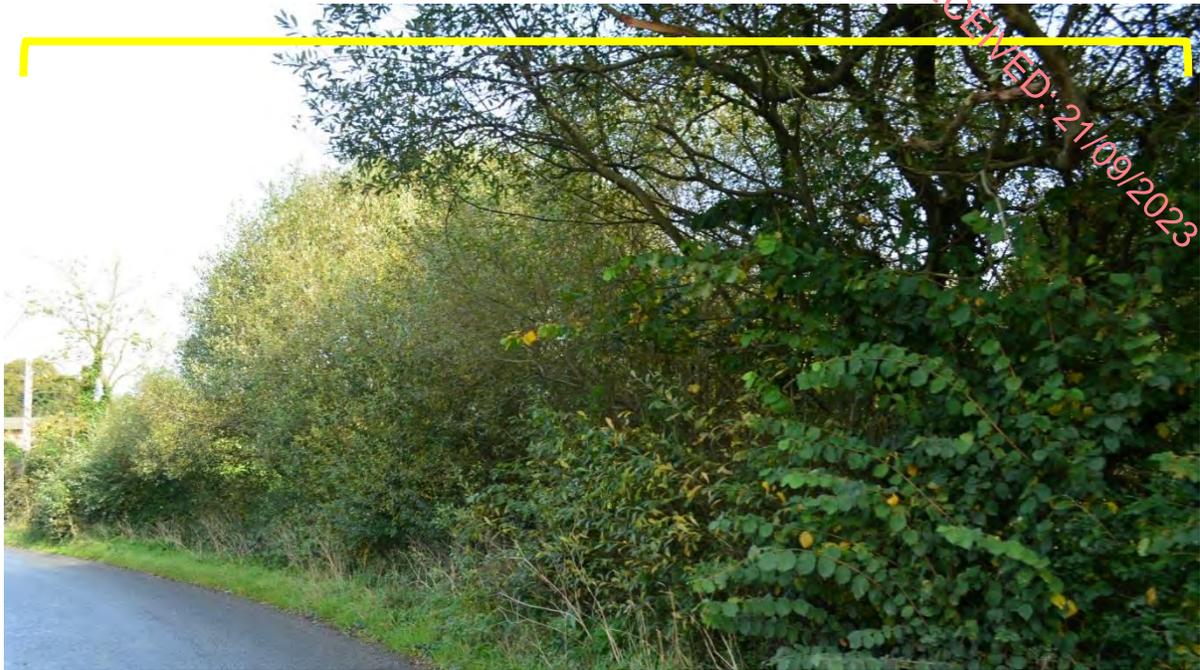
### Viewpoint 20

Viewpoint 20 is from a location further north of the existing site entrance. The existing roadside vegetation provides screening of the application site.

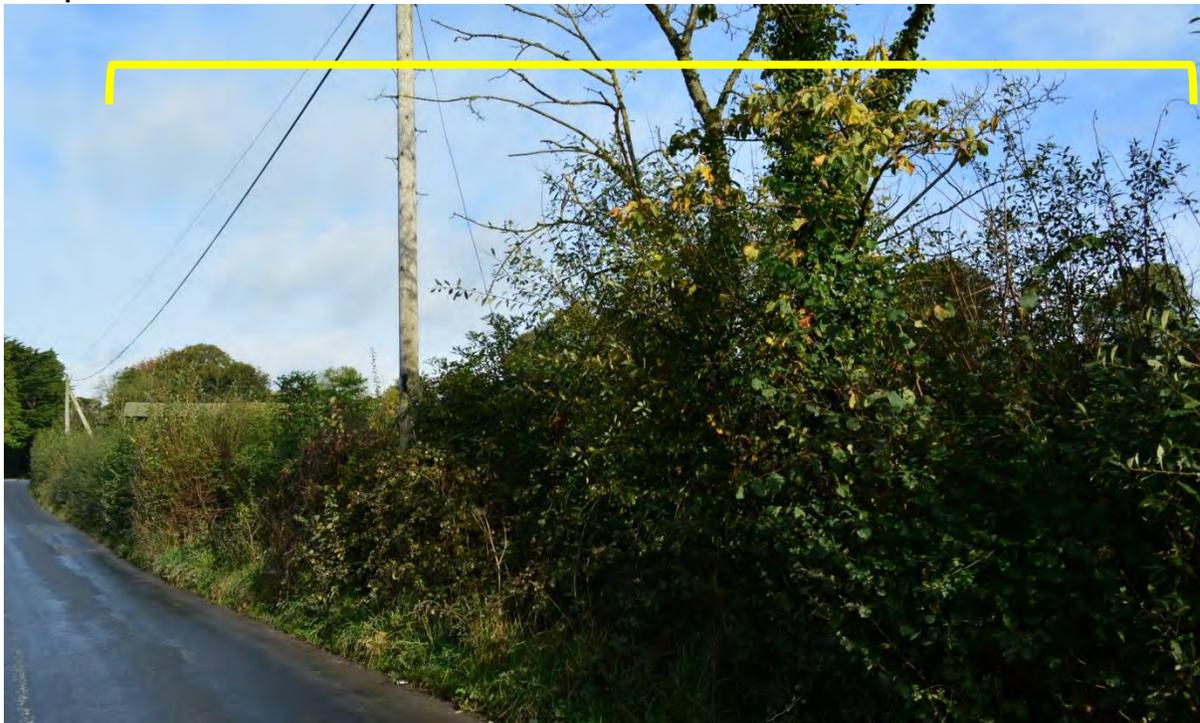
### Viewpoint 21

Viewpoint 21 is from a location along the northwestern boundary of the application site. The application site is not visible at this location due to the roadside vegetation.

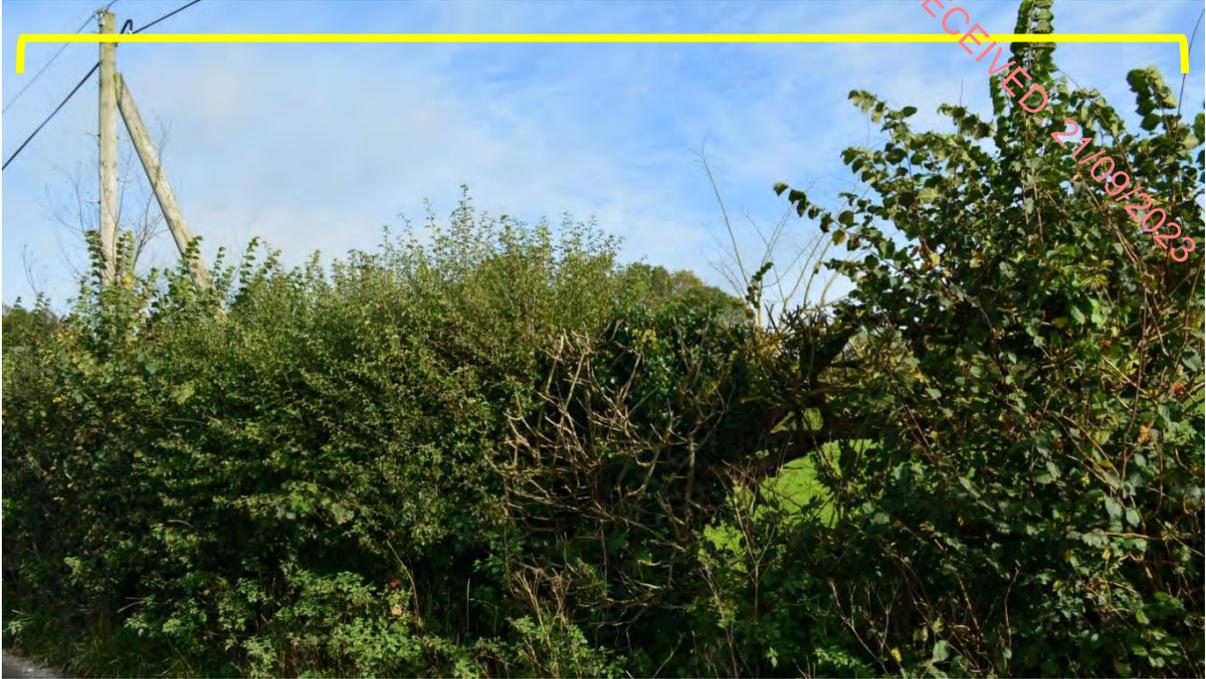
## Viewpoint 22

Viewpoint 22 was taken close to the northwestern corner of the application site. The application site is not visible at this location due to the roadside vegetation.
