## 12.0 LANDSCAPE

### 12.1 Introduction

This section of the EIAR assesses the landscape & visual impact associated with the development on the surrounding landscape in the vicinity of the proposed development. Methodologies used to assess the landscape and visual impacts are outlined and mitigation measures are proposed where required. A landscaping and restoration plan is proposed which will be implemented during the operational lifetime of the development with final restoration undertaken on completion of extraction. A copy of the Landscape & Restoration Plan is attached in Appendix 12.1.

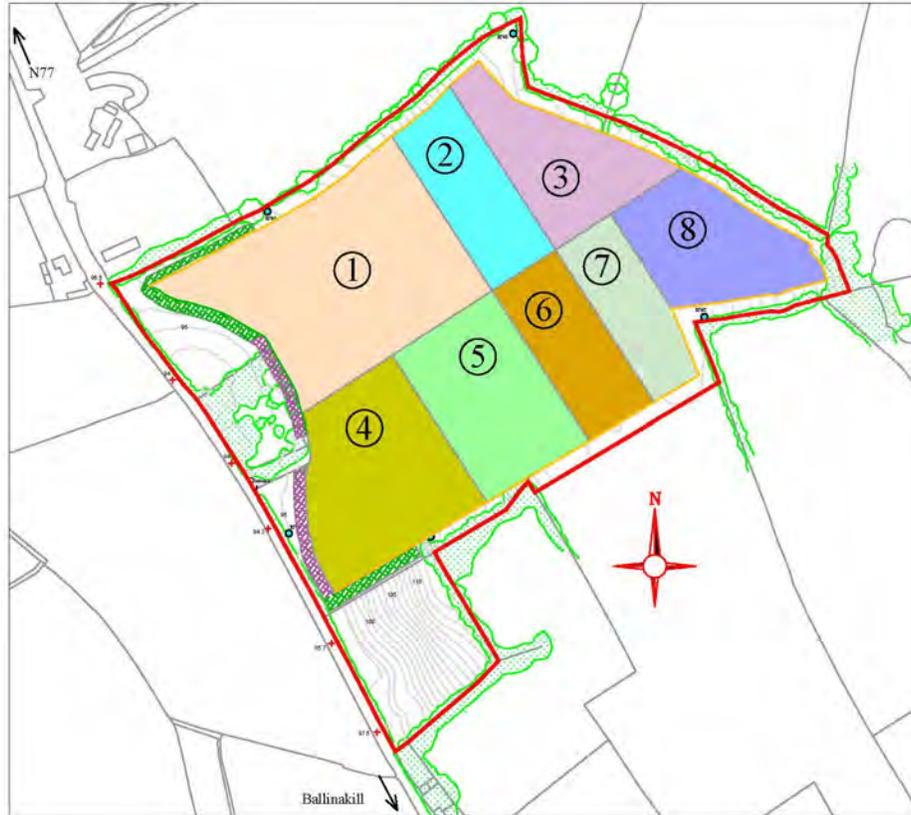
Plate 1: Proposed Extraction Plan

The applicant proposes to remove the existing woodland, vegetation and overburden and extract the underlying sand and gravel material in line with an eight-phase extraction plan as detailed on Plate 1. As illustrated in Plate 1, the extraction of material will be undertaken over 8 phases over a 10 year period with each phases consisting on average of 12 months of material. It is proposed to implement a rolling landscape and restoration plan which will aid in reducing the visual impact associated with the proposed development. This includes the revegetating or areas, provision of berms and planting of trees and shrubs to reduce visibility

of the pit. This will ensure that phases are extracted then restored on a rolling basis with only a minimum area of the site subject to activity.

It is proposed to construct a berm along the western boundary using overburden and sand and gravel material removed from Phase 1. As extraction proceeds into various phases, overburden removed from the working phase will be used to restore the previous phase where material has been extracted. This will be undertaken on a rolling basis to minimise the uncovered area of the site

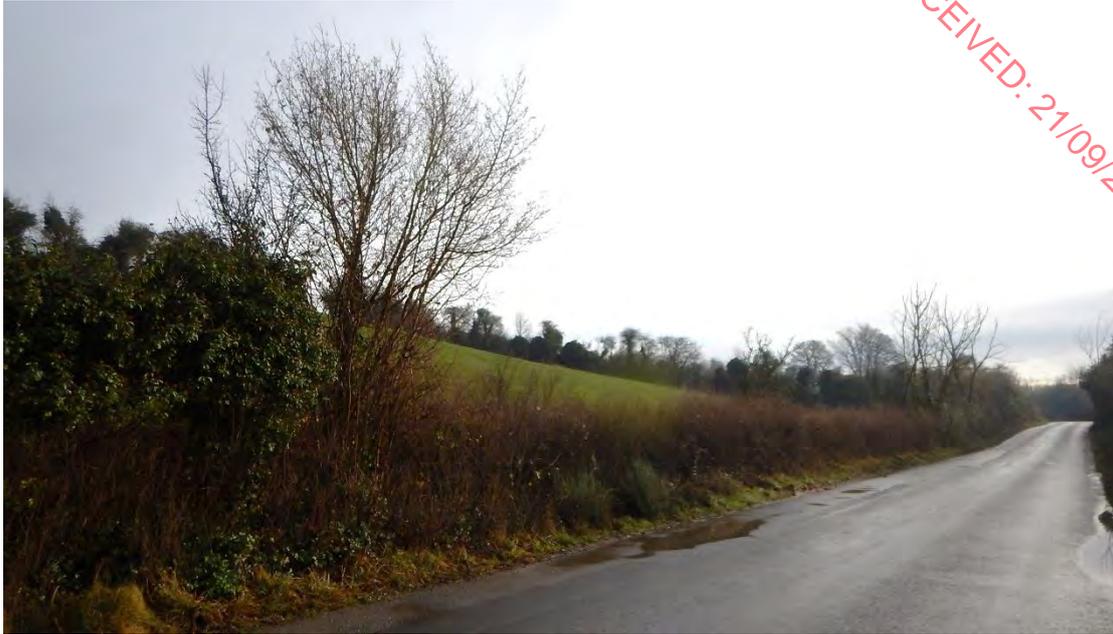
1. Southern half of the roadside hedge H1, viewed from the northwest.

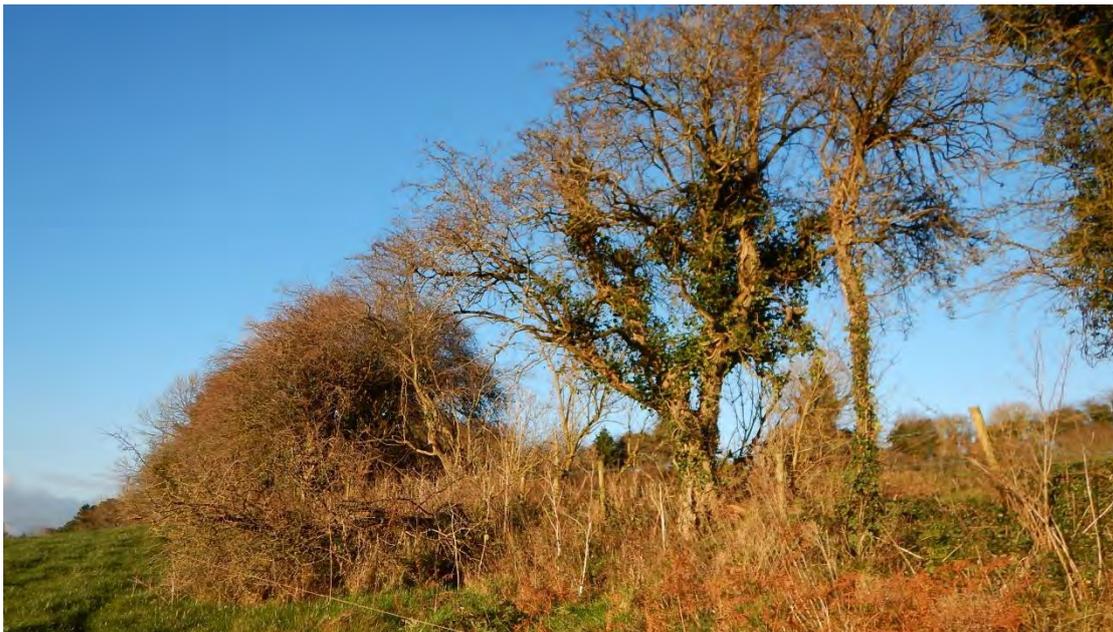
2. Over-mature Hawthorn trees in fragmented hedge-line H3 along the southern boundary area of the site.

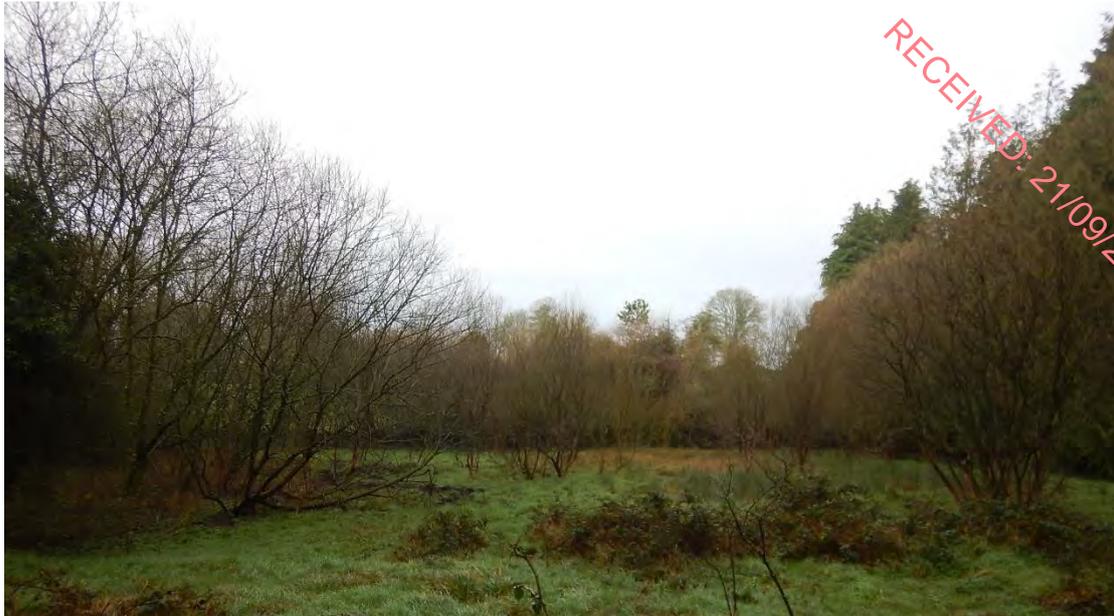
3. Willow regeneration making up group G13 encroaching across unmanaged land in the central part of the western edge of the site.

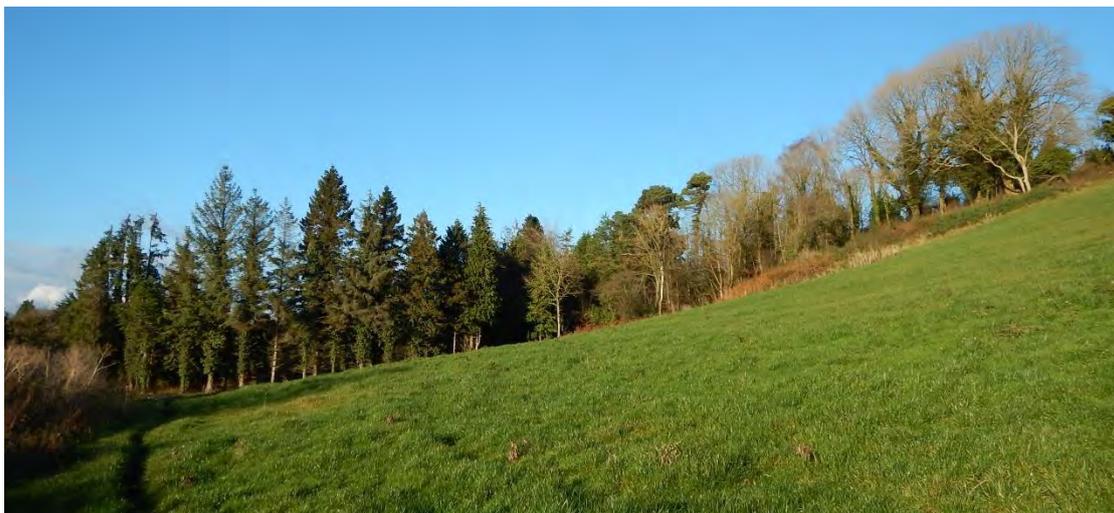
4. Central wooded part of the site seen from the south, with conifer tree group G3 to the left, woodland W1 in the centre and group G1 to the right.

The mixed conifers (groups G3, G4, G6-G8) established as part of a previous land use layout (dwelling house or farmyard), are now well-established and quite prominent from the public road, however they include many individuals of low quality and value. Many of these trees have been subject to poor previous pruning treatments, major bark-stripping by livestock, storm damage and/or overstocking due to a lack of thinning. These conifers are mostly exotic species of limited conservation or landscape value.

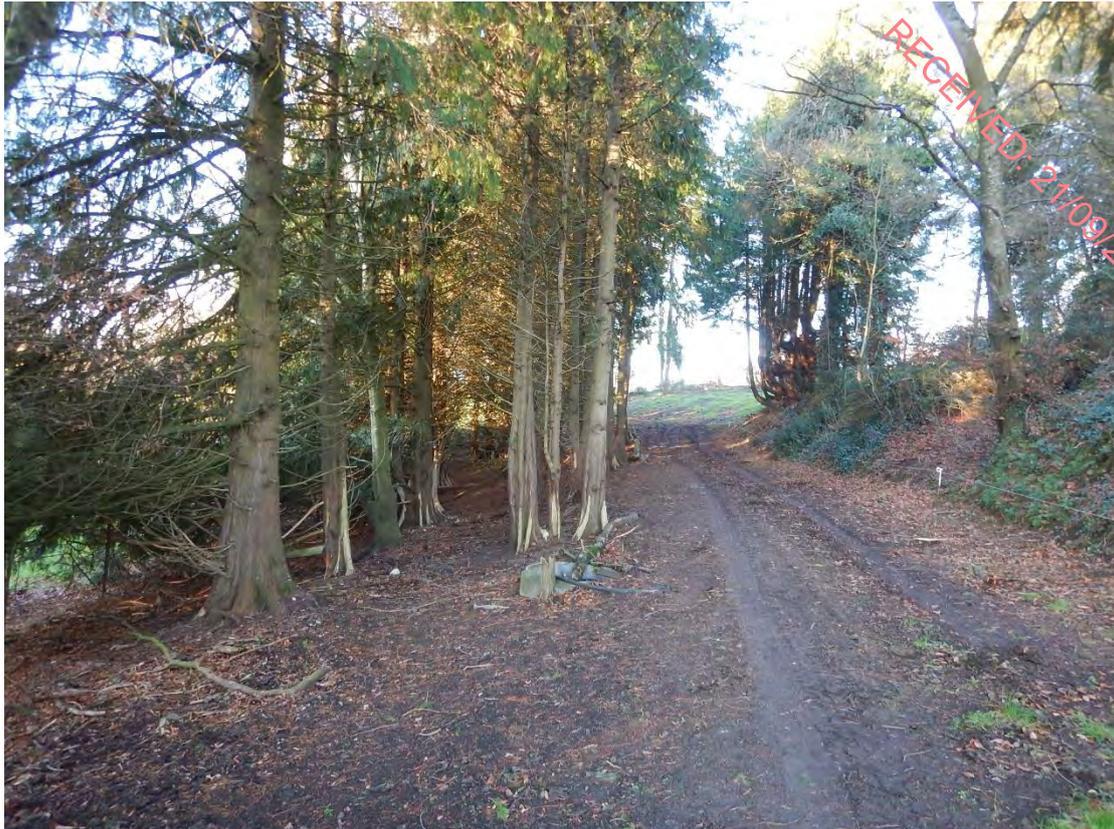
5. Mixed conifer group G4 to the left and group G7 to the right of the old track through the trees.

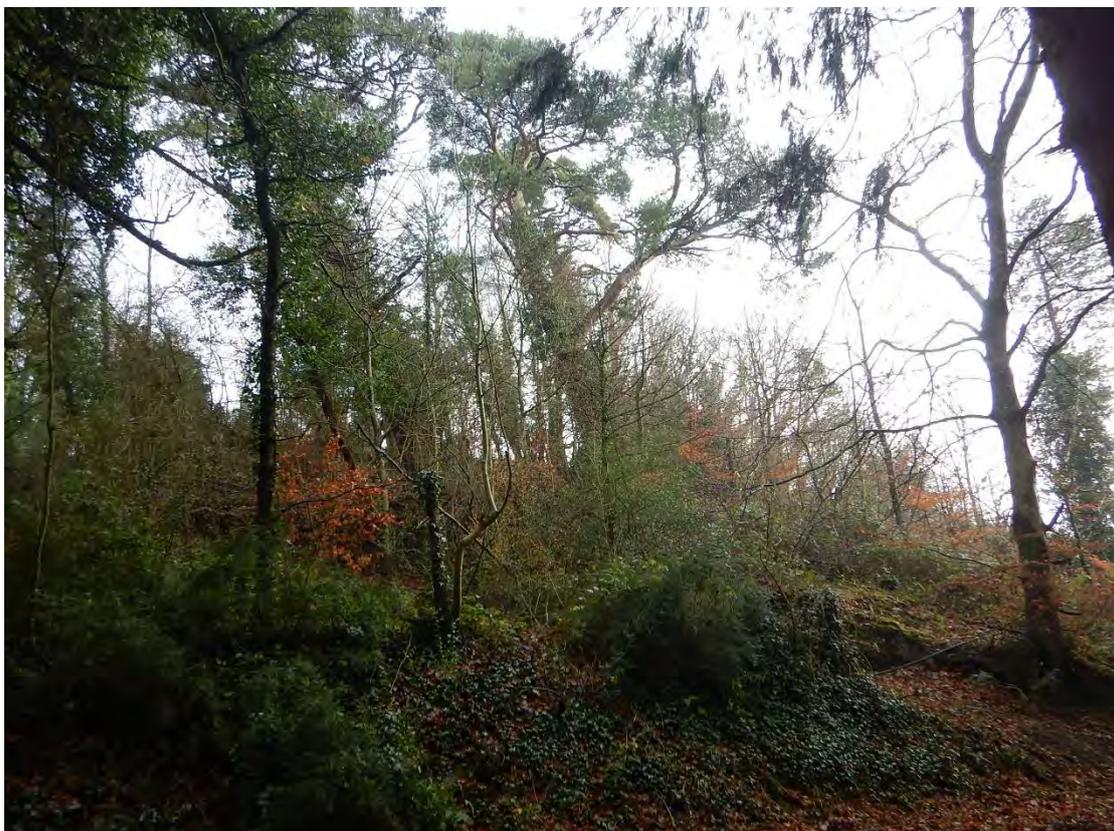
6. Woodland W1 seen from the old track at the western edge of the wood; W1 includes the mature Pine trees (G8) in the centre of the picture.

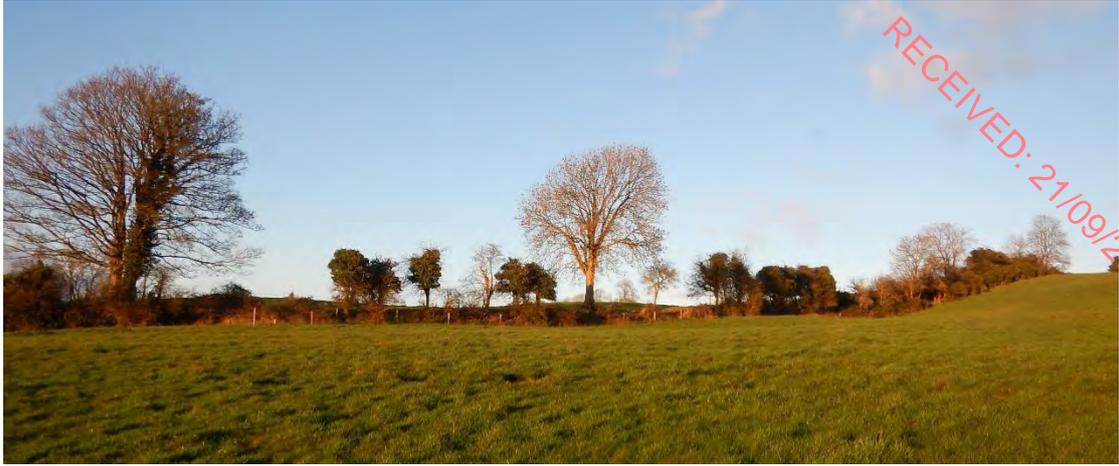
7. Emergent hedgerow trees T1 (to the left) to T5 (far right) along hedge H9 following the northern boundary of the site.

The old farm hedges are in mostly poor condition following years of deferred management. Native species hedges require regular management works to maintain constituent tree health and vitality and hedge density/thickness. Most of the hedgerows on and around the site have started to decline in vitality as the trees and bushes have become overmature (especially the Hawthorn and Elder bushes) or have succumbed to disease (notably the Elm trees, with the Ash trees likely to follow). Traditional practices such as coppicing and hedge-laying help maintain hedge health by encouraging the trees to continue to live in the immature lifecycle phase of growth, deferring these practices often leads to a gradual decline in tree vitality and eventual hedge fragmentation, this is particularly noticeable in the southern half of hedge H1 and hedges H2-H8. The northern ends of hedge H1 and hedge H9 along the northern and north-western boundaries have been more actively managed and show better vitality and continuity. The hedges include relatively few emergent mature trees (trees T1-T10), nearly all of which are Ash trees in variable condition.

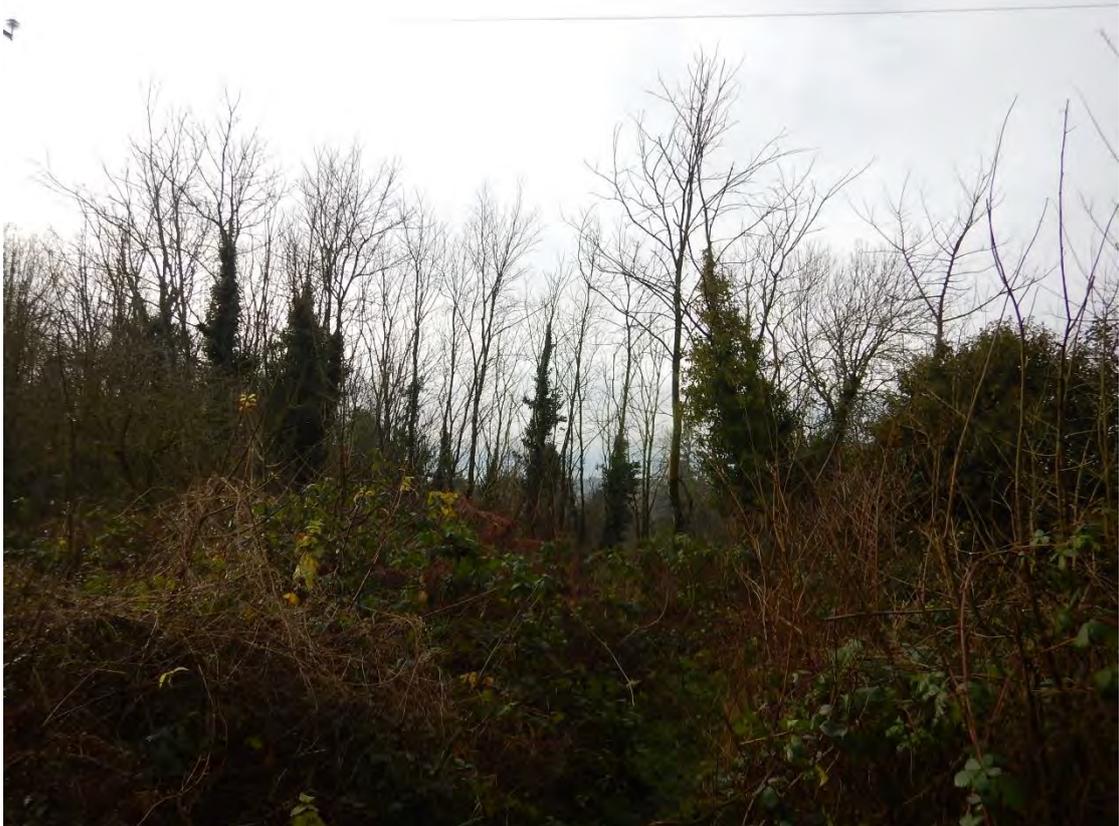
8. Young trees making up dense secondary woodland W2; many of the trees are semi-mature Elm trees now standing dead after being killed by Dutch Elm disease.

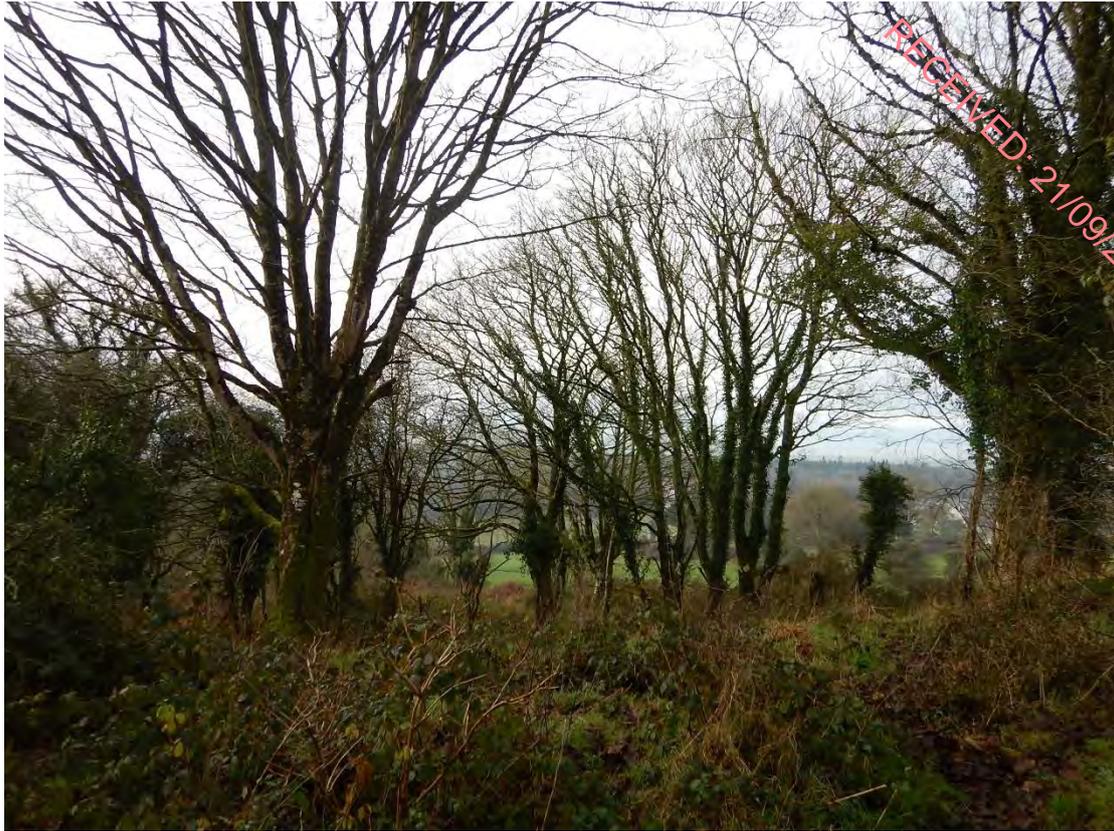
9. Cluster of mature Sycamore and Ash trees (group G9) in the north-eastern part of the wooded central area of the site.

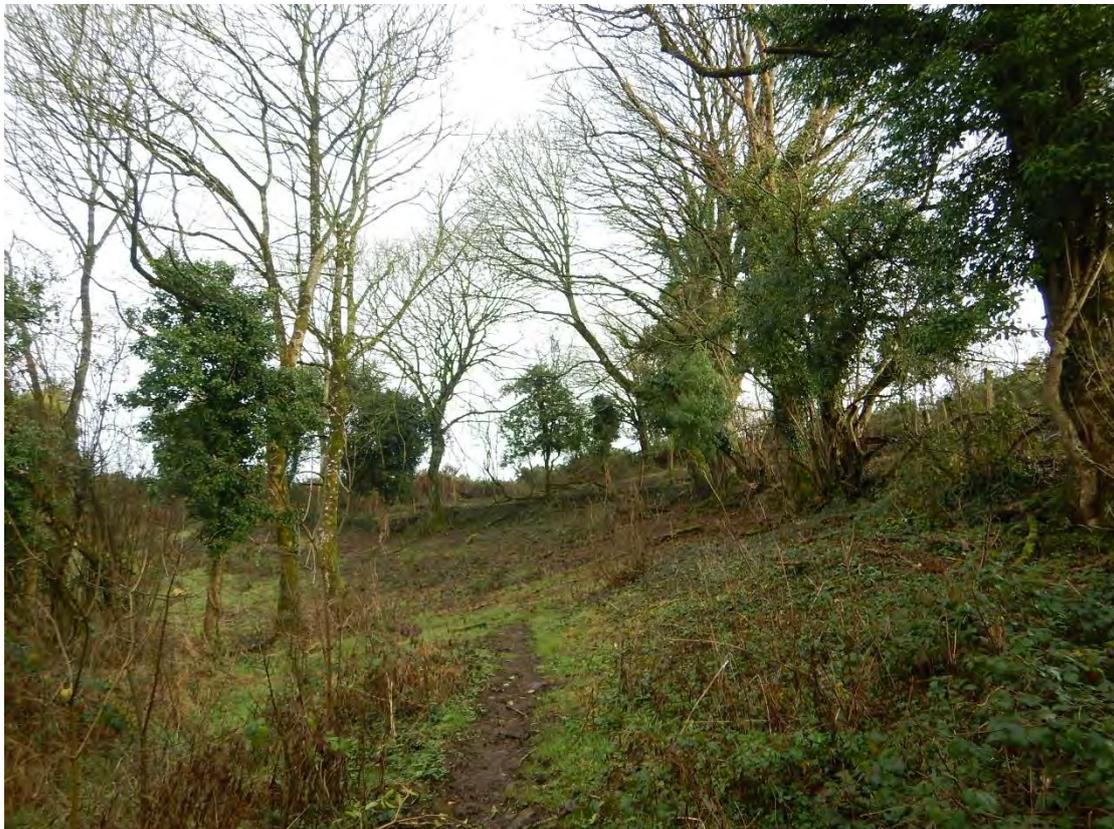
10. Mature trees (T19-T24, G11) in the south western part of the central wooded area of the site.

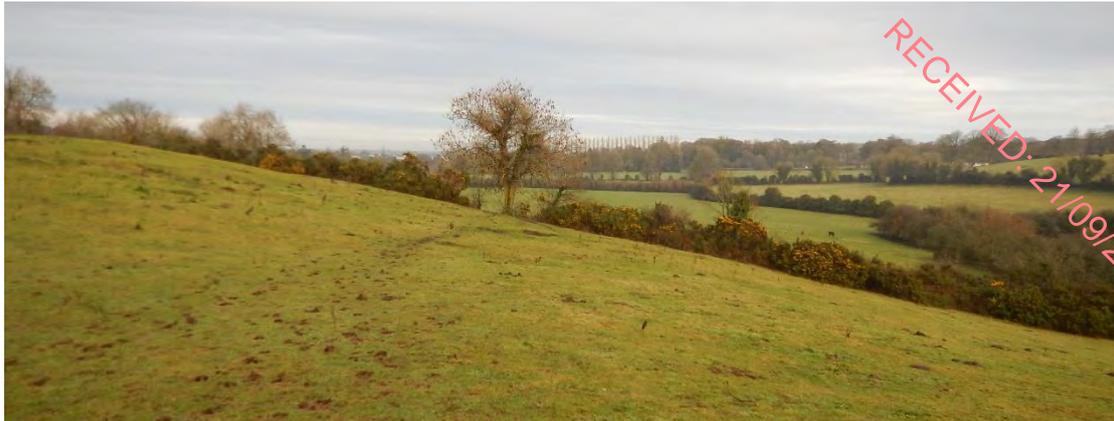
11. Solitary Ash tree (T9) on the boundary hedge H6 at the north-eastern edge of the site; most of this hedge is now made up of Gorse bushes.
