| Appendix 8.9 | Flood Risk Report (Envirologic, 2025) & Hydro-G Consultation Notes. .... | 78 |
| Appendix 8.10 | K Test Site Investigation Information & Summary of Understanding ..... | 134 |

## Appendix 8.1

## Statement of Expertise

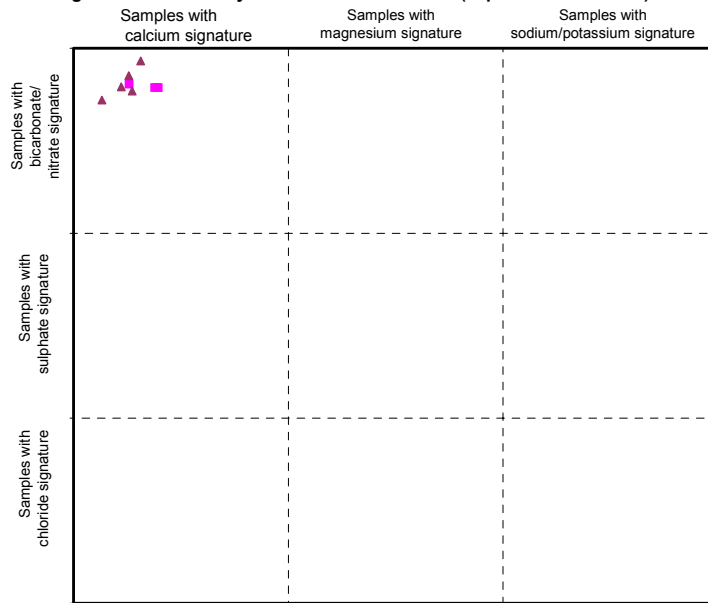
Figure 5 Expanded Durov plot showing hydrochemical signature.

**Chemical Signature of Relatively Uncontaminated Waters (expanded Durov Plot)**

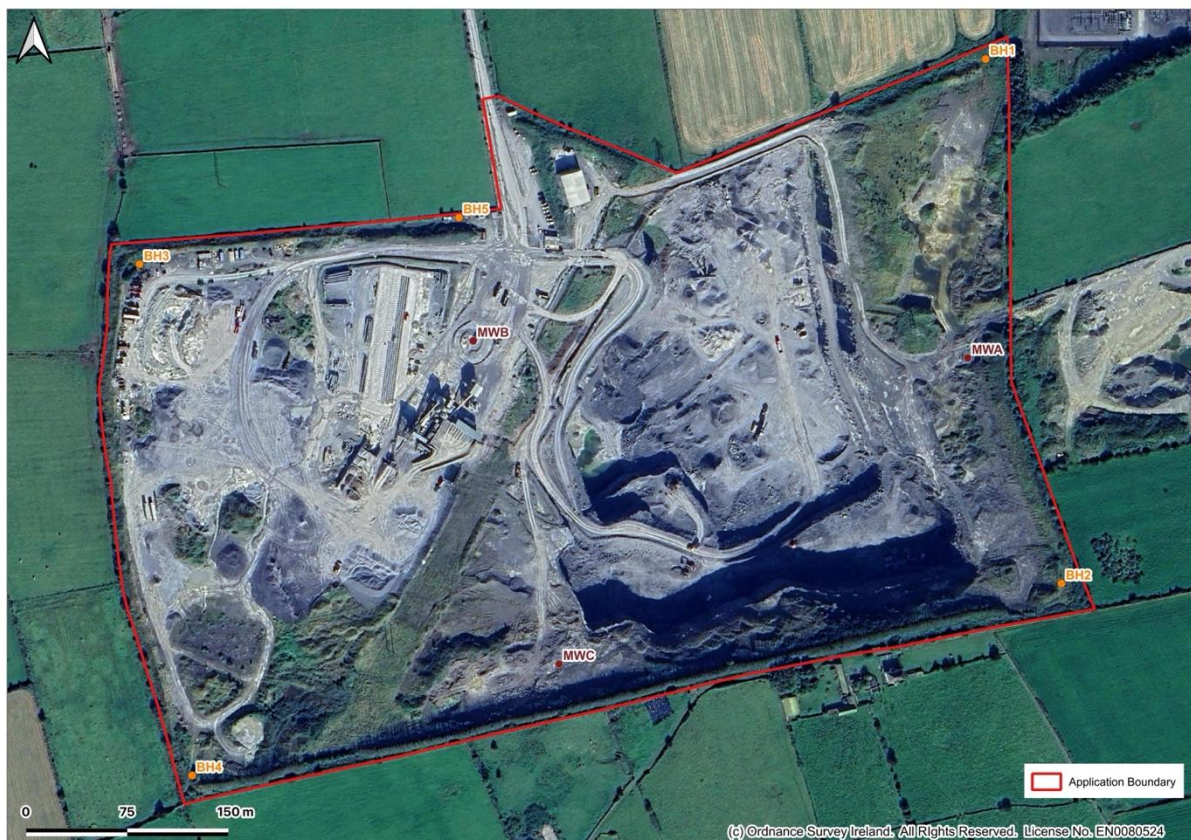
As permitted in the site's Section 4 Licence, in order to maintain a safe and dry working environment all waters arising in the quarry void's sump is pumped to a settlement tank and oil interceptor as a mitigation measure for sediment entrapment and hydrocarbon retention, if present. Treated waters are discharged to ground via a stone-filled infiltration area positioned inside the southwestern corner of the application site. The discharge area is supposed to be a lagoon but there is not enough water encountered at the site to keep the discharge area saturated as a lagoon water body.

**Figure 2 - Aerial Image of application site showing monitoring well locations**

The application site has an area of 27.5 ha. The application site is broadly rectangular in shape with a southwest-northeast length of 690 m running parallel to the M6 and a perpendicular width of 420 m. Refer to Figure 2. The overall quarry site area is 27.5ha, the quarried void at -5mOD is proposed to extend this -5mOD floor laterally by an area of c.4.6ha: comprised of small areas extending towards the northern and southern overall site boundaries and a small triangle to the southwest of the excavation but the majority of the total proposed 4.6ha lateral expansion

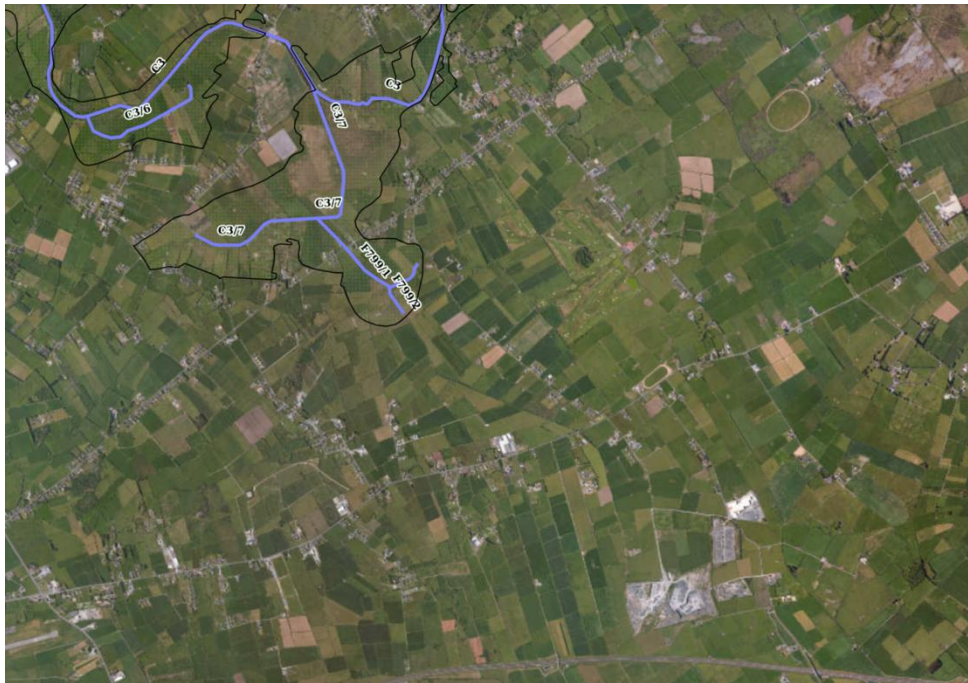
**Plate 1 - Benefitting Land Maps**

The nearest tributaries to the north, Kenny's Drain (OPW Ref. F799/1 and F799/2) and the Islandmore Stream (OPW Ref. C3/7), which outfall to the Clare River (Plate 1) are maintained as part of the Corrib West arterial drainage scheme.

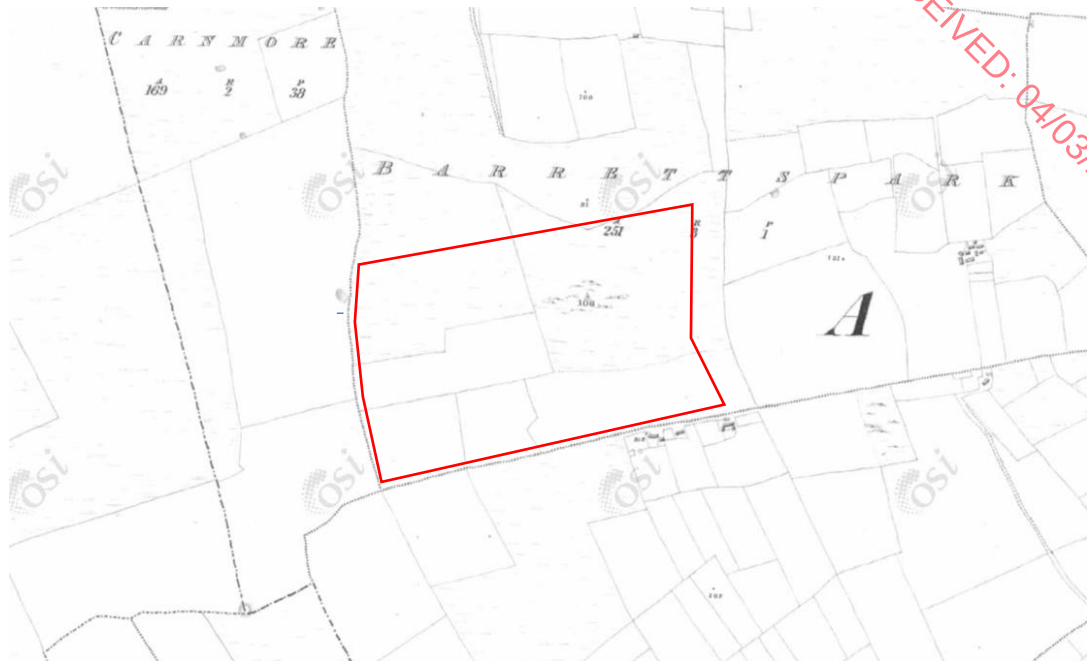
Reference was made to the historical 6" (1837-1842) and 25" OSI maps, presented below as Plates 3 and 4, respectively. These maps do not contain any indicators that suggest the application area or surrounding area was historically at risk of flooding or prone to seasonal wetness.

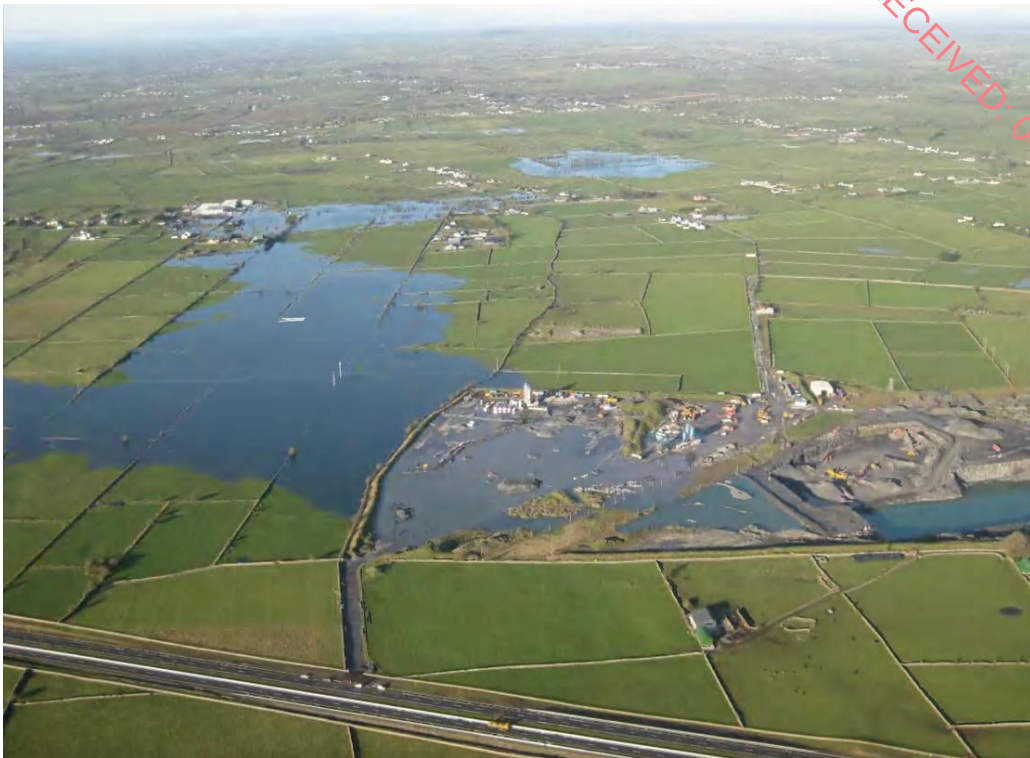
This latter report includes photographs which highlight the flood extents in the Carnmore area in 2009, reproduced here as Plate 7 and Plate 8.

Plate 7 - Flooding at Carnmore, November 2009. Application site in foreground (Source Ryan Hanley, 2010b).

With reference to Figure 14, the groundwater flood polygon displayed coincides with the 2009 flood extents shown in Plate 7.

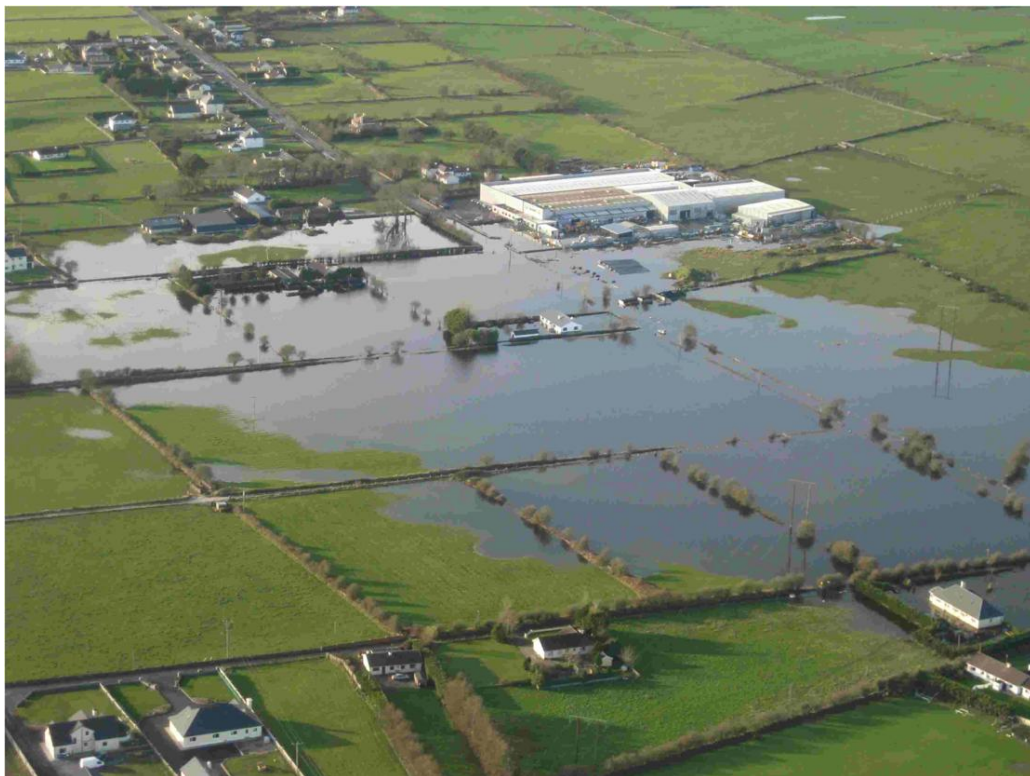
Plate 8 - Flooding at Carnmore, November 2009. This photo was taken approximately 1 km north of the application site, facing west. A flooded Greaney Glass factory is observed (Source Ryan Hanley, 2010b).

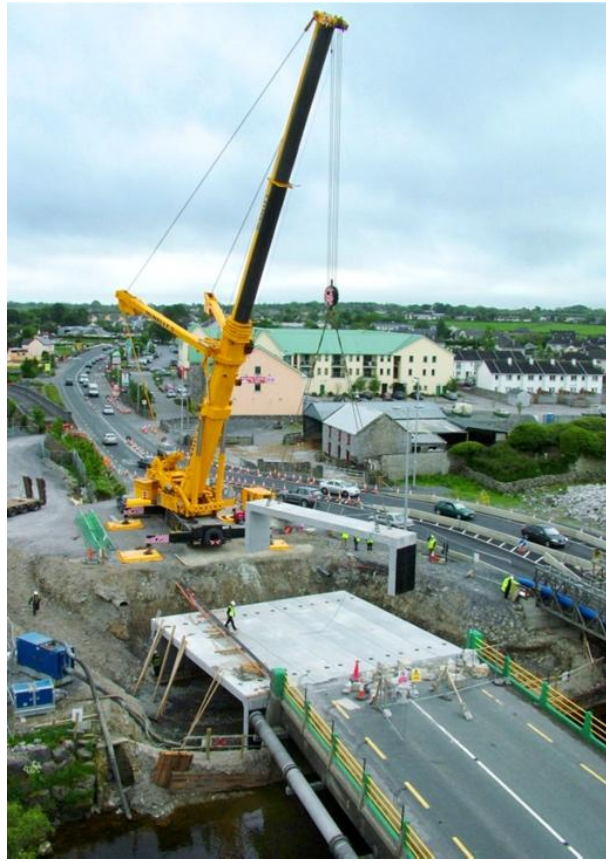
- Channel widening of the Clare River to a point 900 m upstream of Crusheen Bridge;
- Cleaning and limited re-grading of Islandmore Drain;
- Modifications to the bridges in Claregalway (see Plate 10 below) and Crusheen.

**Plate 10 – New bridge ‘Flood Eye’ installed to increase conveyance capacity for the Clare River at Claregalway.**

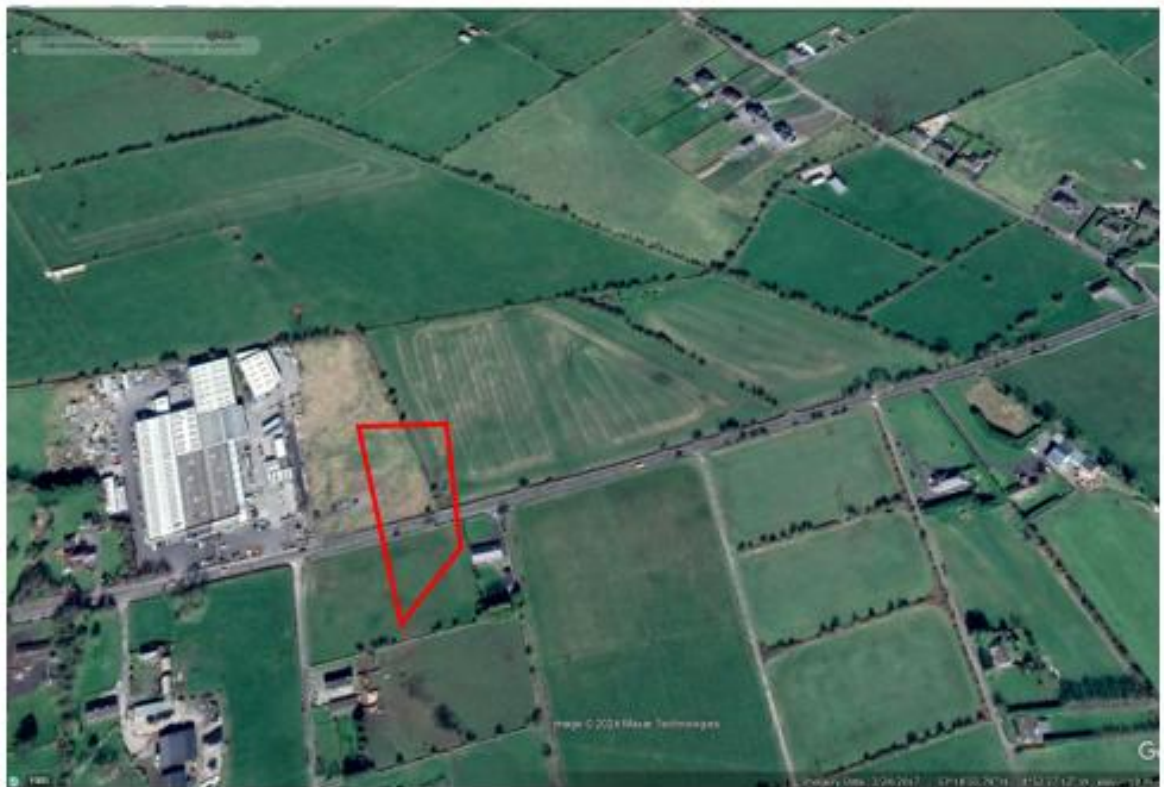
## 2. 2017 no construction evidence

Google Earth images in the vicinity of the “Turlough Busters”

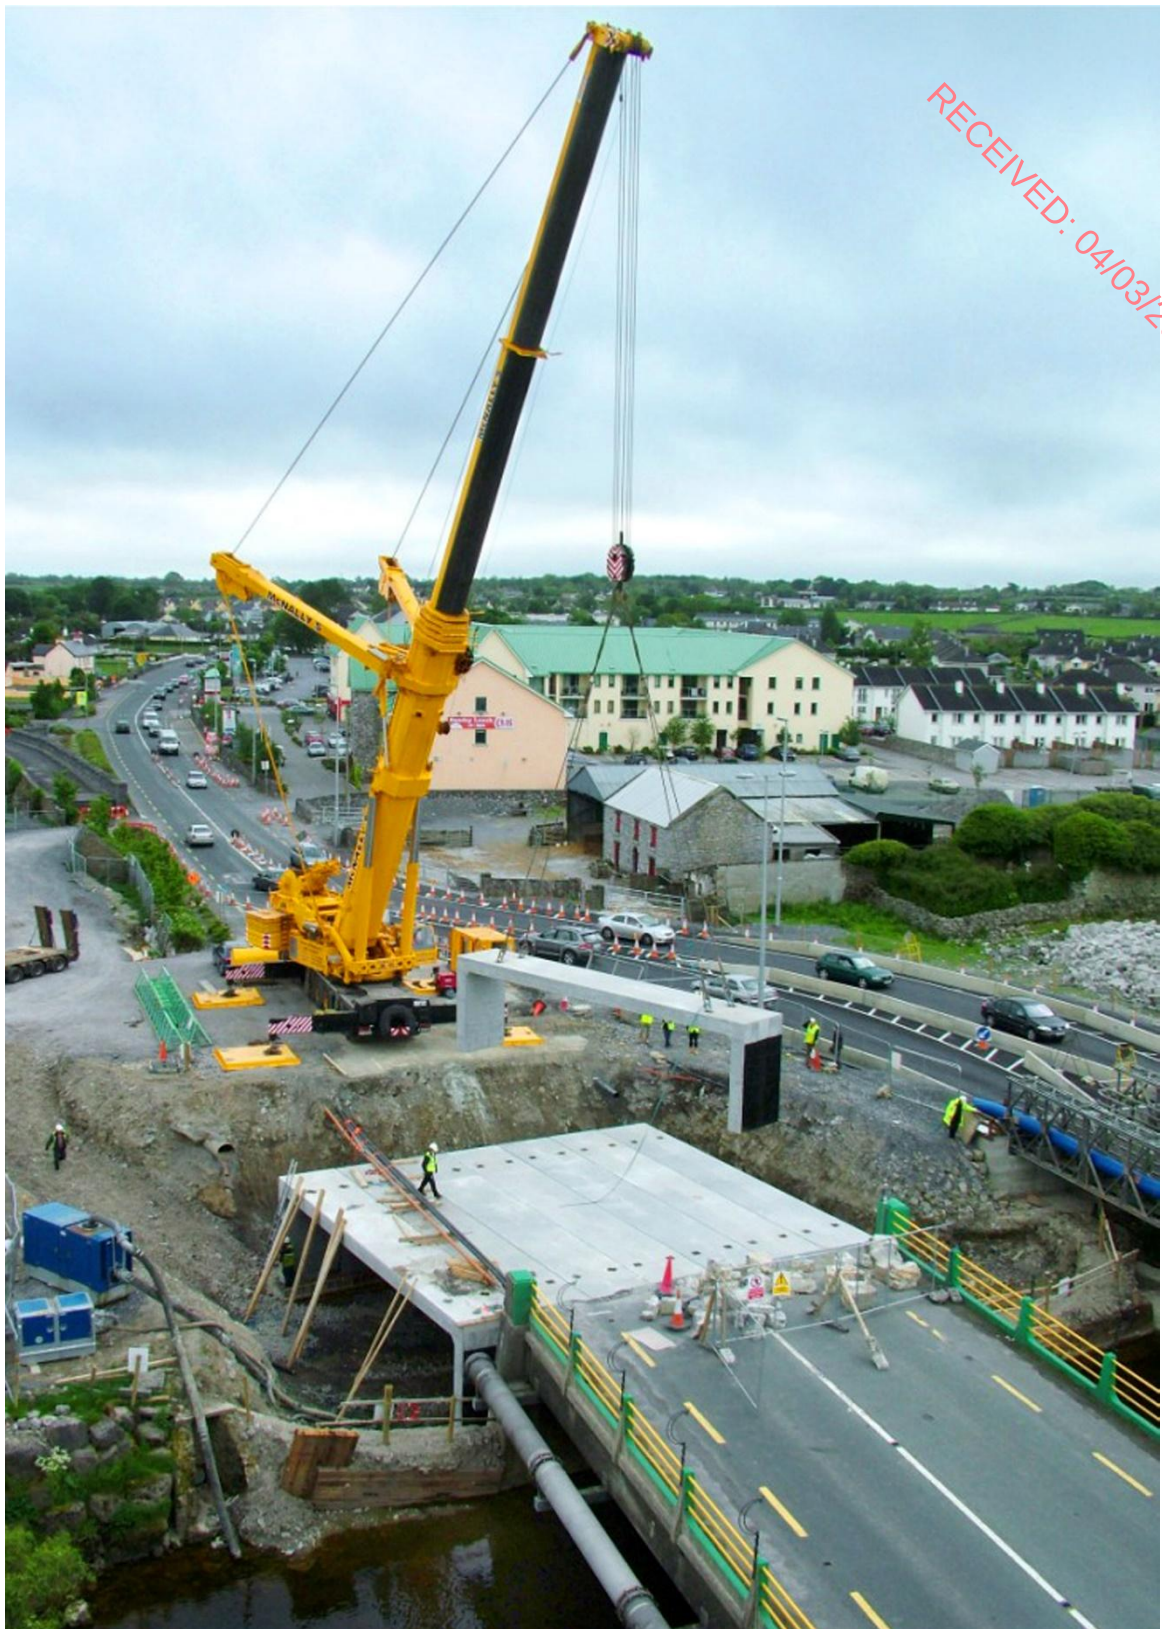
**Photo** from M Joyce Claregalway Flood Eye (2011) installation = has provided Flood Relief for the entire east Galway area and relief at Coshla.

Following the 2009 flood which caused extensive flooding at Claregalway and east of the town and flooding of houses at Lisheenavala, we designed a managed a flood relief scheme at Claregalway which involved the construction of a 12 metre wide flood eye at Claregalway Bridge by the OPW (see attached photo) which has since prevented further flooding of the town and areas to the east of the town.

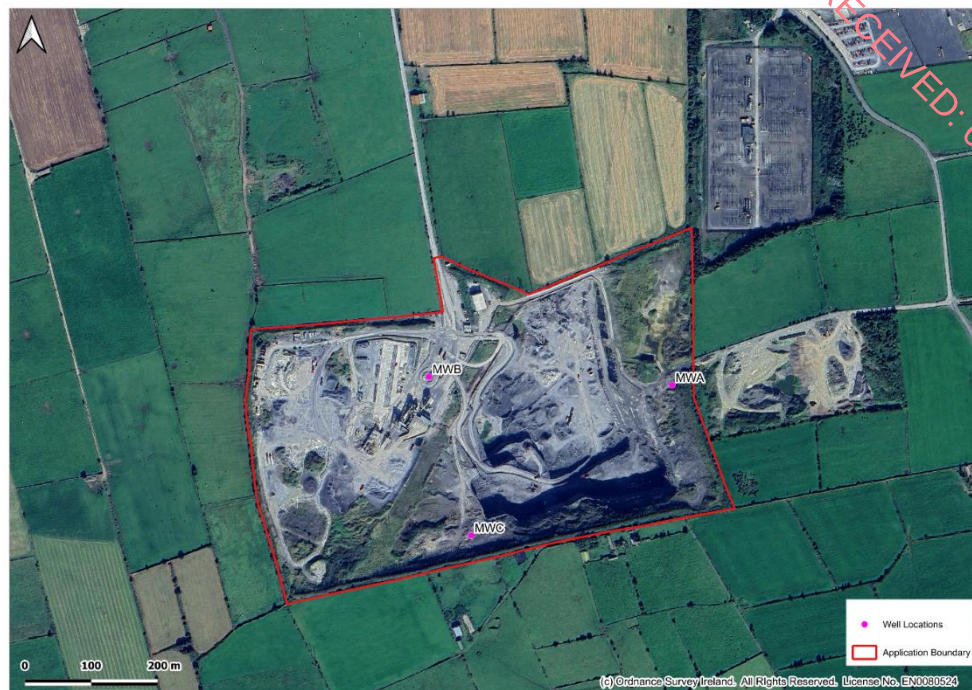
**Figure 1 – Monitoring Well Locations tested: MWA, MWB, MWC**

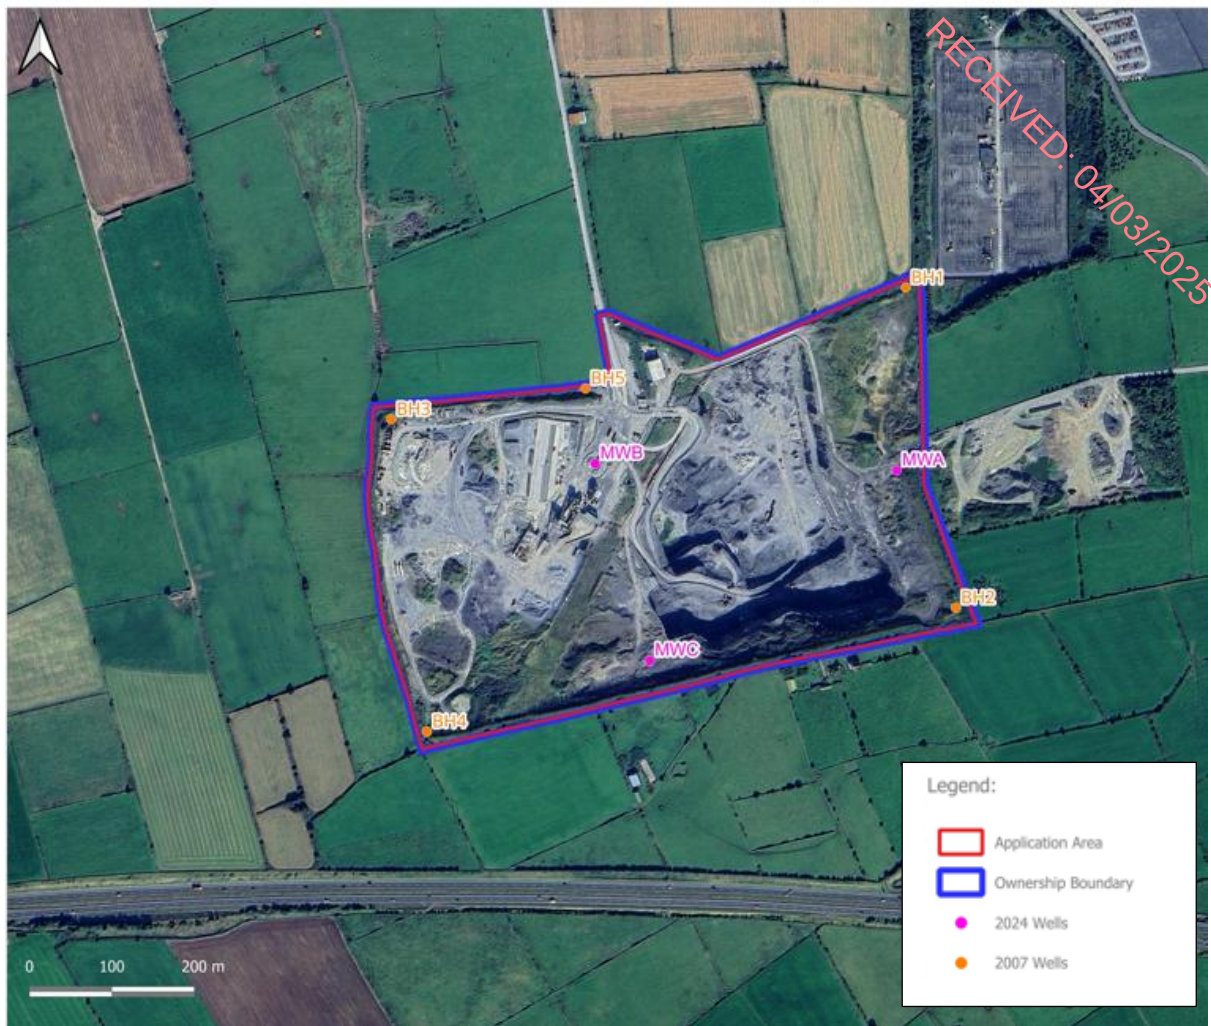
**Figure 8.11.1** Wells at the Site.

BH1 to BH4 are the Quarterly Monitoring BHs. Results are presented over.
