- 6.1 This chapter of the EIAR provides a description of the existing land, soils, and geology conditions in the application area of the site within the context of the regional setting. It assesses the potential impacts the proposed development will have on the land, soils, geological features, and other geological aspects of the development environment in the vicinity of the site. Mitigation measures, if required, are proposed.

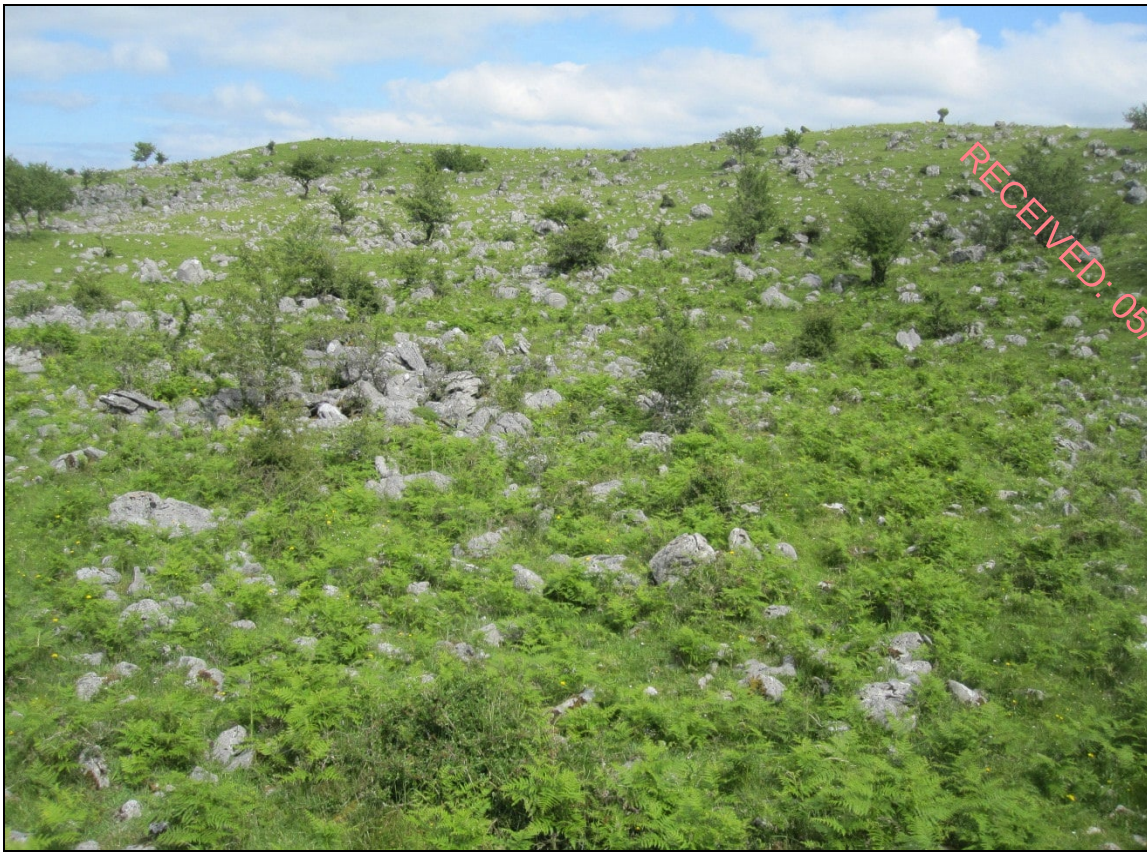
The pristine landscape of limestone boulders on glacial moraine at Killeglan.

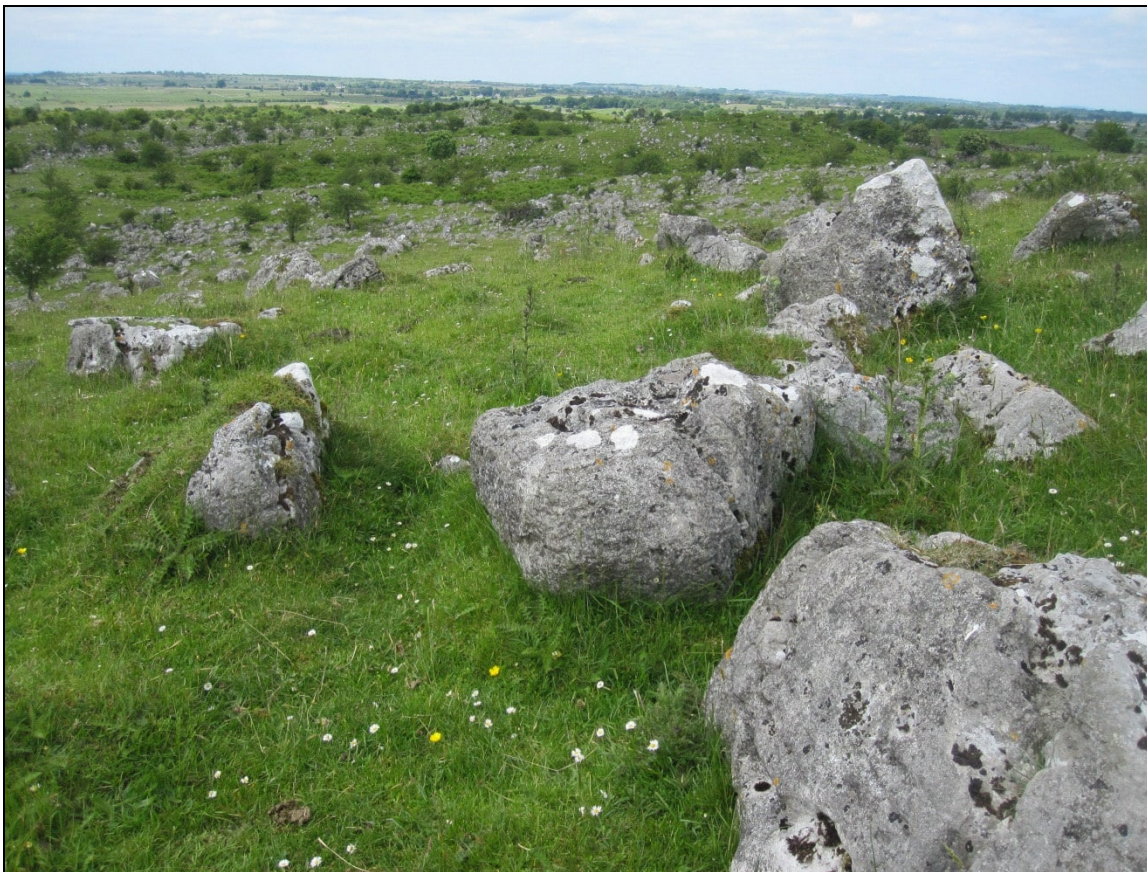
The pristine landscape of limestone boulders on glacial moraine at Killeglan, with karstic weathering imitating limestone bedrock.

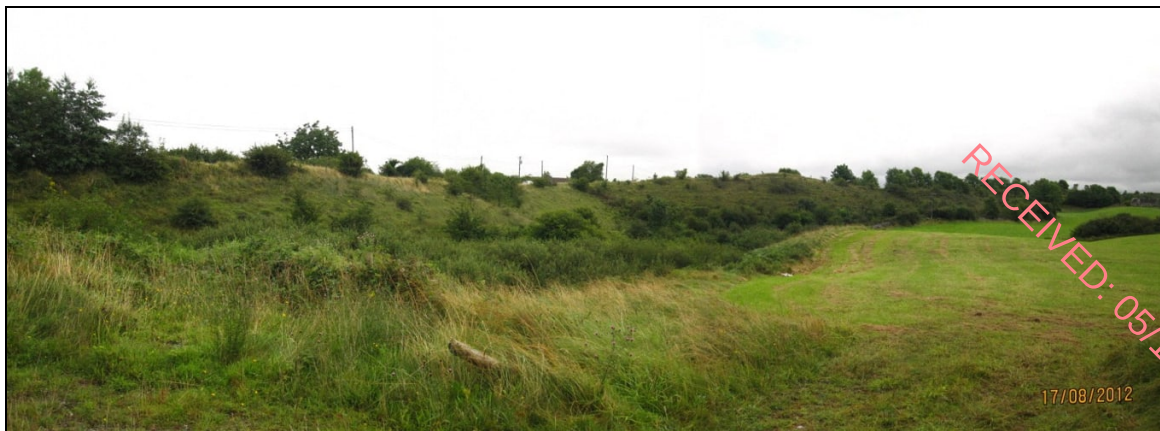
Scrub vegetation on a bead of the Castlesampson esker system.

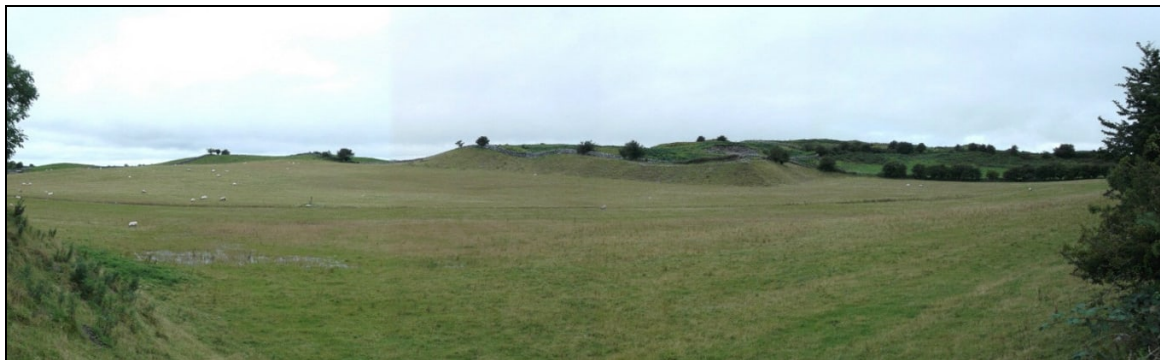
Reclaimed gravel pit within the Castlesampson esker system.

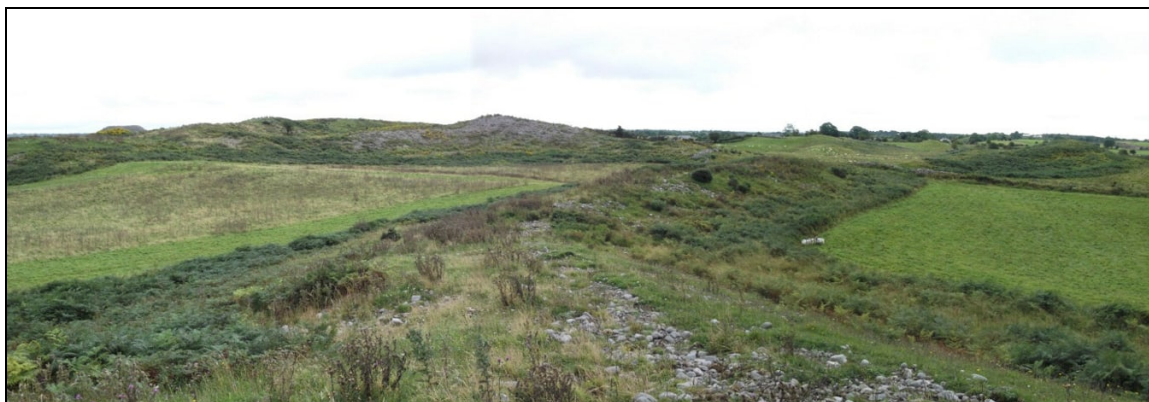
Bare gravels outcropping on the summit of the Castlesampson esker. See the sinuous nature of the feature as it winds away into the distance.

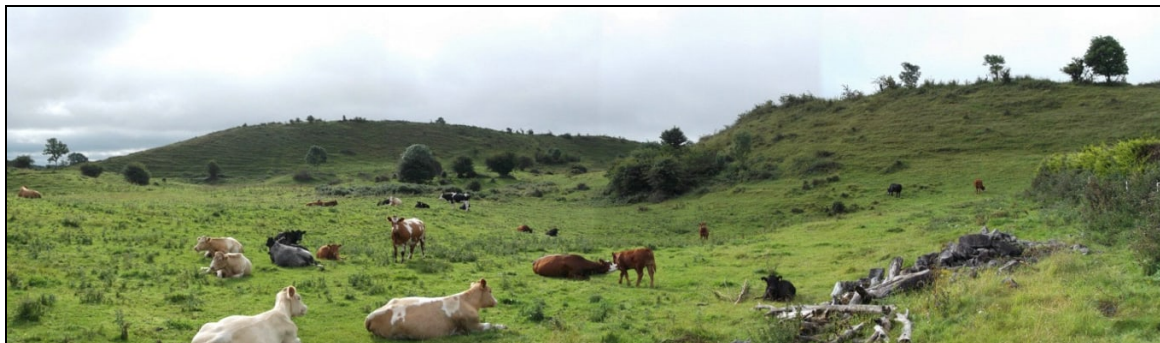
Two distinct beads of the Castlesampson esker system.
