Well Condition Report 2014 & 2023

A.10.1 Well Condition Report 2014 & 2023

N6 Galway City Ring Road

Updated Environmental Impact Assessment Report

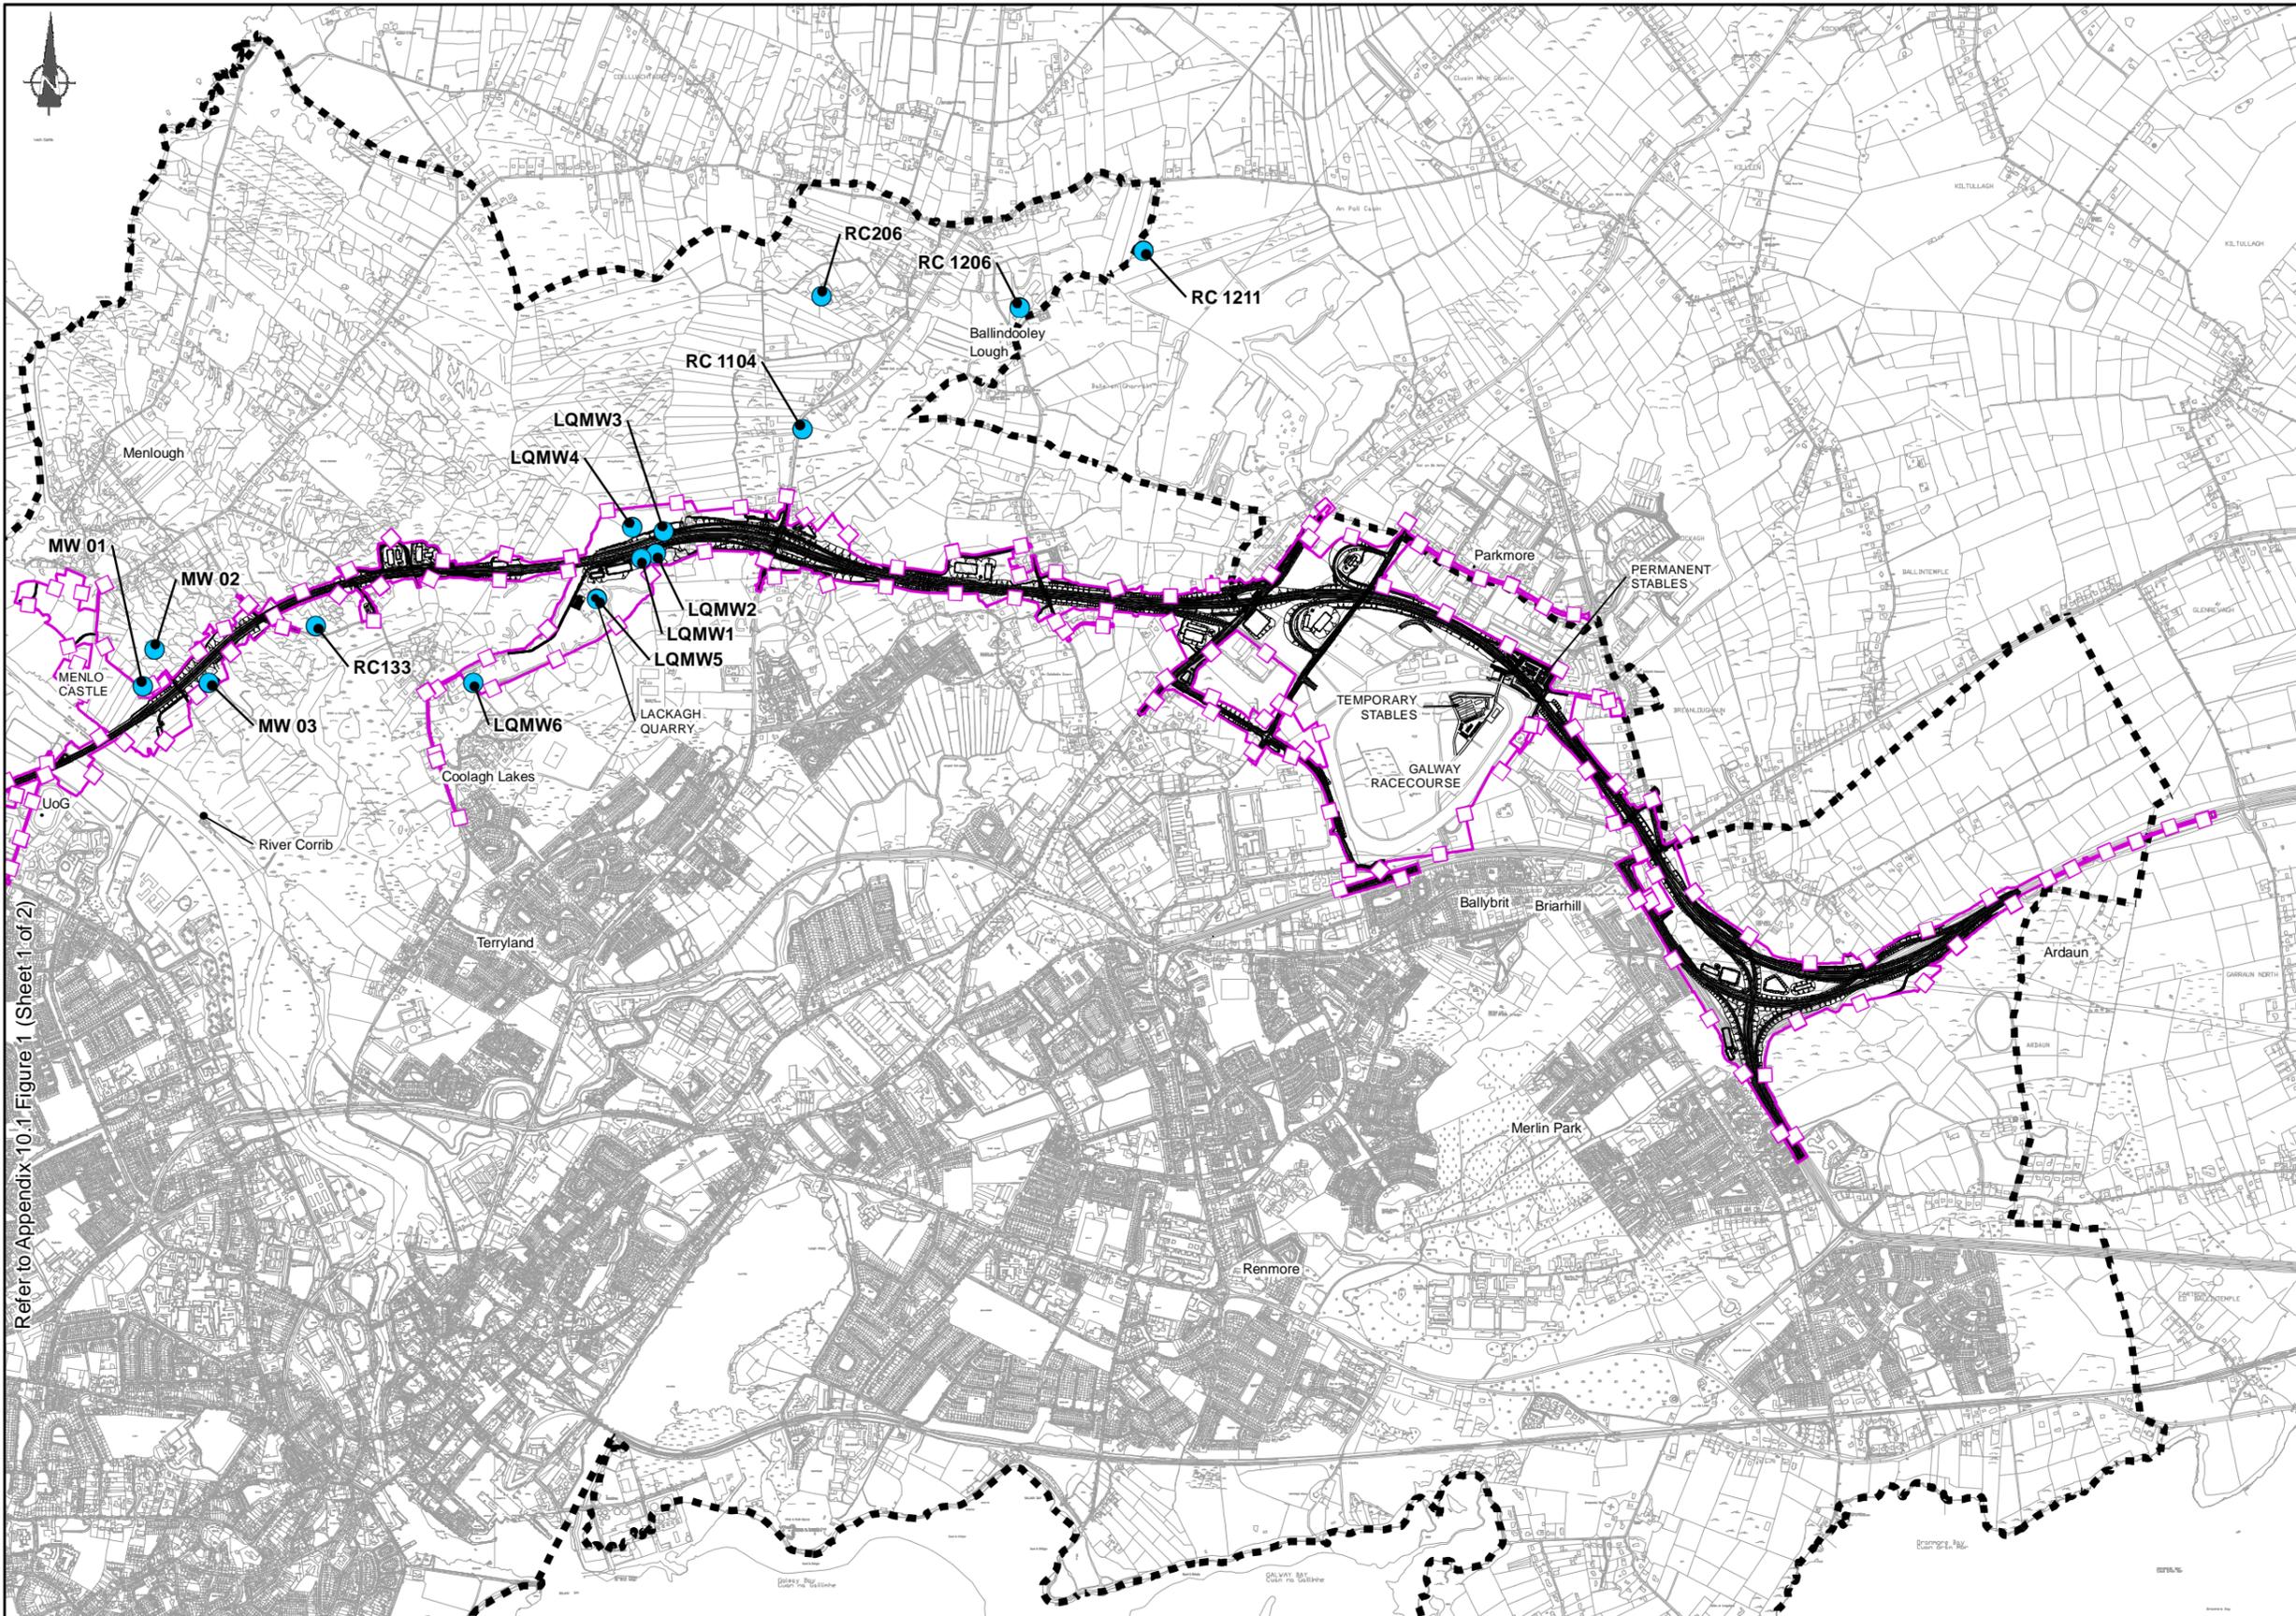
Refer to Appendix 10.1 Figure 1 (Sheet 1 of 2)

- Legend**
- City Boundary
 - - - Assessment Boundary
 - █ Proposed N6 GCRR
 - Groundwater Monitoring Locations

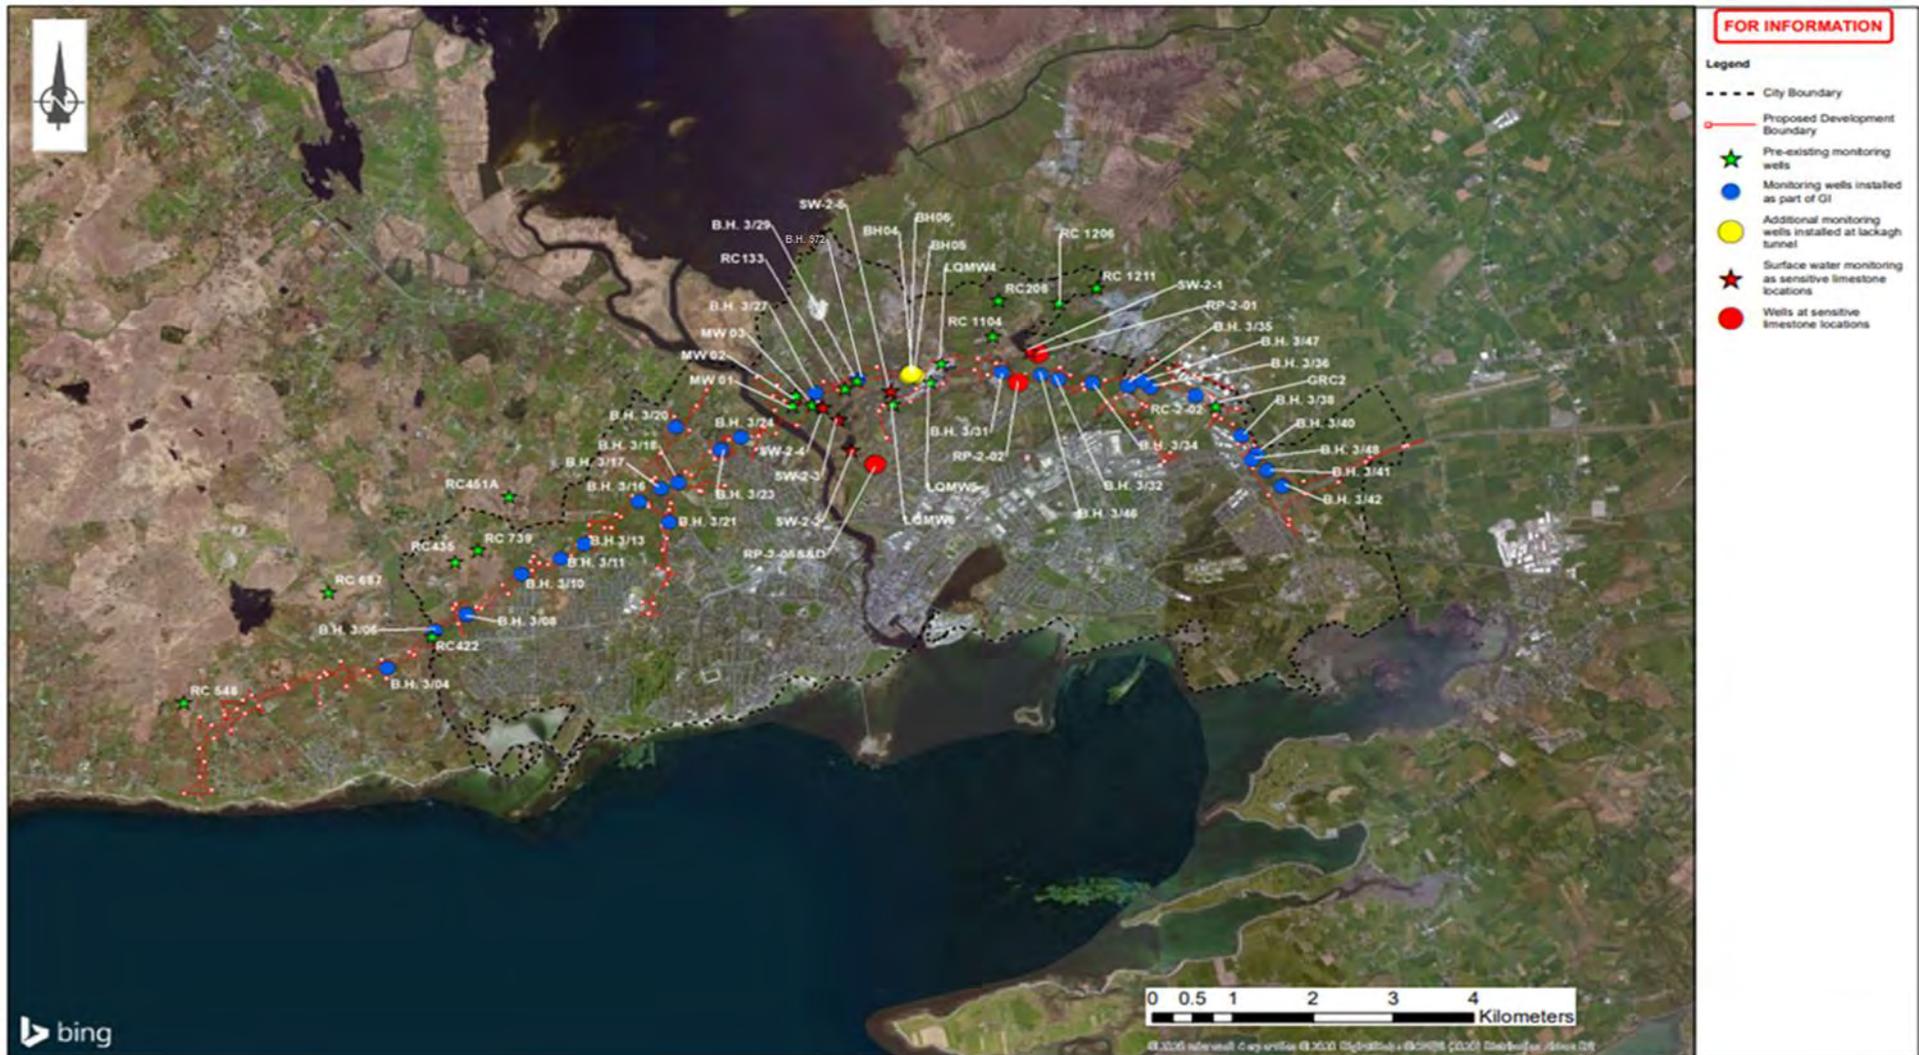
Figure 1 2018 GCRR Groundwater level and surface water monitoring locations

54 (No.) boreholes formed the groundwater level monitoring network of the 2018 N6 GCRR project and of these monitoring wells a total of 17 (No.) were also used for groundwater sampling. The rationale to use 17 (No.) of the 54 (No.) monitoring wells for groundwater sampling was based on their location with respect to local groundwater bodies, their proximity to the Project and their proximity to sensitive hydrogeological receptors. The groundwater monitoring network of 2018 N6 GCRR project is shown in Figure 1.
