# **REMEDIAL ENVIRONMENTAL IMPACT ASSESSMENT REPORT (rEIAR)**

## **Ros an Mhíl Deep Water Quay**

### **Chapter 6: Land and Soils**

**Department of Agriculture, Food and the Marine**

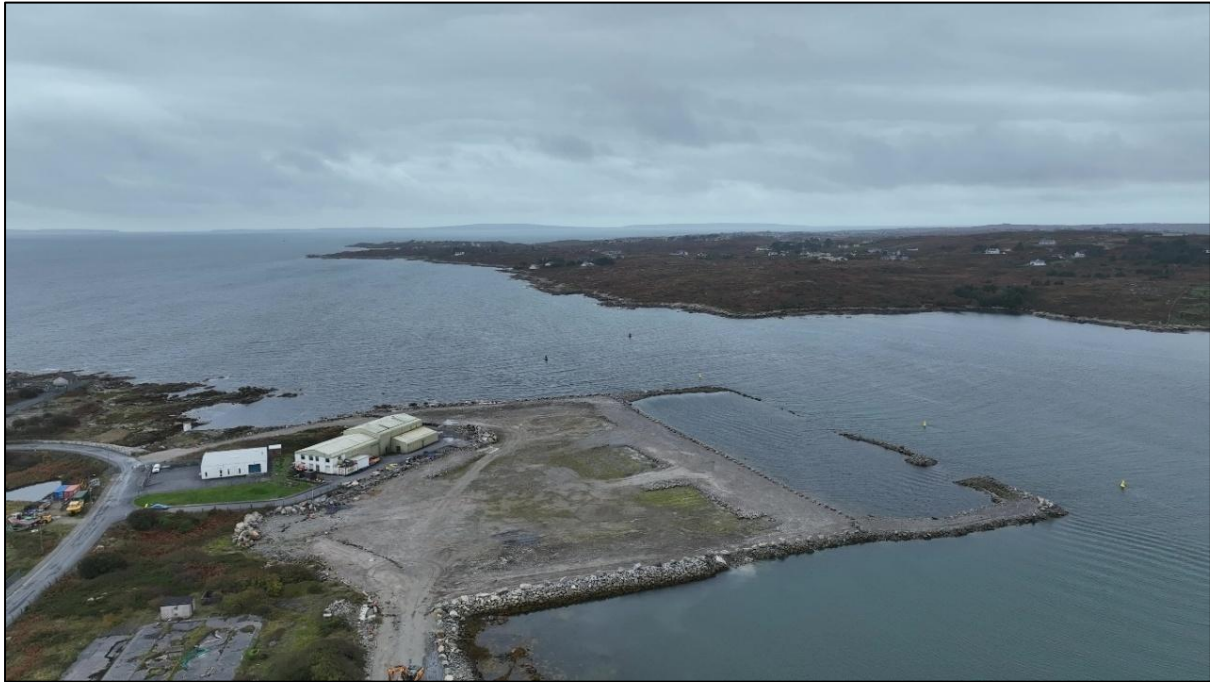
Figure 6-4: Map of existing incomplete Ros an Mhíl Deep Water Quay Facilities

The inner harbour is positioned on the north-east shore of upper Cashla Bay and is well sheltered. The existing harbour currently comprises two piers, known as Piers 1 and 2, along with a dedicated passenger ferry terminal and a small craft harbour. Pier 2 is the more recent development of the two piers. The disposition of these piers is such that they create an approximately rectangular shaped basin at the centre of the harbour. The existing partially completed deep water quay harbour layout is shown in **Figure 6-4**.
