Technical Report to Inspector

ABP-321713-25_App1

Development	Retention permission for a water recycling system w associated ancillary site development works at Roadstone quarry at Clasheen, Killarney, Co. Kerry							
Type of Application	Normal Planning Appeal							
Торіс	Assessment of potential groundwater and surface water issues arising, including an assessment of the capacity of the tanks.							
Scientist	Finbarr Quigley B.Sc., M.Sc. Appl. Sc.							
Date of Site Visit	31 st March, 2025							
Planning Inspector	Bernadette Quinn

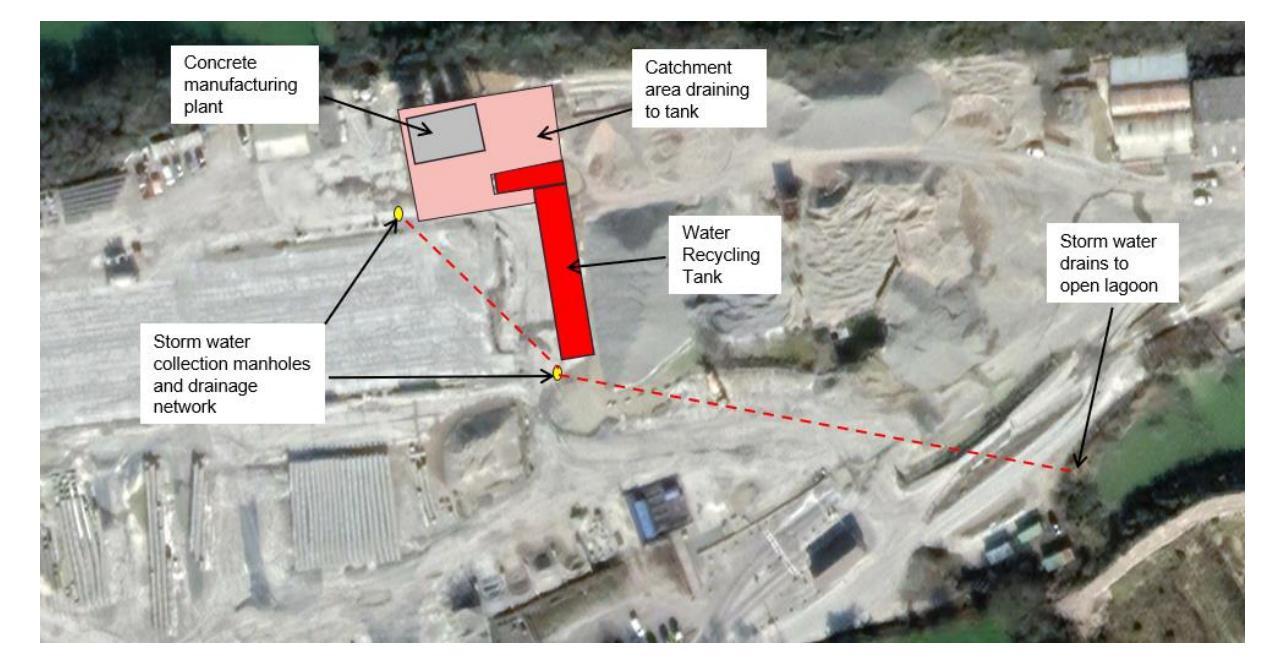
Figure 2. describes the existing stormwater collection system on site which shows that storm water from the block storage area and all other working areas to the west of the new tank drains via a series of collection channels and gullies into the open lagoon located to the east of the weigh bridge. There is no discharge from this open lagoon into surface waters and it is possible that water from this lagoon may have an interaction with groundwaters locally.

Figure 2. Overview of the site with recycling tank, concrete plant and drainage descriptions (not to scale)

2.2. Having visited the site and inspected the works already carried out, I am satisfied that the catchment area for rainfall capture has been defined accurately by the applicants. The proposed tank has the capacity to contain the projected volume of rainfall for a 1 in 75-year 24hr event at this location as modelled by Met Eireann. I can also confirm that the recycling system will be of a closed-loop nature with no direct discharge from the tank to any outlet. Water which has passed through the recycling system will be pumped back to a storage tank and reused in the concrete manufacturing plant or used for washing the plant and trucks as described below.

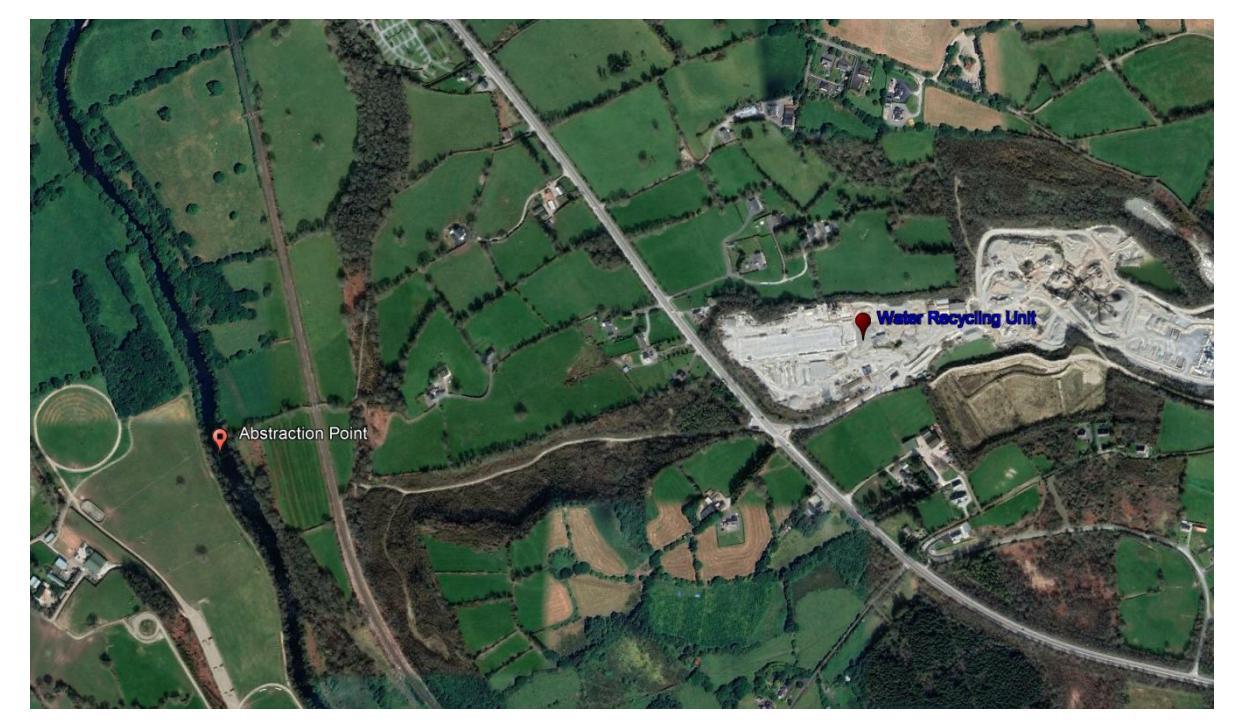
- 5.2.4. The abstraction data was accessed on the publicly available register located at <u>https://leap.epa.ie/abstractions/</u>. It was noted that Roadstone Killarney registered an abstraction of up to 600m³/day of water from the river Flesk for use within the quarry. The location of this abstraction was given at the following coordinates (Easting 100041.414, Northing 88667.25) and this was mapped as shown in Figure 3. below. This maximum daily abstraction rate (600m³/day) from the river Flesk represents approximately 0.44% of the daily 95%ile flow at this location, which indicates a negligible impact even during low flow conditions.

Figure 3. Location of the abstraction point from the river Flesk serving the Roadstone Quarry

- 5.2.5. It was estimated that up to 60m³/day (~30m³/day for concrete manufacturing and ~30m³/day washing water) will be recycled within the site which will reduce the need to abstract from the river Flesk by a minimum of 10%. This could result in a net

improvement in surface water quality due to additional dilution available and quantity in the river Flesk resulting from the operation of the water recycling unit.
