Site Specific Flood Risk Assessment

Project: Holy Cross College SHD 19.253

| Project: | Holy Cross College SHD. |
|---|---|
| Document No: | CLN-BMCE-ZZ-ZZ-RP-C-02 |

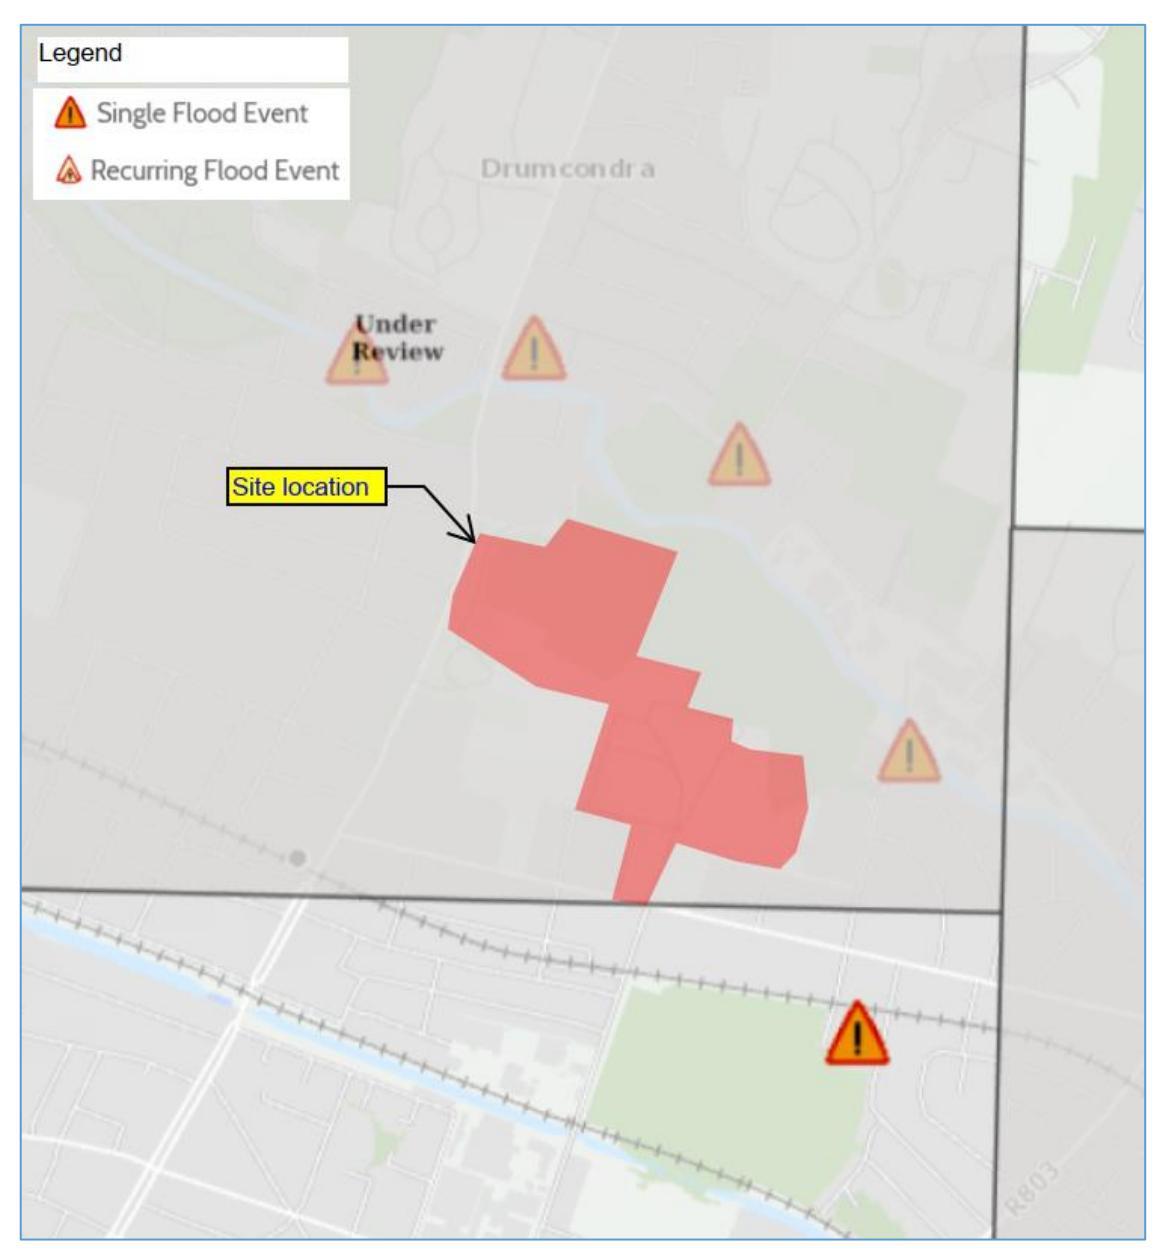
Figure 2.1 Recorded Past Flood Events (Source: OPW – www.floodinfo.ie)

A review of the OPW Historical Flood Maps online was carried out and indicates a number of past flooding events reported in the vicinity (within 2.5km) of the subject site.

The first report dates back to November 1901 and the source of flooding was the River Tolka. The site which was flooded is located approximately 500m north west of the proposed development.

The second flooding event was in November 1965 and the source of flooding was the River Tolka. The site which was flooded is located approximately 300m east of the subject site.

The third flooding incident in the vicinity was in August 1986 and the source of flooding was the River Tolka during hurricane Charley. A number of sites in the vicinity were flooded including a site north west and another north east of the proposed development.

There is a report of a flooding event on Jones Road in July 2013 with very little information on the source of flooding. The single event is shown south east of the proposed development.

There are no records of past flooding at the subject site location in recent history.

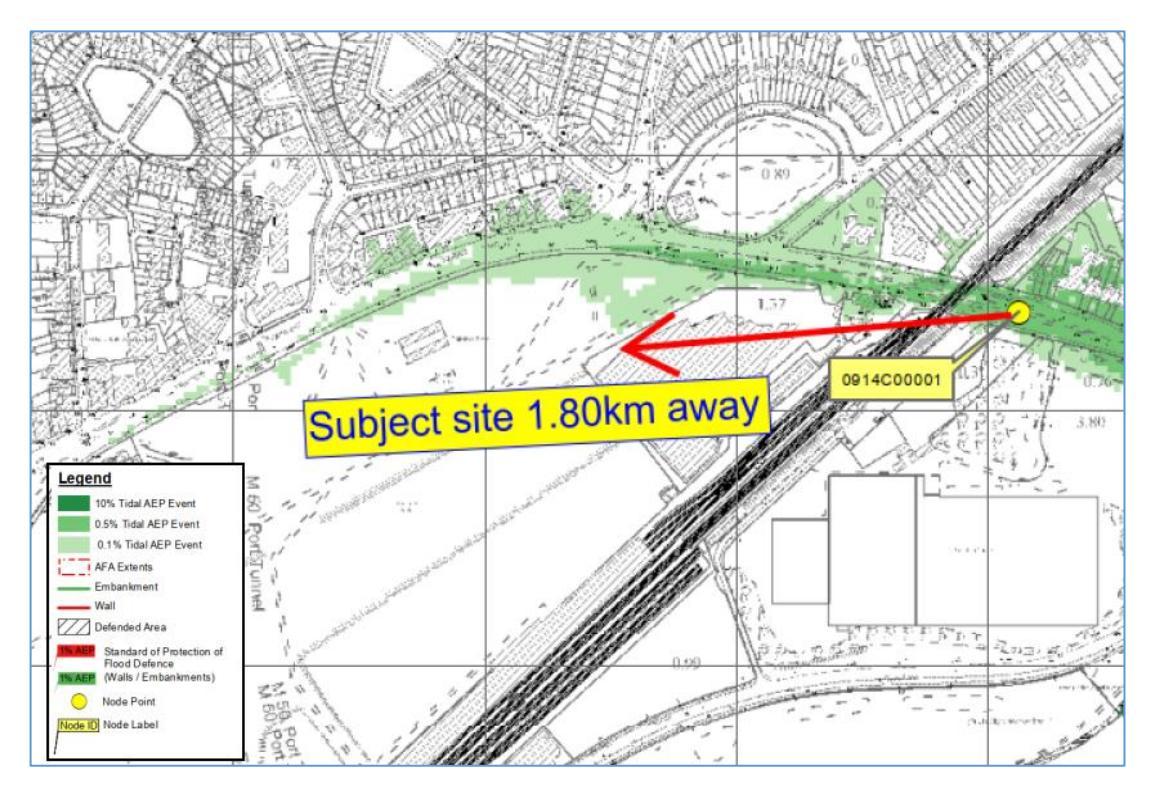
Figure 2.2 Clontarf Tidal Flood Extents (Source: OPW Eastern CFRAM Study)

Coastal flooding occurs when sea levels along the coast or in estuaries exceed neighbouring land levels or overcome coastal defences where these exist. A review of the OPW Tidal Flood Extents Mapping was carried out and indicates no coastal flooding at the subject site for the following flood event probabilities:

Therefore, the risk of tidal flooding is considered low as the subject site lies outside the 0.1% AEP. The OPW tidal flood extents map near the subject site area is included in Appendix 2 for further information.

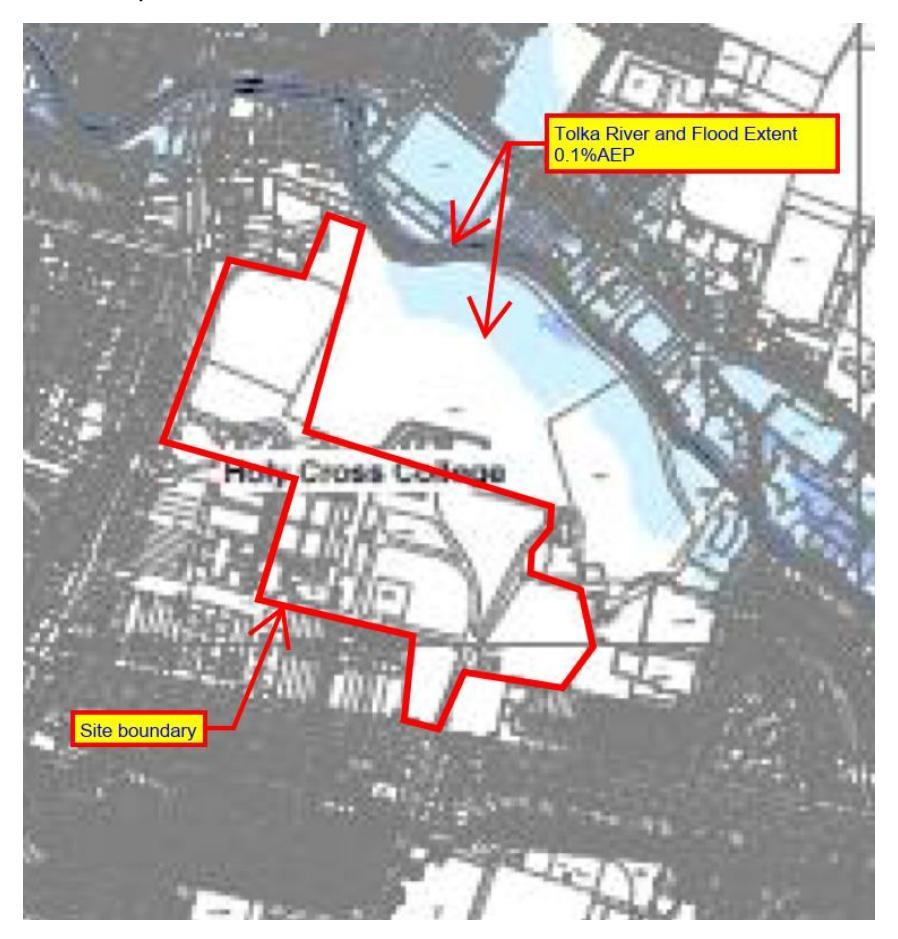
Figure 2.3 Tolka River Flood Extents for 0.1% AEP - Source Dublin City Council

Fluvial flooding occurs when rivers and streams break their banks and water flows out onto the adjacent low-lying areas. The River Tolka runs the full length of the northern boundary of the subject site. The river flows in a south easterly direction before entering the sea at Clontarf. A review of the OPW fluvial flood extents maps of the River Tolka was carried out and unfortunately the area is currently under review. Older information including the Tolka Flood Study in September 2010 carried out by RPS for DCC and OPW was reviewed and it shows that the proposed site development lies outside the 1 in 1000 year fluvial combined with the 1 in 2 year tidal. The study concluded as quoted *'Further to the review of the flood mapping in September 2010 by DCC and OPW, it was concluded that the 0.1% AEP fluvial coupled with the 50% AEP tidal event was the most appropriate to apply to Tolka River for the Dublin City area.'* Refer to Figure 2.3 which shows the proposed

development located outside the 0.1% AEP flood extent. Figure taken from the River Tolka Flood Study.

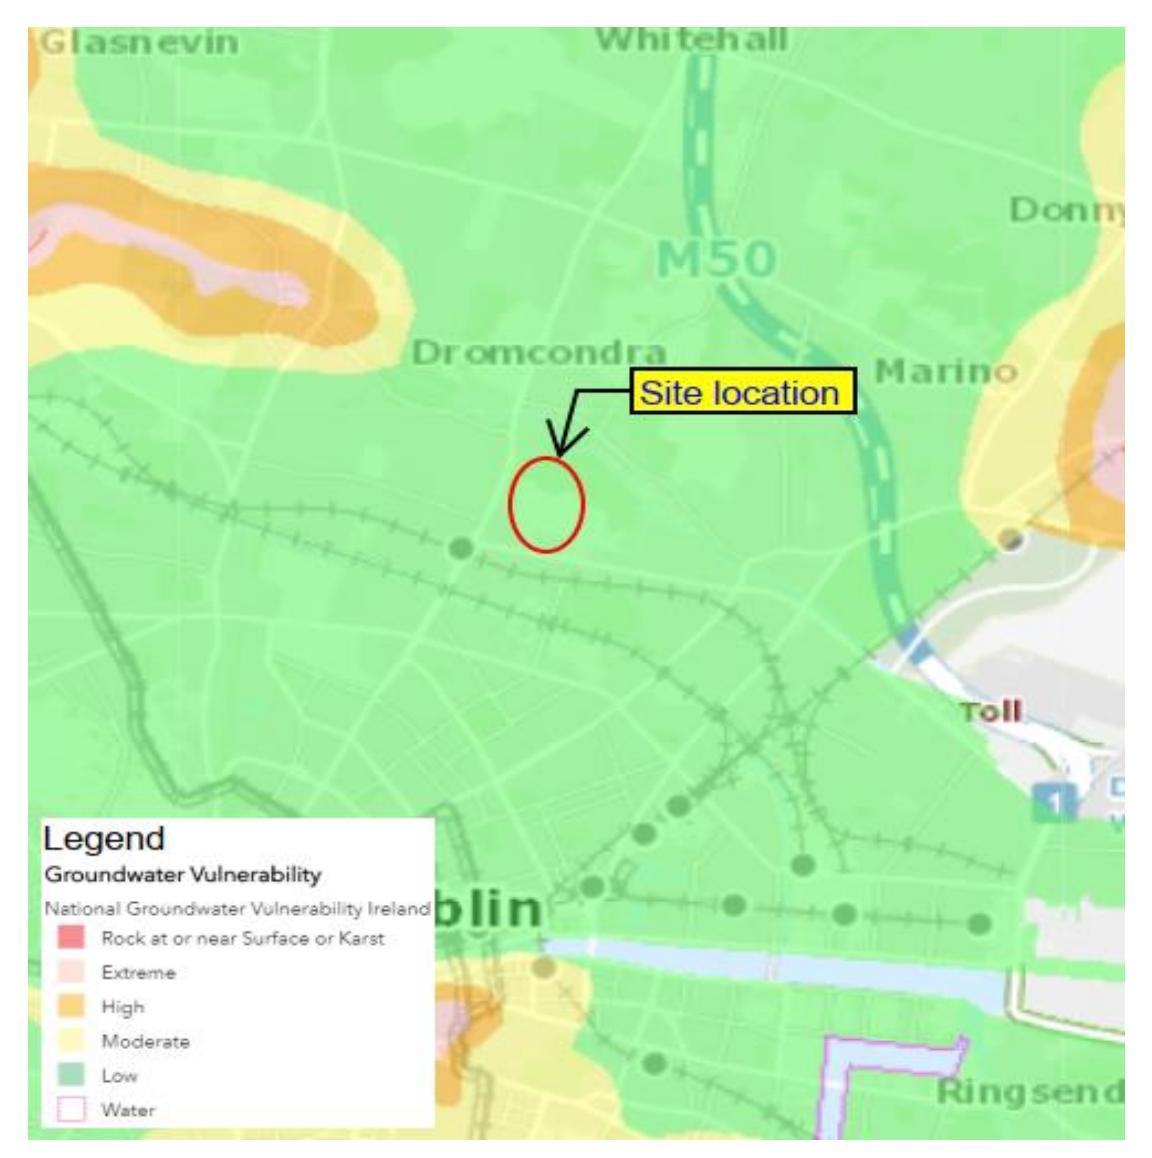
Figure 2.4 Groundwater Vulnerability (Source: GSI Data Viewer Map)

A review of the groundwater vulnerability data from the Geological Survey Ireland (GSI) website was also carried out and the model indicates low risk of groundwater contamination. The map identifies how susceptible areas are to groundwater contamination.

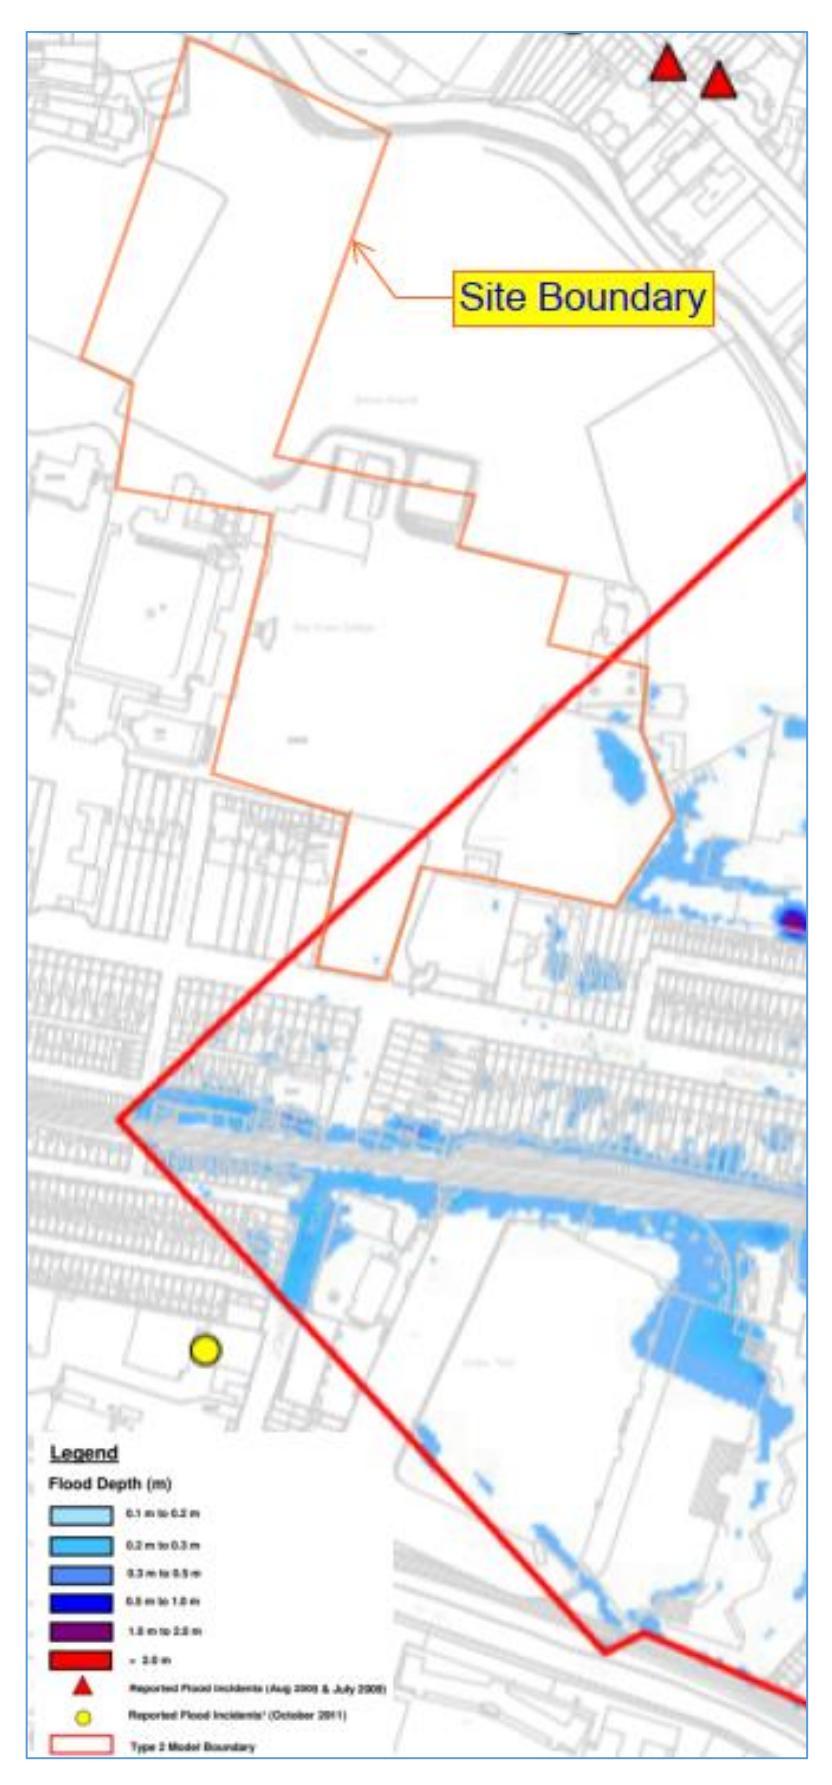
Figure 2.5 DCC Flood Resilient City Project 2% AEP Event - 3hr Duration Map

Pluvial flooding occurs when the amount of rainfall exceeds the capacity of urban surface water drainage systems or the ground to absorb it. A review of the available literature including the DCC Flood Resilient City (FRC) project was carried out, and indicates some pluvial flooding south east of at the subject site boundary. Note, these maps are 'predictive' flood maps showing areas predicted to be inundated during a theoretical or 'design' flood event with an estimated probability of occurrence, rather than information for actual floods that have occurred in the past, which is presented on 'historic' flood maps.

The FRC project and pluvial model prediction was examined further and it highlights a number of anomalies including:

- The area south east of the site boundary shown as flooded is modelled as hardstanding although it is currently greenfield.
- The drainage system is simulated as gravity network to discharge into the River Tolka and Dublin Bay; this is incorrect as we know that the network is pumped at the Poplar Row pumping station to the Ringsend Treatment Works.

Notwithstanding the above, the FRC project considers the subject site to be low risk of pluvial flooding as it is not located in low laying areas. The FRC project identifies the main source of flooding to be surface water run-off conveyed by road networks into low lying areas such as Fairview Strand and Marino Crescent.

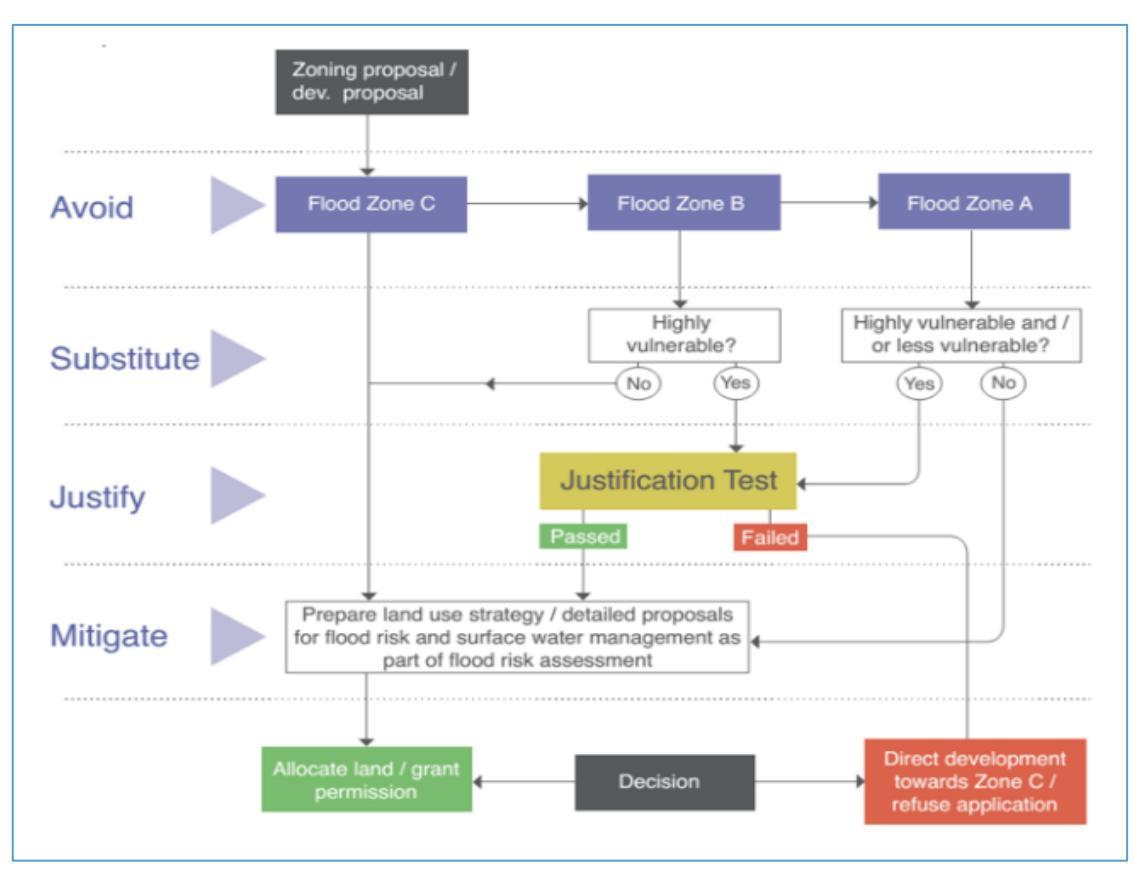
Figure 3.1 Sequential Approach (Source: Guidelines for Planning Authorities, 2009)

The sequential approach used in this assessment follows the guidelines from The Planning System and Flood Risk Management Guidelines for Planning Authorities, 2009, see Figure 3.1 for a graphical representation.

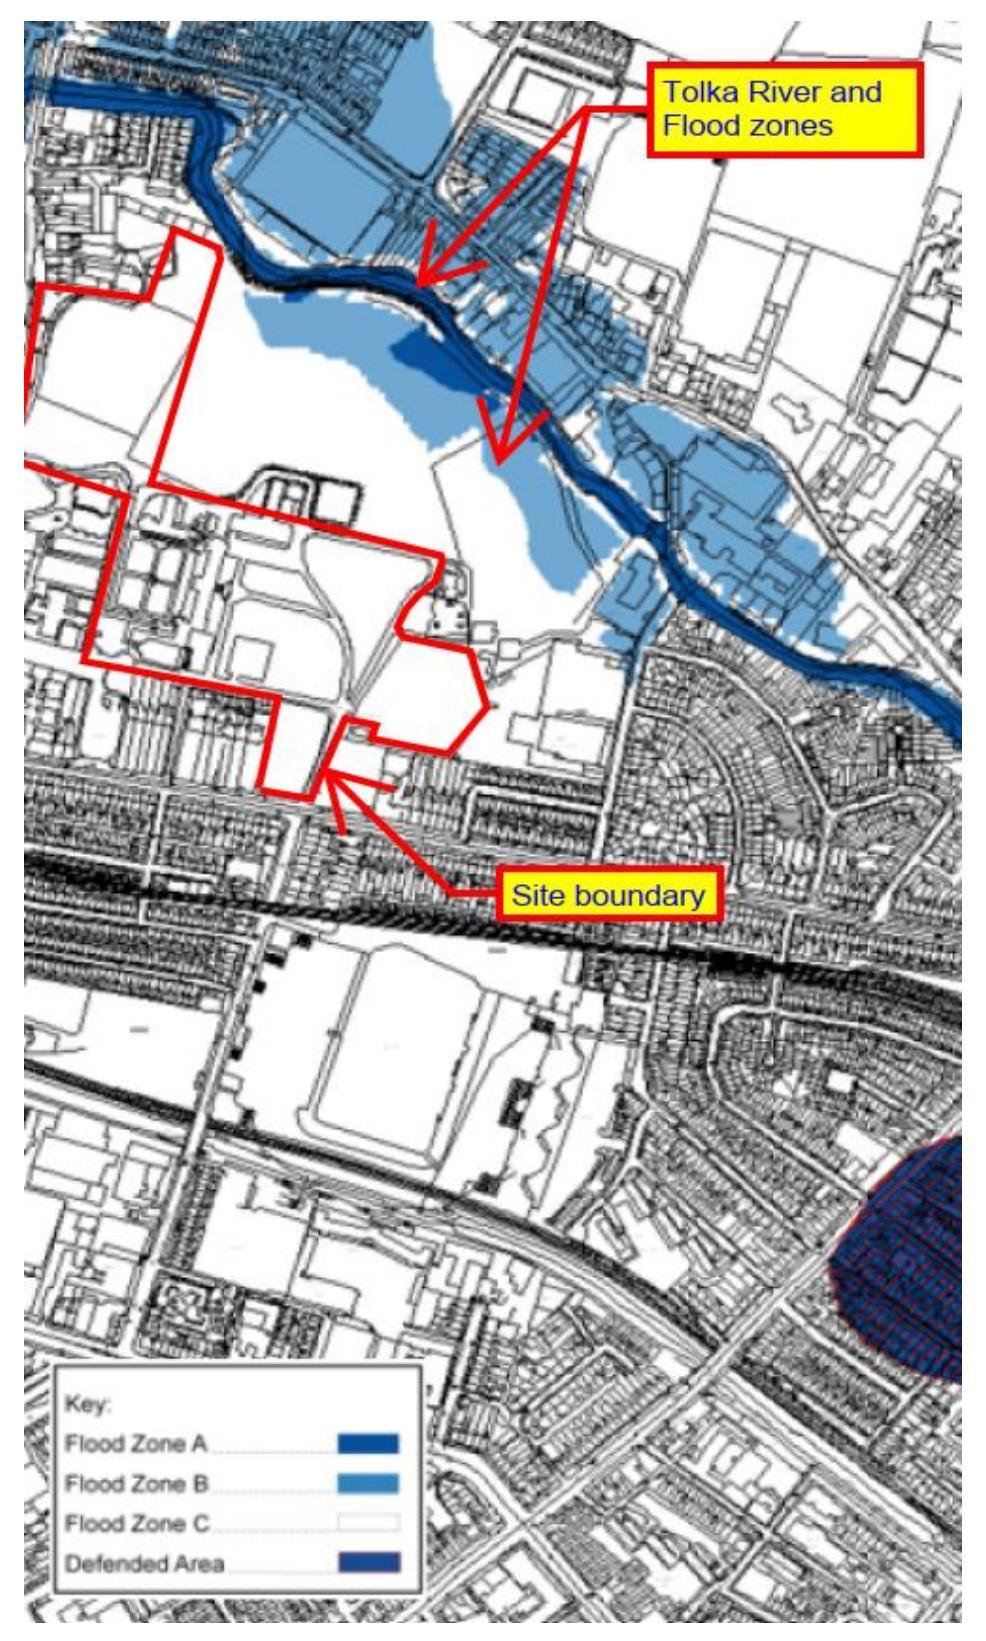
Figure 3.2 Flood Zone Mapping - Source DCC Development Plan 2016-2022

Based on the flood risk identification in Stage 1, the proposed development falls in Flood Zone C. Hence, the proposed development is deemed 'Appropriate' in accordance with the guidelines of the OPW's publication. Therefore, no 'Justification Test' and / or Stage 3 Detailed Flood Risk Assessment is required. The sequential approach shown in recommends mitigation measures for residual risks. In addition, extract from DCC Development Plan 2016-2022 in Figure 3.2 shows the proposed development in Flood Zone C in agreement with this SSFRA.
