# **APPENDIX 1**

Habitat Map

Aquatic Ecology

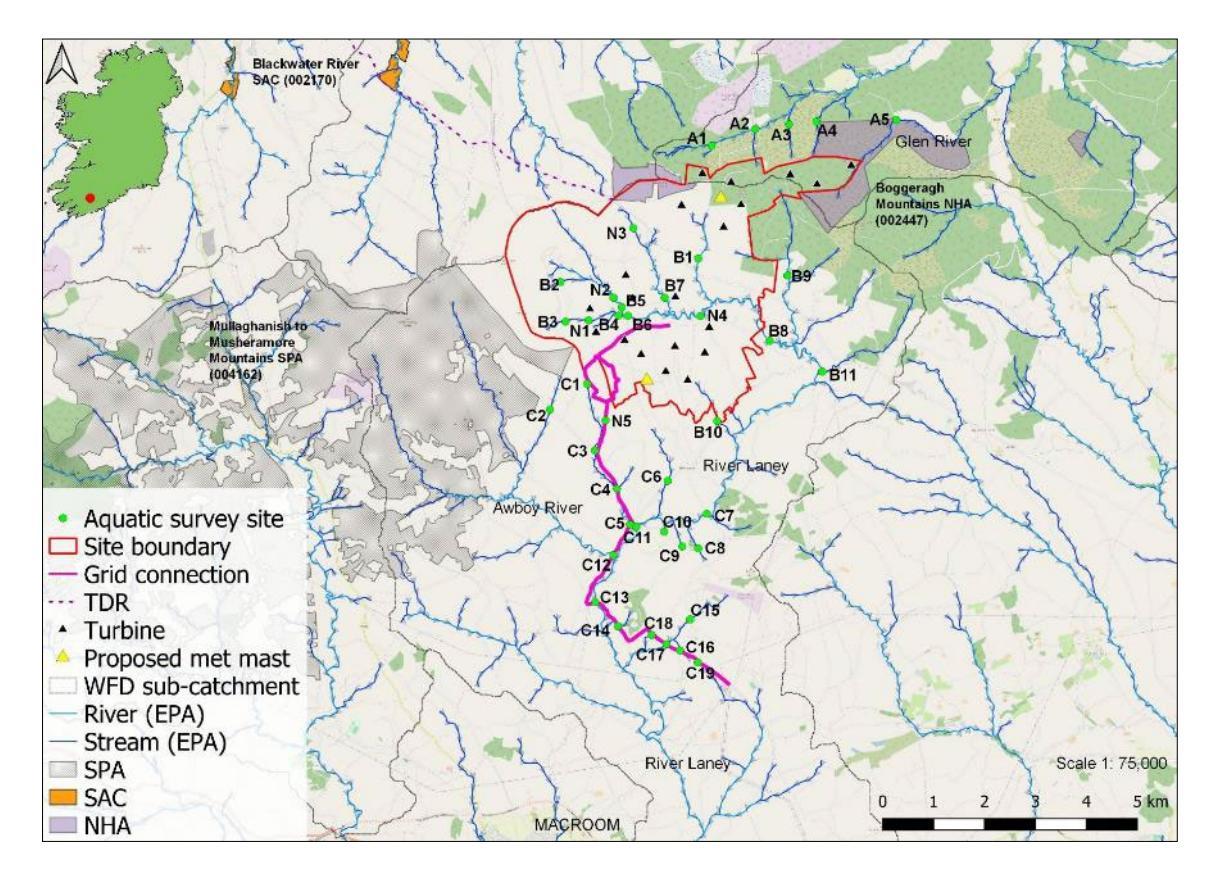
Figure 1: Overview of the *n*=40 aquatic survey locations for the proposed Ballinagree wind farm project, Co. Cork.

A fisheries assessment (including electro-fishing and fisheries habitat appraisal) and white-clawed crayfish survey was undertaken at n=35 sites in June-July 2020 (Table 1 and Figure 1). A fisheries appraisal (no electro-fishing) was undertaken at an additional n=5 locations in June 2021 to reflect the updated site infrastructural layout (i.e., sites N1, N2, N3 & N4 and N5).

A catchment-wide electro-fishing (CWEF) survey of the watercourses within the vicinity of the proposed wind farm (*n*=35 of 39 sites, Table 1, and Figure 1) was conducted in July 2020, following notification to Inland Fisheries Ireland (Macroom) and under the conditions of a Department of Communications, Climate Action & Environment (DCCAE) licence. The survey was undertaken in accordance with best practice and Section 14 licencing requirements.

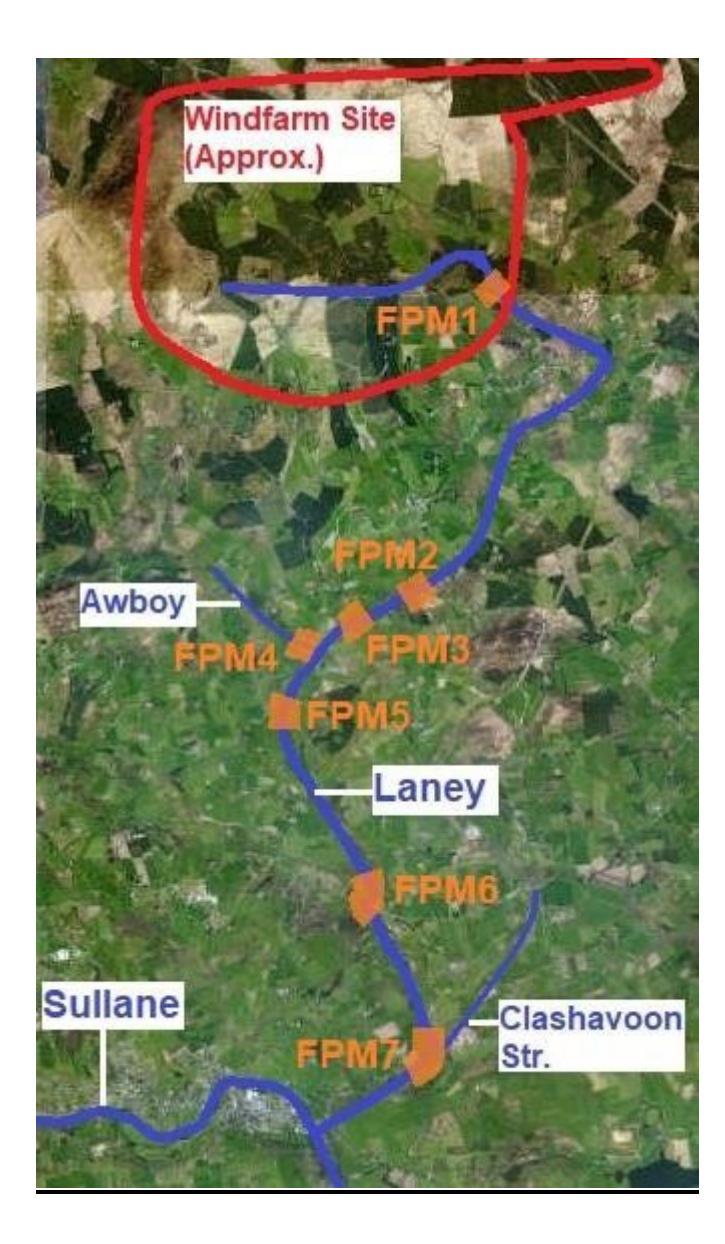
Figure 2: Freshwater Pearl Mussel Survey Sites

A freshwater pearl mussel survey was conducted at seven locations along the River Laney and Awboy River (Table 2 and Figure 2).

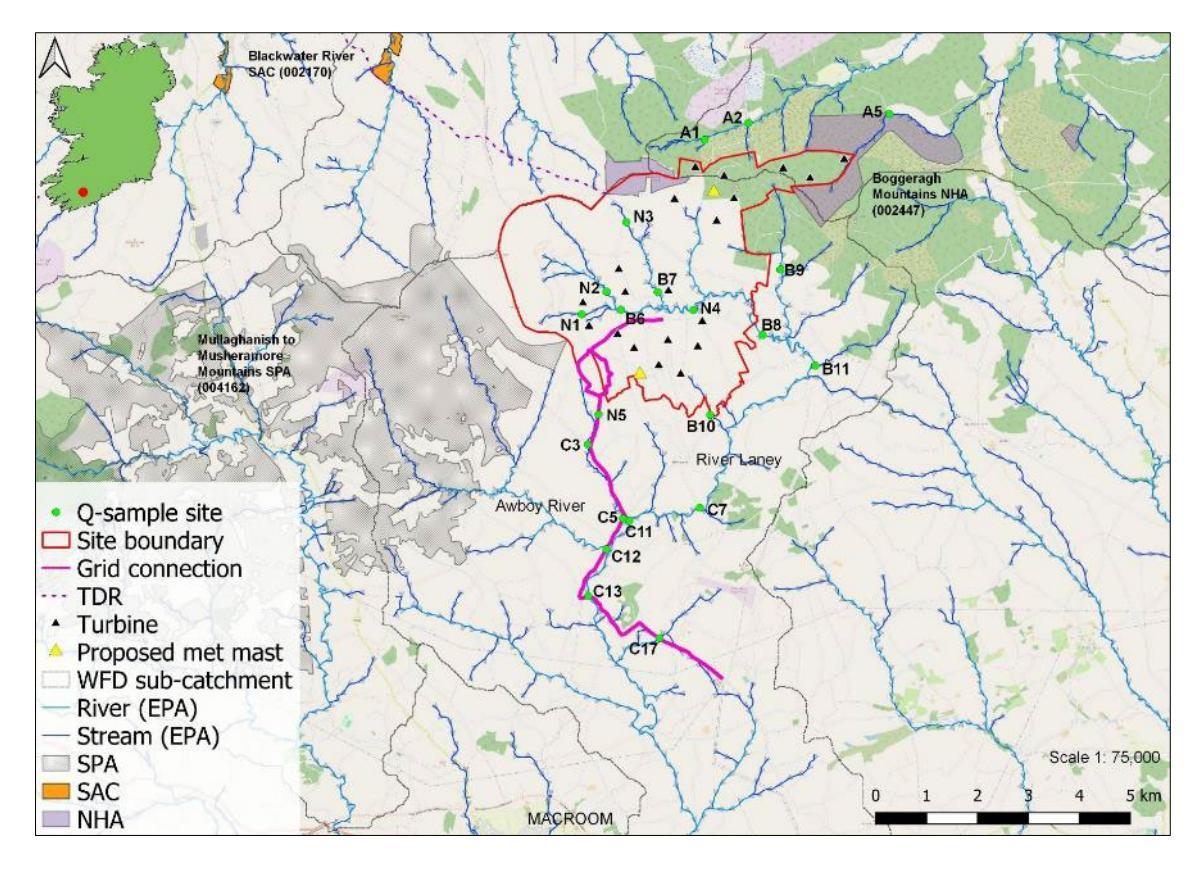
Figure 3: Overview of the *n*=21 Q-sampling locations for the proposed Ballinagree wind farm project, Co. Cork

Biological water quality sampling (Q-sampling) was undertaken at a representative sub-set of these sites (i.e., *n*=21 sites; A1, A2, A5, B6, B7, B8, B9, B10, B11, C3, C5, C7, C11, C12, C13, C17, N1, N2, N3, N4 & N5) (Figure 3).

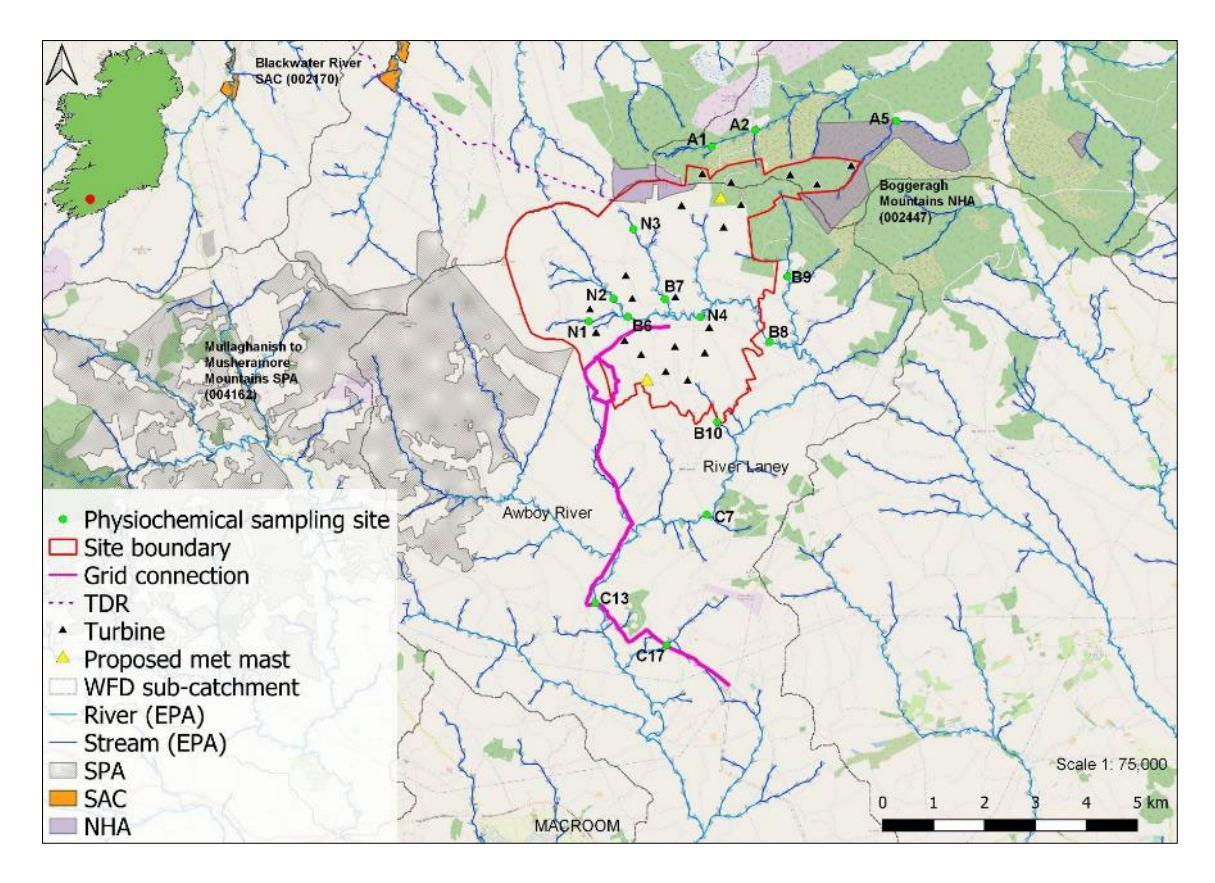
Figure 4: Overview of the *n*=15 physiochemical water quality sampling locations for the proposed Ballinagree wind farm project, Co. Cork

Physiochemical water quality samples were taken from a total of *n*=15 sites (i.e., A1, A2, A5, B6, B7, B8, B9, B10, C7, C13, C17, N1, N2, N3 & N4).

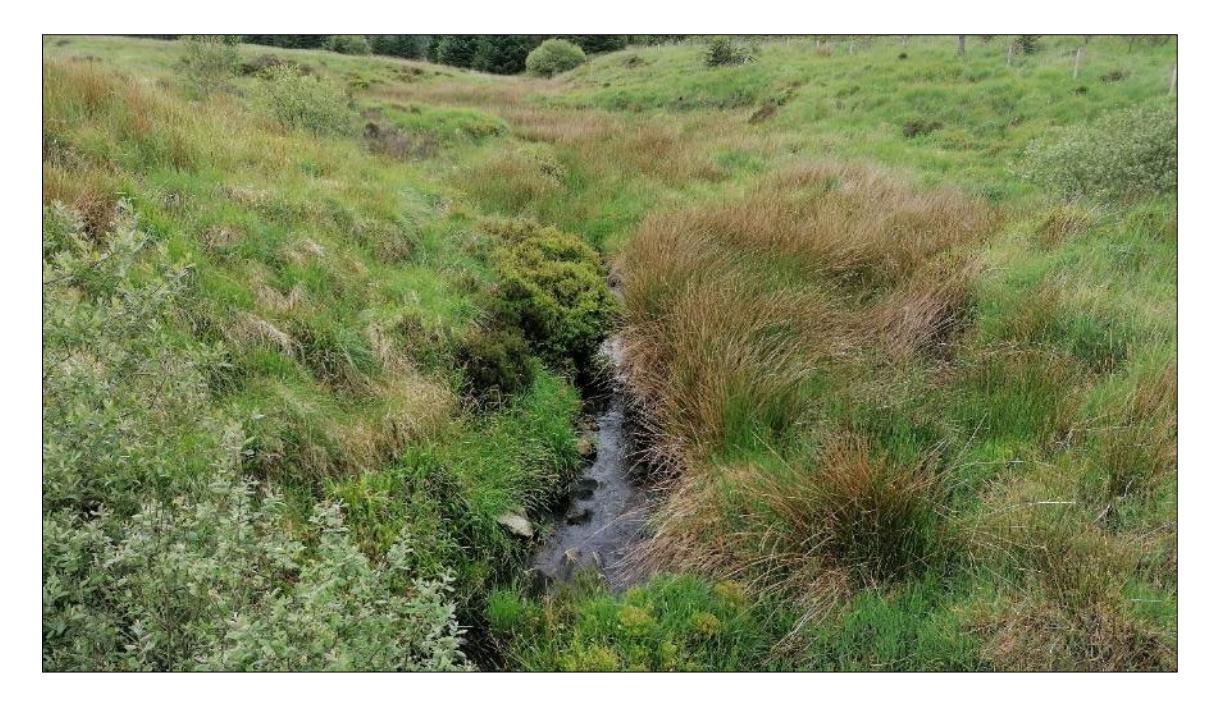
Site A1 was located on the uppermost reaches of the Nadanuller Beg Stream (EPA code: 18N05, also known locally as the Owenaluggin River). The upland eroding watercourse (FW1) was characterised by glide and riffle sequences with localised pool habitat over boulder cascades. The channel was approximately 1m wide and 0.2m deep with peat-stained water at the time of survey. The deep U-shaped channel graded into a valley with shallow slopes adjoining upland conifer plantations (WD4, 10-15 years old). The substrata were dominated by bedrock (20%), boulder (30%), large cobble (20%) and peat, with only localised coarse and medium gravels. The substrata were moderately silted and featured a very high coverage of filamentous algae at the time of survey. The adjoining lands comprised of wet grassland (GS4), blanket bog and pockets of heath, with purple moor grass (*Molinia caerulea*), *Juncus* sp. rushes and marsh bedstraw (*Galium palustre*) dominating. Macrophytes were absent due to the high energy of the site. However, aquatic bryophyte coverage was high locally, with *Fontinalis squamosa* and common earwort (*Scapania undulata*) present on boulder tops.

Plate 1: Representative image of site A1 on the Nadanuller Beg Stream, June 2020 (facing upstream)

Biological water quality, based on Q-sampling, was calculated as Q4 (good status) (Table 6). Molybdate reactive phosphorus (MRP) (0.043mg P/I) and total ammonia (0.094mg N/I) concentrations were high and, thus, the site failed meet the good status thresholds as set out under S.I. No. 77/2019 - European Union Environmental Objectives (Surface Waters) (Amendment) Regulations 2019 (Table 9).

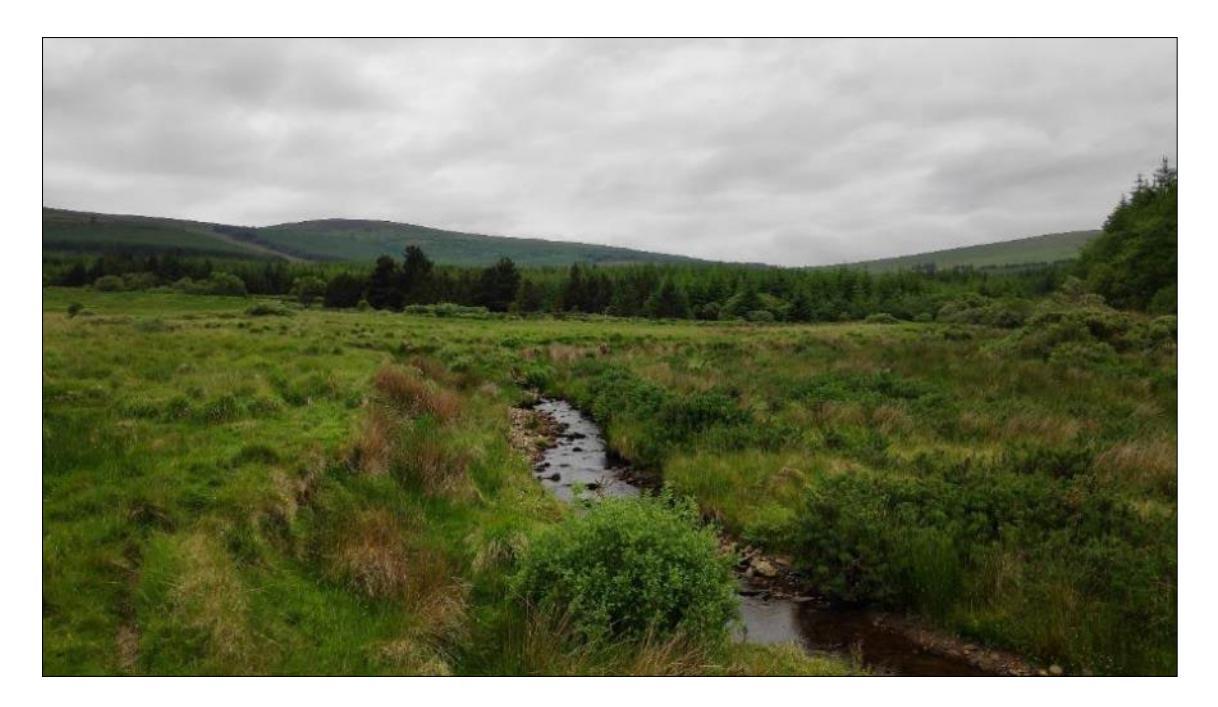
Site B4 was located on the lower reaches of the Knocknagappul Stream (EPA code: 19K04, approx. 50m upstream of the confluence with the River Laney. The natural upland eroding watercourse (FW1) averaged 1-1.5m wide and 0.1-0.2m deep in a deeply cut (near vertical-sided) U-shaped channel. Shallow glide and riffle dominated the site (40% each) with only localised plunge pools, some to 1m in depth but mostly shallower. Bankfull heights were 1.5-2m and the channel evidently conveyed significantly more water during spate conditions. Natural bank scouring was frequent, particularly on the many meanders at the site. The substrata were dominated by small cobble (40%) with occasional small boulder (5%). Fine to medium gravels were frequent (30% overall), with sand also present (10%). Some exposed peat was present locally. Although some silt plumes were present underfoot, overall siltation levels were low in this high-energy channel. The stream meandered through a valley floor with mosaics of lowland blanket bog (PB4) and degraded raised bog (PB1). Common plant species included purple moor grass, soft rush, heath milkwort (Polygala serpyllifolia), marsh lousewort (Pedicularis palustris), tormentil (Potentilla erecta) bog myrtle (Myrica gale) and localised bog cotton (Eriophorum angustifolium). The area was exposed to low intensity sheep grazing and the bank of the stream were open, with low-height scrub and rank grasses. There was no instream macrophyte growth given the typically high energy of the site (spate channel). The bryophyte community was also poorly represented with only very limited drab brook moss (Hygrohypnum luridum) on instream boulders.

Plate 9: Representative image of site B4 on the Knocknagappul Stream (facing upstream from near River Laney confluence).

Brown trout was the only fish species recorded from site B4 via electro-fishing. Only a low number of juveniles were recorded. However, the site was of good value overall for salmonids given good nursery habitat, moderate spawning and moderate holding areas. Salmonid habitat improved in the downstream-connecting River Laney. The site was of moderate value for eel (albeit none recorded) but was considered unsuitable for lamprey (i.e., high-energy, upland eroding spate channel). There was no suitability for freshwater pearl mussel. No white-clawed crayfish were not recorded and there were no records for the species within the catchment. No otter signs were recorded during the survey and the site was considered of low suitability given its small size and upland nature.

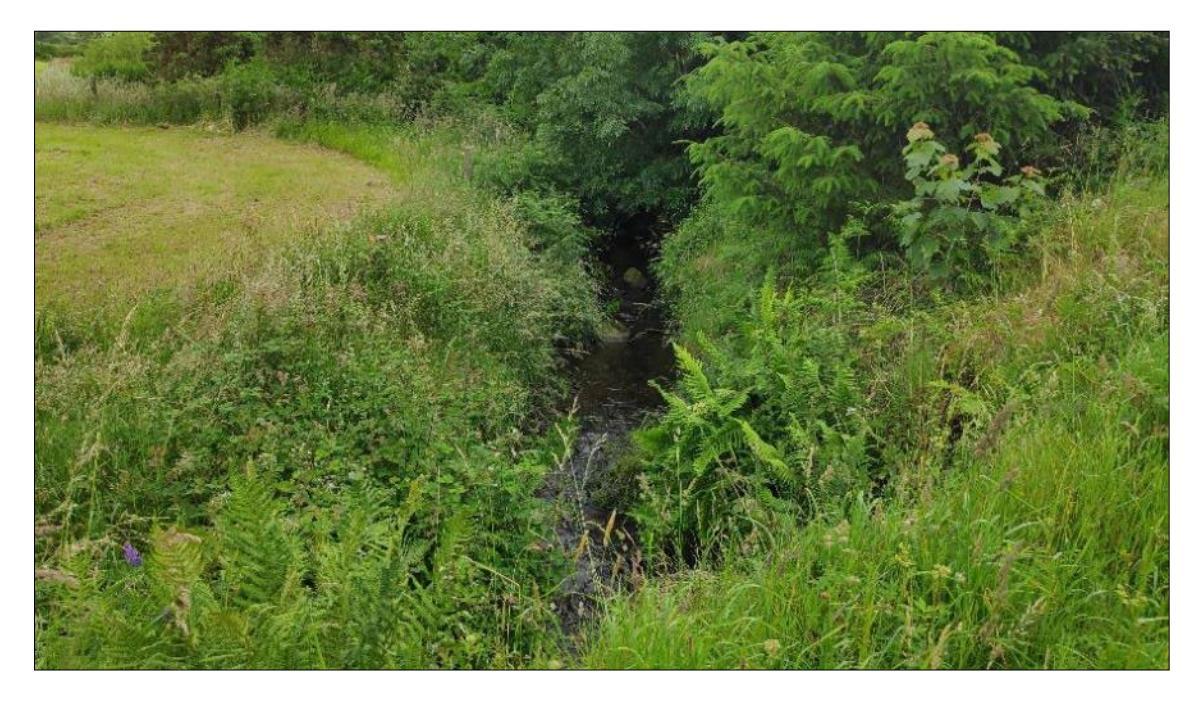
Biological water quality, based on Q-sampling, was calculated as Q3 (poor status) (Table 7). The site failed to meet the EPA nitrate threshold for good status water quality (i.e., very high TON of 2.489mg N/I) (Table 9).

Plate 33: Representative image of site C17 the Coolaniddane River (upstream of road culvert)

The majority of survey locations featured low alkalinity, circum-neutral pH, low MRP and low to moderate total oxidised nitrogen (TON) levels (Table 9). However, TON was particularly high at sites C17 and B10 (failed to meet EPA's threshold for good status). Levels of molybdate reactive phosphorus (MRP) were particularly high at site A1, with the site failing to meet the good status threshold set out under S.I. No. 77/2019 - European Union Environmental Objectives (Surface Waters) (Amendment) Regulations 2019.

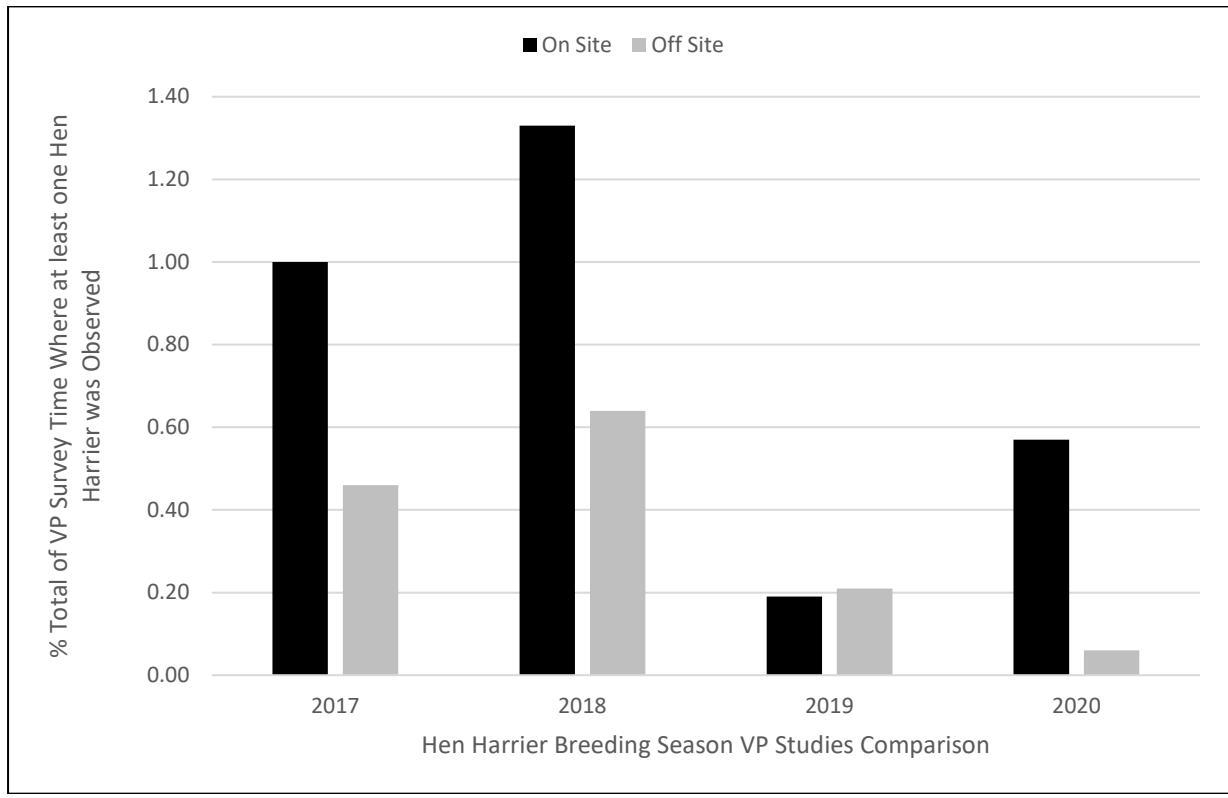
Breeding Season Summary	% Total of VP Survey Time						
Hen Harrier Activity	2017	2018	2019	2020			
On Site	1.00	1.33	0.19	0.57			
Off Site	0.46	0.64	0.21	0.06			
VP Study Survey effort	36 HRS	36 HRS	36 HRS	36 HRS			
No. of VPs	6 VPs	6 VPs	8-10 VPs	10 VPs

Plate 41: Comparison of percentage Hen Harrier activity recorded during the four breeding VP surveys.

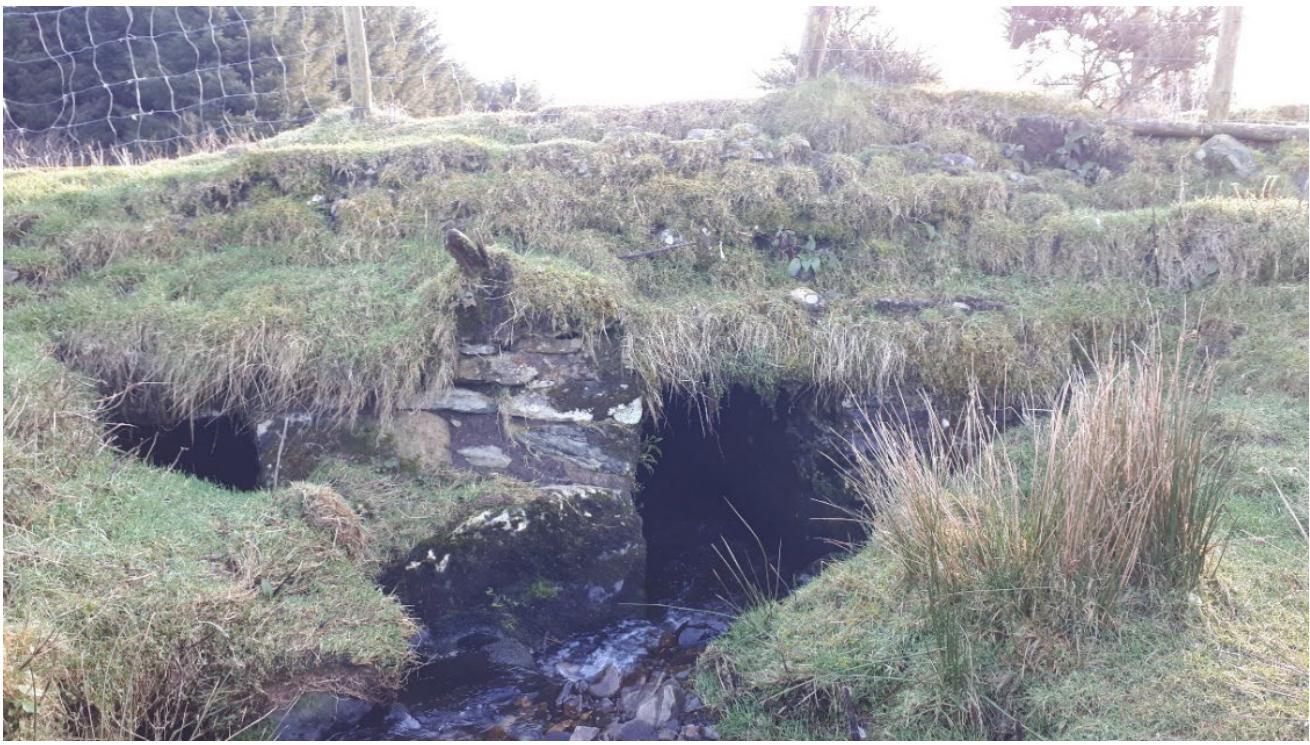
On the turbine delivery route, one watercourse crossing is to be modified. This is an existing bridge (WF-HF8 as shown in Figure 3-14 and Figure 2-2). This will be replaced by a new clear span bridge.

Figure 3-14: Existing Stone Bridge Crossing (WF-HF8)

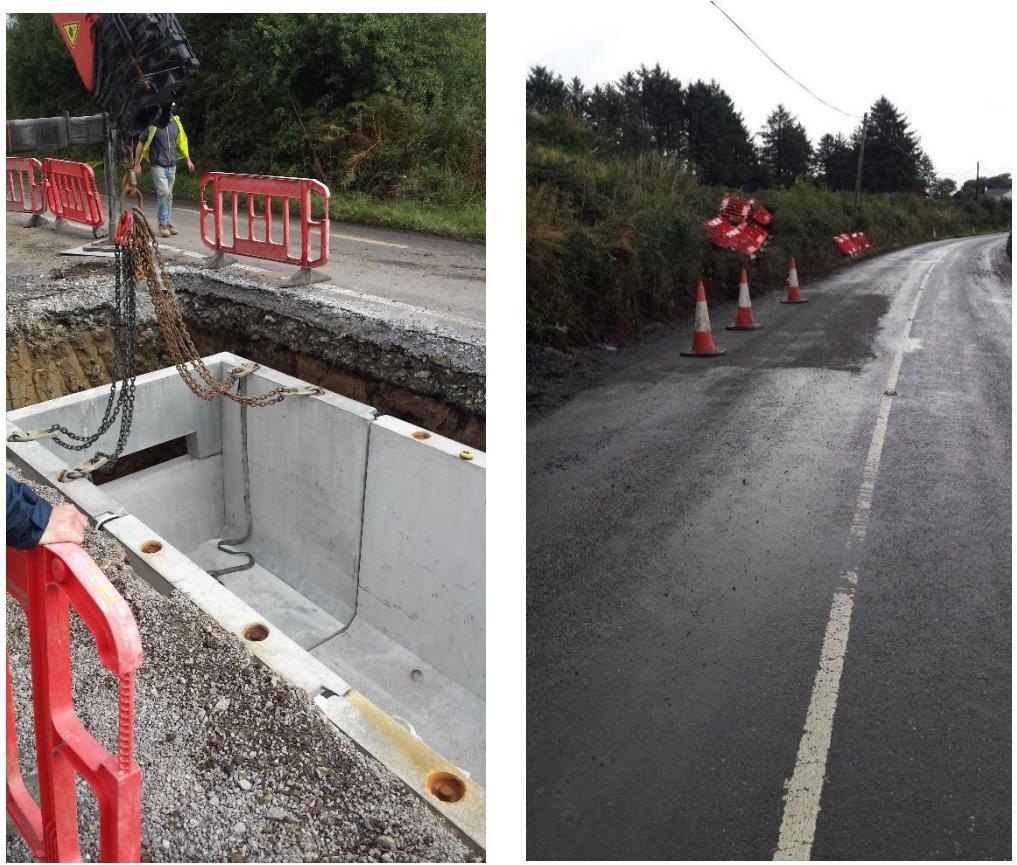
Typical details for Joint Bays and Link Box Chambers are shown on planning drawings P2114-0300-0011, P2114-0300-0012 and P2114-0300-0013.

Figure 3-15: Typical Installation and Temporary Reinstatement of Joint Bay

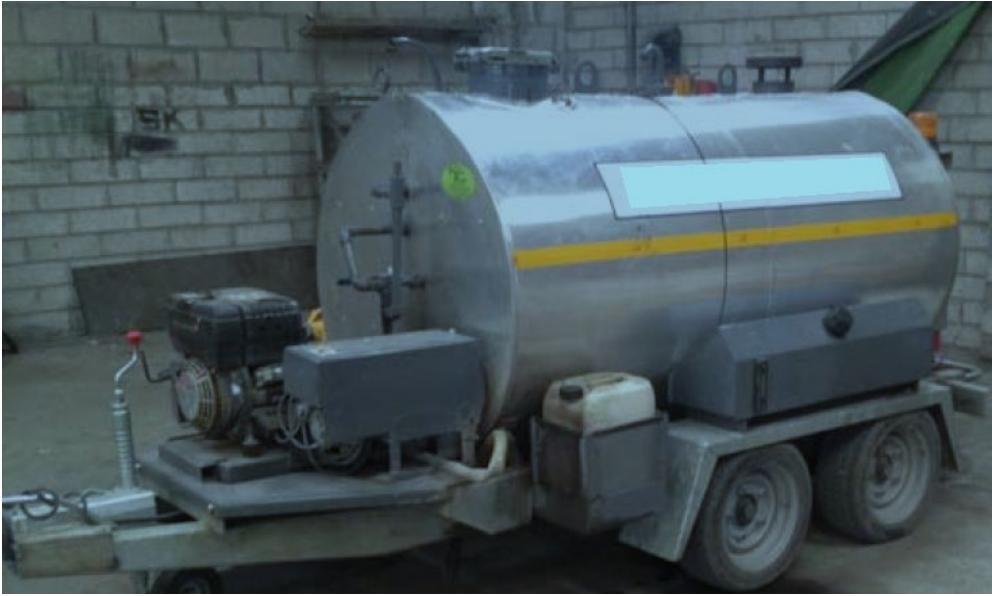
- Delay set macadam may also be required on busier roads, 75mm of delay set macadam shall be placed within the trench at the end of each working day, by means of skid steer and trench reinstatement bucket and compacted.

Figure 3-16: Towable Sprayer for Temporary Reinstatement

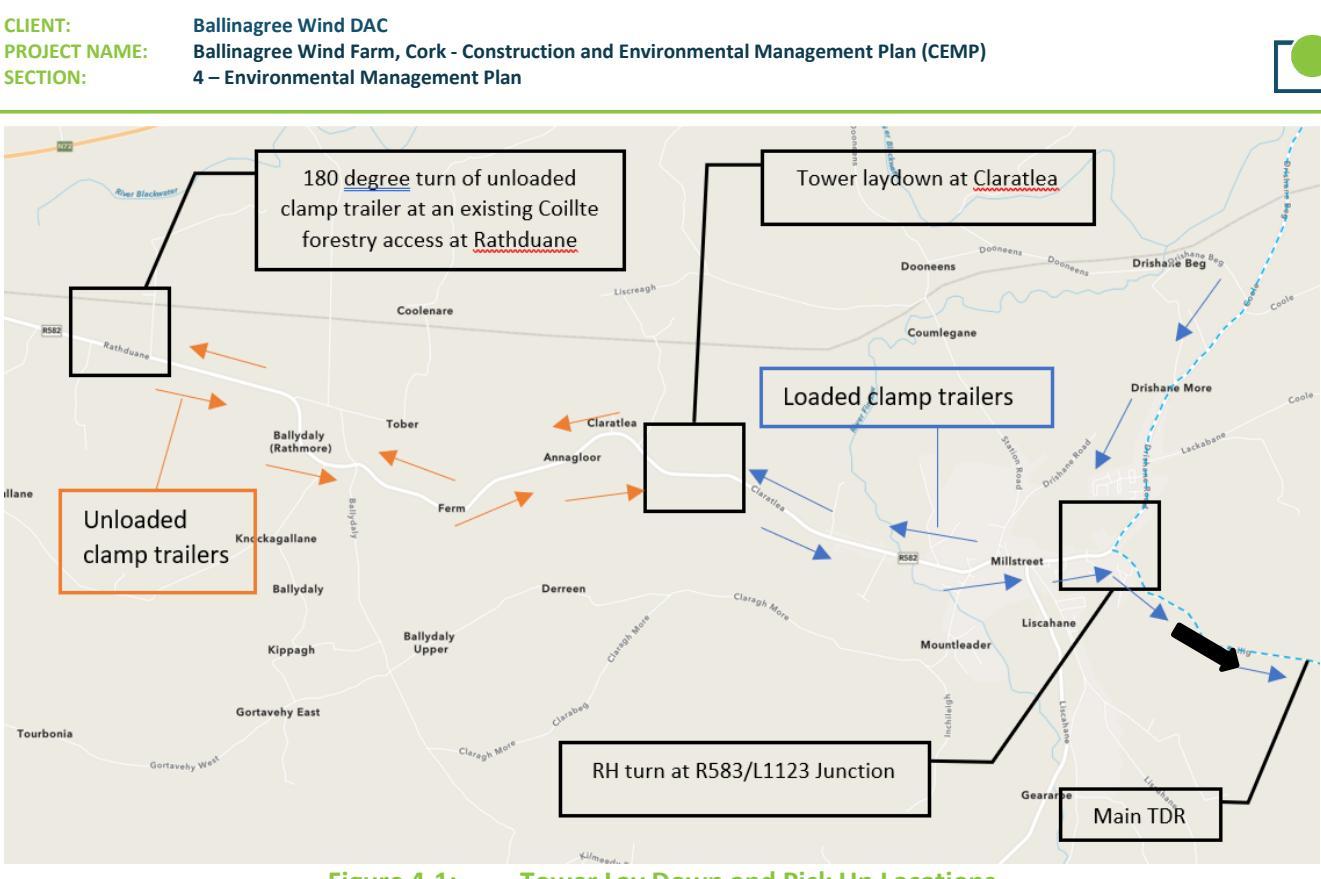
The manoeuvre will take place at night and can be carried out for up to 3no. turbine base tower sections in convoy. It is expected that the manoeuvre can be carried out in approximately hour per convoy and will be required to take place on up to 7no. separate occasions over a period of several months with the possibility of reducing the number of occasions if several convoys are transported together. The manoeuvre shall be carried out in accordance with a traffic management plan and under Garda escort.

Figure 4-1: Tower Lay Down and Pick Up Locations

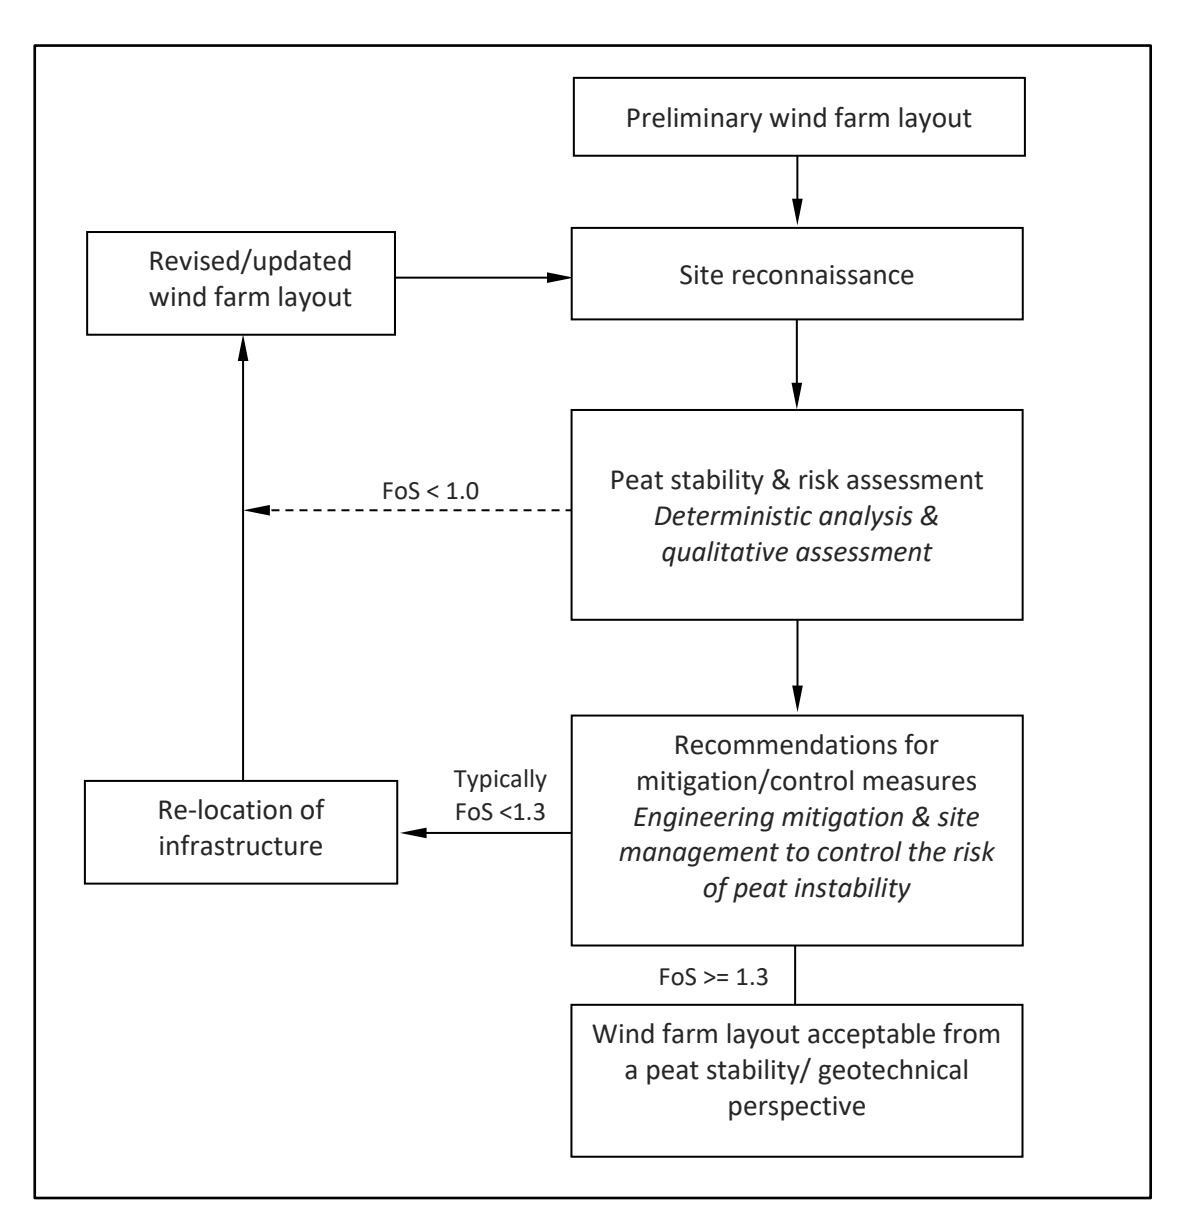
Figure 2-1: Methodology for Peat Stability Assessment

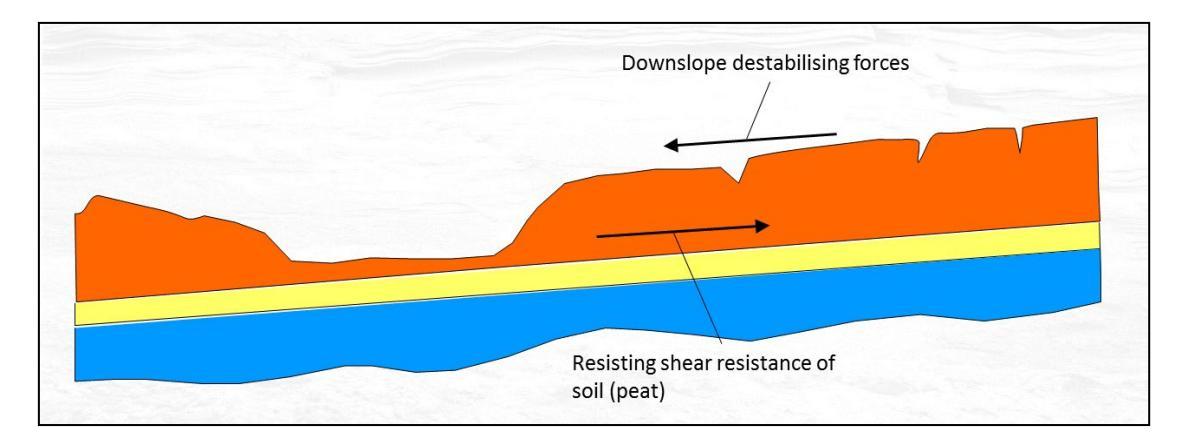
Figure 2-2: Peat Slope Showing Balance of Forces to Maintain Stability
