Title: DMURS QUALITY AUDIT

Road Safety Audit Stage 1, Access Audit, Cycle Audit and Walking Audit.

Ratoath Outer Relief Road, Including R155 Signalised Junction and Internal Development.

Report reference: 1478R01

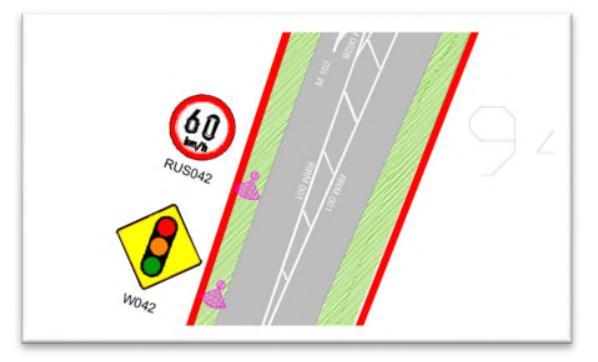
Drawing L308-OCSC-XX-XX-DR-C-0112 S4, P04, R155 Junction.

The drawing shows a 60km/hr speed limit on the R155 northbound approach to the junction. The current speed limit is 80km/hr and the area is rural in nature. There is a risk that drivers will not slow to 60km/hr due to the presence of the 60km/hr sign alone, and will not expect an urban type junction in an otherwise rural area. This could lead to collisions with queuing traffic or crossing vulnerable road users on the R155.

It is recommended that a gateway treatment and transition zone be provided on the R155 on approach to the extended urban area.

| | Paragraph No. Problem in Quality accepted Audit Report (yes/no) | | Recommended measure accepted (yes/no) | Alternative measures (describe) | Alternative measures accepted by Auditors (Yes/No) |
|--|---|---|--|--|--|
| | 3.1 Y | | Ν | Additional development is currently in planning to the south of the site. A gateway option that can easily be relocated will therefore be implement. This will entail setting up gateway signs on both sides of the roadway and including transverse yellow lines. | Yes |

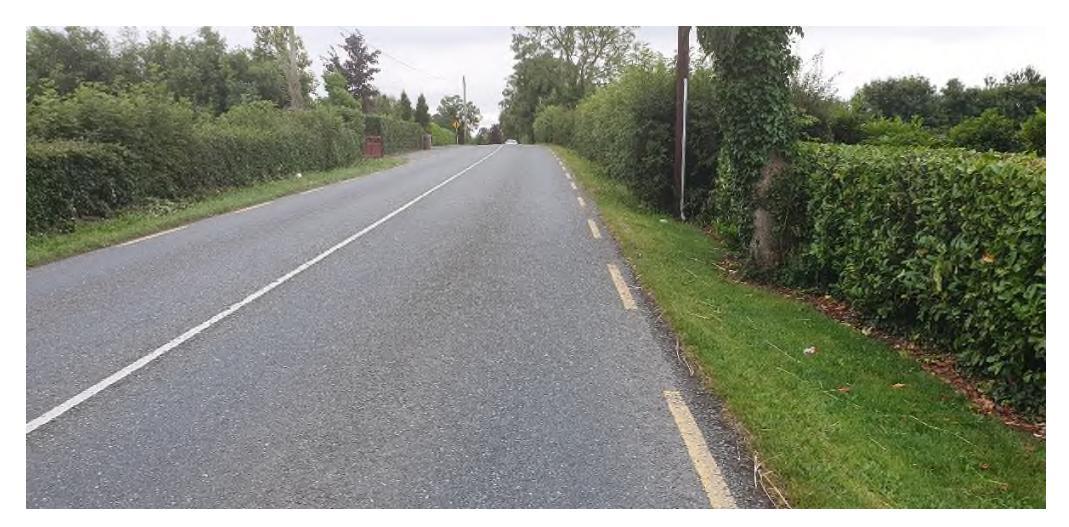
Drawing L308-OCSC-XX-XX-DR-C-0112 S4, P04 & Site observation, R155 Junction

There is a vertical crest in the R155 South of the proposed junction. There is a risk that a driver travelling eastbound will not realise that there is a queue of traffic ahead and may not slow in sufficient time leading to rear-end collisions.

It is recommended that the stopping sight distance be checked for vehicles approaching the rear of the longest predicted queue from the traffic signals. The stopping sight distance should be calculated for the actual speed rather than the speed limit if speeds cannot be reduced to the speed limit as outlined in Problem 3.1 above.

| | Paragraph No. Problem in Quality accepted Audit Report (yes/no) | | Recommended measure accepted (yes/no) | Alternative measures (describe) | Alternative measures accepted by Auditors (Yes/No) |
|--|---|---|--|--|--|
| | 3.2 | Y | Y | Speeds will be reduced to 60km/h. Vertical sight distance checked and compliant for 60km/h. | Yes |

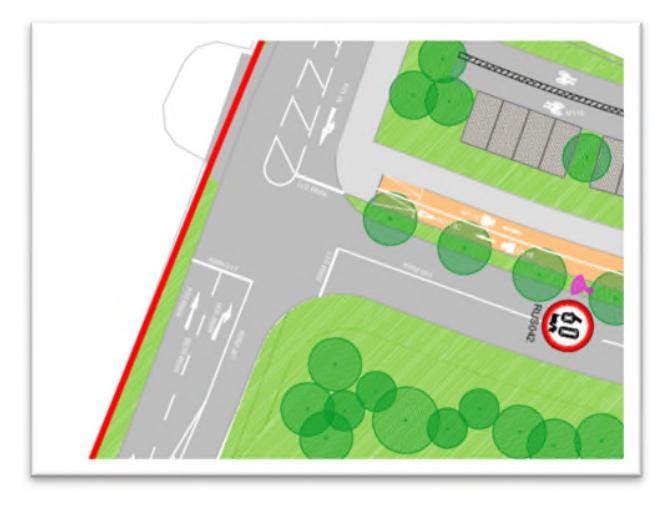
Drawing L308-OCSC-XX-XX-DR-C-0112 S4, P04, R155 Junction.

It is proposed to provide a footpath and cycle track along the northern verge of the RORR. There are however no proposed crossing facilities or pedestrian and cyclists facilities towards the town centre along the R155. Without a safe crossing location vulnerable road users could be struck by through traffic. Without facilities towards the town centre vulnerable road users will be led to an unsafe location.

It is recommended that pedestrian and cycle facilities be provided on approach to the junction and that crossings be provided on each arm. In addition continuous facilities should be provided towards the town centre to cater for vulnerable road users.

| | Paragraph No. Problem in Quality accepted Audit Report (yes/no) | | Recommended measure accepted (yes/no) | Alternative measures (describe) | Alternative measures accepted by Auditors (Yes/No) |
|--|---|---|--|--|--|
| | 3.3 | γ | Ν | There is a part 8 Ratoath Pedestrian and cycle scheme issued. We are tying into the proposed infrastructure as planned in the scheme and following the same implementation. This part 8 application is currently active and on Meath County Council's website. We were instructed by Meath County council to incorporate it into our design. Their scheme provides for a 3m shared path only provided along the Eastern side of the carriageway. We will therefore provide a 3m shared facility to the north but no crossing facility to the south, as no cyclist or pedestrian facility is in planning till the development of the Loblolly land, and pedestrians are accommodated into the RORR as | Yes |

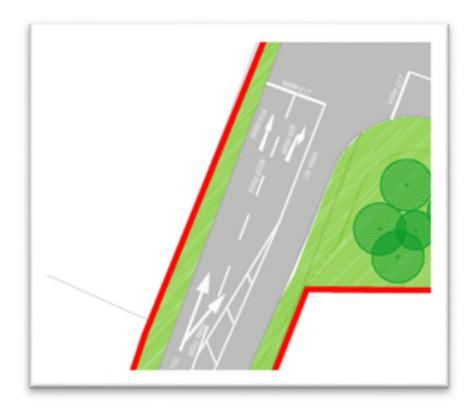
Drawing L308-OCSC-XX-XX-DR-C-0112 S4, P04, R155 Right turning lane.

The proposed right turning lane on the R155 to the relief road appears to be too short to be able to cater for the volume of traffic that would be turning right onto the RORR when it is fully complete and the speed that traffic would be approaching the junction. This could lead to excessive queuing on the R155 which whould result in rear-end shunts.

It is recommended that the right turning lane be extended to cater for the future traffic demand.

| | | | planned for in the Part 8 planning scheme. | |
|---|---|---|---|---|
| 3.4 | N | Ν | A traffic analysis has been performed and the queue length calculated. Peak max queue length has been calculated for in 2039 and 15m has been allowed for. Storage capacity | Yes |

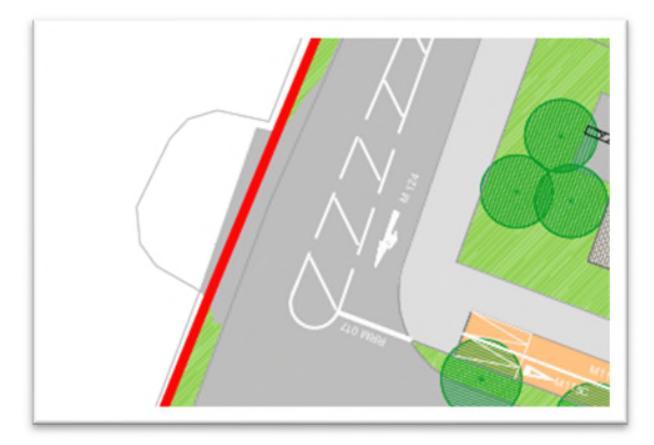
Drawing L308-OCSC-XX-XX-DR-C-0112 S4, P04 , R155 access from dwelling at the proposed signalised junction.

There is a risk that drivers exiting the private dwelling north of the junction may exit at an inappropriate time when a green signal is provided for right turning traffic from the RORR or for northbound traffic on the R155. This could lead to side-impact or rear-end collisions.

It is recommended that the private access be part of the signalised junction for exiting vehicles.

| | | | planned for in the Part 8 planning scheme. | |
|---|---|---|---|---|
| 3.5 | Y | Ν | As it is only an entrance to one dwelling, our proposal is to provide an appropriate all red time at the signalised junction, to provide the opportunity for the owner to enter his/her residence safely. The position of the junction was provided by Meath county council as the proposed location of the junction and cannot be shifted to the north to allow for a 4 way junction to include the 1 residence. | Yes |

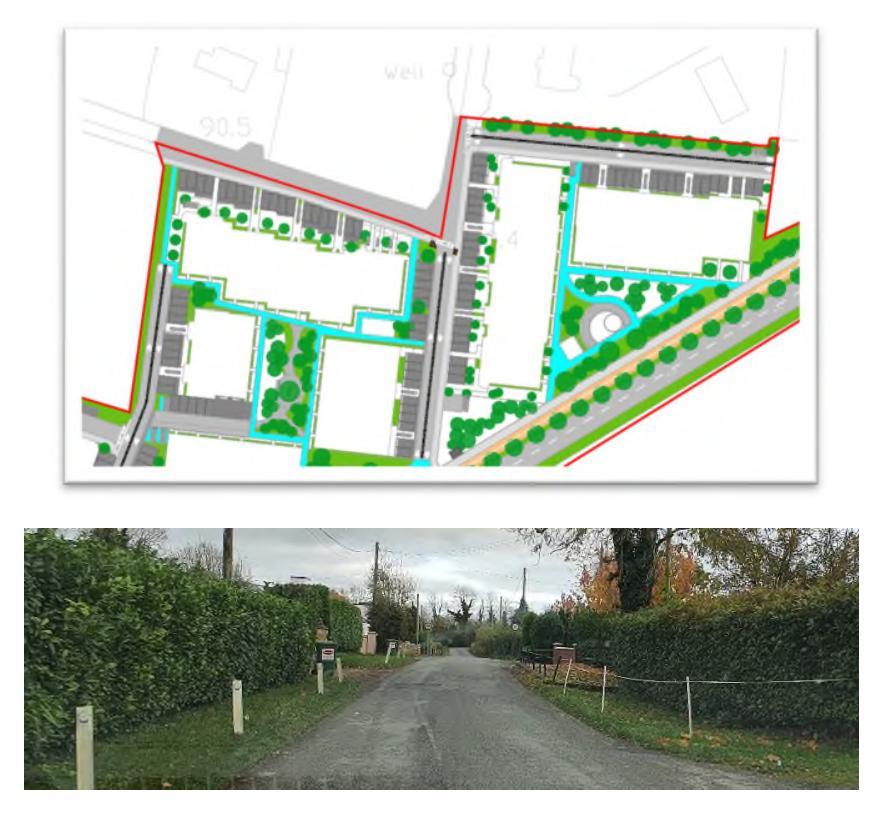
Drawing L308-OCSC-XX-XX-DR-C-0111 S4, P04

It is proposed that some new residential units at the eastern end of the scheme will be accessed off Glascarn Lane and not the RORR. Glascarn Lane has very poor facilities for vulnerable road users and the intensification of use would lead to an increased likelihood of collisions.

It is recommended that pedestrian and cyclist facilities be provided along the entire length of Glascarn Lane between the proposed units and the R155 or that the units be accessed off the RORR.

| | | | planned for in the Part 8 planning scheme. | |
|---|---|---|---|---|
| 3.6 | Y | Ν | We will implement a walkway for the residents planned for in our scheme as far as our boundary allows on the southern side of Glascarn lane. The rest of Glascarn lane including the northern edge is outside the scope of our project and redline boundary, we cannot include infrastructure on it. The site's internal road network is set up in such a way that additional traffic will run through the RORR | Yes |

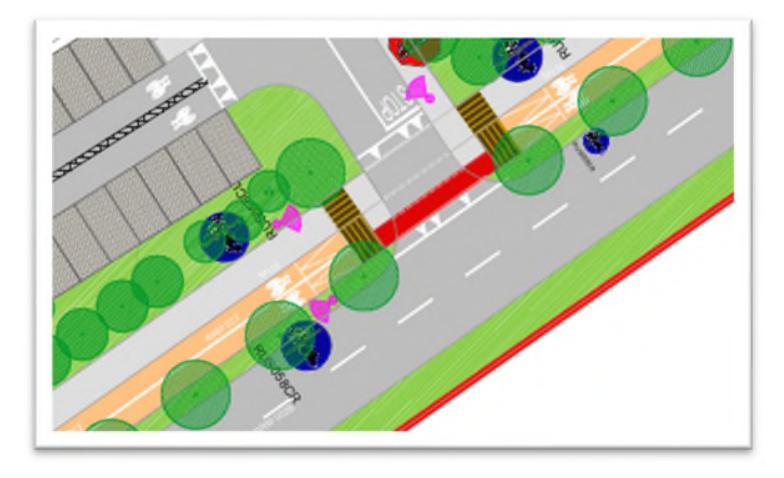
LOCATION RORR Verge.

Tree are shown in the 1.5m verge between the RORR carriageway and the two-way cycle track. There is a risk that some of the trees, either singularly or cumulatively, may obscure visibility at junctions and to crossing pedestrians and cyclists.

It is recommended that trees are chosen with suitable girths when mature, canopy heights and spacings to ensure that they do not obscure a drivers visibility.

| | | | planned for in the Part 8 planning scheme. | |
|---|---|---|---|---|
| 3.7 | Y | Y | Suitable greenery will be implemented as recommended | Yes |

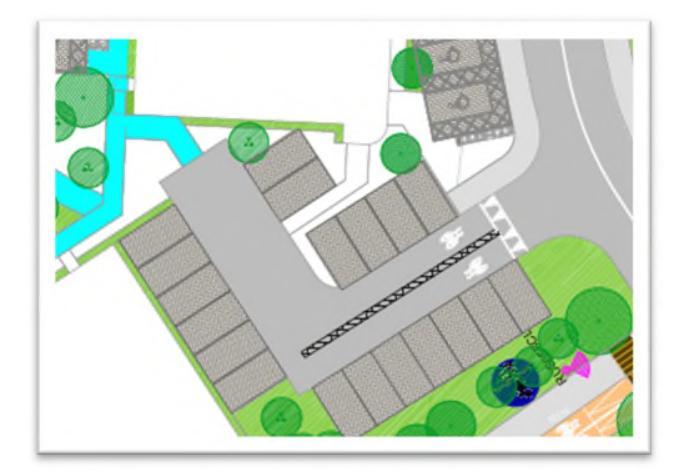
General, Perpendicular parking along 5m wide carriageways.

There are areas within the development where it is proposed to provide perpendicular parking with standard sized parking bays along shared use streets with 5m wide carriageways. This may lead to material damage of vehicles as drivers try to negotiate the tight parking spaces

Example only

It is recommended that buffer zones be provided or wider spaces be provided.

| | | | planned for in the Part 8 planning scheme. | |
|---|---|---|---|---|
| 3.8 | Y | Y | Vehicle tracking has been run through the site for a large passenger vehicle, fire tender and refuse vehicle to ensure adequate drivability through the site. Buffers | Yes |

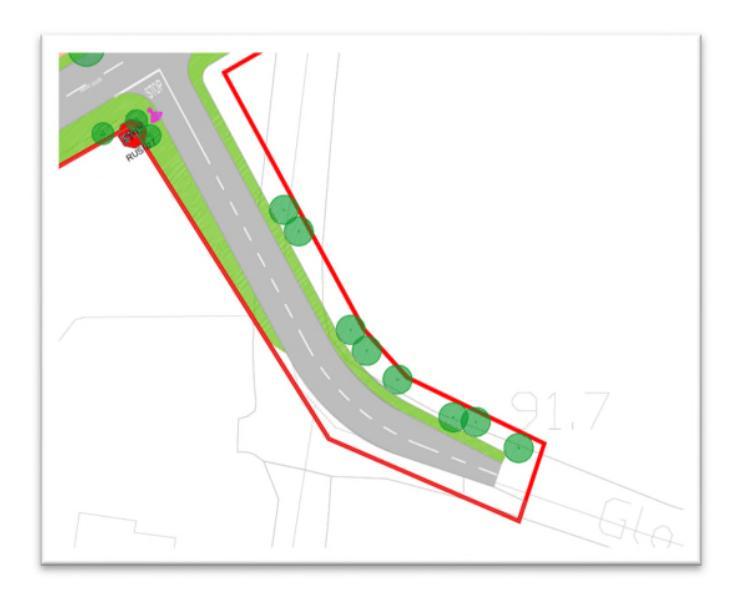
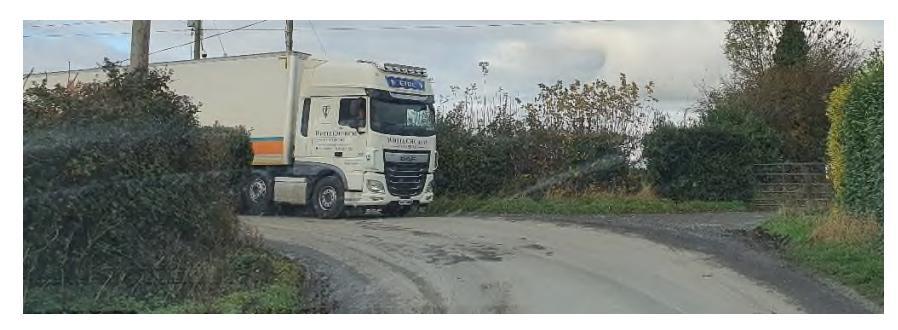
Drawing L308-OCSC-XX-XX-DR-C-01203 S4, P04, Glascarn Lane (South)

It was observed during the site visit that there is a commercial premises on Glencarn lane to the East of the development which utilises large heavy goods vehicles. It is unclear if the realigned road can cater for stopping sight distance around the sharp bend at Ch 50 approx and if the junction with the RORR can cater for the swept paths of such vehicles. A lack of space to accommodate such vehicles could lead to head-on collisions.

Ensure that vehicles using the commercial premises are adequately catered for in the design.

| | | | have been added in areas that show issues. | |
|---|---|---|---|---|
| 3.9 | Y | Y | Glascarn lane has been widened and a 50km/h compliant curve has been introduced. Visibility has also been addressed | Yes |

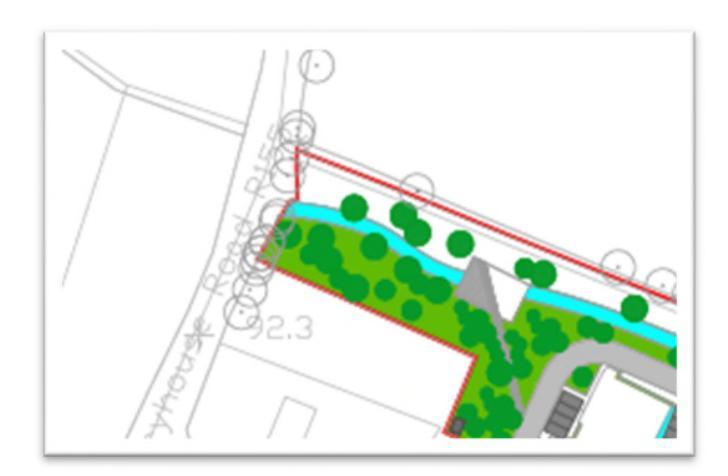
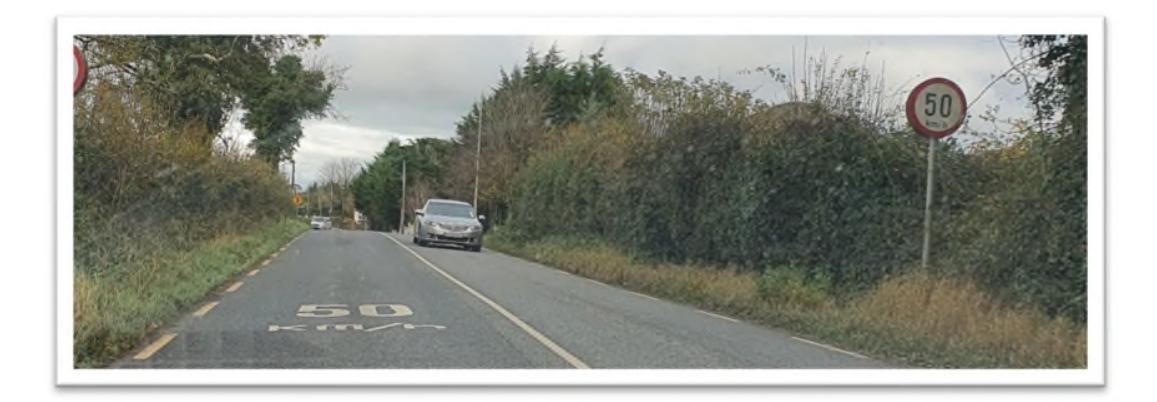
LOCATION R155 Pedestrian /cyclist link.

There is a proposed greenway joining the R155 South of the Carraig Na Gabhna residential development. There is no footpath or cycle track along the R155 for this greenway to connect to. This may lead pedestrians and cyclists entering the carriageway where they would be at greater risk of being struck by passing vehicles.

It is recommended that a footpath be provided along the R155 from the signalised junction to the existing footpath North of Carraig na Gabhna. A crossing facility of the R155 should be provided at the greenway tie-in to allow cyclists get to the opposite side of the R155 and continue towards the town centre.

| | | | have been added in areas that show issues. | |
|---|---|---|---|---|
| 3.11 | Y | N | We are bringing the proposed greenway up to a shared facility planned for in the different Part 8 application that is providing for a shared pedestrian and cyclist facility that only runs on the Eastern side of the RORR. We are tying into this Eastern Boundary. The crossing is not being implemented as pedestrian and cyclist infrastructure will only be provided for on the eastern side of the R155 in this area. | Yes |
