MetroLink

Transport Infrastructure Ireland

Buildings Desk Study

| P02

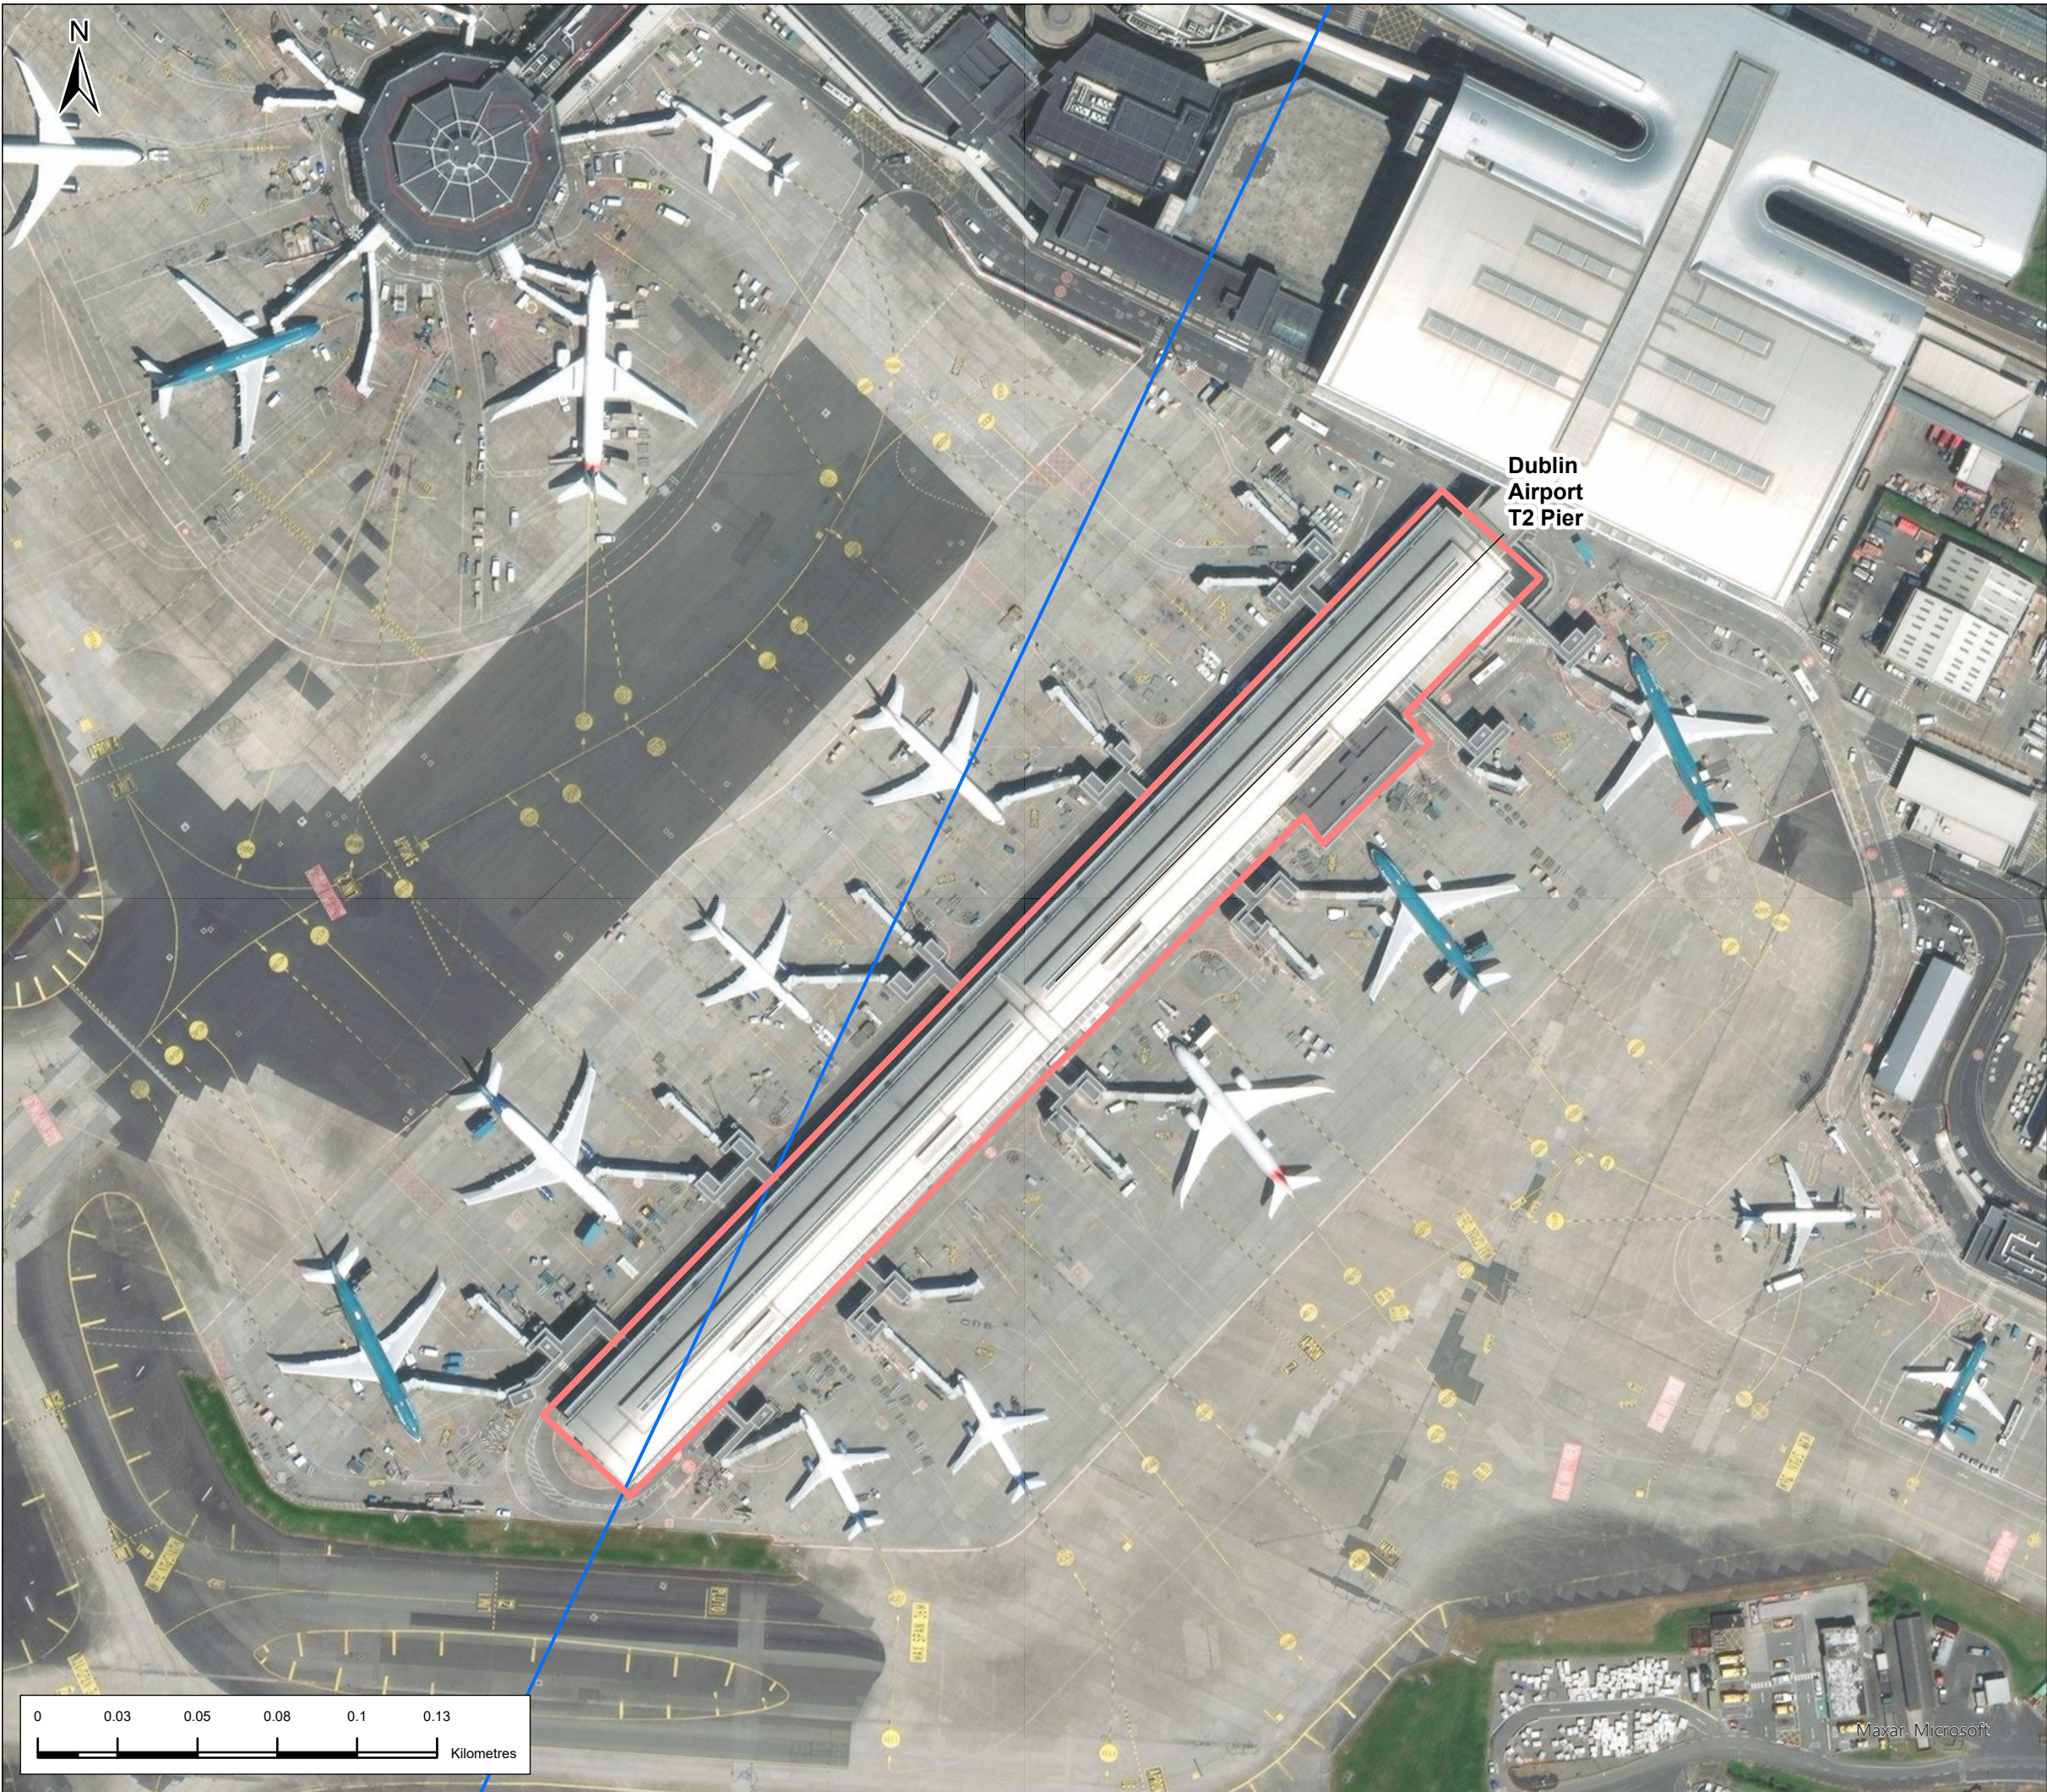
The location of these buildings are indicated on the maps in Appendix A.
