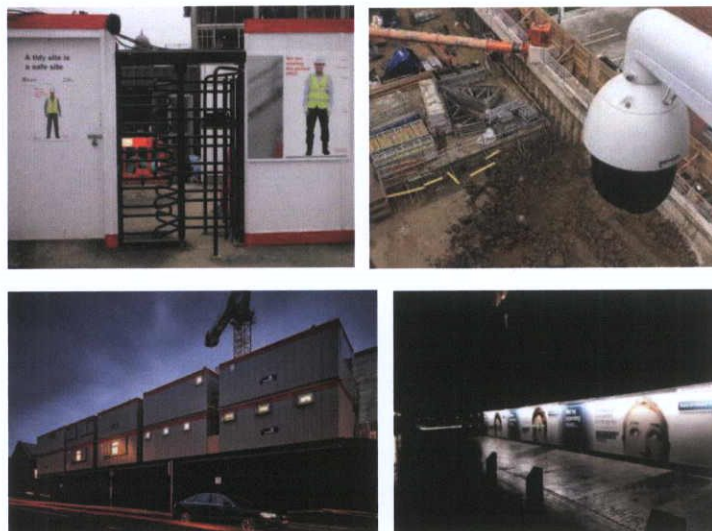
Figure 4 | Typical Site Security Measures

- A dedicated site security team with 24hr access to the site and direct contact with the local An Garda Siochana station.
- Each person on site will have been inducted and fingerprint access control will be used for site entry and exit. The Contractor will know who is on site at all times.
- There will be a site CCTV system which may be extended to cover the footpaths and roads around the site at access points (depending on the GDPR regulations).
- Hoarding lighting will be incorporated to increase the general illumination levels around the site with the exception of boundaries to residential gardens and houses.
- Siting the cabins behind the hoarding with windows overlooking the streets will provide a greater degree of natural surveillance to the area ward against anti-social behaviour.

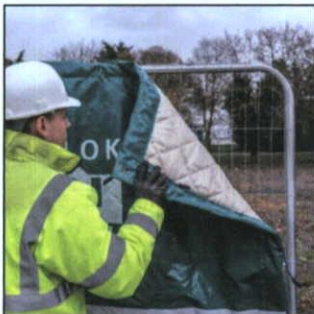
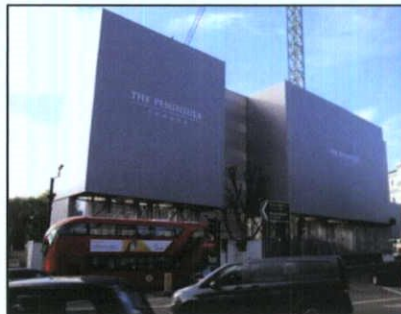
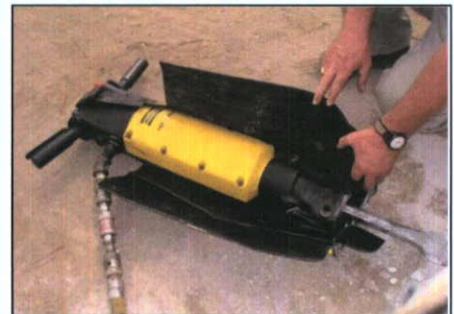
Figure 8 | Typical Noise Mitigation Measures

1. The installation of a solid timber hoarding to provide noise insulation.
2. A high-level acoustic wrap applied to the scaffolding to provide some degree of noise barrier.
3. Particularly noisy works can have an acoustic noise control barrier put around them when the works are being carried out.
4. When jack hammers are used a “no racket” jacket will be applied which reduced the noise by up to 10db when 50ft away.

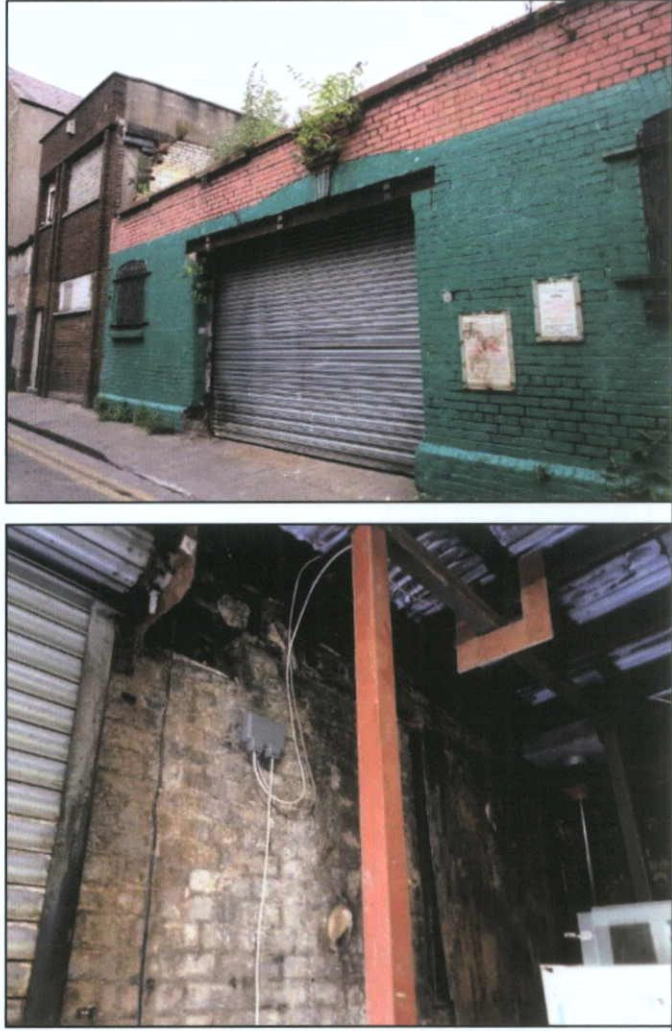
Building	PRFs	PRF Suitability	Photograph
<p>10-11 Moore Lane</p>	<p>Flat roofed building, with gaps on external wall between brick work and roof, and access into building above sliding door at entrance.</p>	<p>Low</p>

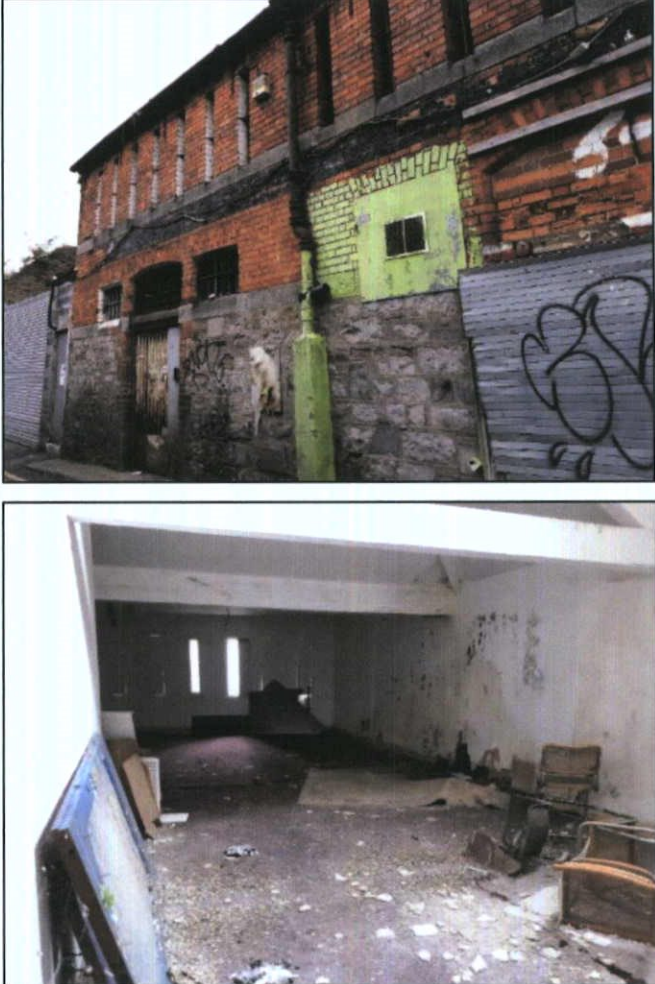
Building	PRFs	PRF Suitability	Photograph
<p>6-8 Moore Lane</p>	<p>Pitched roof building with open grated buildings allowing access within, also gaps between brickwork on external walls.</p>	<p>Low</p>

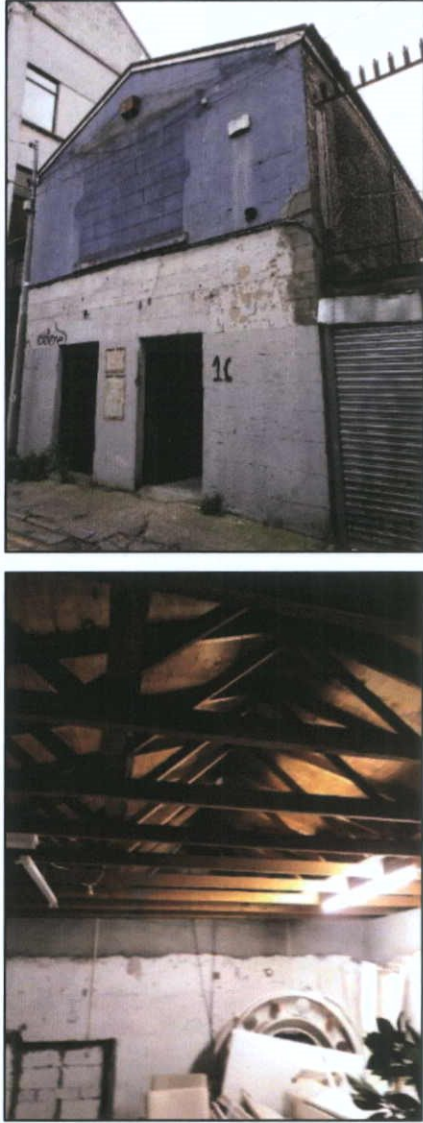
Building	PRFs	PRF Suitability	Photograph
<p>10 Henry Place</p>	<p>Pitched roof building with attic space, PRFs on external walls between brickwork and soffits where they join the external walls.</p>	<p>Low</p>

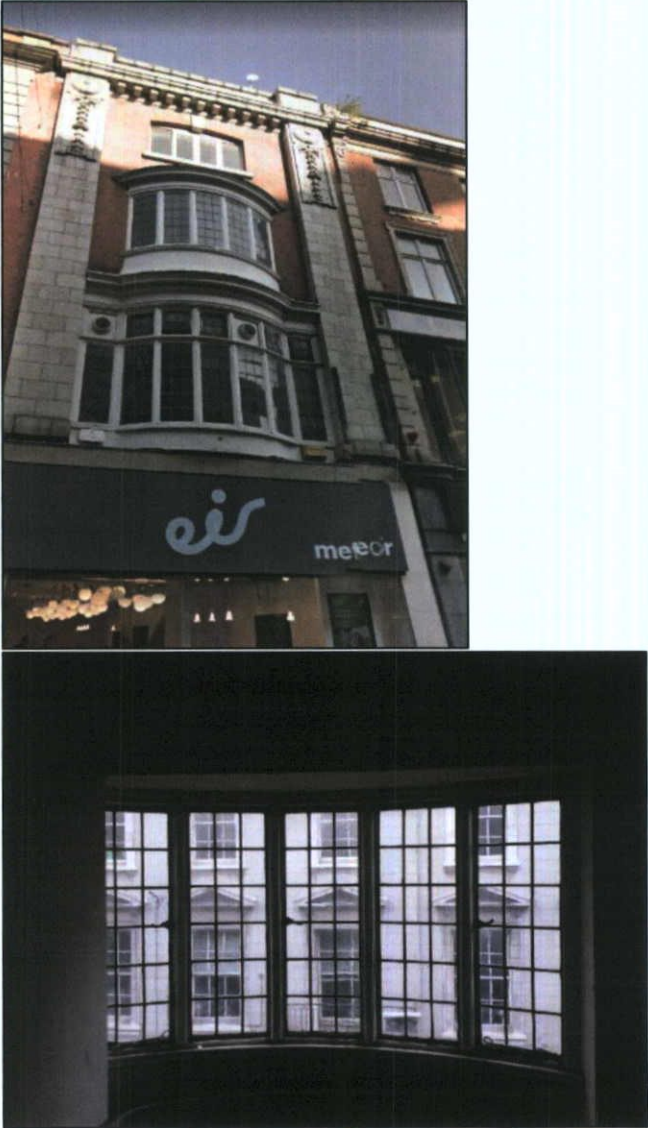
Building	PRFs	PRF Suitability	Photograph
<p>37 Henry Street</p>	<p>No attic space within this building (flat roof), but PRFs on external walls and above window lintels .</p>	<p>Low</p>

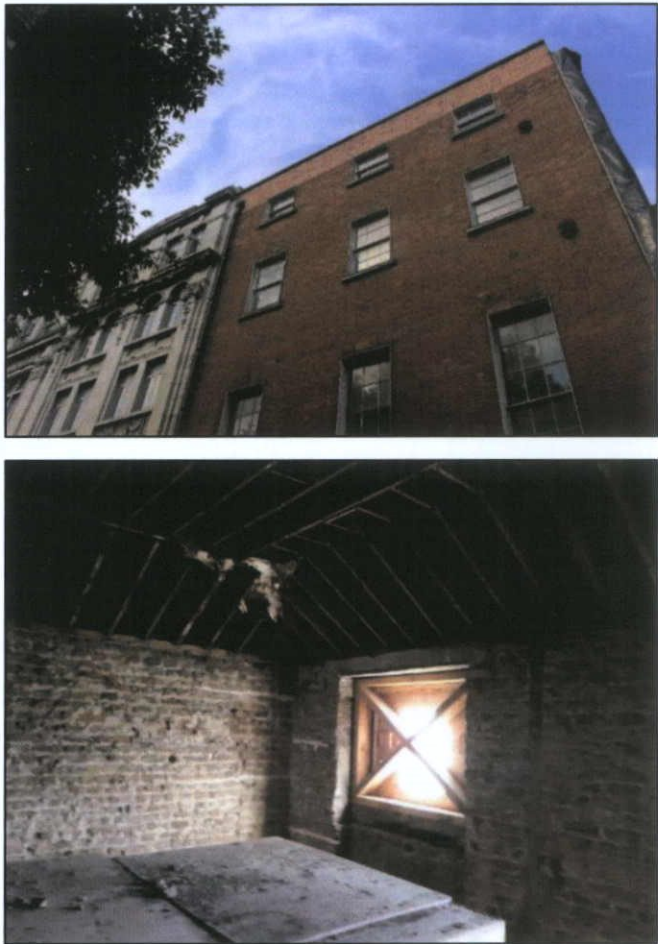
<p>42 O'Connell Street</p>	<p>Attic Space within this building, Potential gaps where brick wall joined roof, and on rear of building where windows were missing providing access into pitched roof attic space.</p>	<p>Low</p>

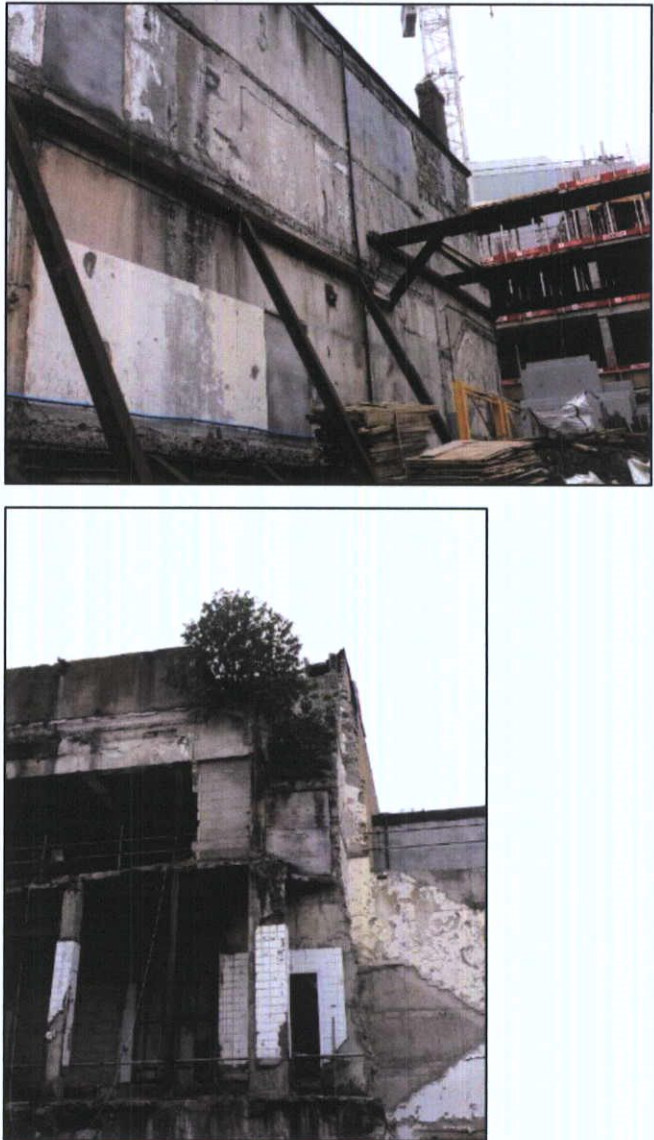
<p>43 O'Connell Street</p>	<p>No PRFs as no building exists here anymore, however PRFs visible from this site on adjacent properties where walls etc. have come away leaving potential gaps/crevices.</p>	<p>Negligabl e</p>

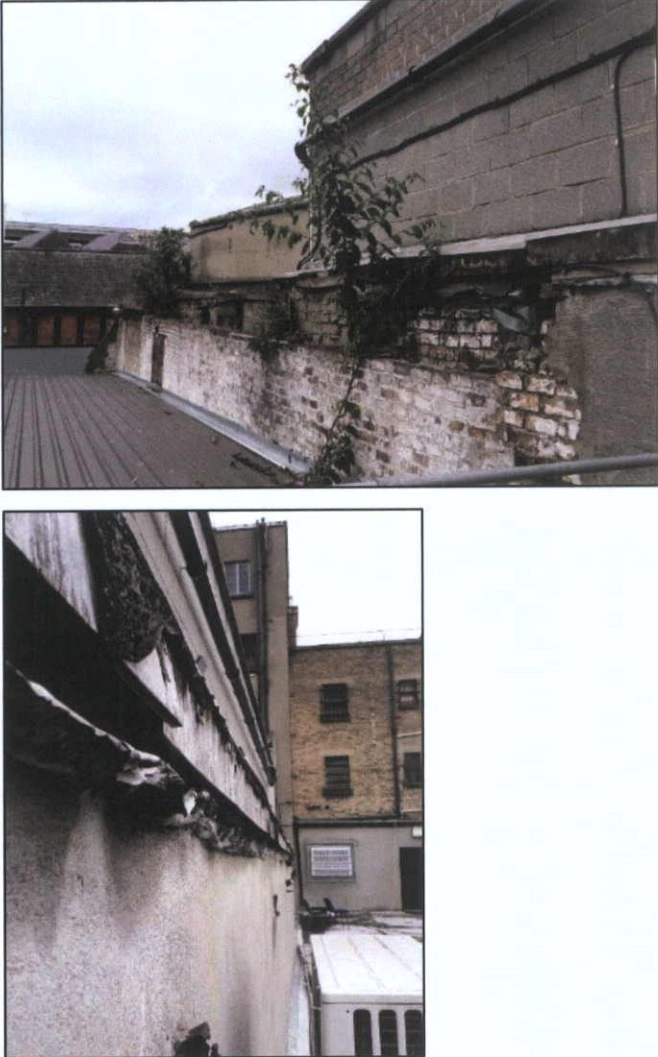
<p>58 O'Connell Street (Site 2)</p>	<p>Roof access was permitted here as no attic space. Missing bricks and crevices under soffits and plywood boards on adjoining buildings was evident.</p>	<p>Low</p>

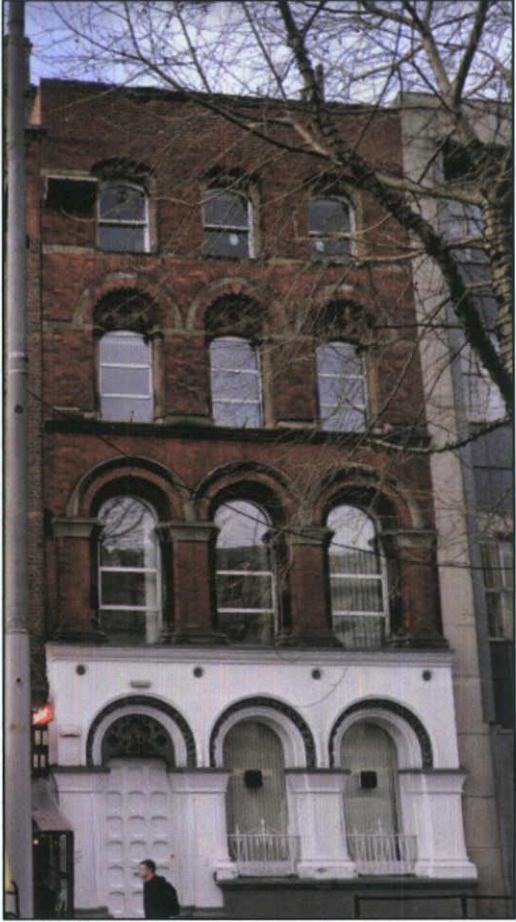
<p>61 O'Connell Street</p>	<p>No attic space in this building, flat roofed. PRFs at top of windows, and possibly between brickwork.</p>	<p>Low</p>
