APPENDIX D: BENCHMARKS

Gort Town Centre First Plan

Case studies

September 2023

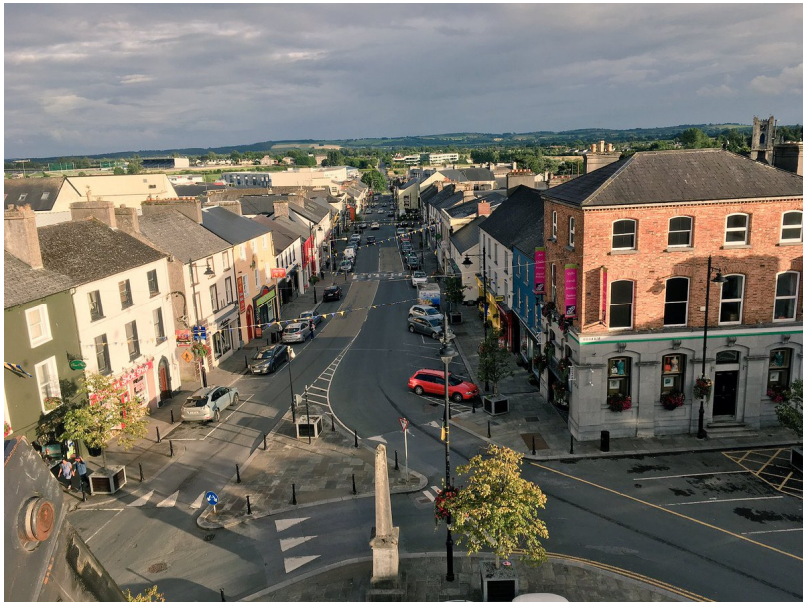
Figure 1: Roscommon Town Centre

- Revised traffic layout, reduced carriageway lane widths, realigned carriageway to improve traffic flow.
- Proposed removal of car parking in several locations in the town centre.
- Upgrade links to car parks
- Enhance **pedestrian crossings**.
- Create more **pedestrianised areas** by widening footpaths: a paved pedestrian civic space to be provided to the north and south of Market Square.
- Implement new **signage** directing people to the town centre.
- Proposed **a network of cycling tracks** to provide inter-connection between the town's core services, out of town retail, schools and other services.

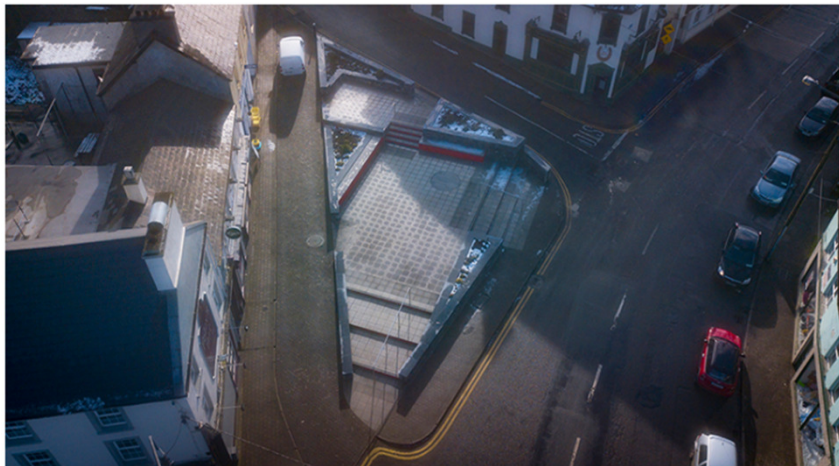
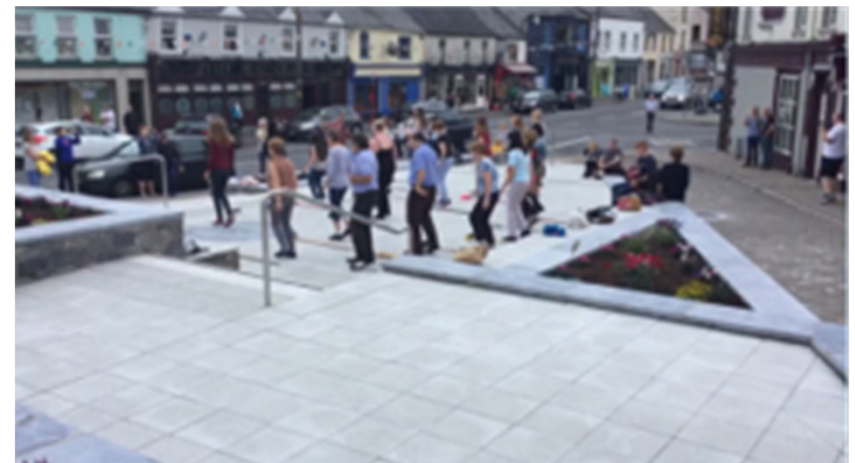
Figure 2 and 3: Tobar Place redeveloped in Sligo

- Analysis of the **local calendar of events, pedestrian routes and traffic flow.**
- Improvement of Tobar Place: terraced platform that acts as a **'route through'** and links an existing pedestrian route to the town centre (accessibility for vulnerable road users unknown).
- Other **pedestrian links** to be improved to link several public spaces and **create journeys** through the town **for pedestrians.**

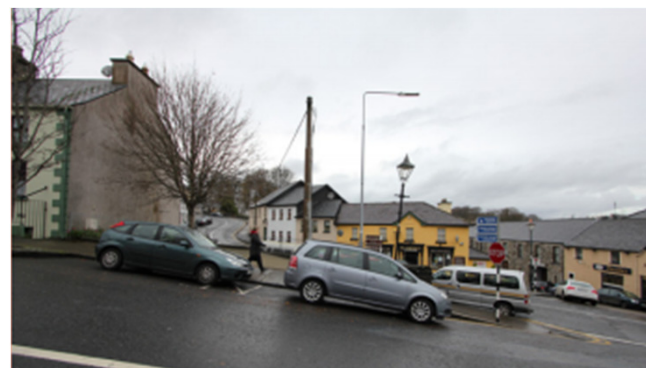
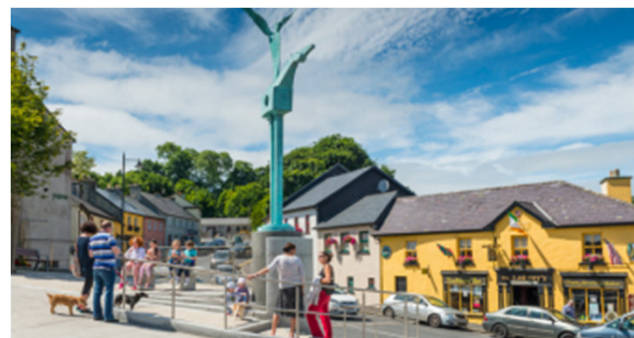
Public square

- Created a coherent design strategy: **Town Design Statement, 'Westport 2000'**.
- The Town Hall was refurbished and **car parking spaces** near it **removed** to improve the quality of the public realm and make it more attractive and pedestrian friendly.
- The town created a square and removed **parking spaces** around it to create a place to move and stay. Public art (a sculpture) was provided to enhance the sense of place.

- **Re-allocating road space** and **on-street car parking** to improve pedestrian routes, create public squares or introducing cycle lanes and parking
 - Example: **Westport** removing car parking space to create a public square
- Introducing **traffic calming measures** to make the environment more pedestrian friendly
 - Example: **Thomas David Square**
- Conducting analysis of the local context: events, traffic flow, pedestrian movement to increase the local community's support.
 - Example: **Tobar Place** evaluating the local calendar of events

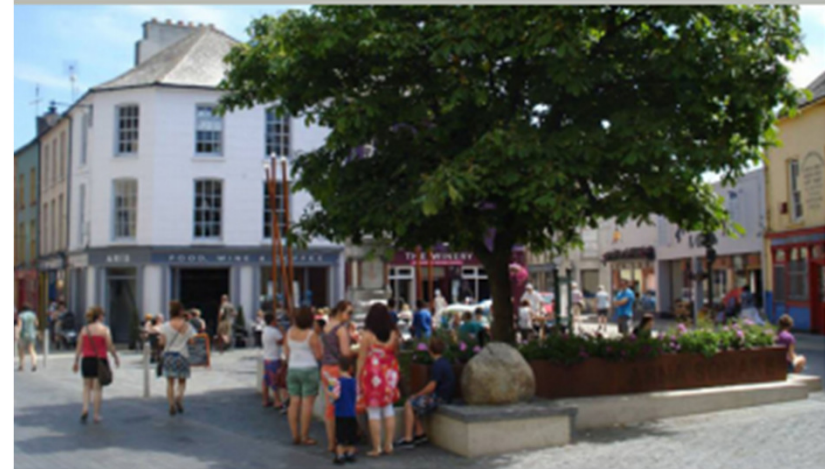
- **Re-allocating car parking** was seen as an **opportunity** to improve the public realm and created more pedestrianised space and allowed space for **street furniture** and **tree planting**.
- Establishing pedestrian priority was central to reallocating road space.
- **Asna Square** consists of a **shared surface** which accommodates passing cars, café seating and informal gatherings around a new pocket park and ensures pedestrian priority.
- The property market confirms higher value, and the **empty buildings are now occupied**, delivering new urban vibrancy and sense of community.

Figure 5: Asna Square, pedestrianisation

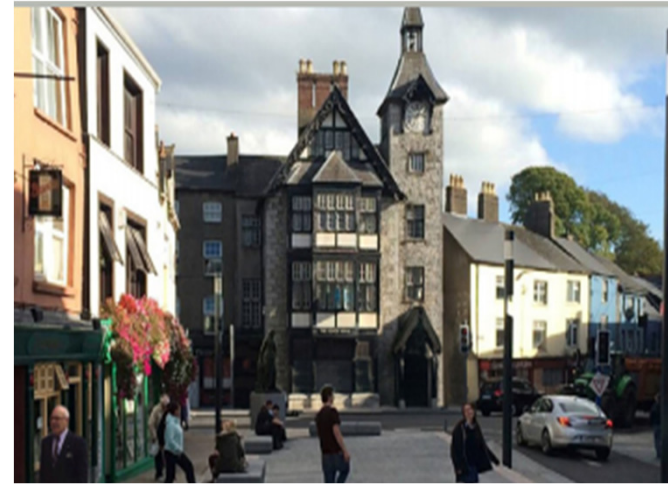
Figure 7: Thomas David Square redeveloped

- Pedestrian links improved, more crossing points provided. **Traffic was reduced to one lane** on Thomas David Square which made the area more welcoming to pedestrians.

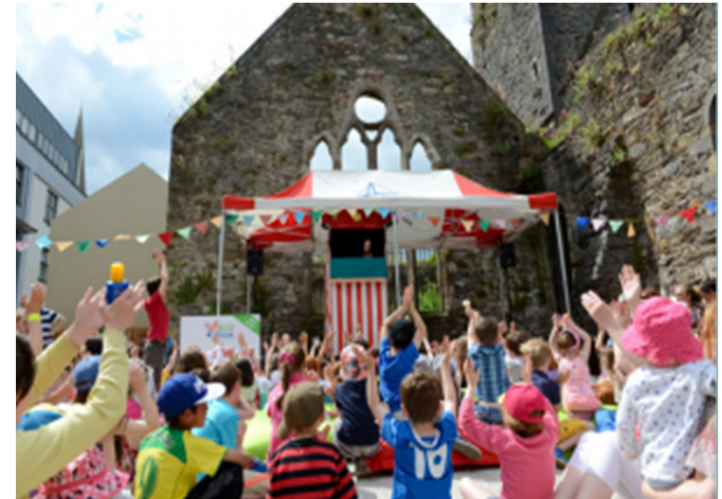
- Creation of **new and improved public spaces and pedestrian links** by removing car parking, creating journeys via interconnected streets and adding public art in public spaces.
- **Place making was aligned with history:** The principle was “1000 Years in 1000 steps” with new museums being aligned in chronological order.
- One of the Waterford car parks was turned into a **public space for events and festivals**.
- The three museums now attract **105,000 visitors per year. Seventeen new retail premises** have opened since 2011.

Figure 8: A former car park in Waterford is now a public space for events and festivals
