## **DRUMCLIFF BURIAL GROUNDS, ENNIS, CO. CLARE**

Hydrological and Hydrogeological Assessment for the Proposed Extension to Drumcliff  
Burial Grounds, Ennis, Co. Clare

### **FINAL REPORT**

Prepared for:  
**CLARE COUNTY COUNCIL**

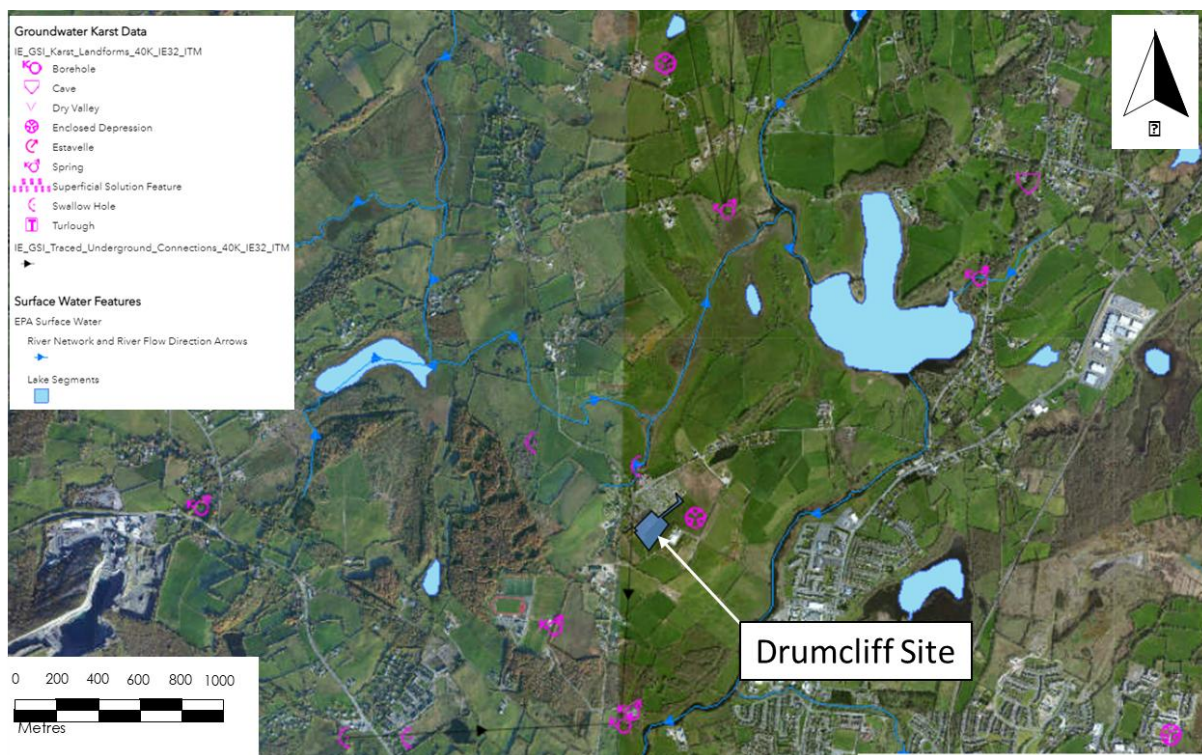
**Figure B: Local Surface Watercourses with Mapped Karst Features**

There are no surface water features within the site and therefore there are no direct hydrological connections or pathways to downstream surface waterbodies and designated sites. Local surface water features are shown in **Figure B**.

The OSI historical mapping shows no record of karst features within the proposed development site. Historical mapping does identify karst features in the surrounding areas, including “Poulacorey” swallow hole north of the site and “Kinnally's Holes” to the east of the site, additionally labelled as an area liable to flooding in 25” historic mapping.

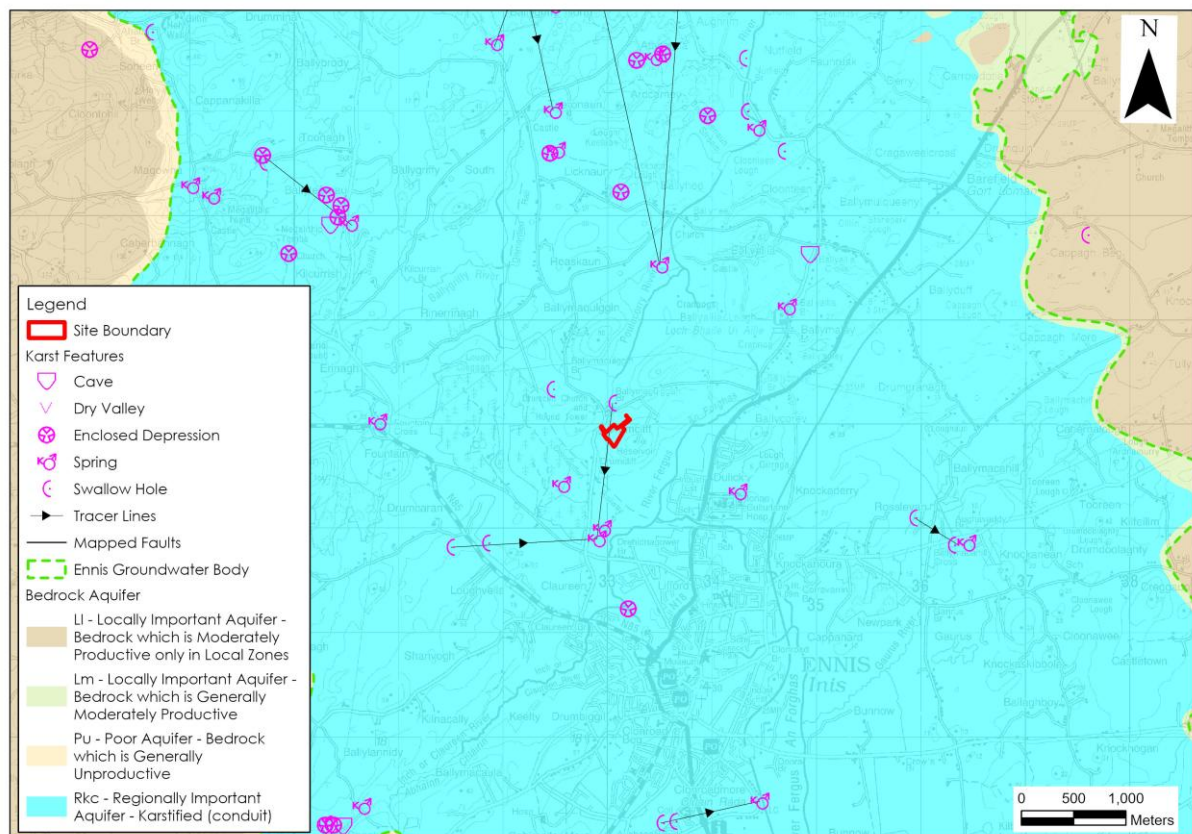
**Figure D: Groundwater Body Map**

This proposed development site is located within a karstified Limestone Aquifer (**Figure D**), while there are no karst features mapped within the site, karst features including swallow holes, springs, caves, and enclosed depressions are present within the wider Ennis area (refer to **Figure D**).

Groundwater within the site will follow the topography and flow downgradient, in a northern direction. No groundwater was encountered during the trial pitting site investigations.

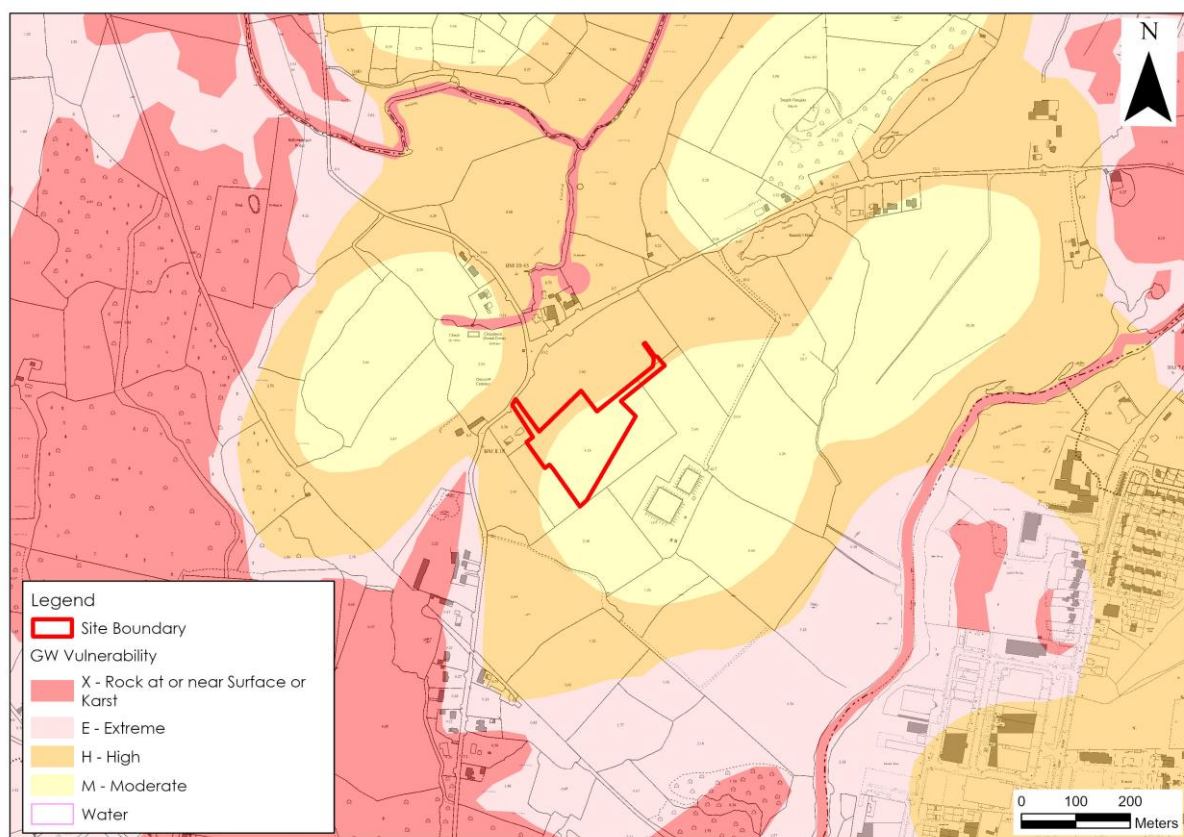
**Figure E: Groundwater Vulnerability Map**

A local groundwater vulnerability map is shown in **Figure E**.

- The thickness of subsoils present at the site (8.5-13.5m), which places the site within an area of Low-Moderate groundwater vulnerability (as per **Plate A**);
- The low-moderate infiltration rate;
- The elevated nature of the extension site relative to surrounding surface water bodies;
- The lack of groundwater presence at grave base depth (~1.8m); and,
- The historical data on groundwater quality at Pouladower swallow hole, indicates good quality water, with no increased levels of Ammonia (Poulacorey swallow hole ammonia rates were lower than Drumcliff Spring).

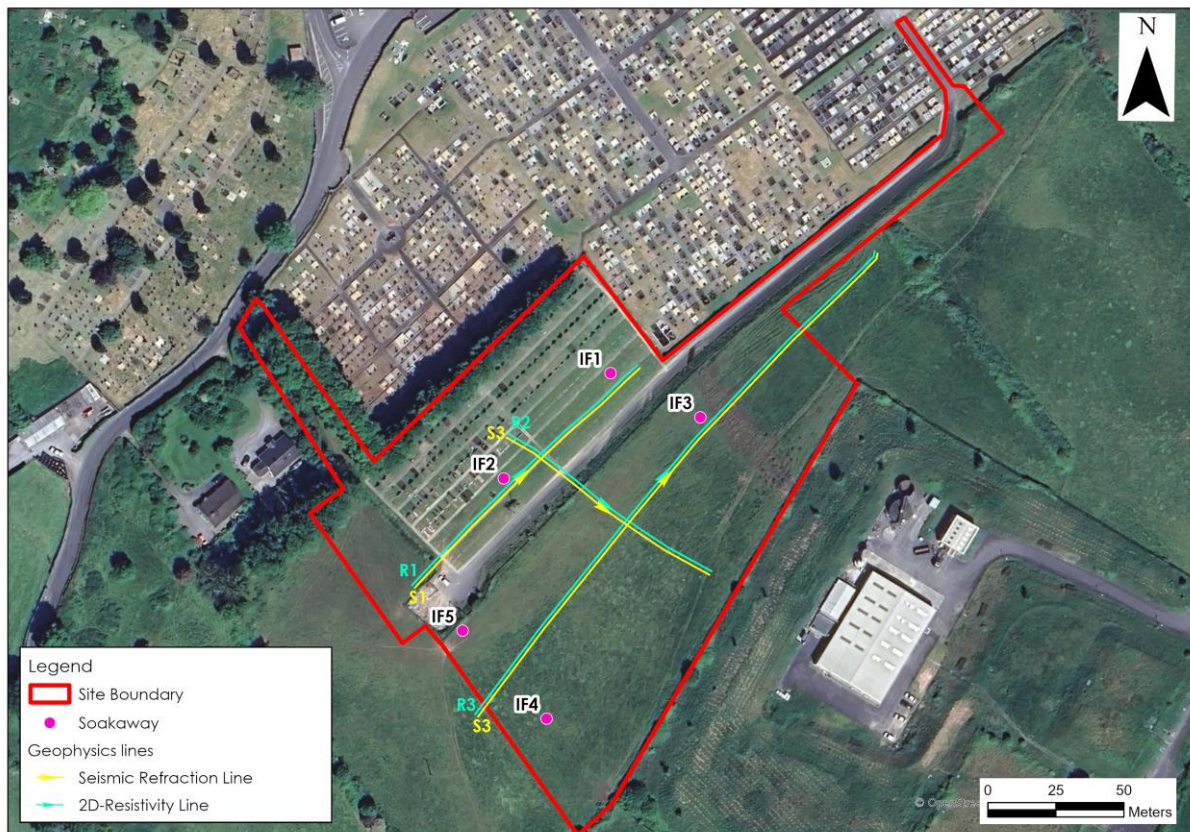
**Figure F: Site Investigation Locations**

- Site walkover to observe existing ground conditions;
- Excavate 5 No. Trial Pits to a maximum depth of 1.90mbgl; and,
- Perform 5 No. Soakaways to determine a soil infiltration value to BRE digest 365.

No groundwater was noted during the investigation however the exploratory holes did not remain open for sufficiently long periods of time to establish the hydrogeological regime and groundwater levels would be expected to vary with the time of year, rainfall, nearby construction and other factors. Surface water was present in close proximity to IF3, likely due to the impermeable nature of the Topsoil in that area.

Infiltration rates of  $f=6.257 \times 10^{-6}$  m/s,  $f=4.685 \times 10^{-6}$  m/s,  $f=4.446 \times 10^{-6}$  m/s and  $2.771 \times 10^{-6}$  m/s respectively were determined from site testing.

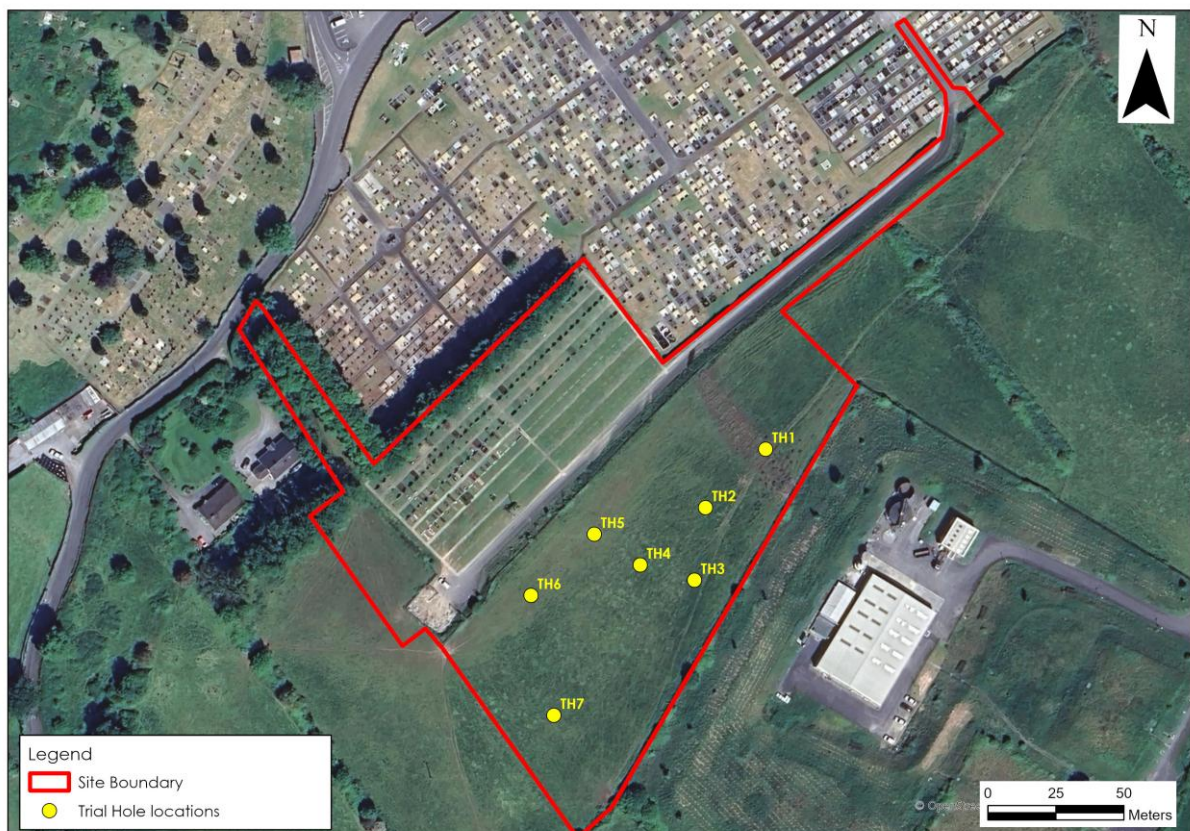
**Figure G: Trial Hole Locations**

The ground generally comprised approximately 150 mm of brown, slightly sandy/gravelly topsoil overlying reddish brown slightly sandy gravelly Clay with cobbles and some boulders, extending to the full depth of each excavation. Trial Hole TH3 encountered noticeably stiffer boulder clay within the final 1 m of depth. While excavation remained achievable, it required increased effort from the machine. The presence of this denser material may present moderate resistance to conventional grave digging equipment and should be considered in planning burial operations in these zones.

The area is generally suitable for grave excavation to a depth of 2.4 m below finished levels. The presence of stiff zone (TH3 vicinity) may present moderate resistance to conventional grave digging equipment. It is recommended that, as part of the tender documentation for the burial ground, provision be made for excavating to a depth of 2.4 m in the identified stiffer zones (notably around TH3), followed by backfilling with the same material. This would ensure ease of future grave excavations using standard burial equipment.

Seven trial holes (TH1 to TH7) were excavated across the proposed development area, as indicated on Drawing No. 7421-02-X3.

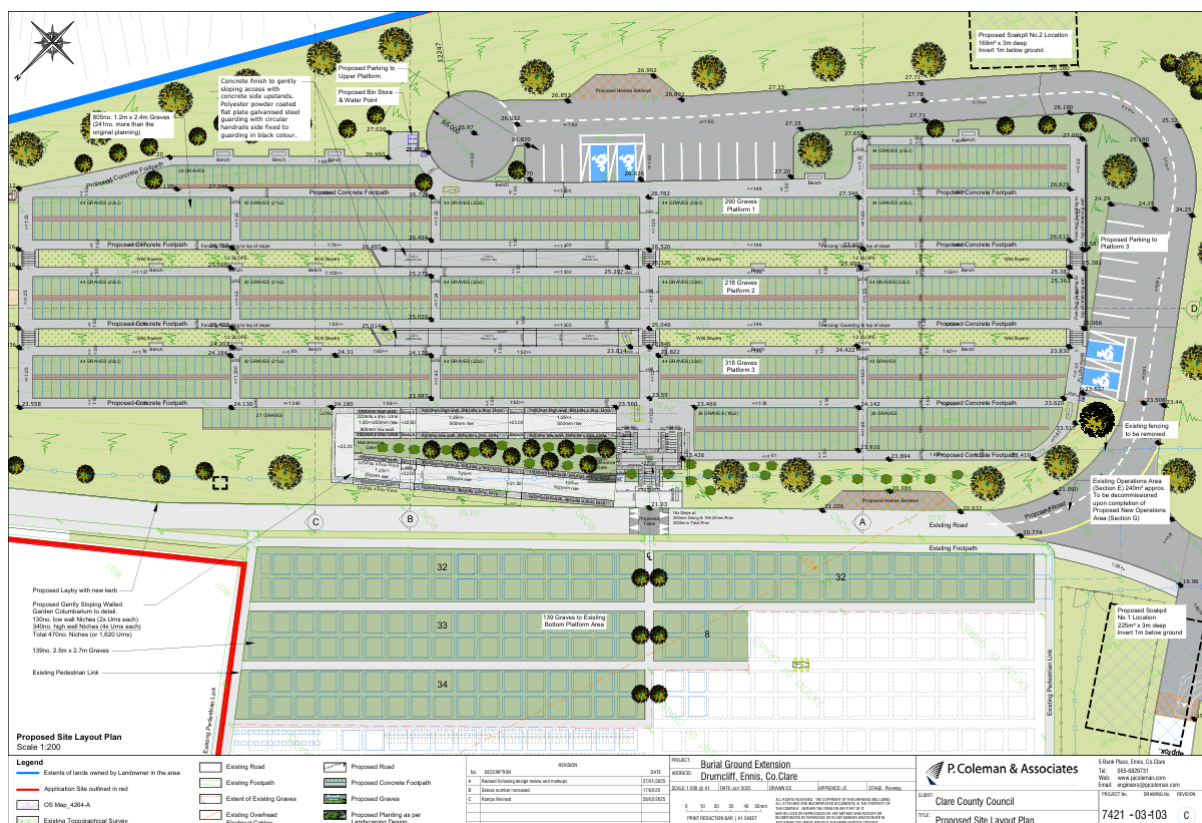
### Figure H: Proposed Site Layout

- 1) An addition of circa 413 double plots (or 826 single plots) including provision for ash plots.
- 2) Access road improvements including lay-bys, turning circle and traffic calming measures.
- 3) Provision of columbarium walls with circa 470 niches.
- 4) Parking; 23 standard spaces, 6 designated spaces for people with disabilities.
- 5) Footpaths and the provision of access ramps.
- 6) Drainage, landscaping works, and planting.
- 7) Associated Site Works.

The proposed site layout is shown as **Figure H** below.

(please note the north arrow direction)

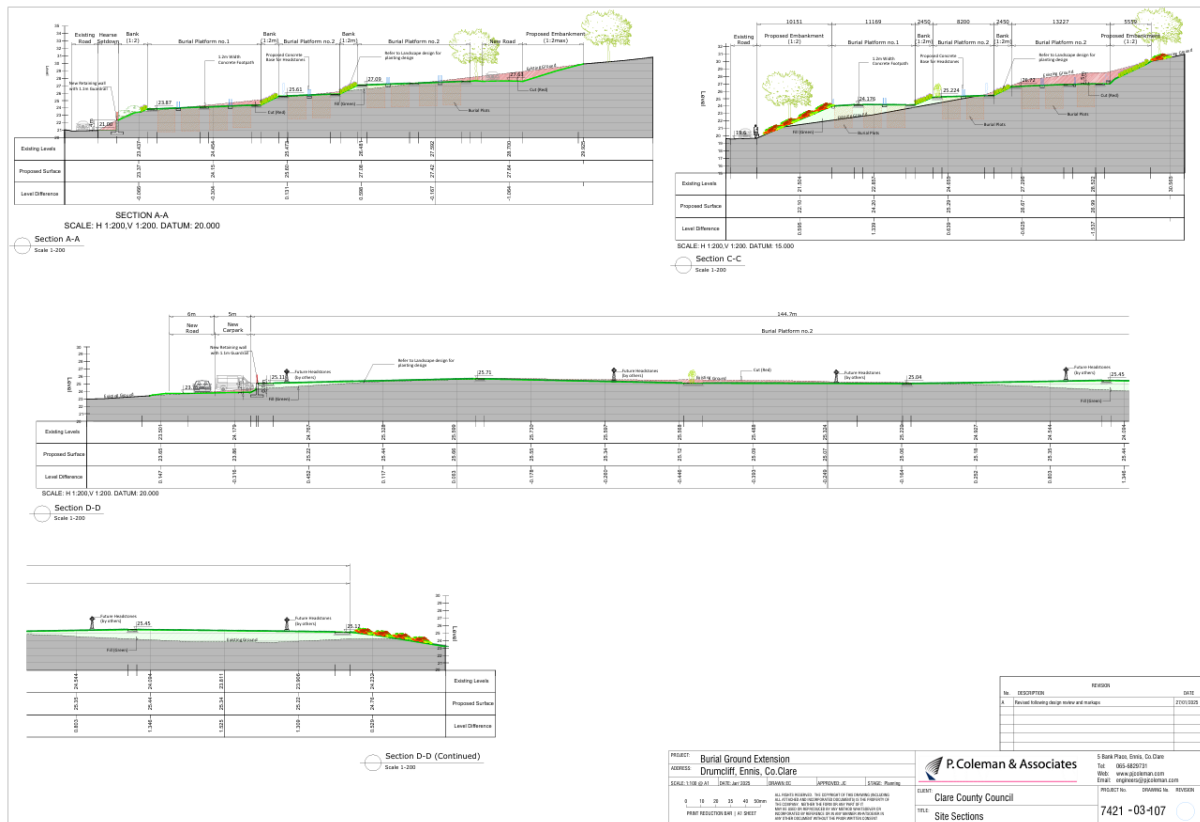
**Figure I: Site Cross Section**

The proposed development has several open space areas. Due to the slope and the proposed site levels as shown in **Figure 1**, areas are dedicated to open green space. The central space will be maintained as a central area for social meeting. A network of pathways will extend from the public path to provide circulation routes around and through this space

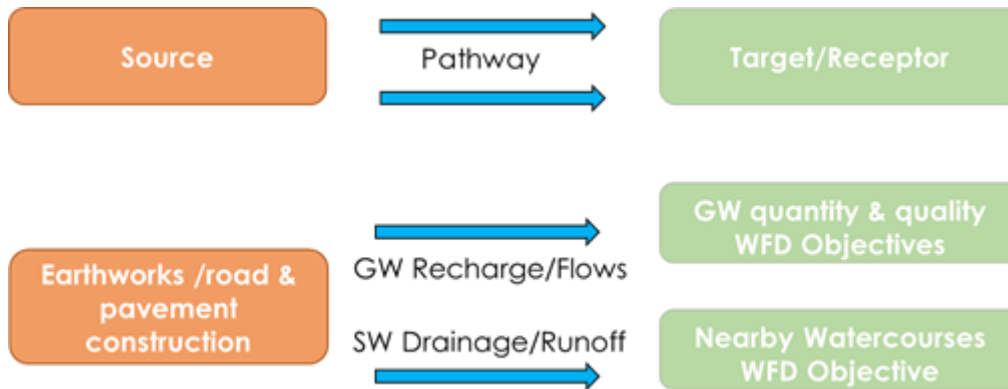
The conventional source-pathway-target model, as seen below, was applied to assess potential impacts on downstream environmental receptors (see below, bottom as an example) as a result of the proposed development.

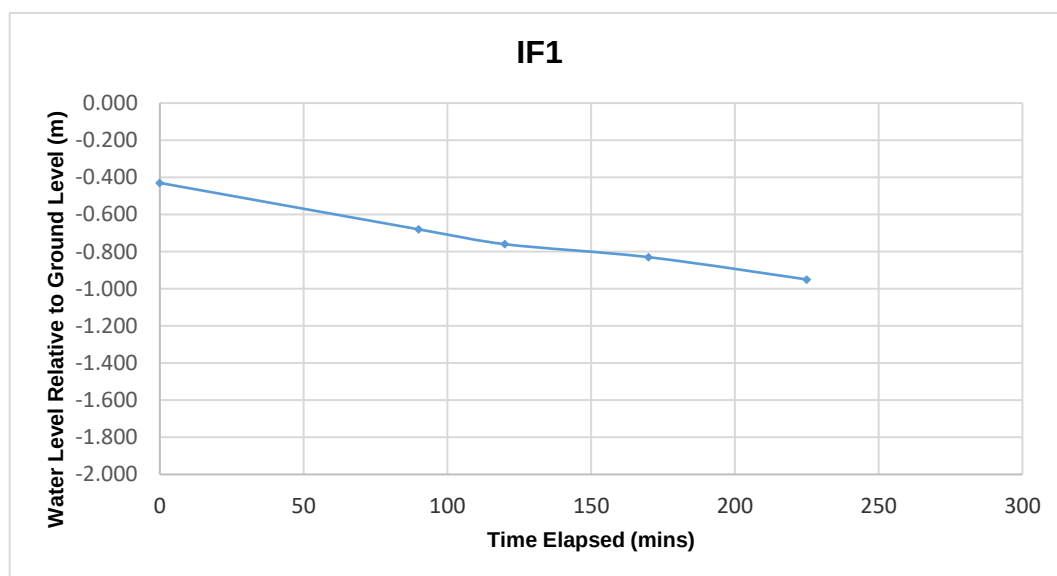
| Tp75-25 (from graph) (s) | 21000 | | 50% Eff Depth<br>0.735 | ap50 (m2)<br>3.58 |
| <b>f =</b> | <b>6.257E-06</b> | <b>m/s</b> | | |

Infiltration rates of  $f=6.257 \times 10^{-6}$  m/s,  $f=4.685 \times 10^{-6}$  m/s,  $f=4.446 \times 10^{-6}$  m/s and  $2.771 \times 10^{-6}$  m/s respectively were calculated for the soakaway locations SA01, SA03, SA04 and SA05. At the location of SA02 the water level dropped too slowly to allow calculation of 'f' the soil infiltration rate.

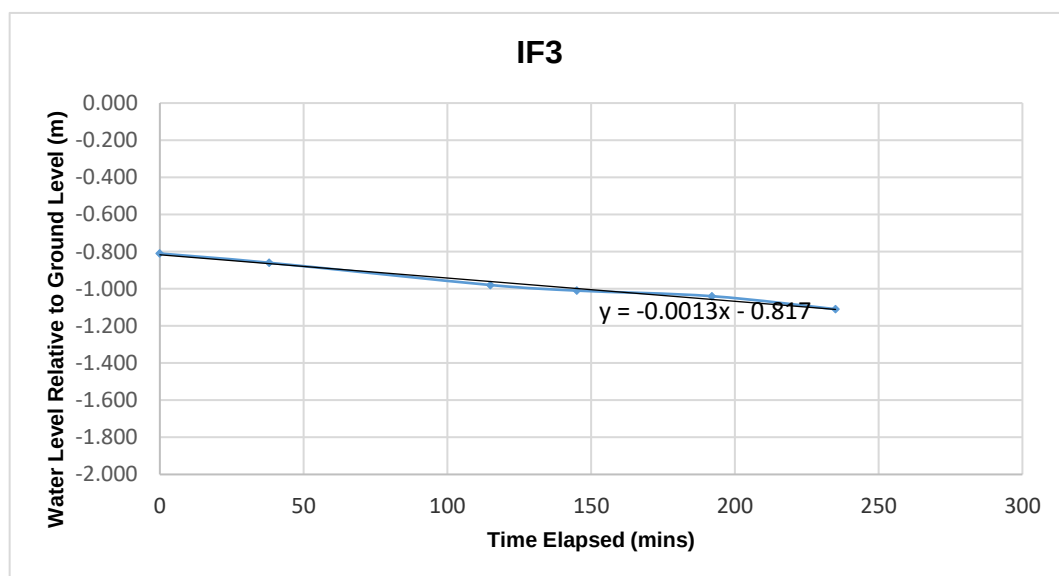
| Tp75-25 (from graph) (s) | <b>25500</b> | | 50% Eff Depth<br>0.545 | ap50 (m2)<br>3.6935 |
| <b>f =</b> | <b>4.658E-06</b> | <b>m/s</b> | | |

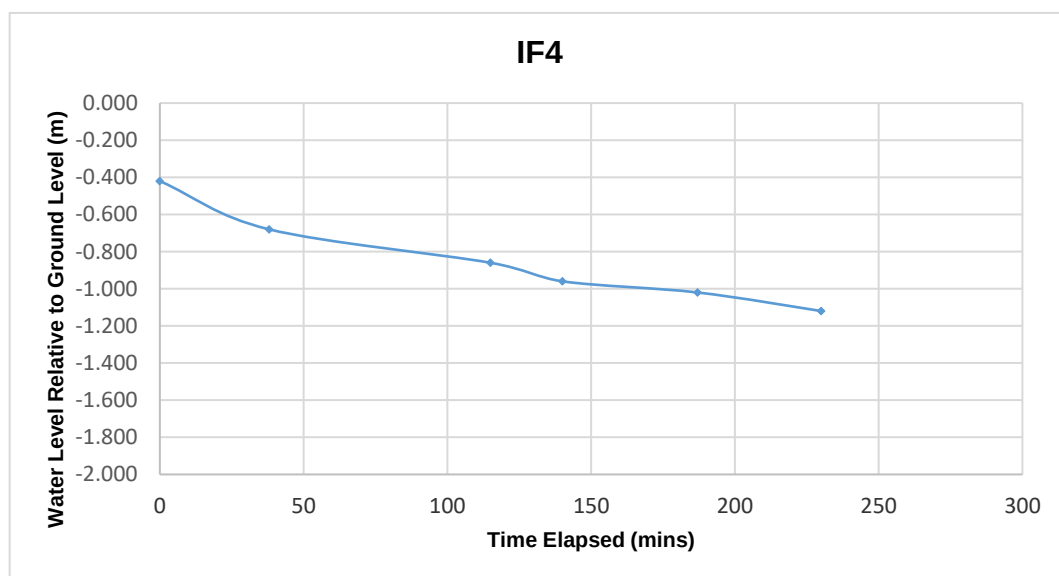
| Tp75-25 (from graph) (s) | <b>28000</b> | | 50% Eff Depth<br>0.690 | ap50 (m2)<br>4.462 |
| <b>f =</b> | <b>4.446E-06</b> | <b>m/s</b> | | |

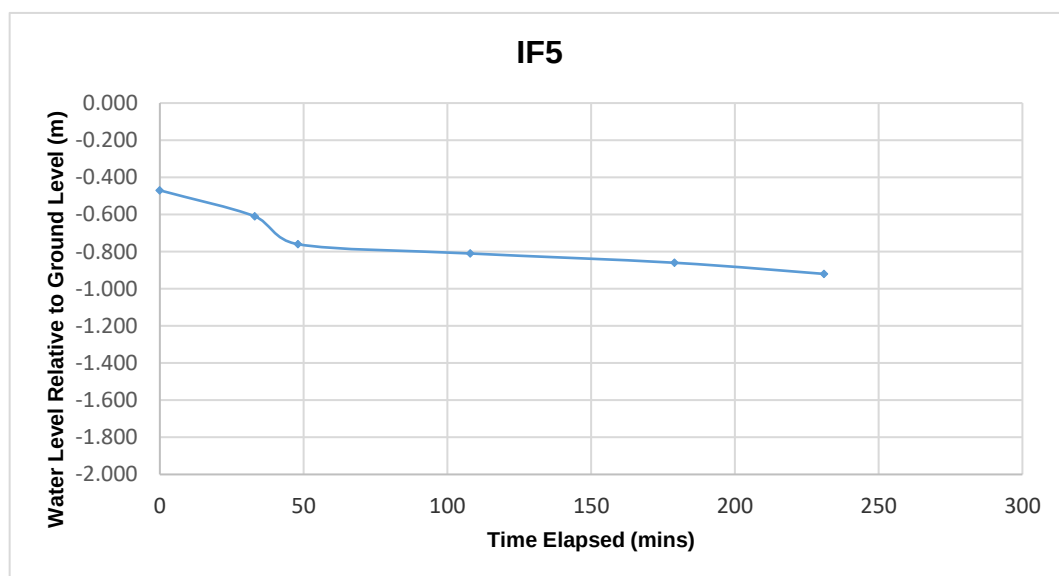
| Tp75-25 (from graph) (s) | 44400 | | 50% Eff Depth<br>0.665 | ap50 (m2)<br>4.1615 |
| <b>f =</b> | <b>2.771E-06</b> | <b>m/s</b> | | |

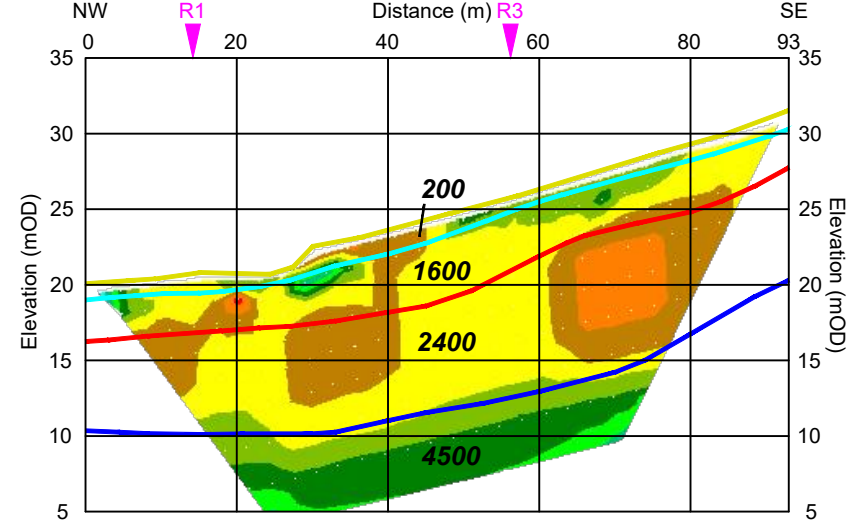
2D-Resistivity Line R2 and Seismic Refraction Line S2 Model

- Ground Surface/Top of Layer 1 (200 - 300 m/s)
- Top of Layer 2 (1600 m/s)
- Top of Layer 3 (2400 m/s)
- Top of Layer 4 (4500 m/s)
- 1600 Seismic Velocity in m/s

1. Layer 1: has a thickness of up to 2m and seismic velocities of 200 - 300m/s. This overburden would be soil with a soft or loose stiffness or compaction.
2. Layer 2: was modelled with a velocity of 1600m/s and reaches a depth between 2.5 and 5.5m. The velocity indicates overburden material with very stiff strength or compaction.
3. Layer 3: velocities of 2400m/s indicate predominantly overburden with hard strength or compaction. The thickness or depth varies between 4 and 9.5 m.
4. Layer 4: Strong rock is indicated by seismic velocities of 4500m/s and the top of this strong rock varied between 8.5 and 13.5m.

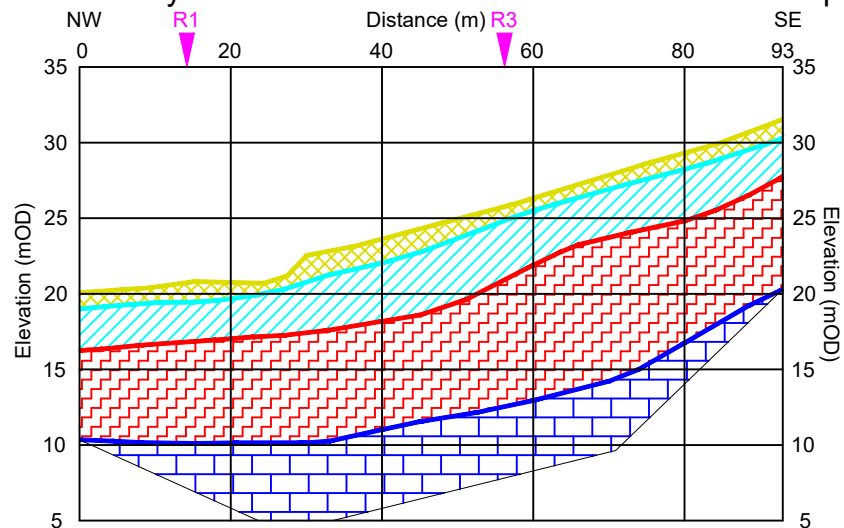
2D-Resistivity Line R2 and Seismic Refraction Line S2 Interpretation

- Ground Surface/Top of Layer 1 (200 - 300 m/s)
- Top of Layer 2 (1600 m/s)
- Top of Layer 3 (2400 m/s)
- Top of Layer 4 (4500 m/s)
