**Lands at Halverstown**

**Ground Investigation &  
Geotechnical  
Interpretative Report**

**Project No. 24330**

**July 2023**

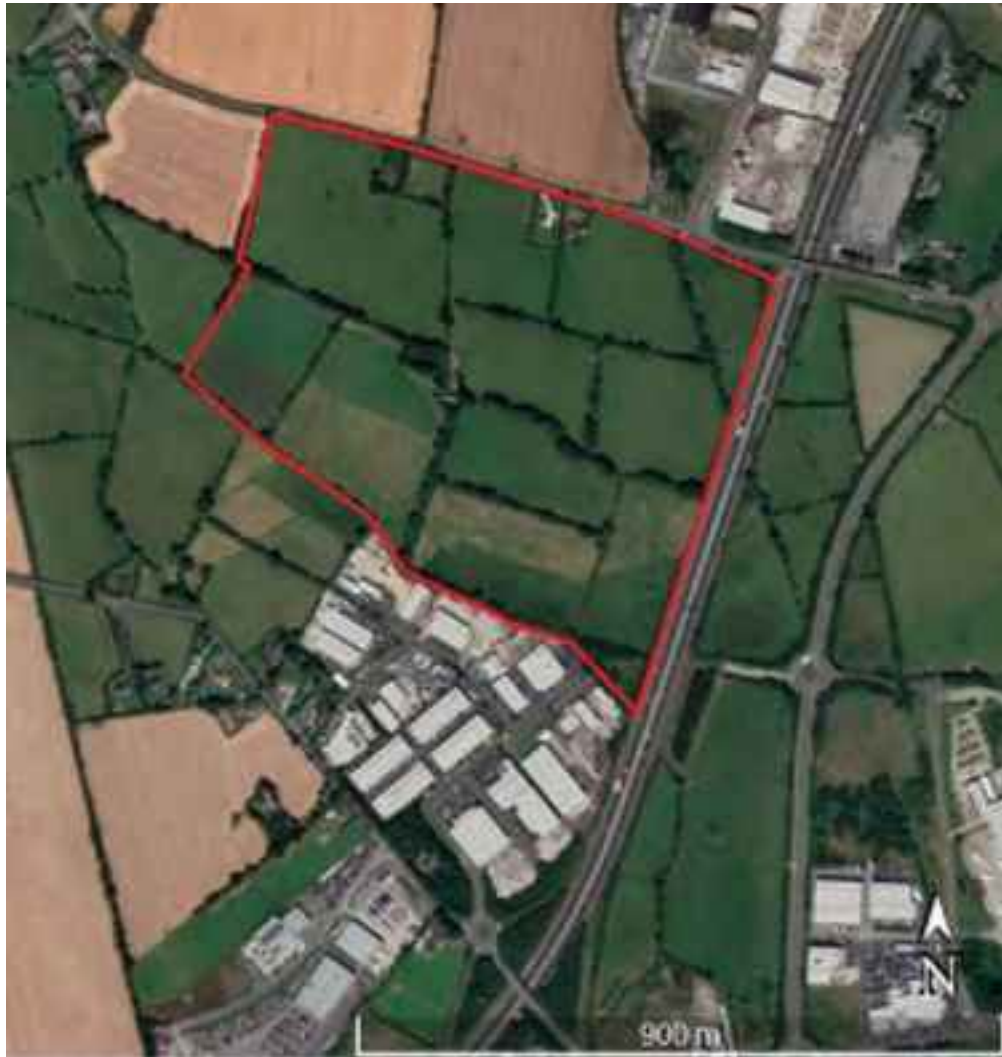
Retrieved from Google Earth Professional 08/2022

Two high voltage transmission lines run across the property with a three-phase line also running north-south through the farm. The site is relatively flat lying, falling towards a stream which forms the southern boundary. Levels range from 85m OD in the northwest to 77.6m OD in the southeast. Intrusive investigation locations were set out as per the J&L Surveys Limited drawing entitled "Lands at Halverstown, Naas, Co. Kildare." Micro-siting was performed where proposed locations were found to lie too close to tress, field boundaries / ditches or in proximity to the hazard zone of overhead power lines. ESB Networks HV Transmission overseers were contacted ahead of works

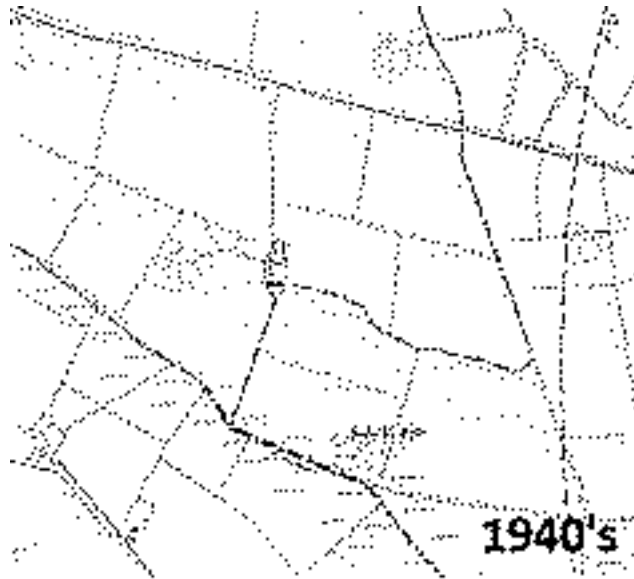
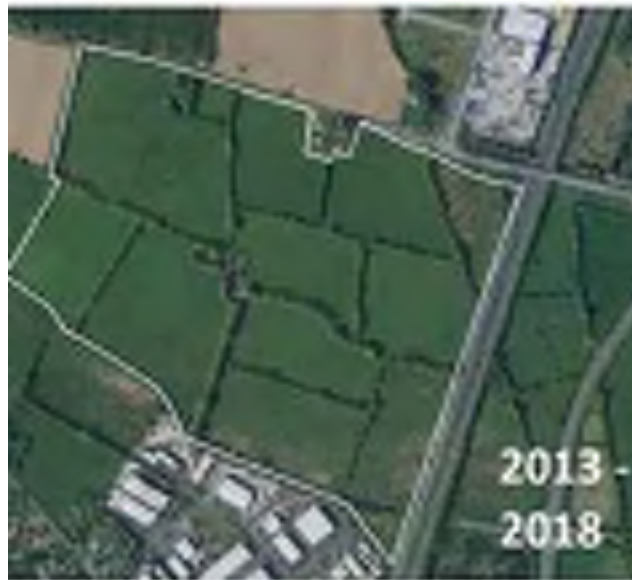
**Figure 2A & 2B – ca. 1940's OSI drawing for the Halverstown site and Modern (2013-2018) orthophotograph**

From the 2013-2018 aerial image (Fig 2B), some of the lower lying areas can be identified as they are covered in tussocky grasses which appear light brown in colour. The areas are located towards

the southern fringe of the site and in the northeastern triangular-shaped field. The construction in 1983 of the adjacent motorway, then the Naas Motorway Bypass, bisected the farmland. Truncated hedgelines can be identified in the landscape to this day both east and west of the motorway.

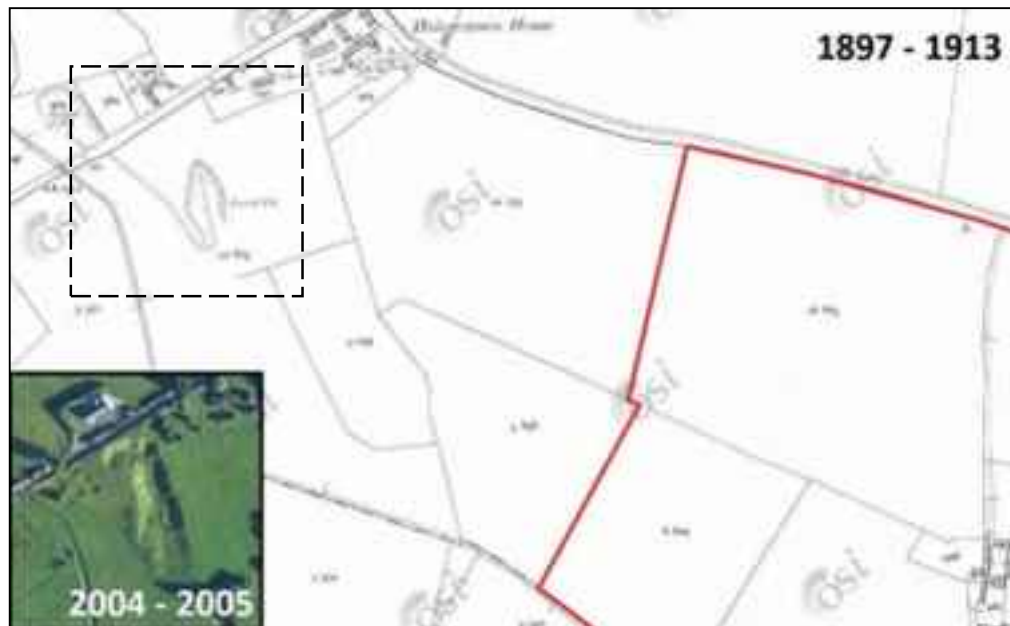
**Figure 3 – OSI 1897-1913 survey with 2004-2005 inset showing former extraction pits or 'Gravel Pit' at Halverstown, 350m west of the site. Dashed section equals approximate area shown in 2004-2005 orthophotograph.**

The OSI drawing dated 1897-1913 (Figure 3) shows the presence of a series of NW-SE trending 'Gravel Pit' open pits located ca. 350m west of the site (site outlined in red). The scar on the landscape can be viewed clearly in the OSI 2004-2005 aerial image. The western site boundary is lined in red.

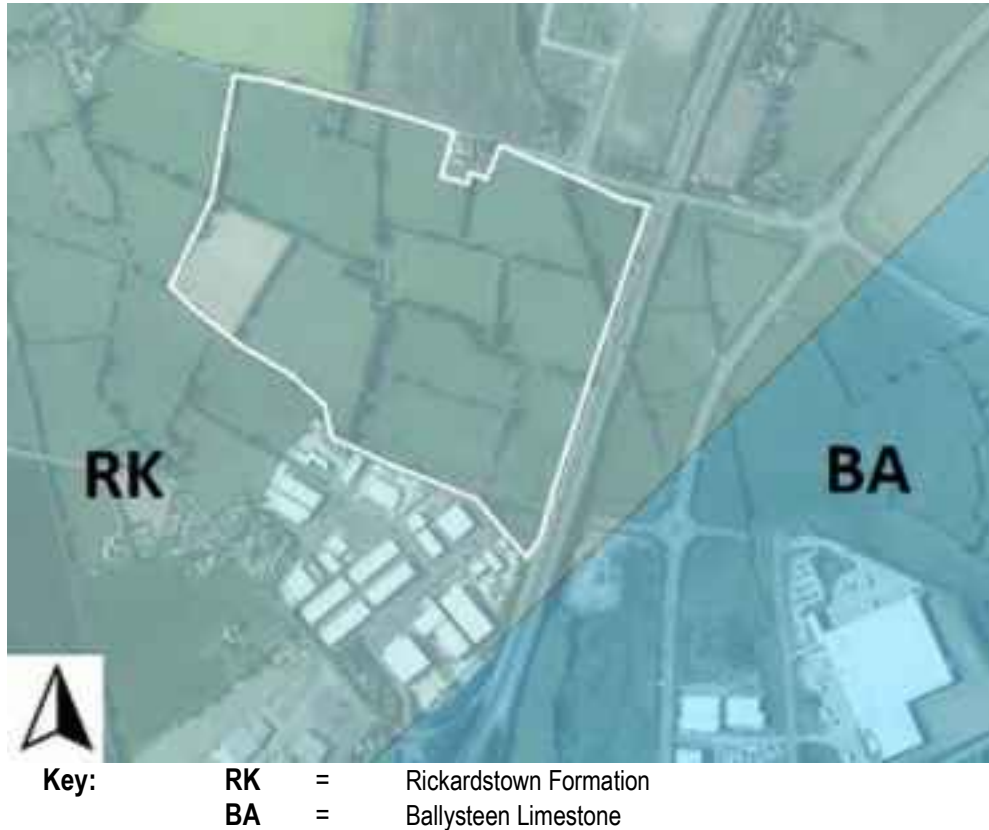
**Figure 5 - Bedrock Geological Map for the Halverstown Site** (retrieved from GSI website)

Reference to the GSI map for the area (Figure 5, 1:100,000 Solid Geology series) shows that the site is underlain by the Carboniferous, Viséan-aged Rickardstown Formation. The rock formation consists of cherty often dolomitised limestone. No outcrops were found on site. Rotary drilling was carried out at five locations and proved a variably weak to strong limestone bedrock described as thickly to thinly bedded, pale to mid bluish grey fine-grained LIMESTONE. Crystalline calcite was unearthed at depth in coreholes RC01 and RC01A.

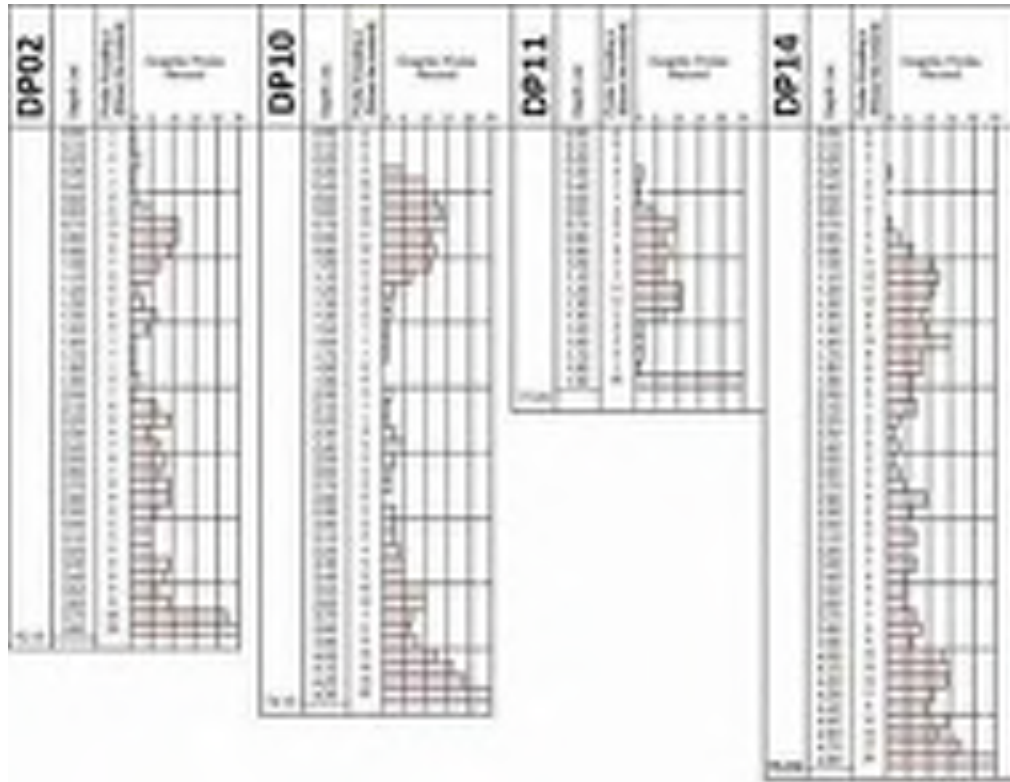
**Figure 7 - Mixed probe results in southern fields at Area 1**

- The occurrence of sand intervals within mixed firm and stiff fines and gravelly strata can generate an inconsistent  $N_{100}$  profile. Figure 7 demonstrates the passage of high  $N_{100}$

values passing abruptly into low values and vice versa. This is attributed to the sand pockets and lenses found in the mixed fluvio-glacial deposit.

- In proximity to DP10, TP/RO09 reports the presence of a very sandy GRAVEL overlying a grey slightly gravelly silty SAND from 1.0m (76.31m OD). It extends to the pit base at 2.80m depth (73.11m OD). This tallies well with the high blowcounts initially recorded in DP10 followed by the low blowcounts from 1.40m (77.13m OD) to ca. 2.80m (75.73m OD). However, equally, BRE SA04 shows the existence of an upper GRAVEL layer (0.30-1.20m) underlain by a soft to firm dark grey slightly sandy very gravelly CLAY. This sequencing also appears plausible when viewing the pattern of the probe blowcounts in DP10.

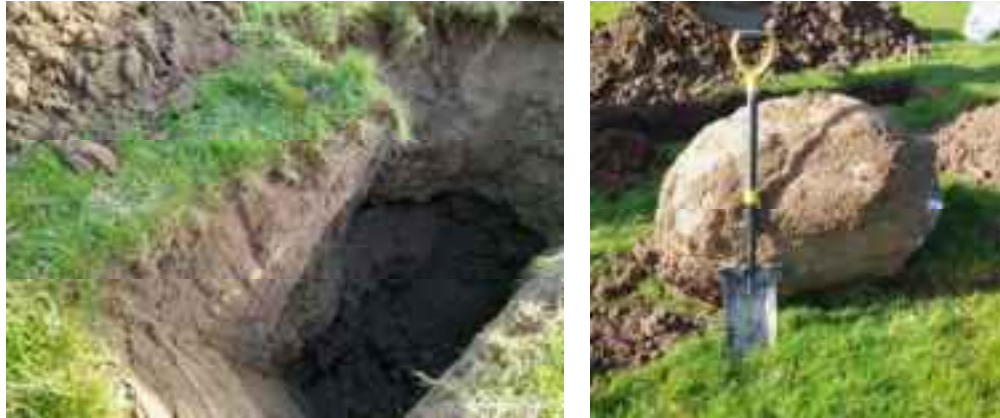
**Figure 8A & 8B – Sidewall photo of TP05 showing SILT over dense GRAVEL at 2.0m (78.91m OD). Boulder found in pit at 1.80m measuring 1200mm.**

- Cases of large diameter, rounded boulders occurring in pits were common, some of which were up to 1200mm (TP05 at 1.80m bgl) (Figure 8B)
- SPT's were undertaken in boreholes BH01-BH04 in the southern part of 'Area 1'. A plot showing the scatter of N values achieved versus depth is presented in Figure 9. It illustrates the presence of generally firm soils at 1.0m, passing to stiff from 2.0m depth.

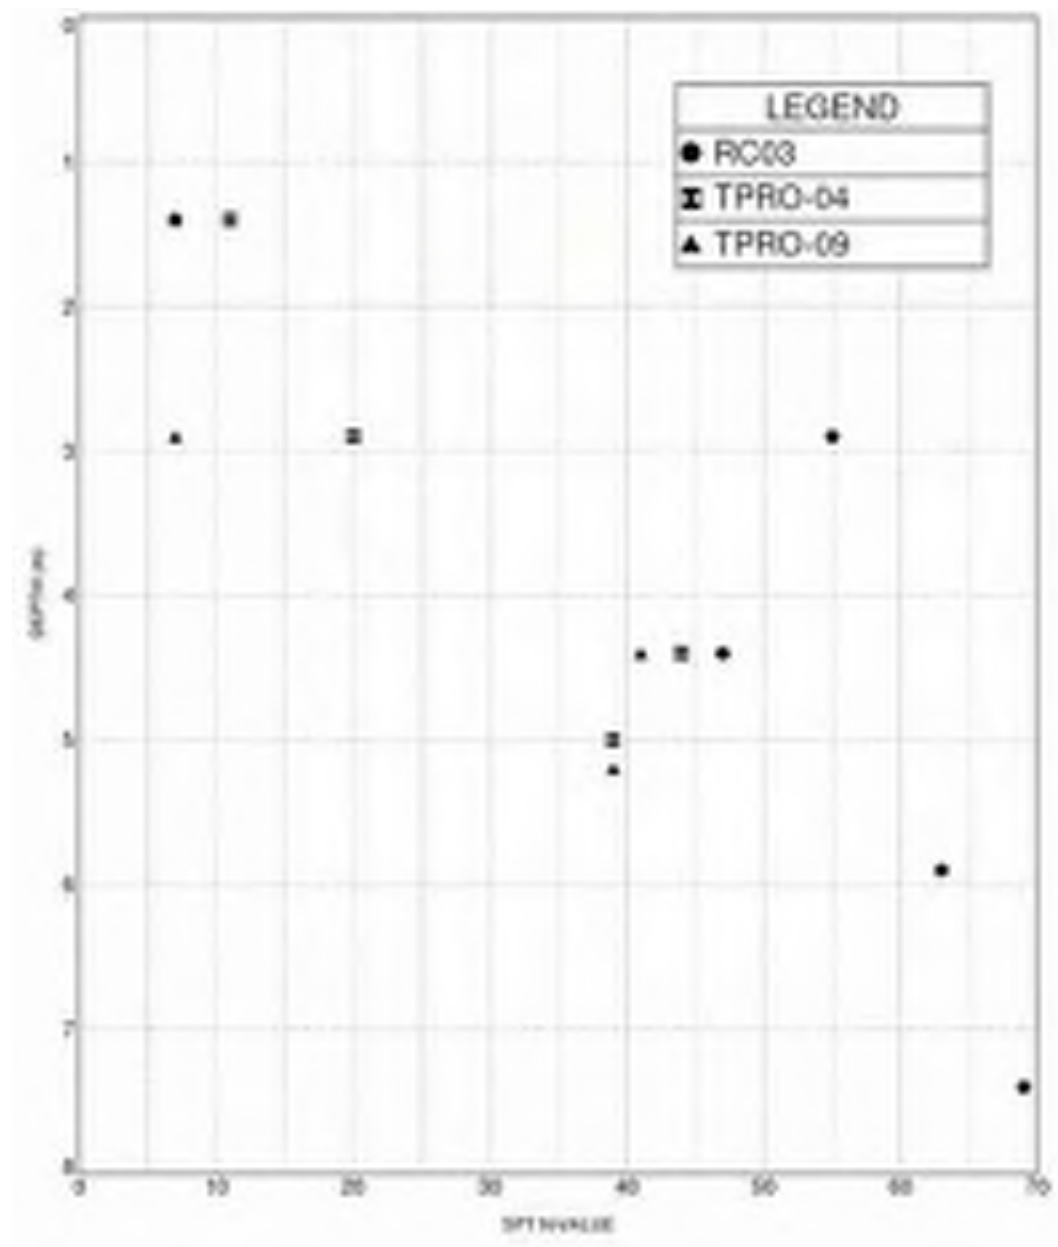
**Figure 10 – SPT Vs Depth plot for TPRO-04, TPRO-09 & RC03**

- Limestone bedrock was cored in RC03 from a depth of 8.80m bgl (70.57m OD). The drillhole reported initially loose (N=7 at 1.50m) becoming dense grey brown sandy silty/clayey GRAVEL.

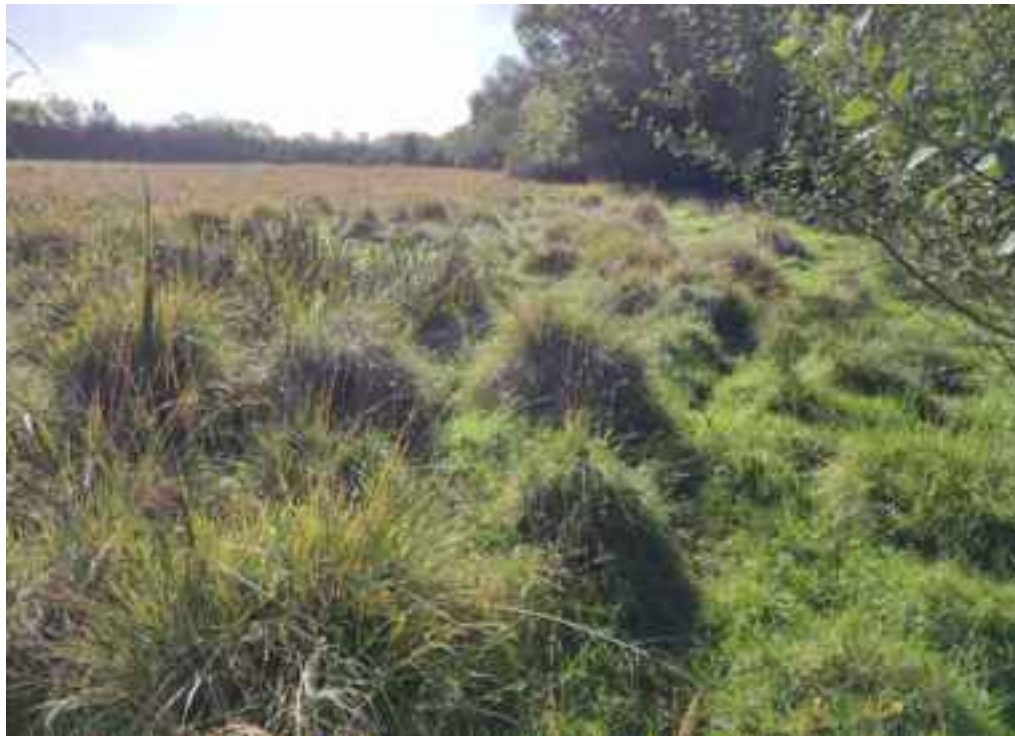
**Figure 11 – Tussock grasses in triangular-shaped field to east of Area 2. View SE.**

- Topsoil ranges in thickness from 0.20m to 0.50m across the area, thinning towards the east in the low-lying field adjacent to the motorway (Figure 11). It was noted that up to 0.50m of topsoil was present in TP28.

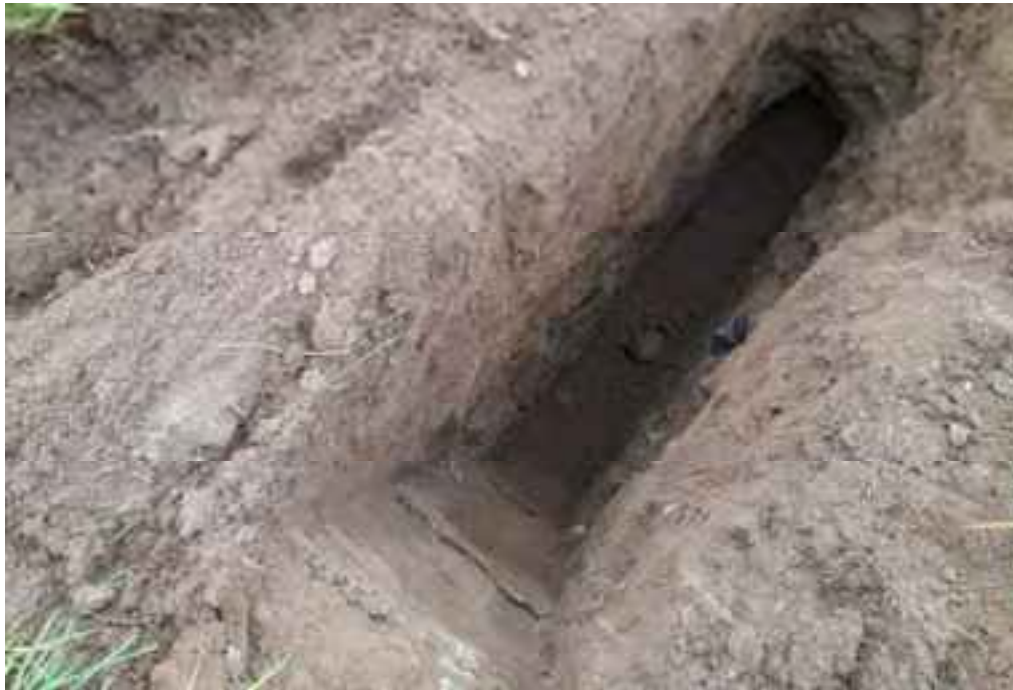
**Figure 12 – Sandy stratum from 1.20-2.40m in TP25**

- A band of buried sand was flagged in both TP25 and in BRE06 / SATP06. From 1.20m (84.16m OD) to 2.40m (82.96m OD) in TP25, a greyish brown gravelly clayey SAND with cobbles and occasional boulders was recorded (Figure 10). In nearby SATP06, a grey brown gravelly silty SAND with cobbles was logged from 1.20m (82.25m OD) to a pit end depth of 2.0m (81.45m OD). Probes did not extend deep enough to penetrate this layer. However, given the stability viewed in sidewalls, and the reported stiffness of adjacent layers, it is likely to be dense / medium dense. The log for BRE12 / SATP12 also notes the presence of grey brown gravelly silty SAND from 1.20m (83.12m OD) to the pit base at 2.20m (82.12m OD).

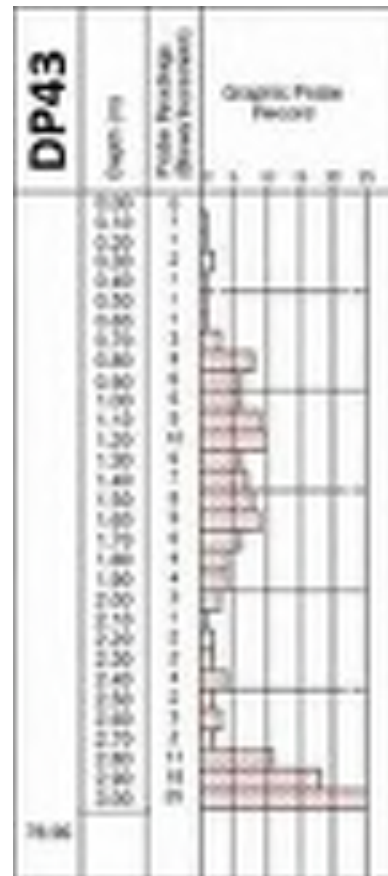
Figure 13 – Probe results for DP43

- Trial pit TP/RO07 intercepted a layer of soft to firm light brown sandy very gravelly CLAY from 1.80m (81.06m OD) to 2.50m (80.36m OD). Two seepages were encountered in this stratum. Potential water-softening may be accountable for the low blowcounts registered in nearby DP43 (Figure 13). The marked increase in blowcounts from 2.80m (79.26m OD) likely hints to a basal dense GRAVEL as found in TP/RO07 from 2.50m (80.36m OD) to the pit base at 3.30m (79.56m OD).

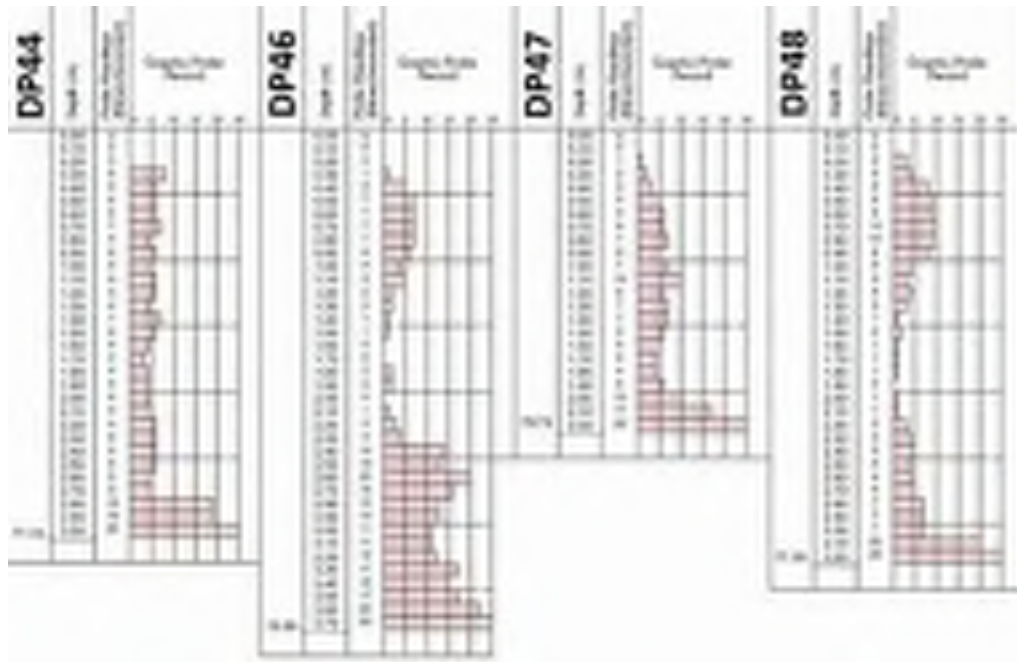
**Figure 14 - Mixed probe results in the triangular field in Area 2**

- The resulting blowcounts from probes DP44, DP46-48 are shown in Figure 14. Both probe DP46 and probe DP48 show low (0 and 1)  $N_{100}$  values from ca. 1.50m to 2.0m. The pit nearby, BRE09 / SATP09, shows the presence of grey brown gravelly silty SAND from 0.80m to 1.80m. This stratum, it is thought, is responsible for the low to freefall drop in respective probe drives DP46 and DP48.

- Neither DP44 nor DP47 show any fluctuation in  $N_{100}$  blowcount to depths of 3.10m and 2.30m. The  $N_{100}$  values are remarkably consistent throughout each probe drive suggestive of an homogeneous stiff soil stratigraphy.

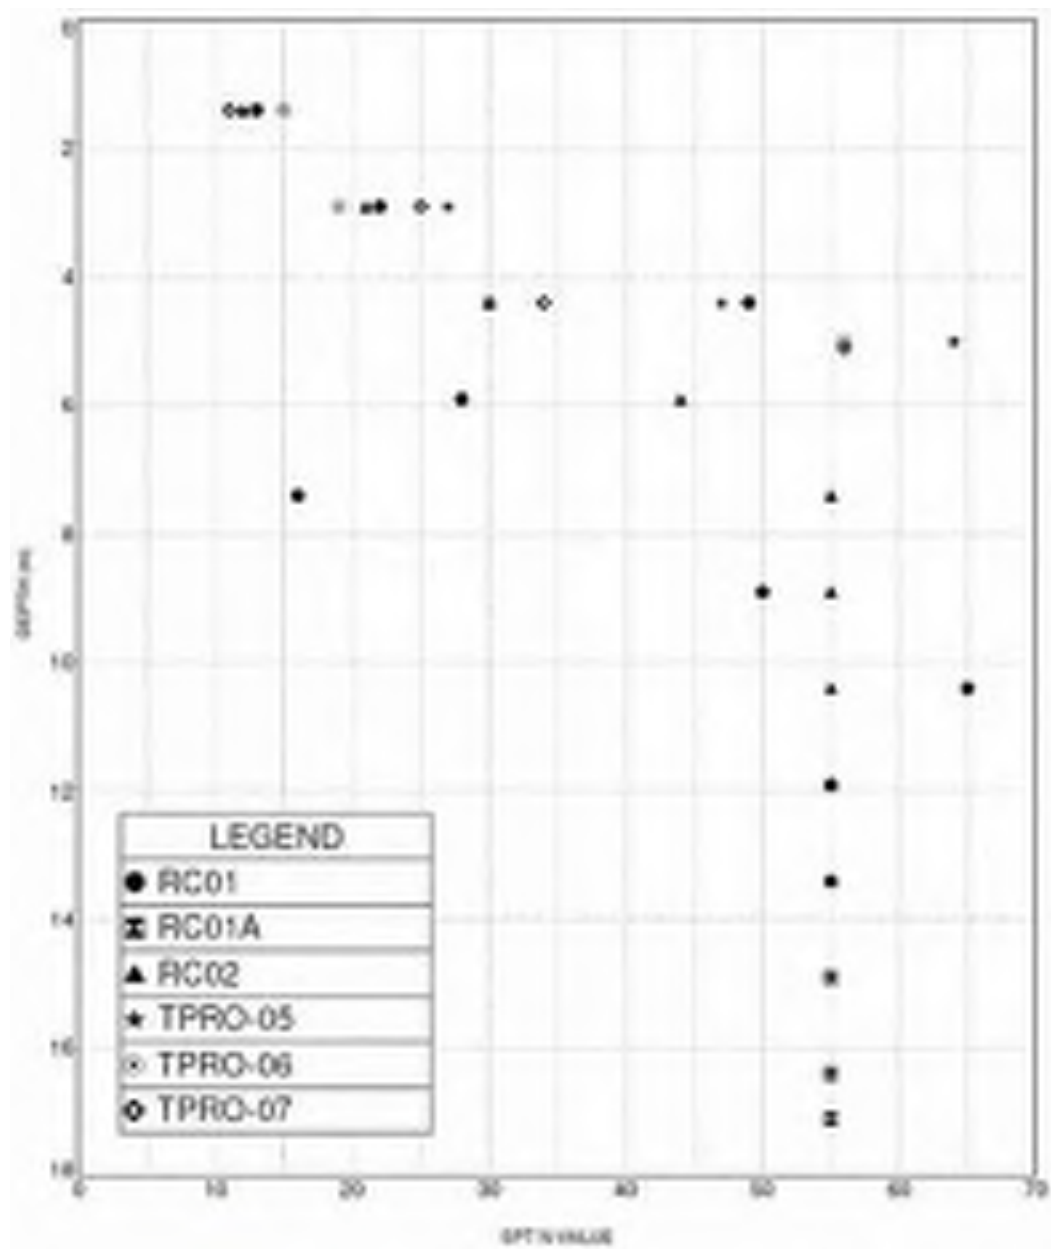
Figure 16 – SPT Vs Depth plot for TPRO-05, TPRO-06, TPRO-07 &amp; RC01 / 01A &amp; RC02

depth, albeit only achieving probe depths between 1.10m and 1.70m prior to refusal. Equally, the SPT plot for the tests undertaken in the drillholes in the area reflect the firm nature of the soils from 1.50m (Figure 16).

Additional investigation in 2023 at 'Building 1' involved the construction of two rotary coreholes, a rotary open-hole and a trial pit. The rotary holes each unearthed a sequence of initially firm soil passing to progressively stiff to very stiff / dense soils from 3.0m (based on SPT data – see Figure 16). TP/RO05, excavated in the central area of proposed 'Building 1' reported firm CLAY to 3.60m with an intervening water-bearing gravel horizon from 1.50-2.90m bgl. The gravel layer, deemed dense on the basis of probe blowcounts, is thought to be the reason for shallow termination in nearby probes DP37, 38 & 39. Rotary open-hole drilling also highlighted the presence of the gravel layer (from 1.60-2.0m) and showed (by SPT blowcounts) the underlying CLAY to be stiff, becoming very stiff. Gravel was again intercepted at depth (from 4.60m to 5.0m). The rotary coreholes both suggest stiff and very stiff soils extend to depth with some medium dense gravel interbeds (ca. 7.50 – 9.0m bgl). Rock was reported at depths ranging ca. 14.80m to 17.10m bgl. Should larger loadings be

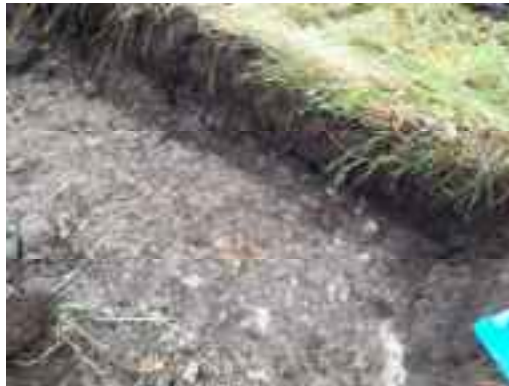
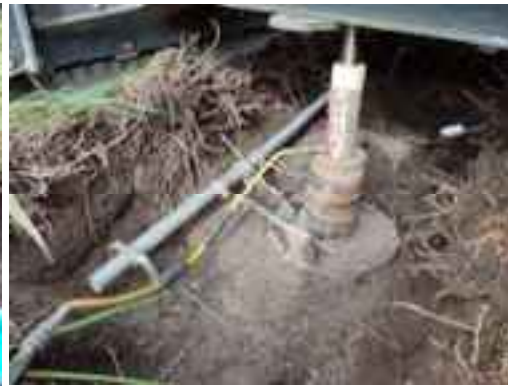
**Figures 17A & 17B – Upper organic soils in PB04 & PB05**

- Topsoil ranges in thickness from 0.15m to 0.40m. The normally soft brown slightly gravelly sandy silty CLAY topsoil gives way to a darker peaty CLAY nearing the southernmost stream as evidenced in the trenches excavated for plate test PB04 (Figure 17A) and PB05 (Figure 17B). At PB05, the upper organic soil was underlain by stiff grey sandy gravelly CLAY.

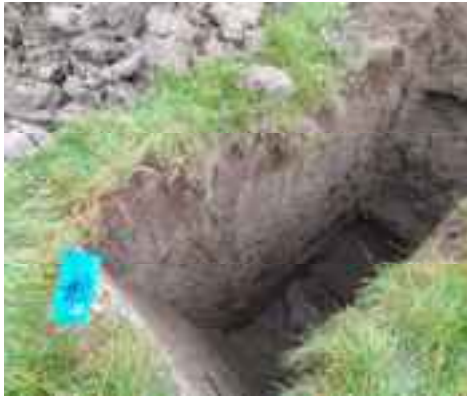
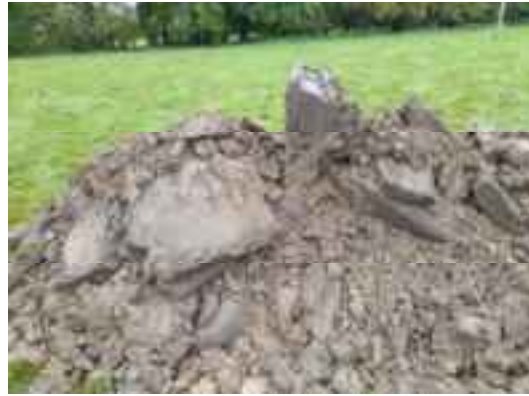
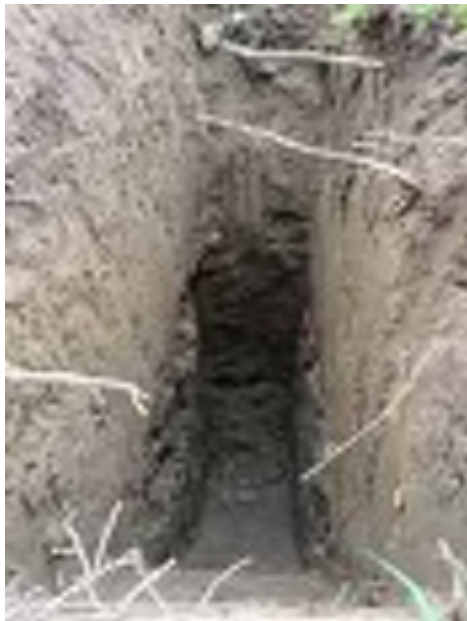
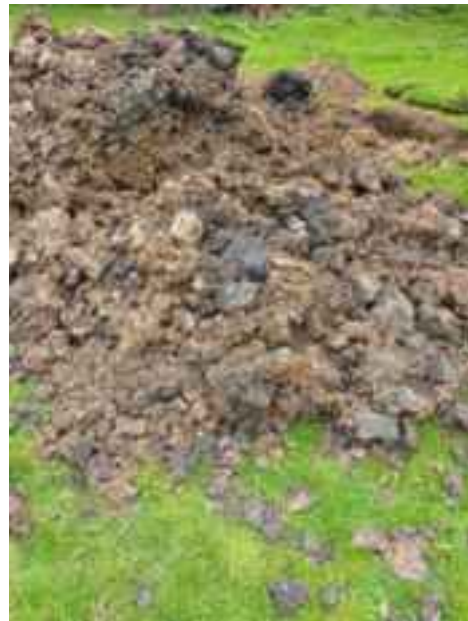
- Mirroring the high strength soils found in both TP12 and in BH05, dynamic probe DP20 achieved only 1.0m before refusal. DP19 also reported high  $N_{100}$  values in the upper 2.0m. However, in DP19 a notable 800mm long sequence of  $N_{100}=0$  blowcounts was logged from 2.30m to 3.10m bgl. This is considered to be a pocket of uniform SAND or CLAY/SILT offering little in the way of resistance to the driven probe. It is not thought to be a soft to very soft soil - the assumption is based on the generally high strength, consolidated nature of the soils both above and below the same stratum in addition to the visual observation made in nearby TP13 where a 'firm slightly sandy gravelly silty CLAY' was logged from 2.40m to 2.70m (See Figure 19A & 19B).

- The high strength lower till is also intercepted in both rotary open-hole TPRO-08 and TPRO-10 with SPT refusals from 3.0m depth. Trial pits TP/RO08 and TP/RO10 both show stiff to very stiff dark brown sandy very gravelly CLAY from 2.90m (78.50m OD) and 2.70m (74.57m OD). At 1.50m, SPT N-values suggest the presence of firm soils.

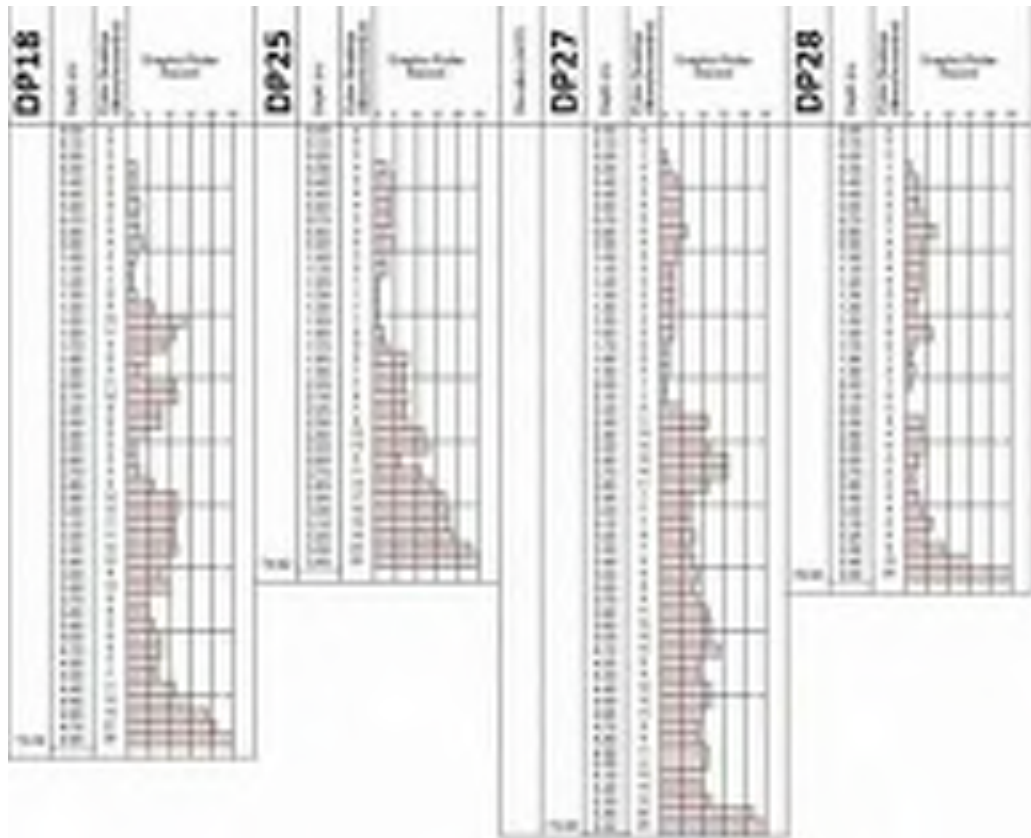
**Figure 20 – Probe blowcounts in dynamic probes DP18, DP25, DP27 and DP28 in the southern section of ‘Area 3’**

- Overall, the  $N_{100}$  values viewed in DP18 show no coherent pattern of strengthening or densifying deposits with depth in the upper three metres. This may highlight the locally changeable till composition and consistency as well as possible cobble / clast content which may cause obstructions locally.

- Towards the central / southern part of the site, probes DP18, DP25, DP27 and DP28 combined with the findings of borehole BH07 (from 0.50m to 1.70m), signal a decrease in strength in the uppermost soil layer. Probes extended to significant depth locally (5.60m at DP27 – Figure 15) and suggest collectively that the upper 1.50m to 2.0m comprises a mix of firm and firm/stiff or medium dense soils. Based on blowcounts, there appears to be a discrete stratum of possible soft and soft to firm soil / loose fine sand from 1.10m-1.30m in DP18, 1.20-1.60m in DP25, 2.0m to 2.20m in DP27 and 2.0 to 2.30m in DP28 (See Figure 20). Lenses of fine sand were observed in nearby TP17 from 1.10 to 1.30m with very sandy SILT to 2.0m bgl. These lenses may account for the localised low blowcounts.

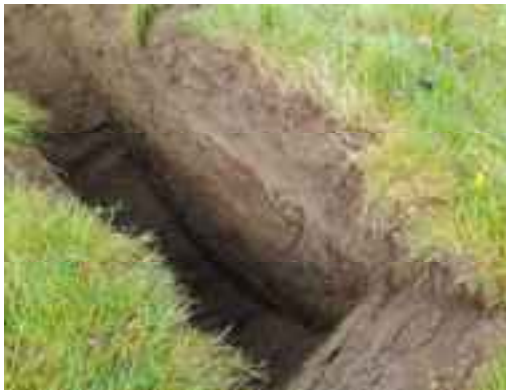
**Fig 21A**

**Figure 21A & 21B – Sidewalls in trial pits located in Area 3. Fig 21A** Sidewall in TP20 showing firm and firm to stiff clayey SILT and silty CLAY to 2.60m. A firm occasionally soft to firm blackish grey clayey SILT was logged from 2.60m to 3.0m (76.78m OD) **Fig 21B** Sidewall collapse in BRE SA05. Water sitting at 1.70m bgl.

- Probes to the northeastern extent of 'Area 3' show a marked consistency in blowcounts from ground level to, in the case of DP29, 5.20m. Soils are clearly stiff and dense in probes DP29 and DP30 and do not show any loose / soft intervals. Both probes DP31 and DP32 terminated on shallow, apparently progressively stiff to very stiff / dense soils. In the base of nearby pit TP20, the soils were remarked as 'firm, occasionally soft to firm'. In any case, the vertical pit sidewalls appear stable to 3.0m (76.78m OD) depth (Figure 16A).

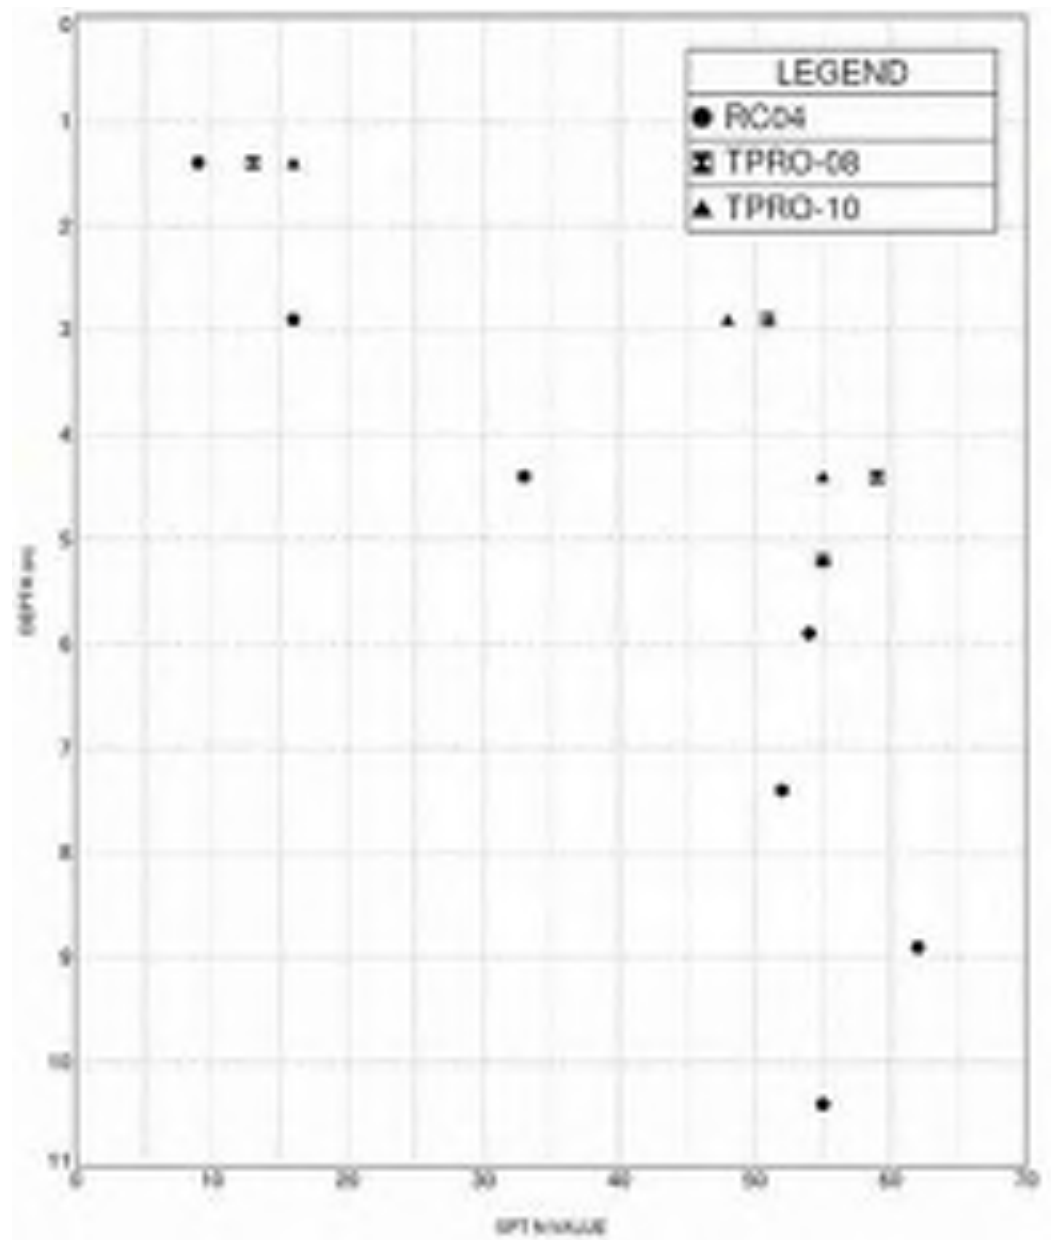
Figure 22 – SPT Vs Depth plot for TPRO-08, TPRO-10 &amp; RC04

- Supplementary pitting at TP/RO10 (near DP28) did encounter a soft to firm grey brown sandy very gravelly CLAY with “frequent pockets of sand” from 1.0m to 1.80m (76.27-75.47m OD). This aligns well with the findings in DP28 and nearby probes where the upper strata generated often mixed  $N_{100}$  blowcounts. No other soil softening was noted in TP/RO10 in what was otherwise a pit comprising firm and stiff CLAY. No SPT results suggestive of soft soils were generated in either TPRO-08 or TPRO-10 (See Figure 22).

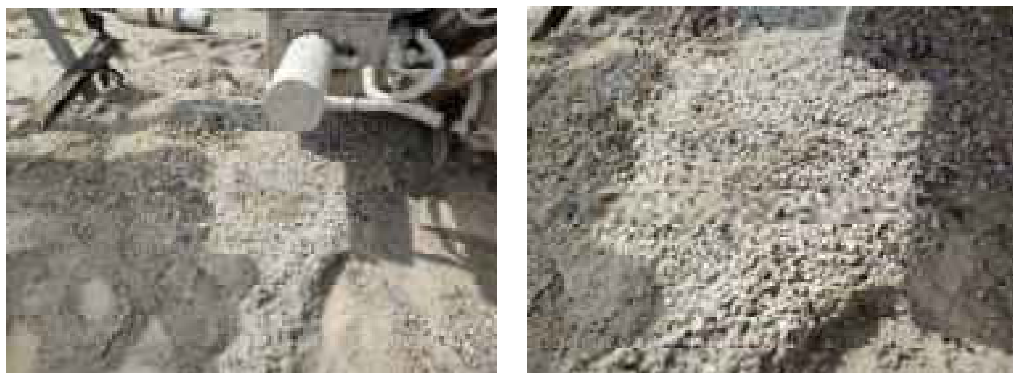
**Figure 25 – Pulverised returns at the surface following open-hole drilling through crystalline calcite at RC01**

Recovered cores in RC02, RC03 and RC04 were logged as slightly weathered, thickly to thinly bedded, light blue grey, fine-grained LIMESTONE with localised dolomitization. A stromatolitic structure was evident in the cores as well as abundant calcite veining (Figure 24). RC04 displayed more visibly interbedded calcisiltite and argillaceous layers. In the case of RC01 and RC01A, no competent bedrock was met. Instead, the recovered cores (RC01A) returned a clay / calcite crystal mix from 17.30 – 18.70m. Given the un lithified, brittle crystalline structure of the calcite, open-hole techniques were deployed in both RC01 and RC01A. SPT testing was undertaken to provide further detail on density of the calcite veinfill. Arisings from the drilling at RC01 were photographed on the ground following drilling (Figure 25).

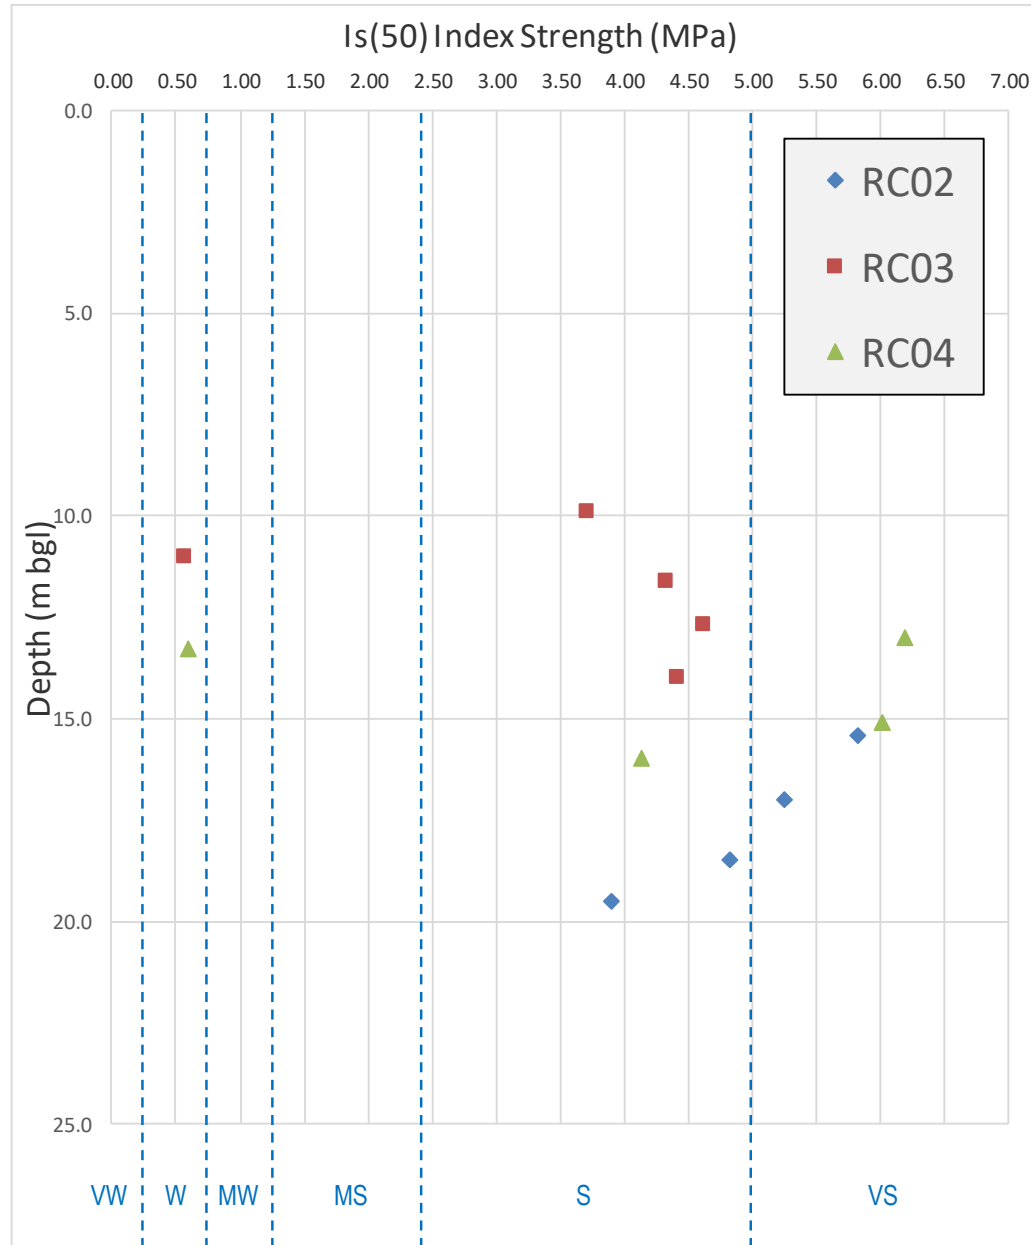
**Figure 26 –  $I_s(50)$  strengths obtained from diametrial Point Load Strength Index testing**

The point load strength index (PLSI) test data produced  $I_s(50)$  values ranging from 0.57 to 6.20 MPa, with a mean value of 4.19 MPa. The strengths when plotted show a broad scatter but are chiefly placed in the centre of the PLSI chart (Figure 26), corroborating the largely medium strong strengths recorded in core logging.

VW = Very Weak, W = Weak, MW = Moderately Weak, MS = Medium Strong, S = Strong, VS = Very Strong (ISO 14689:2017 (E))

Using a correlation factor (K) of 20 to assess compressive strength, this suggests a characteristic strength envelope in the order of 11 to 124 MPa and categorizes the bedrock as weak (5 to 12.5 MPa) to very strong (100 to 250 MPa). The visual strength descriptors determined during engineering geological logging marry well with the overall plot scatter in Figure 26.

ISO 14689:2017 (E) rock strength parameters are drawn on Figure 26 to allow correlation between UCS and Point Load Strength tests. A correlation factor (K) of 20 was used to plot the ISO 14689:2017 (E) MPa strength divisions on the Point Load strength ( $I_s(50)$ ) plot.

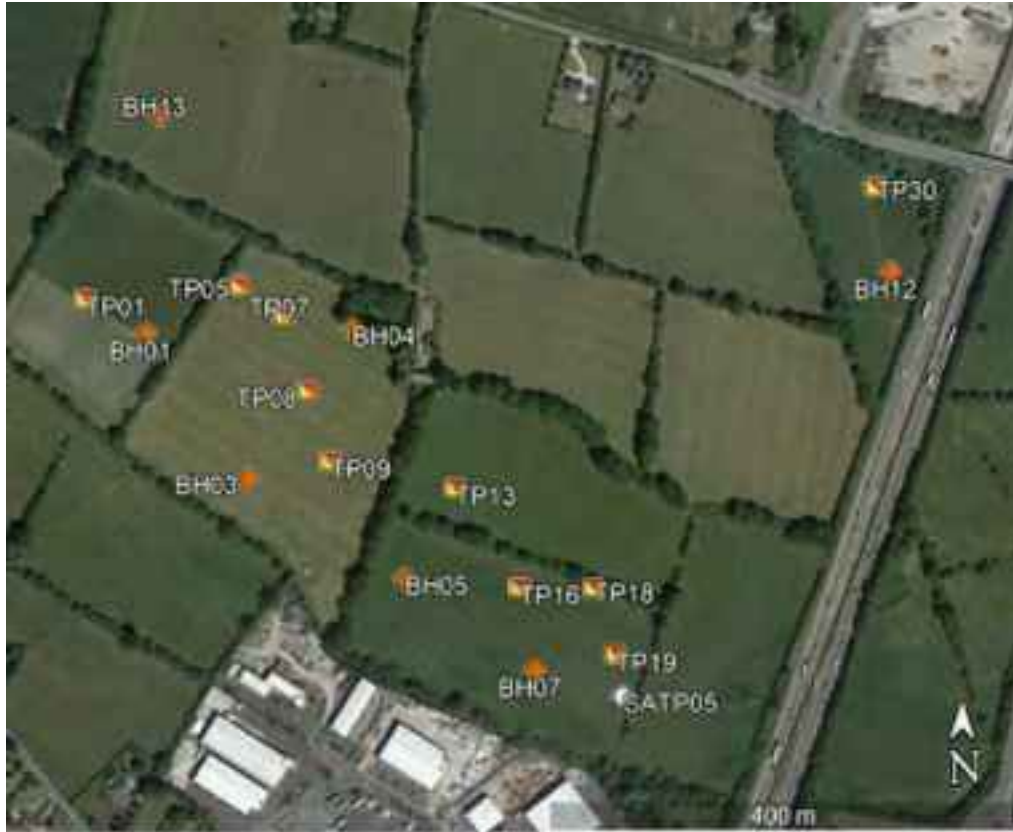
**Figure 27 – Trial pits and boreholes where groundwater entry was recorded (initial 2022 phase of investigation)**

Water strikes (seepage, slow and moderate inflows) were intercepted during shallow trial pit excavation, with groundwater also struck during borehole construction at BH01, BH02, BH04 and BH12. A well installed in BH13 later reported water only to be dipped dry in July 2023. With the exception of TP30 and BH12 in the northeast, during the 2022 phase of investigation, shallow groundwater was found exclusively towards the south of the site, near the stream boundary (See holes identified on Figure 27 & Table 4).

During the 2022 investigation, for the most part the groundwater entries were reported as seepages in trial pits, frequently in gravel horizons at the base of trial pits at ca. 3.0m. Instability and sidewall collapse generally accompanied the entry of water into open pits. Figure 27 shows the individual exploratory hole locations where water strikes were encountered (2022). There is a pattern across the site which follows, for the most part, the occurrence of buried Gravel and Sand at depth (at ca. 2.50-3.0m).

Both DP19 and DP28 are placed spatially in a linear trend where waterstrikes were encountered in both trial pits and boreholes (See Figure 27). If this were the case, this would imply the presence of water saturated, likely granular soils at depth and this may correspond to the low  $N_{100}$  interval.

A plan of the pits and boreholes where water strikes were encountered during the 2022 investigation is shown in Figure 27. The influence local topography has on the occurrence of groundwater strikes is clearly demonstrated in 'Area 3'. Strikes were intercepted generally in buried sandy GRAVEL soils at depths in the region 2.0m bgl in the trial pits and from 2.0m to 3.0m in boreholes. In boreholes, it was frequently noted that after a twenty-minute observation period, the strikes rose appreciably.

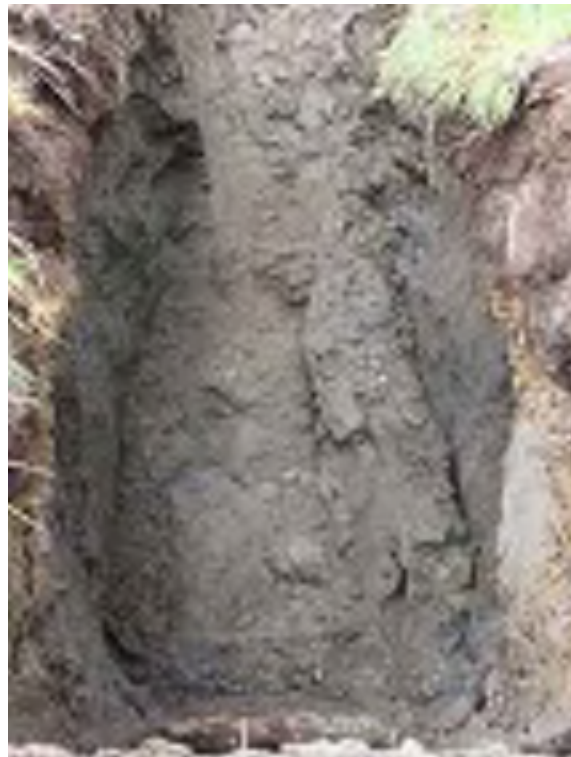
**Figure 28** – Sidewall collapse in grey silty SAND upon completion of TP/RO09 excavation.

Within the fields to the south of 'Area 1', trial pits again encountered water strikes, save for TP/RO09 which remained dry to its base at 2.80m (74.51m OD). It may be the case that the pit did not remain open for a period long enough to allow groundwater equilibrate. Nearby, rotary open-hole TPRO-09 reported 'blowing sands' from 1.20-4.20m with a water strike encountered at 4.0m bgl. For sands to 'blow' in the casing, there must be water present to allow for sand solifluction to occur. It is deemed therefore that the sands observed were likely water saturated. Collapse during trial pit excavation suggests water-laden silty sands were present (Figure 28).

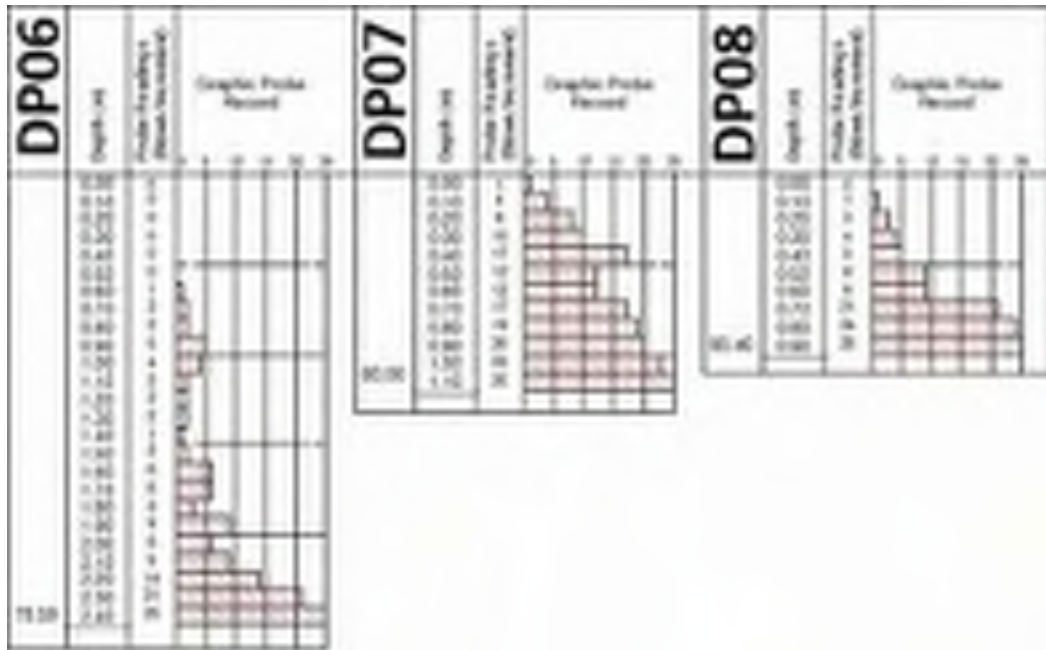
**Figure 30 – Probes positioned in NW corner of DC Building 3**

Geotechnical inconsistencies are once again present when the findings of the intrusive holes over the 'Building 3' footprint are considered. These are illustrated most succinctly in the blowcount pattern recovered from probes DP06, DP07 and DP08. Shallow obstructions were recorded in both DP07 and DP08 but low  $N_{100}$  blowcounts were obtained in DP06 to a depth of ca. 1.50m (Figure 30). Nearby TP02 reported firm sandy gravelly cobbly SILT to ca. 3.0m. The only deviation from this was the occurrence of a brownish grey gravelly clayey SAND from 0.80m to 1.0m. This may be the cause of the low blowcounts in DP06 to ca. 1.50m.
