**Lands at Halverstown**

**Ground Investigation &  
Geotechnical  
Interpretative Report**

**Project No. 24330**

**July 2023**

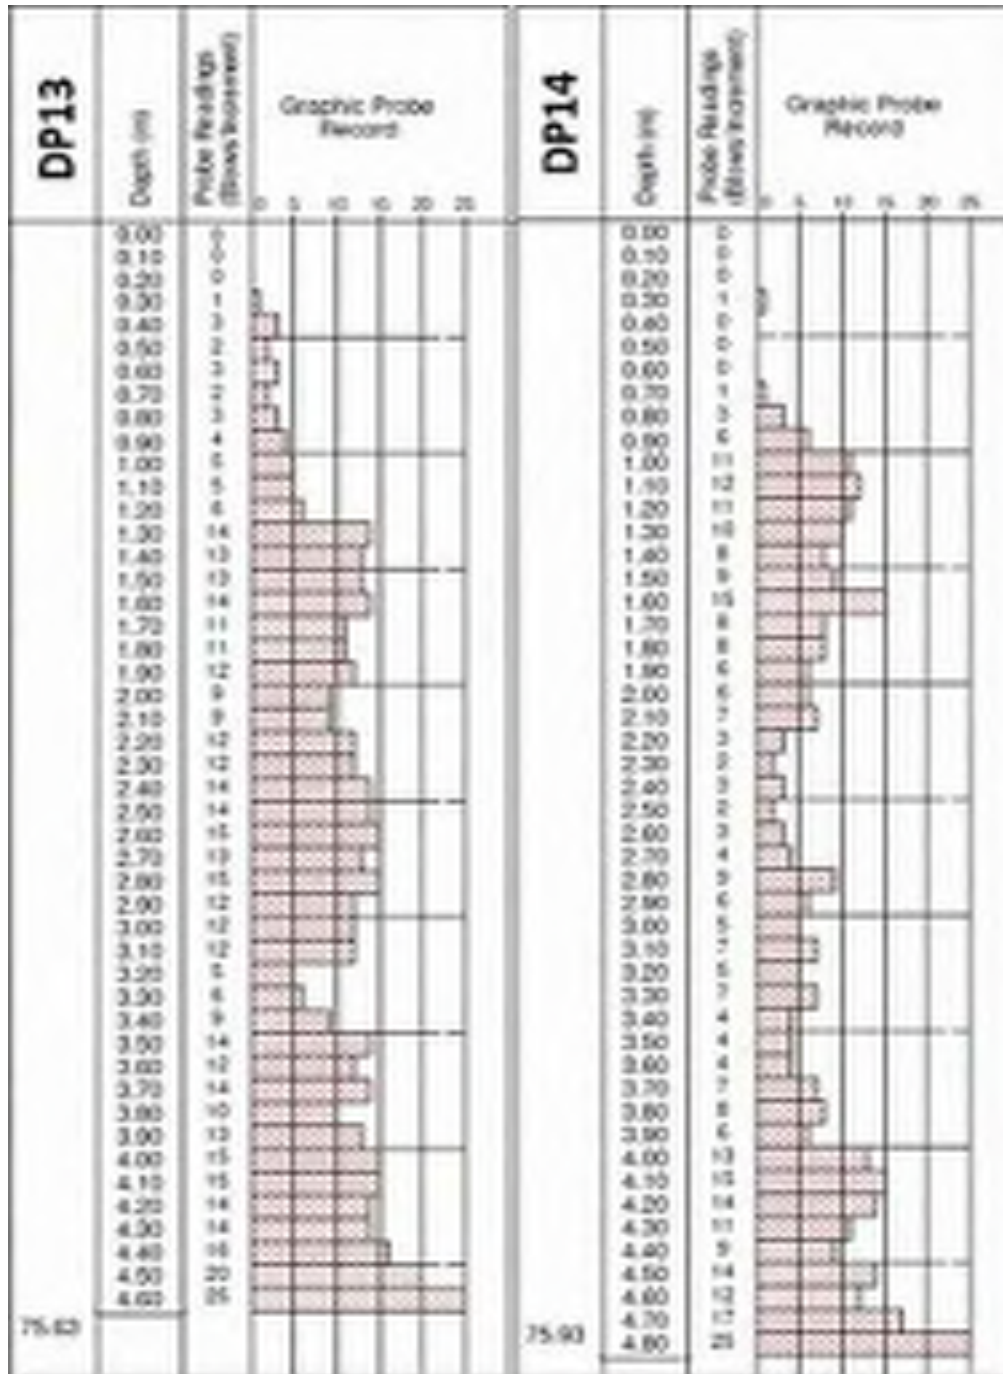
Figure 31 – DP13 & DP14 profiles - both located towards the southeast of Building 4

Aside from probes DP13 and DP14 located to the southeast of the proposed footprint, all other probes terminated at shallow levels generally shy of 1.60m bgl. These shallow refusals are thought attributable to increasing clast / gravel content in the till. The two probes which extended to depth (4.70m and 4.90m respectively) do not show an overly similar pattern in blowcounts (Figure 31). Given that locally pits reported the entry of gravel at depths between 2.0 to 2.30m bgl, the inconsistencies between probe  $N_{100}$  values are thought due to the heterogeneity of the gravel at depth interspersed occasionally with finer sand lenses. In contrast to SPT N values, probes DP13 and DP14 suggest dense / stiff soils from ca. 1.20m.

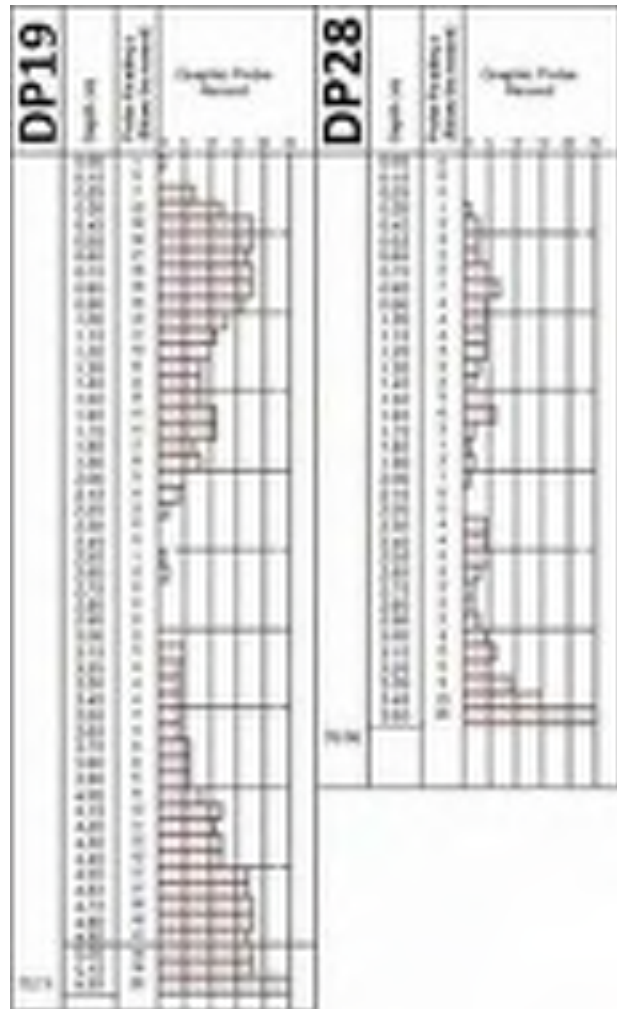
**Figure 32 – DP19 and DP28 profiles**

A number of probes extended to depths ranging ca. 3.50 – 5.20m bgl at this area. In these probes, an array of  $N_{100}$  patterns exist. Some show steady increase in blowcounts with depth, ie., DP21, whilst others suggest the presence of deeply buried, potential soft / low strength zones, ie., DP19 & DP28 (Figure 32).

Both DP19 and DP28 are placed spatially in a linear trend where waterstrikes were encountered in both trial pits and boreholes (See Figure 27). If this were the case, this would imply the presence of water saturated, likely granular soils at depth and this may correspond to the low  $N_{100}$  interval.

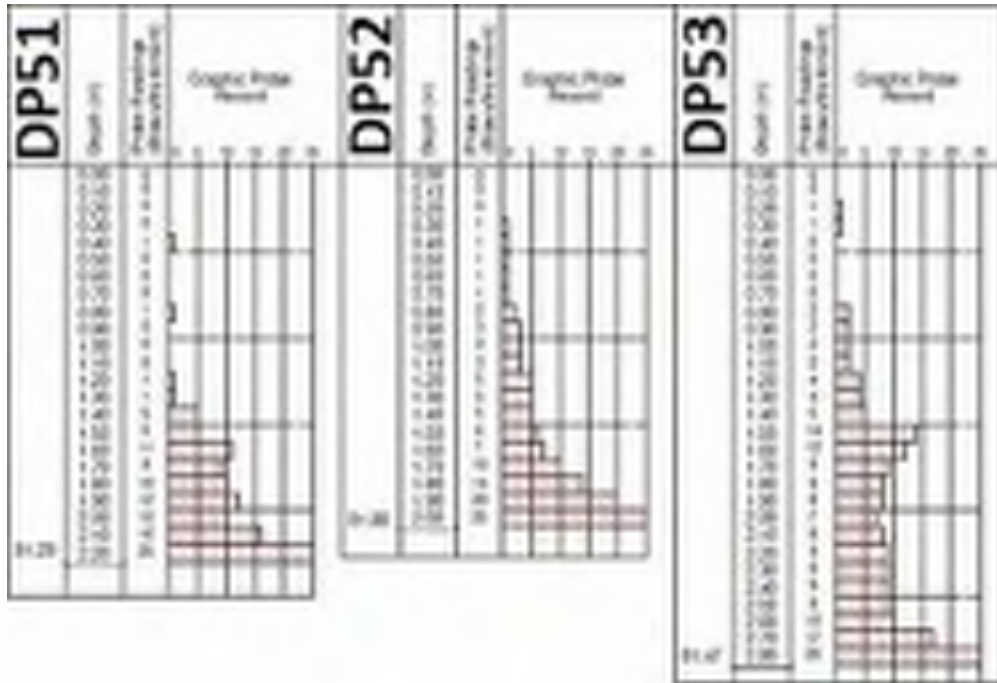
Figure 33 – Probes positioned W to E across GiS Sub showing low  $N_{100}$  values for 1m bgl

Trial pitting across the GiS Sub area reported firm onto stiff soils at 1.0m bgl. The stratum was logged as very sandy throughout. Probes constructed through the upper layer revealed negligible resistance with successive 0 and 1 blowcounts per 100mm (Figure 33). It is thought this is related to the sandy nature of the soil rather than highlighting a soft zone. Equally, boreholes BH13 and BH14 reported low SPT N-values indicative of loosened soils. A bearing capacity of 125kPa should be possible on the sandy clay soils at 1.0m based on visual observations in trial pits. Use of large diameter plate bearing tests at formation level will allow for better assessment of the density of the soils at 1.0m. Should larger capacities be required, it is likely the use of soil stabilisation measures would see an increase in the bearing pressures of 250 to 300 kPa.

- There are incidences of consecutive zero  $N_{100}$  values found in probes extending from ground level throughout the same area, namely DP51 to 1.40m bgl, DP52 to ca. 0.70m, DP53 to ca. 0.80m and DP55 to 0.90m (See Figure 33). It is assumed that these probes, rather than passing through very soft or soft soils, are in fact penetrating a predominantly fine sand deposit. A firm very sandy slightly gravelly silty CLAY was logged in a number of trial pits. This type of stratigraphy, occasionally becoming more sand-dominant at shallow levels, would explain the mixed probe results obtained locally.
- Plate test results in the same area suggest soft to firm soils at depths of 0.50m. A SPT N-value of 3 was recorded at 1.0m in BH14 which again highlights the presence of loose, likely sand-dominant upper soils. SPT N-values improved significantly with depth.

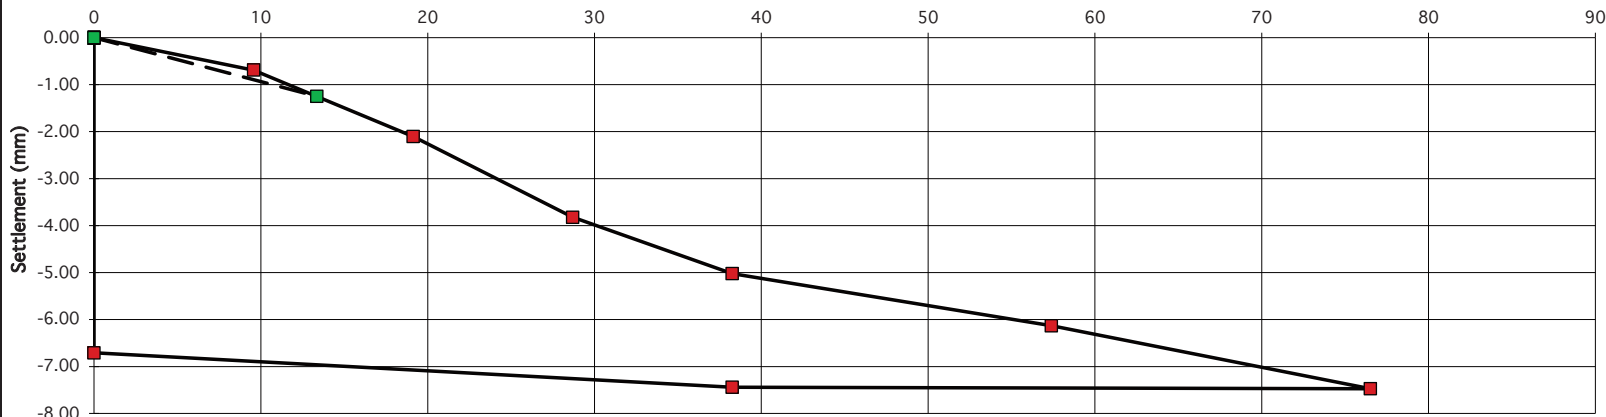
**Pressure / Settlement**

| Pressure (kN/m <sup>2</sup> ) | Settlement (mm) - Upper Series | Settlement (mm) - Lower Series |

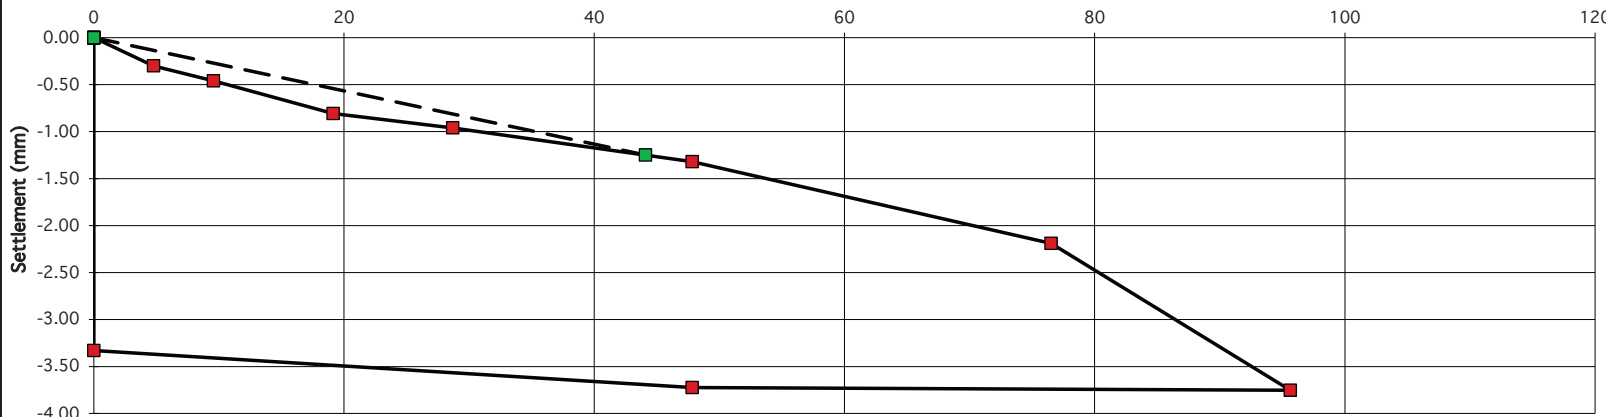
| PLATE TEST REPORT SHEET (F3.1) | | Applied Pressure/Settlement Curve | |
|---|---|---|---|
| <div style="text-align: center; margin-bottom: 10px;"><b>Pressure / Settlement</b></div> <div style="display: flex; justify-content: space-between; margin-top: 10px;"> <div style="width: 30%;"> <p>Gradient at 1.25 mm settlement intersection = 35</p> <p>Modulus of subgrade reaction = 23 MPa/m</p> <p>Correction factor applied = 0.64 as per HD 25-26/10</p> </div> <div style="width: 40%; text-align: center;"> <p>Equivalent CBR value in accordance with NRA HD25-26/10</p> </div> <div style="width: 30%; text-align: right;"> <p>2.2 %</p> </div> </div> | | | |

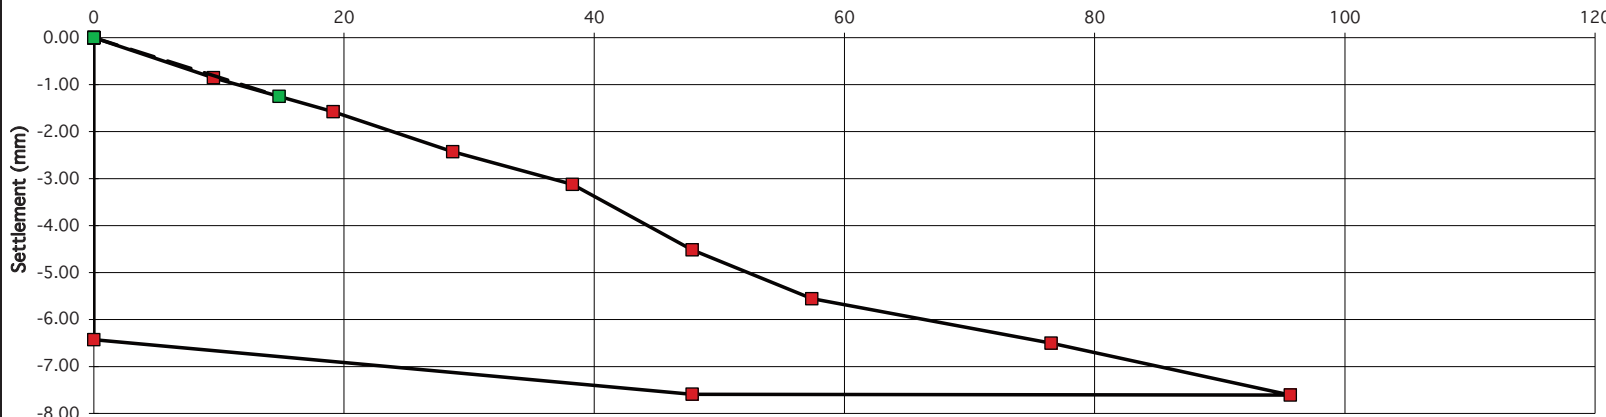
**Pressure / Settlement**

| Pressure (kN/m <sup>2</sup> ) | Settlement (mm) - Upper Curve | Settlement (mm) - Lower Curve |

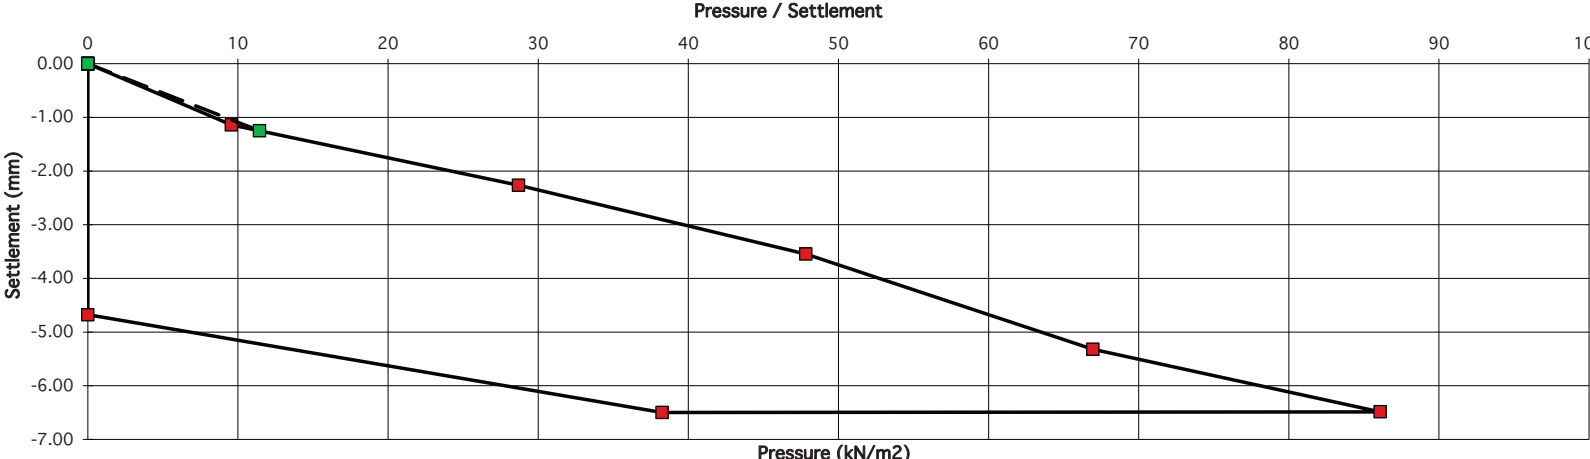
| PLATE TEST REPORT SHEET (F3.1) | | Applied Pressure/Settlement Curve | |
|---|---|---|---|
| Gradient at 1.25 mm settlement intersection = 9<br>Modulus of subgrade reaction = 6 MPa/m<br>Correction factor applied = 0.64 as per HD 25-26/10 | | | |
| | | Equivalent CBR value in accordance with NRA HD25-26/10<br>0.2 % | |

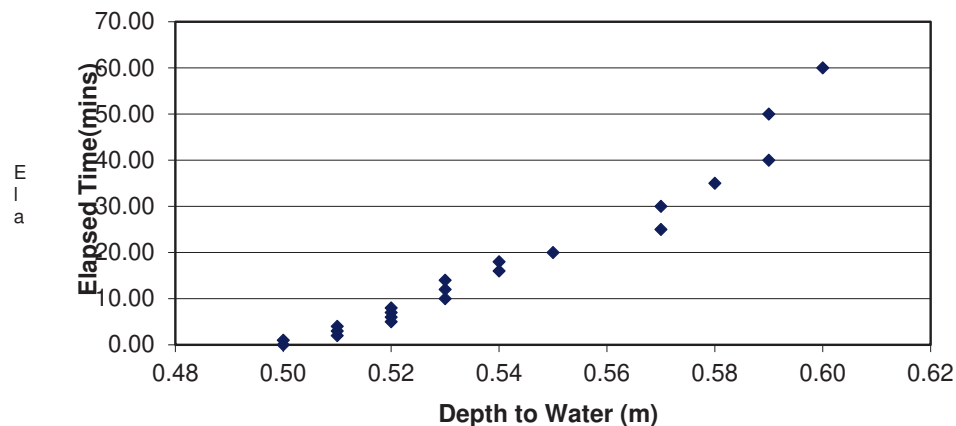
**f= 0.00041 m/min or 6.887E-06 m/sec**

Depth of water vs Elapsed Time (mins)

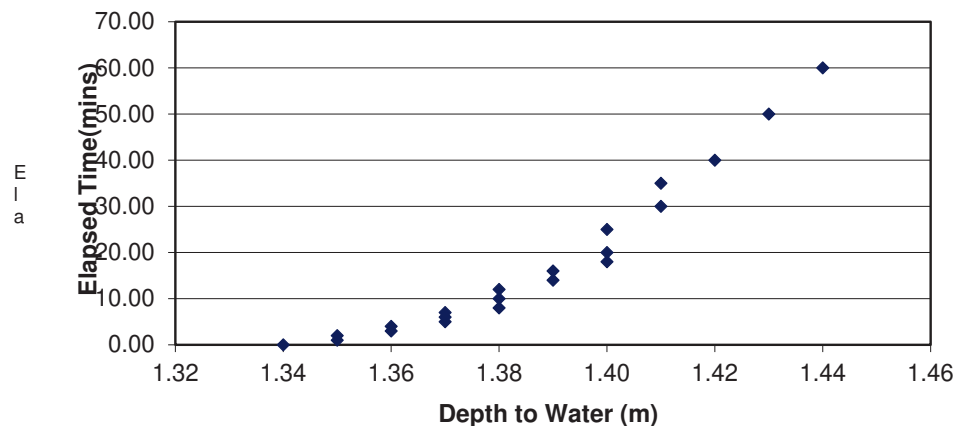
**f= 0.0003 m/min or 5.002E-06 m/sec**

Depth of water vs Elapsed Time (mins)

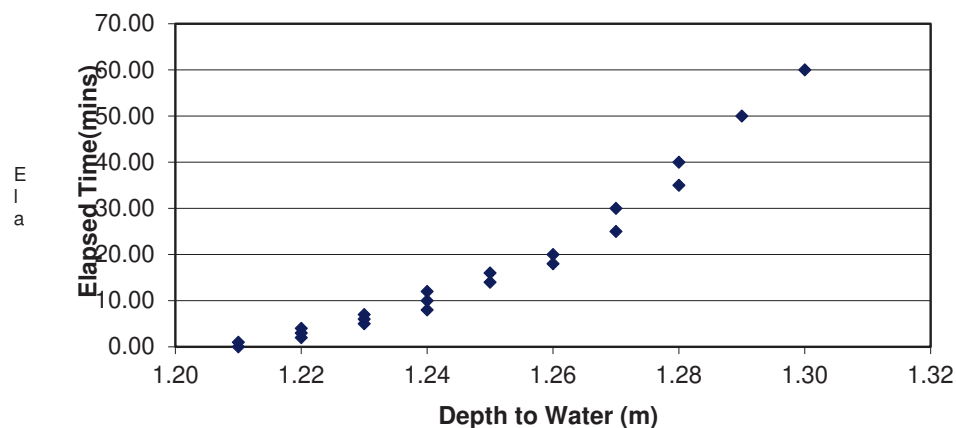
**f= 0.00024 m/min or 3.961E-06 m/sec**

Depth of water vs Elapsed Time (mins)

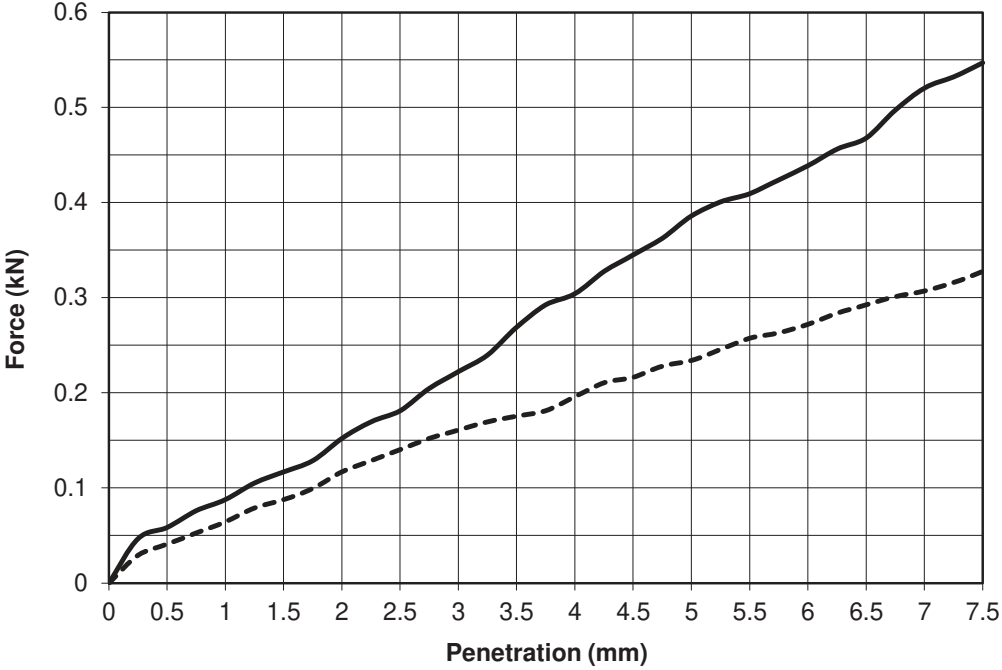
| IGSL Ltd<br>Materials Laboratory<br>Unit J5,M7 Business Park<br>Naas Co.Kildare<br>045 899324 | <b>TEST REPORT</b><br><b>Determination of California Bearing Ratio (CBR)</b><br><br>Tested in accordance with BS1377:Part 4:1990, clause 7 | <br><small>ISO 17025<br/>ACCREDITED<br/>TESTING<br/>DETAILED IN SCOPE REG NO.1331</small> | | | | | | | | | | | | | | | | | | | | | | | | |
|---|---|---|---|---|---|---|---|---|---|---|---|---|---|---|---|---|---|---|---|---|---|---|---|--|--|--|
| <p>Key:      ————— Top      - - - - - Base</p> <table border="1" style="width: 100%; border-collapse: collapse;"> <tr> <td colspan="4">Description:    Mottled brown slightly sandy slightly gravelly CLAY</td> </tr> <tr> <td colspan="4">Initial Condition:            Unsoaked</td> </tr> <tr> <td>Moisture Content (%):</td> <td>15</td> <td>Bulk Density (Mg/m<sup>3</sup>):</td> <td>2.13</td> </tr> <tr> <td>Surcharge (kg):</td> <td>4</td> <td>Dry Density (Mg/m<sup>3</sup>):</td> <td>1.85</td> </tr> <tr> <td>% Material &gt;20mm:</td> <td>14</td> <td colspan="2"></td> </tr> <tr> <td colspan="4">Method of compaction:    Static Compaction Method 2</td> </tr> </table> | | | Description:    Mottled brown slightly sandy slightly gravelly CLAY | | | | Initial Condition:            Unsoaked | | | | Moisture Content (%): | 15 | Bulk Density (Mg/m <sup>3</sup> ): | 2.13 | Surcharge (kg): | 4 | Dry Density (Mg/m <sup>3</sup> ): | 1.85 | % Material >20mm: | 14 | | | Method of compaction:    Static Compaction Method 2 | | | |

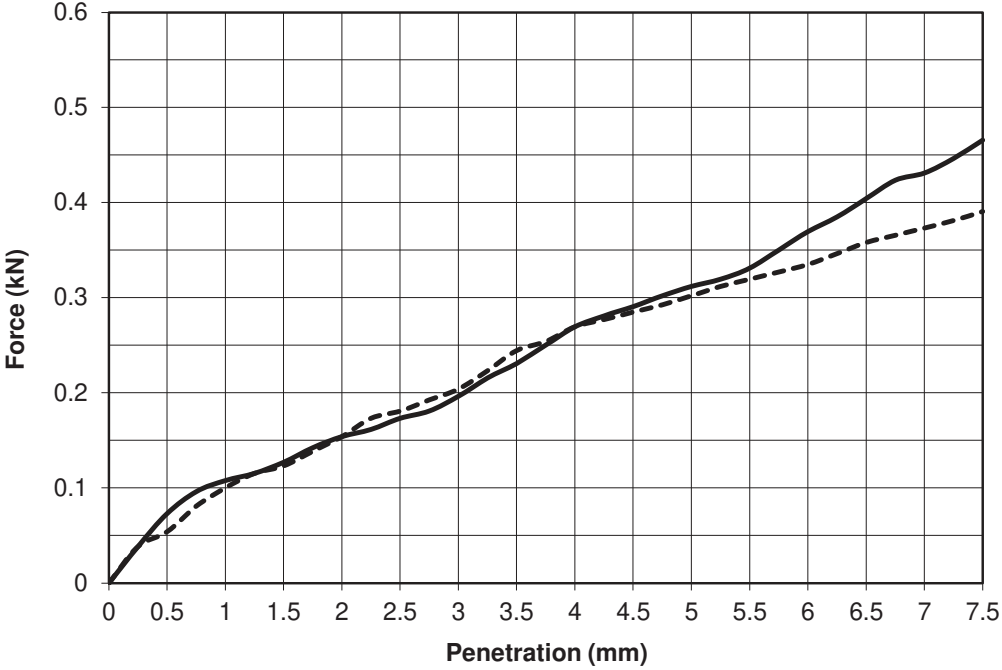
| IGSL Ltd<br>Materials Laboratory<br>Unit J5,M7 Business Park<br>Naas Co.Kildare<br>045 899324 | <b>TEST REPORT</b><br><b>Determination of California Bearing Ratio (CBR)</b><br><br>Tested in accordance with BS1377:Part 4:1990, clause 7 | <br><small>ISO 17025<br/>ACCREDITED<br/>TESTING<br/>DETAILED IN SCOPE REG NO.1331</small> | | | | | | | | | | | | | | | | | | | | | | | | |
|---|---|---|---|---|---|---|---|---|---|---|---|---|---|---|---|---|---|---|---|---|---|---|---|--|--|--|
| <table border="1" style="width: 100%; border-collapse: collapse;"> <tr> <td colspan="4">Description: Mottled brown sandy gravelly SILT/CLAY</td> </tr> <tr> <td colspan="2">Initial Condition:</td> <td colspan="2">Unsoaked</td> </tr> <tr> <td>Moisture Content (%):</td> <td>13</td> <td>Bulk Density (Mg/m<sup>3</sup>):</td> <td>2.20</td> </tr> <tr> <td>Surcharge (kg):</td> <td>4</td> <td>Dry Density (Mg/m<sup>3</sup>):</td> <td>1.95</td> </tr> <tr> <td>% Material &gt;20mm:</td> <td>8.4</td> <td colspan="2"></td> </tr> <tr> <td colspan="4">Method of compaction: Static Compaction Method 2</td> </tr> </table> | | | Description: Mottled brown sandy gravelly SILT/CLAY | | | | Initial Condition: | | Unsoaked | | Moisture Content (%): | 13 | Bulk Density (Mg/m <sup>3</sup> ): | 2.20 | Surcharge (kg): | 4 | Dry Density (Mg/m <sup>3</sup> ): | 1.95 | % Material >20mm: | 8.4 | | | Method of compaction: Static Compaction Method 2 | | | |

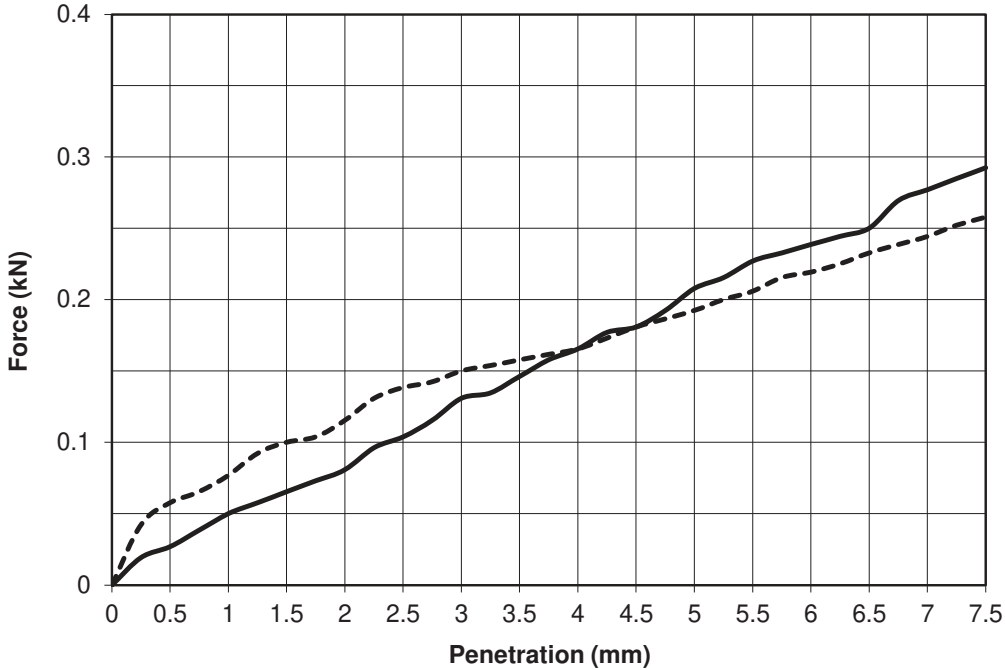
| IGSL Ltd<br>Materials Laboratory<br>Unit J5,M7 Business Park<br>Naas Co.Kildare<br>045 899324 | <b>TEST REPORT</b><br><b>Determination of California Bearing Ratio (CBR)</b><br><br>Tested in accordance with BS1377:Part 4:1990, clause 7 | | | | | | | | | | | | | | | | | | | | | | | | | |
|---|---|---|---|---|---|---|---|---|---|---|---|---|---|---|---|---|---|---|---|---|---|---|---|--|--|--|
| <p>Key:      ————— Top      - - - - - Base</p> <table border="1" style="width: 100%; border-collapse: collapse;"> <tr> <td colspan="4">Description: Mottled brown slightly sandy slightly gravelly SILT/CLAY</td> </tr> <tr> <td colspan="4">Initial Condition: Unsoaked</td> </tr> <tr> <td>Moisture Content (%):</td> <td>13</td> <td>Bulk Density (Mg/m<sup>3</sup>):</td> <td>2.19</td> </tr> <tr> <td>Surcharge (kg):</td> <td>4</td> <td>Dry Density (Mg/m<sup>3</sup>):</td> <td>1.93</td> </tr> <tr> <td>% Material &gt;20mm:</td> <td>7.6</td> <td colspan="2"></td> </tr> <tr> <td colspan="4">Method of compaction: Static Compaction Method 2</td> </tr> </table> | | | Description: Mottled brown slightly sandy slightly gravelly SILT/CLAY | | | | Initial Condition: Unsoaked | | | | Moisture Content (%): | 13 | Bulk Density (Mg/m <sup>3</sup> ): | 2.19 | Surcharge (kg): | 4 | Dry Density (Mg/m <sup>3</sup> ): | 1.93 | % Material >20mm: | 7.6 | | | Method of compaction: Static Compaction Method 2 | | | |

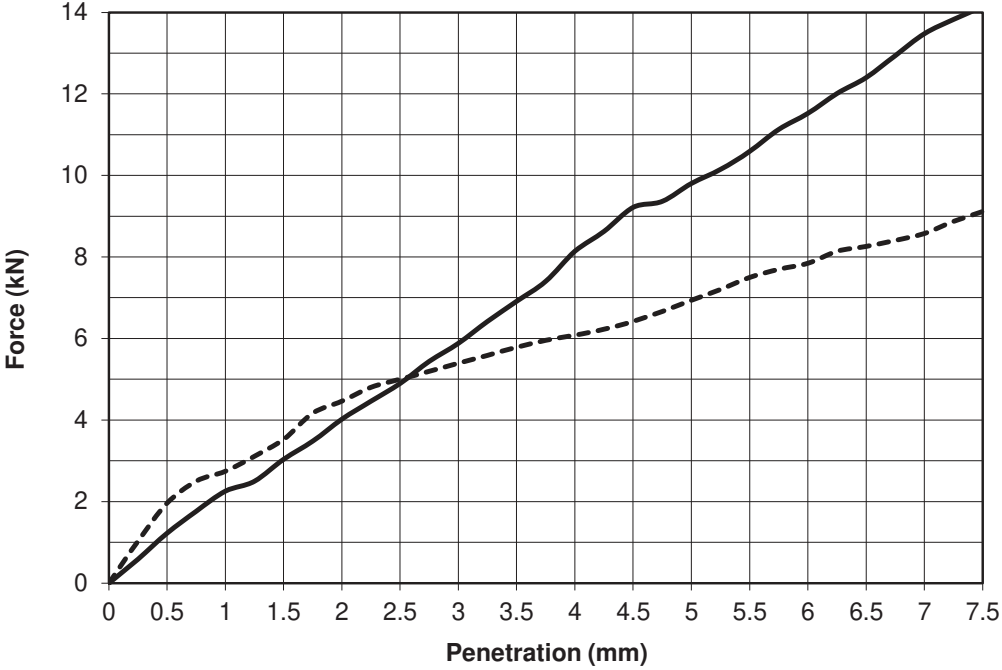
| <p>Key:      ————— Top      - - - - - Base</p> <table border="1" style="width: 100%; border-collapse: collapse;"> <tr> <td colspan="4">Description:    Mottled brown slightly sandy slightly gravelly CLAY</td> </tr> <tr> <td colspan="4">Initial Condition:            1% Lime/ 7 Days Soaked</td> </tr> <tr> <td>Moisture Content (%):</td> <td>12</td> <td>Bulk Density (Mg/m<sup>3</sup>):</td> <td>2.17</td> </tr> <tr> <td>Surcharge (kg):</td> <td>4</td> <td>Dry Density (Mg/m<sup>3</sup>):</td> <td>1.94</td> </tr> <tr> <td>% Material &gt;20mm:</td> <td>14</td> <td colspan="2"></td> </tr> <tr> <td colspan="4">Method of compaction:    Static Compaction Method 2</td> </tr> </table><br><table border="1" style="width: 100%; border-collapse: collapse; text-align: center;"> <tr> <td style="width: 30%;">Test Result</td> <td style="width: 35%;">Top</td> <td style="width: 35%;">Base</td> </tr> <tr> <td><b>CBR %</b></td> <td><b>49</b></td> <td><b>38</b></td> </tr> <tr> <td>Moisture Content %</td> <td>12</td> <td>12</td> </tr> </table> | | | Description:    Mottled brown slightly sandy slightly gravelly CLAY | | | | Initial Condition:            1% Lime/ 7 Days Soaked | | | | Moisture Content (%): | 12 | Bulk Density (Mg/m <sup>3</sup> ): | 2.17 | Surcharge (kg): | 4 | Dry Density (Mg/m <sup>3</sup> ): | 1.94 | % Material >20mm: | 14 | | | Method of compaction:    Static Compaction Method 2 | | | | Test Result | Top | Base | <b>CBR %</b> | <b>49</b> | <b>38</b> | Moisture Content % | 12 | 12 |

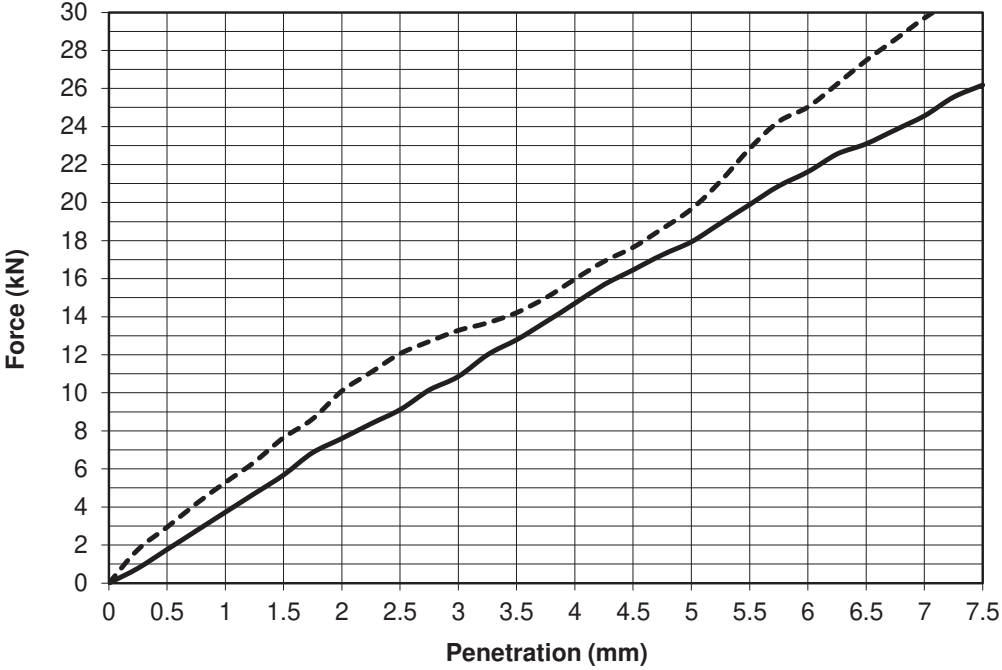
| IGSL Ltd<br>Materials Laboratory<br>Unit J5,M7 Business Park<br>Naas Co.Kildare<br>045 899324 | <b>TEST REPORT</b><br><b>Determination of California Bearing Ratio (CBR)</b><br><br>Tested in accordance with BS1377:Part 4:1990, clause 7 | | | | | | | | | | | | | | | | | | | | | | | | | |
|---|---|---|---|---|---|---|---|---|---|---|---|---|---|---|---|---|---|---|---|---|---|---|---|--|--|--|
| <table border="1" style="width: 100%; border-collapse: collapse;"> <tr> <td colspan="4">Description: Mottled brown slightly sandy slightly gravelly CLAY</td> </tr> <tr> <td colspan="4">Initial Condition: 1% Lime 2% Cement/7 Days Soaked</td> </tr> <tr> <td>Moisture Content (%):</td> <td>12</td> <td>Bulk Density (Mg/m<sup>3</sup>):</td> <td>2.14</td> </tr> <tr> <td>Surcharge (kg):</td> <td>4</td> <td>Dry Density (Mg/m<sup>3</sup>):</td> <td>1.91</td> </tr> <tr> <td>% Material &gt;20mm:</td> <td>14</td> <td colspan="2"></td> </tr> <tr> <td colspan="4">Method of compaction: Static Compaction Method 2</td> </tr> </table> | | | Description: Mottled brown slightly sandy slightly gravelly CLAY | | | | Initial Condition: 1% Lime 2% Cement/7 Days Soaked | | | | Moisture Content (%): | 12 | Bulk Density (Mg/m <sup>3</sup> ): | 2.14 | Surcharge (kg): | 4 | Dry Density (Mg/m <sup>3</sup> ): | 1.91 | % Material >20mm: | 14 | | | Method of compaction: Static Compaction Method 2 | | | |

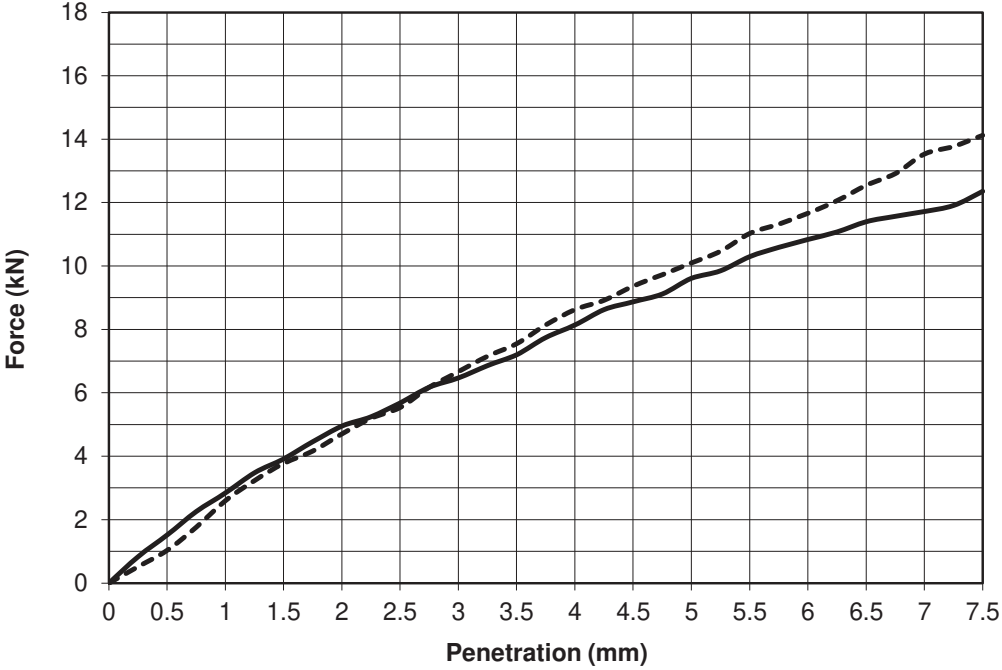
| IGSL Ltd<br>Materials Laboratory<br>Unit J5,M7 Business Park<br>Naas Co.Kildare<br>045 899324 | <b>TEST REPORT</b><br><b>Determination of California Bearing Ratio (CBR)</b><br><br>Tested in accordance with BS1377:Part 4:1990, clause 7 | <br><small>ISO 17025<br/>ACCREDITED<br/>TESTING<br/>DETAILED IN SCOPE REG NO.1331</small> | | | | | | | | | | | | | | | | | | | | | | | | |
|---|---|---|---|---|---|---|---|---|---|---|---|---|---|---|---|---|---|---|---|---|---|---|---|--|--|--|
| <table border="1" style="width: 100%; border-collapse: collapse;"> <tr> <td colspan="4">Description: Brown slightly sandy slightly gravelly CLAY</td> </tr> <tr> <td colspan="4">Initial Condition: 3% Lime/ 7 Days Soaked</td> </tr> <tr> <td>Moisture Content (%):</td> <td>15</td> <td>Bulk Density (Mg/m<sup>3</sup>):</td> <td>2.17</td> </tr> <tr> <td>Surcharge (kg):</td> <td>4</td> <td>Dry Density (Mg/m<sup>3</sup>):</td> <td>1.90</td> </tr> <tr> <td>% Material &gt;20mm:</td> <td>14</td> <td colspan="2"></td> </tr> <tr> <td colspan="4">Method of compaction: Static Compaction Method 2</td> </tr> </table> | | | Description: Brown slightly sandy slightly gravelly CLAY | | | | Initial Condition: 3% Lime/ 7 Days Soaked | | | | Moisture Content (%): | 15 | Bulk Density (Mg/m <sup>3</sup> ): | 2.17 | Surcharge (kg): | 4 | Dry Density (Mg/m <sup>3</sup> ): | 1.90 | % Material >20mm: | 14 | | | Method of compaction: Static Compaction Method 2 | | | |

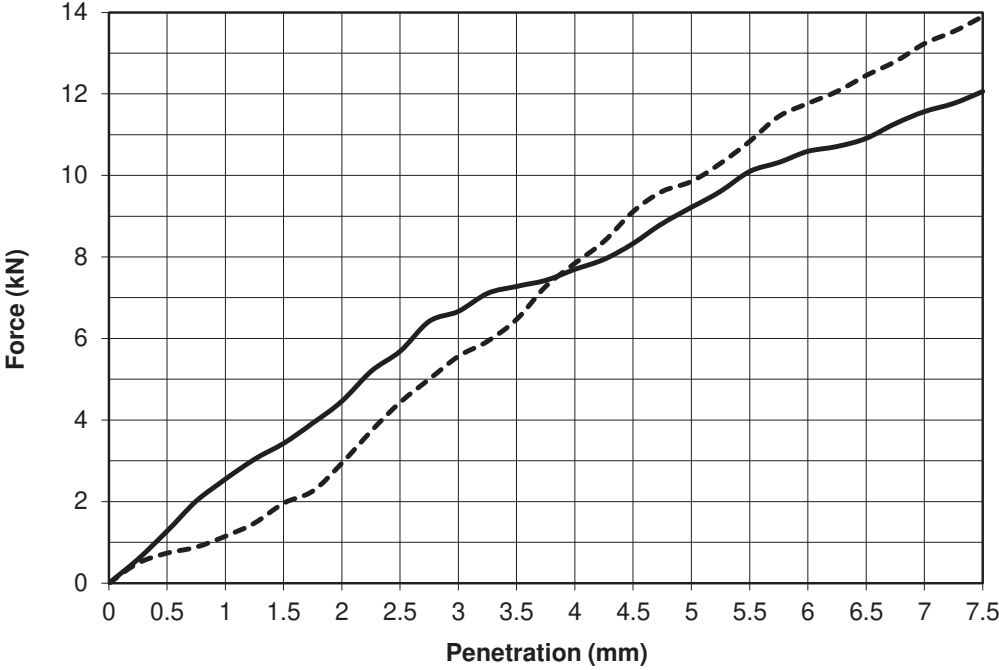
| IGSL Ltd<br>Materials Laboratory<br>Unit J5,M7 Business Park<br>Naas Co.Kildare<br>045 899324 | <b>TEST REPORT</b><br><b>Determination of California Bearing Ratio (CBR)</b><br><br>Tested in accordance with BS1377:Part 4:1990, clause 7 | | | | | | | | | | | | | | | | | | | | | | | | | |
|---|---|---|---|---|---|---|---|---|---|---|---|---|---|---|---|---|---|---|---|---|---|---|---|--|--|--|
| <p>Key:      ————— Top      - - - - - Base</p> <table border="1" style="width: 100%; border-collapse: collapse;"> <tr> <td colspan="4">Description: Mottled brown slightly sandy slightly gravelly CLAY</td> </tr> <tr> <td colspan="4">Initial Condition: 2 % Lime/5 Day Soaked</td> </tr> <tr> <td>Moisture Content (%):</td> <td>14</td> <td>Bulk Density (Mg/m<sup>3</sup>):</td> <td>2.24</td> </tr> <tr> <td>Surcharge (kg):</td> <td>4</td> <td>Dry Density (Mg/m<sup>3</sup>):</td> <td>1.97</td> </tr> <tr> <td>% Material &gt;20mm:</td> <td>7.6</td> <td colspan="2"></td> </tr> <tr> <td colspan="4">Method of compaction: Static Compaction Method 2</td> </tr> </table> | | | Description: Mottled brown slightly sandy slightly gravelly CLAY | | | | Initial Condition: 2 % Lime/5 Day Soaked | | | | Moisture Content (%): | 14 | Bulk Density (Mg/m <sup>3</sup> ): | 2.24 | Surcharge (kg): | 4 | Dry Density (Mg/m <sup>3</sup> ): | 1.97 | % Material >20mm: | 7.6 | | | Method of compaction: Static Compaction Method 2 | | | |

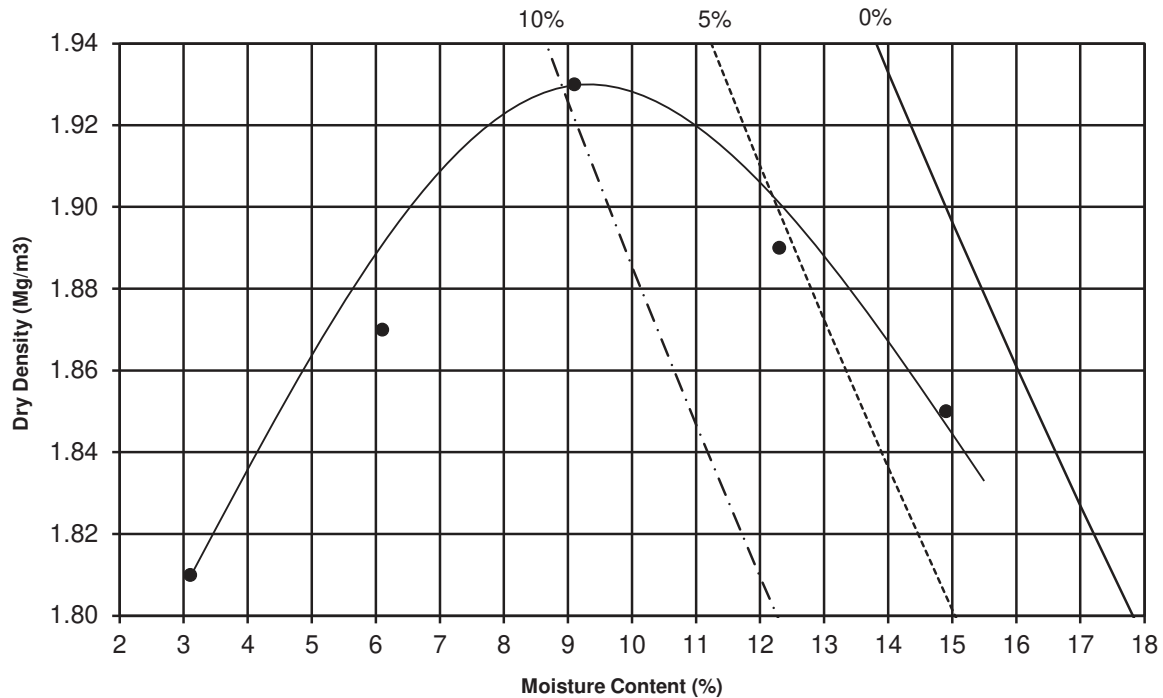
Maximum Dry Density (Mg/m<sup>3</sup>): 1.93 Optimum Moisture Content (%): 9

Description: Mottled brown sandy gravelly SILT/CLAY

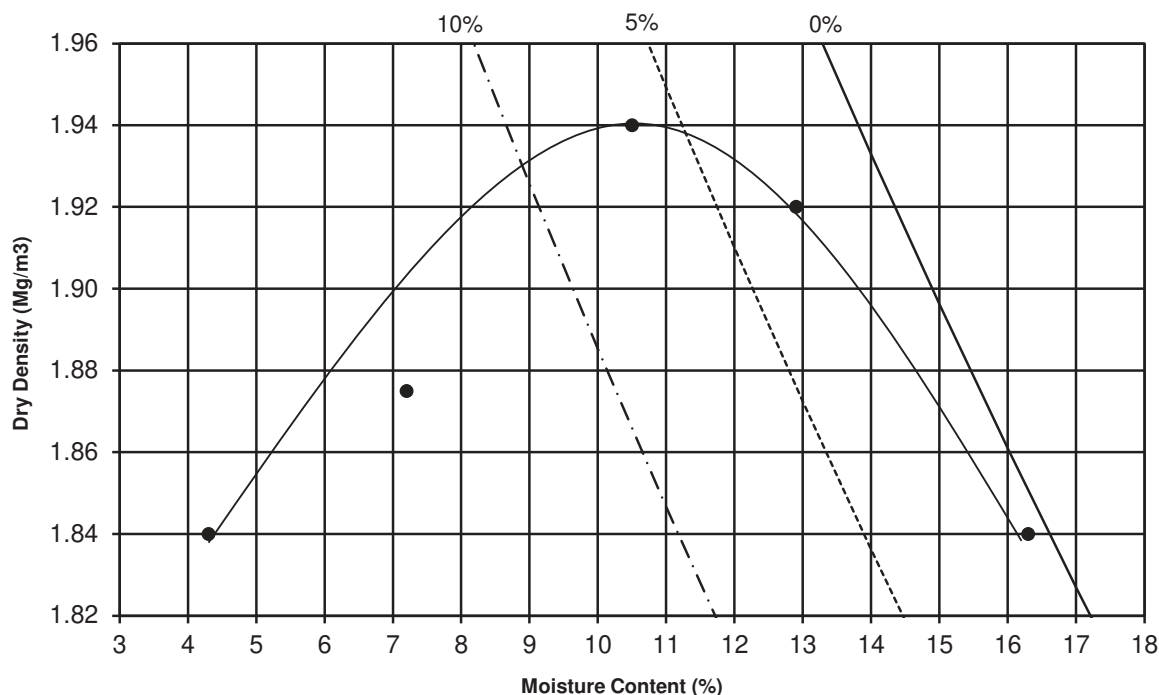
Maximum Dry Density (Mg/m<sup>3</sup>): 1.94 Optimum Moisture Content (%): 11

Description: Mottled brown slightly sandy, slightly gravelly, CLAY
