PROPOSED LARGE-SCALE RESIDENTIAL DEVELOPMENT, BOHERBOY,
SAGGART, CO. DUBLIN

EIAR Volume 3

Appendices

Evvara Developments Ltd & Kelland Homes Ltd

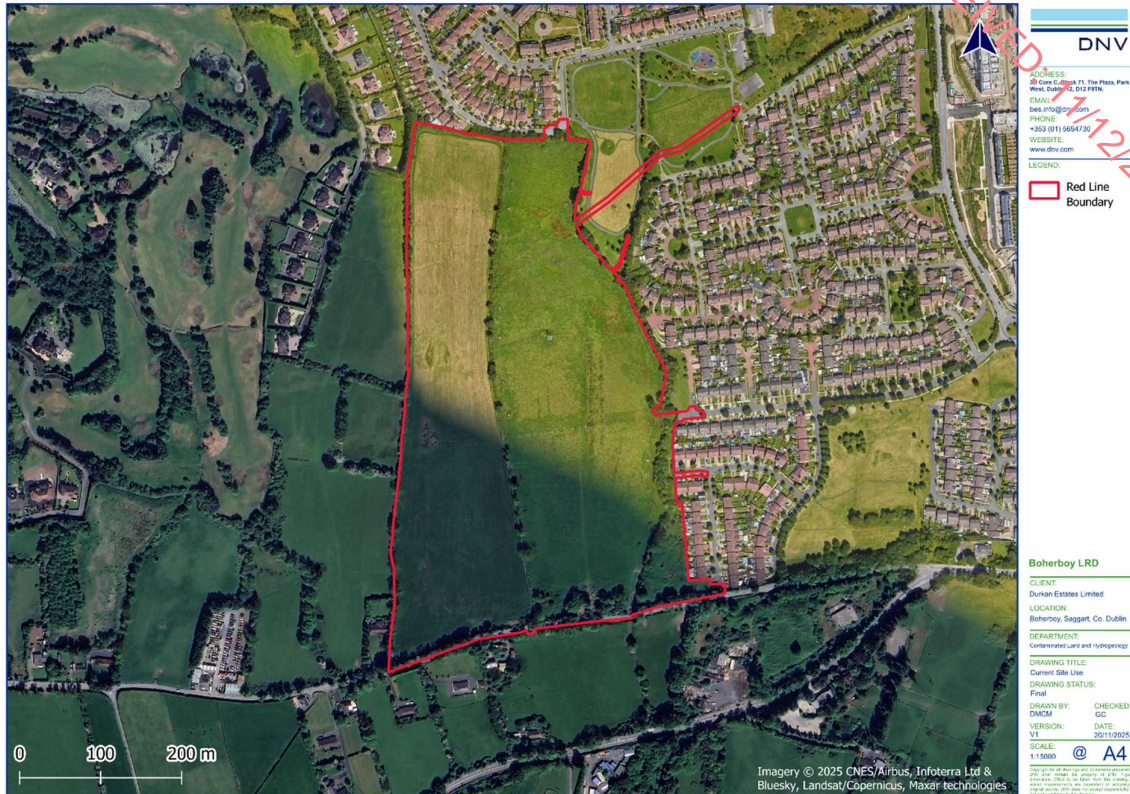
Figure 3-2. Existing Site Layout

The site comprises approximately 18.5 hectares (Ha) of primarily undeveloped agricultural lands. The lands comprise of two agricultural grassland fields which are separated by a hedgerow and stream. There are three (3 No.) overhead power lines crossing the site (10kV-38kV). The Corbally stream runs along much of the eastern and southern boundary of the site. The Coldwater stream flows along the western boundary, and the Cooldown stream is noted along the central field boundary on the site. The site also comprises a small area of disused grassland, located to the east of the Corbally Stream. Hedgerows and treelines surround the lands. Cattle graze on the agricultural fields, with open cow sheds in the south of the site, adjacent to the entrance.

The Site location is presented in Figure 2-1 and the current layout of the site is presented in Figure 2-2.

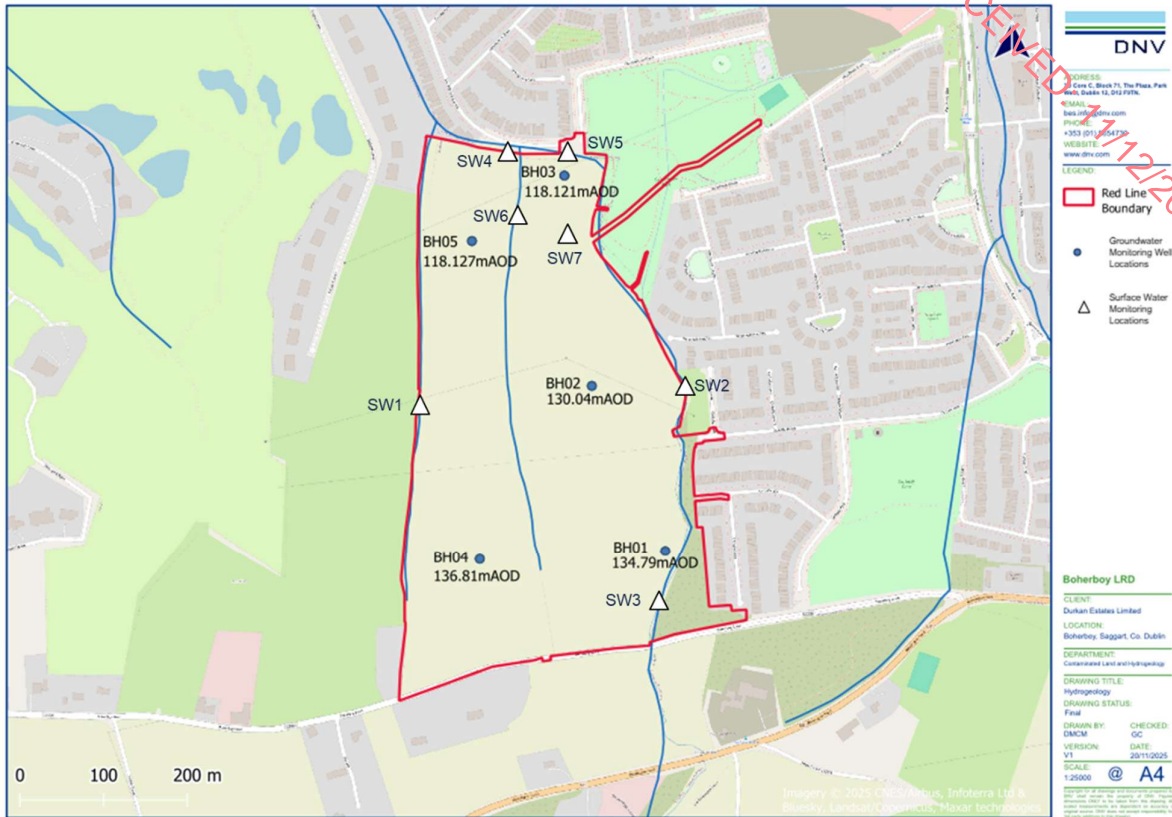
Figure 5-1. Site Investigation Locations

The locations of the five (5 No.) groundwater monitoring wells were surveyed by DNV relative to Ordnance Datum and ITM (Irish Transverse Mercator). The top of the well outer casing (i.e., heavy-duty upright cover) was surveyed to provide a fixed reference point for groundwater level monitoring.

The locations of the newly installed groundwater monitoring wells are presented in Figure 5-1.

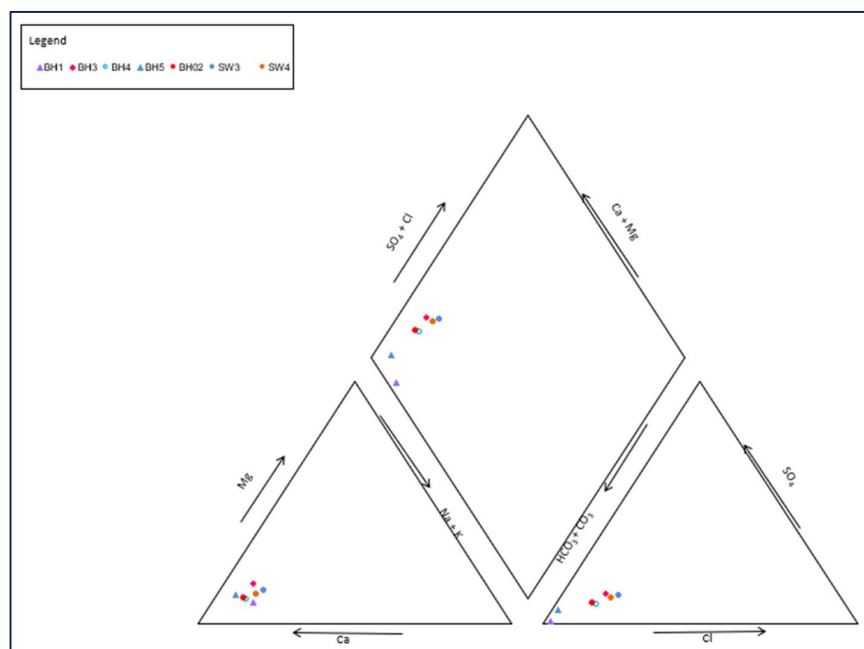
Figure 6-2. Piper Diagram for Surface water and Groundwater Samples

The surface water samples (SW3 and SW4) and the groundwater samples (BH1 through BH5) were analysed for a suite of major ions. The hydrochemical data for major ions were produced graphically for each sample using the Piper diagram which is a graphical representation of the chemistry of a water sample or samples. The trilinear piper diagram can show the percentage composition of different ions, which shows the classification of water samples from various lithological environments and/or different conditions (i.e., saline intrusion, brackish water, etc).

The objective of the Piper Diagram was to analyse the major ions composition of the samples and determine the extent of any potential hydraulic connectivity between the groundwater beneath the site and receiving surface water receptor. The hydrochemistry plots generated are provided in Figure 6-2.

The Piper diagram and associated hydrochemical data indicate that groundwater samples BH1 through BH5, as well as surface water samples SW3 and SW4, exhibit broadly similar ionic compositions. This suggests that these waters are hydrochemically related and likely originate from the same source or are influenced by similar geochemical processes. The dominance of calcium and bicarbonate ions, along with relatively low concentrations of sodium and chloride, points to a groundwater system primarily recharged by rainfall percolating through subsurface geological strata
