**CUTAWAY BOG
DECOMMISSIONING AND
REHABILITATION PLAN
(LEMANAGHAN,
CURRAGHALASSA,
DERRYNAGUN)**

**Lemanaghan Bog
(Lemanaghan Wind farm)**

**Draft Cutaway Bog Decommissioning
and Rehabilitation Plan
2024**

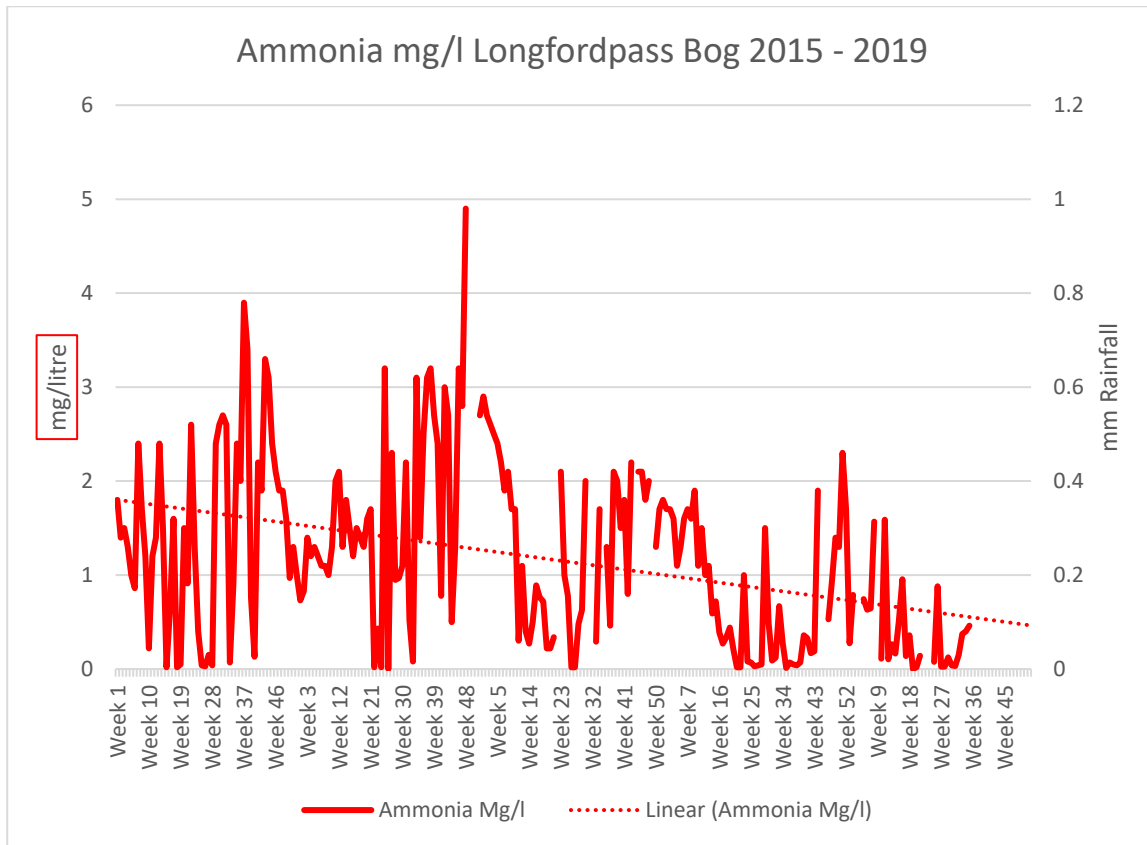
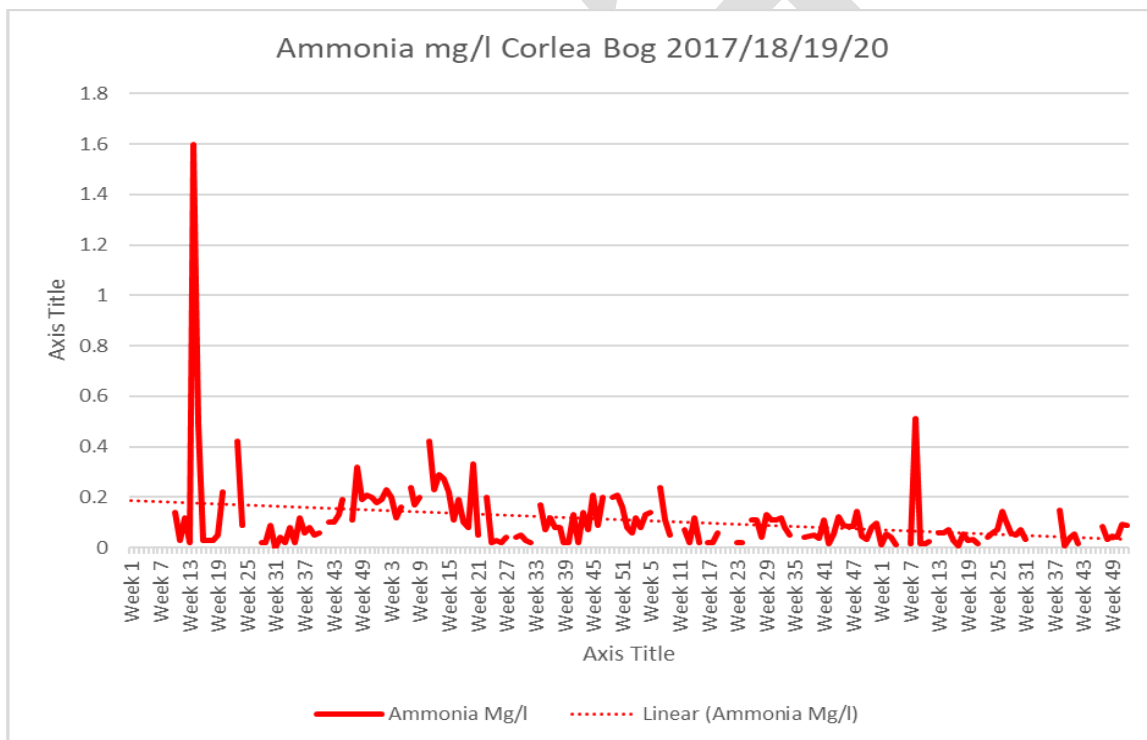
Figure 7.1. Ammonia levels over the period 2015-2019/2020 at Longfordpass and Corlea.

With regard to predicting and estimating likely trends that might materialize or could be considered as a target, the results of monitoring of surface water ammonia emissions from Longfordpass bog in Littleton over 4 years, post cessation of peat extraction with ongoing rehabilitation, were considered. These are indicating a downward trend in Ammonia concentrations (Figure 7.1).

Similarly monitoring of surface water ammonia emissions from a Corlea bog in Mountdillon over the past 4 years post cessation of peat extraction with ongoing rehabilitation indicate downward trends.
