APPENDIX 8-1

TRIAL PIT LOGS

Project No: P1685-0
Site: Carrow Wind Farm
Client: Carrow Renewable Energy Ltd

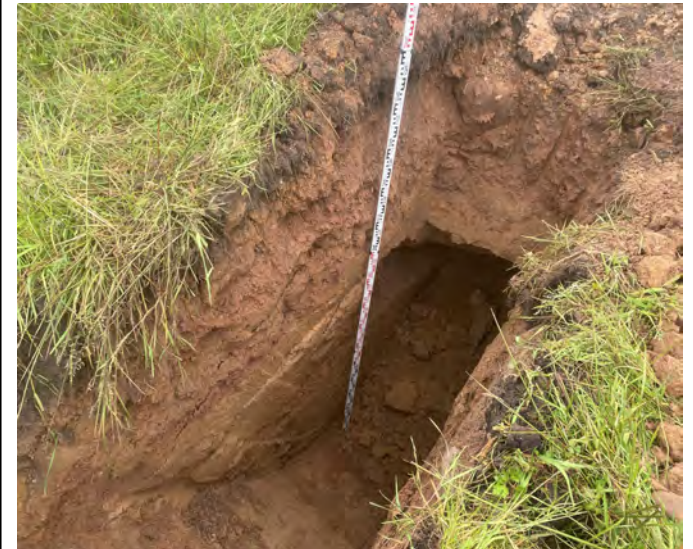
Trial Pit Log TP01

Depth	Symbol	Depth/Elev.	Description	Water Strikes	Sample Type	Comments
0.00		0.00	Ground Surface			
		0.00	Peaty Topsoil			
			Firm, reddish brown, slightly gravelly SILT/CLAY			
1.00		-1.20				
		1.20	Firm, reddish brown SILT with some gravel lenses			
2.00						
3.00		-3.00				
		3.00

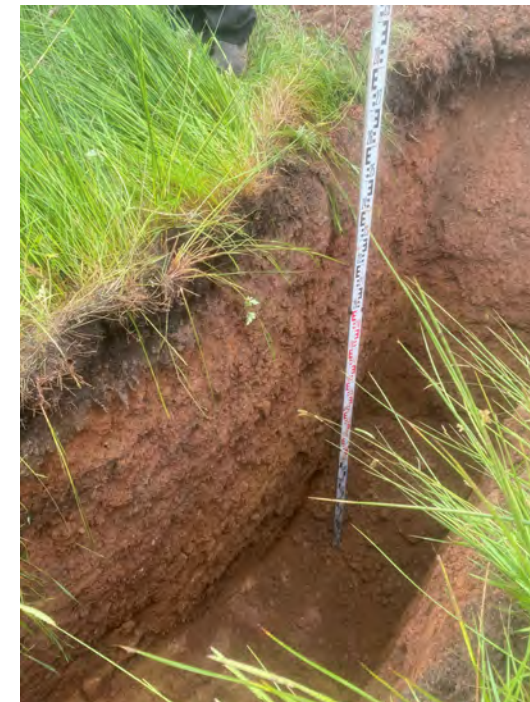
Trial Pit Log TP02

Depth	Symbol	Depth/Elev.	Description	Water Strikes	Sample Type	Comments
0.00		0.00	Ground Surface			
		0.00	Peaty Topsoil			
			Firm, reddish brown, sandy, gravelly SILT/CLAY			
1.00						
2.00						
		-2.50				
		2.50	Refusal

Remarks: Refusal on broken angular siltstone/sandstone

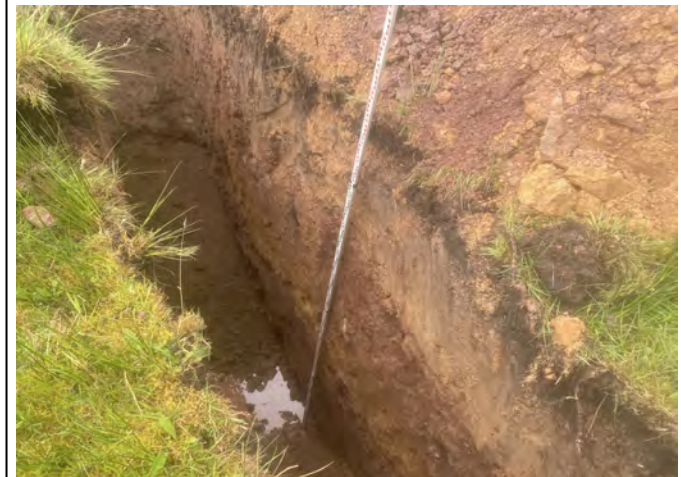
Trial Pit Log TP03

Depth	Symbol	Depth/Elev.	Description	Water Strikes	Sample Type	Comments
0.00		0.00	Ground Surface			
		0.00	Peaty Topsoil			
			Soft, grey SILT			
		-0.60				
		0.60	Very firm, gravelly CLAY			
1.00						
		-1.30				
		1.30	Firm, orange SAND			
2.00						
		-2.00				
		2.00	Very firm, gravelly CLAY			
3.00						
		-3.30				
		3.30	Refusal	▼		Small inflows at base of hole

Remarks: Refusal on broken angular siltstone/sandstone

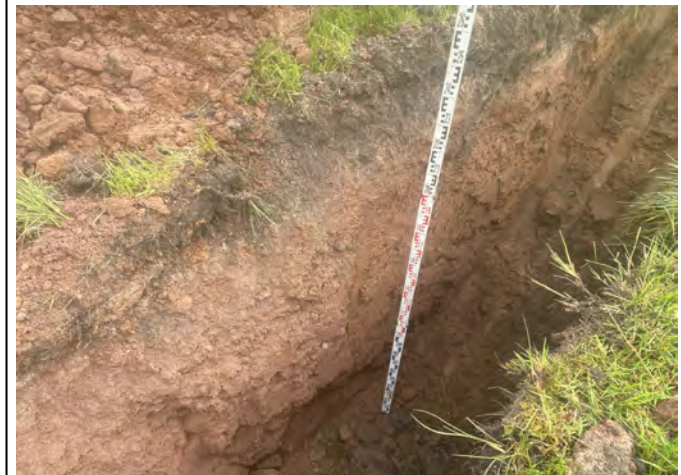
Trial Pit Log TP04

Depth	Symbol	Depth/Elev.	Description	Water Strikes	Sample Type	Comments
0.00		0.00	Ground Surface			
		0.00	Peaty Topsoil			
			Soft, grey SILT			
			Firm, reddish brown, slightly gravelly SILT			
1.00		-1.30				
		1.30	Firm, sandy, gravelly SILT			
2.00		-2.40				
		2.40	Refusal

Remarks: Refusal on broken (blocky) sandstone/siltstone

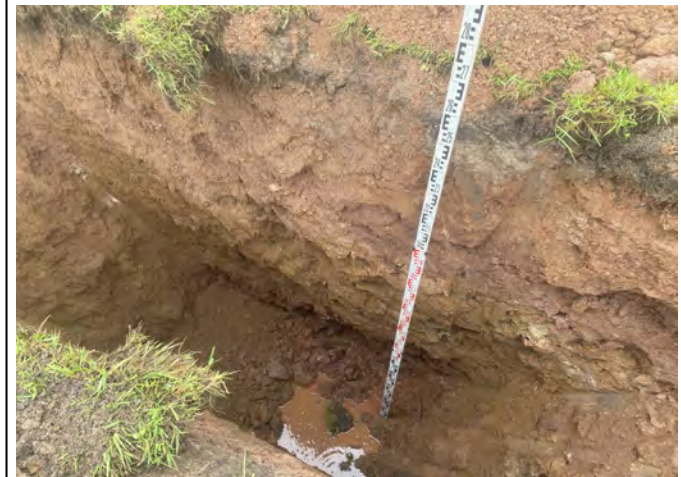
Trial Pit Log TP05

Depth	Symbol	Depth/Elev.	Description	Water Strikes	Sample Type	Comments
0.00		0.00	Ground Surface			
		0.00	Peaty Topsoil			
			Soft, grey SILT			
			Firm, reddish brown, slightly gravelly SILT			
1.00		-1.30				
		1.30	Firm, sandy, gravelly SILT			
2.00		-2.60				
		2.60	Refusal	▼		Small inflows at top of rock

Remarks: Refusal on broken (blocky) sandstone/siltstone

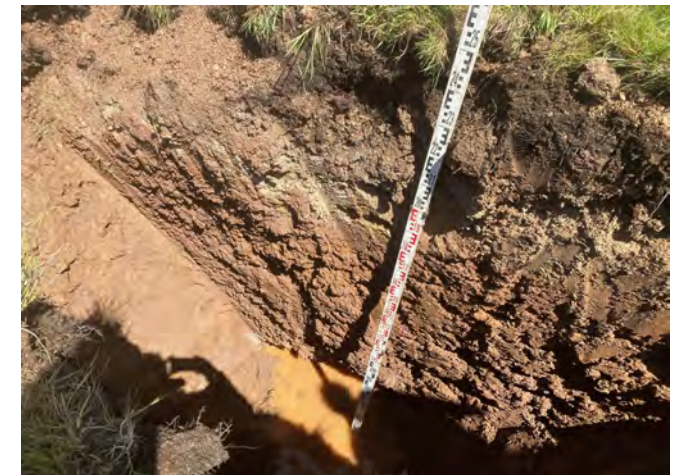
Trial Pit Log TP06

Depth	Symbol	Depth/Elev.	Description	Water Strikes	Sample Type	Comments
0.00		0.00	Ground Surface			
		0.00	Peaty Topsoil			
		-0.50	Soft, grey SILT			
		0.50	Firm, reddish brown, gravelly SILT			
1.00						
2.00						
		-2.40	Refusal	▼		Small inflows at top of rock
		2.40

Remarks: Refusal on broken (blocky) sandstone/siltstone

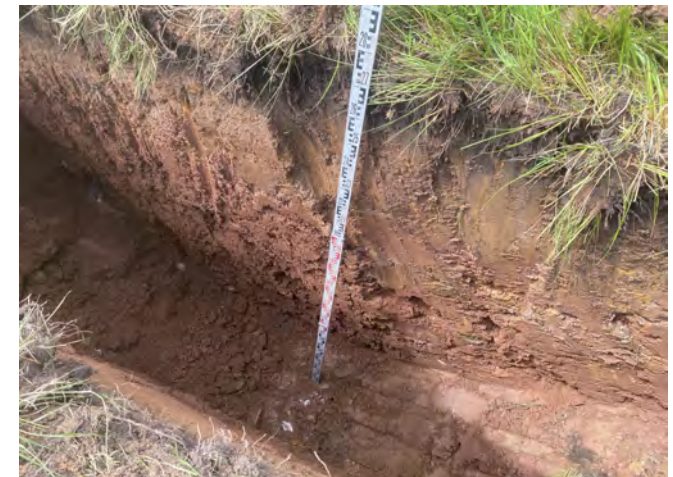
Trial Pit Log TP07

Depth	Symbol	Depth/Elev.	Description	Water Strikes	Sample Type	Comments
0.00		0.00	Ground Surface			
		0.00	Peaty Topsoil			
			Firm, reddish brown, slightly gravelly SILT			
1.00						
2.00						
		-2.80				
		2.80				
3.00

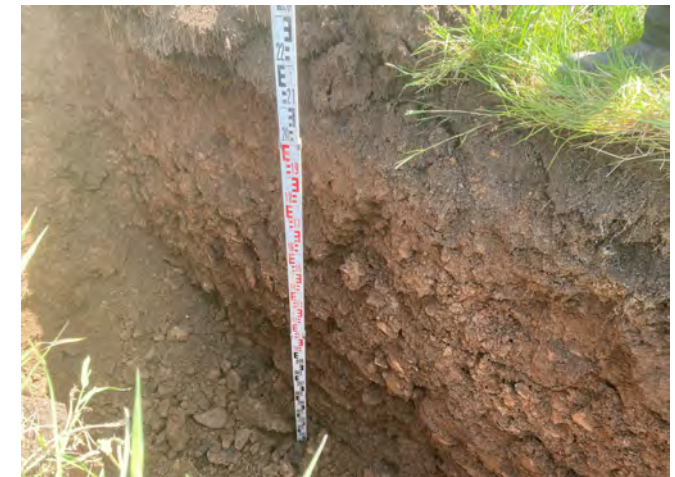
Trial Pit Log TP08

Depth	Symbol	Depth/Elev.	Description	Water Strikes	Sample Type	Comments
0.00		0.00	Ground Surface			
		0.00	Organic Topsoil			
		-0.40	Soft, grey SILT			
		0.40	Firm, reddish brown, gravelly SILT/CLAY			
1.00						
2.00						
		-2.20				
		2.20

Remarks: Refusal on broken (blocky) sandstone/siltstone

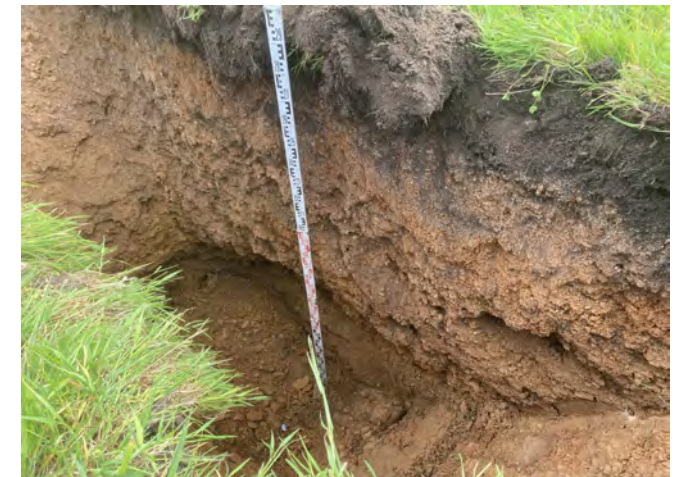
Trial Pit Log TP09

Depth	Symbol	Depth/Elev.	Description	Water Strikes	Sample Type	Comments
0.00		0.00	Ground Surface			
		0.00	Organic Topsoil			
		-0.40	Soft, grey SILT			
		0.40	Firm, reddish brown, gravelly SILT/CLAY			
1.00						
		-1.90				
2.00		1.90	Weak siltstone/shale			
		-2.90				
3.00		2.90

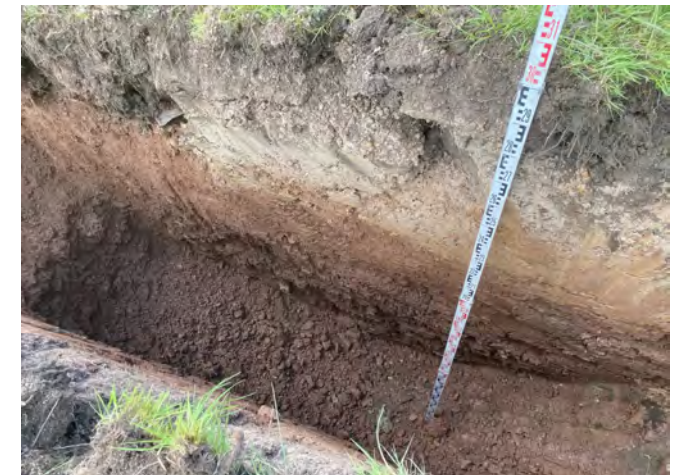
Trial Pit Log TP10

Depth	Symbol	Depth/Elev.	Description	Water Strikes	Sample Type	Comments
0.00		0.00	Ground Surface			
		0.00	Organic Topsoil			
		-0.70	Soft, grey SILT			
1.00		0.70	Firm, reddish brown, slightly gravelly SILT/CLAY			
2.00		-2.30	Weak siltstone/shale			
		2.30				
3.00		-2.90				
		2.90

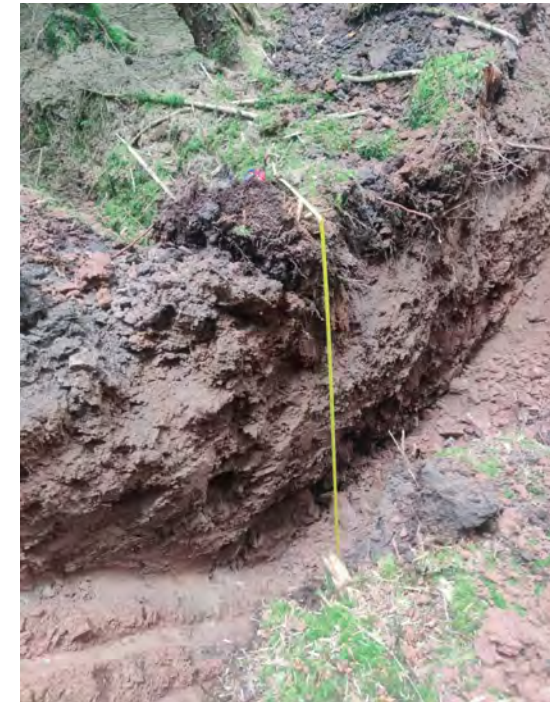
Trial Pit Log TP11

Depth	Symbol	Depth/Elev.	Description	Water Strikes	Sample Type	Comments
0.00		0.00	Ground Surface			
		0.00	Organic Topsoil			
		-0.30	Firm, grey/light brown, silty SAND			
		0.30	Firm, reddish brown, silty SAND with cobbles			
1.00						
		-1.80				
		1.80				
2.00

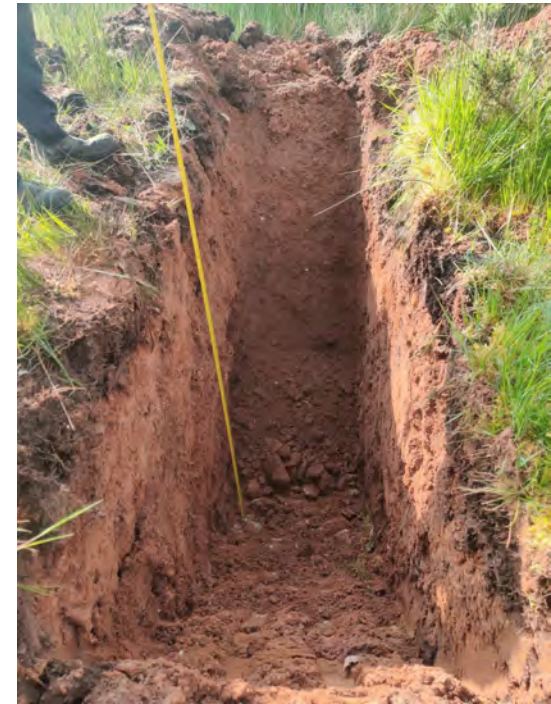
Trial Pit Log TP12

Depth	Symbol	Depth/Elev.	Description	Water Strikes	Sample Type	Comments
0.00		0.00	Ground Surface			
		0.00	Organic Topsoil			
		-0.20	Firm, grey CLAY			
		0.20	Firm, reddish brown, slightly gravelly, sandy CLAY			
1.00						
2.00		-2.00	Refusal			
		2.00

Remarks: Refusal on broken (blocky) sandstone/siltstone

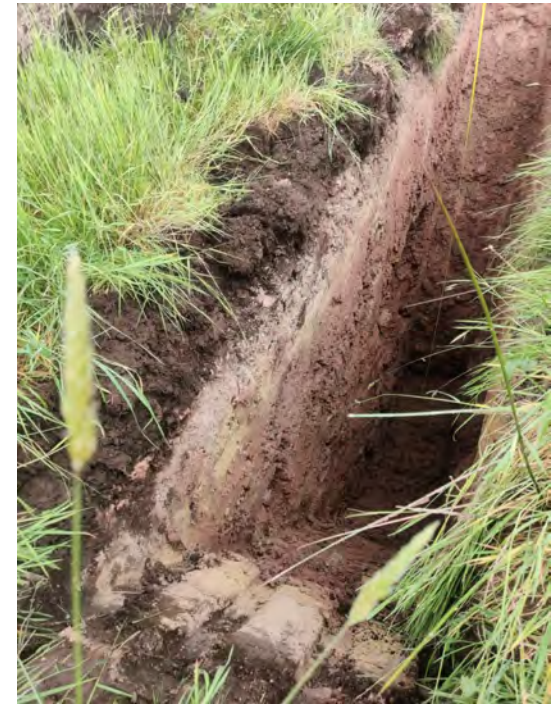
Trial Pit Log TP13

Depth	Symbol	Depth/Elev.	Description	Water Strikes	Sample Type	Comments
0.00		0.00	Ground Surface			
		0.00	Organic Topsoil			
			Firm, grey, sandy CLAY			
		-0.70	Firm, grey/orange, clayey SAND			
1.00		0.70	Firm, reddish purple, gravelly, silty SAND with cobbles			
2.00						
3.00						
4.00						
5.00		-5.00				
		5.00

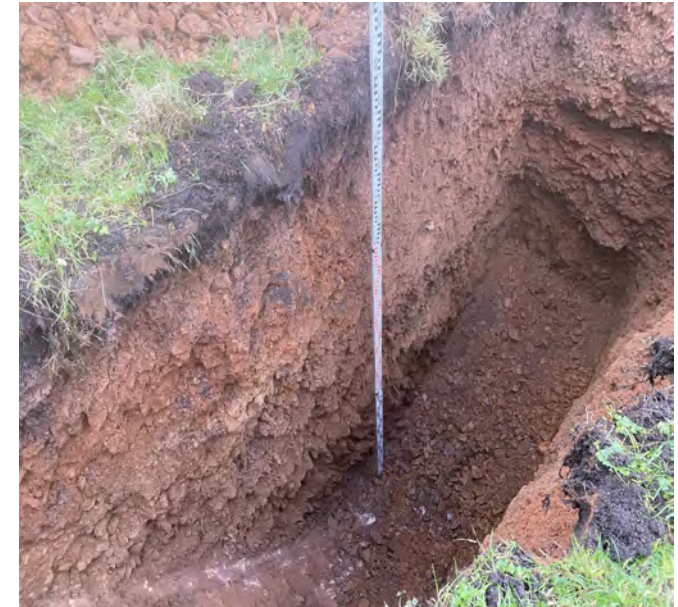
Trial Pit Log TP14

Depth	Symbol	Depth/Elev.	Description	Water Strikes	Sample Type	Comments
0.00		0.00	Ground Surface			
		0.00	Peaty Topsoil			
			Red, firm, very gravelly SILT/CLAY with cobbles			
1.00		-1.20				
		1.20	Weak SILTSTONE/SHALE			
2.00		-2.60				
		2.60

Remarks: Refusal on competent siltstone/shale

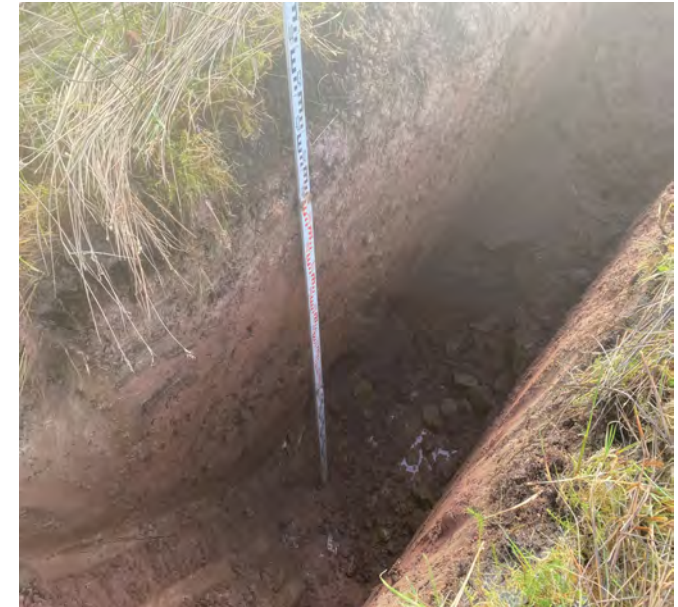
Trial Pit Log TP15

Depth	Symbol	Depth/Elev.	Description	Water Strikes	Sample Type	Comments
0.00		0.00	Ground Surface			
		0.00	Peaty Topsoil			
		-0.20				
		0.20	Grey, soft, sandy SILT			
		-0.40				
		0.40	Red, soft to firm, gravelly sandy SILT			
1.00						
		-1.60				
		1.60	Weathered blocky SANDSTONE			
2.00						
		-2.50				
		2.50

Remarks: Refusal on sandstone bedrock

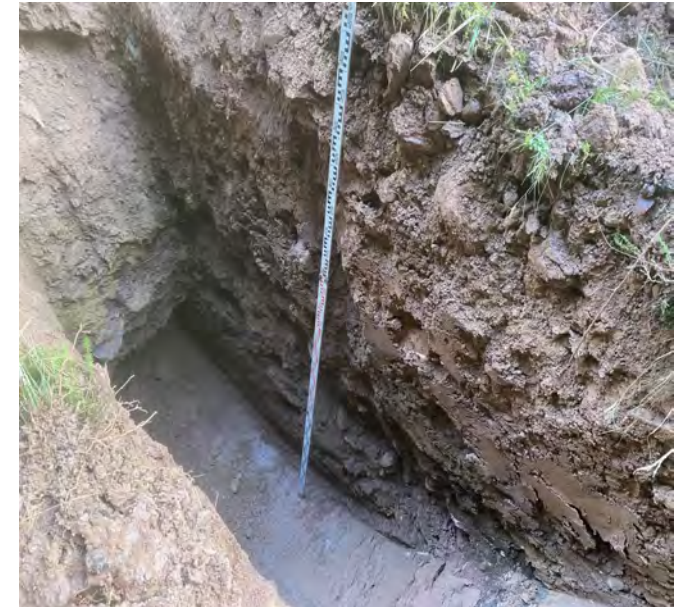
Trial Pit Log TP16

Depth	Symbol	Depth/Elev.	Description	Water Strikes	Sample Type	Comments
0.00		0.00	Ground Surface			
		0.00	Peaty Topsoil			
			Red, firm, sandy, gravelly SILT/CLAY			
1.00						
2.00						
3.00		-3.00 3.00

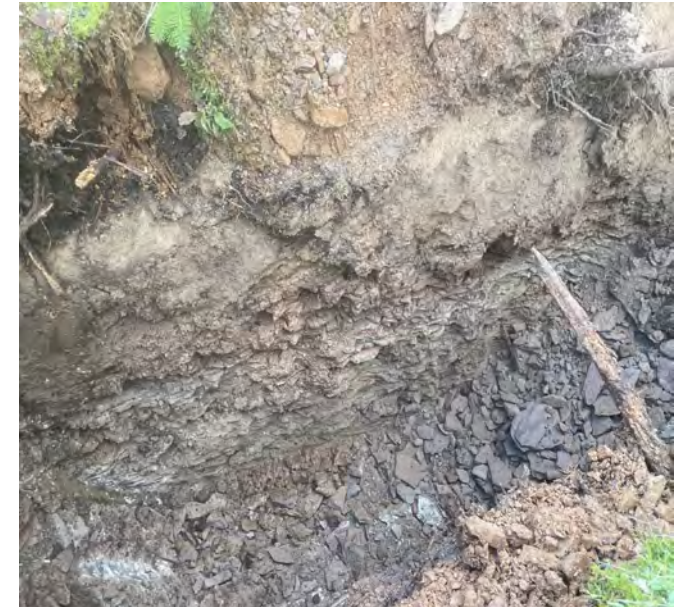
Trial Pit Log TP17

Depth	Symbol	Depth/Elev.	Description	Water Strikes	Sample Type	Comments
0.00		0.00	Ground Surface			
		0.00	Peaty Topsoil			
			Grey, soft, sandy SILT			
1.00		-1.00 1.00	Grey, weathered, flaggy SANDSTONE			
		-1.70 1.70

Remarks: Refusal on sandstone bedrock

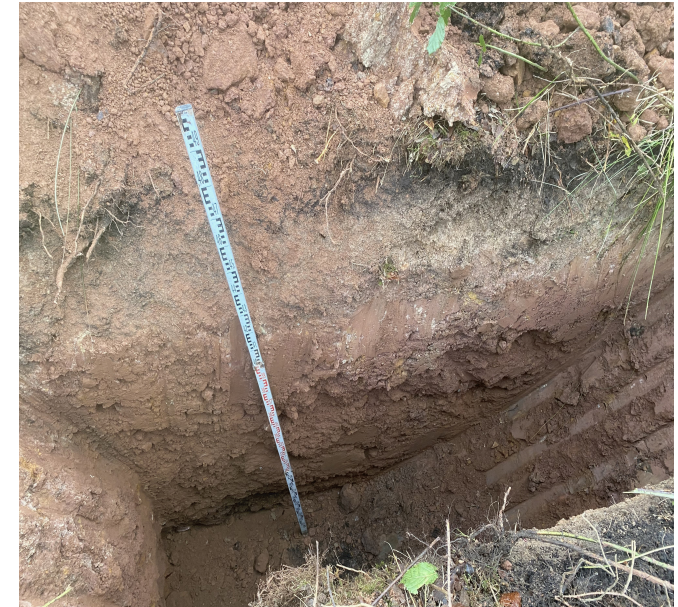
Trial Pit Log TP18

Depth	Symbol	Depth/Elev.	Description	Water Strikes	Sample Type	Comments
0.00		0.00	Ground Surface			
		0.00	Peaty Topsoil			
		-0.30	Soft, grey SILT			
		0.30	Red, firm, sandy, gravelly SILT			
1.00						
2.00						
		-2.70				
		2.70

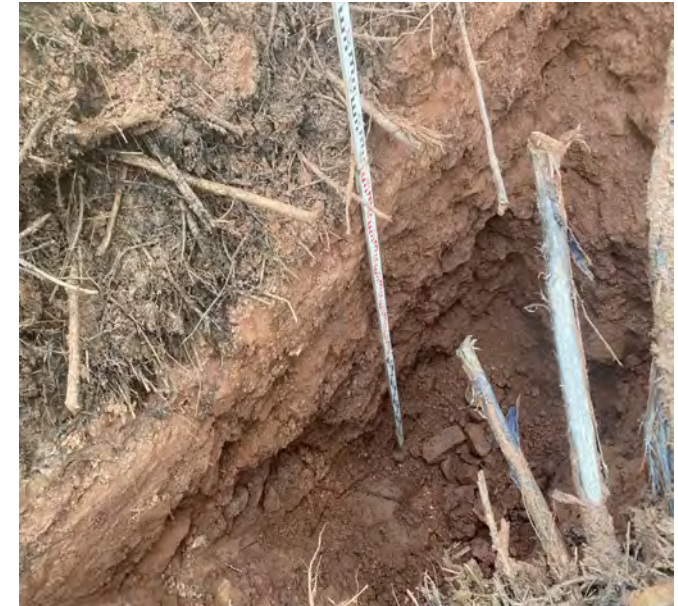
Trial Pit Log TP20

Depth	Symbol	Depth/Elev.	Description	Water Strikes	Sample Type	Comments
0.00		0.00	Ground Surface			
		0.00	Peaty Topsoil with tree roots			
		-0.30				
		0.30	Grey, soft SILT			
		-0.60				
		0.60	Red, firm, sandy gravelly SILT			
1.00						
		-2.00				
2.00		2.00	Weathered, blocky SANDSTONE			
		-2.30				
		2.30

Remarks: Refusal on sandstone bedrock

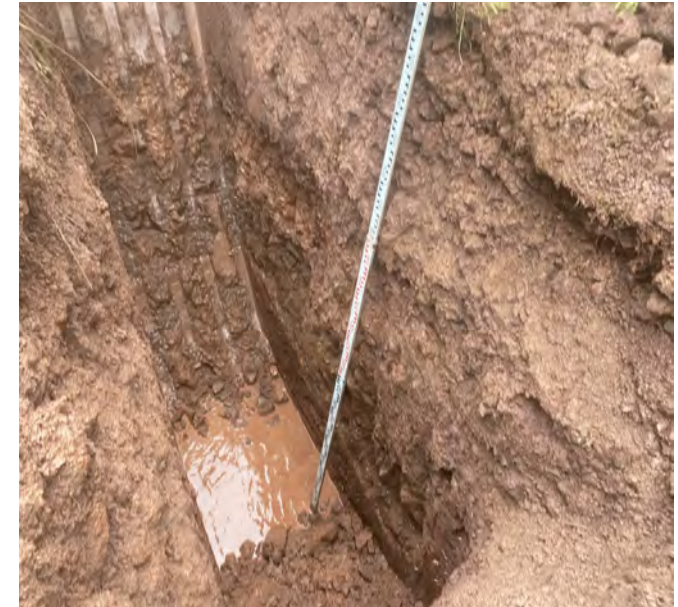
Trial Pit Log TP21

Depth	Symbol	Depth/Elev.	Description	Water Strikes	Sample Type	Comments
0.00		0.00	Ground Surface			
		0.00	Topsoil			
			Red, firm, gravelly SILT			
1.00		-1.20				
		1.20	Weak, weathered SILTSTONE/SHALE			
2.00		-2.50				
		2.50

Remarks: Refusal on competent siltstone/shale

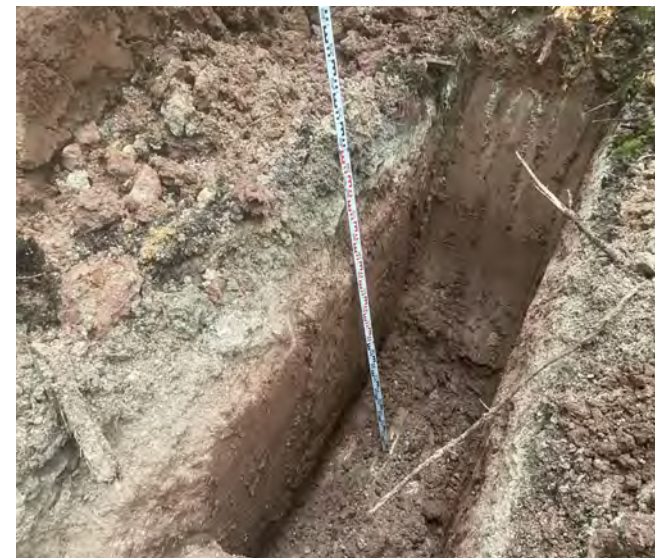
Trial Pit Log TP26

Depth	Symbol	Depth/Elev.	Description	Water Strikes	Sample Type	Comments
0.00		0.00	Ground Surface			
		0.00	Firm, reddish brown, sandy, gravelly SILT			
1.00						
2.00		-2.00				
		2.00

Refusal on strong blocky SILTSTONE/SANDSTONE

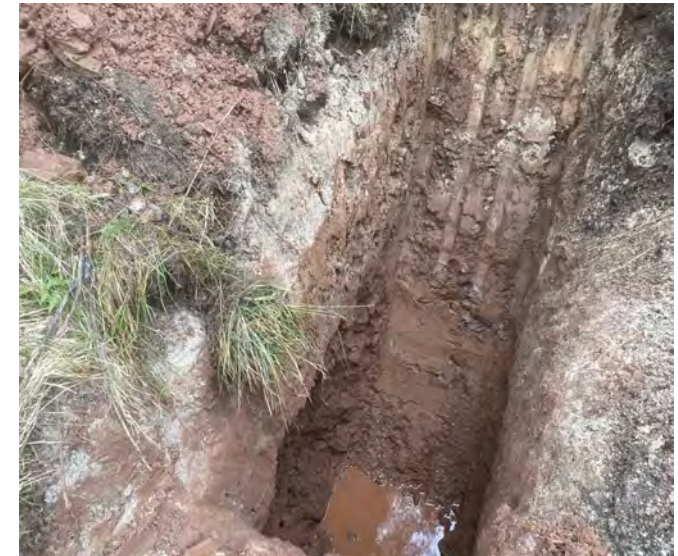
Trial Pit Log TP27

Depth	Symbol	Depth/Elev.	Description	Water Strikes	Sample Type	Comments
0.00		0.00	Ground Surface			
	×××××	0.00	Firm grey SILT			
	×××××	-0.40	Firm, reddish brown, sandy, gravelly SILT			
1.00	×××××	0.40				
	×××××	-1.50	Weathered blocky SILTSTONE/SANDSTONE			
2.00	×××××	1.50				
	×××××	-2.50				
		2.50

GW seepages below 1.3mbgl
