Appendix 7.2 – Site Investigation Report, 2019

S.I. Ltd Contract No: 5662

Kellystown,
Porterstown, Dublin 15
Site Investigation Report

Issue Date:	10/01/2020
Status	Final
Revision	1

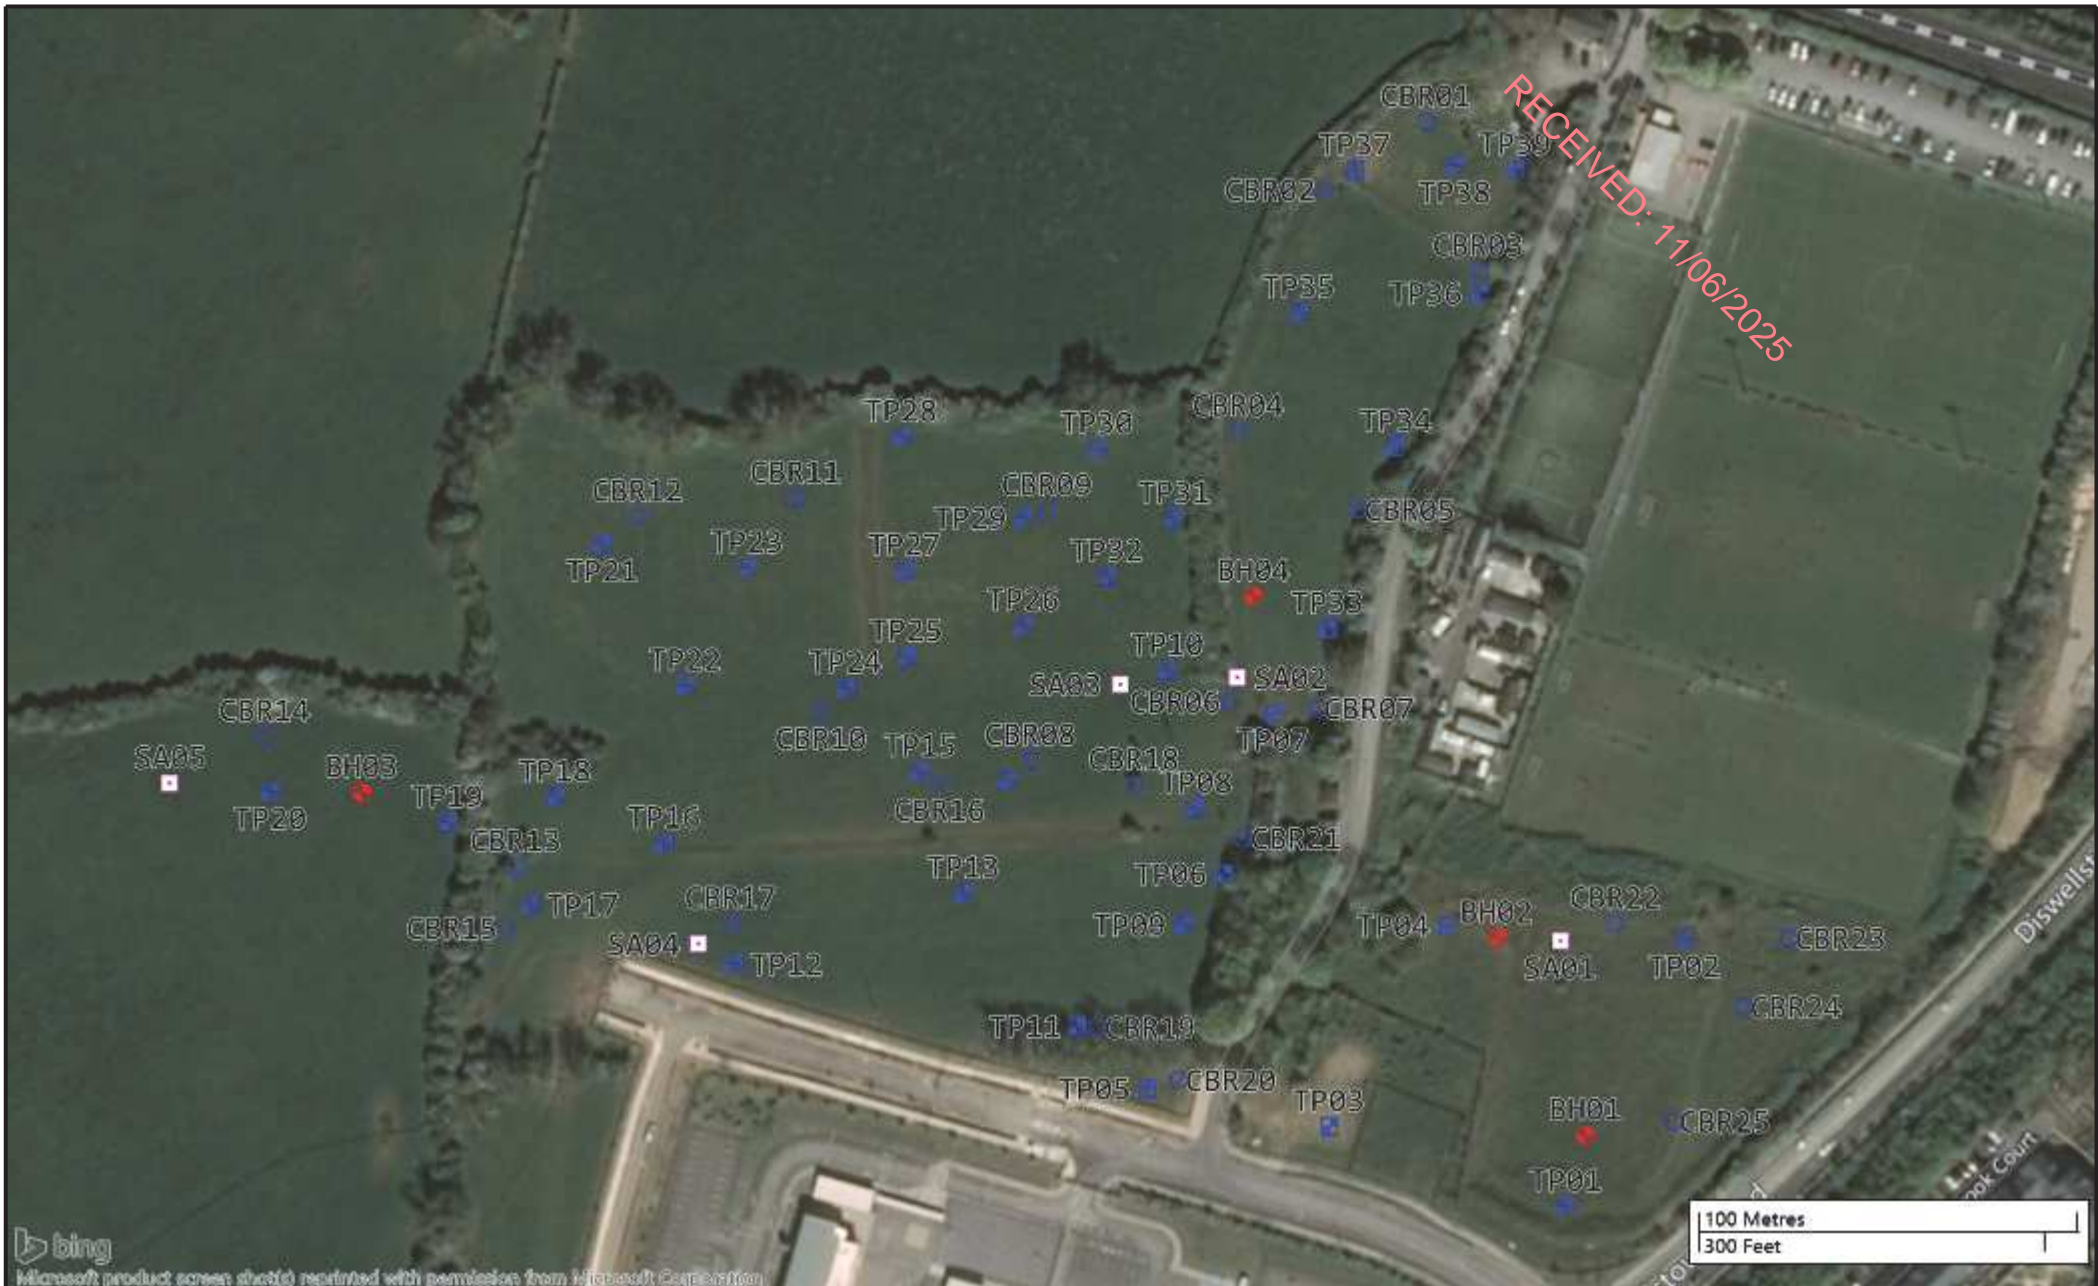
Site Investigations Ltd The Grange 12th Lock Road Lucan Co. Dublin T: 01 6108768 e: info@siteinvestigations.ie	Contract No:	5662	Client:	Castlethorn	Legend Key + Locations By Type - CP O Locations By Type - ICBR □ Locations By Type - IP
	Contract Name:	Kellystown	Engineer:	Waterman Moylan		
	Location:	Porterstown, Dublin 15	Scale:	1:2000		
	Title:	Site Plan	Drawn By:	SL
