Chapter 7:
Land and Soils

This section of the EIAR assesses the impacts of the proposed apartment development at the Frascati Shopping Centre Blackrock, on the land and soils in the area. This section should be read in conjunction with the architectural drawings for the development & the project description sections of this EIAR. The proposed residential extension consists of three floors of residential development above the rejuvenated Frascati Centre. An extra level of car parking will also be added to the existing car park structure to serve the development. A soils, geology and hydrogeology chapter was included with the previous EIS for the rejuvenation project. The proposed residential and car parks extensions do not involve any construction works below ground floor level and therefore will not have any impact on land and soils. Where ‘**Existing**’ is referred to in the text below it refers to the site prior to the commencement of the rejuvenation works in late 2016 and including the already in progress and near completion Frascati Shopping Centre Blackrock Rejuvenation works which has been covered in a separate previously submitted Report.

GROUND INVESTIGATION REPORT

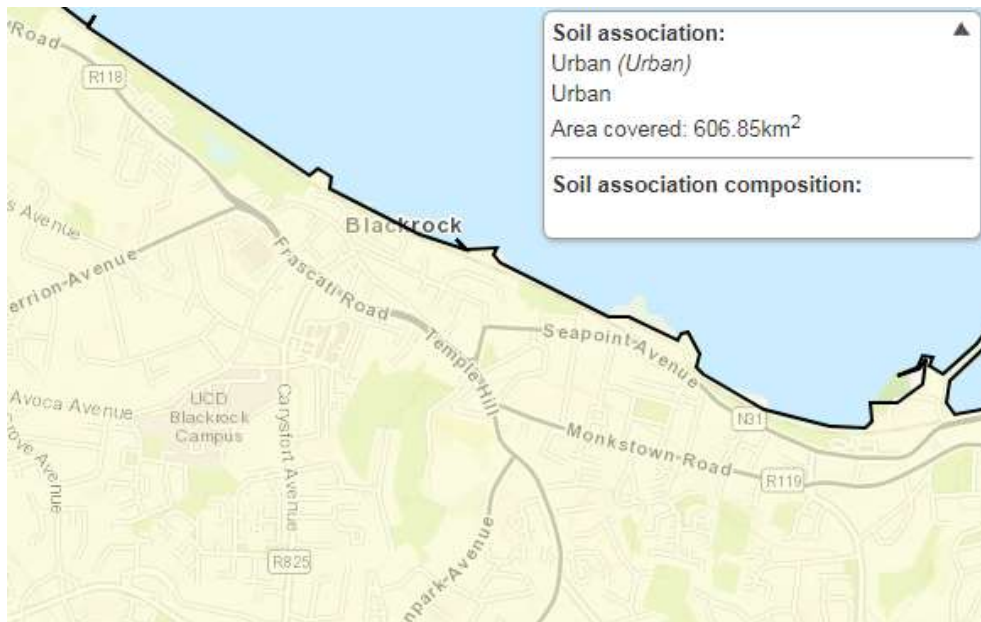
Teagasc soil maps classify soils beneath the majority of the site as Urban, Figure 7.3.

Figure 7.3 – Extract from Teagasc Soil Map.

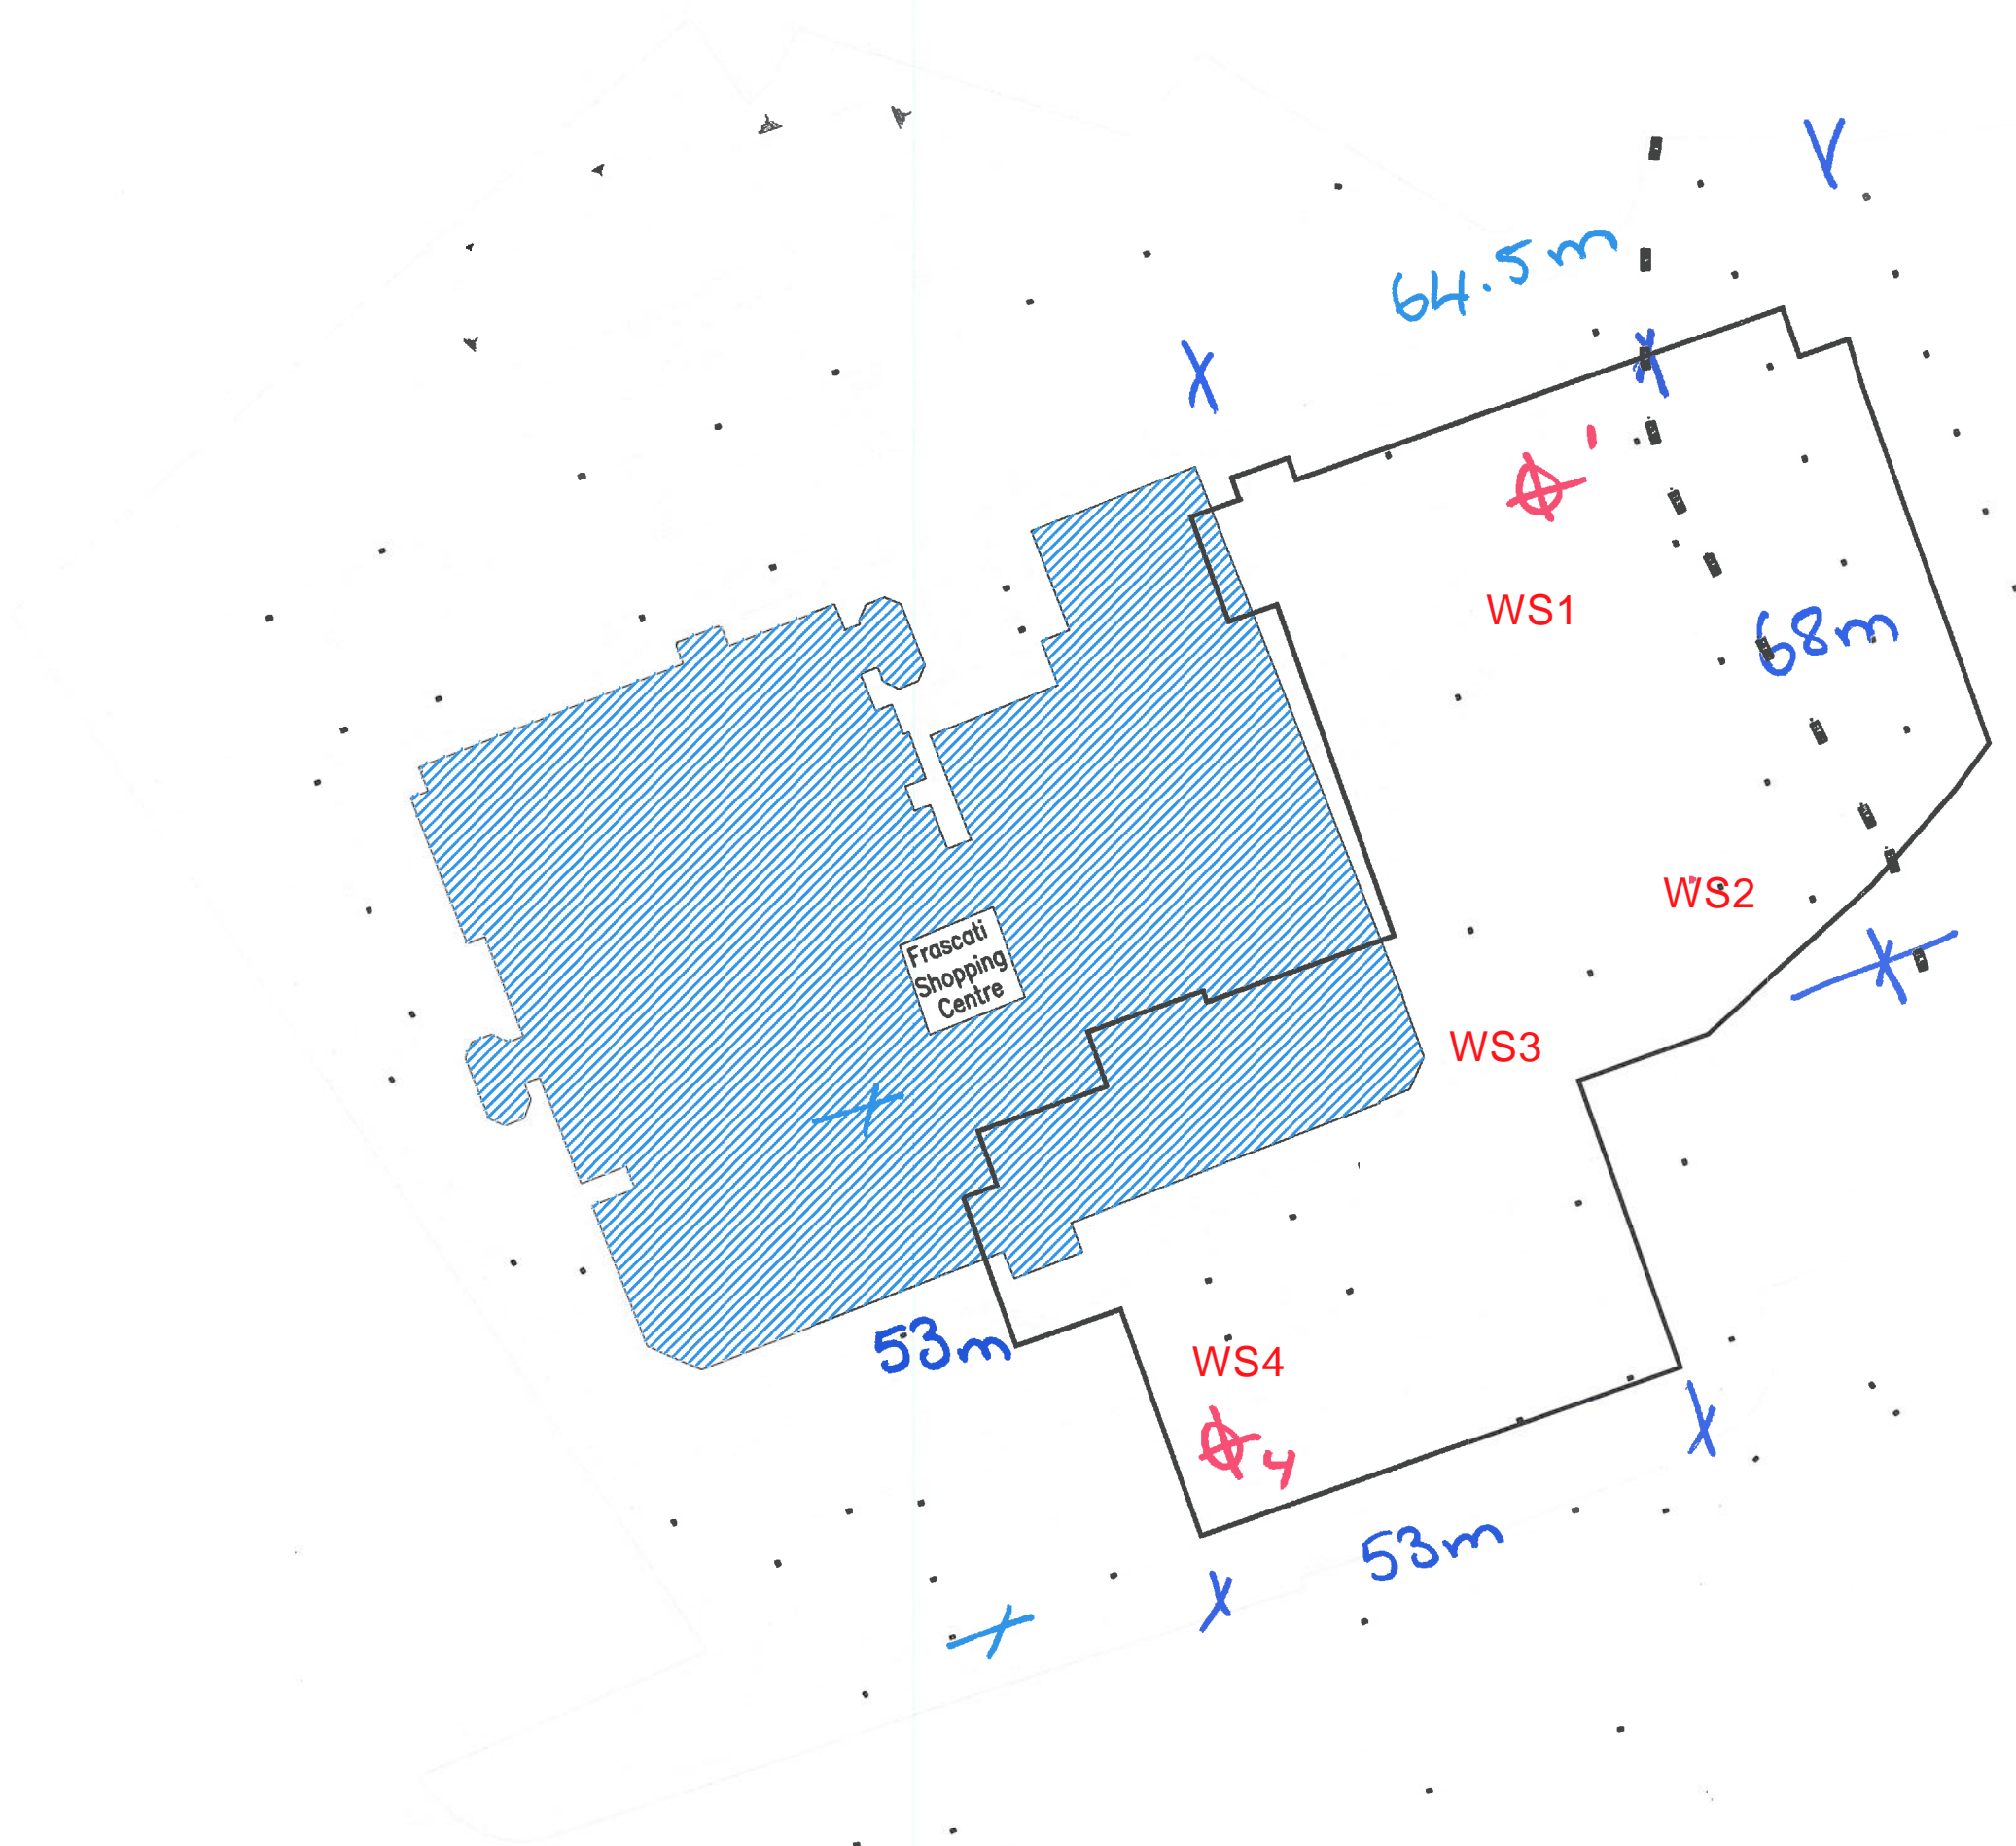
Ground Investigation Location Plan Frascati Shopping Centre

| ① | Depth of Dg

1.13m |

| ② | 1.09m |
| ③ | 2.085m |
| ④ | 2.385m |

- Visit project site to observe existing conditions
- Carry out 4 No. Window Sample boreholes to a maximum depth of 3.1m BGL
- Environmental Laboratory testing
- Report with recommendations
