Borrow Pit Assessment - Trial Pits			
Project title	Derryadd Wind Farm	Job number	10325
Client	Bord na Mona	File reference	TP/BP Dec 2017
Prepared by	John Dillon	Date	13th March 2018
Subject	Ground investigation (Trial Pits)		
IMT			
Site Location:	Derryadd		
Trial Pit No:	BP1		
Date & Time:	4 th Dec 2017		
BP Testing details:			
	The following layers were observed in this Trial Pit:		
	0.00 – 0.2 m: Shallow Black fibrous with rootlets		
	0.2 – 0.50 m: Light grey, soft, slightly sandy, gravelly CLAY		
	0.5m – 0.8 m: Light grey very soft slightly sandy silty CLAY with significant amount of gravel, cobbles and boulders.		
	Trial pit terminated at 0.7 m due to abundance of large angular boulders.		
Observations & recommendations:	No water present		
	· Relatively firm surface.		
	· Walls of trial pit stable

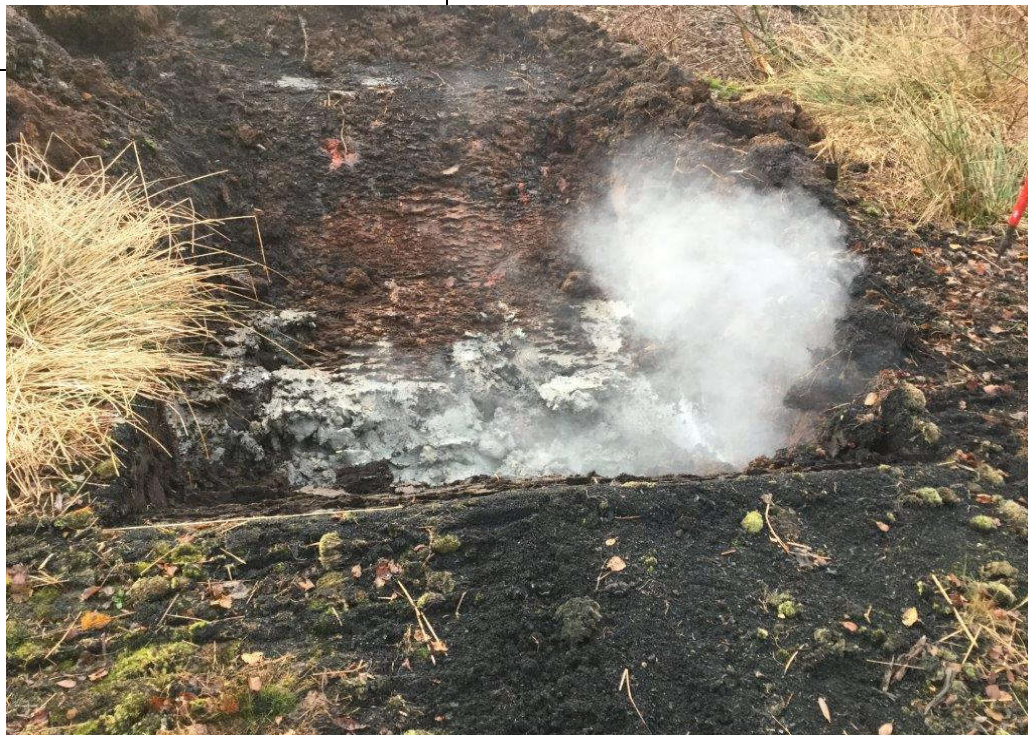
Borrow Pit Assessment - Trial Pits			
Project title	Derryadd Wind Farm	Job number	10325
Client	Bord na Mona	File reference	TP/BP Dec 2017
Prepared by	John Dillon	Date	13th March 2018
Subject	Ground investigation (Trial Pits)		
	IMT		
Site Location:	Derryadd		
Trial Pit No:	BP2		
Date & Time:	4 th Dec 2017		
BP Testing details:			
	The following layers were observed in this Trial Pit:		
	0.00 – 0.5 m: Shallow Black/brown fibrous with rootlets		
	0.5 – 2.5 m: Light grey, soft, slighty sandy, gravelly CLAY		
	2.5 m: Significant amount of gravel, cobbles and boulders. Boulders change from SR to Angular. Spring inflow from TP base, possible bedrock		
	Trial pit terminated at 2.5m due to abundance of large angular boulders and Bedrock		
Observations & recommendations:	Spring water inflow from TP base, possible bedrock		
	· Relatively firm surface.		
	· Walls of trial pit stable

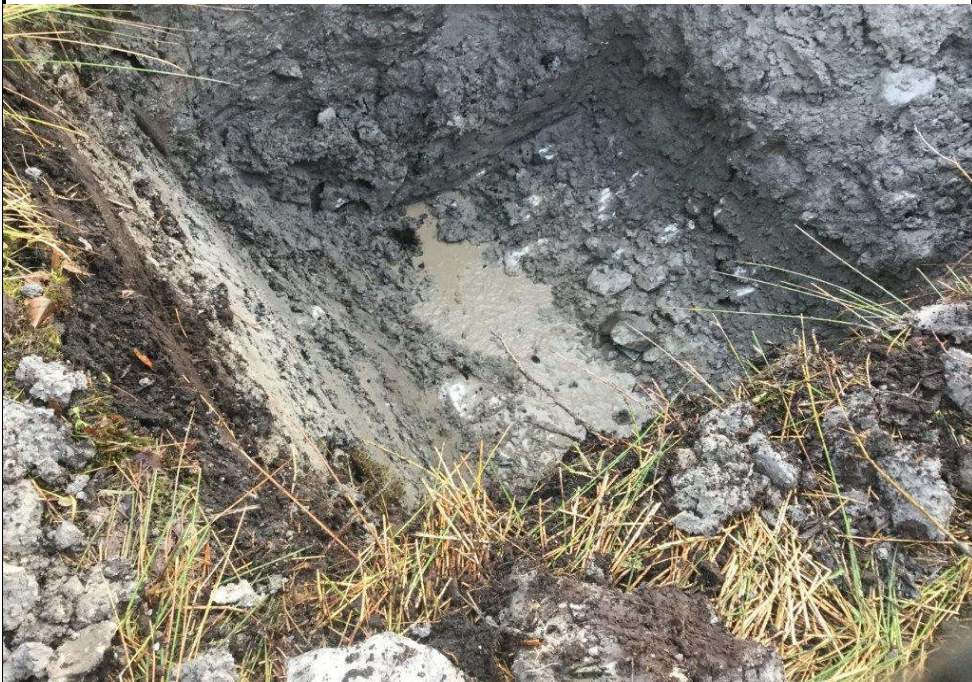
Borrow Pit Assessment - Trial Pits			
Project title	Derryadd Wind Farm	Job number	10325
Client	Bord na Mona	File reference	TP/BP Dec 2017
Prepared by	John Dillon	Date	13th March 2018
Subject	Ground investigation (Trial Pits)		
	IMT		
Site Location:	Derryadd		
Trial Pit No:	BP3		
Date & Time:	4 th Dec 2017		
BP Testing details:			
	The following layers were observed in this Trial Pit:		
	0.00 – 0.5 m: Shallow Black/brown fibrous with rootlets		
	0.5 – 2.5 m: Light grey, soft, slighty sandy, gravelly CLAY		
	2.5 m: Significant amount of gravel, cobbles and boulders. Boulders change from SR to Angular. Spring inflow from TP base, possible bedrock		
	Trial pit terminated at 2.5 m due to abundance of large angular boulders.		
Observations & recommendations:	Spring water inflow from TP base, possible bedrock		
	· Relatively firm surface.		
	· Walls of trial pit stable

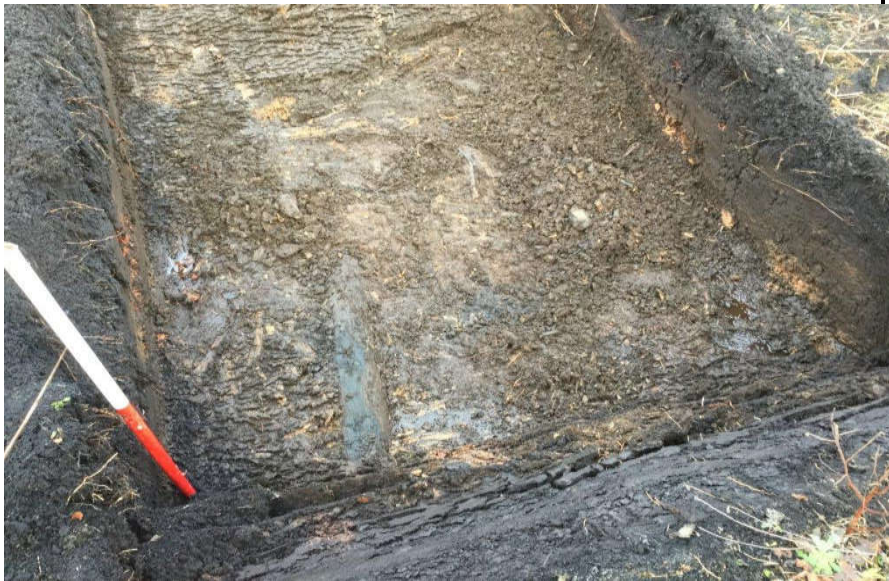
Borrow Pit Assessment - Trial Pits			
Project title	Derryadd Wind Farm	Job number	10325
Client	Bord na Mona	File reference	TP/BP Dec 2017
Prepared by	John Dillon	Date	13th March 2018
Subject	Ground investigation (Trial Pits)		
	IMT		
Site Location:	Derryadd		
Trial Pit No:	BP4		
Date & Time:	4 th Dec 2017		
BP Testing details:			
	The following layers were observed in this Trial Pit:		
	0.00 – 0.2 m: Shallow Black fibrous with rootlets		
	TP terminated at possibel ARCHAEOLOGY feature.		
Observations & recommendations:	Possible Archacology

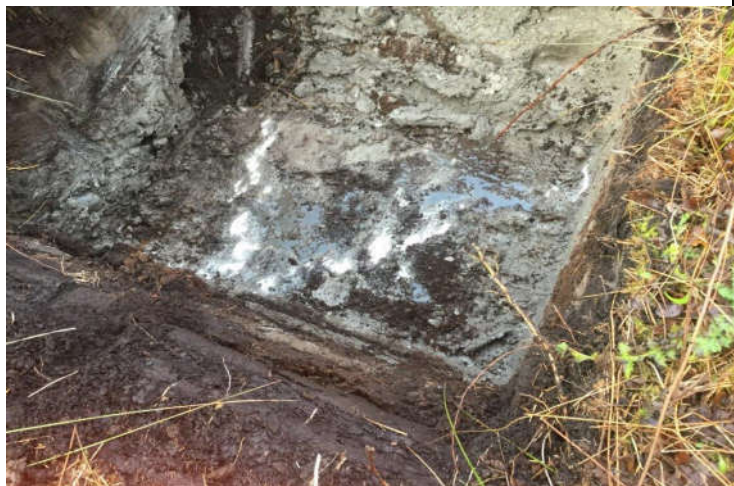
Borrow Pit Assessment - Trial Pits			
Project title	Derryadd Wind Farm	Job number	10325
Client	Bord na Mona	File reference	TP/BP Dec 2017
Prepared by	John Dillon	Date	13th March 2018
Subject	Ground investigation (Trial Pits)		
	IMT		
Site Location:	Derryadd		
Trial Pit No:	BP5		
Date & Time:	4 th Dec 2017		
BP Testing details:			
	The following layers were observed in this Trial Pit:		
	0.00 – 0.15 m: Shallow Black fibrous with rootlets		
	0.15 – 1.2 m: Light grey, soft, slighty sandy, gravelly SILT/CLAY		
	1.2m: Significant amount of gravel, cobbles and boulders. Boulders change from SR to Angular. Spring inflow from TP base, bedrock evident		
Observations & recommendations:	Large inflow at the base of the trail pit. Inflow is from the bedrock		
	· Relatively firm surface.		
	· Walls of trial pit stable

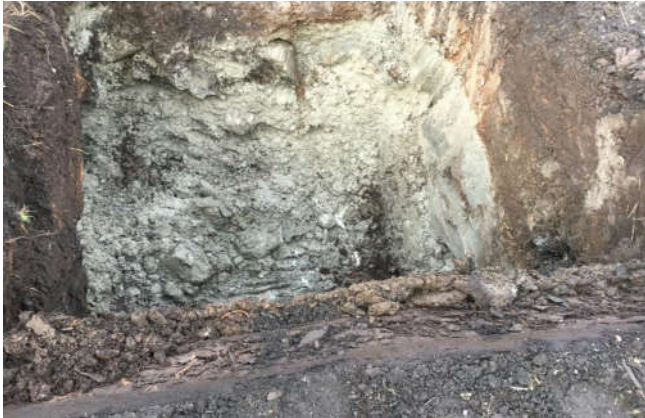
Borrow Pit Assessment - Trial Pits			
Project title	Derryadd Wind Farm	Job number	10325
Client	Bord na Mona	File reference	TP/BP Dec 2017
Prepared by	John Dillon	Date	13th March 2018
Subject	Ground investigation (Trial Pits)		
	IMT		
Site Location:	Derryadd		
Trial Pit No:	BP6		
Date & Time:	4 th Dec 2017		
BP Testing details:			
	The following layers were observed in this Trial Pit:		
	0.00 – 1.2 m: Shallow Black fibrous with rootlets		
	1.2 – 2.80 m: Light gre, soft, slighty sandy, gravelly CLAY. Cobbles SR becoming		
	nated at 2.8 m due to abundance of large angular boulders and water inflows. Po		
Observations & recommendations:	Possible Archaeology on the southern face of the trial pit		
	<ul style="list-style-type: none"> · Relatively firm surface. · Walls of trial pit stable

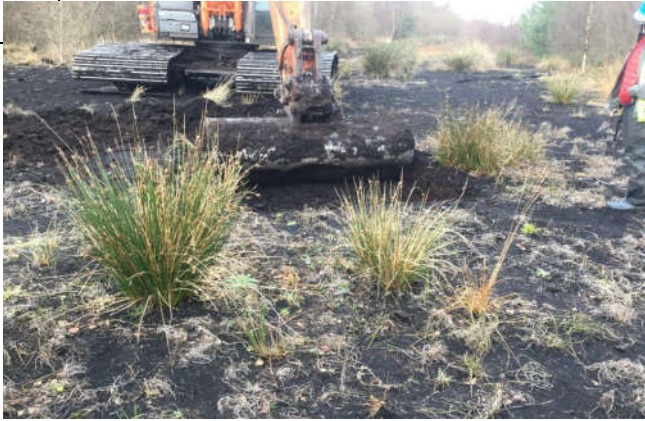
Borrow Pit Assessment - Trial Pits			
Project title	Derryadd Wind Farm	Job number	10325
Client	Bord na Mona	File reference	TP/BP Dec 2017
Prepared by	John Dillon	Date	13th March 2018
Subject	Ground investigation (Trial Pits)		
	IMT		
Site Location:	Derryadd		
Trial Pit No:	BP6		
Date & Time:	4 th Dec 2017		
BP Testing details:	The following layers were observed in this Trial Pit:		
	0.00 – 1.0 m: Shallow Black/brown peat with rootlets		
	1.0 – 1.4 m: Light grey/olive, soft, organic silts and shelly marl.		
	1.4 – 2.70 m: Light grey, soft, slightly sandy, gravelly CLAY. Cobbles SR . Obstruction at the base		
Observations & recommendations:	Trial pit terminated at 2.7 m due to a large boulders. Possible bedrock however not major water inflows suggesting bedrock maybe deeper at this location		
	· Relatively firm surface.		
	· Walls of trial pit stable

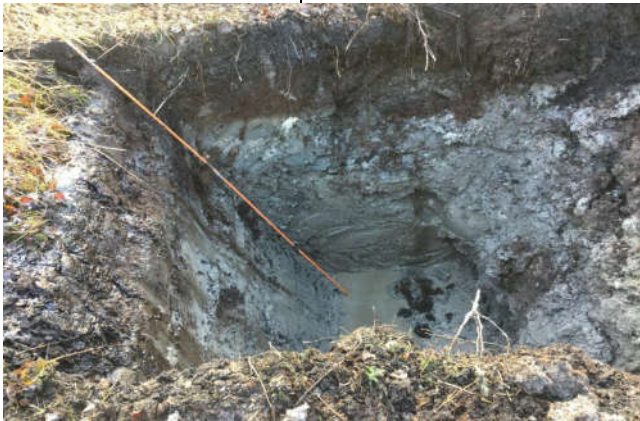
Borrow Pit Assessment - Trial Pits			
Project title	Derryadd Wind Farm	Job number	10325
Client	Bord na Mona	File reference	TP/BP Dec 2017
Prepared by	John Dillon	Date	13th March 2018
Subject	Ground investigation (Trial Pits)		
	IMT		
Site Location:	Derryadd		
Trial Pit No:	BP6		
Date & Time:	4 th Dec 2017		
BP Testing details:			
	The following layers were observed in this Trial Pit:		
	0.00 – 1.2 m: Shallow Black fibrous with rootlets		
	1.2 – 2.80 m: Light gre, soft, slighty sandy, gravelly CLAY. Cobbles SR becoming		
	nated at 2.8 m due to abundance of large angular boulders and water inflows. Po		
Observations & recommendations:			
	· Relatively firm surface.		
	· Walls of trial pit stable

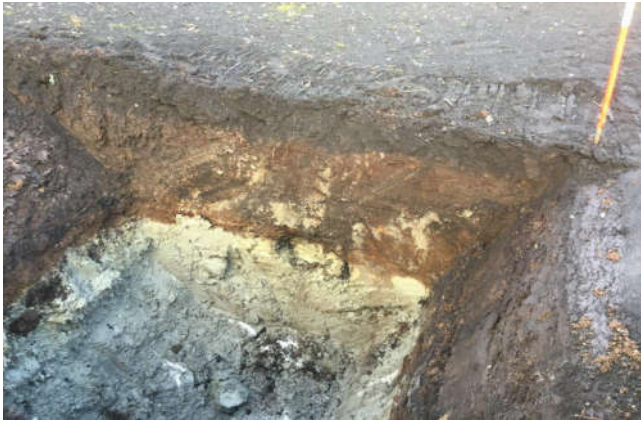
Borrow Pit Assessment - Trial Pits			
Project title	Deryadd Wind Farm	Job number	10325
Client	Bord na Mona	File reference	TP/BP Dec 2017
Prepared by	John Dillon	Date	13th March 2018
Subject	Ground investigation (Trial Pits)		
	IMT		
Site Location:	Deryadd		
Trial Pit No:	BP6		
Date & Time:	4 th Dec 2017		
BP Testing details:	The following layers were observed in this Trial Pit:		
	0.00 – 1.2 m: Black fibrous overlying reddish brown peat with rootlets and timber		
	1.2 – 1.4 m: Light grey/olive, soft, organic silts and shelly marl. Cobbles SR becoming angular at base		
	1.4 – 2.70 m: Light grey, soft, slightly sandy, gravelly CLAY. Cobbles SR . Obstruction at the base		
Observations & recommendations:	2.8 m due to obstruction. Possible bedrock however cobbles remained subround		
	· Relatively firm surface.		
	· Walls of trial pit stable		
	No Water inflows

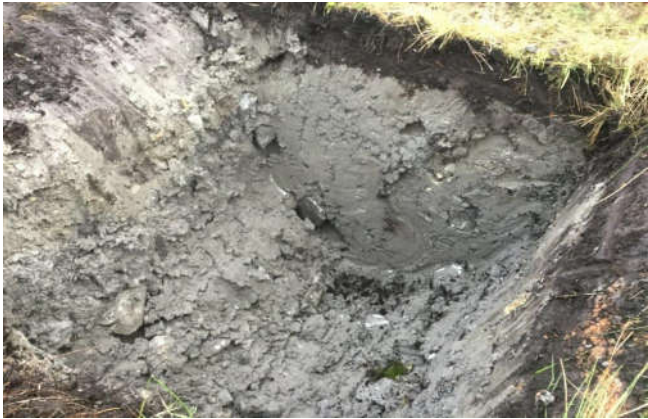
Borrow Pit Assessment - Trial Pits			
Project title	Derryadd Wind Farm	Job number	10325
Client	Bord na Mona	File reference	TP/BP Dec 2017
Prepared by	John Dillon	Date	13th March 2018
Subject	Ground investigation (Trial Pits)		
Site Location:	Derryadd		
Trial Pit No:	BP8		
Date & Time:	4 th Dec 2017		
BP Testing details:	The following layers were observed in this Trial Pit:		
	0.00 – 0.20 m: Interbedded black and brown organic peat		
	0.2 – 2.5 m: Sandy very silty/clayey GRAVEL with numerous cobbles and boulders. Moist and moderately dense. Mottled light brown, olive, grey in top 1.4 m		
	Trial pit terminated at 2.5 m due to abundance of large boulders.		
Observations & recommendations:	Relatively firm surface.		
	Walls of trial pit slightly unstable and crumbling		
	No Water inflows

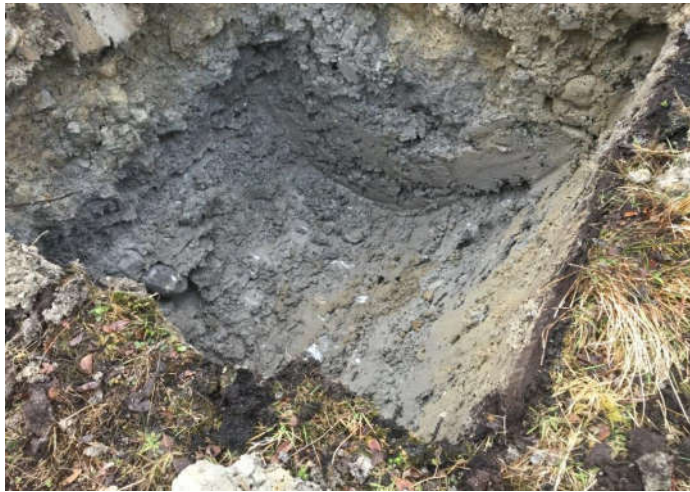
Borrow Pit Assessment - Trial Pits			
Project title	Derryadd Wind Farm	Job number	10325
Client	Bord na Mona	File reference	TP/BP Dec 2017
Prepared by	John Dillon	Date	13th March 2018
Subject	Ground investigation (Trial Pits)		
	IMT		
Site Location:	Derryadd		
Trial Pit No:	BP9		
Date & Time:	4 th Dec 2017		
BP Testing details:			
	The following layers were observed in this Trial Pit:		
	0.00 – 0.20 m: Interbedded black and brown organic peat		
	0.2 – 2.5 m: Sandy very silty/clayey GRAVEL with numerous cobbles and boulders. Moist and moderately dense. Mottled light brown, olive, grey in top 1.2 m		
Observations & recommendations:	no major water inflows		
	Relatively firm surface.		
	Walls of trial pit slightly unstable and crumbling

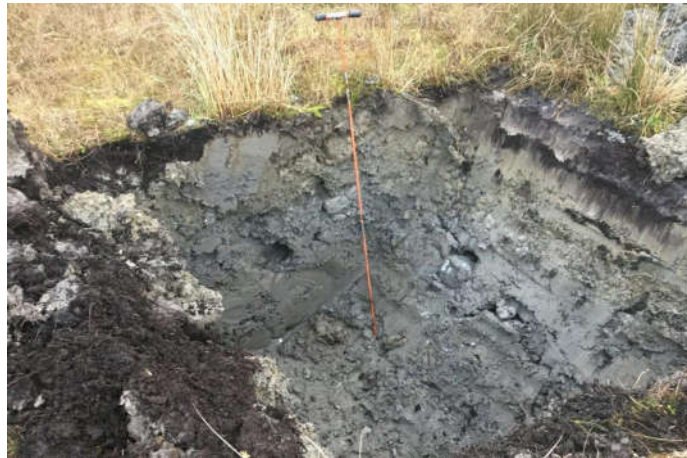
Borrow Pit Assessment - Trial Pits			
Project title	Derryadd Wind Farm	Job number	10325
Client	Bord na Mona	File reference	TP/BP Dec 2017
Prepared by	John Dillon	Date	13th March 2018
Subject	Ground investigation (Trial Pits)		
	IMT		
Site Location:	Derryadd		
Trial Pit No:	BP10		
Date & Time:	4 th Dec 2017		
BP Testing details:			
	0.00 – 0.20 m: Interbedded black and brown organic peat		
	0.2 – 2.5 m: Sandy very silty/clayey GRAVEL with numerous cobbles and boulders.		
	Moist and moderately dense. Mottled light brown, olive, grey in top 1.4 m		
	Trial pit terminated at 2.5 m due to abundance of large angular boulders.		
Observations & recommendations:	No major water inflows		
	Relatively firm surface.		
	Walls of trial pit slightly unstable and crumbling

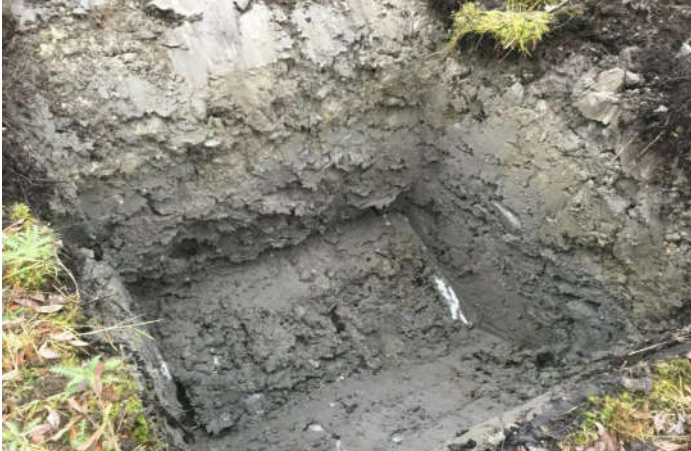
Borrow Pit Assessment - Trial Pits			
Project title	Derryadd Wind Farm	Job number	10325
Client	Bord na Mona	File reference	TP/BP Dec 2017
Prepared by	John Dillon	Date	13th March 2018
Subject	Ground investigation (Trial Pits)		
	IMT		
Site Location:	Derryadd		
Trial Pit No:	BP11		
Date & Time:	4 th Dec 2017		
BP Testing details:			
	0.00 – 0.20 m: Interbedded black and brown organic peat		
	0.2 – 2.4m: Sandy very silty/clayey GRAVEL with numerous cobbles and boulders.		
	Moist and moderately dense. Mottled light brown, olive, grey in top 1.6 m		
	Trial pit terminated at 2.4m due to abundance of large angular boulders.		
Observations & recommendations:			
	Relatively firm surface.		
	Walls of trial pit slightly unstable and crumbling		
	No major water inflows

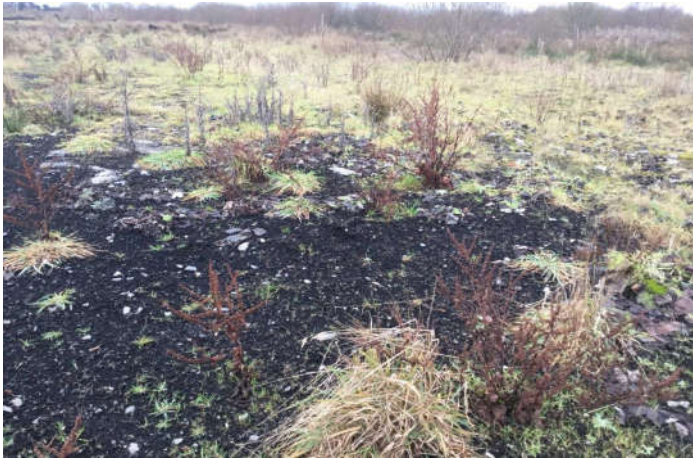
Borrow Pit Assessment - Trial Pits			
Project title	Derryadd Wind Farm	Job number	10325
Client	Bord na Mona	File reference	TP/BP Dec 2017
Prepared by	John Dillon	Date	13th March 2018
Subject	Ground investigation (Trial Pits)		
	IMT		
Site Location:	Derryadd		
Trial Pit No:	BP12		
Date & Time:	5th Dec 2017		
BP Testing details:			
	The following layers were observed in this Trial Pit:		
	0.00 – 0.20 m: black organic peat		
	0.2 – 0.50 m: Weathered bedrock with regular angular blocks of pale grey,		
Observations & recommendations:	Water inflows at the bedrock		
	Relatively firm surface.		
	Walls of trial pit slightly unstable and crumbling

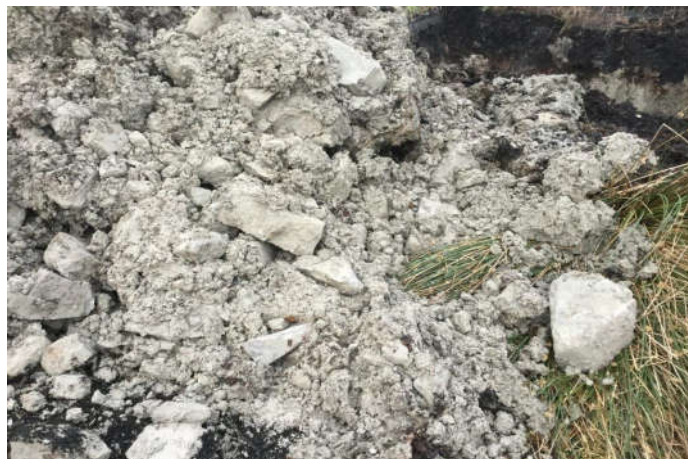
Borrow Pit Assessment - Trial Pits			
Project title	Derryadd Wind Farm	Job number	10325
Client	Bord na Mona	File reference	TP/BP Dec 2017
Prepared by	John Dillon	Date	13th March 2018
Subject	Ground investigation (Trial Pits)		
	IMT		
Site Location:	Derryadd		
Trial Pit No:	BP13		
Date & Time:	5th Dec 2017		
BP Testing details:			
	The following layers were observed in this Trial Pit:		
	0.00 – 0.20 m: black organic peat		
	0.2 – 0.50 m: Weathered bedrock with regular angular blocks of pale grey,		
Observations & recommendations:	Water inflows at the bedrock surface

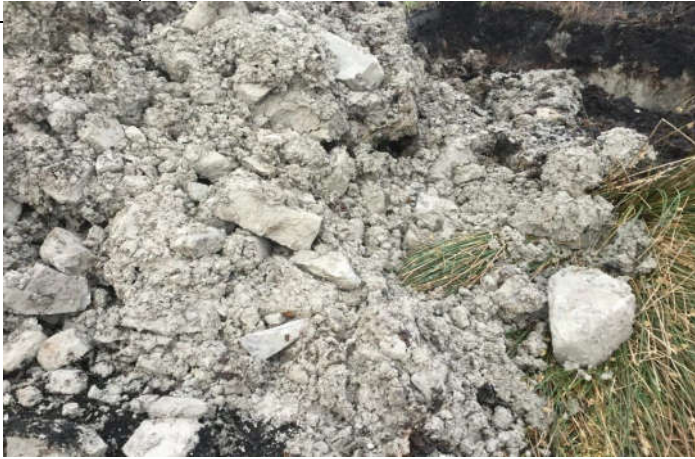
Borrow Pit Assessment - Trial Pits			
Project title	Derryadd Wind Farm	Job number	10325
Client	Bord na Mona	File reference	TP/BP Dec 2017
Prepared by	John Dillon	Date	13th March 2018
Subject	Ground investigation (Trial Pits)		
	IMT		
Site Location:	Derryadd		
Trial Pit No:	BP14		
Date & Time:	5th Dec 2017		
BP Testing details:			
	The following layers were observed in this Trial Pit:		
	0.00 – 0.10 m: black organic peat		
	0.1– 2.3 m: Light grey/olive, soft, slightly sandy, gravelly CLAY. Cobbles SR .		
Observations & recommendations:	No water inflow. Not certain that bedrock is present however angular blocks of limestone are present		
	Possible Bedrock or Obstruction at 2.3m

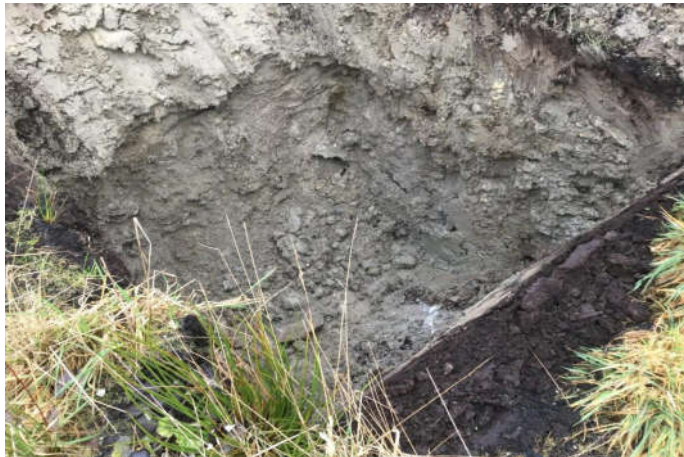
Borrow Pit Assessment - Trial Pits			
Project title	Derryadd Wind Farm	Job number	10325
Client	Bord na Mona	File reference	TP/BP Dec 2017
Prepared by	John Dillon	Date	13th March 2018
Subject	Ground investigation (Trial Pits)		
	IMT		
Site Location:	Derryadd		
Trial Pit No:	BP15		
Date & Time:	5th Dec 2017		
BP Testing details:			
	The following layers were observed in this Trial Pit:		
	0.00 – 0.30 m: black organic peat		
	0.3– 2.5 m: Light grey/olive, soft, slightly sandy, gravelly CLAY. Cobbles SR .		
Observations & recommendations:	No significant water inflows

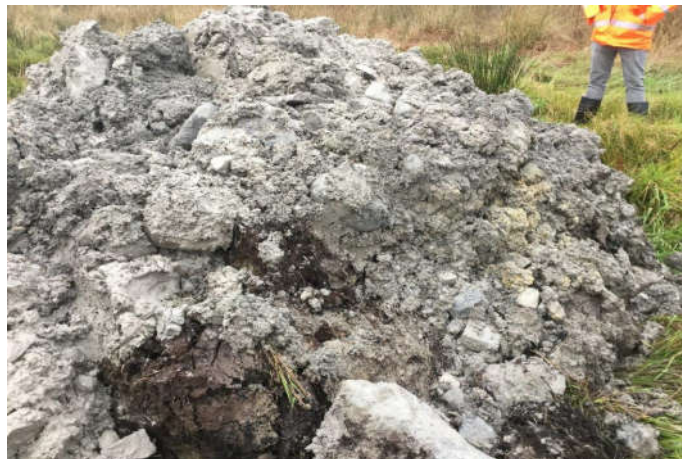
Borrow Pit Assessment - Trial Pits			
Project title	Derryadd Wind Farm	Job number	10325
Client	Bord na Mona	File reference	TP/BP Dec 2017
Prepared by	John Dillon	Date	13th March 2018
Subject	Ground investigation (Trial Pits)		
	IMT		
Site Location:	Derryadd		
Trial Pit No:	BP16		
Date & Time:	5th Dec 2017		
BP Testing details:			
	The following layers were observed in this Trial Pit:		
	0.00 – 0.30 m: black organic peat		
	0.3– 2.2 m: Light grey/olive, soft, slightly sandy, gravelly CLAY. Cobbles SR .		
Observations & recommendations:	Water inflows at the bedrock		
	Relatively firm surface.		
	Walls of trial pit slightly unstable and crumbling		
	Possible Bedrock or Obstruction at 2.2m

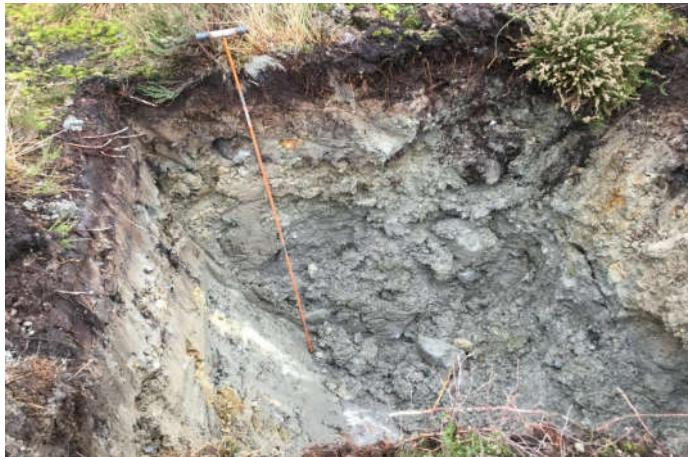
Borrow Pit Assessment - Trial Pits			
Project title	Derryadd Wind Farm	Job number	10325
Client	Bord na Mona	File reference	TP/BP Dec 2017
Prepared by	John Dillon	Date	13th March 2018
Subject	Ground investigation (Trial Pits)		
	IMT		
Site Location:	Derryadd		
Trial Pit No:	BP17		
Date & Time:	5th Dec 2017		
BP Testing details:			
	The following layers were observed in this Trial Pit:		
	0.00 – 0.30 m: black organic peat		
	0.3– 2.1 m: Light grey/olive, soft, slightly sandy, gravelly CLAY. Cobbles SR .		
	Obstruction at 2.1m		
Observations & recommendations:	No significant water inflows		
	Relatively firm surface.		
	Walls of trial pit slightly unstable and crumbling

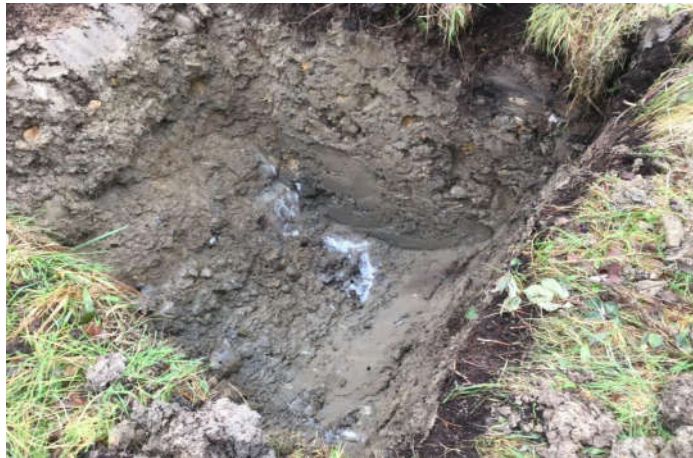
Borrow Pit Assessment - Trial Pits			
Project title	Derryadd Wind Farm	Job number	10325
Client	Bord na Mona	File reference	TP/BP Dec 2017
Prepared by	John Dillon	Date	13th March 2018
Subject	Ground investigation (Trial Pits)		
	IMT		
Site Location:	Derryadd		
Trial Pit No:	BP18		
Date & Time:	5th Dec 2017		
BP Testing details:			
	The following layers were observed in this Trial Pit:		
	0.00 – 0.30 m: black organic peat		
	0.3– 3 m: Light grey/olive, soft, slightly sandy, gravelly CLAY. Cobbles SR .		
	Possible Bedrock or Obstruction at 3m		
Observations & recommendations:	Water inflows at the bedrock surface		
	Relatively firm surface.		
	Walls of trial pit slightly unstable and crumbling

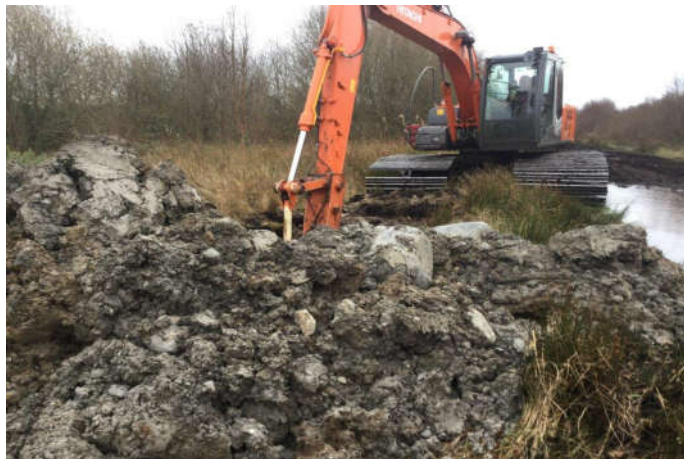
Borrow Pit Assessment - Trial Pits			
Project title	Derryadd Wind Farm	Job number	10325
Client	Bord na Mona	File reference	TP/BP Dec 2017
Prepared by	John Dillon	Date	13th March 2018
Subject	Ground investigation (Trial Pits)		
	IMT		
Site Location:	Derryadd		
Trial Pit No:	BP19		
Date & Time:	5th Dec 2017		
BP Testing details:			
	The following layers were observed in this Trial Pit:		
	0.00 – 0.20 m: black organic peat		
	0.2– 2 m: Light grey/olive, soft, slightly sandy, gravelly CLAY. Cobbles SR .		
	Obstruction at 2m		
Observations & recommendations:	No significant water inflows		
	Relatively firm surface.		
	Walls of trial pit slightly unstable and crumbling

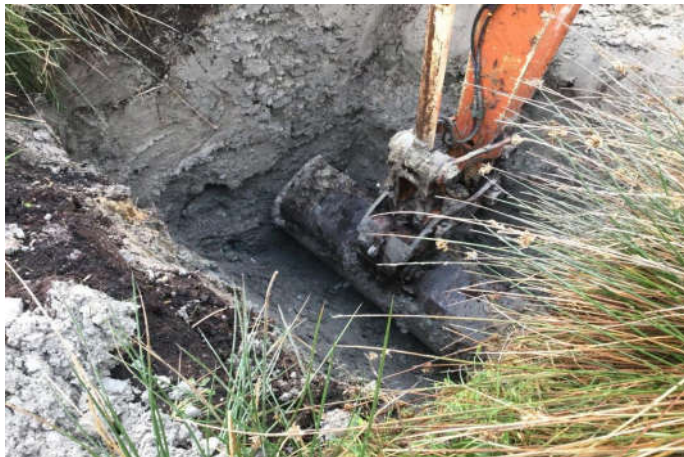
Borrow Pit Assessment - Trial Pits			
Project title	Derryadd Wind Farm	Job number	10325
Client	Bord na Mona	File reference	TP/BP Dec 2017
Prepared by	John Dillon	Date	13th March 2018
Subject	Ground investigation (Trial Pits)		
	IMT		
Site Location:	Derryadd		
Trial Pit No:	BP20		
Date & Time:	5th Dec 2017		
BP Testing details:			
	The following layers were observed in this Trial Pit:		
	0.00 – 0.30 m: black organic peat		
	0.3– 2.5 m: Light grey/olive, soft, slightly sandy, gravelly CLAY. Cobbles SR . Obstruction at		
	Possible Bedrock or Obstruction at 2.5m		
Observations & recommendations:	Water inflow at base of peat and in the base of trial pit		
	Relatively firm surface.		
	Walls of trial pit slightly unstable and crumbling

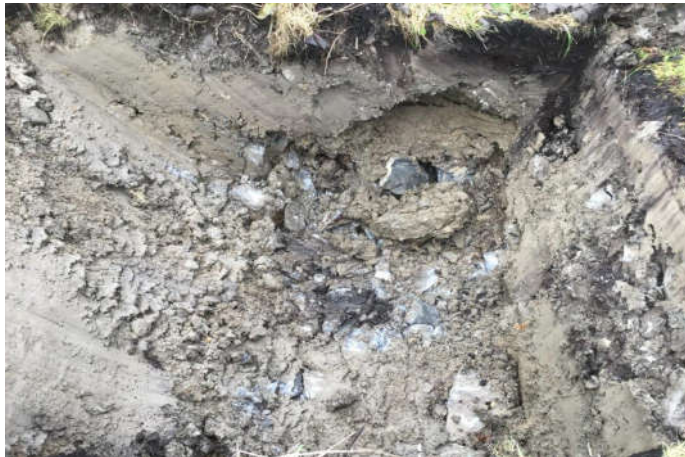
Borrow Pit Assessment - Trial Pits			
Project title	Derryadd Wind Farm	Job number	10325
Client	Bord na Mona	File reference	TP/BP Dec 2017
Prepared by	John Dillon	Date	13th March 2018
Subject	Ground investigation (Trial Pits)		
	IMT		
Site Location:	Derryadd		
Trial Pit No:	BP21		
Date & Time:	5th Dec 2017		
BP Testing details:			
	The following layers were observed in this Trial Pit:		
	0.00 – 0.10 m: Black organic peat		
	0.1 – 0.80 m: Light grey/olive, very soft, slightly sandy, gravelly SILT/CLAY.		
	Trial pit terminated at 0.8 due to bedrock		
Observations & recommendations:	Trial pit collapsing - water inflows from the base of trial pit		
	· Relatively firm surface.		
	· Walls of trial pit slightly unstable and crumbling

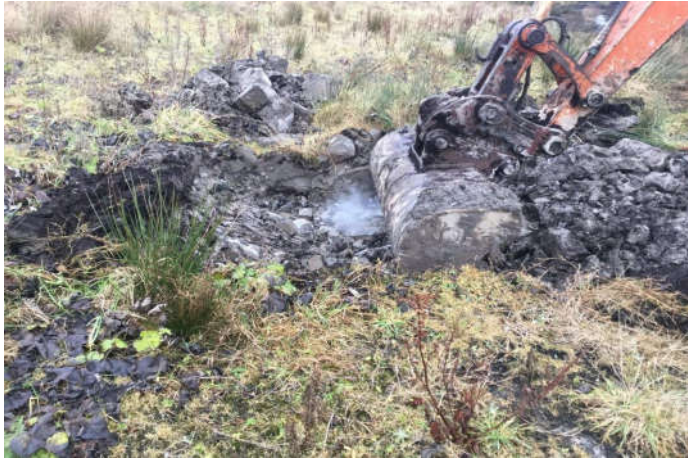
Borrow Pit Assessment - Trial Pits			
Project title	Derryadd Wind Farm	Job number	10325
Client	Bord na Mona	File reference	TP/BP Dec 2017
Prepared by	John Dillon	Date	13th March 2018
Subject	Ground investigation (Trial Pits)		
	IMT		
Site Location:	Derryadd		
Trial Pit No:	BP12		
Date & Time:	5th Dec 2017		
BP Testing details:			
	The following layers were observed in this Trial Pit:		
	0.00 – 0.20 m: black organic peat		
	0.2 – 0.50 m: Weathered bedrock with regular angular blocks of pale grey,		
Observations & recommendations:	Dry - no major inflows		
	Relatively firm surface.		
	Walls of trial pit slightly unstable and crumbling

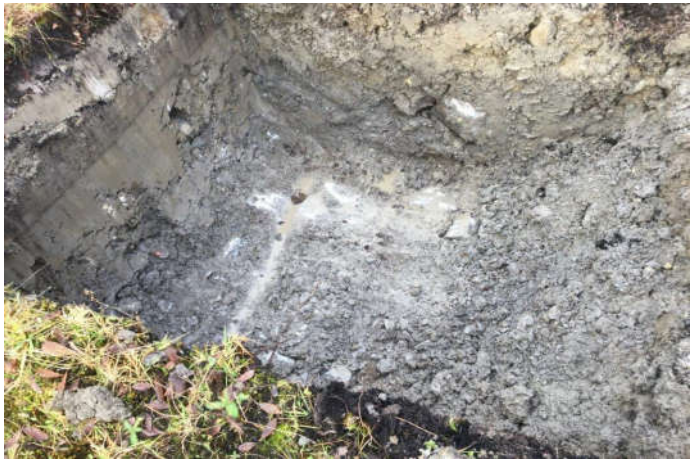
Borrow Pit Assessment - Trial Pits			
Project title	Derryadd Wind Farm	Job number	10325
Client	Bord na Mona	File reference	TP/BP Dec 2017
Prepared by	John Dillon	Date	13th March 2018
Subject	Ground investigation (Trial Pits)		
	IMT		
Site Location:	Derryadd		
Trial Pit No:	BP22		
Date & Time:	5th Dec 2017		
BP Testing details:			
	The following layers were observed in this Trial Pit:		
	0.00 – 0.3 m: Interbedded black and brown/red organic peat.		
	0.3 – 1.2 m: Very soft running sands and sandy gravelly silt/CLAY		
	1.2m - Bedrock and large water inflows		
	Trial pit terminated at 1.2 m due to abundance of large angular boulders & bedrock.		
Observations & recommendations:	Large water inflows		
	Relatively firm surface.		
	Walls of trial pit slightly unstable and crumbling

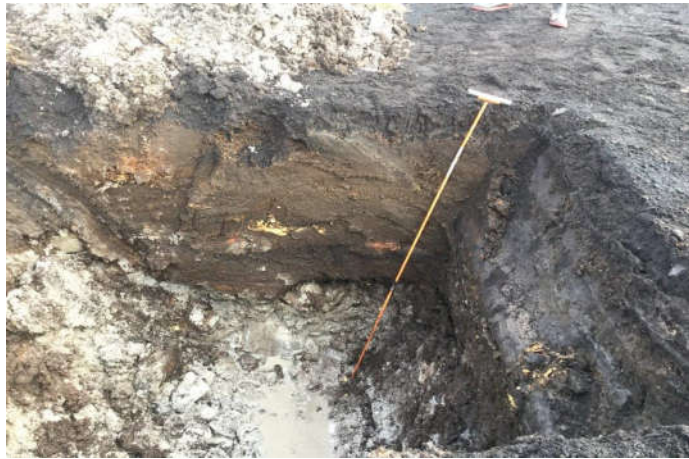
Borrow Pit Assessment - Trial Pits			
Project title	Derryadd Wind Farm	Job number	10325
Client	Bord na Mona	File reference	TP/BP Dec 2017
Prepared by	John Dillon	Date	13th March 2018
Subject	Ground investigation (Trial Pits)		
	IMT		
Site Location:	Derryadd		
Trial Pit No:	BP23		
Date & Time:	5th Dec 2017		
BP Testing details:			
	The following layers were observed in this Trial Pit:		
	0.00 – 0.3 m: Interbedded black and brown/red organic peat.		
	0.3 – 1.2 m: Very soft running sands and sandy gravelly silt/CLAY		
	1.2m - Bedrock and large water inflows		
	Trial pit terminated at 1.2 m due to abundance of large angular boulders & bedrock.		
Observations & recommendations:	Water inflows in the base of trial pit		
	Relatively firm surface.		
	Walls of trial pit slightly unstable and crumbling

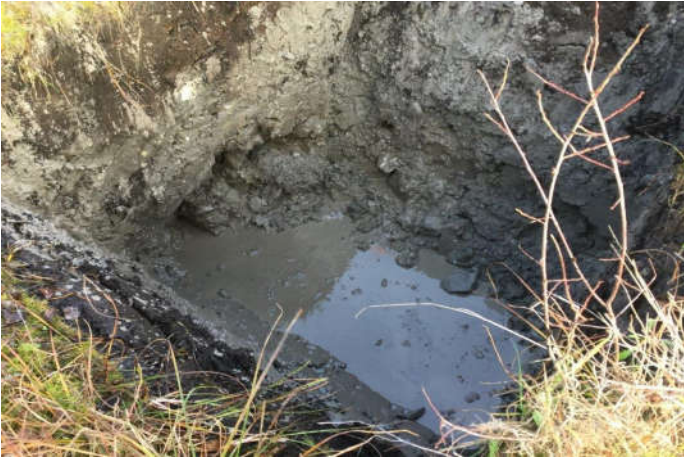
Borrow Pit Assessment - Trial Pits			
Project title	Derryadd Wind Farm	Job number	10325
Client	Bord na Mona	File reference	TP/BP Dec 2017
Prepared by	John Dillon	Date	13th March 2018
Subject	Ground investigation (Trial Pits)		
	IMT		
Site Location:	Derryadd		
Trial Pit No:	BP24		
Date & Time:	5th Dec 2017		
BP Testing details:			
	The following layers were observed in this Trial Pit:		
	0.00 – 1.1 m: Interbedded black and brown/red organic peat.		
	1.1 – 2.3 m: Very soft running sands and sandy gravelly silt/CLAY		
	2.2m - Bedrock and large water inflows		
	Trial pit terminated at 2.3 m due to abundance of large angular boulders & bedrock.		
Observations & recommendations:			
	Relatively firm surface.		
	Walls of trial pit slightly unstable and crumbling

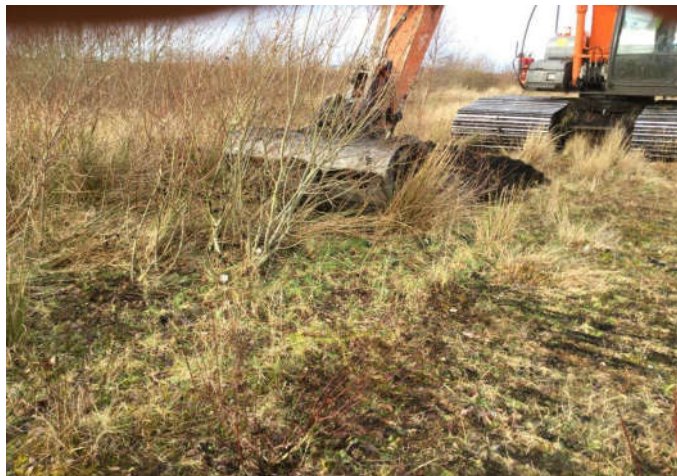
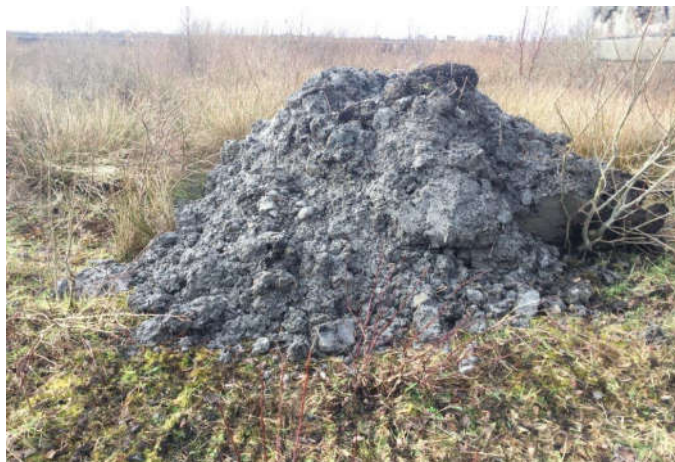
Borrow Pit Assessment - Trial Pits			
Project title	Derryadd Wind Farm	Job number	10325
Client	Bord na Mona	File reference	TP/BP Dec 2017
Prepared by	John Dillon	Date	13th March 2018
Subject	Ground investigation (Trial Pits)		
	IMT		
Site Location:	Derryadd		
Trial Pit No:	BP25		
Date & Time:	5th Dec 2017		
BP Testing details:			
	The following layers were observed in this Trial Pit:		
	0.00 – 0.3 m: Interbedded black and brown/red organic peat.		
	0.3 – 2.1 m: Light grey/ mid grey silty sandy GRAVEL - TP at this location		
	No Bedrock encountered - Obstruction at 2.1m		
	Trial pit terminated at 2.1 m due to large boulders		
Observations & recommendations:			
	Relatively firm surface.		
	Walls of trial pit slightly unstable and crumbling

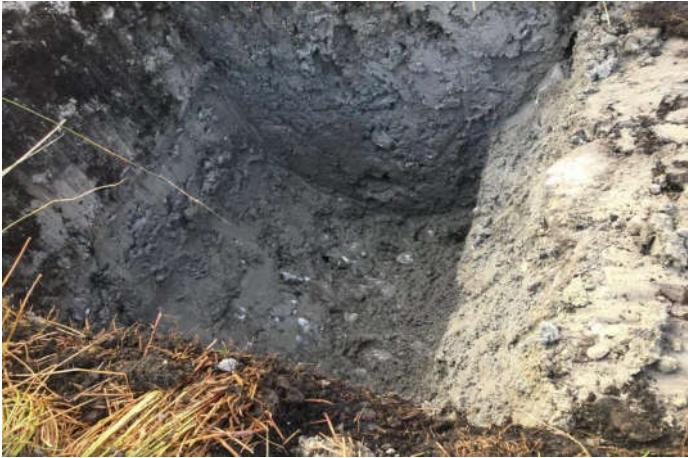
Borrow Pit Assessment - Trial Pits			
Project title	Derryadd Wind Farm	Job number	10325
Client	Bord na Mona	File reference	TP/BP Dec 2017
Prepared by	John Dillon	Date	13th March 2018
Subject	Ground investigation (Trial Pits)		
	IMT		
Site Location:	Derryadd		
Trial Pit No:	BP26		
Date & Time:	5th Dec 2017		
BP Testing details:			
	The following layers were observed in this Trial Pit:		
	0.00 – 0.4 m: Interbedded black and brown/red organic peat.		
	0.4-2 m: Light grey/ mid grey silty sandy GRAVEL - TP at this location		
	2 m- obstruction at 2m		
	Trial pit terminated at 2 m due to abundance of large angular boulders & bedrock.		
Observations & recommendations:			
	Relatively firm surface.		
	Walls of trial pit slightly unstable and crumbling

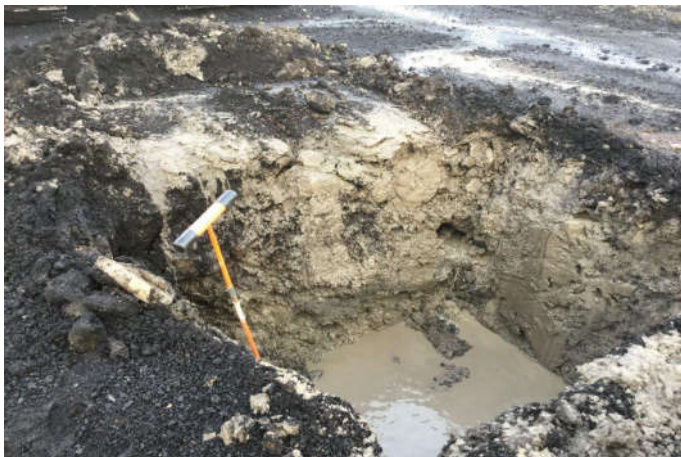
Borrow Pit Assessment - Trial Pits			
Project title	Derryadd Wind Farm	Job number	10325
Client	Bord na Mona	File reference	TP/BP Dec 2017
Prepared by	John Dillon	Date	13th March 2018
Subject	Ground investigation (Trial Pits)		
	IMT		
Site Location:	Derryadd		
Trial Pit No:	BP27		
Date & Time:	5th Dec 2017		
BP Testing details:			
	The following layers were observed in this Trial Pit:		
	0.00 – 0.6 m: Interbedded black and brown/red organic peat.		
	0.6– 1.7 m: Very soft running sands and sandy gravelly silt/CLAY		
	1.7m - Bedrock and large water inflows		
	Trial pit terminated at 1.7 m due to abundance of large angular boulders & bedrock.		
Observations & recommendations:	Large inflow at 1.7m		
	Relatively firm surface.		
	Walls of trial pit slightly unstable and crumbling

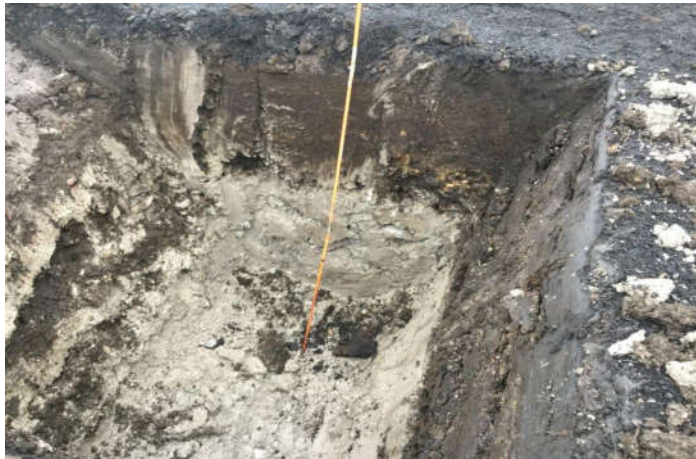
Borrow Pit Assessment - Trial Pits			
Project title	Derryadd Wind Farm	Job number	10325
Client	Bord na Mona	File reference	TP/BP Dec 2017
Prepared by	John Dillon	Date	13th March 2018
Subject	Ground investigation (Trial Pits)		
	IMT		
Site Location:	Derryadd		
Trial Pit No:	BP28		
Date & Time:	5th Dec 2017		
BP Testing details:			
	The following layers were observed in this Trial Pit:		
	0.00 – 0.8 m: Interbedded black and brown/red organic peat.		
	0.8– 2.3m: Very soft sandy gravelly silt/CLAY		
	2.3m - Large cobbles and angular bedrock at 2.3m. Possible bedrock		
	Trial pit terminated at 2.3 m due to abundance of large angular boulders & bedrock.		
Observations & recommendations:	Minor inflow at base of trial pit		
	Relatively firm surface.		
	Walls of trial pit slightly unstable and crumbling

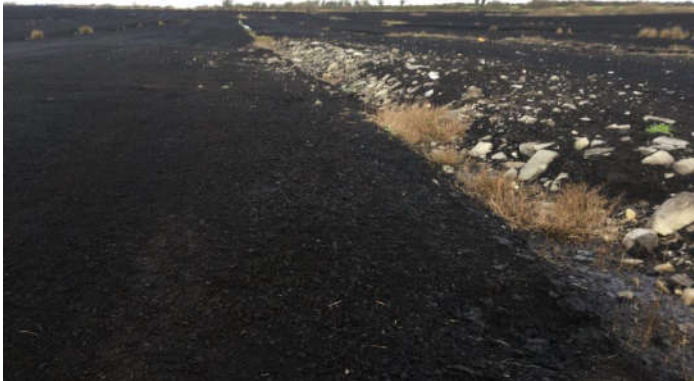
Borrow Pit Assessment - Trial Pits			
Project title	Derryadd Wind Farm	Job number	10325
Client	Bord na Mona	File reference	TP/BP Dec 2017
Prepared by	John Dillon	Date	13th March 2018
Subject	Ground investigation (Trial Pits)		
	IMT		
Site Location:	Derryadd		
Trial Pit No:	BP29		
Date & Time:	5th Dec 2017		
BP Testing details:			
	The following layers were observed in this Trial Pit:		
	0.00 – 0.2 m: Interbedded black and brown/red organic peat.		
	0.2m - Large Bedrock outcrop and exposure at this location		
Observations & recommendations:	Rock at surface		
	Minor inflows at the base of trial pit

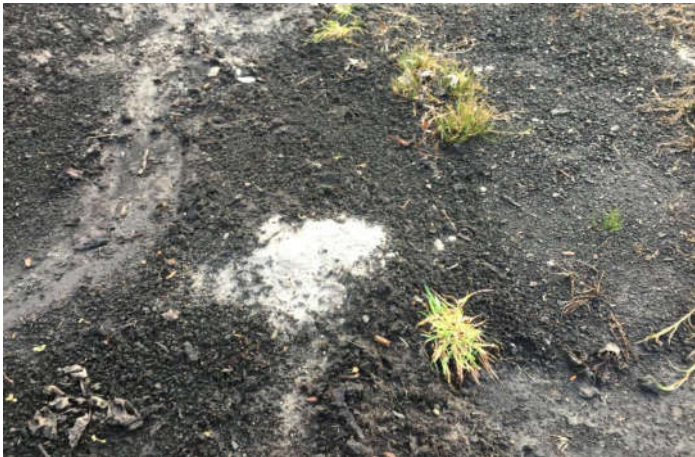
Borrow Pit Assessment - Trial Pits			
Project title	Derryadd Wind Farm	Job number	10325
Client	Bord na Mona	File reference	TP/BP Dec 2017
Prepared by	John Dillon	Date	13th March 2018
Subject	Ground investigation (Trial Pits)		
	IMT		
Site Location:	Derryadd		
Trial Pit No:	BP30		
Date & Time:	5th Dec 2017		
BP Testing details:			
	The following layers were observed in this Trial Pit:		
	0.00 – 0.2 m: Interbedded black and brown/red organic peat.		
	0.2m - Large Bedrock outcrop and exposure at this location		
Observations & recommendations:	Rock at surface		
	No inflows

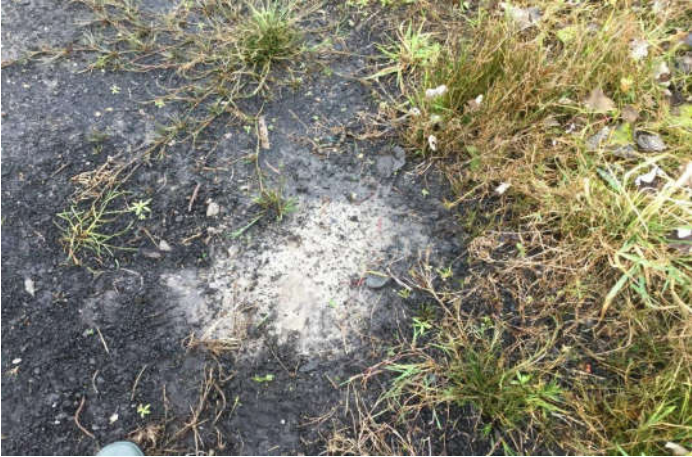
Borrow Pit Assessment - Trial Pits			
Project title	Derryadd Wind Farm	Job number	10325
Client	Bord na Mona	File reference	TP/BP Dec 2017
Prepared by	John Dillon	Date	13th March 2018
Subject	Ground investigation (Trial Pits)		
	IMT		
Site Location:	Derryadd		
Trial Pit No:	BP31		
Date & Time:	5th Dec 2017		
BP Testing details:			
	The following layers were observed in this Trial Pit:		
	0.00 – 0.2 m: Interbedded black and brown/red organic peat.		
	0.2m - Large Bedrock outcrop and exposure at this location		
Observations & recommendations:	Rock at surface		
	No inflows
