Borrow Pit Assessment	- Trial Pits			7		
				PEAT		
Project title	Derryadd Wind Farm	Job number	10325	MARL		
Client	Bord na Mona	File reference	TP -Turbine locations Mar 18	TILL		
Prepared by	John Dillon	Date	27th March 2018	BEDROCK		
Subject	Ground investigation (Trial	Pits)	•	Possible BEDRO		
,	ITM	/		Archaeology		
Site Location:	Derryadd					
Trial Pit No:		TP18-1				
Date & Time:	27th March 2018					
BP Testing details:						
8	The follow:	ing layers were observed	d in this Trial Pit:	_

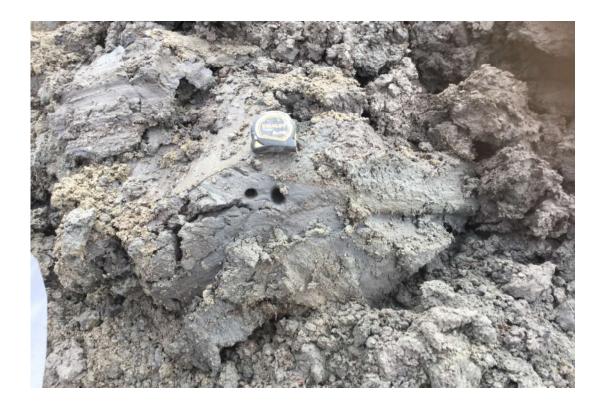
0.00 – 0.1 m: S	hallow Black fibrous	PEAT with rootlets			
	0.7 – 2.0 m: Light grev r	noist, moderately Firm	slightly sandy, gravelly CLAY.			
	2.0-2.9 m: Light grey moderat	telv firm verv silty sligh	tly sandy GRAVEL with significant	t

2.0-2.9 m: Light grey moderately firm very silty, slightly sandy GRAVEL with significant amount of gravel, cobbles and boulders.				
	Trial pit terminate	ed at 2.9m due to abund	ance of large boulders.	1		
Observations &		No water present				
recommendations:		F				
		 Relatively firm su 	ırface.			
		· Walls of trial pit	stable			
		1				
				1

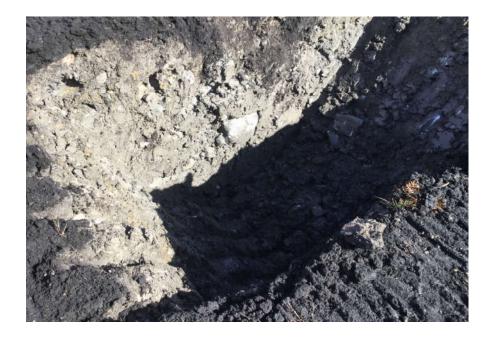
0.00 – 0.1 m: S	hallow Black fibrous	PEAT with rootlets			
	0.2 – 0.50 m [·] I	ight grev soft slightly s	andy gravelly CLAY			
		0.2 – 0.50 m: Light grey, soft, slightly sandy, gravelly CLAY 0.5m – 2.7 m: Light grey mod firm slightly sandy silty CLAY with significant amount of				
		gravel, cobbles and bou				
		Statel, cobbies and bod				
	Trial pit terminate	ed at 2.7m due to abund	ance of large boulders.			
Observations &		No				
recommendations:		No water present				
recommendations:						
		· Relatively firm su	unfança			
		Walls of trial pit				
		· waiis of trial pit	stable			
	I

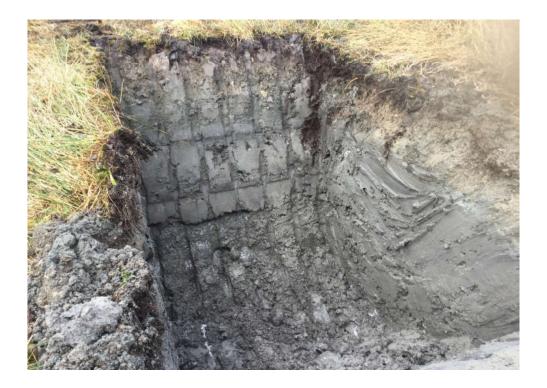
0.00 – 0.3 m: S	hallow Black fibrous	PEAT with rootlets			
	0.3m – 0.8 m	0.3m – 0.8 m : Light grey moderately dense silty SAND.				
	0.8-2.2m; Moist, soft,					
	······, ····, ····,					
	Possible bedrock at 2.2m			-

-		
	Trial pit terminated at	2.2m due to abundance	of large boulders/bedrock.			
Observations & recommendations:		No water present				
		· Relatively firm su	rface.	-		
		· Walls of trial pit	stable	1

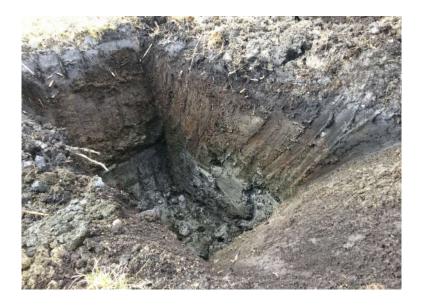
Borrow Pit Assessment -	- Trial Pits			
				PEAT
Project title	Derryadd Wind Farm	Job number	10325	MARL
Client	Bord na Mona	File reference	TP -Turbine locations Mar 18	TILL
Prepared by	John Dillon	Date	28th March 2018	BEDROCK
Subject	Ground investigation (Trial I	Pits)		Possible BEDROC
	IMT	Derryadd		Archaeology
Site Location:				
Trial Pit No:		TP18-4		
Date & Time:	28th March 2018			
BP Testing details:				
0	The following	ing layers were observed	l in this Trial Pit:	
	0.00 – 1.6 m: l	Black/brown fibrous	PEAT - H4 to H6	
	1.6-3 m: Light grey, soft, v			
	Trial pit te	rminated at 3m due to p	oossiblebedrock.	
Observations &	Mir	nor water inflows at bas	e present	
recommendations:				
		· Relatively firm su	rface.	
		· Walls of trial pit	stable

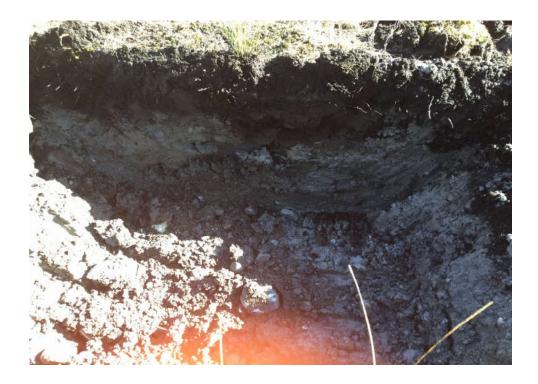
0.00 – 0.1 m: S	Shallow Black fibrous	PEAT with rootlets			
	0.1 – 1.3 m. Light grey soft y	0.1 – 1.3 m : Light grey, soft, very sandy, gravelly SILT. Occasional sand lens between 1.0				
		ery sundy, gravery sing		-		
				4		
	Trial 1	pit terminated at 1.3 due	to bedrock			
	,					
Observations &		No water present				
recommendations:						
		D.1.1.7	<u>,</u>	-		
		Relatively firm su		-		
		· Walls of trial pit	stable
